Expertise

Protocol number: 46002240
Order No. / Reference: 26260896
Inspection date: 16 Jun 2026

Model: 317 CDI Sprinter Standard HA 9G-TRONIC

VIN: W1V9076331P402832

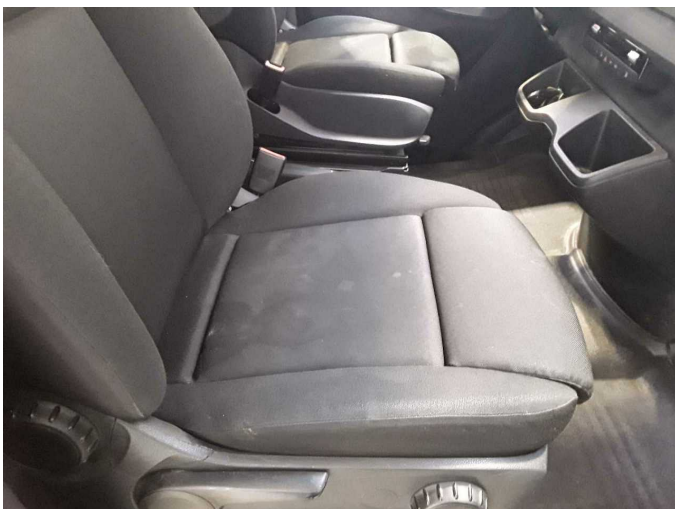
Damage 1: Seat - front: Seat cover - right side - Soiled - Clean

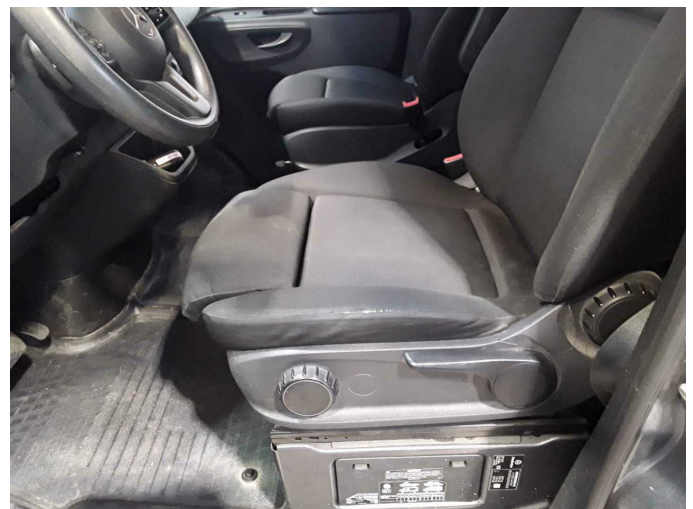
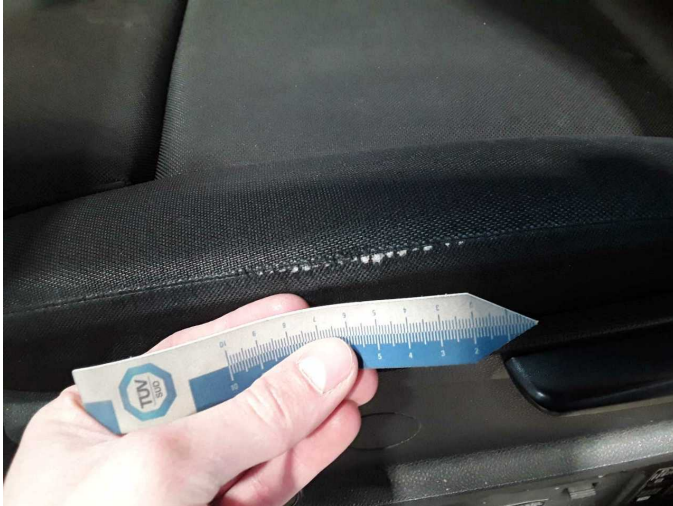
Damage 3: Seat - front: Seat cover - left side - Broken / torn - Replace

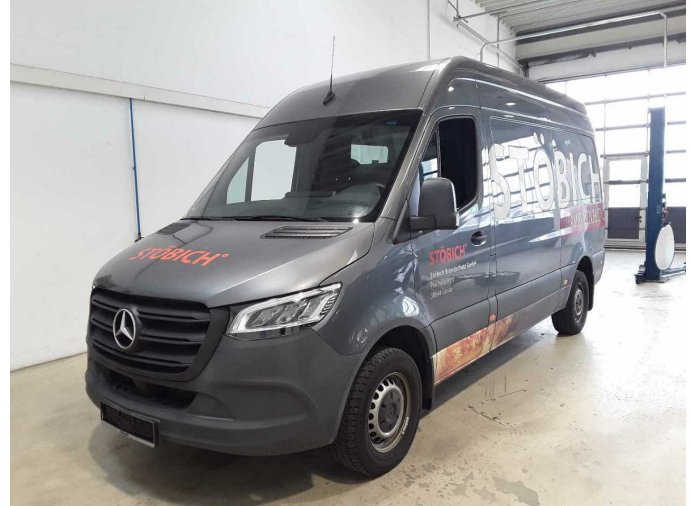
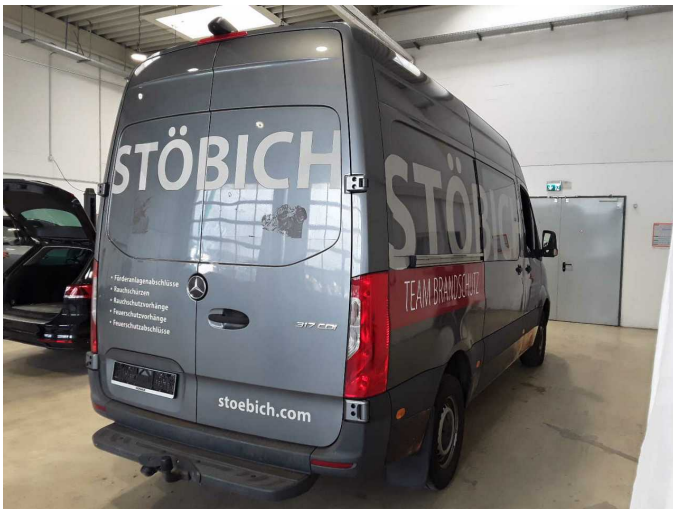
Damage 4: Body: Body - Glued / labelled - De-glug / neutralise

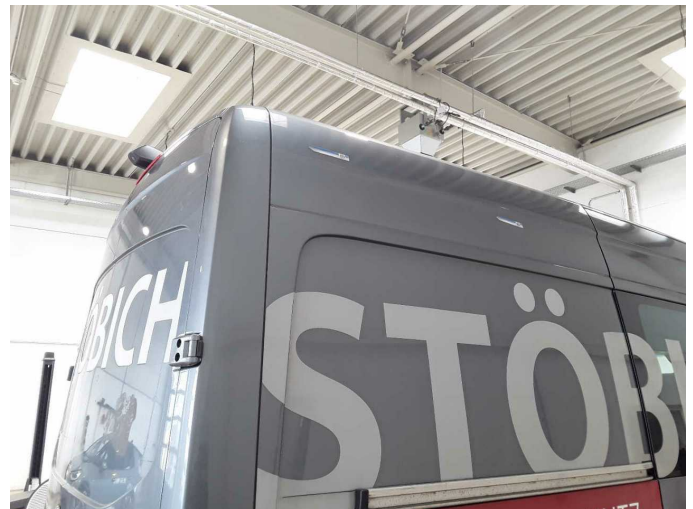
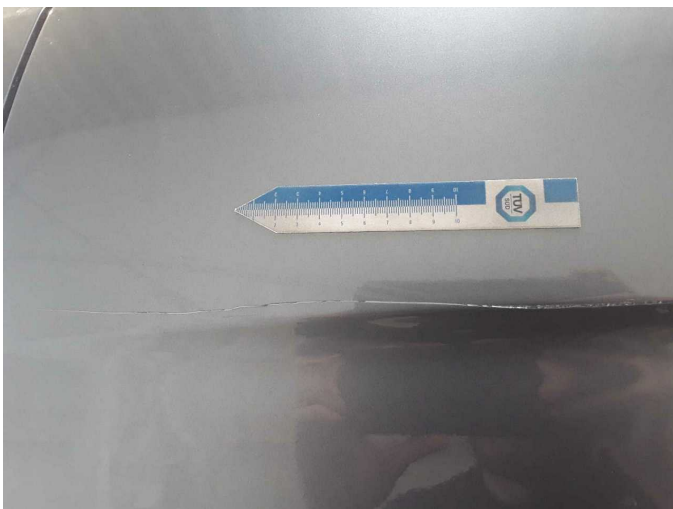
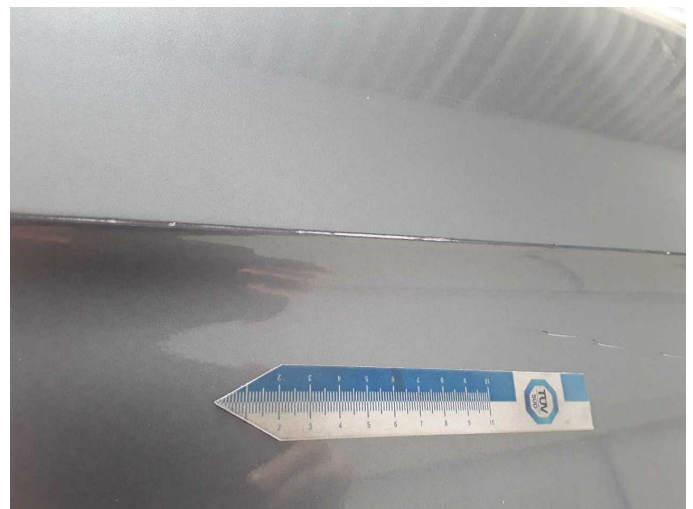
Damage 5: Side panel - rear right side: Side panel - Scratch(es) - Paint
