Expertise

Protocol number: 46864235  
Order No. / Reference: 26776811  
Inspection date: 3 Aug 2026

| Manufacturer: Opel | Model: Astra 1.5 D Start/Stop Sports Tourer Automatik Elegance |
| VIN: W0VBE8EV6N8039834 | |

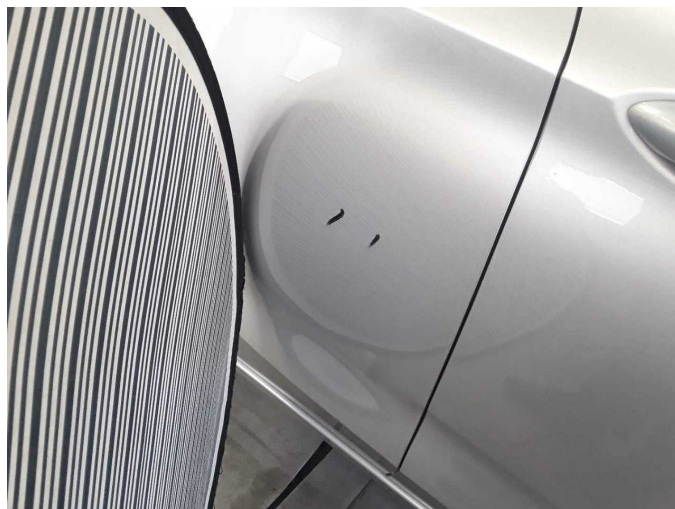
| No. | Component group | Description |
|---|---|---|
| 1 | Door - front right side | Door - dent(s) - Smooth repair work |

**Damage 1:** Door - front right side: Door - dent(s) - Smooth repair work

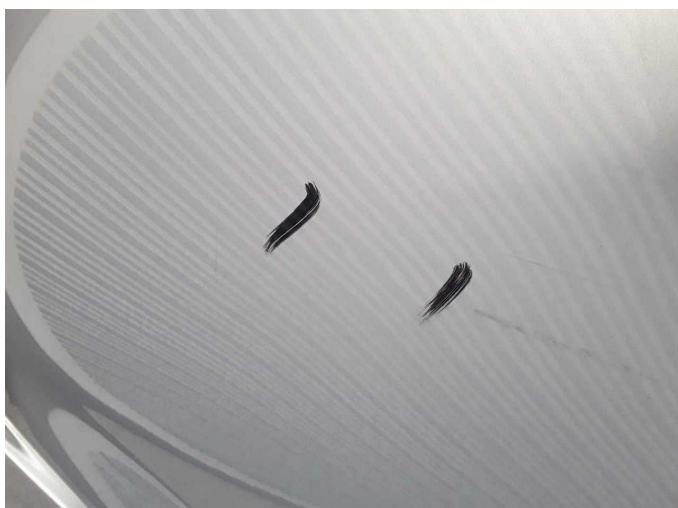
**Damage 1:** Door - front right side: Door - dent(s) - Smooth repair work

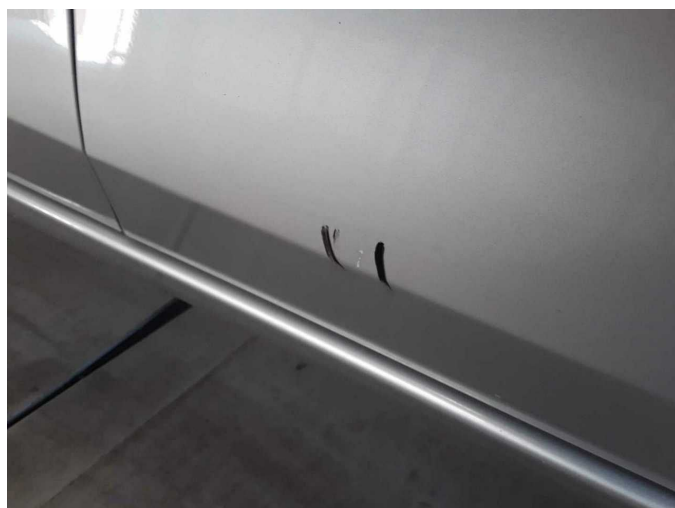
| No. | Component group | Description |
|---|---|---|
| 2 | Door - front right side | Door - Scratch(es) - Smart repair |

**Damage 2:** Door - front right side: Door - Scratch(es) - Smart repair

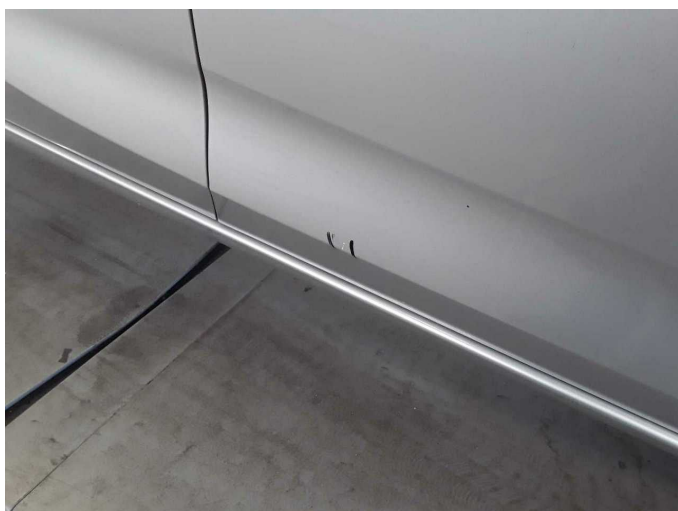
**Damage 2:** Door - front right side: Door - Scratch(es) - Smart repair

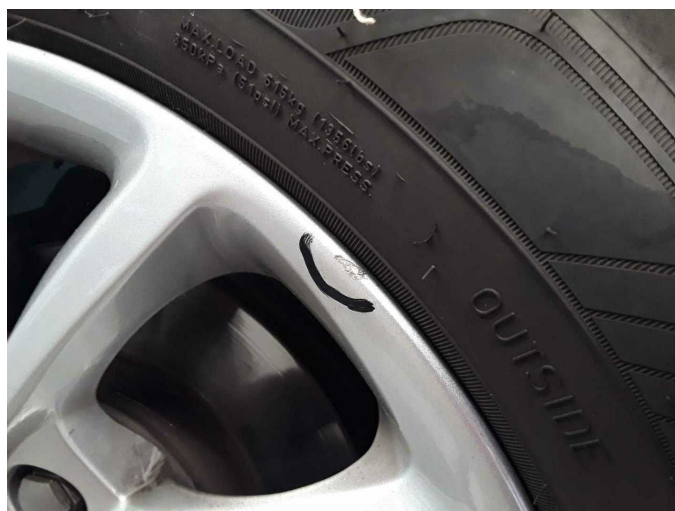
| No. | Component group | Description |
|---|---|---|
| 3 | Wheel / tyres | Alloy rim - front left side - Scratch(es) - Smart repair |

**Damage 3:** Wheel / tyres: Alloy rim - front left side - Scratch(es) - Smart repair

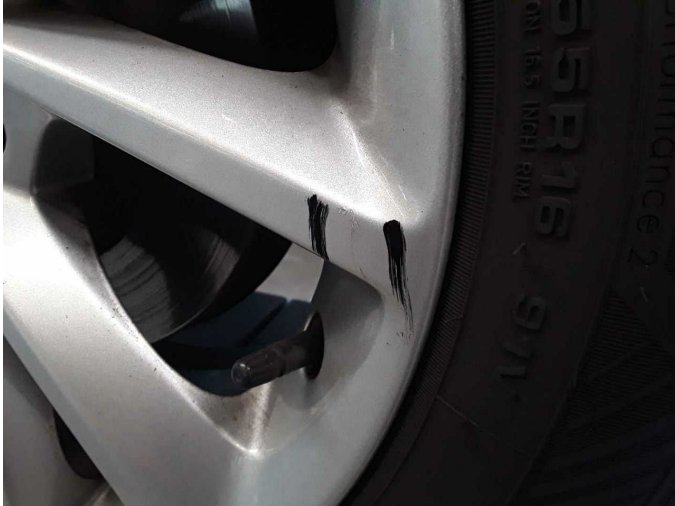
**Damage 3:** Wheel / tyres: Alloy rim - front left side - Scratch(es) - Smart repair

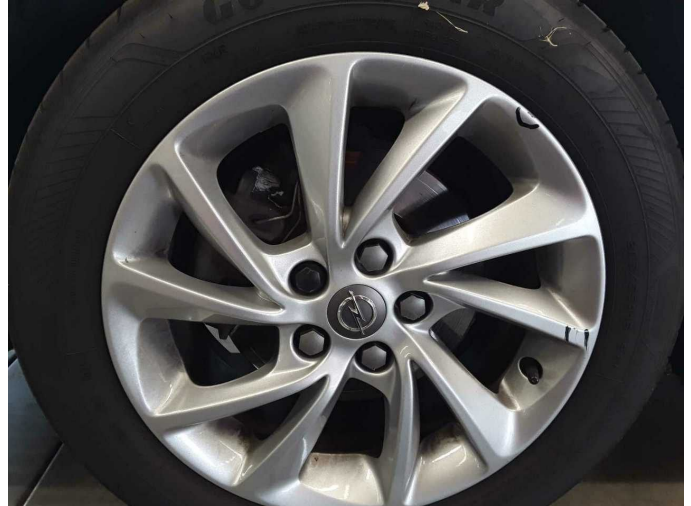
**Damage 3:** Wheel / tyres: Alloy rim - front left side - Scratch(es) - Smart repair

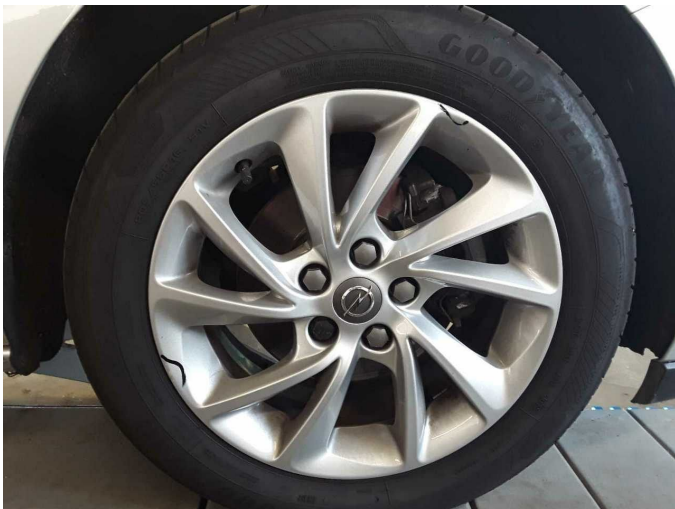
| No. | Component group | Description |
|---|---|---|
| 4 | Wheel / tyres | Alloy rim - front right side - Scratch(es) - Smart repair |

**Damage 4:** Wheel / tyres: Alloy rim - front right side - Scratch(es) - Smart repair

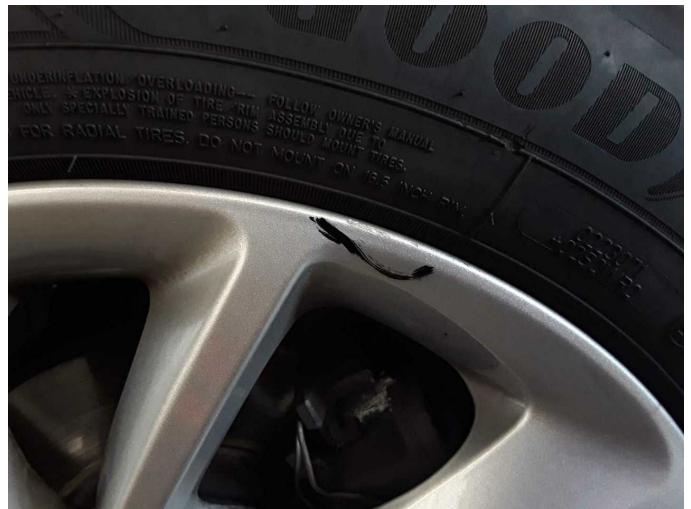
**Damage 4:** Wheel / tyres: Alloy rim - front right side - Scratch(es) - Smart repair

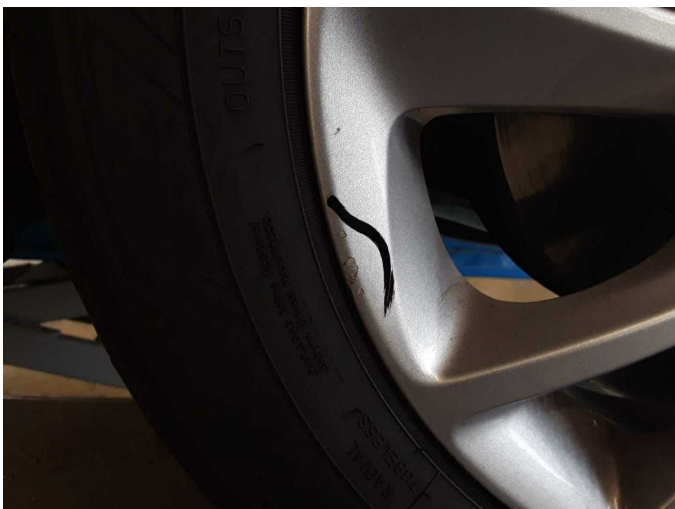
**Damage 4:** Wheel / tyres: Alloy rim - front right side - Scratch(es) - Smart repair

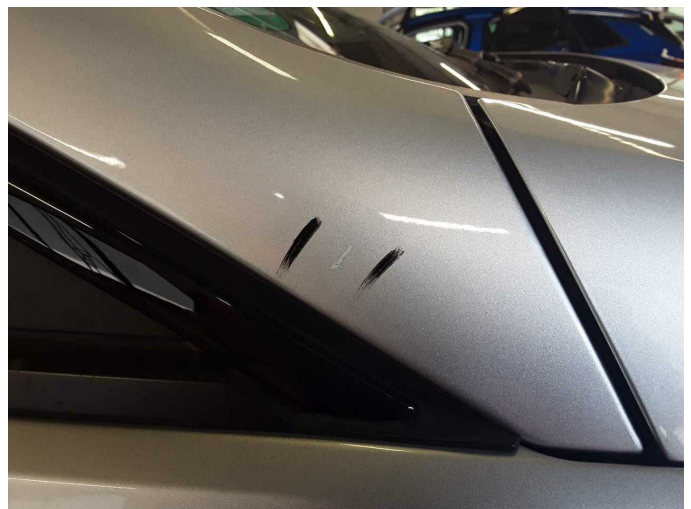
| No. | Component group | Description |
|---|---|---|
| 5 | Body | A-pillar - right side - Scratch(es) - Smart repair |

**Damage 5:** Body: A-pillar - right side - Scratch(es) - Smart repair

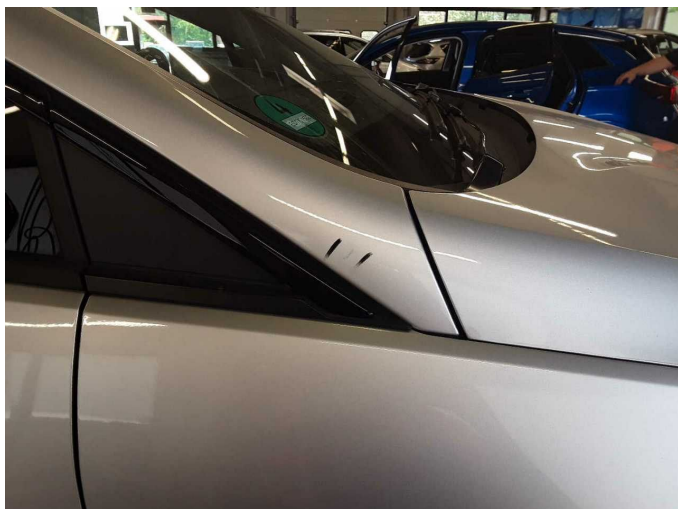
**Damage 5:** Body: A-pillar - right side - Scratch(es) - Smart repair

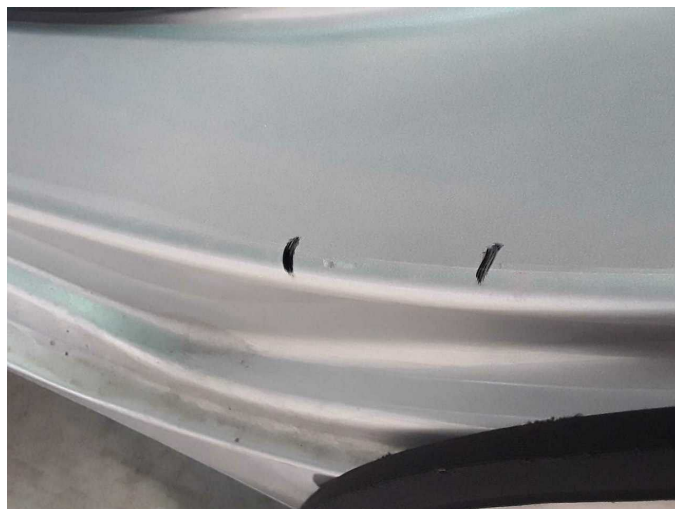
| No. | Component group | Description |
|---|---|---|
| 6 | Side panel - rear left side | Elbow - Scratched - Paint |

**Damage 6:** Side panel - rear left side: Elbow - Scratched - Paint

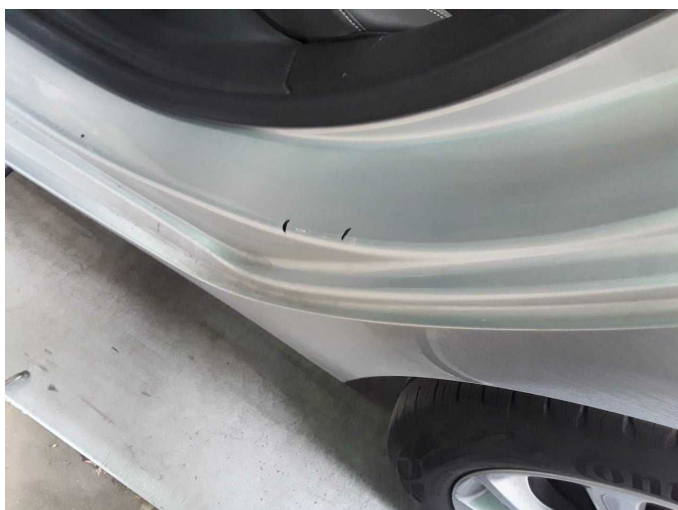
**Damage 6:** Side panel - rear left side: Elbow - Scratched - Paint

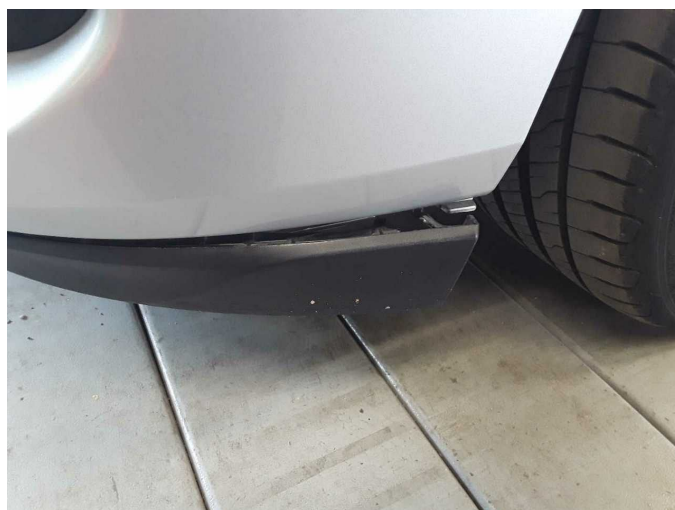
| No. | Component group | Description |
|---|---|---|
| 7 | Front bumper | Spoiler - Scratched - Replace |

**Damage 7:** Front bumper: Spoiler - Scratched - Replace

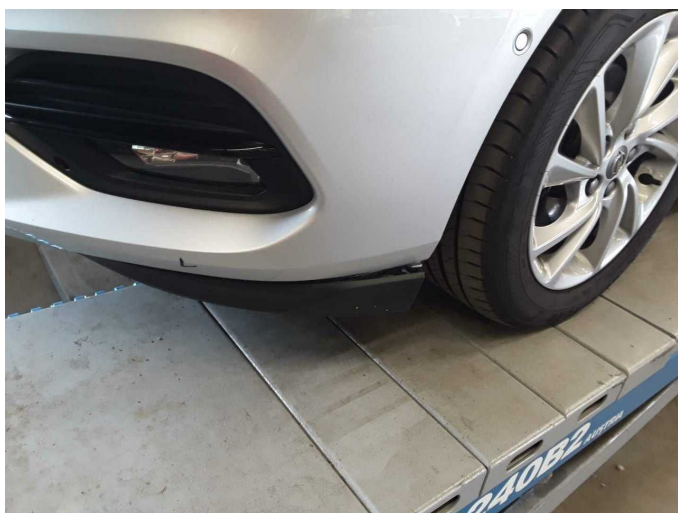
**Damage 7:** Front bumper: Spoiler - Scratched - Replace

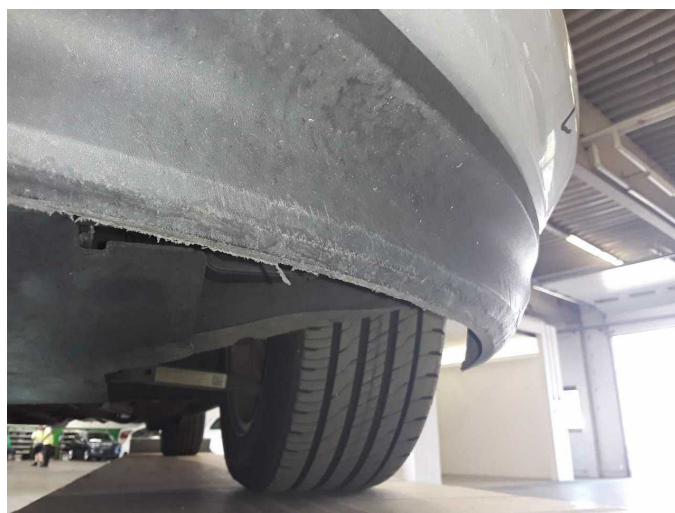
**Damage 7:** Front bumper: Spoiler - Scratched - Replace

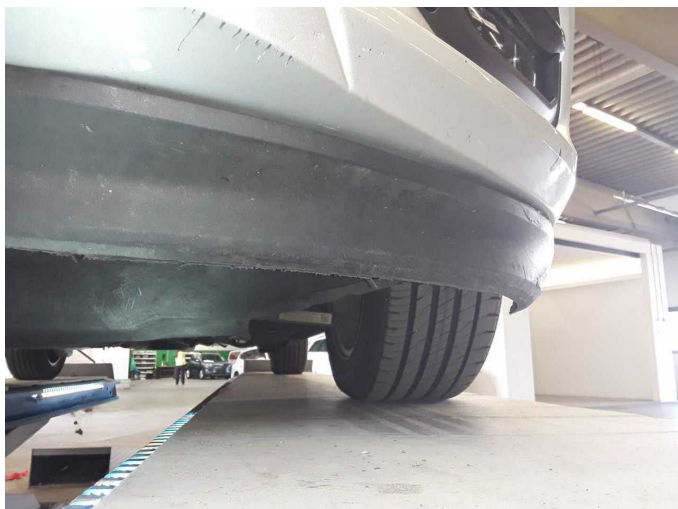
**Damage 7:** Front bumper: Spoiler - Scratched - Replace

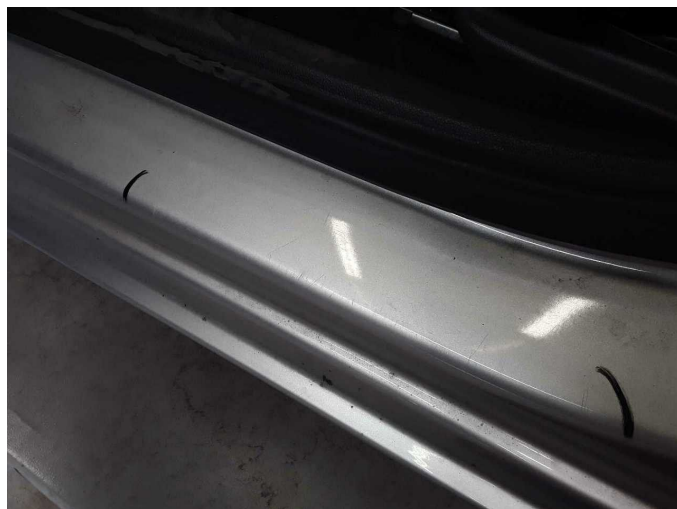
| No. | Component group | Description |
|---|---|---|
| 8 | Sill - left side | Sill (Einstieg Tür vorn links) - Scratch(es) - Paint |

**Damage 8:** Sill - left side: Sill (Einstieg Tür vorn links) - Scratch(es) - Paint

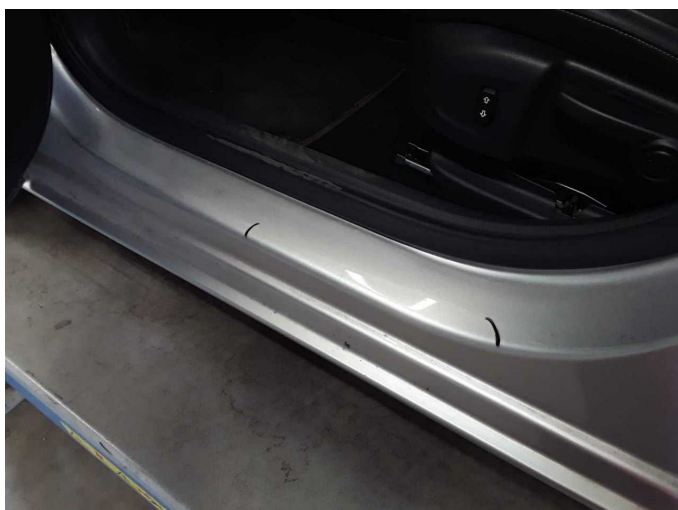
**Damage 8:** Sill - left side: Sill (Einstieg Tür vorn links) - Scratch(es) - Paint

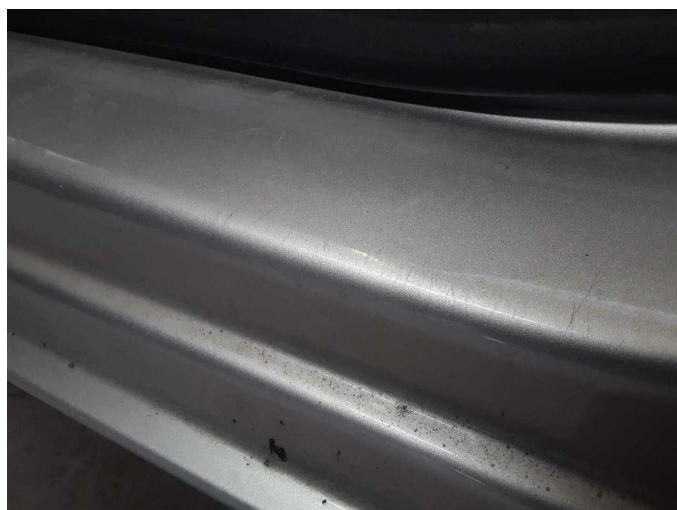
**Damage 8:** Sill - left side: Sill (Einstieg Tür vorn links) - Scratch(es) - Paint

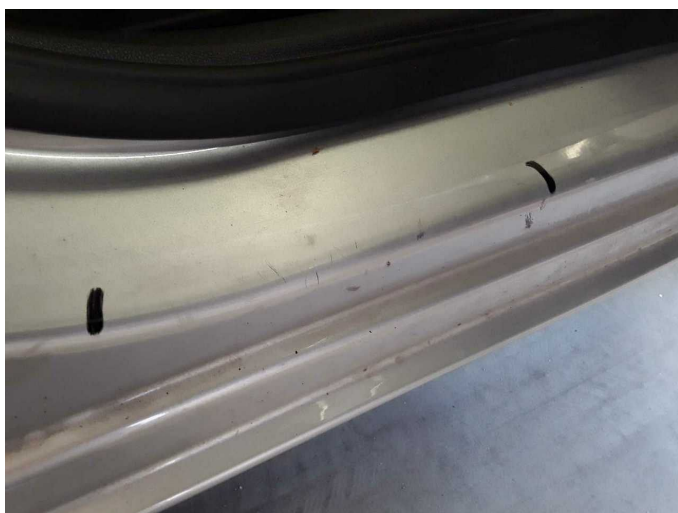
| No. | Component group | Description |
|---|---|---|
| 9 | Sill - right side | Sill (Einstieg vorn rechts) - Scratch(es) - Paint |

**Damage 9:** Sill - right side: Sill (Einstieg vorn rechts) - Scratch(es) - Paint

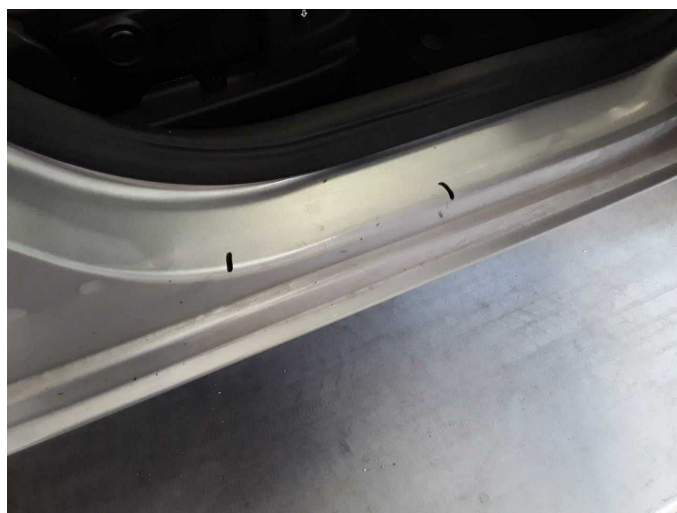
**Damage 9:** Sill - right side: Sill (Einstieg vorn rechts) - Scratch(es) - Paint

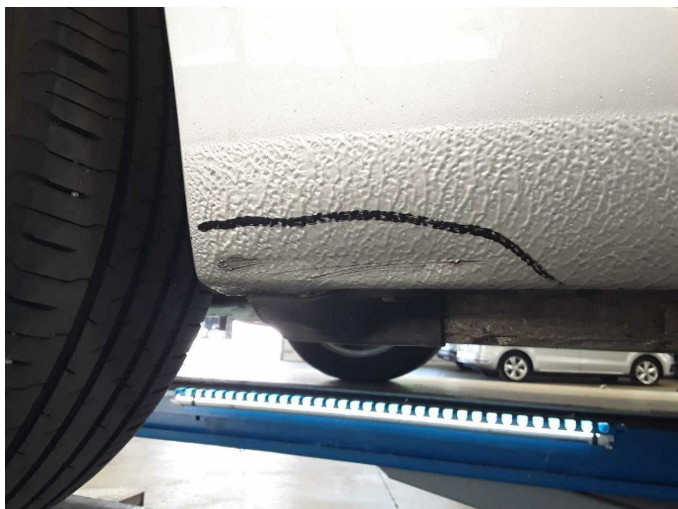
| No. | Component group | Description |
|---|---|---|
| 10 | Sill - right side | Sill - Scratched - Repair and paint |

**Damage 10:** Sill - right side: Sill - Scratched - Repair and paint

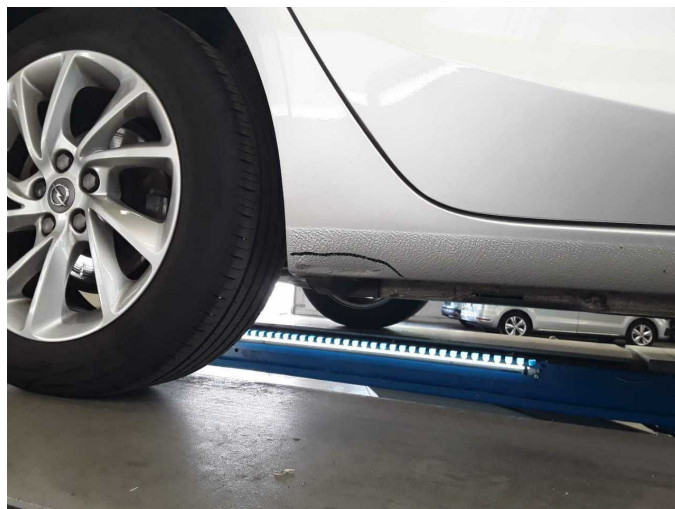
**Damage 10:** Sill - right side: Sill - Scratched - Repair and paint

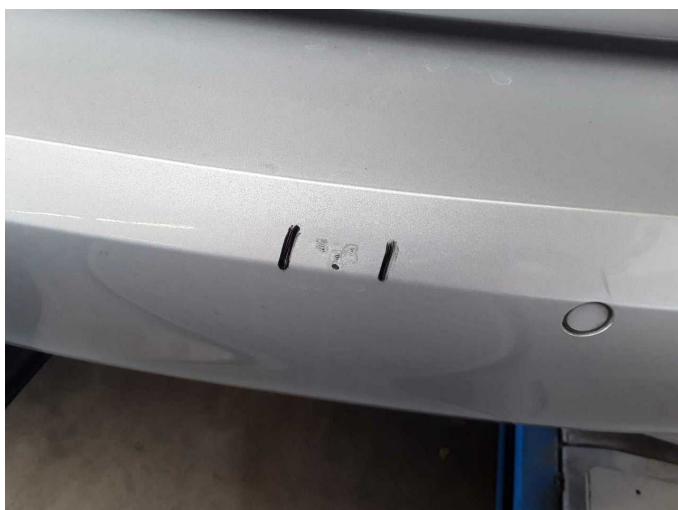
| No. | Component group | Description |
|---|---|---|
| 11 | Rear bumper | Rear bumper - Scratched - Paint |

**Damage 11:** Rear bumper: Rear bumper - Scratched - Paint

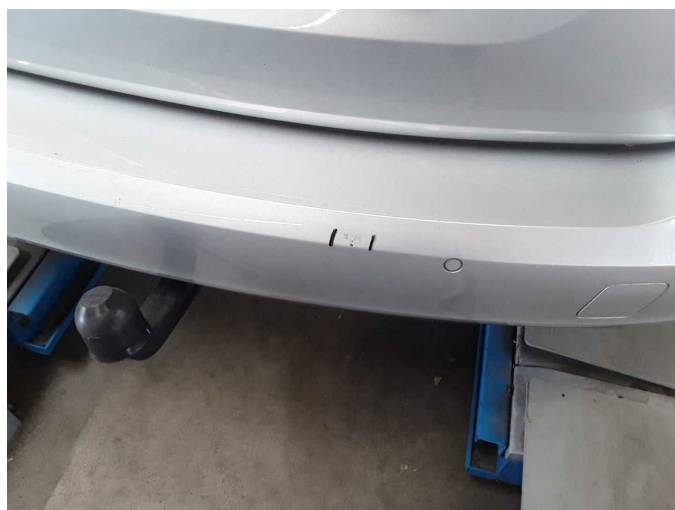
**Damage 11:** Rear bumper: Rear bumper - Scratched - Paint

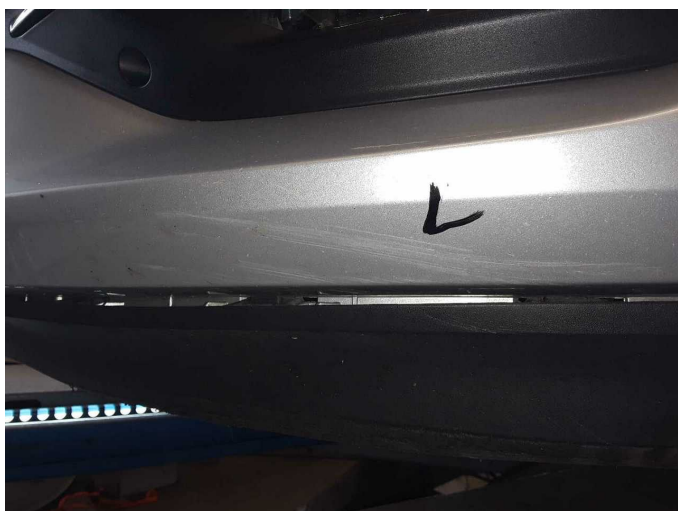
| No. | Component group | Description |
|---|---|---|
| 12 | Front bumper | Front bumper - Scratched - Paint |

**Damage 12:** Front bumper: Front bumper - Scratched - Paint

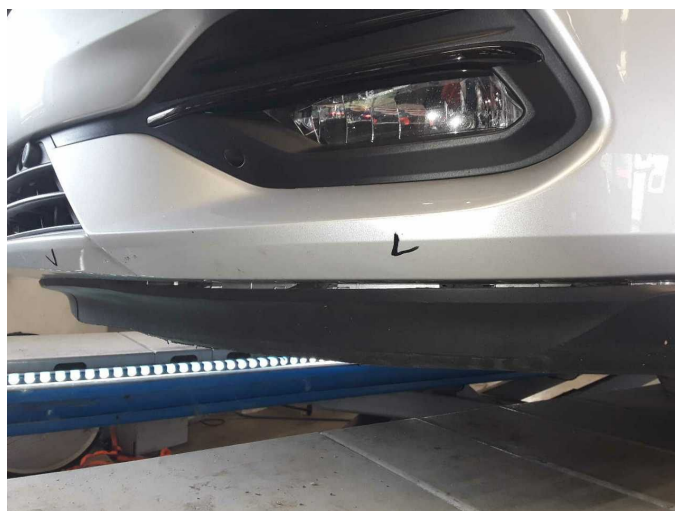
**Damage 12:** Front bumper: Front bumper - Scratched - Paint

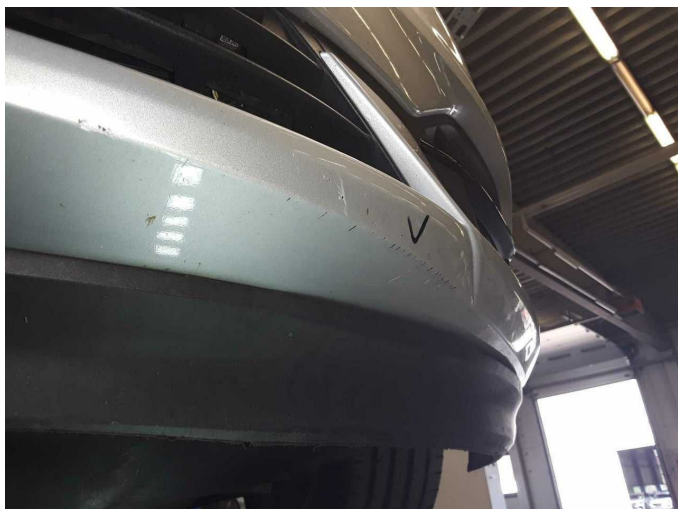
**Damage 12:** Front bumper: Front bumper - Scratched - Paint

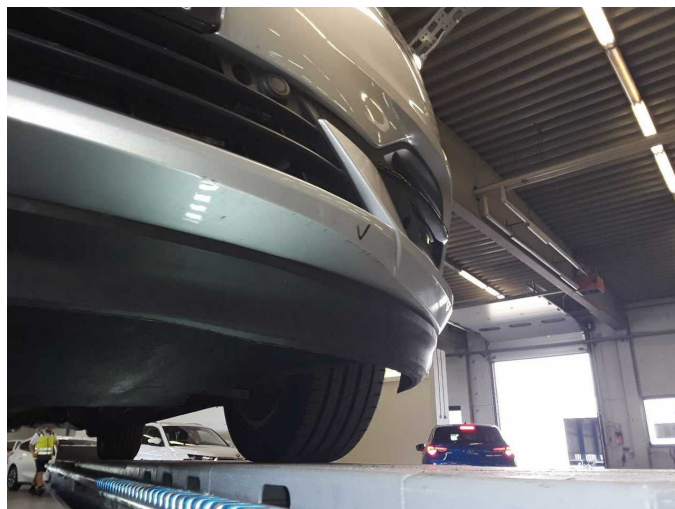
**Damage 12:** Front bumper: Front bumper - Scratched - Paint

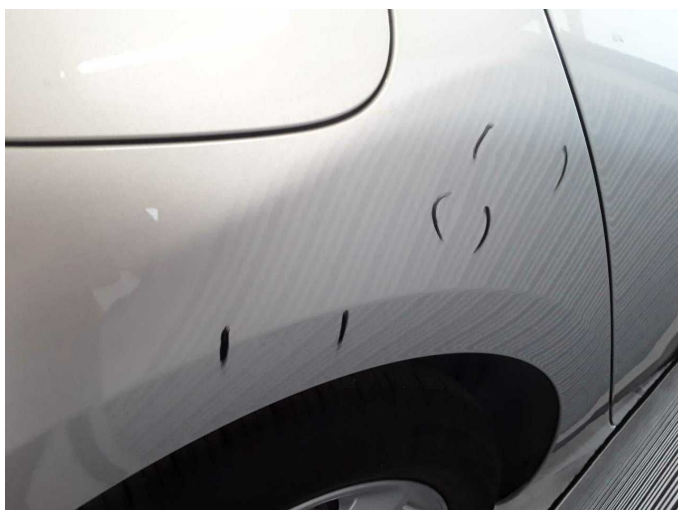
| No. | Component group | Description |
|---|---|---|
| 13 | Side panel - rear right side | Side panel - Dent / paintcoat damage - Repair and paint |

**Damage 13:** Side panel - rear right side: Side panel - Dent / paintcoat damage - Repair and paint

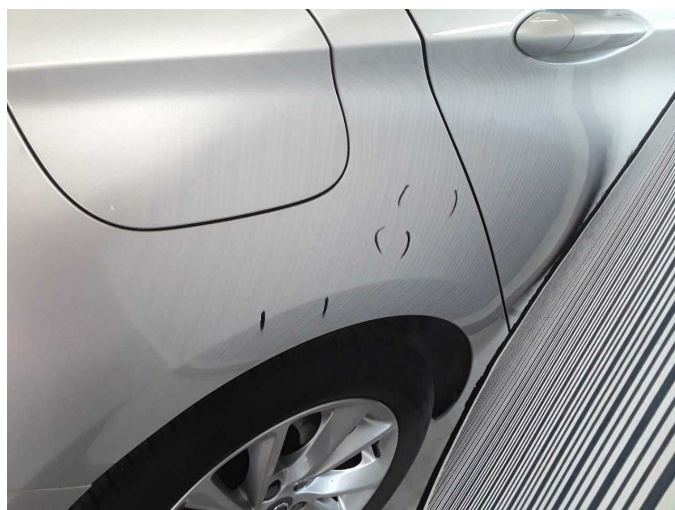
**Damage 13:** Side panel - rear right side: Side panel - Dent / paintcoat damage - Repair and paint

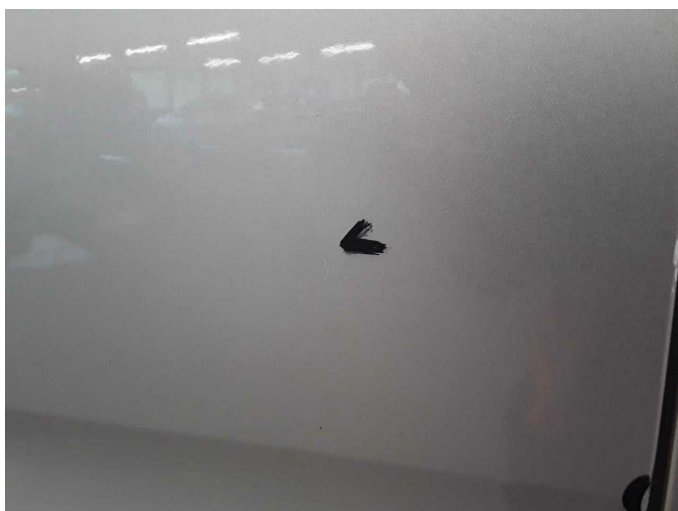
| No. | Component group | Description |
|---|---|---|
| 14 | Door - front left side | Door - Scratch(es) - Paint |

**Damage 14:** Door - front left side: Door - Scratch(es) - Paint

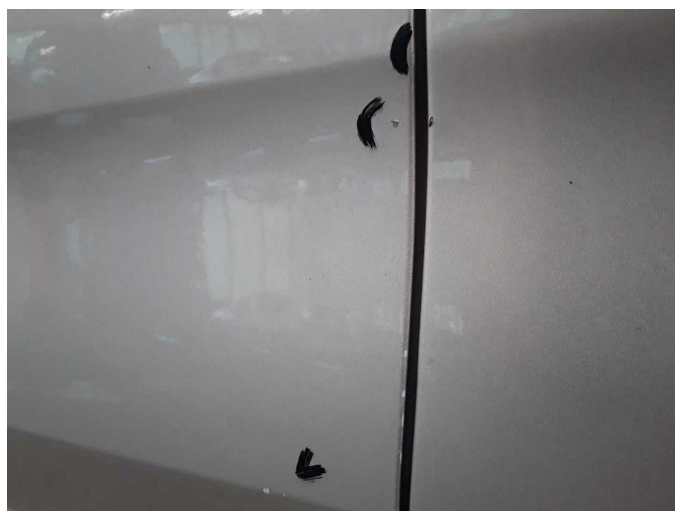
**Damage 14:** Door - front left side: Door - Scratch(es) - Paint

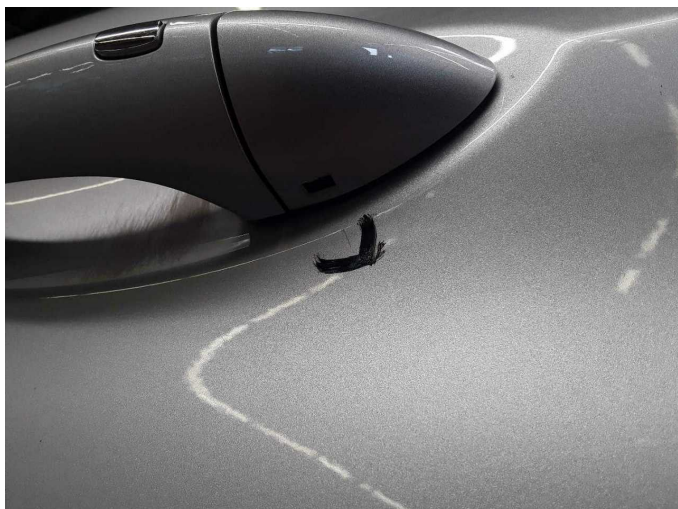
**Damage 14:** Door - front left side: Door - Scratch(es) - Paint

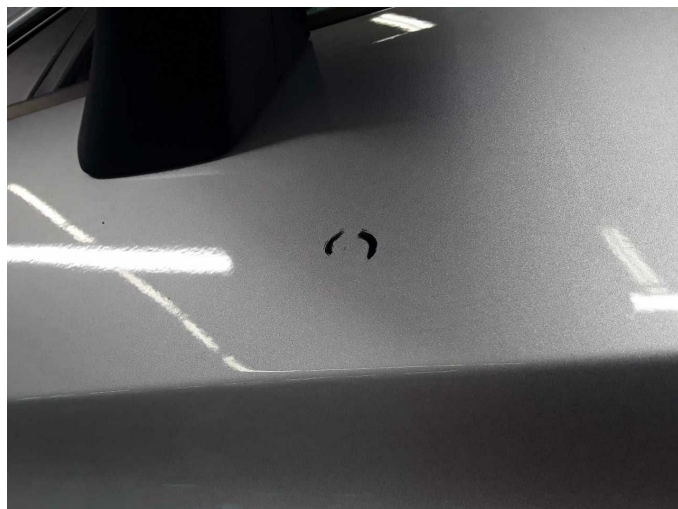
**Damage 14:** Door - front left side: Door - Scratch(es) - Paint

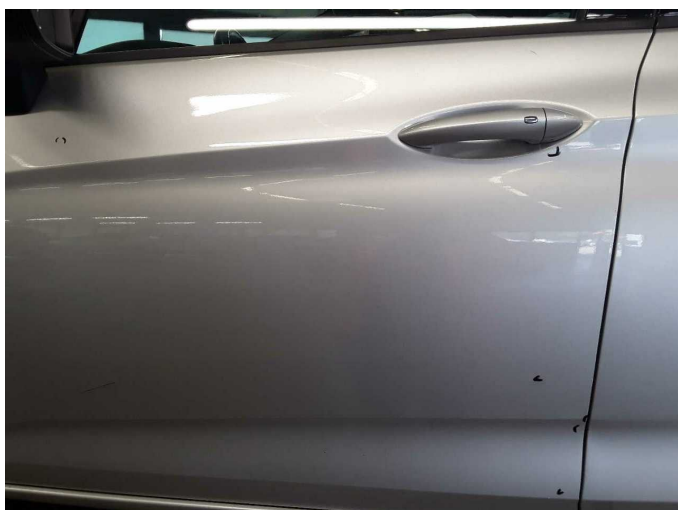
**Damage 14:** Door - front left side: Door - Scratch(es) - Paint

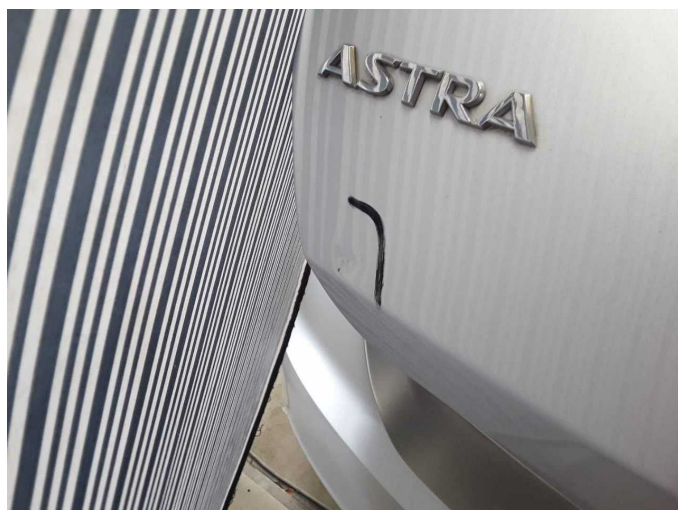
| No. | Component group | Description |
|---|---|---|
| 15 | Boot lid / rear door | Boot lid - Dent / paintcoat damage - Repair and paint |

**Damage 15:** Boot lid / rear door: Boot lid - Dent / paintcoat damage - Repair and paint

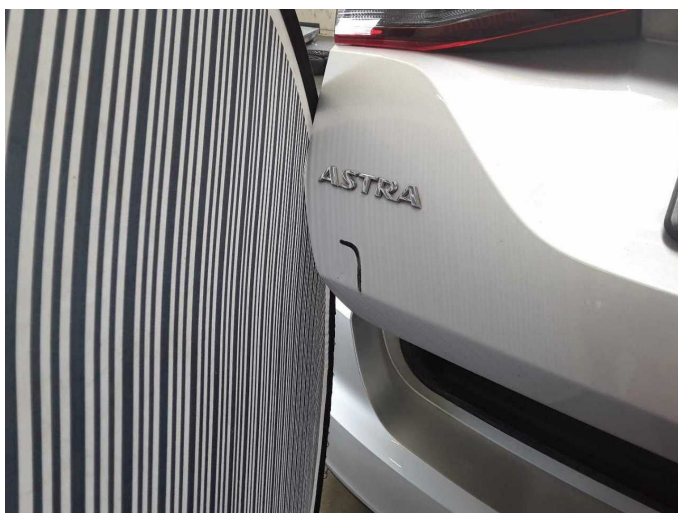
**Damage 15:** Boot lid / rear door: Boot lid - Dent / paintcoat damage - Repair and paint

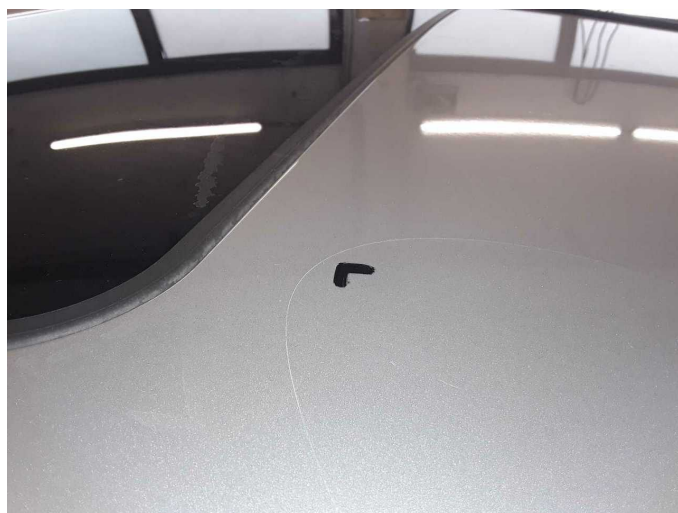
| No. | Component group | Description |
|---|---|---|
| 16 | Roof | Roof - Scratch(es) - Paint |

**Damage 16:** Roof: Roof - Scratch(es) - Paint

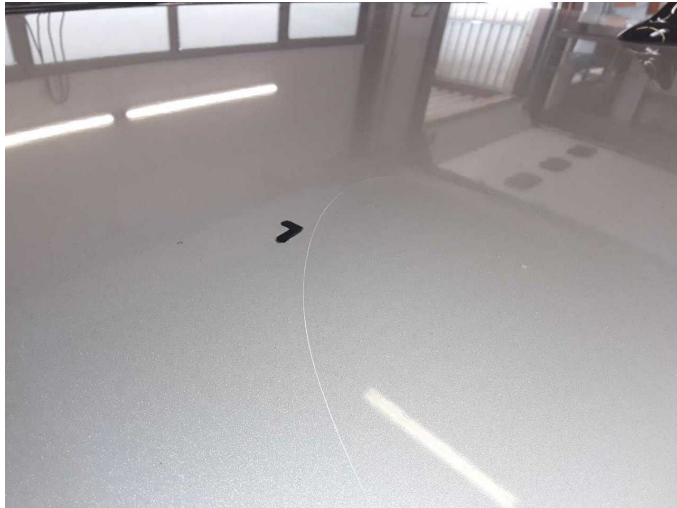
**Damage 16:** Roof: Roof - Scratch(es) - Paint

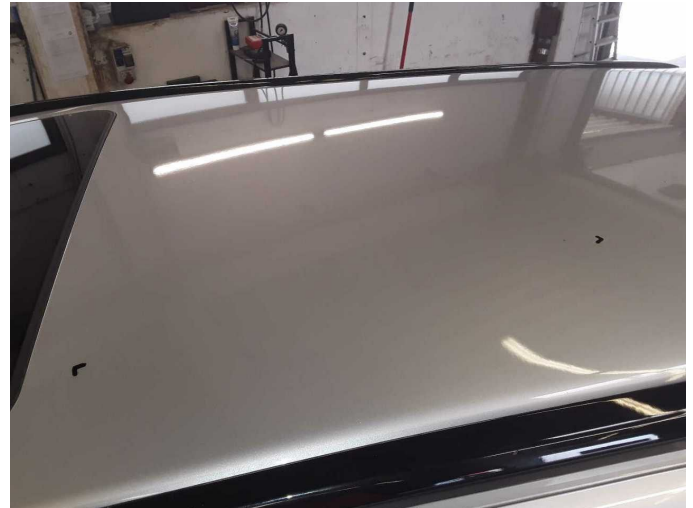
**Damage 16:** Roof: Roof - Scratch(es) - Paint

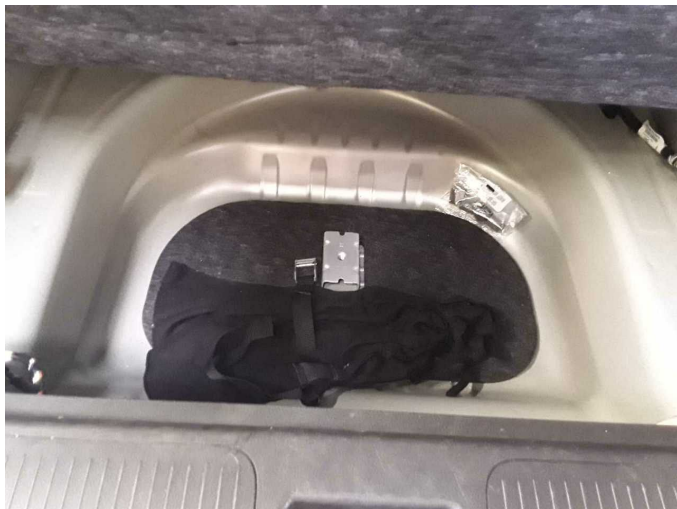
Equipment - Tirefit complete

**Missing part 1:** Equipment: Tirefit complete - Missing - Replace

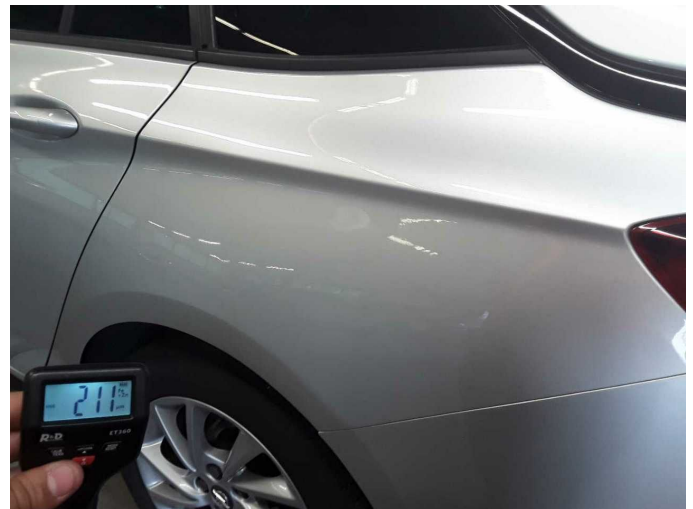
1 Side panel - rear left side

**Side panel - rear left side:** 211 µm
