## Skoda Octavia (UKL): 2AMB838

| Vinnumber: | <b>TMBJW9NX5MY139660</b> | Versionname: | <b>Octavia Combi Clever 1.4TSi iV 204pk/cv 5p DSG6</b> |

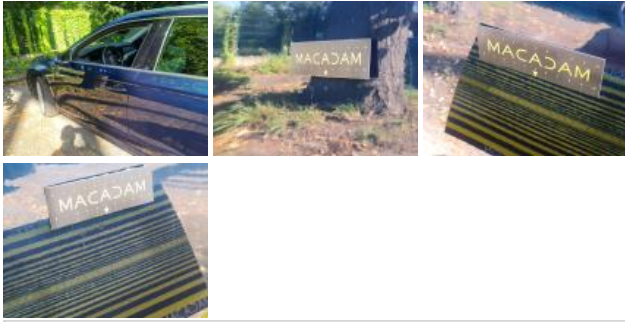
Door FL, Bad repair, Repair and paint (complete)

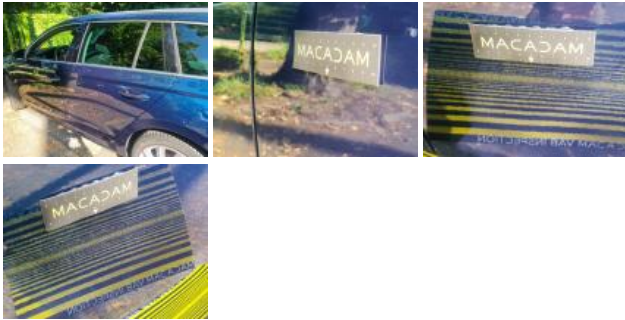
Door RL, Bad repair, Repair and paint (complete)

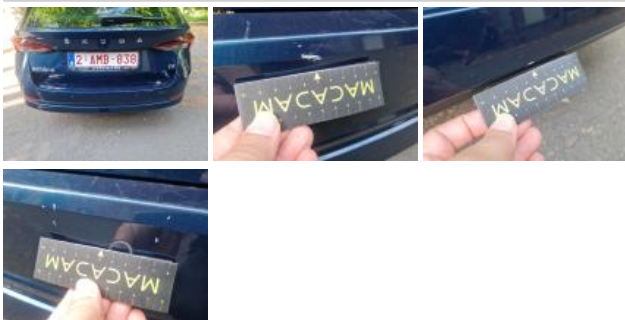
Bumper R, Scratch(es), Acceptable

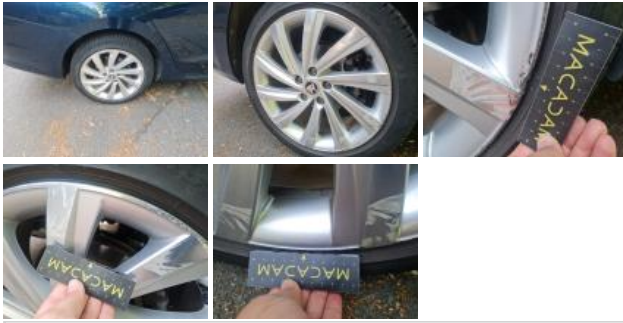
Alloy rim RR polished, Scratch(es), Replace
