Expertise

Protocol number: 46158582  
Order No. / Reference: 26495112  
Inspection date: 24 Jun 2026

Manufacturer: Skoda  
VIN: TMBJG8NX5PY054846

Model: Octavia Combi 2.0 TDI DSG Tour

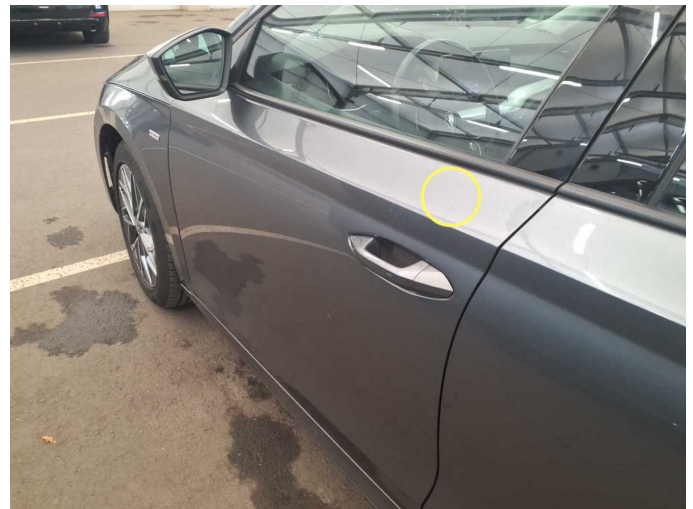
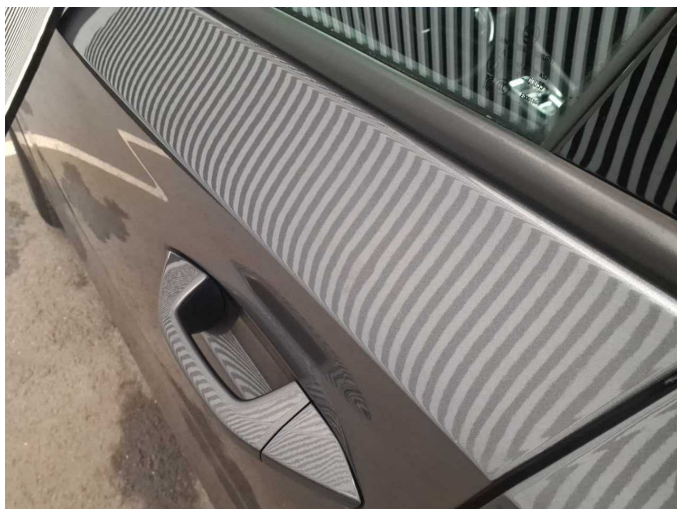
| No. | Component group | Description |
|---|---|---|
| 2 | Door - front left side | Door - dent(s) - Smooth repair work |

**Damage 2:** Door - front left side: Door - dent(s) - Smooth repair work

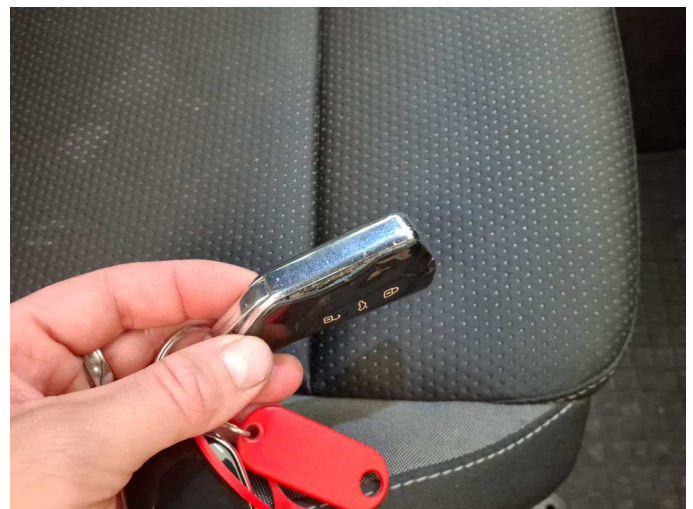
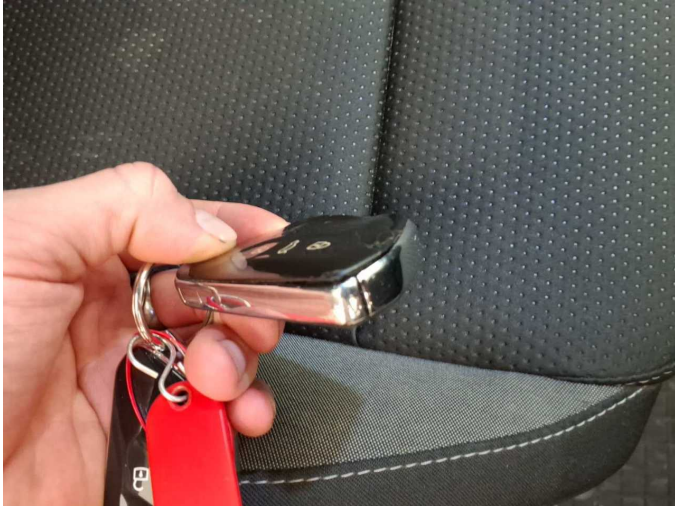
| No. | Component group | Description |
|---|---|---|
| 3 | Equipment | Vehicle key with remote control - Broken / torn - Replace |

**Damage 3:** Equipment: Vehicle key with remote control - Broken / torn - Replace

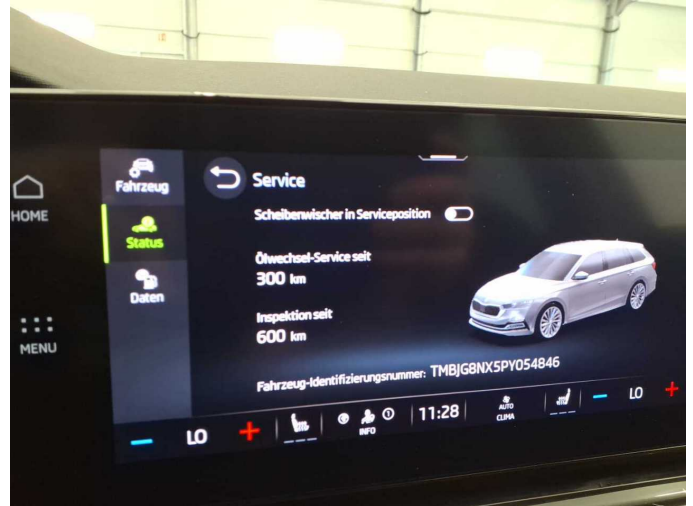
| <b>Maintenance booklet / proof</b> | digital evidence / incomplete | <b>Next maintenance in</b> | -600 km |

| No. | Component group | Description |
|---|---|---|
| 4 | Misc. | Inspection / maintenance - Due - Perform |

**Damage 4:** Misc.: Inspection / maintenance - Due - Perform

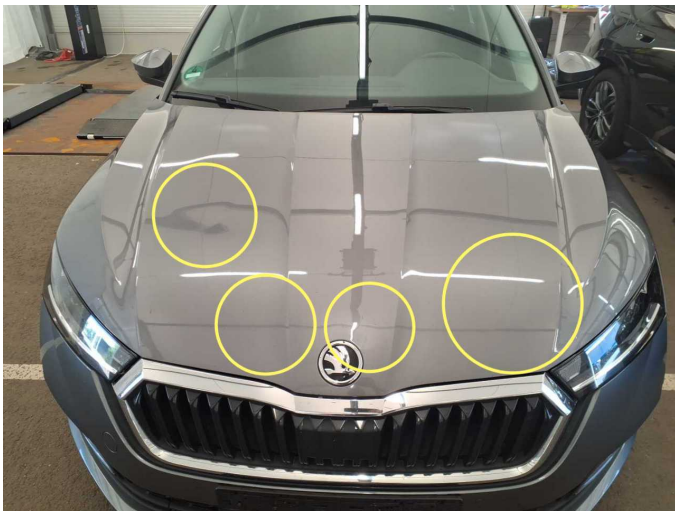
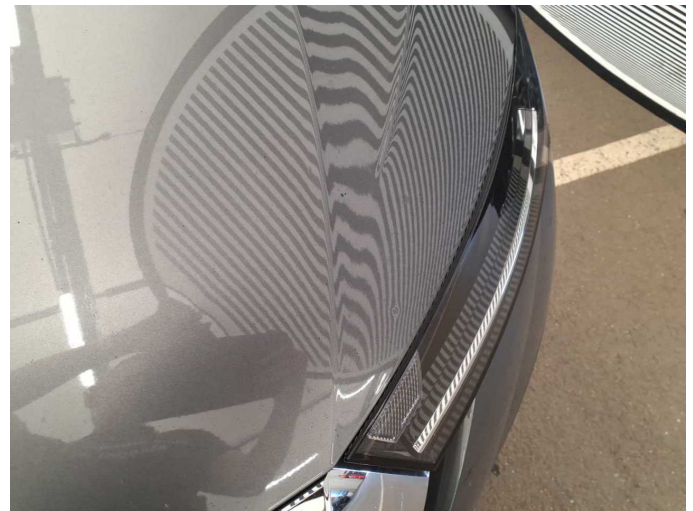
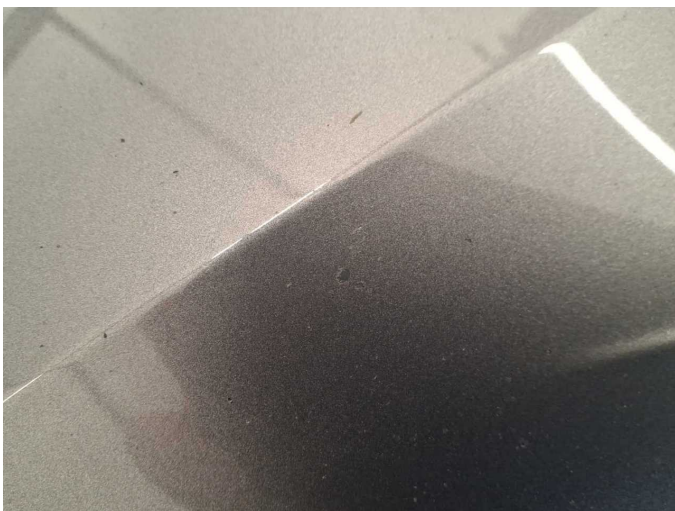
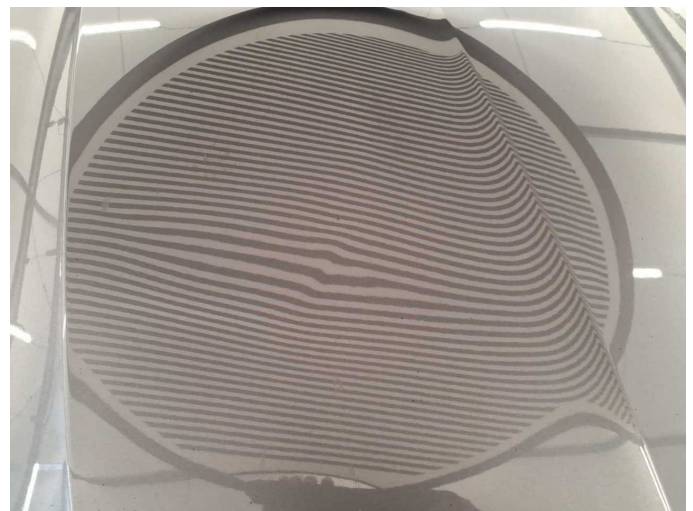
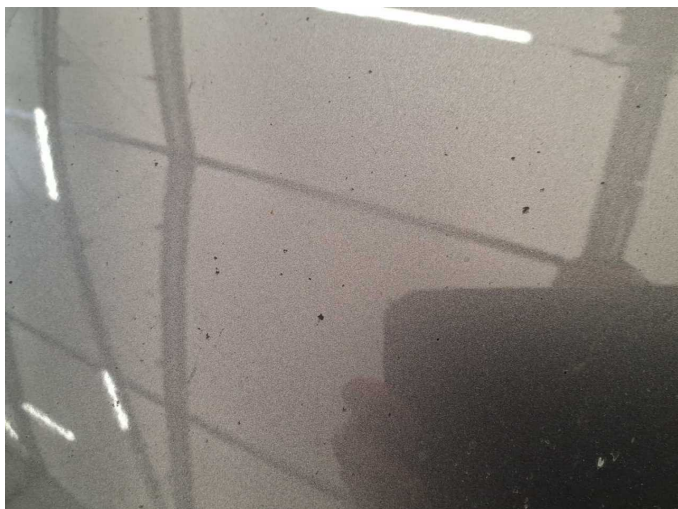
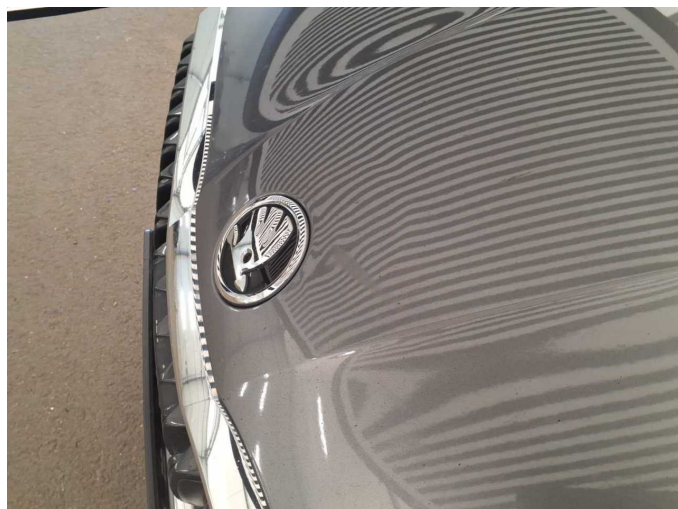
| No. | Component group | Description |
|---|---|---|
| 5 | Bonnet | Bonnet - Dent / paintcoat damage - Repair and paint |

**Damage 5:** Bonnet: Bonnet - Dent / paintcoat damage - Repair and paint

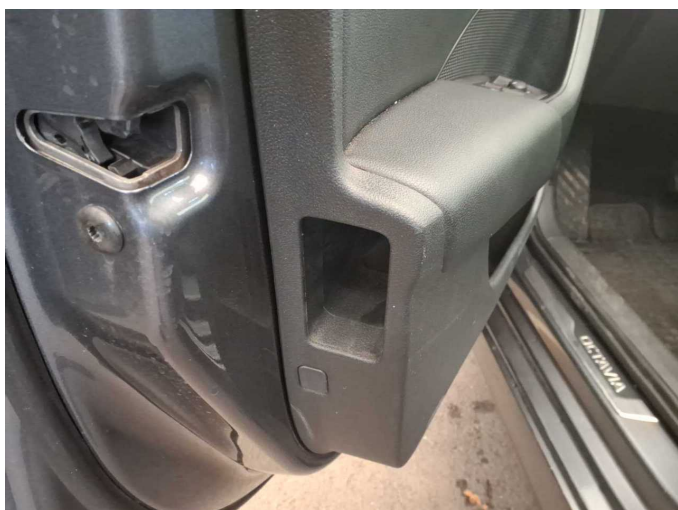
- Equipment - Umbrella
- Equipment - Tirefit filler

**Missing part 1:** Equipment: Umbrella - Missing - Replace

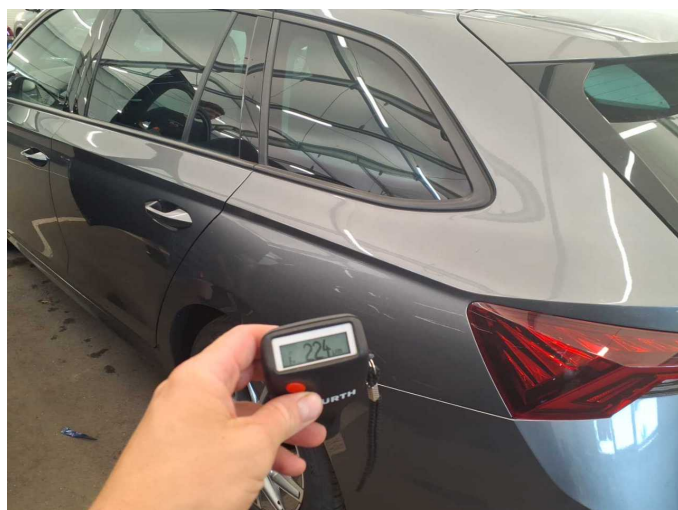
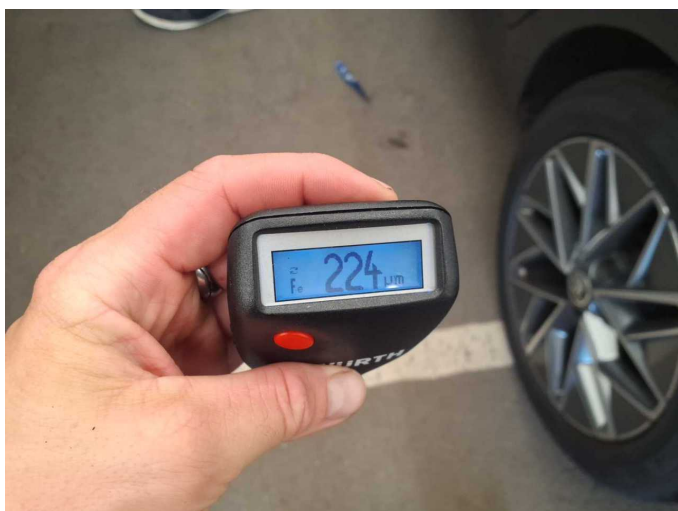
1 Side panel - rear left side, Professionally carried out, Invoice of repair done Non-existent

Side panel - rear left side 224 µm |

**Repainting 1:** Side panel - rear left side
