Expertise

Protocol number: 46515174  
Order No. / Reference: 26588365  
Inspection date: 1 Jul 2026

Manufacturer: Seat

Model: Cupra Born 150kW/58kWh

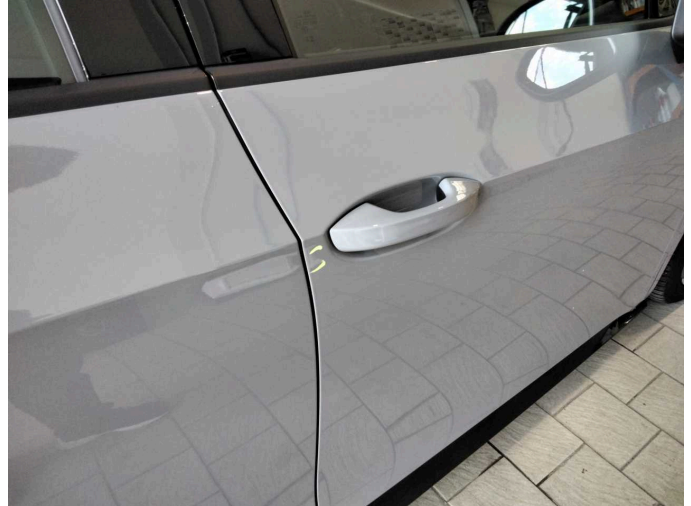
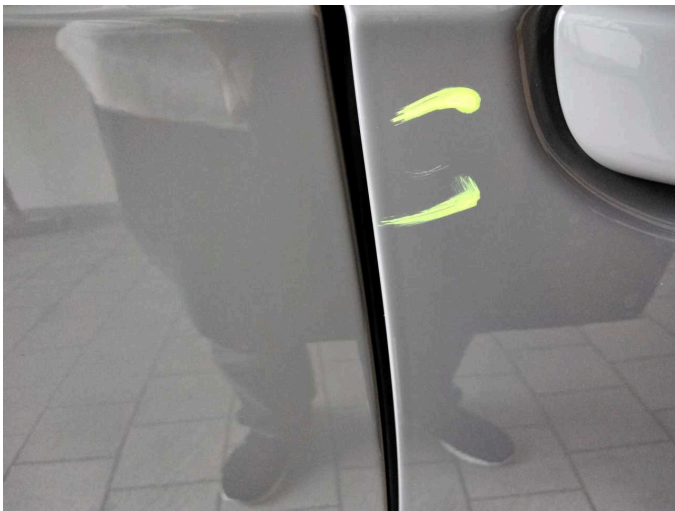
| No. | Component group | Description |
|---|---|---|
| 1 | Door - front right side | Door - Scratch(es) - Smart repair |

**Damage 1:** Door - front right side: Door - Scratch(es) - Smart repair

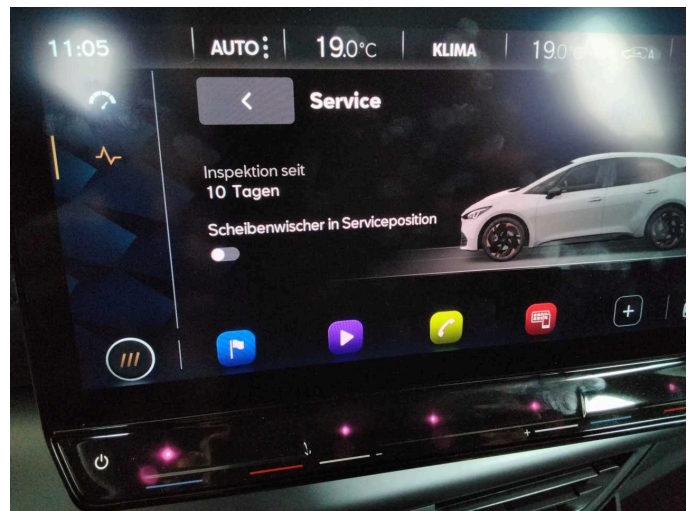
| No. | Component group | Description |
|---|---|---|
| 2 | Misc. | Inspection / maintenance - Due - Perform |

**Damage 2:** Misc.: Inspection / maintenance - Due - Perform

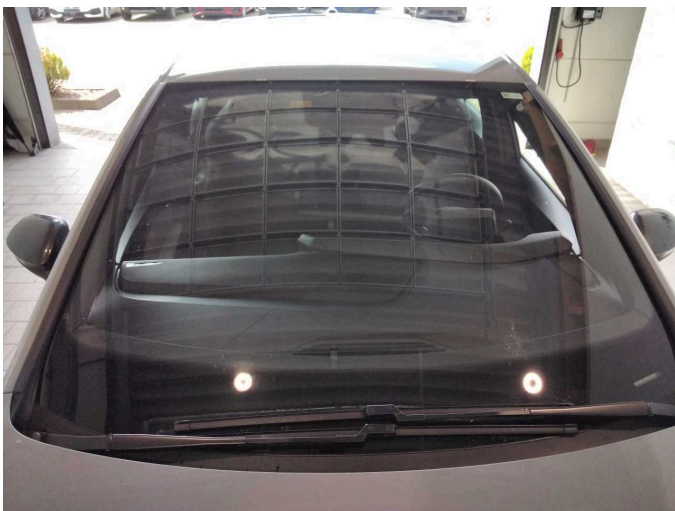
| No. | Component group | Description |
|---|---|---|
| 1 | Vehicle glazing | Windscreen - Stone chips - No deduction |

**Wear and tear 1:** Vehicle glazing: Windscreen - Stone chips - No deduction
