Expertise

Protocol number: 46857112  
Order No. / Reference: 26776872  
Inspection date: 4 Aug 2026

Manufacturer: Skoda  
VIN: TMBJB9NS1P8018659

Model: Kodiahq 1.5 TSI ACT DSG Ambition

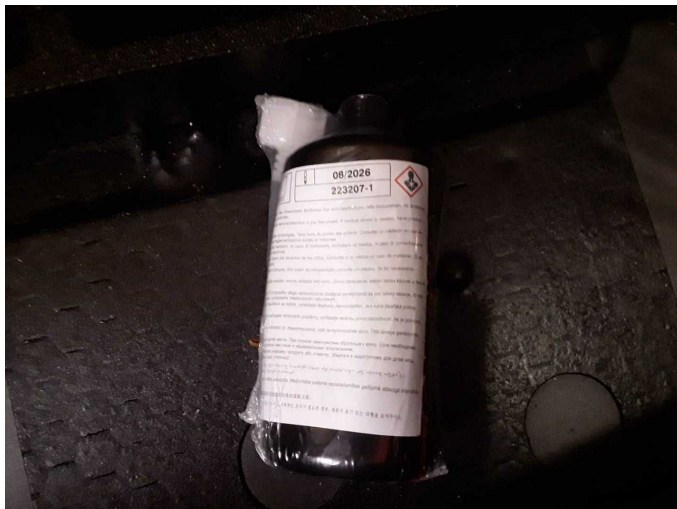
Damage 1: Equipment: Tirefit filler - Expired - Replace

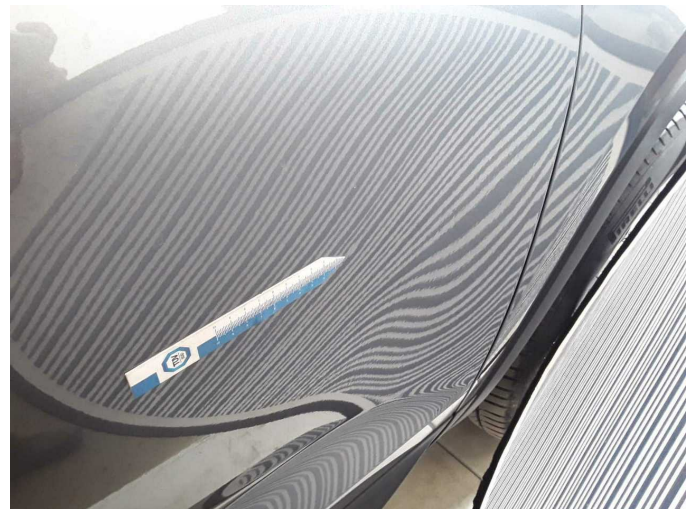
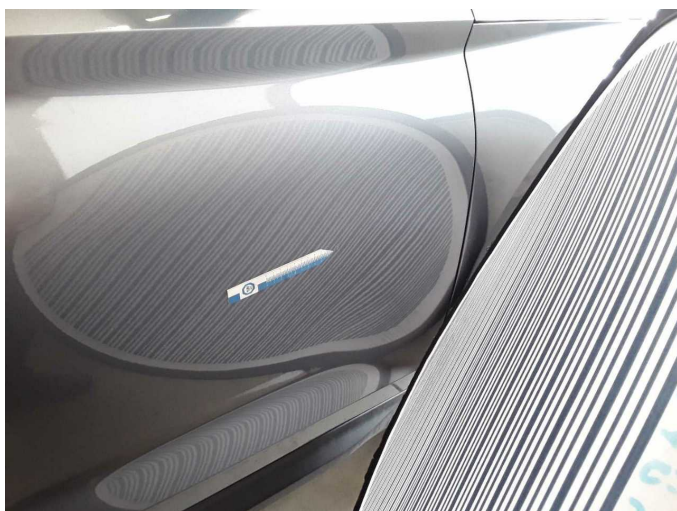
Damage 2: Door - front right side: Door - dent(s) - Smooth repair work

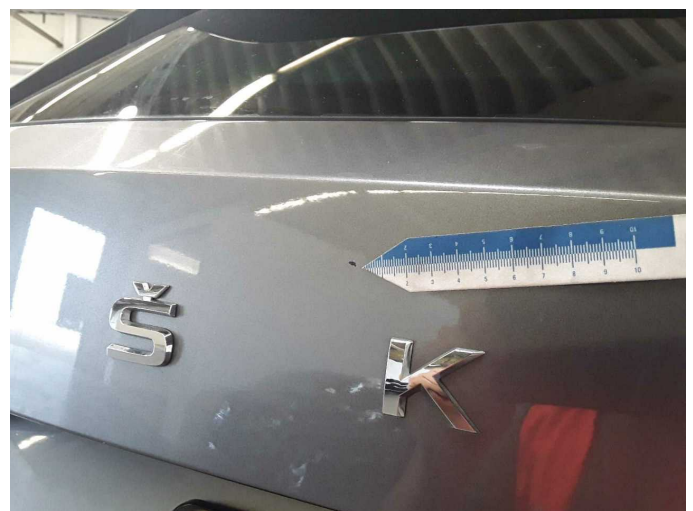
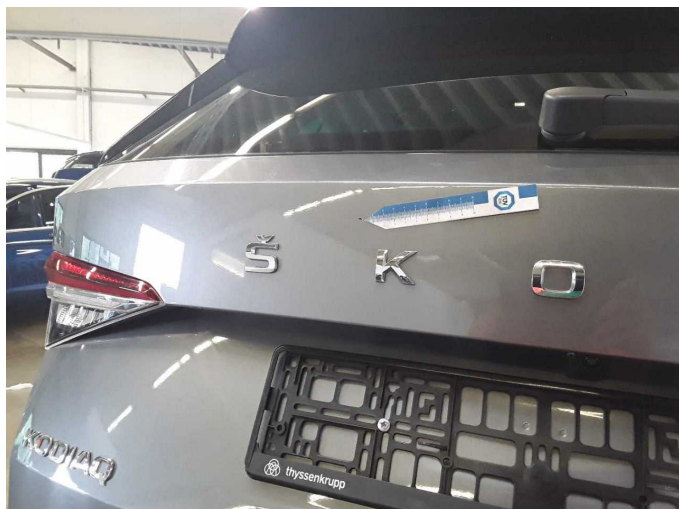
Damage 3: Boot lid / rear door: Boot lid - Scratch(es) - Smart repair

**Damage 3:** Boot lid / rear door: Boot lid - Scratch(es) - Smart repair

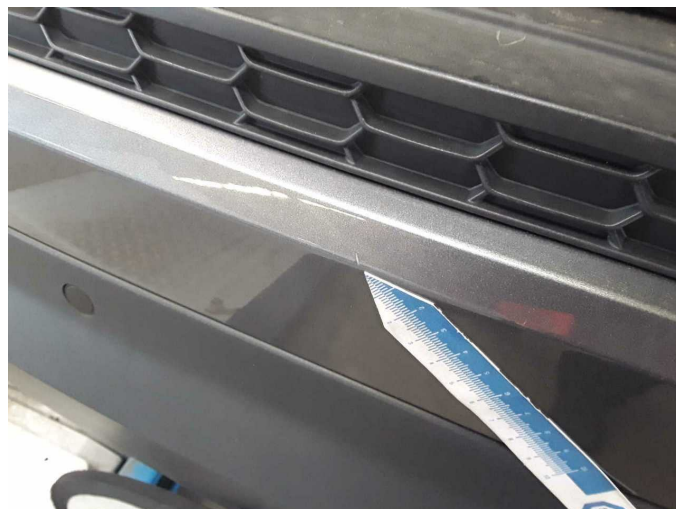
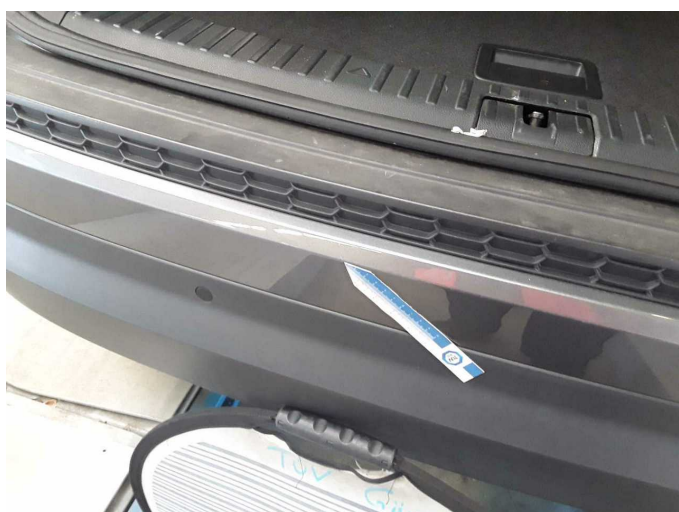
**Damage 4:** Rear bumper: Rear bumper - Scratch(es) - Smart repair

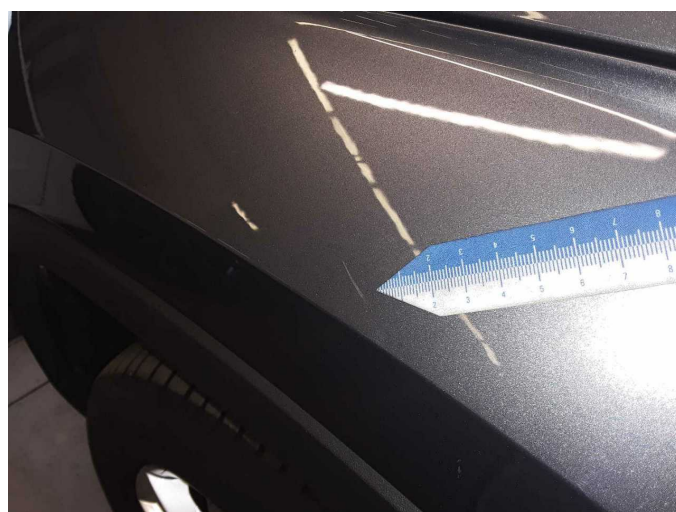
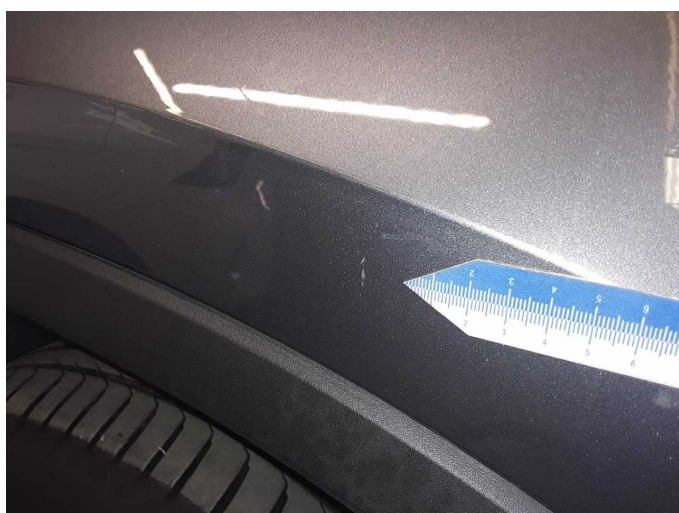
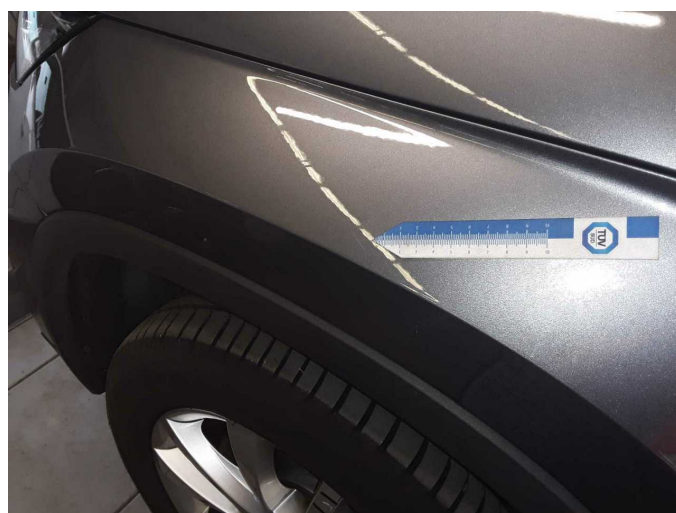
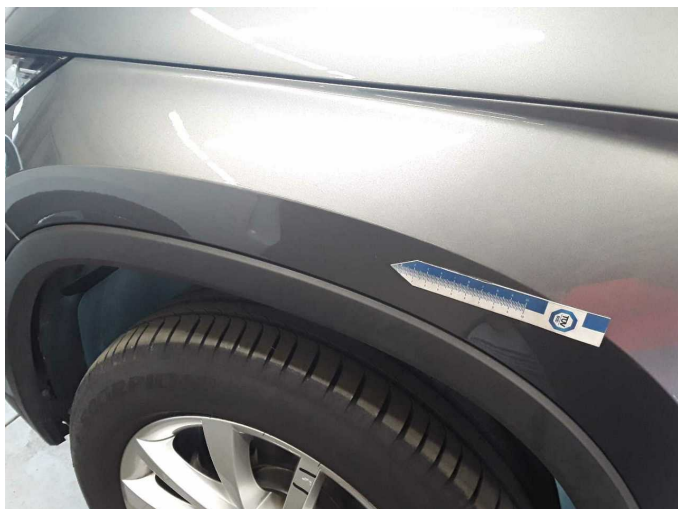
**Damage 5:** Mudguard - left side: Mudguard - left side - Scratch(es) - Smart repair

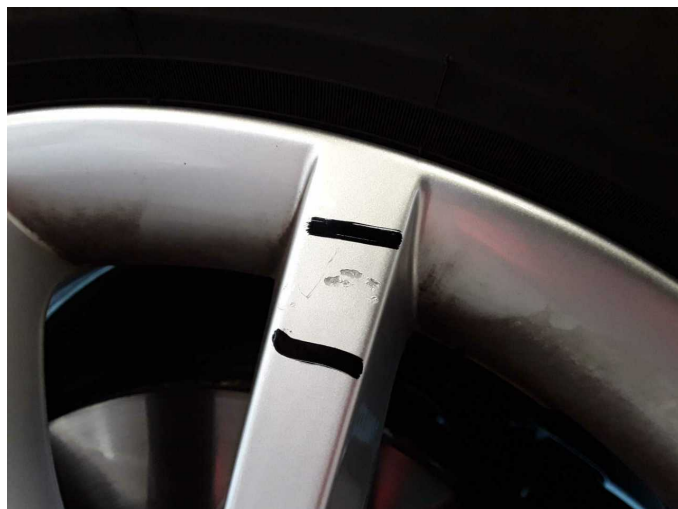
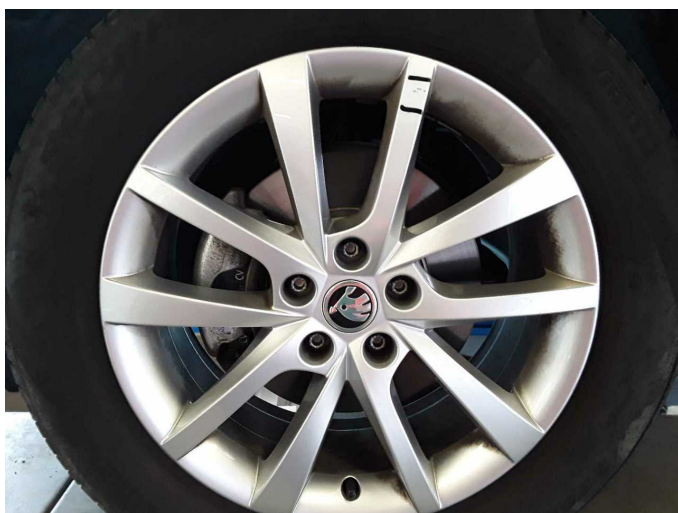
**Damage 6:** Wheel / tyres: Alloy rim - front left side - Scratch(es) - Loss in value

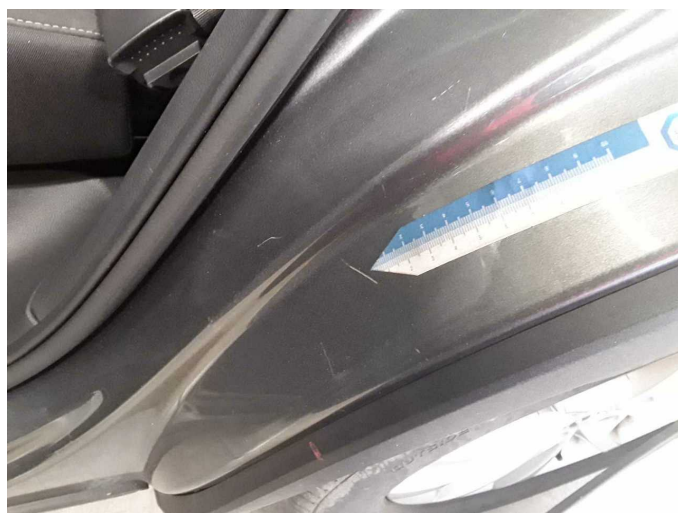
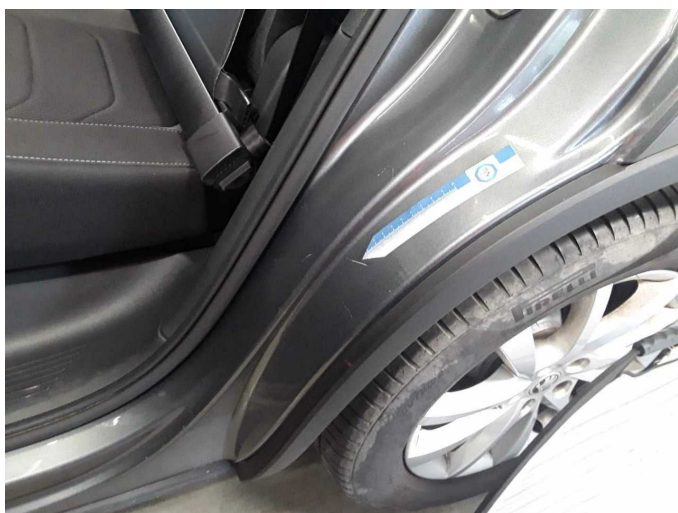
**Damage 7:** Side panel - rear left side: Sill - Scratch(es) - Smart repair

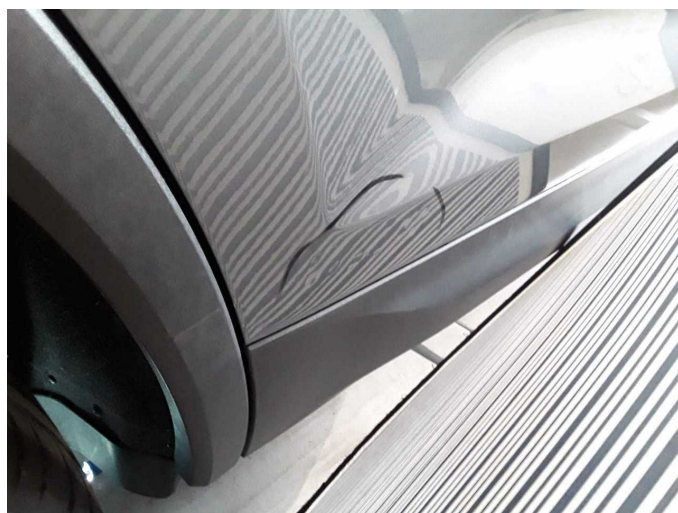
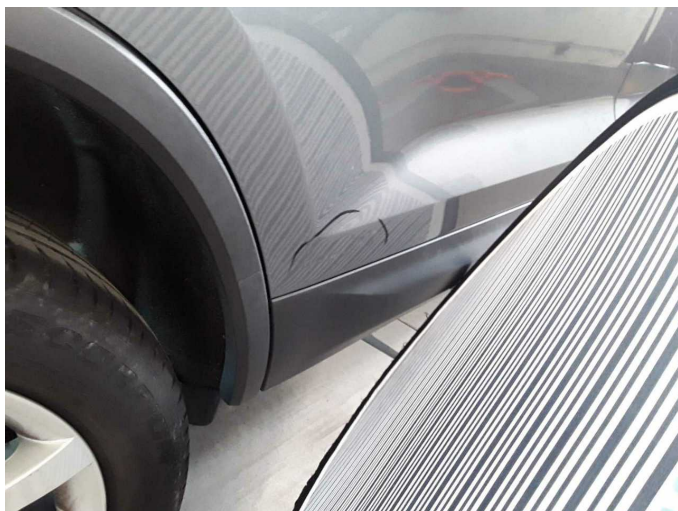
**Damage 8:** Door - rear right side: Door - dent(s) - Repair and paint

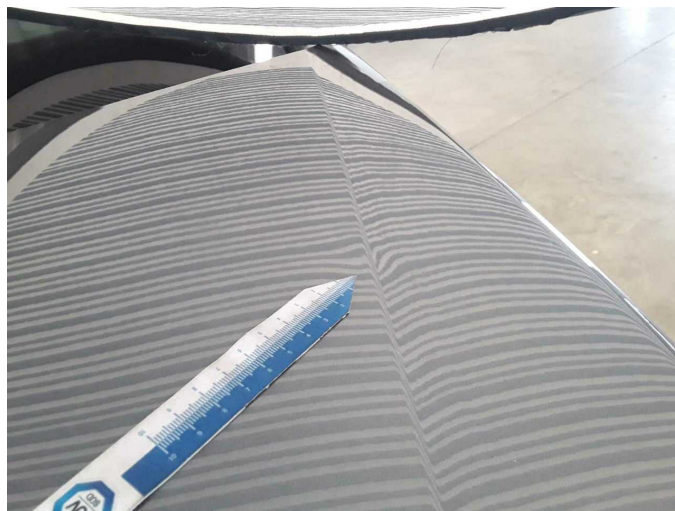
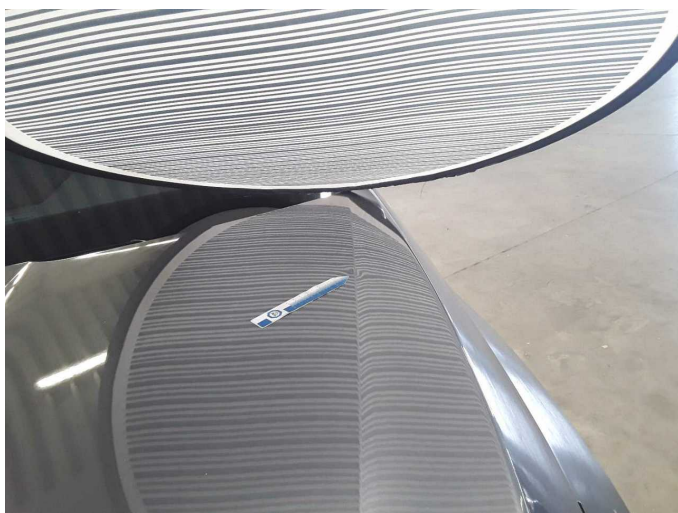
**Damage 9:** Bonnet: Bonnet - dent(s) - Repair and paint

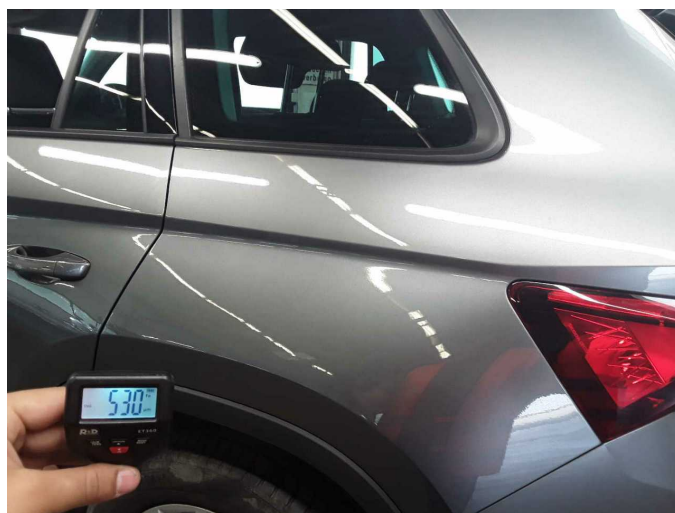
- 1 Side panel - rear left side, Door - rear left side, Professionally carried out

**Side panel - rear left side:** 530 µm

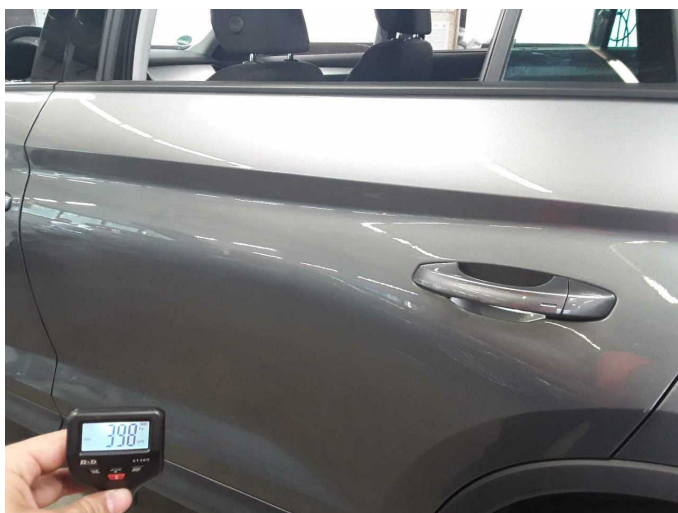
**Door - rear left side:** 398 µm
