Expertise

Protocol number: 46137759
Order No. / Reference: 26488547
Inspection date: 24 Jun 2026

Manufacturer: Polestar

Model: 2 Single Motor 78kWh

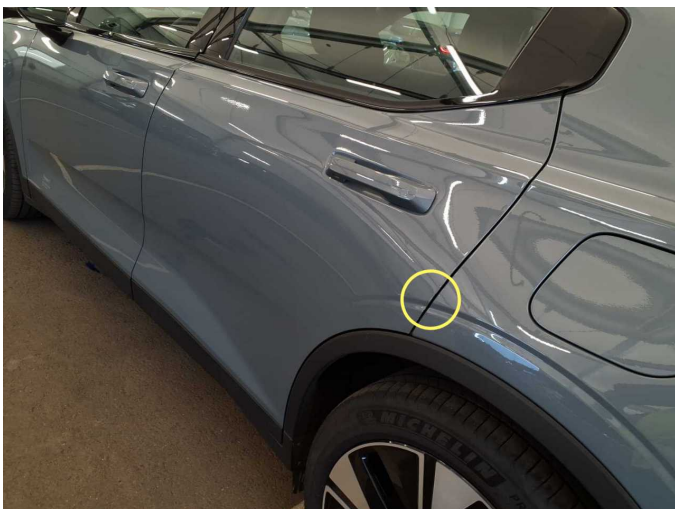
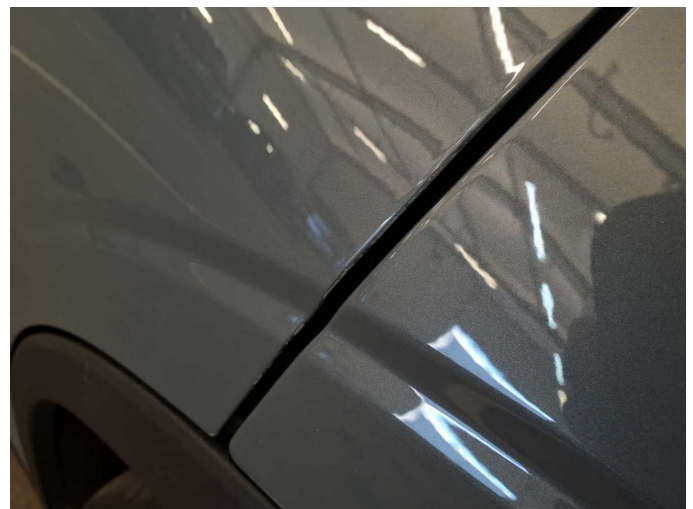
Damage 2: Door - rear left side: Door - Scratch(es) - Smart repair

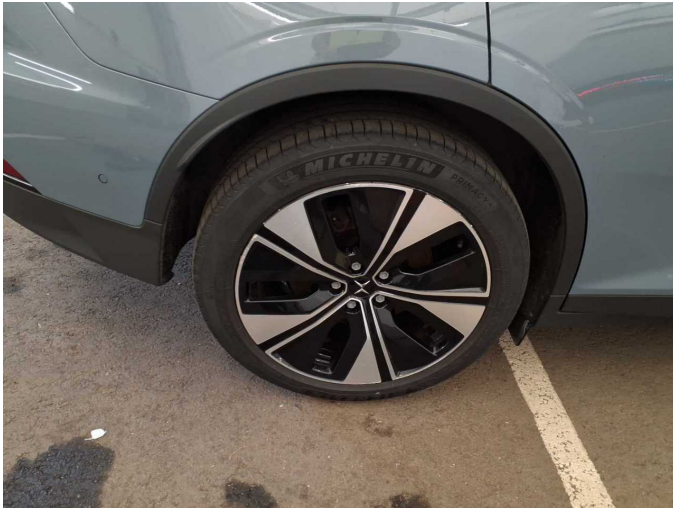
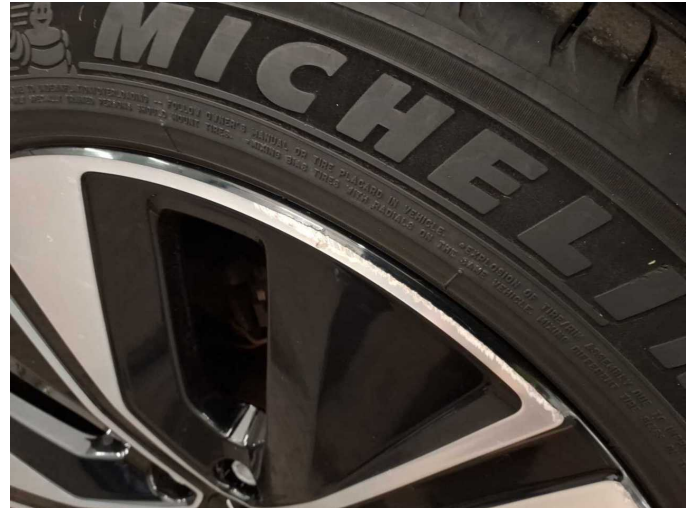
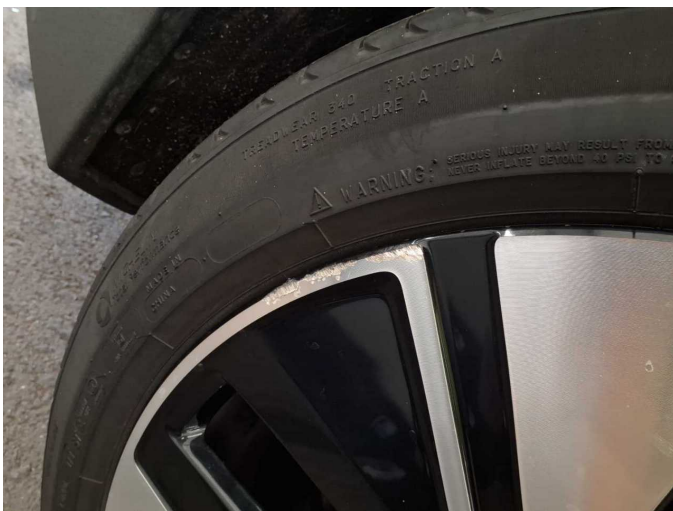
Damage 3: Wheel / tyres: Alloy rim - rear right side (Materialabtrag) - Scratched - Replace

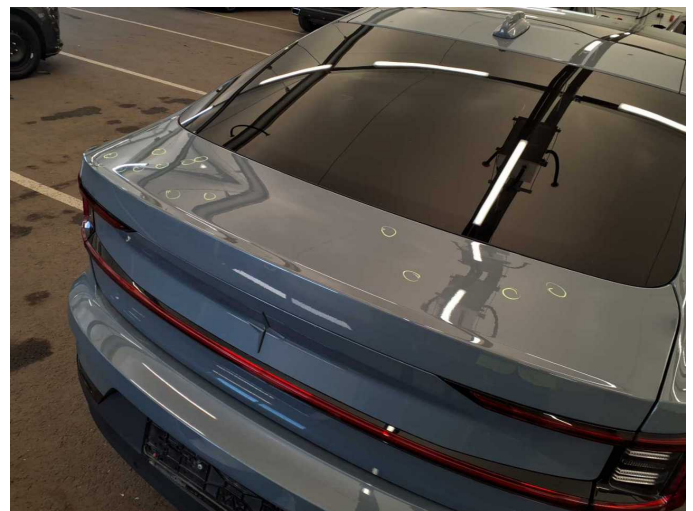
Damage 4: Body: Body - Damage by hail - repair according to calculation

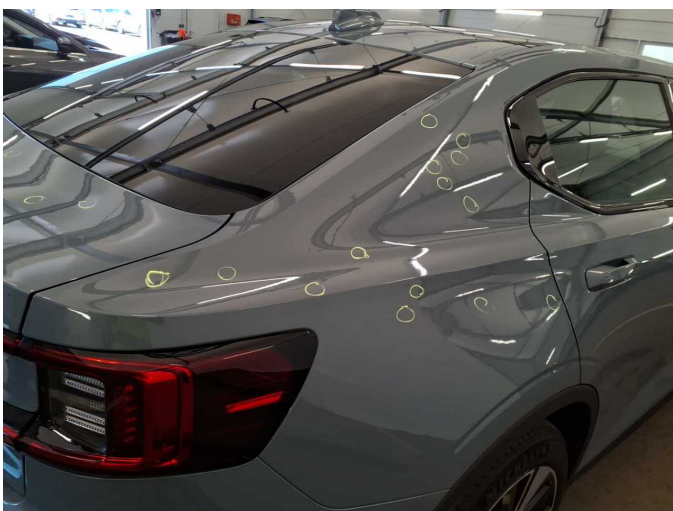
Damage 4: Body: Body - Damage by hail - repair according to calculation

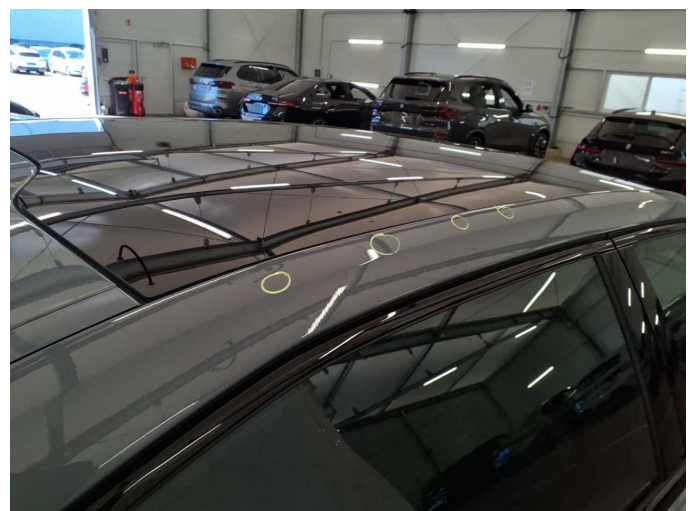
Damage 4: Body: Body - Damage by hail - repair according to calculation

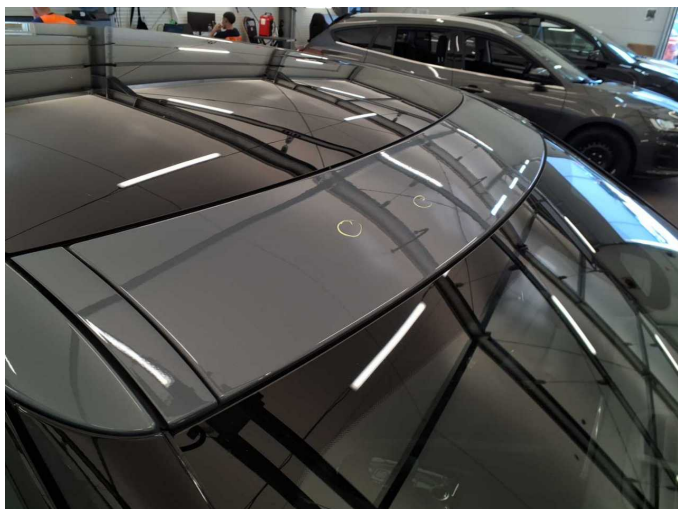
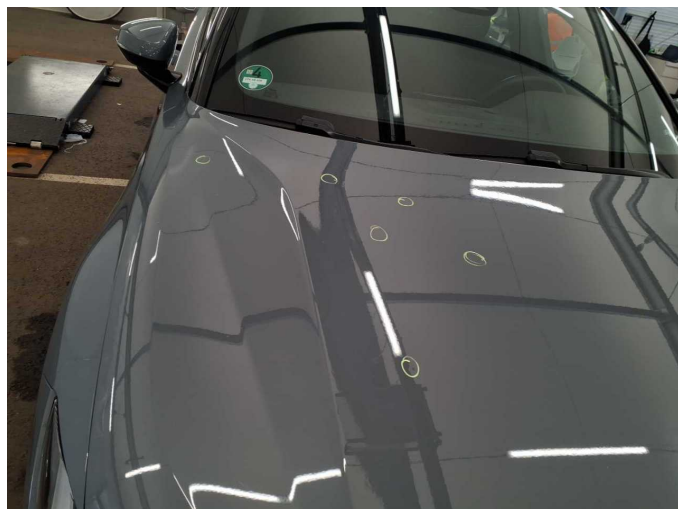
Damage 4: Body: Body - Damage by hail - repair according to calculation
