Protocol number: 46288851
Order No. / Reference: 26471899
Inspection date: 19 Jun 2026

Manufacturer: Opel

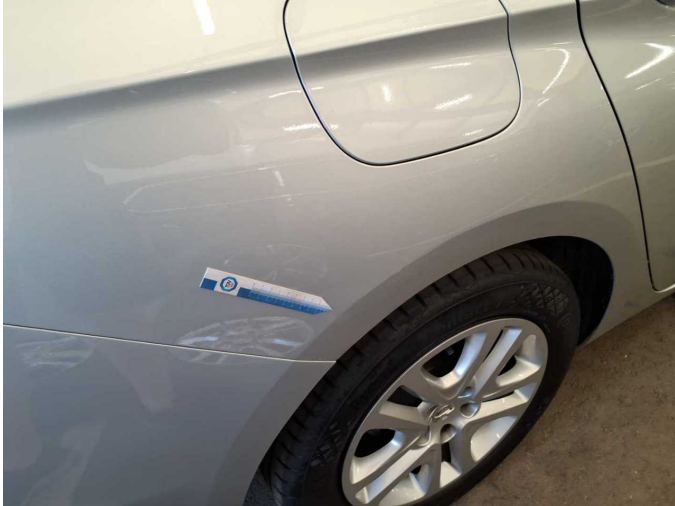
Damage 2: Side panel - rear right side: Side panel - dent(s) - Smooth repair work

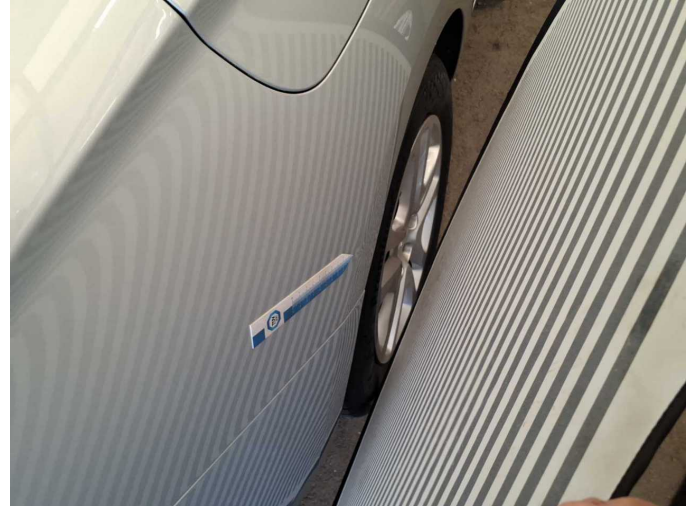
Damage 2: Side panel - rear right side: Side panel - dent(s) - Smooth repair work

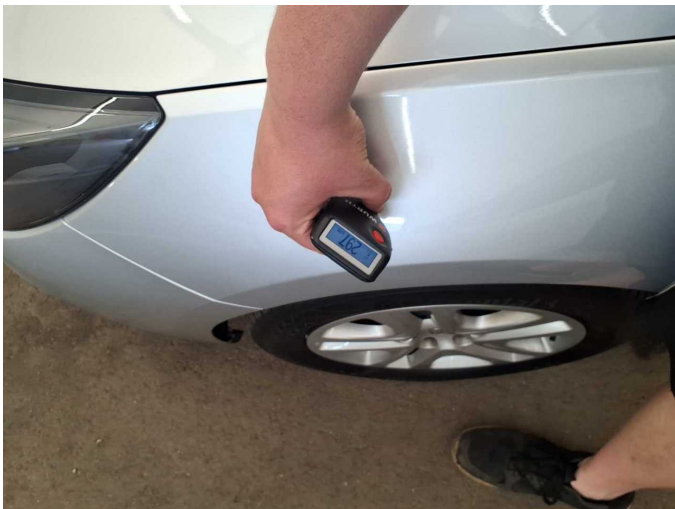
Repainting 1: Mudguard - left side, Side panel - rear left side, Door - rear left side, Door - front left side
