Expertise

Protocol number: 46334382  
Order No. / Reference: 26600985  
Inspection date: 6 Jul 2026

Manufacturer: Ford

Model: S-Max 2.0 EcoBlue Aut. TITANIUM

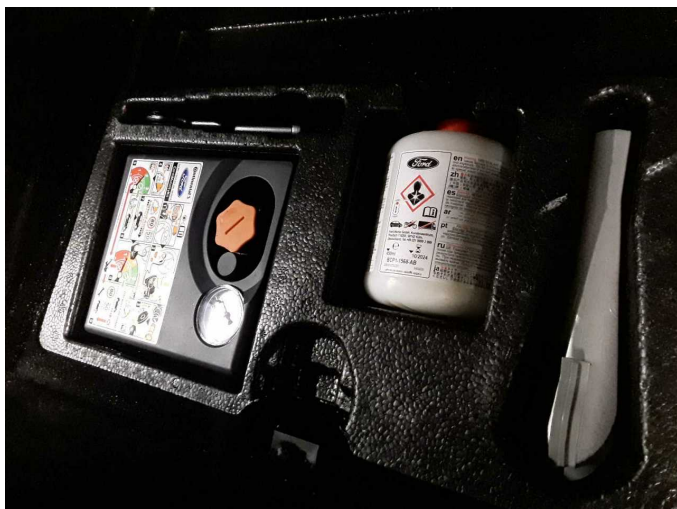
| No. | Component group | Description |
|---|---|---|
| 1 | Equipment | Tirefit filler - Expired - Replace |

Damage 1: Equipment: Tirefit filler - Expired - Replace

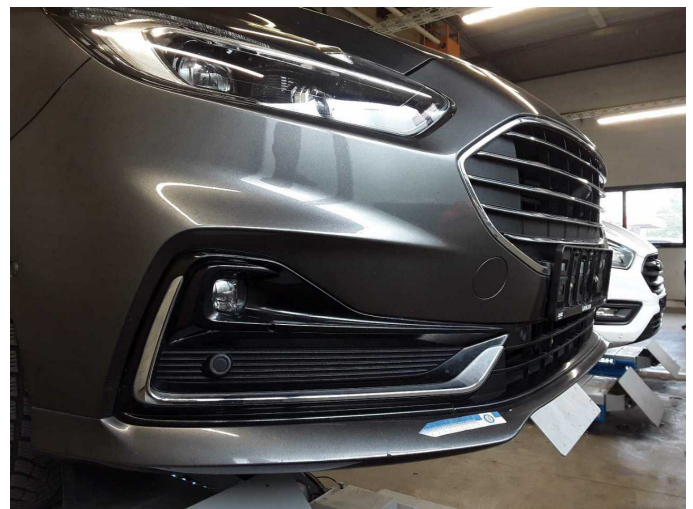
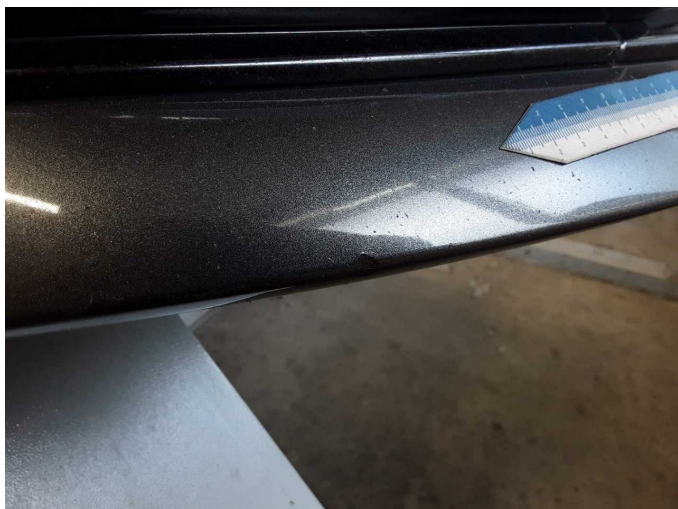
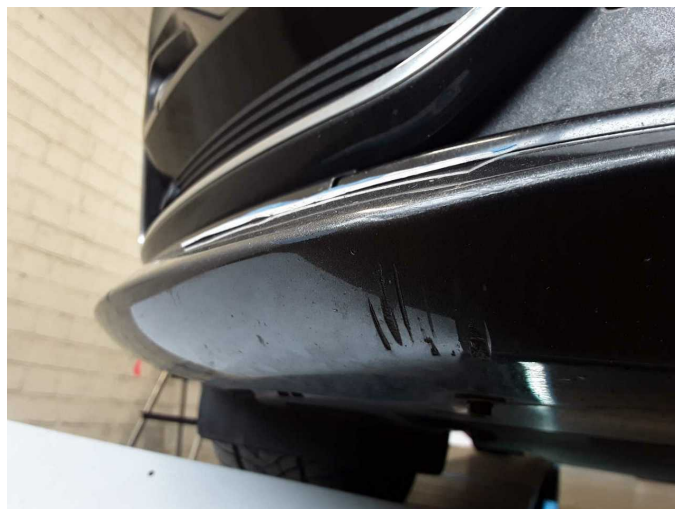
| No. | Component group | Description |
|---|---|---|
| 2 | Front bumper | Front bumper - Scratch(es) - Smart repair |

Damage 2: Front bumper: Front bumper - Scratch(es) - Smart repair

**Damage 2:** Front bumper: Front bumper - Scratch(es) - Smart repair

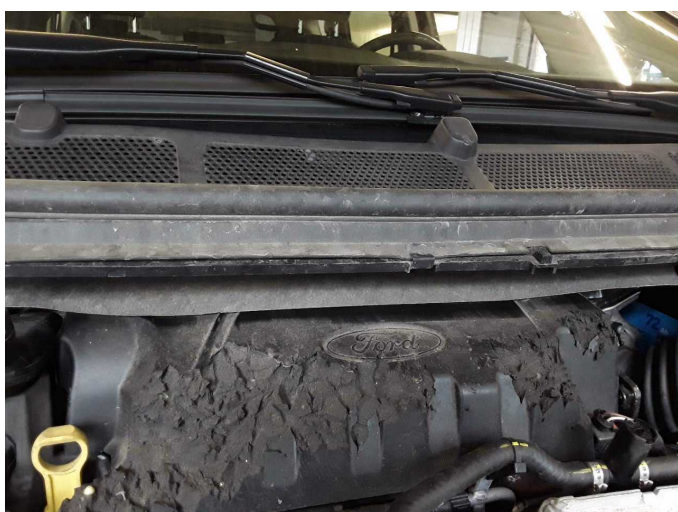
| No. | Component group | Description |
|---|---|---|
| 3 | Engine | Engine cover - Damaged - Replace |

**Damage 3:** Engine: Engine cover - Damaged - Replace

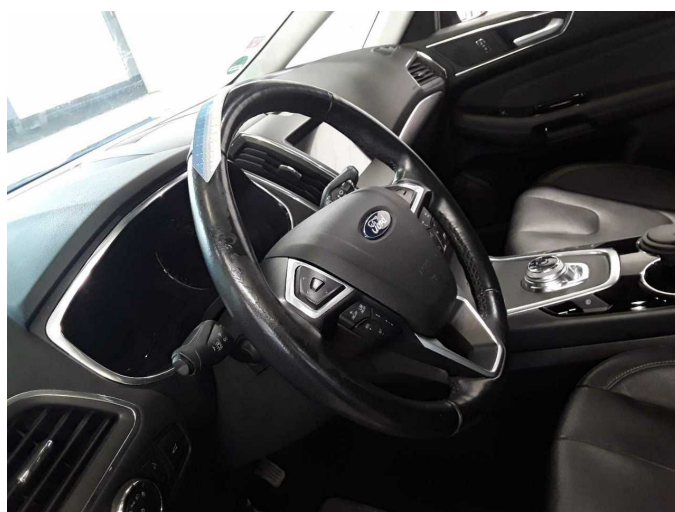
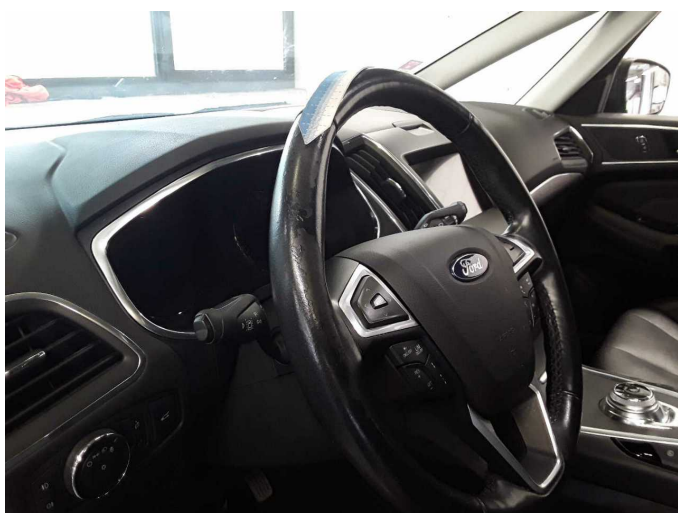
| No. | Component group | Description |
|---|---|---|
| 4 | Steering system | Steering wheel - Abrasion - Smart repair |

**Damage 4:** Steering system: Steering wheel - Abrasion - Smart repair

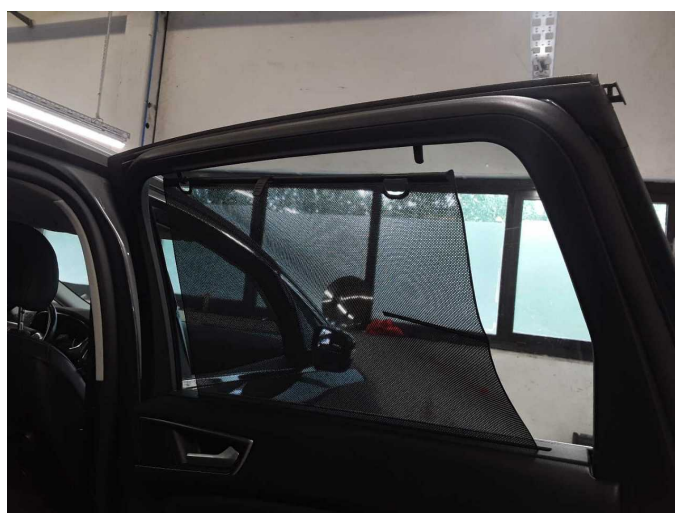
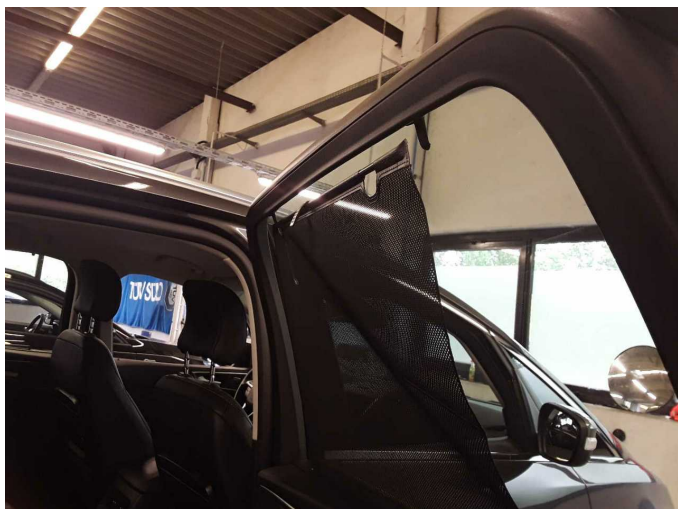
| No. | Component group | Description |
|---|---|---|
| 5 | Interior | Roller blind rear window (Seitenfenster tür hinten rechts) - Damaged - Replace |

**Damage 5:** Interior: Roller blind rear window (Seitenfenster tür hinten rechts) - Damaged - Replace

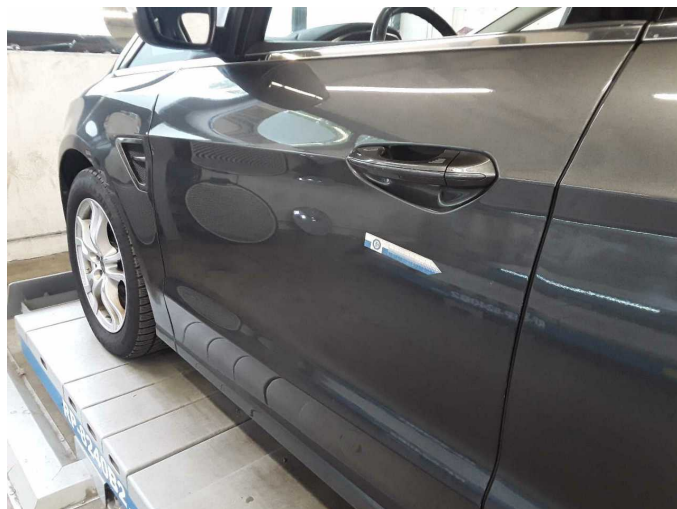
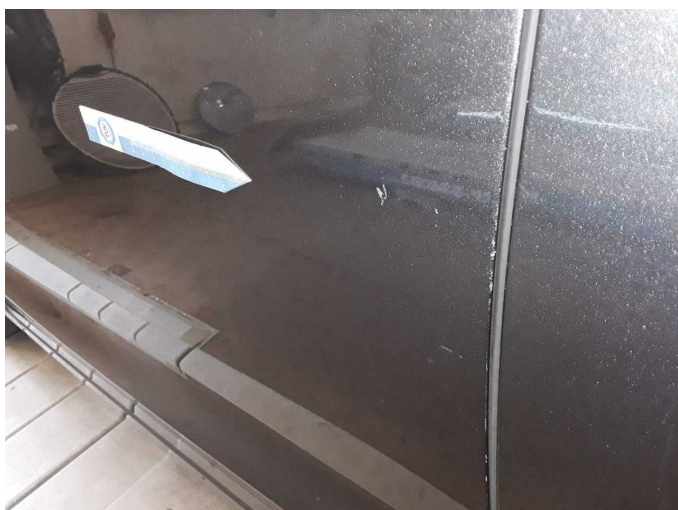
| No. | Component group | Description |
|---|---|---|
| 6 | Door - front left side | Door - Scratch(es) - Paint |

**Damage 6:** Door - front left side: Door - Scratch(es) - Paint

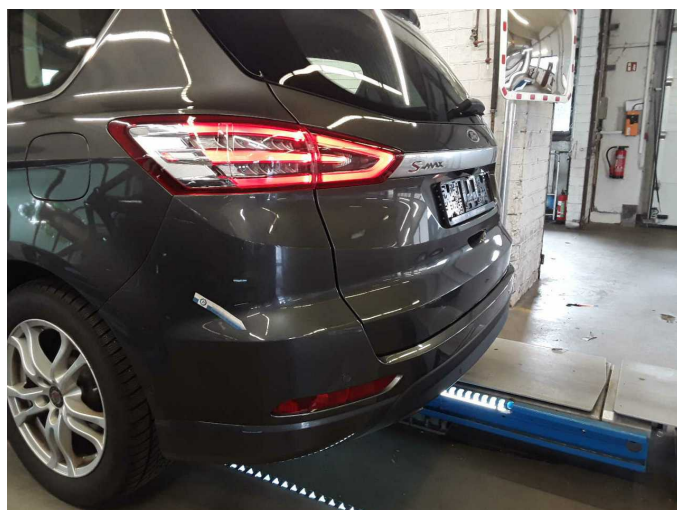
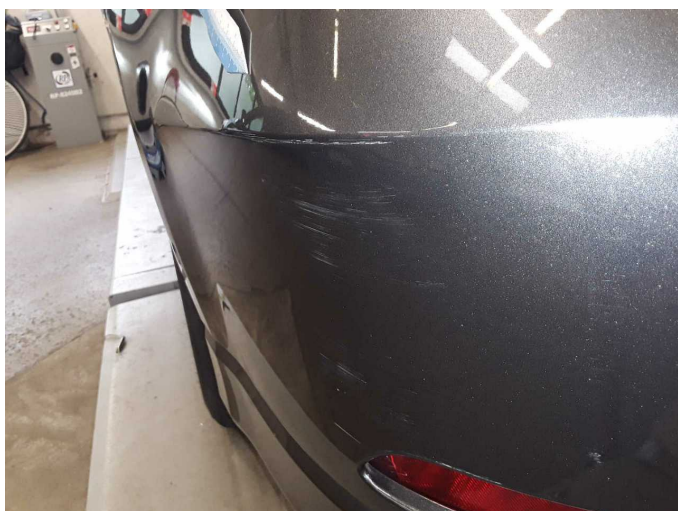
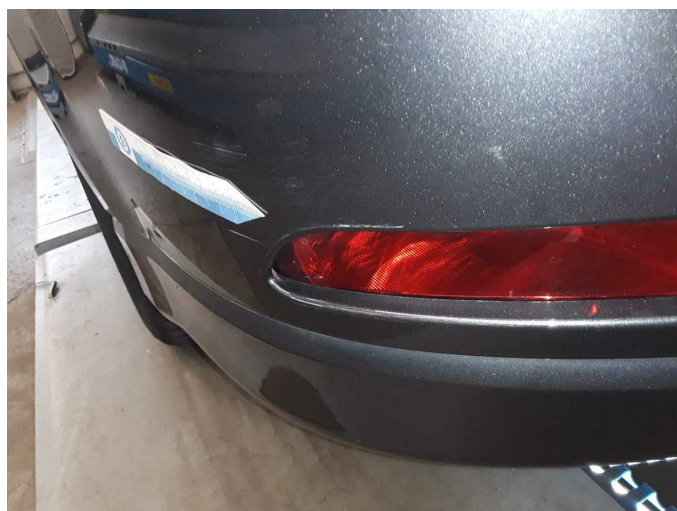
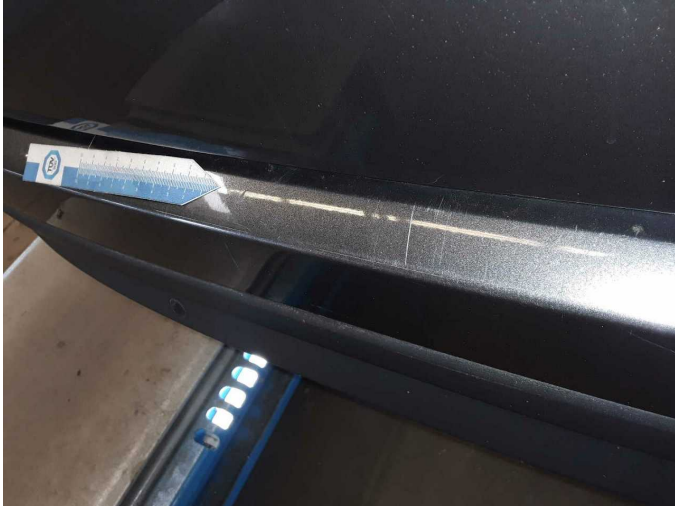
| No. | Component group | Description |
|---|---|---|
| 7 | Rear bumper | Rear bumper - Scratch(es) - Paint |

**Damage 7:** Rear bumper: Rear bumper - Scratch(es) - Paint

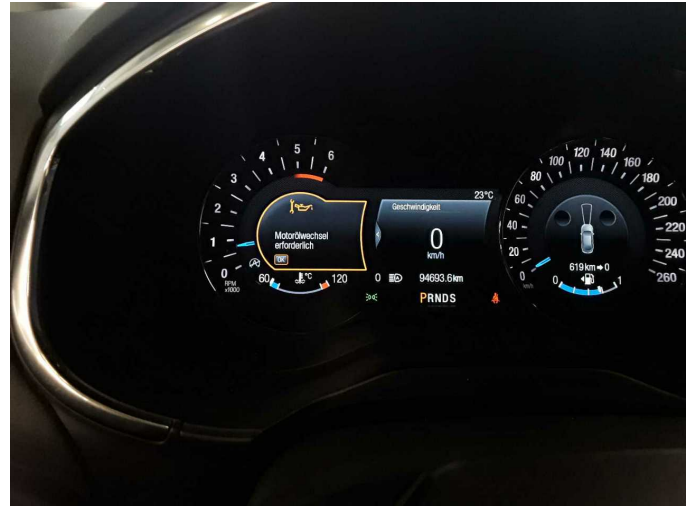
| No. | Component group | Description |
|---|---|---|
| 8 | Misc. | Inspection / maintenance - Due - Perform |

**Damage 8:** Misc.: Inspection / maintenance - Due - Perform
