Expertise

Protocol number: 46237677
Order No. / Reference: 26504685
Inspection date: 29 Jun 2026

Manufacturer: Opel

Model: Combo Life XL 1.5 D Start/Stop Elegance

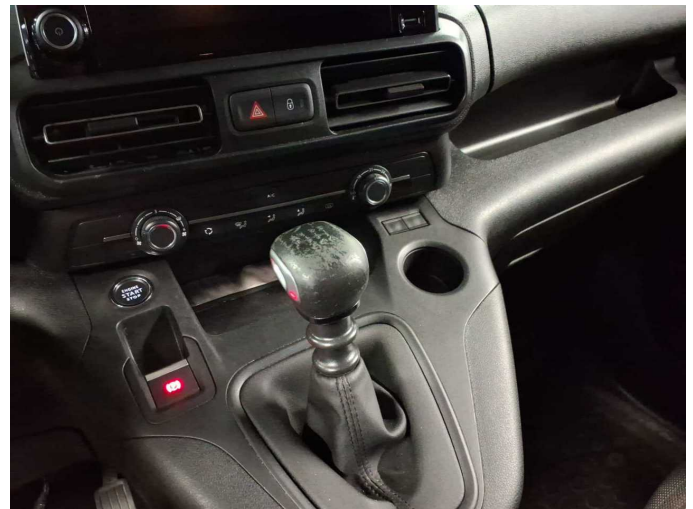
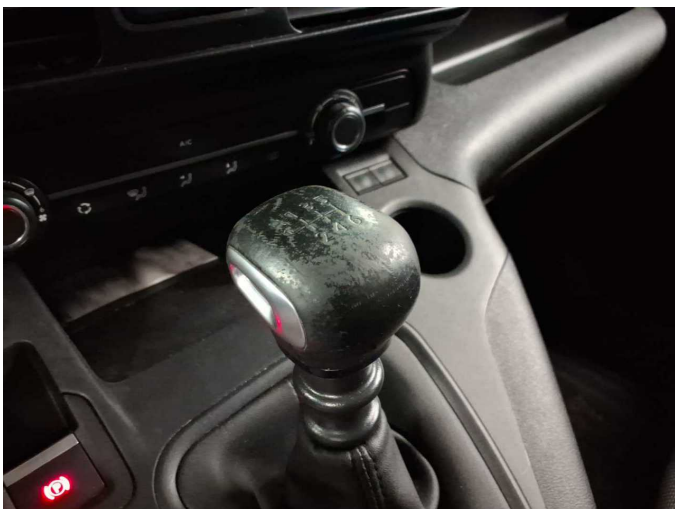
Damage 1: Gearbox: Gear knob - Abrasion - Replace

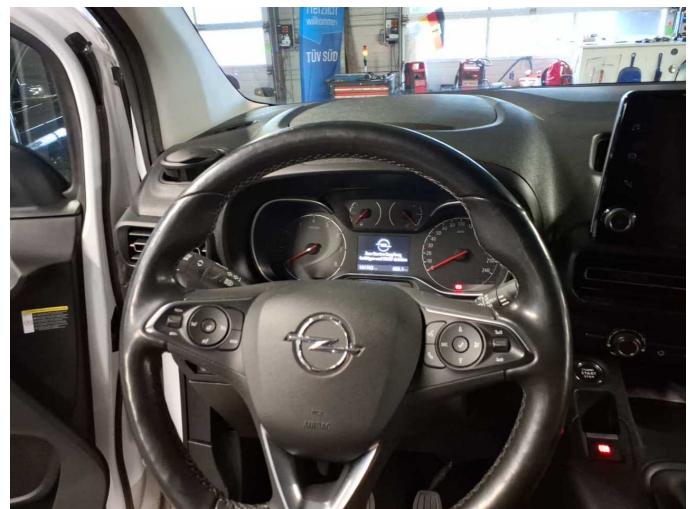
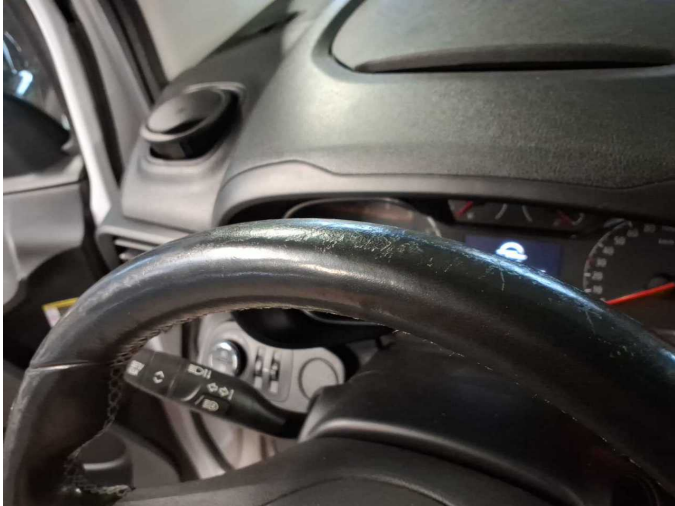
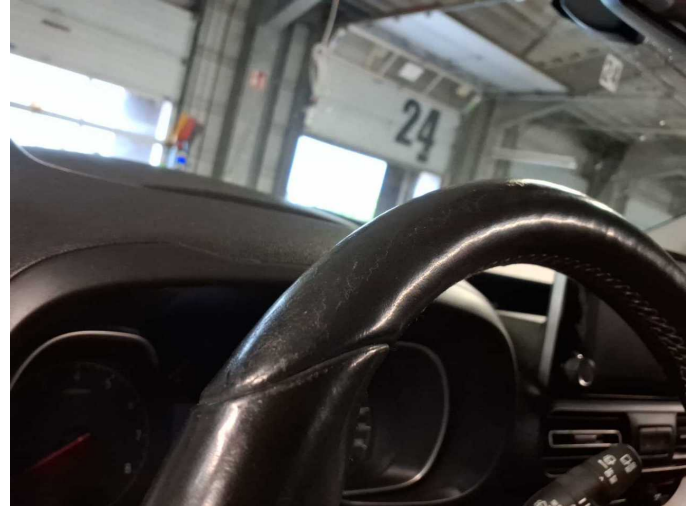
Damage 2: Steering system: Steering wheel - Abrasion - Smart repair

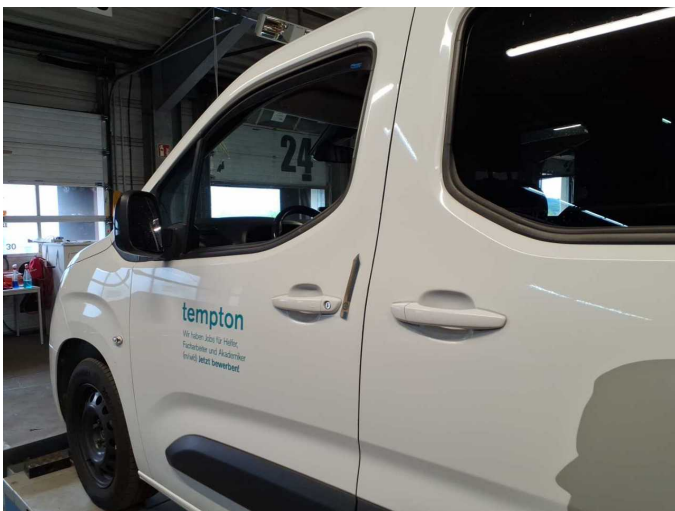
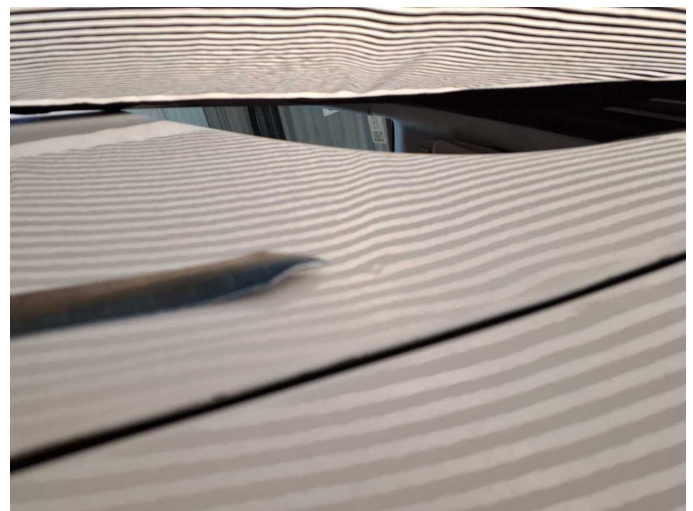
Damage 3: Door - front left side: Door - dent(s) - Smooth repair work

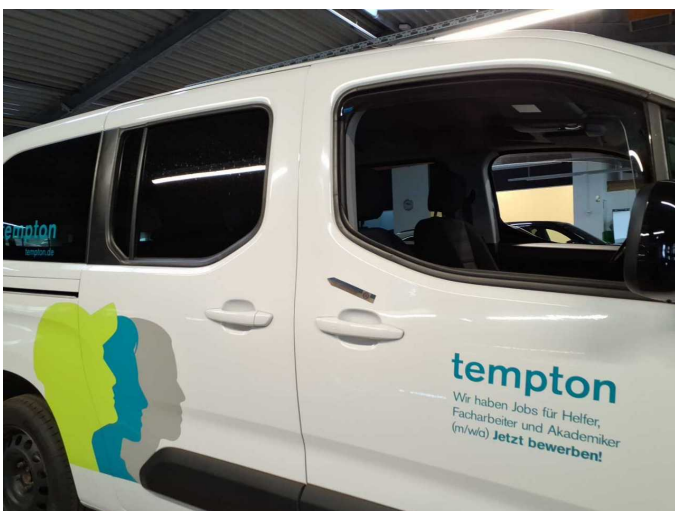
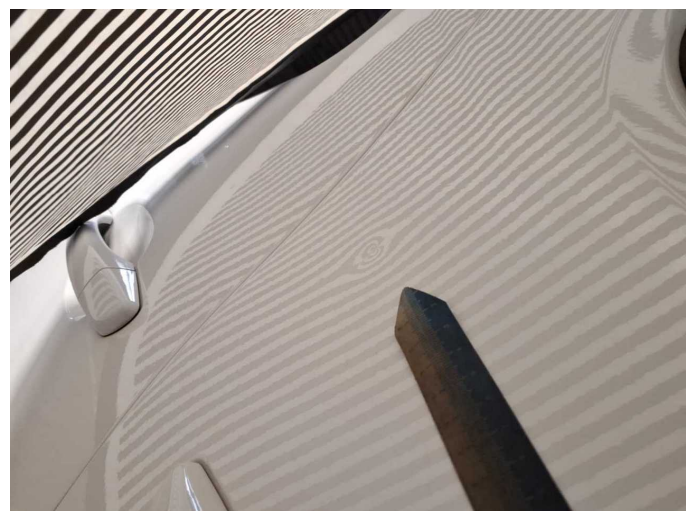
Damage 4: Door - front right side: Door - dent(s) - Smooth repair work

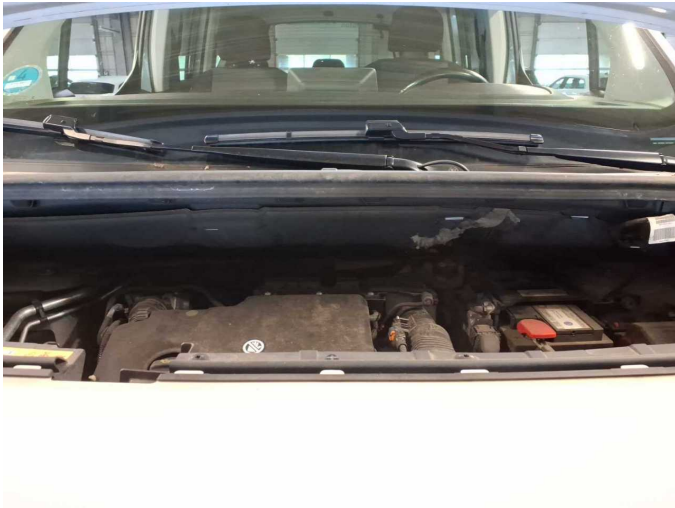
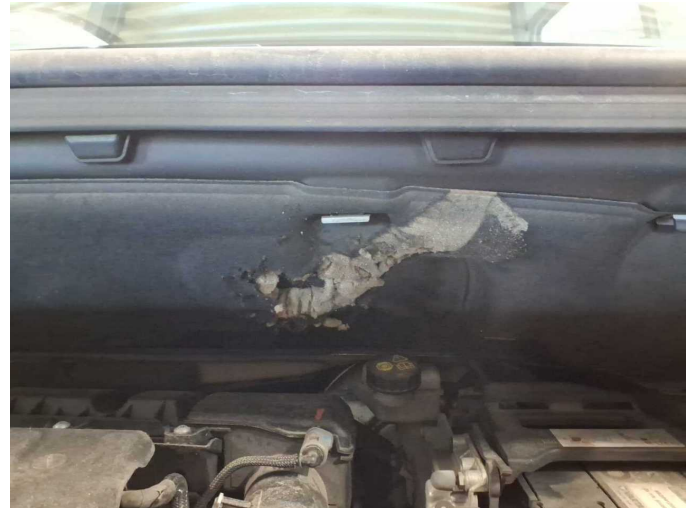
Damage 5: Misc.: Misc. (Dämmung Stirnwand) - Damage caused by marten / rodent - Replace

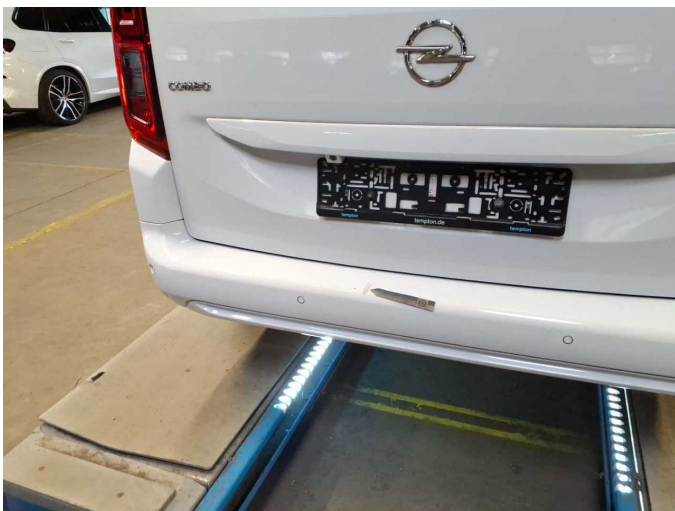
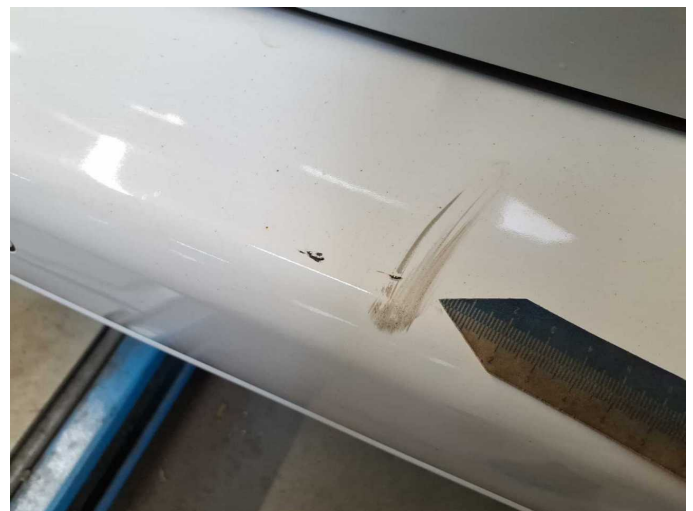
Damage 6: Rear bumper: Rear bumper - Scratch(es) - Smart repair

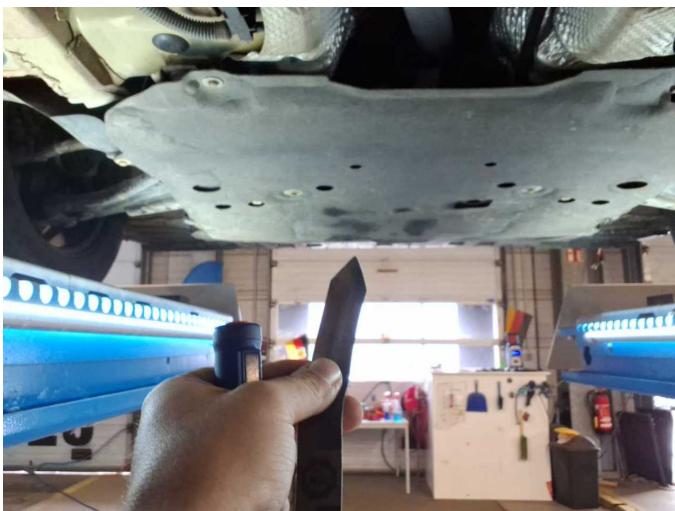
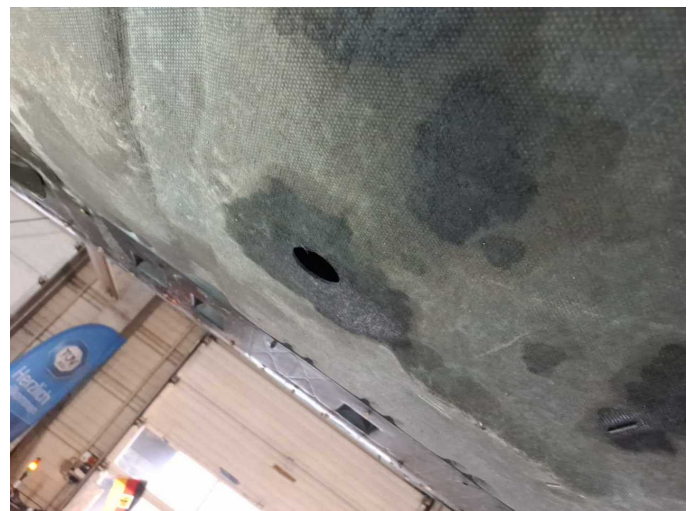
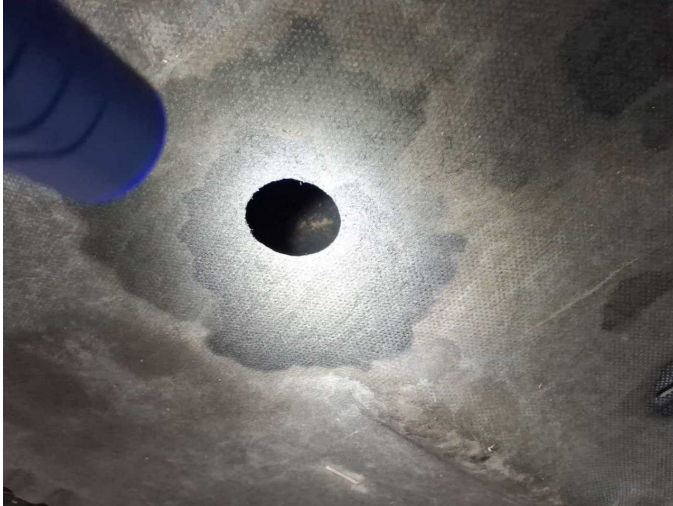
Damage 7: Engine: Engine - Leaking - Perform diagnosis

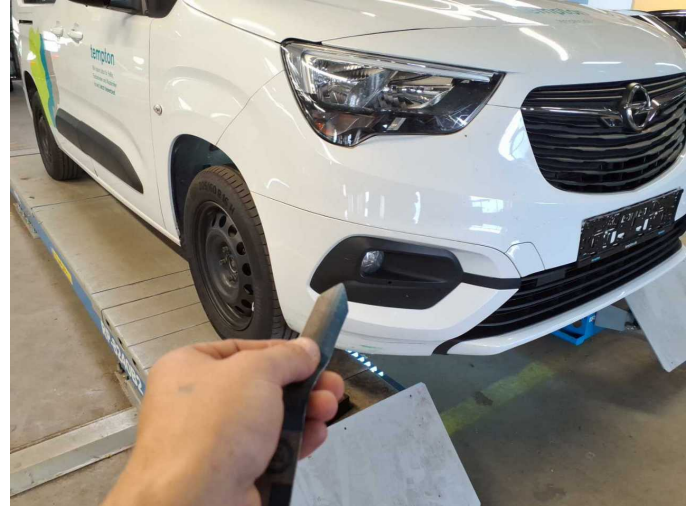
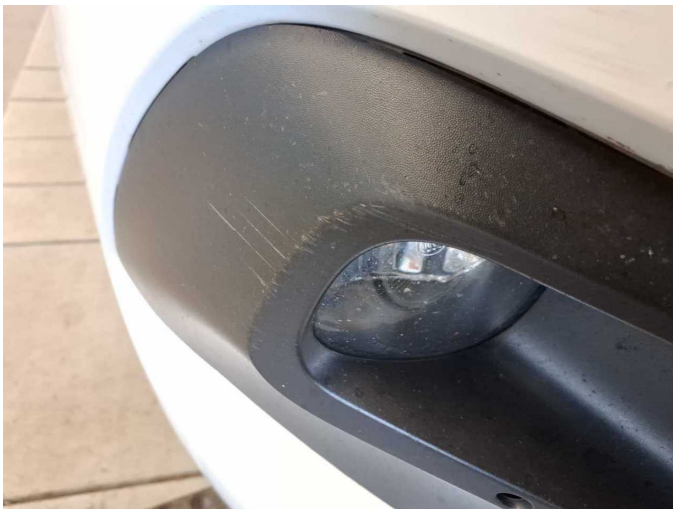
Damage 8: Fog lamp: Fog lamp - front right side (Rahmen) - Scratched - Replace

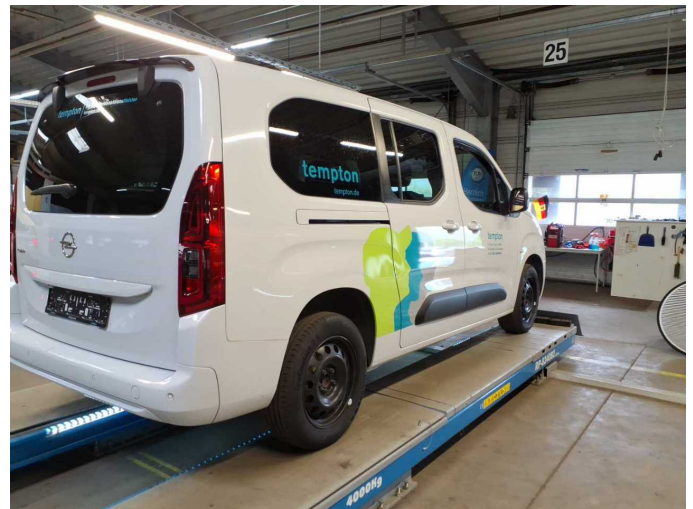
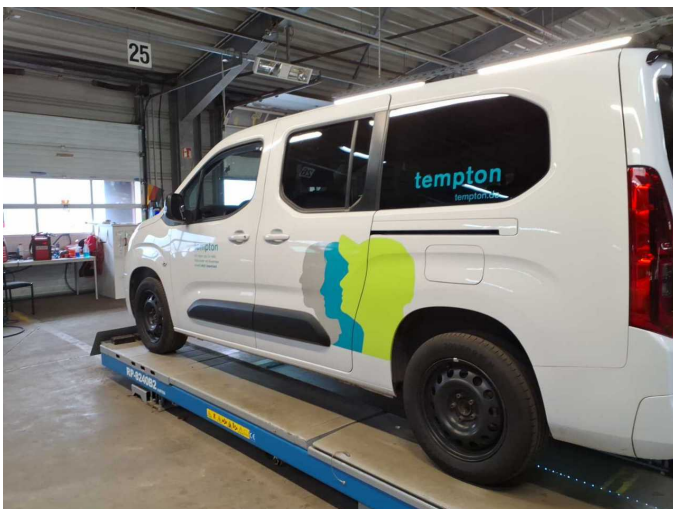
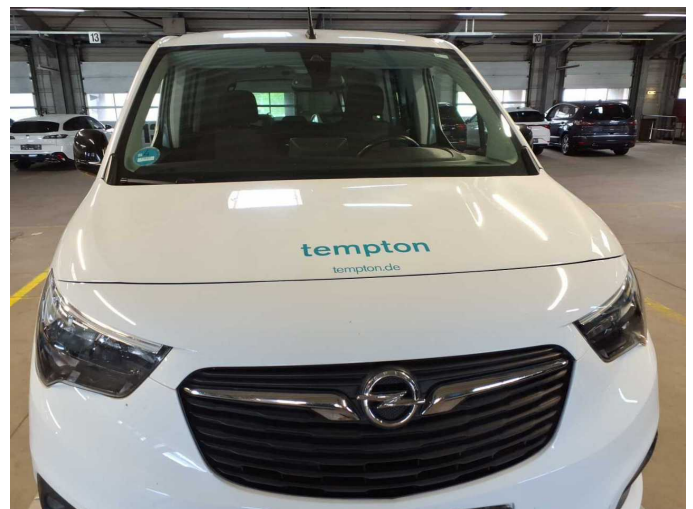
Damage 9: Body: Body - Glued / labelled - De-glue / neutralise

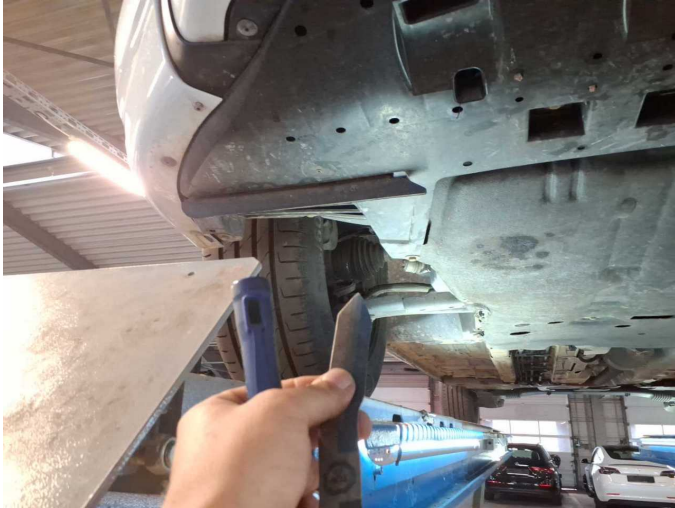
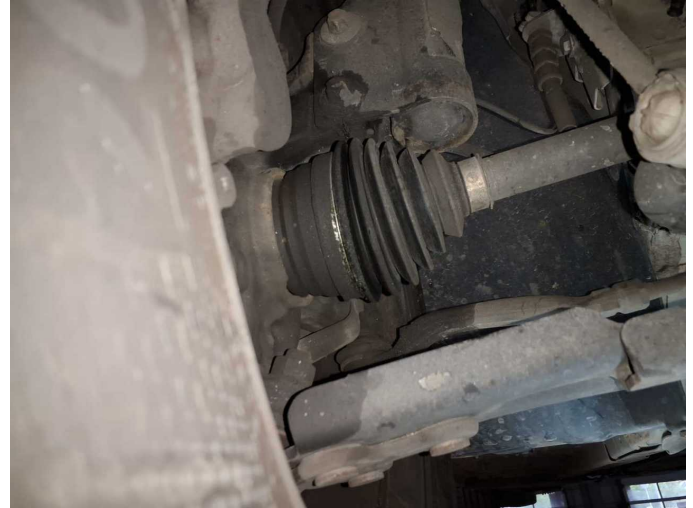
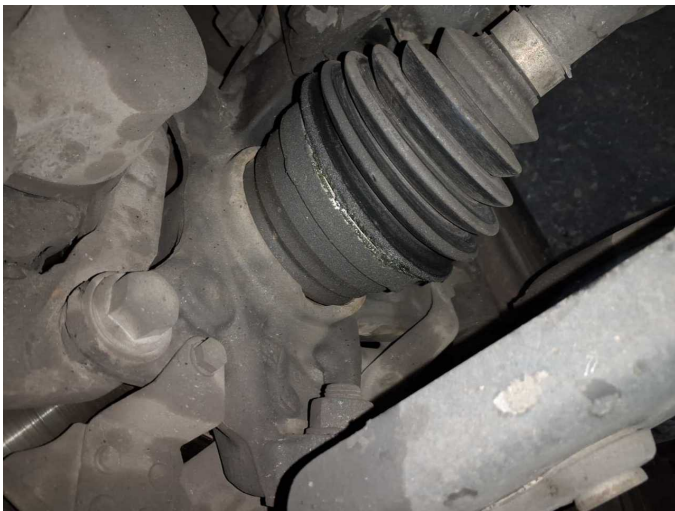
Damage 10: Drive train: Sleeve prop shaft - front right side - Broken / torn - Replace

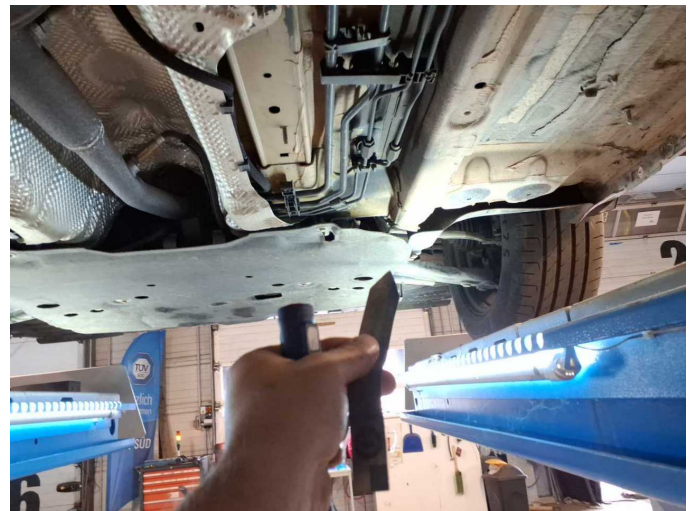
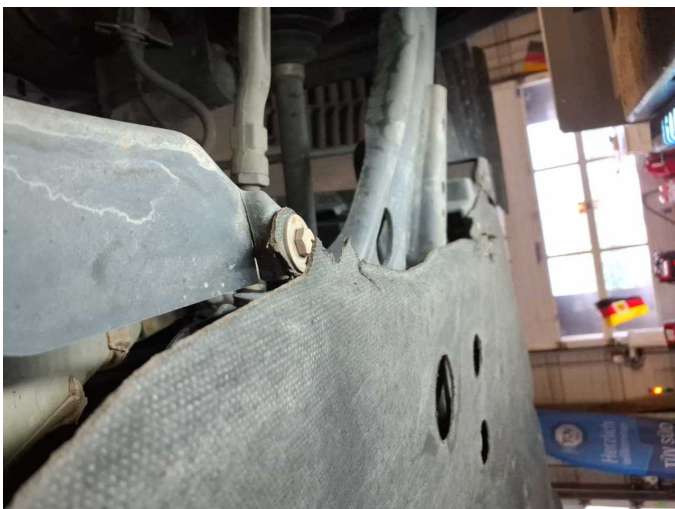
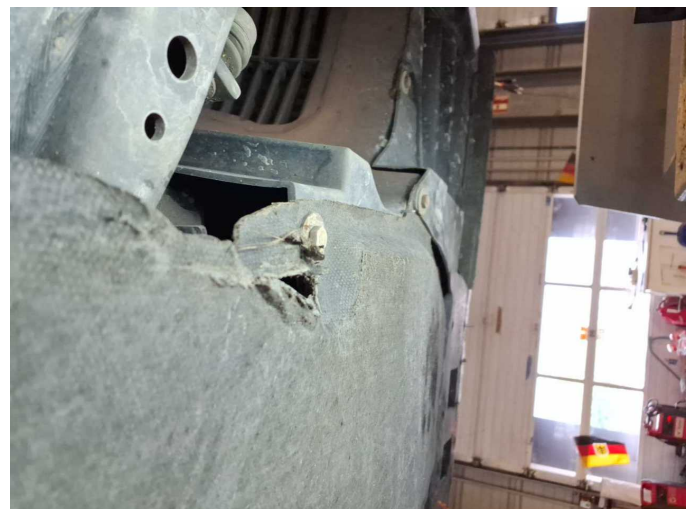
Damage 11: Engine: Engine cowling - lower - Broken / torn - Replace

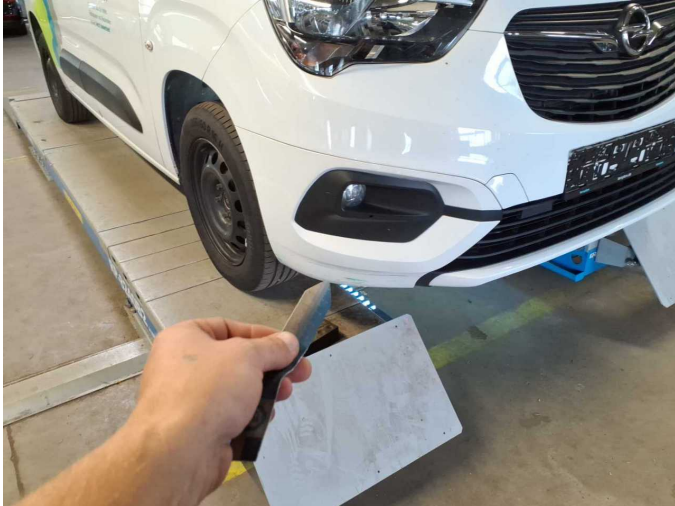
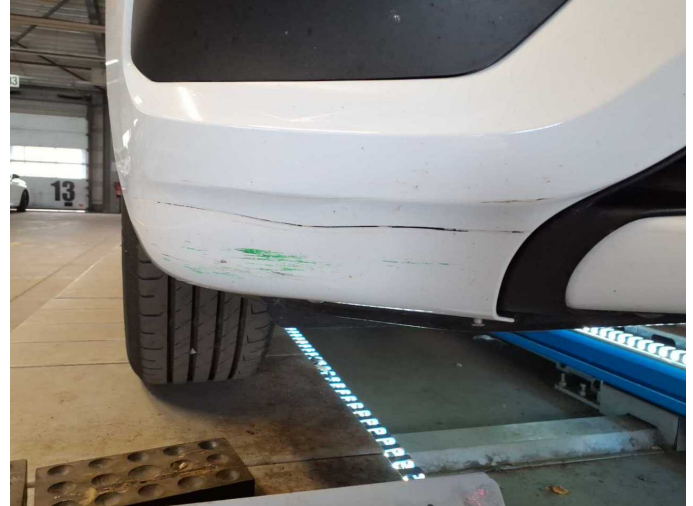
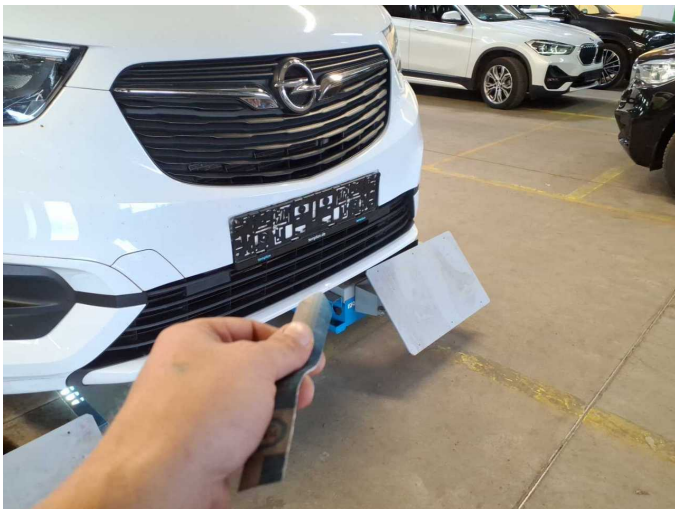
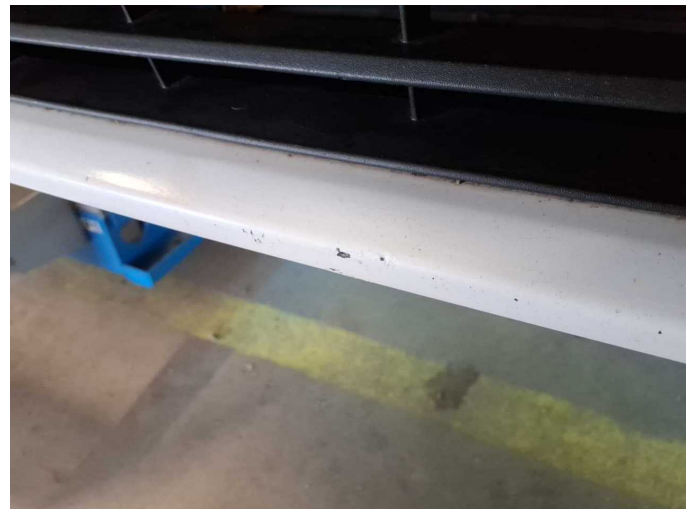
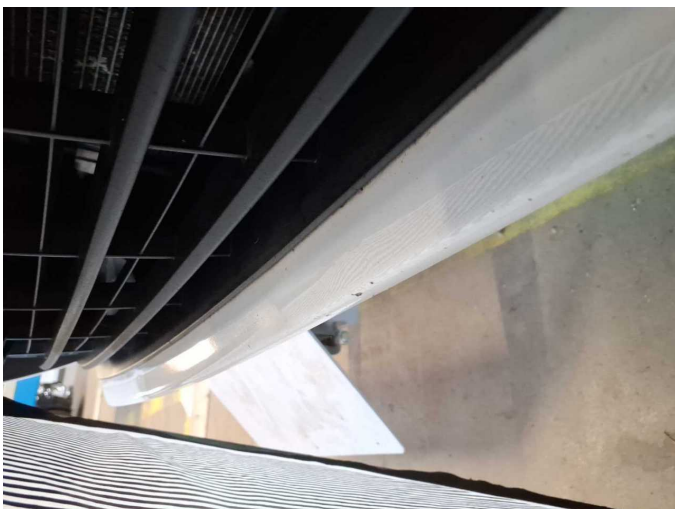
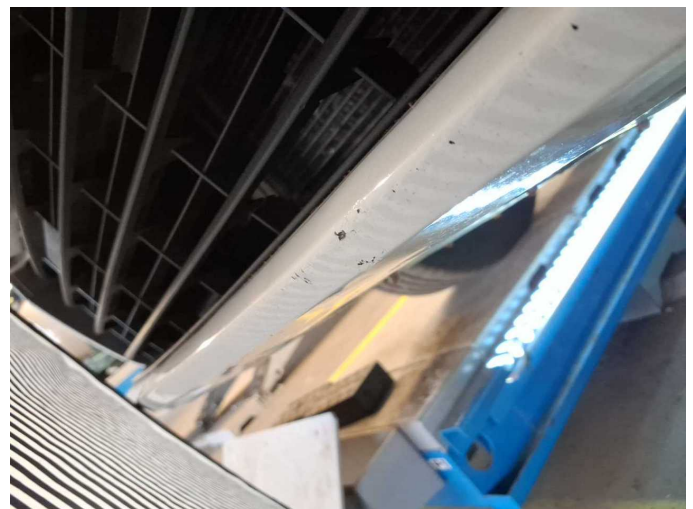
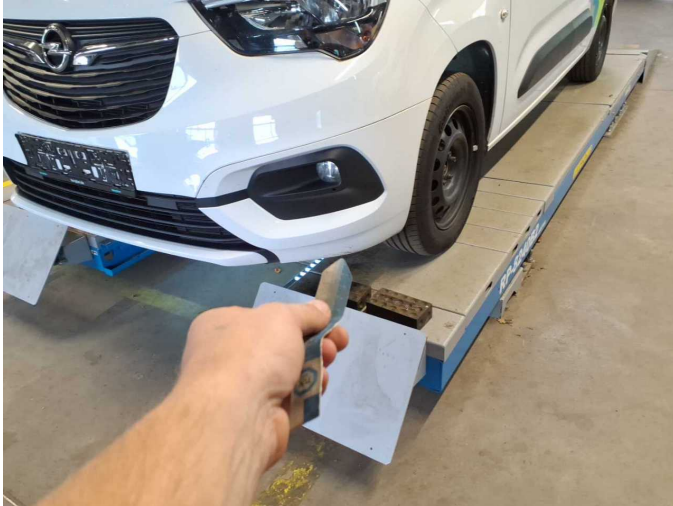
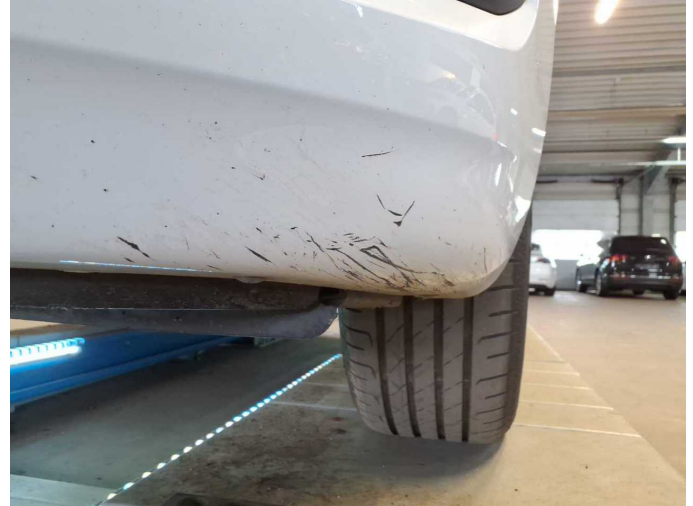
Damage 12: Front bumper: Front bumper (Leicht eingedrückt) - Scratched - Repair and paint

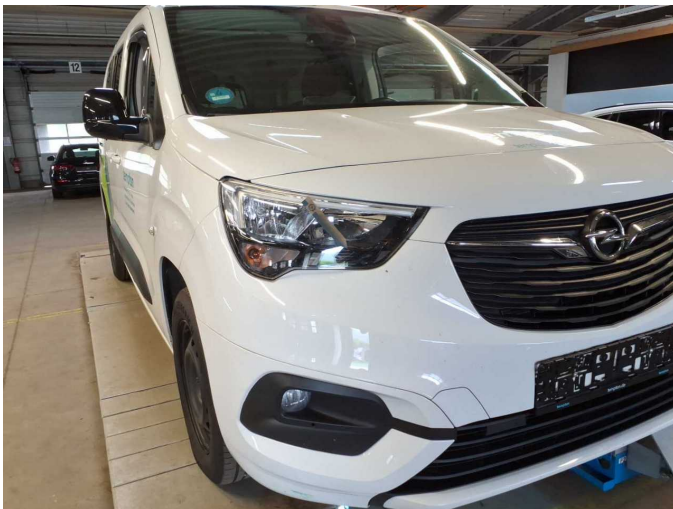
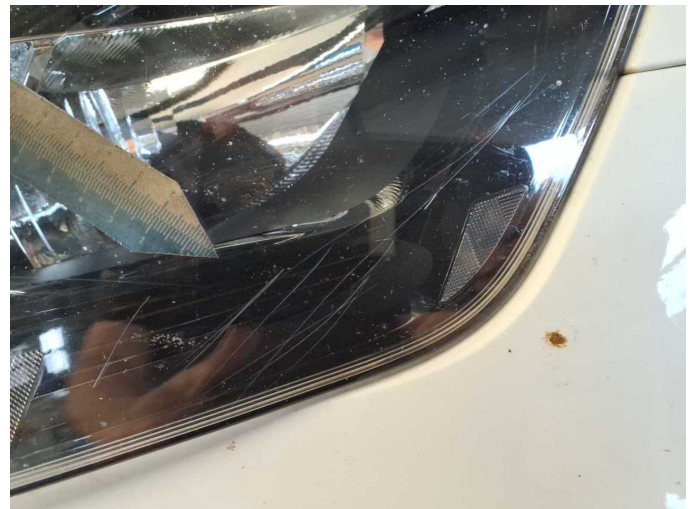
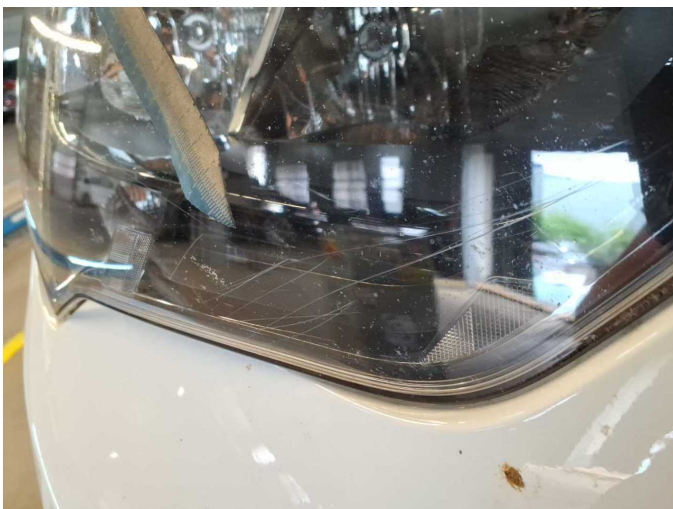
Damage 13: Headlight: Headlight - right side - Scratched - Replace

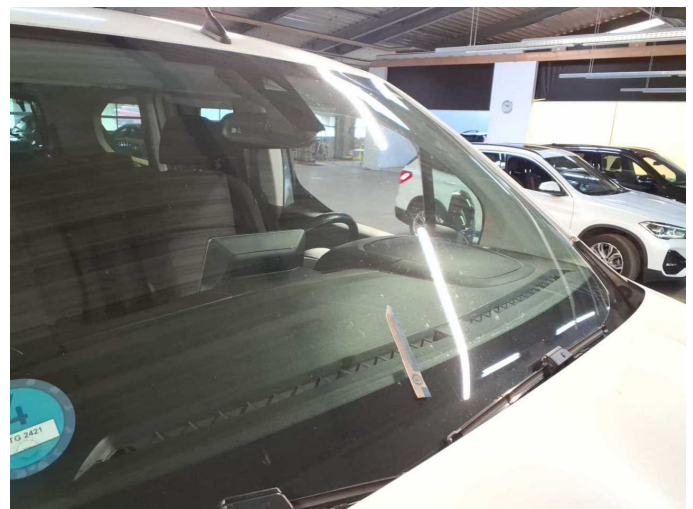
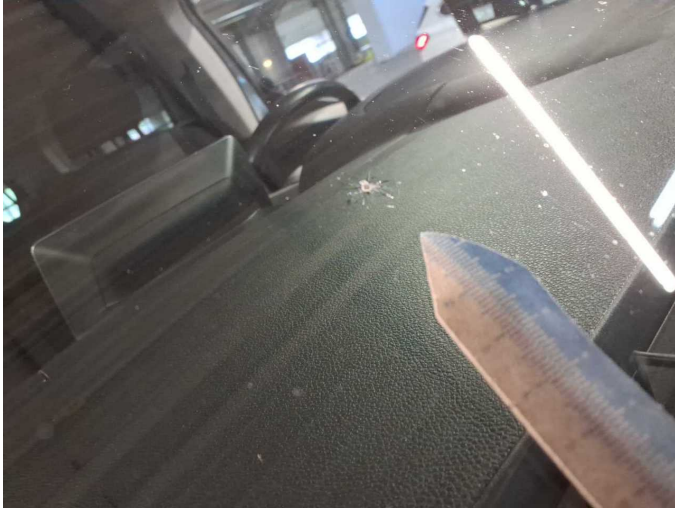
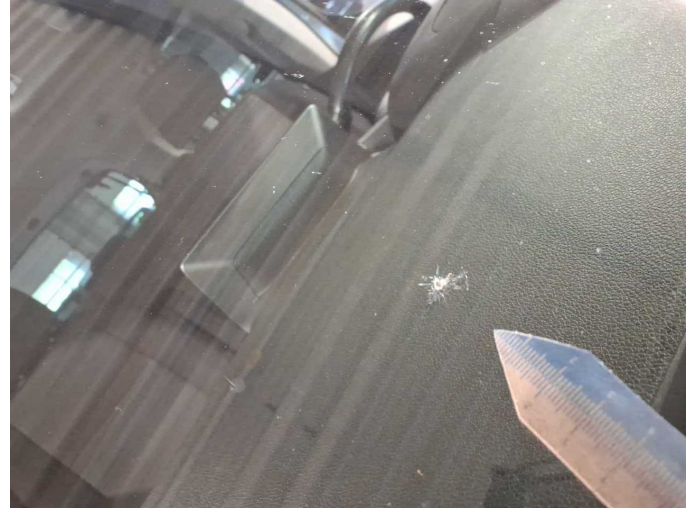
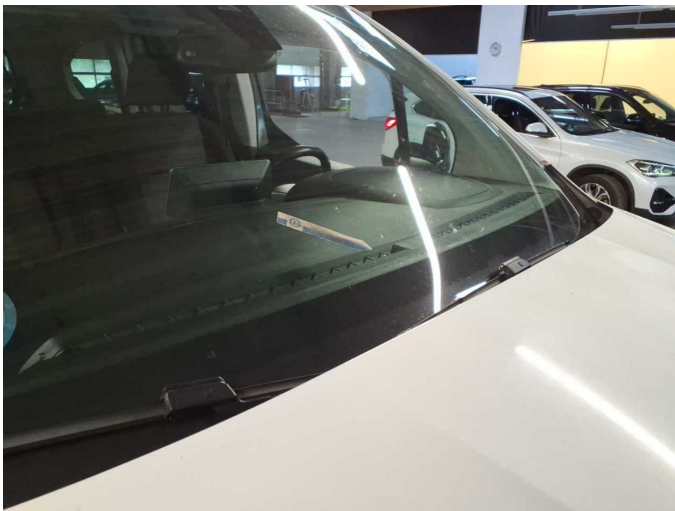
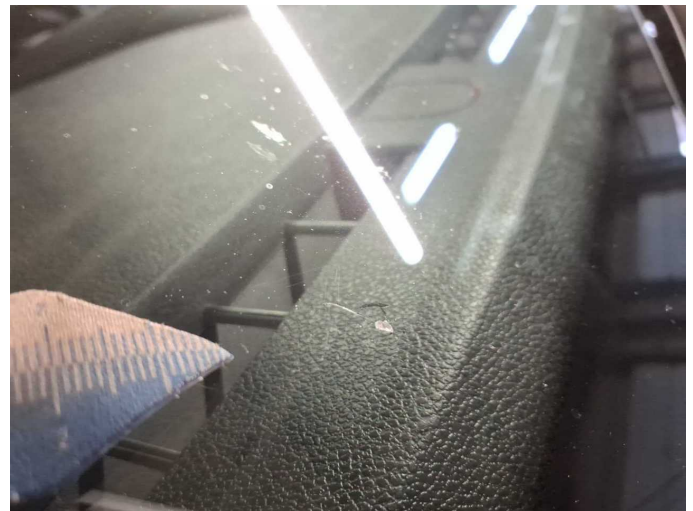
Damage 14: Vehicle glazing: Windscreen (Rissbildung) - Stone chips - Replace

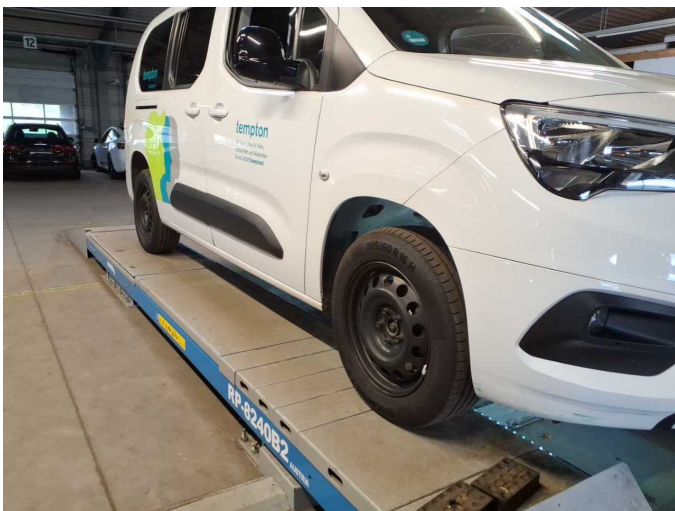
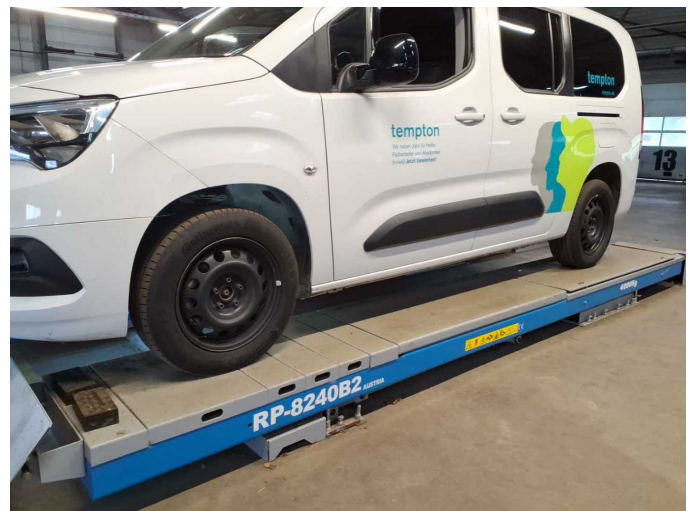
Damage 15: Wheel / tyres: Tyres - complete set (Stahl statt Alufelgen) - Differs from the original configuration - Replace
