Expertise

Protocol number: 46438670  
Order No. / Reference: 26618343  
Inspection date: 10 Jul 2026

Manufacturer: Ford

Model: Kuga 2.5 Duratec PHEV ST-LINE X

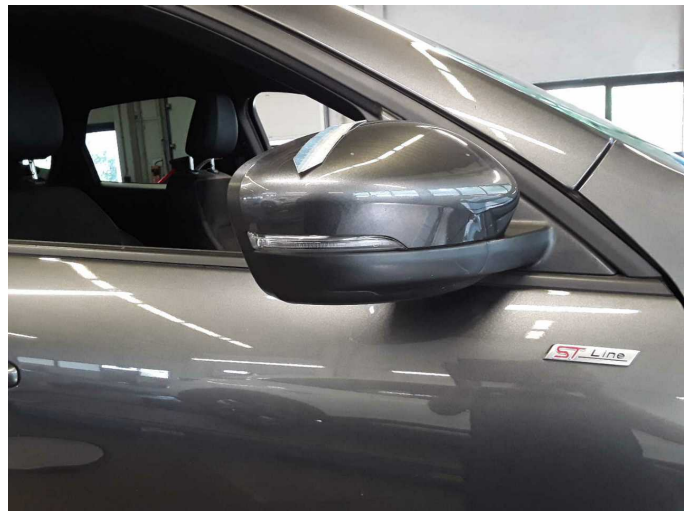
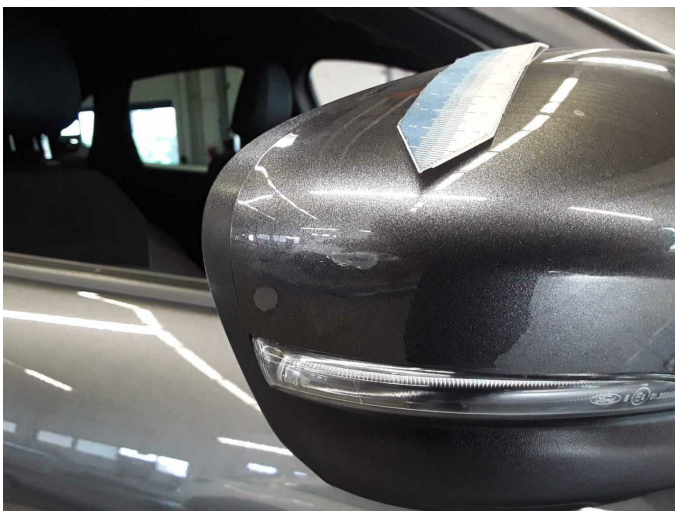
| No. | Component group | Description |
|---|---|---|
| 1 | Wing mirror - right side | Cap - Scratch(es) - Smart repair |

**Damage 1:** Wing mirror - right side: Cap - Scratch(es) - Smart repair

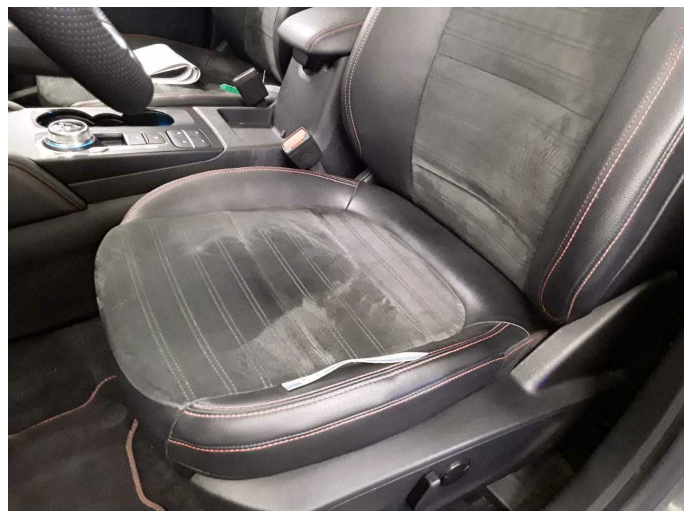
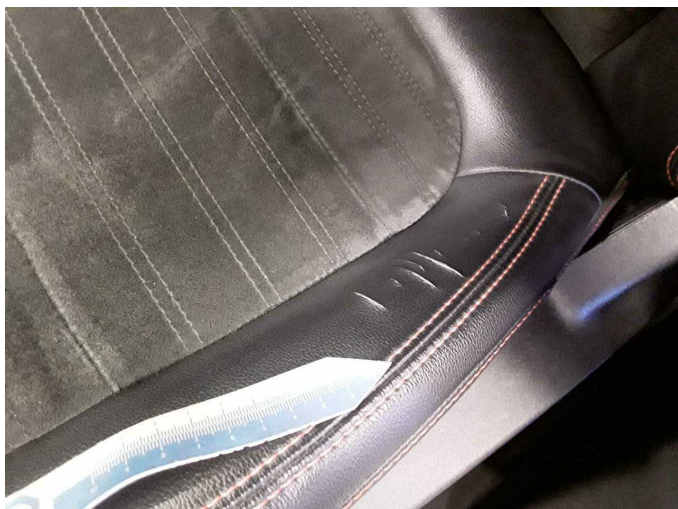
| No. | Component group | Description |
|---|---|---|
| 2 | Seat - front | Seat cover - left side - Porous / cracked - Smart repair |

**Damage 2:** Seat - front: Seat cover - left side - Porous / cracked - Smart repair

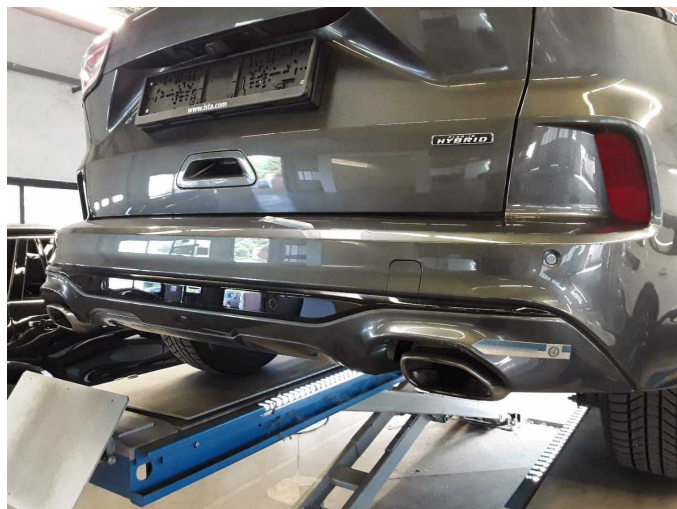
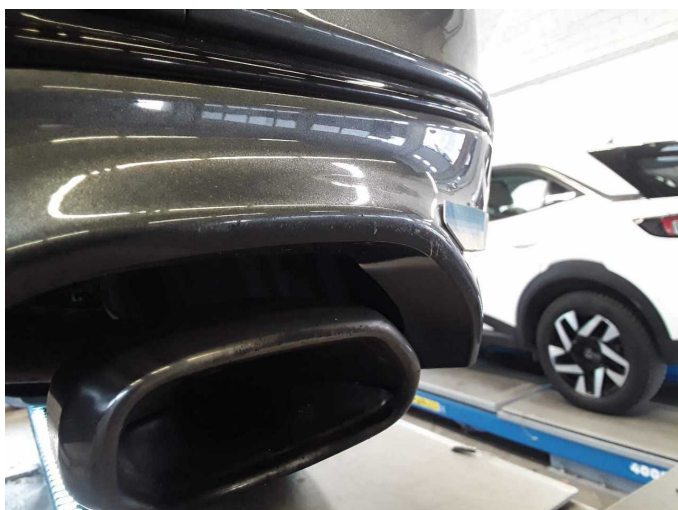
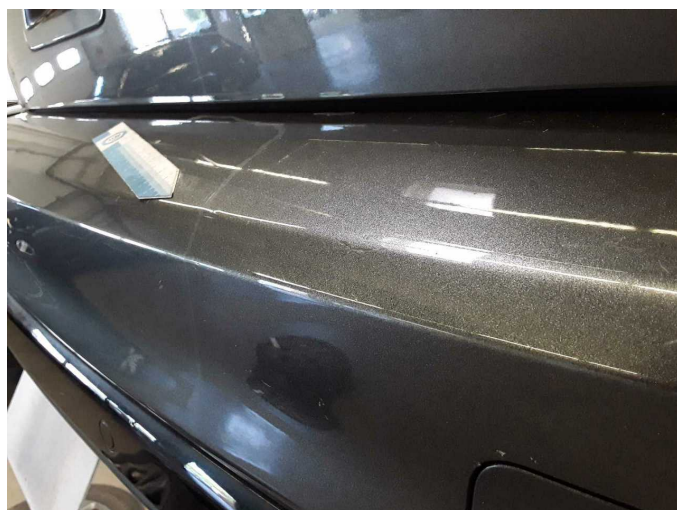
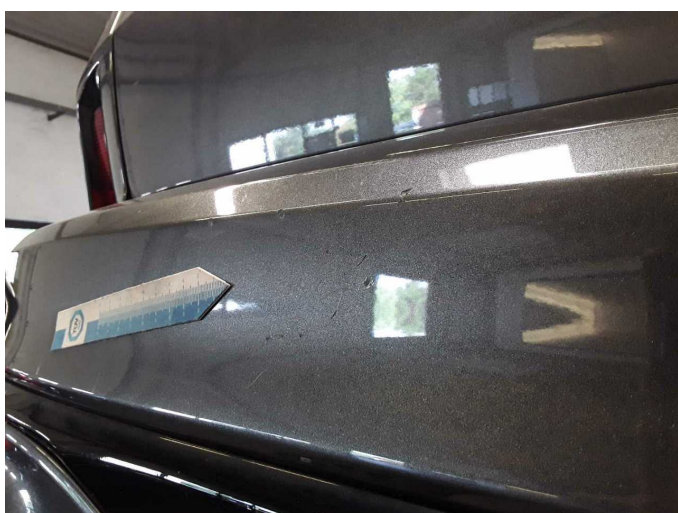
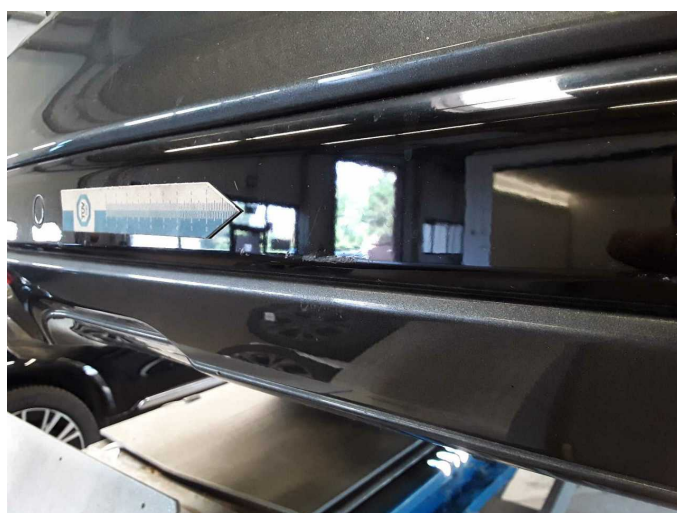
| No. | Component group | Description |
|---|---|---|
| 3 | Rear bumper | Rear bumper - Scratch(es) - Paint |

**Damage 3:** Rear bumper: Rear bumper - Scratch(es) - Paint

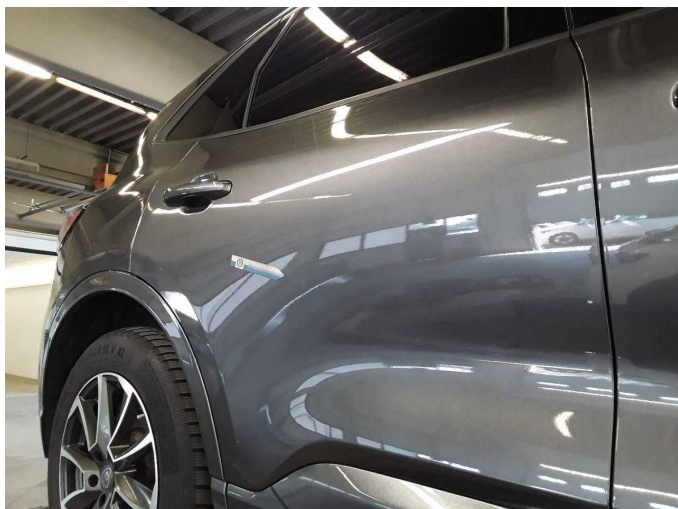
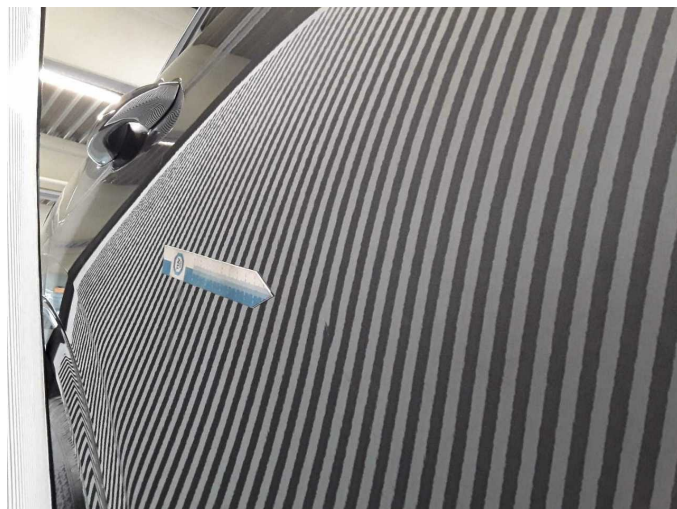
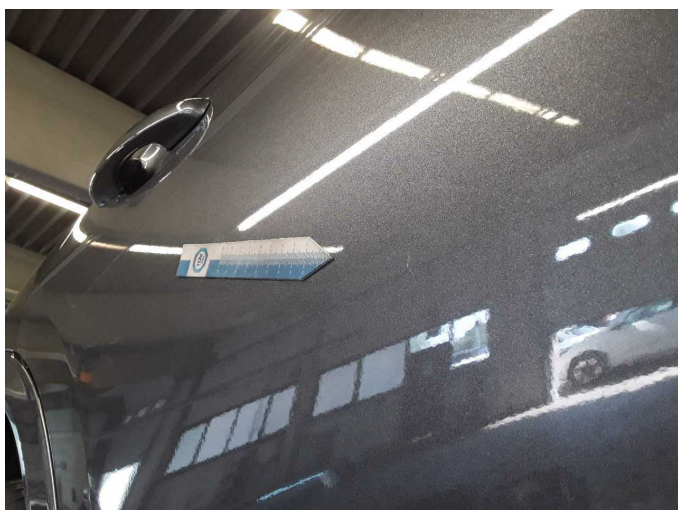
| No. | Component group | Description |
|---|---|---|
| 4 | Door - rear right side | Door - Dent / paintcoat damage - Repair and paint |

**Damage 4:** Door - rear right side: Door - Dent / paintcoat damage - Repair and paint

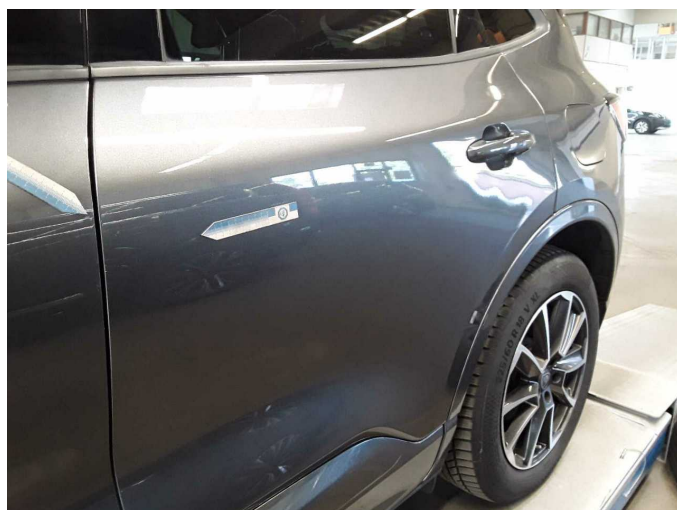
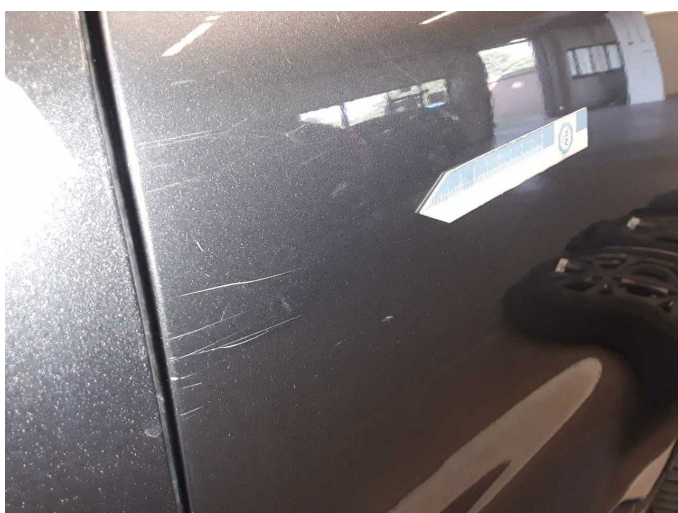
| No. | Component group | Description |
|---|---|---|
| 5 | Door - rear left side | Door - Scratch(es) - Paint |

**Damage 5:** Door - rear left side: Door - Scratch(es) - Paint

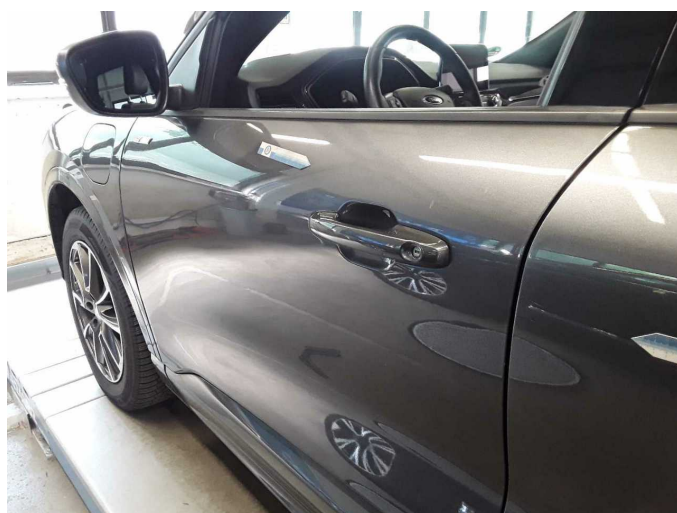
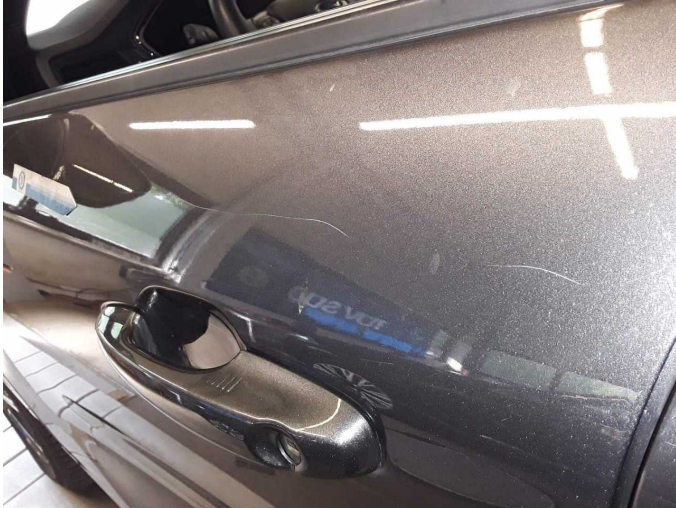
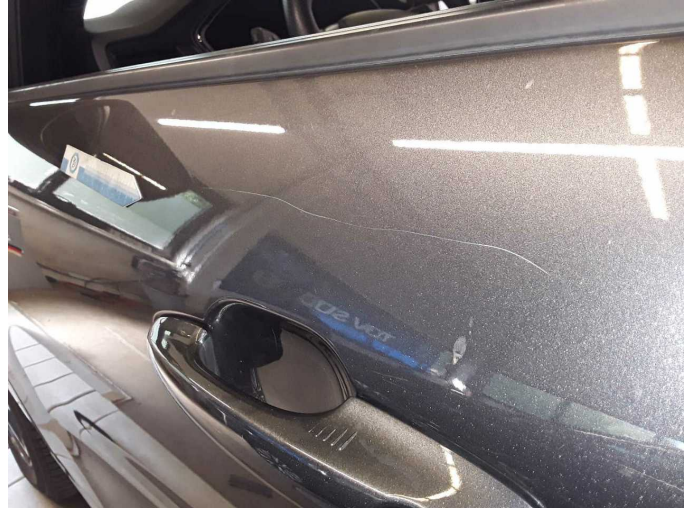
| No. | Component group | Description |
|---|---|---|
| 6 | Door - front left side | Door - Scratch(es) - Paint |

**Damage 6:** Door - front left side: Door - Scratch(es) - Paint

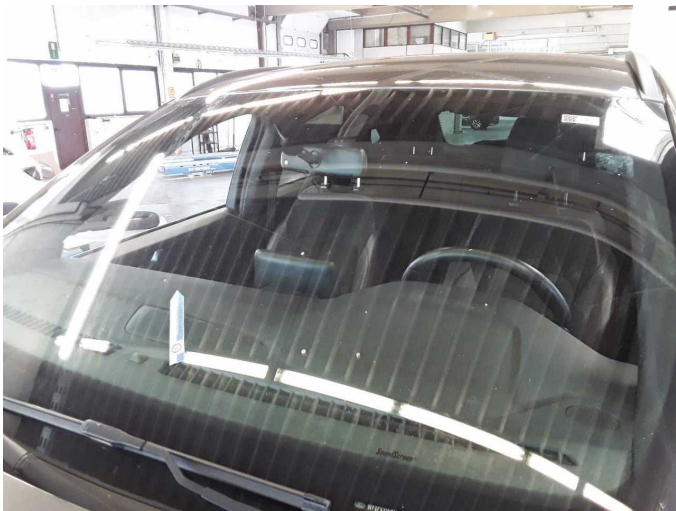
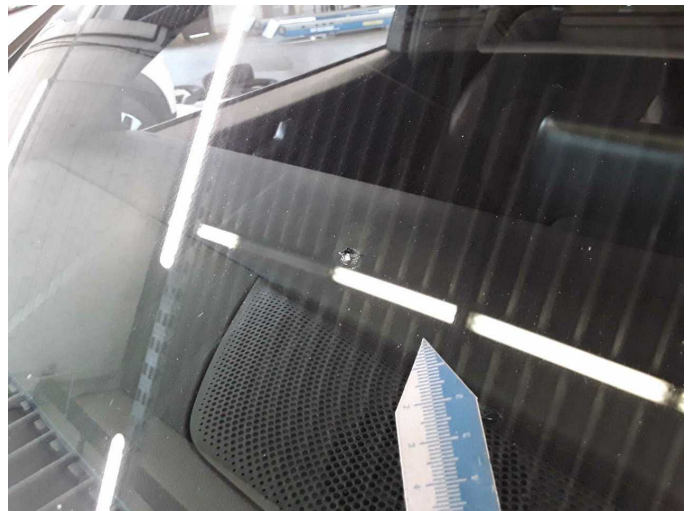
| No. | Component group | Description |
|---|---|---|
| 7 | Vehicle glazing | Windscreen - Stone chips - Replace |

**Damage 7:** Vehicle glazing: Windscreen - Stone chips - Replace

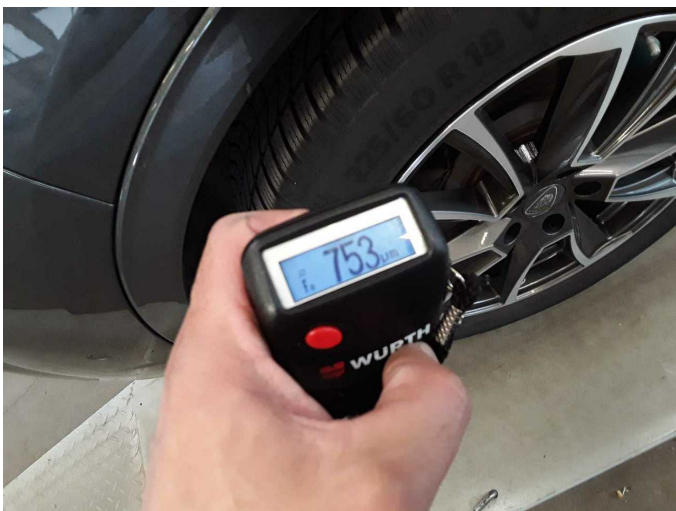
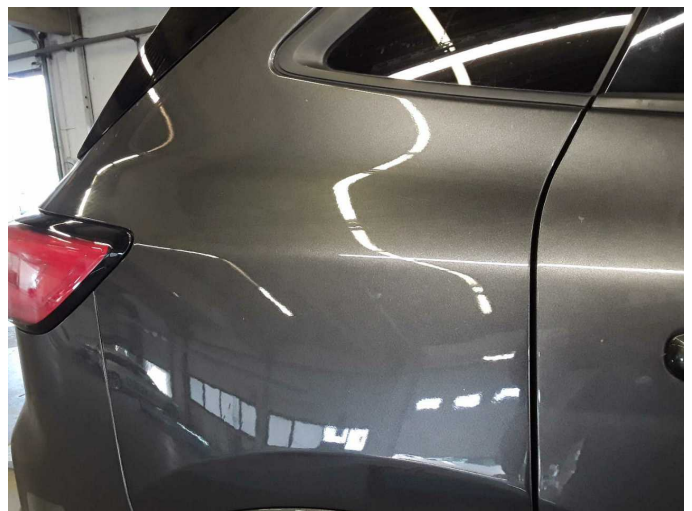
1 Side panel - rear right side, Professionally carried out, Invoice of repair done Non-existent

Side panel - rear right side

753 µm

**Repainting 1:** Side panel - rear right side
