Expertise

Protocol number: 46605201  
Order No. / Reference: 26754606  
Inspection date: 16 Jul 2026

Manufacturer: Opel

Model: Astra 1.5 D Start/Stop Sports Tourer Business Edition

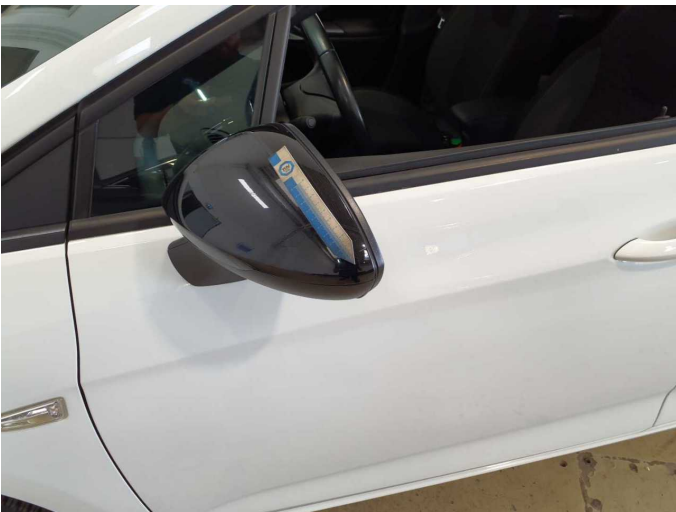
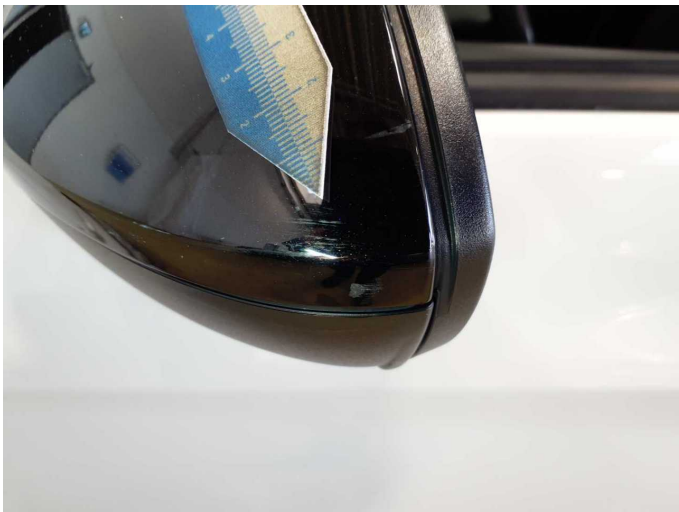
| No. | Component group | Description |
|---|---|---|
| 2 | Wing mirror - left side | Cap - Scratch(es) - Smart repair |

Damage 2: Wing mirror - left side: Cap - Scratch(es) - Smart repair

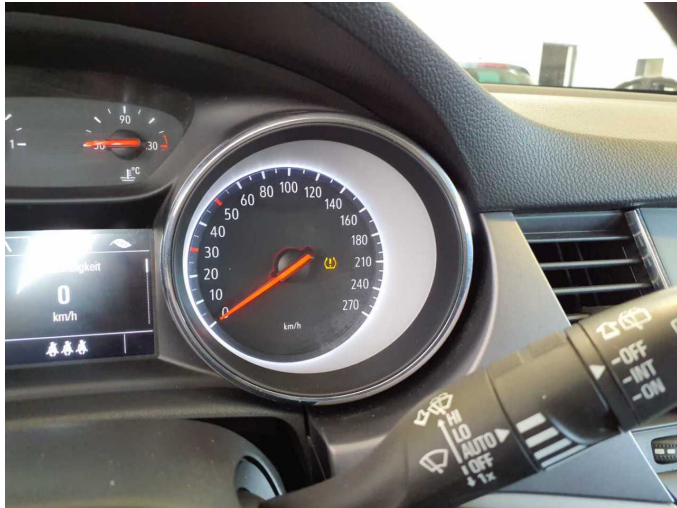
| No. | Component group | Description |
|---|---|---|
| 3 | Wheel / tyres | Tyres - complete set (Reifendruck) - Specify findings - Perform diagnosis |

**Damage 3:** Wheel / tyres: Tyres - complete set (Reifendruck) - Specify findings - Perform diagnosis

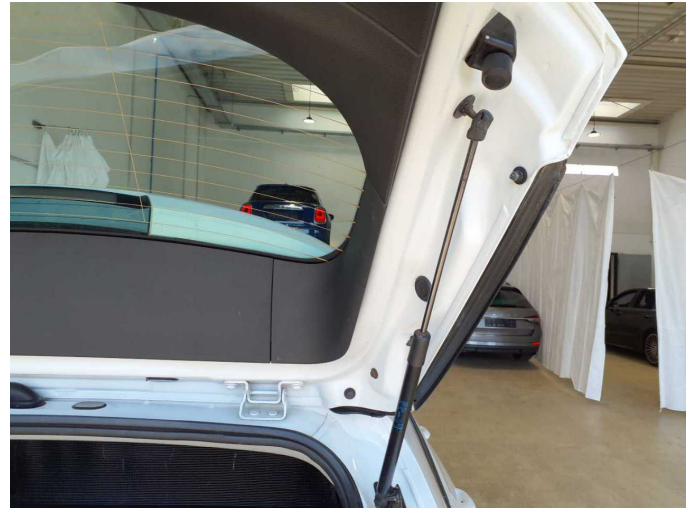
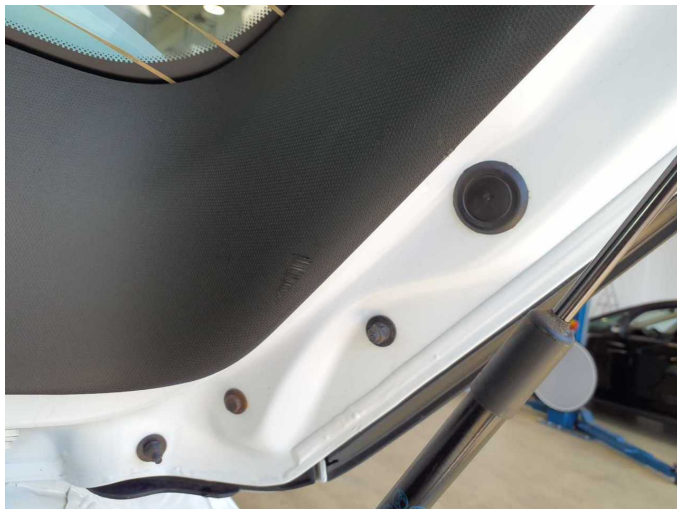
| No. | Component group | Description |
|---|---|---|
| 4 | Trim / covers | Boot lid - interior trim - Scratch(es) - Smart repair |

**Damage 4:** Trim / covers: Boot lid - interior trim - Scratch(es) - Smart repair

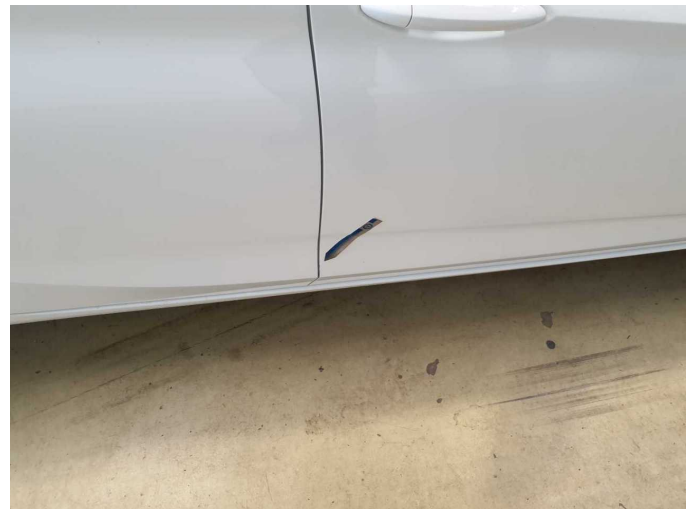
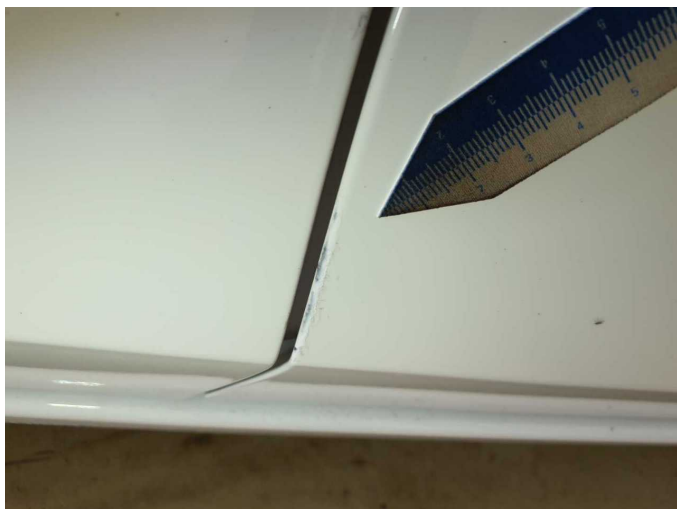
| No. | Component group | Description |
|---|---|---|
| 5 | Door - front right side | Door edge - Scratch(es) - Smart repair |

**Damage 5:** Door - front right side: Door edge - Scratch(es) - Smart repair

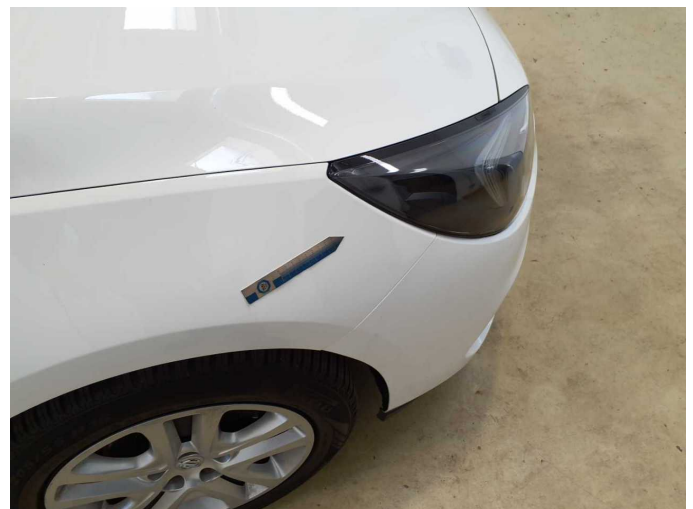
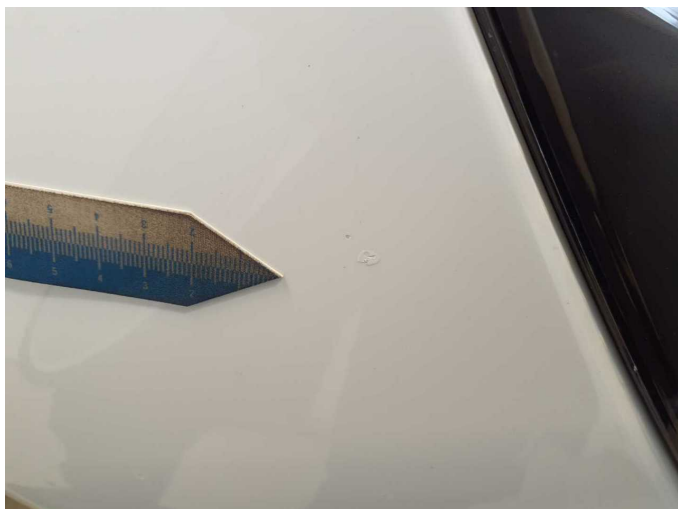
| No. | Component group | Description |
|---|---|---|
| 6 | Mudguard - right side | Mudguard - right side - Scratch(es) - Smart repair |

**Damage 6:** Mudguard - right side: Mudguard - right side - Scratch(es) - Smart repair

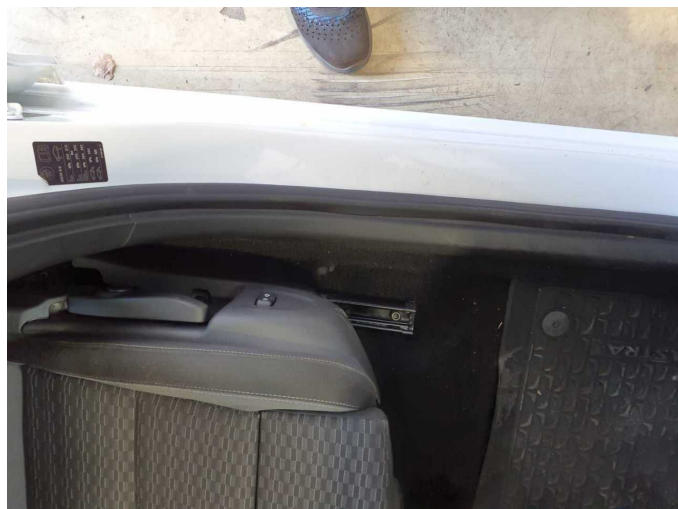
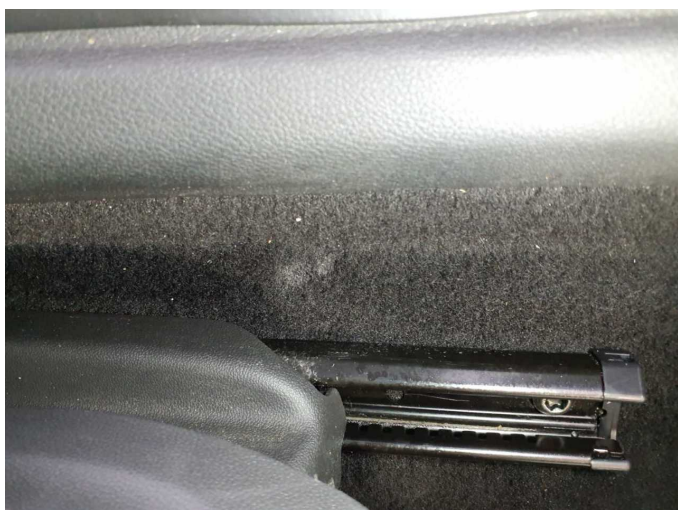
| No. | Component group | Description |
|---|---|---|
| 7 | Trim / covers | Carpet - front left side - Burn hole (cigarettes) - Smart repair |

**Damage 7:** Trim / covers: Carpet - front left side - Burn hole (cigarettes) - Smart repair

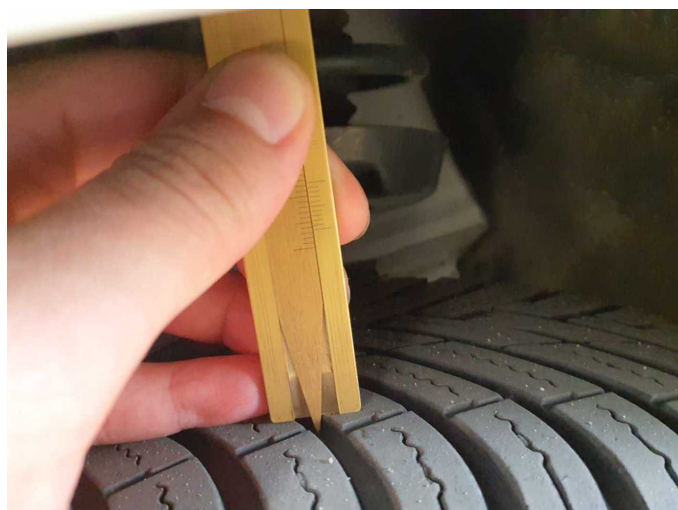
| No. | Component group | Description |
|---|---|---|
| 8 | Wheel / tyres | Wheel cover - front right side - Does not meet the leasing specifications - Replace |

**Damage 8:** Wheel / tyres: Wheel cover - front right side - Does not meet the leasing specifications - Replace

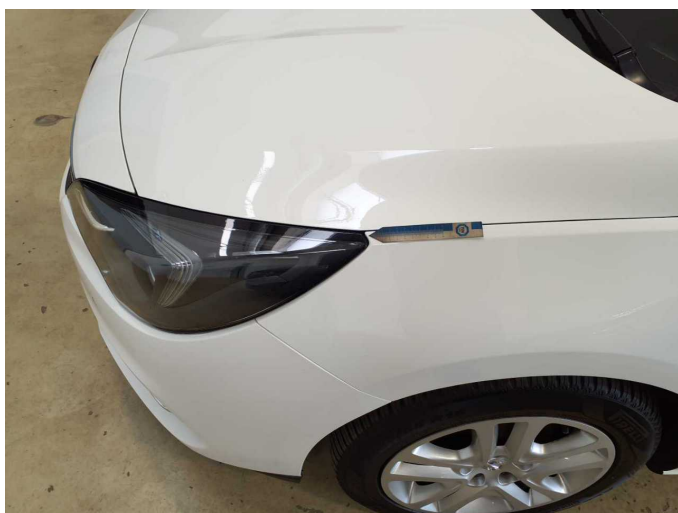
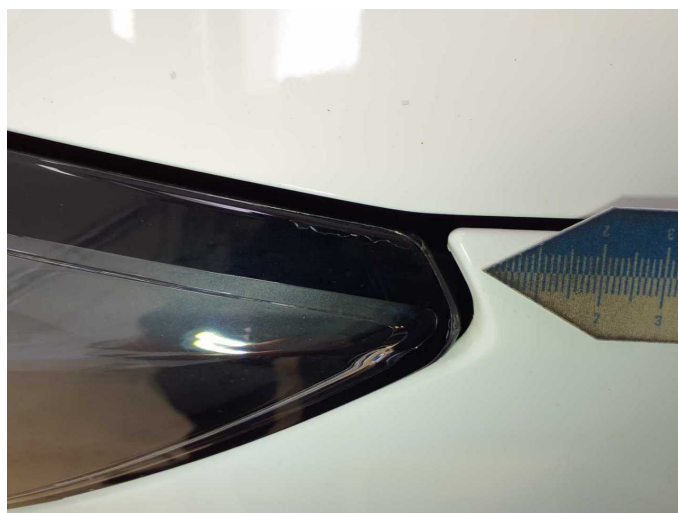
| No. | Component group | Description |
|---|---|---|
| 9 | Headlight | Headlight - left side (Klarlack löst sich, Randbereich) - Paint defect - Replace |

**Damage 9:** Headlight: Headlight - left side (Klarlack lack löst sich, Randbereich) - Paint defect - Replace

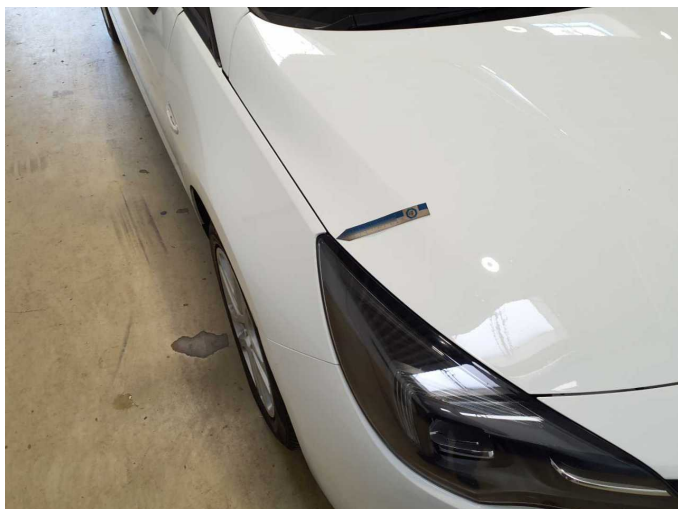
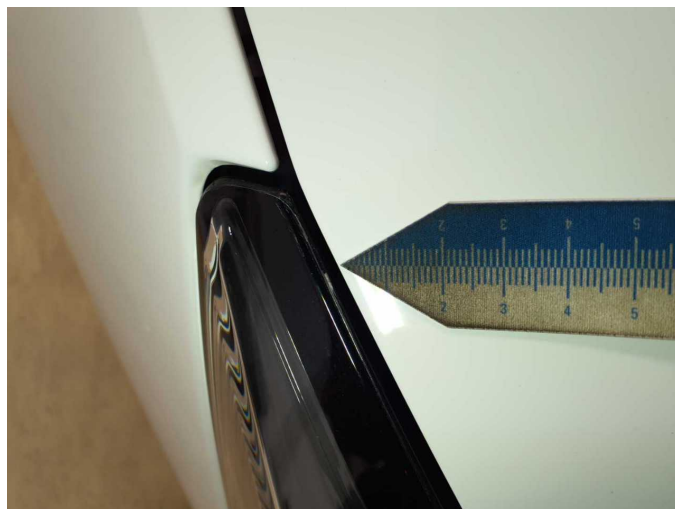
| No. | Component group | Description |
|---|---|---|
| 10 | Headlight | Headlight - right side (Klarlack löst sich, Randbereich) - Paint defect - Replace |

**Damage 10:** Headlight: Headlight - right side (Klarlack löst sich, Randbereich) - Paint defect - Replace

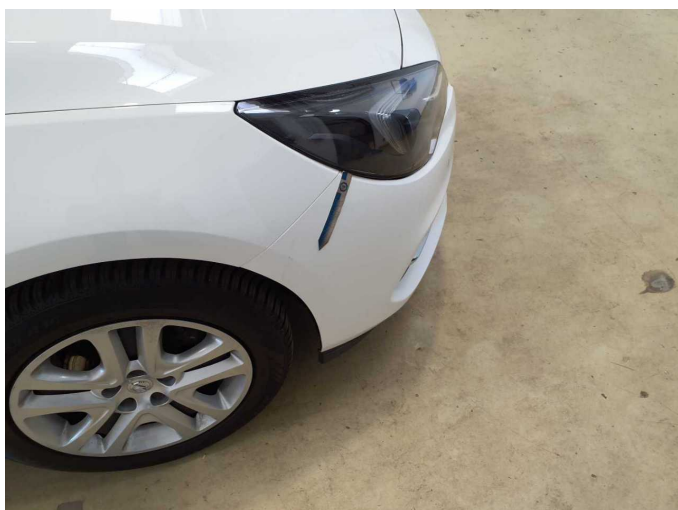
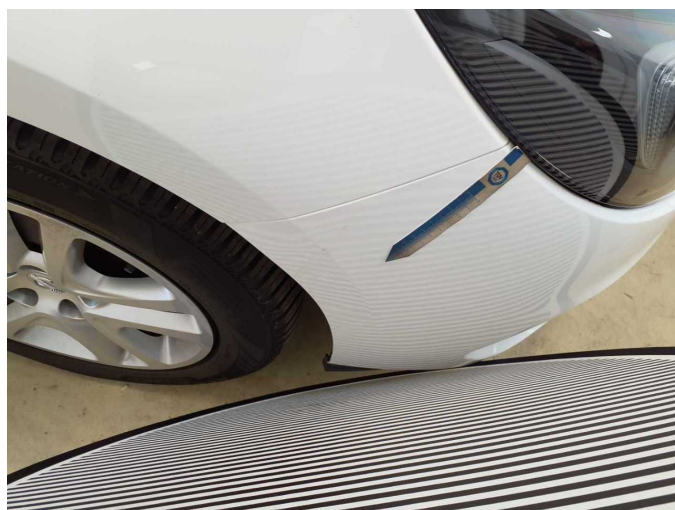
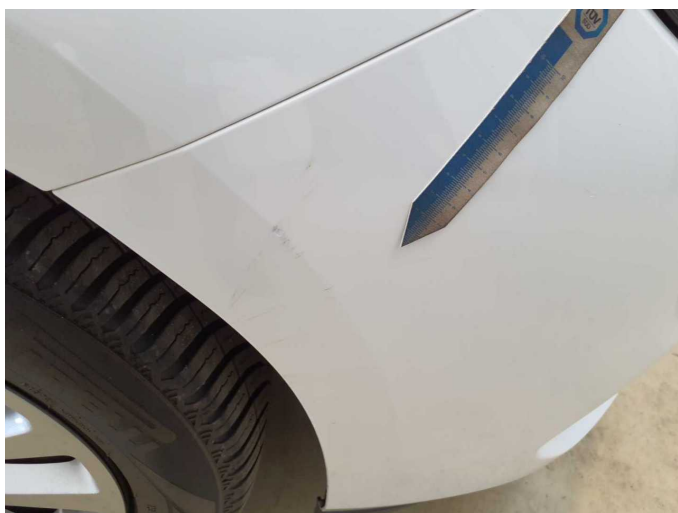
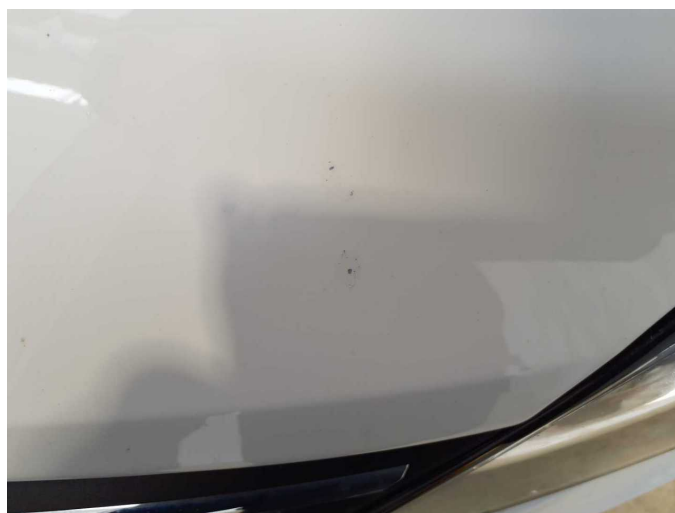
| No. | Component group | Description |
|---|---|---|
| 11 | Front bumper | Front bumper - Dent / paintcoat damage - Paint |

**Damage 11:** Front bumper: Front bumper - Dent / paintcoat damage - Paint

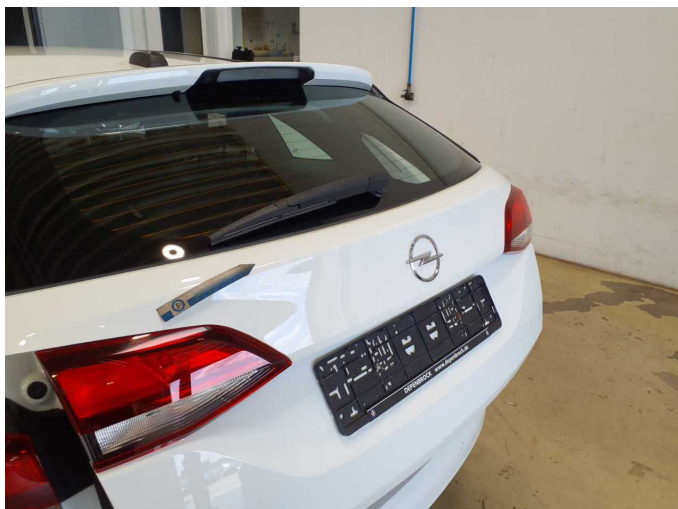
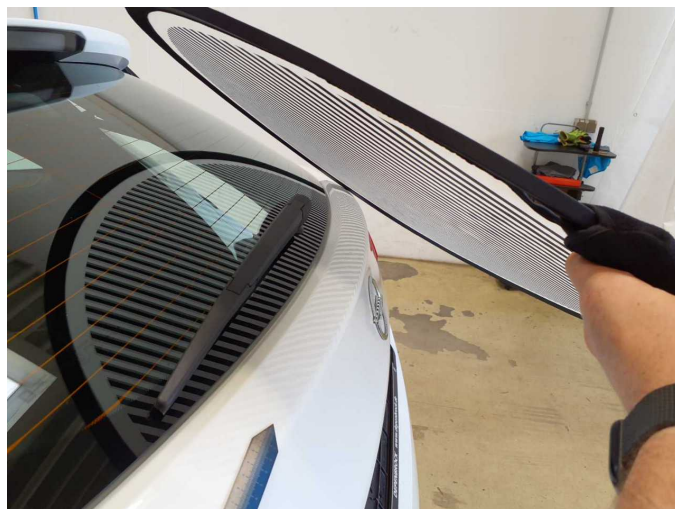
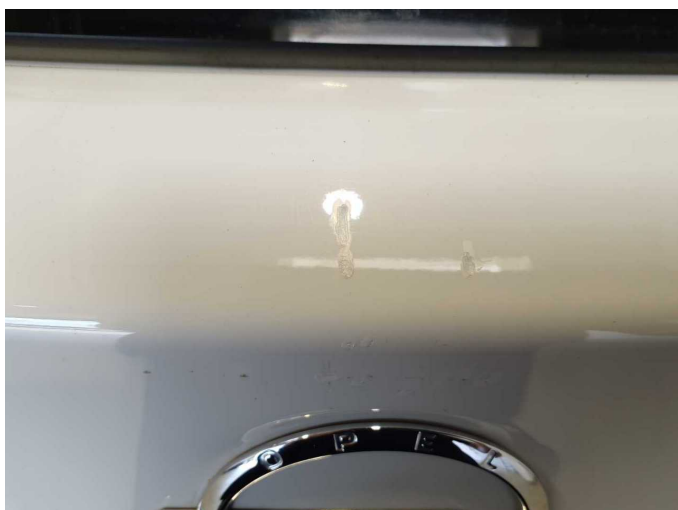
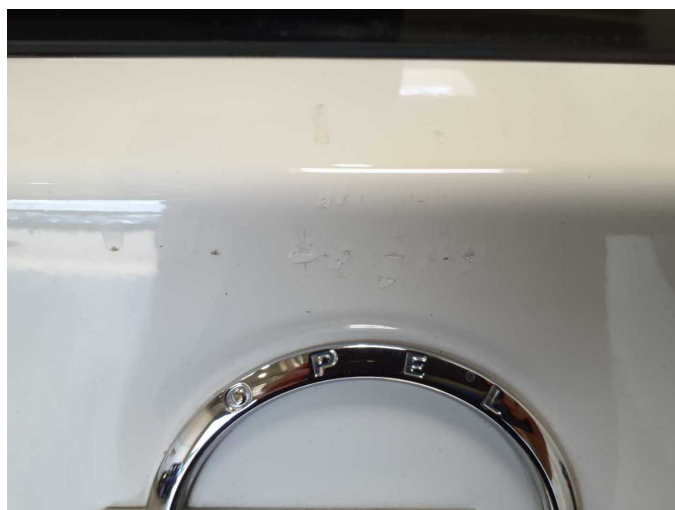
| No. | Component group | Description |
|---|---|---|
| 12 | Boot lid / rear door | Boot lid - Dent / paintcoat damage - Repair and paint |

**Damage 12:** Boot lid / rear door: Boot lid - Dent / paintcoat damage - Repair and paint

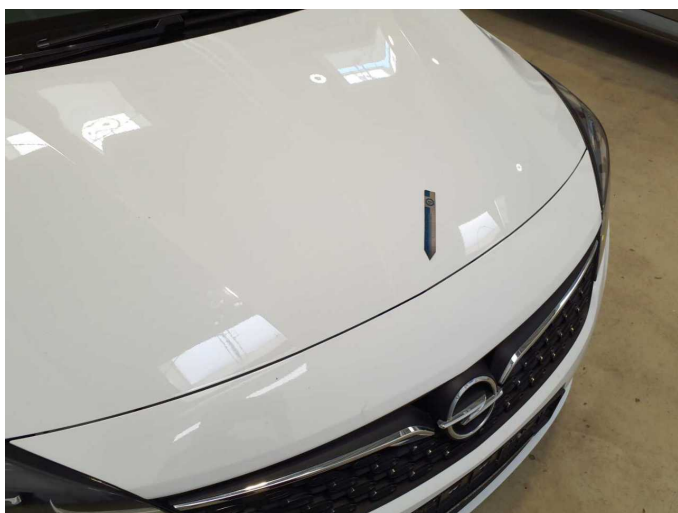
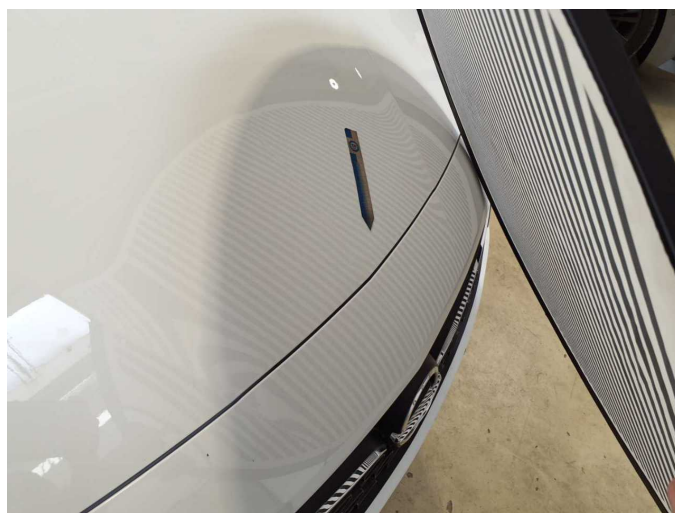
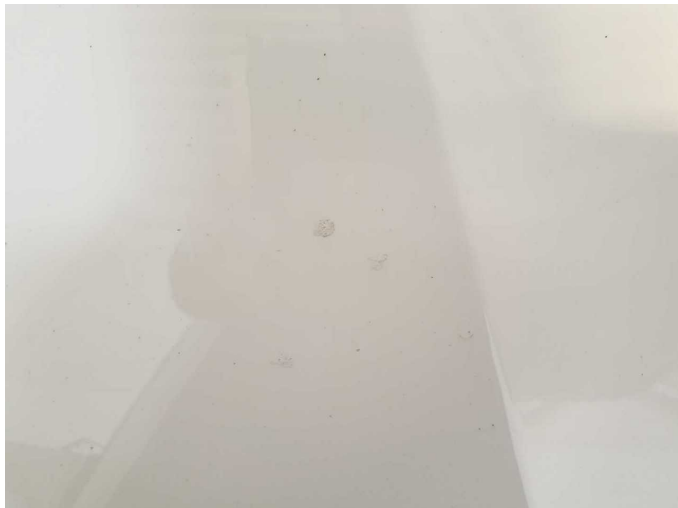
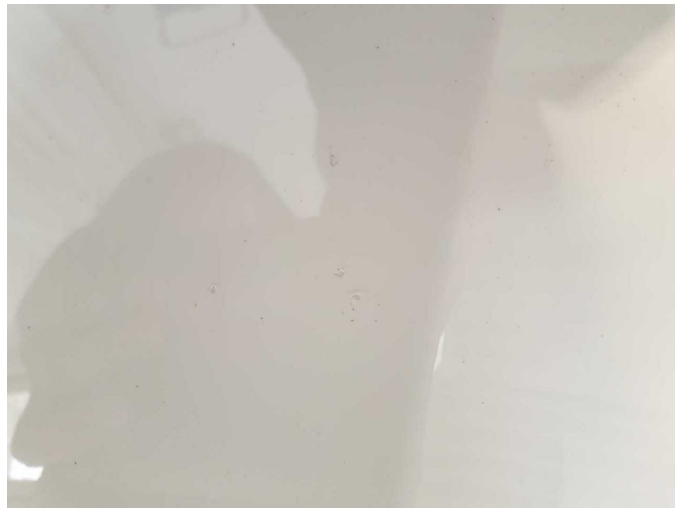
| No. | Component group | Description |
|---|---|---|
| 13 | Bonnet | Bonnet - Dent / paintcoat damage - Repair and paint |

**Damage 13:** Bonnet: Bonnet - Dent / paintcoat damage - Repair and paint

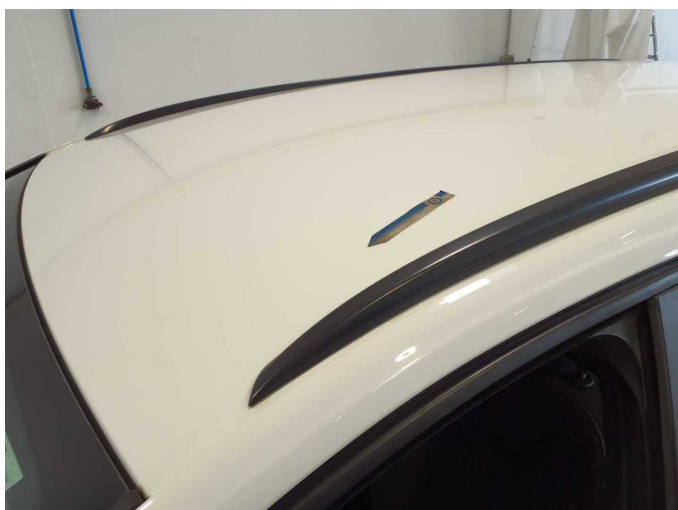
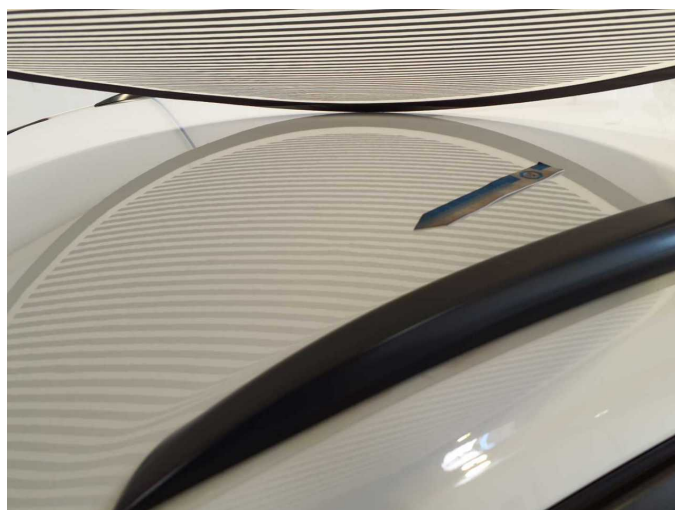
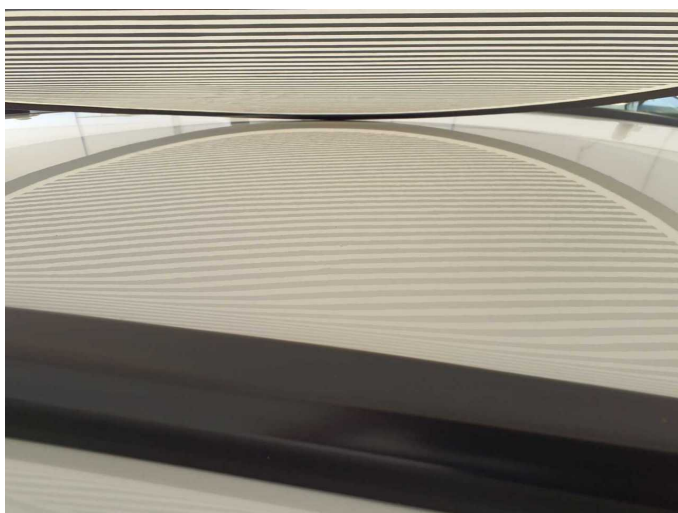
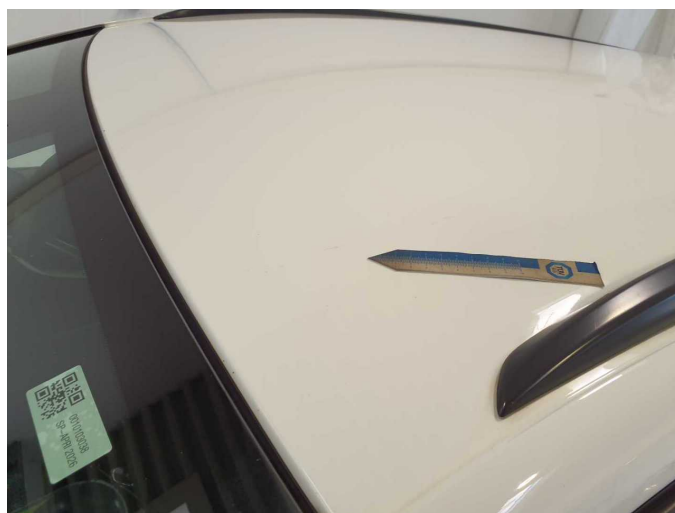
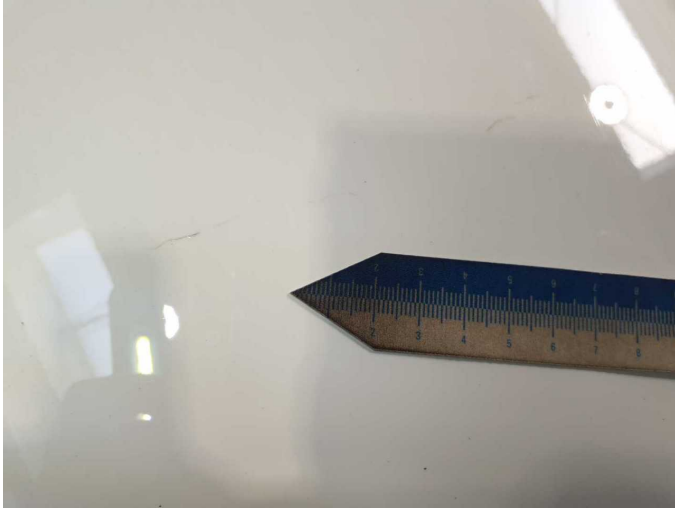
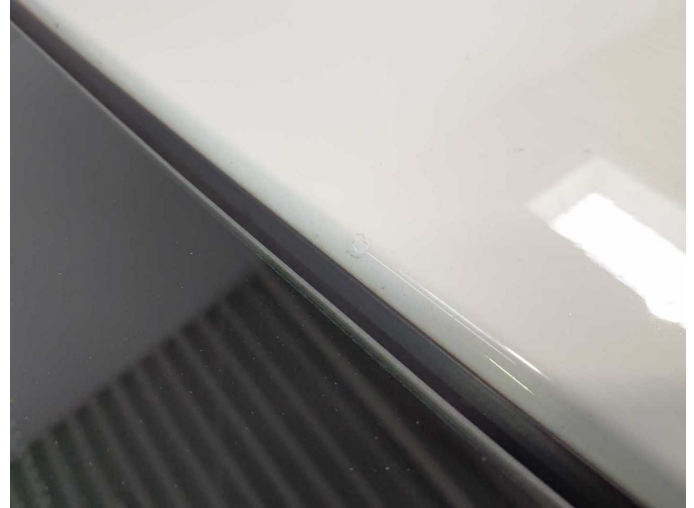
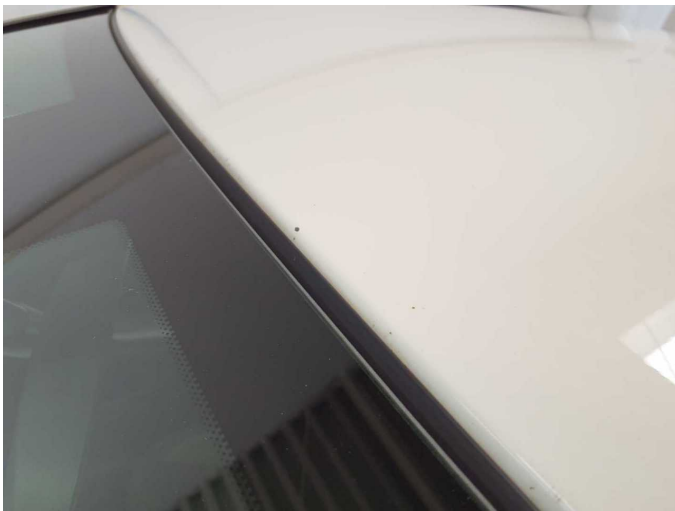
| No. | Component group | Description |
|---|---|---|
| 14 | Roof | Roof - Dent / paintcoat damage - Paint |

**Damage 14:** Roof: Roof - Dent / paintcoat damage - Paint
