Expertise

Protocol number: 46229175
Order No. / Reference: 26153507
Inspection date: 15 Jun 2026

Manufacturer: Mercedes-Benz

Model: Vito 116 CDI Lang HA Aut. PRO

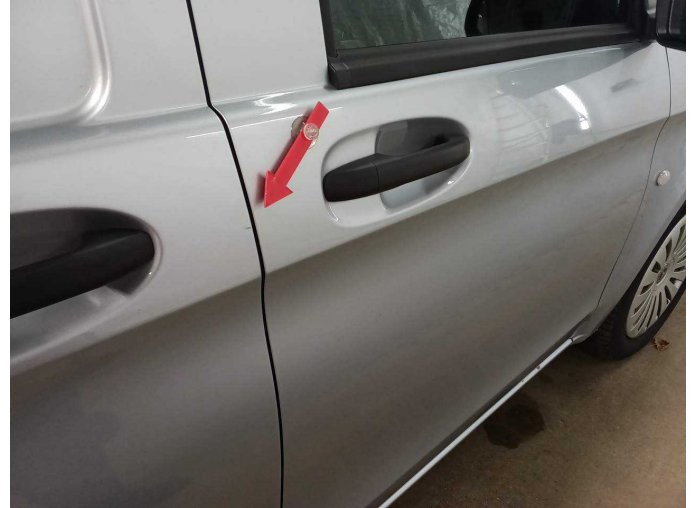
Damage 1: Door - front right side: Door edge - Scratch(es) - Smart repair

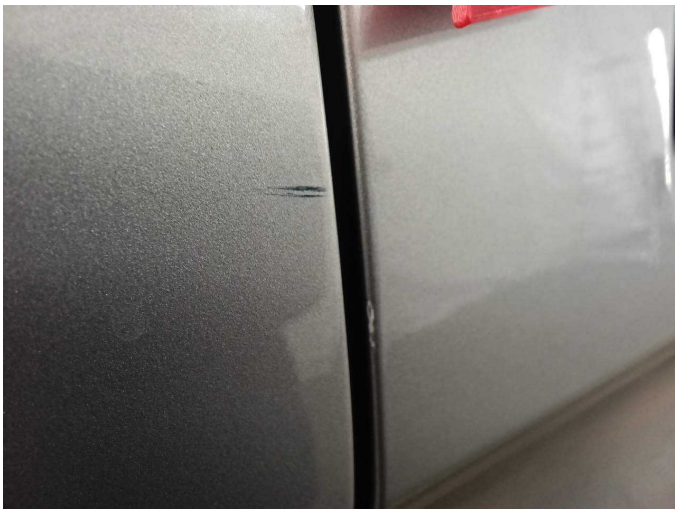
Damage 1: Door - front right side: Door edge - Scratch(es) - Smart repair

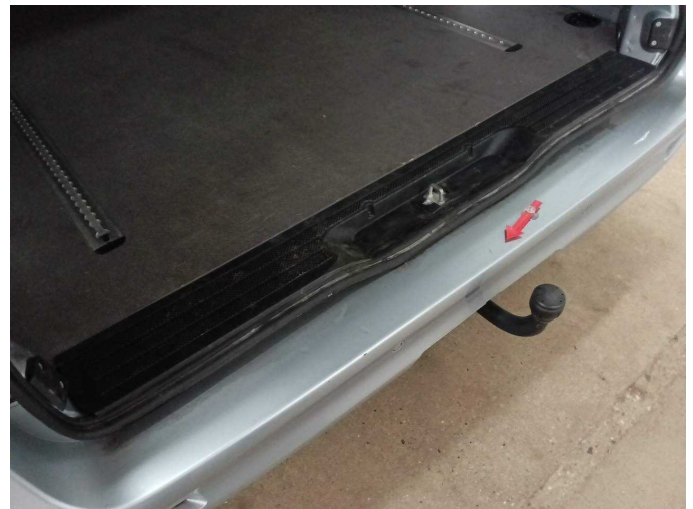
Damage 2: Rear bumper: Rear bumper (Verlade- / Einstiegsbereich) - Scratch(es) - Smart repair

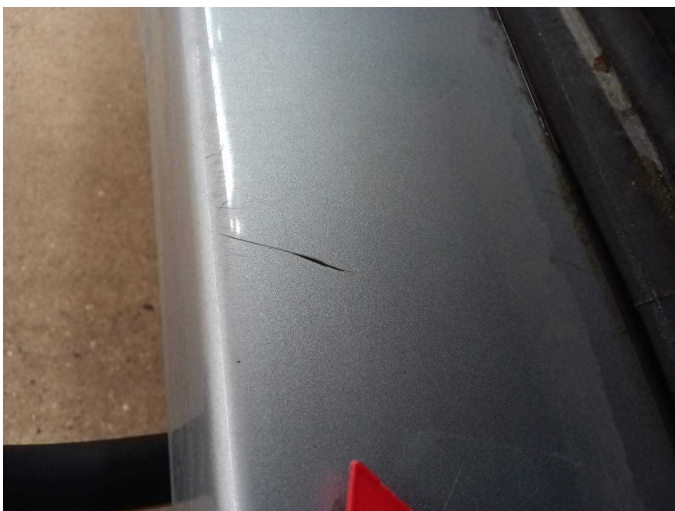
Damage 2: Rear bumper: Rear bumper (Verlade- / Einstiegsbereich) - Scratch(es) - Smart repair

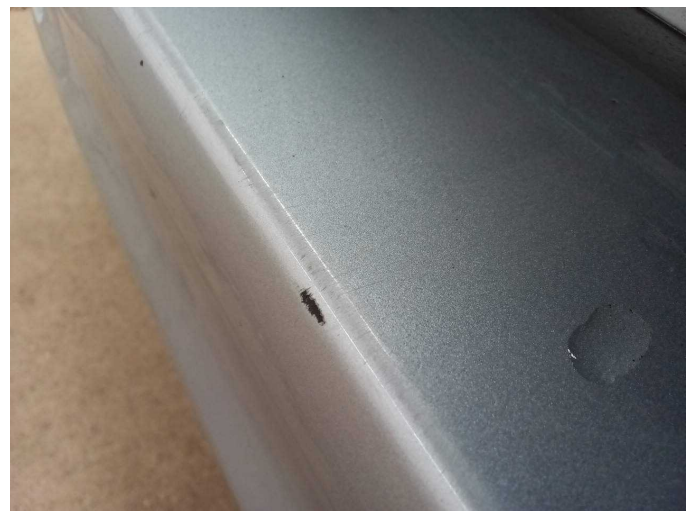
Damage 2: Rear bumper: Rear bumper (Verlade- / Einstiegsbereich) - Scratch(es) - Smart repair

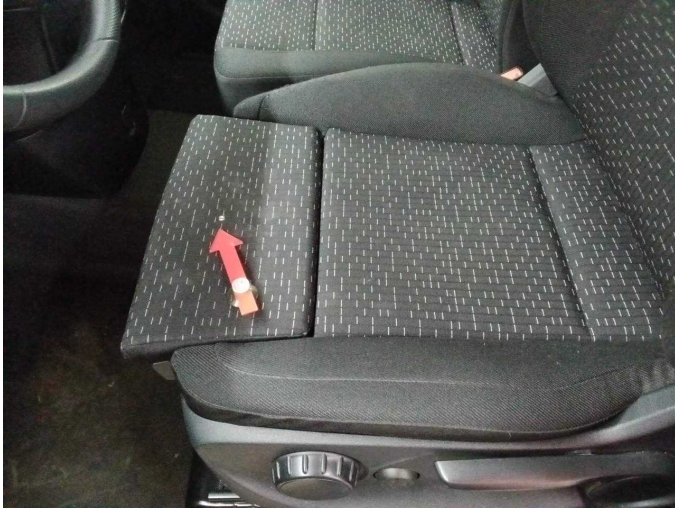
Damage 3: Seat - front: Seat cover - left side - Holes - Replace

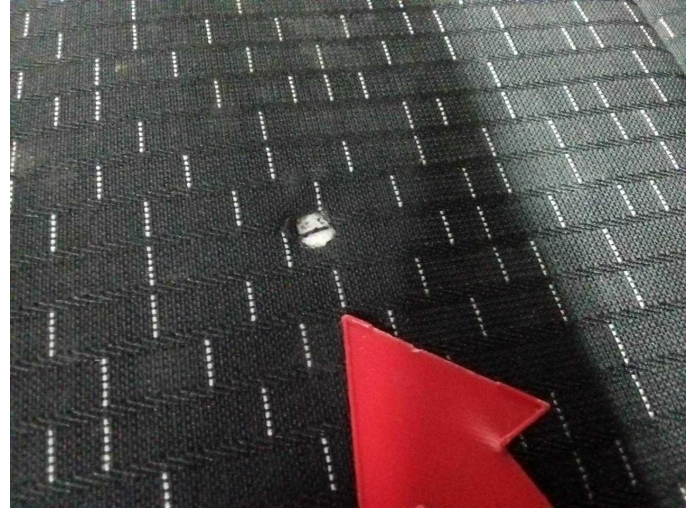
Damage 3: Seat - front: Seat cover - left side - Holes - Replace

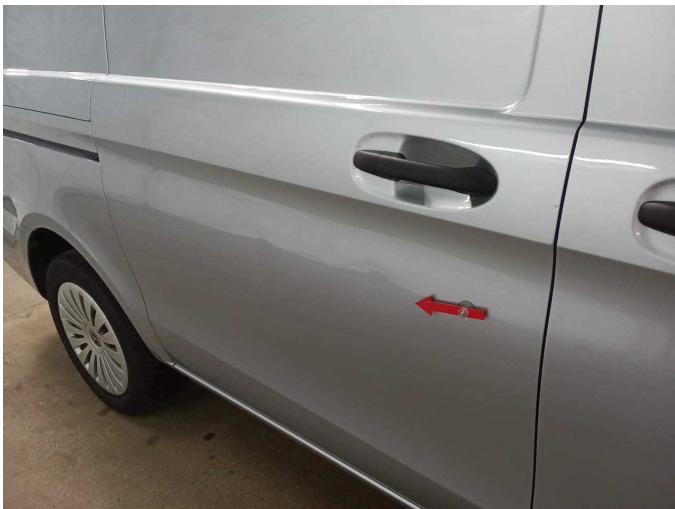
Damage 4: Sliding door, right: Sliding door - dent(s) - Repair and paint

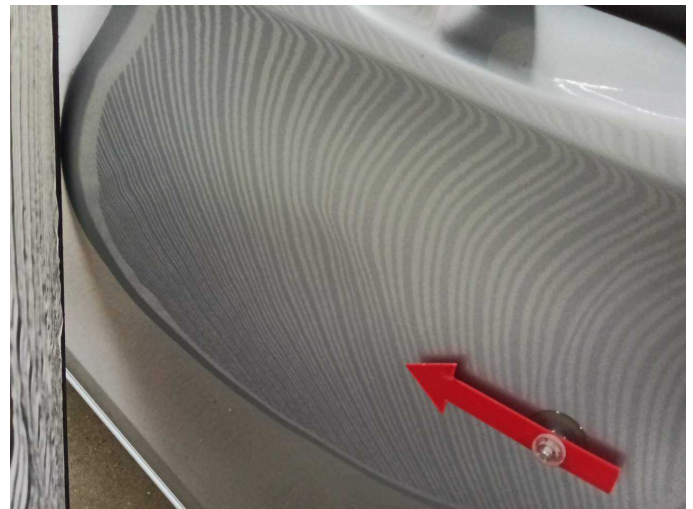
Damage 4: Sliding door, right: Sliding door - dent(s) - Repair and paint

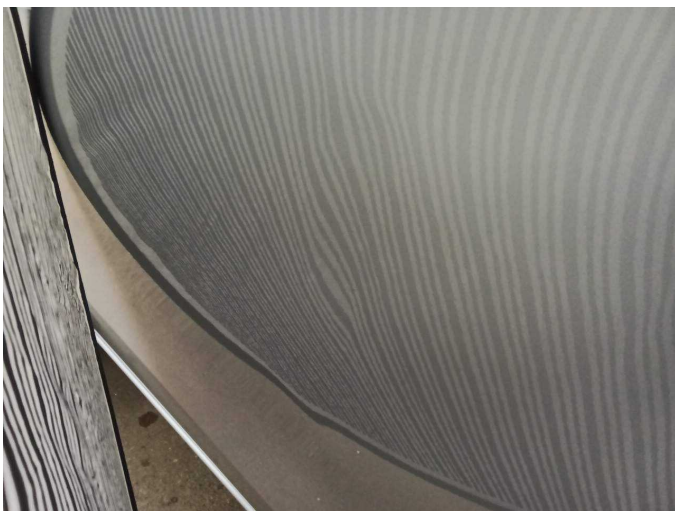
Damage 4: Sliding door, right: Sliding door - dent(s) - Repair and paint
