Expertise

Protocol number: 46652018  
Order No. / Reference: 26479489  
Inspection date: 22 Jul 2026

Manufacturer: Skoda  
VIN: TMBJJ8NX8PY045821

Model: Octavia Combi 2.0 TDI DSG Tour

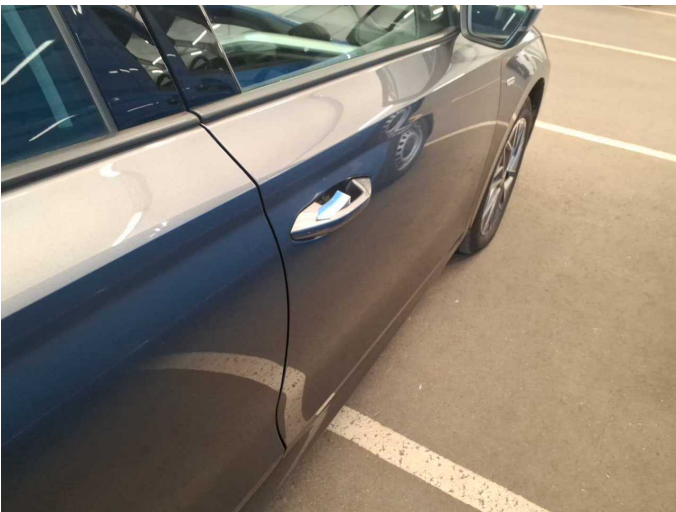
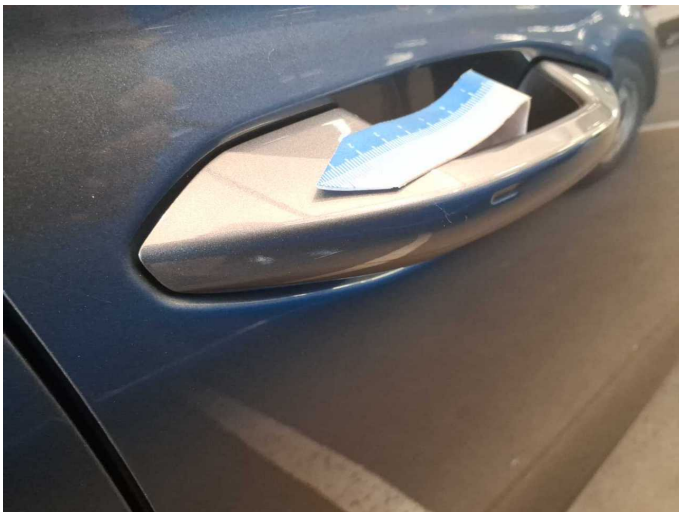
| No. | Component group | Description |
|---|---|---|
| 1 | Door - front right side | Door handle - outside - Scratched - Smart repair |

Damage 1: Door - front right side: Door handle - outside - Scratched - Smart repair

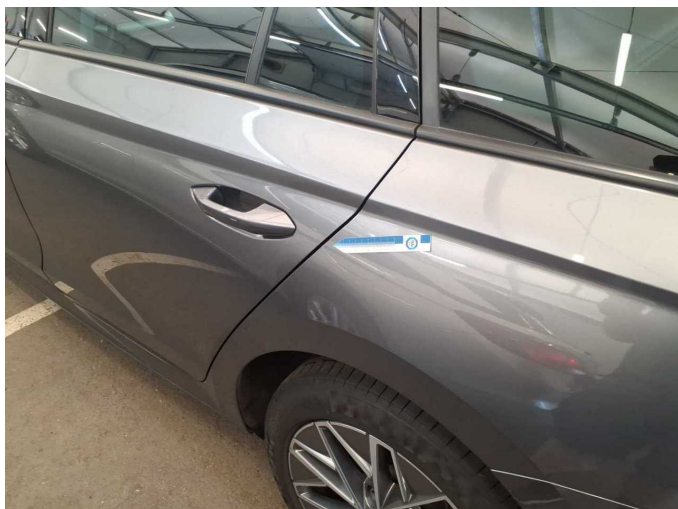
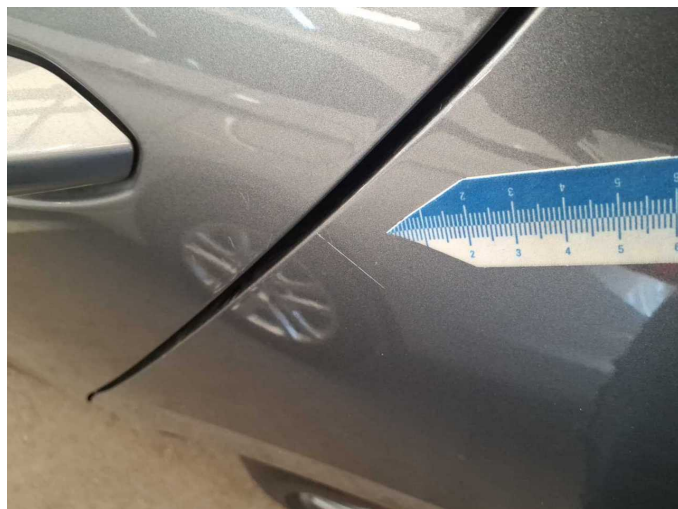
| No. | Component group | Description |
|---|---|---|
| 2 | Side panel - rear left side | Side panel - Scratched - Smart repair |

**Damage 2:** Side panel - rear left side: Side panel - Scratched - Smart repair

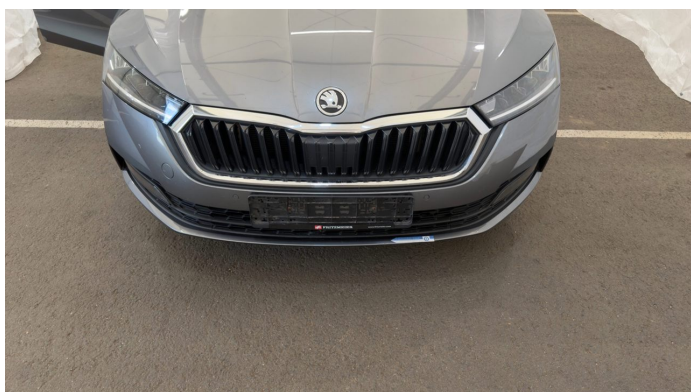
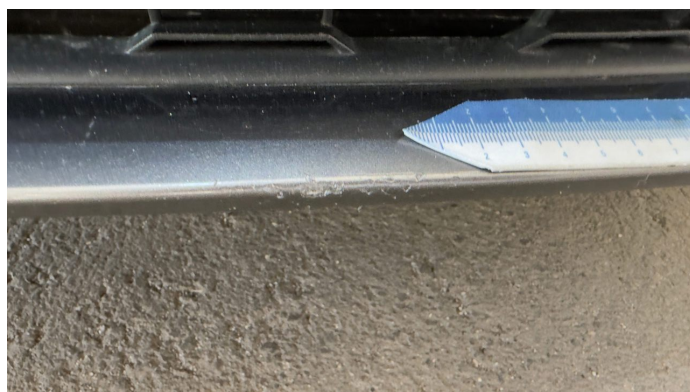
| No. | Component group | Description |
|---|---|---|
| 3 | Front bumper | Front bumper - Scratched - Smart repair |

**Damage 3:** Front bumper: Front bumper - Scratched - Smart repair

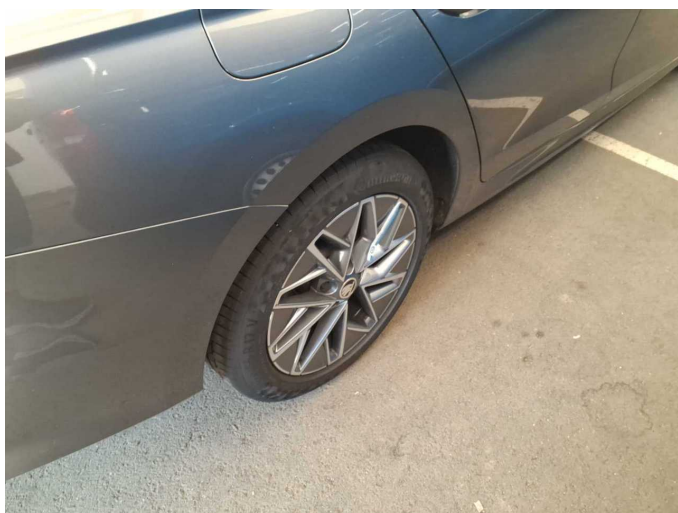
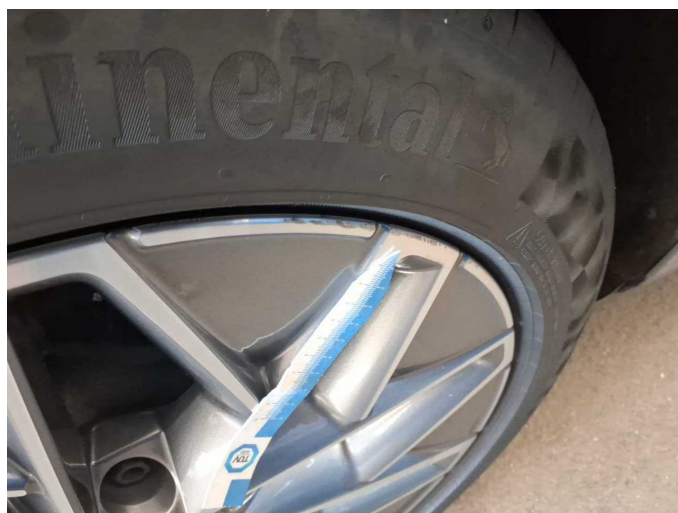
| No. | Component group | Description |
|---|---|---|
| 4 | Wheel / tyres | Alloy rim - rear right side - Scratched - Loss in value |

**Damage 4:** Wheel / tyres: Alloy rim - rear right side - Scratched - Loss in value

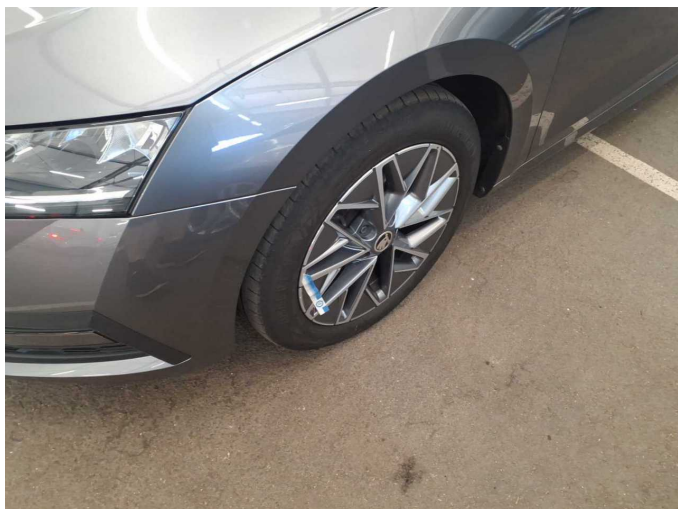
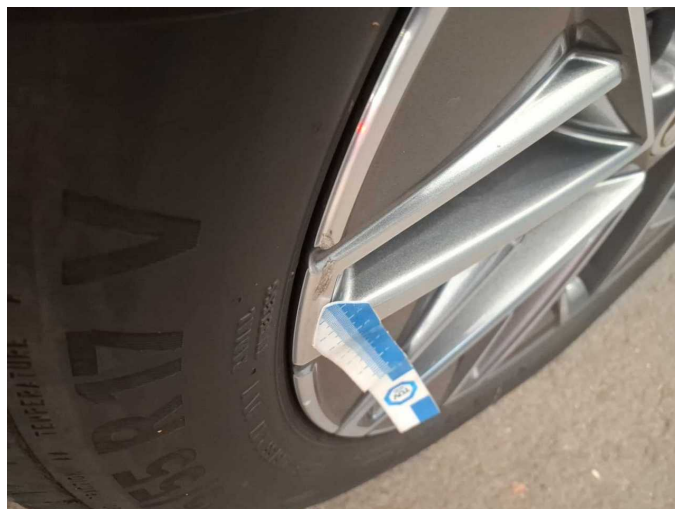
| No. | Component group | Description |
|---|---|---|
| 5 | Wheel / tyres | Alloy rim - front left side - Scratched - Loss in value |

**Damage 5:** Wheel / tyres: Alloy rim - front left side - Scratched - Loss in value

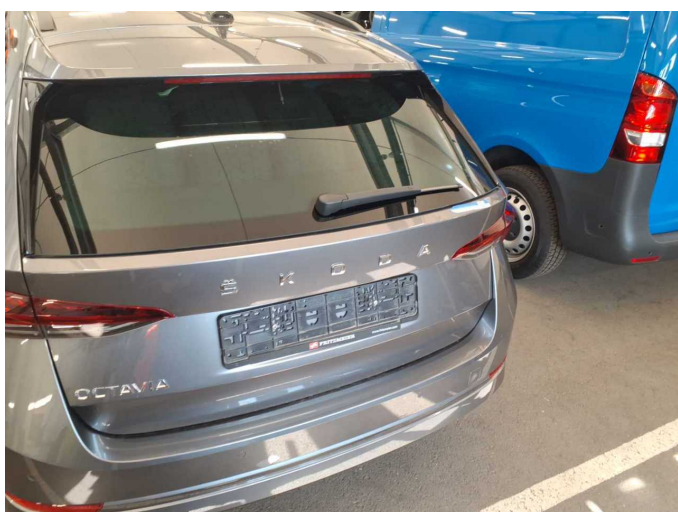
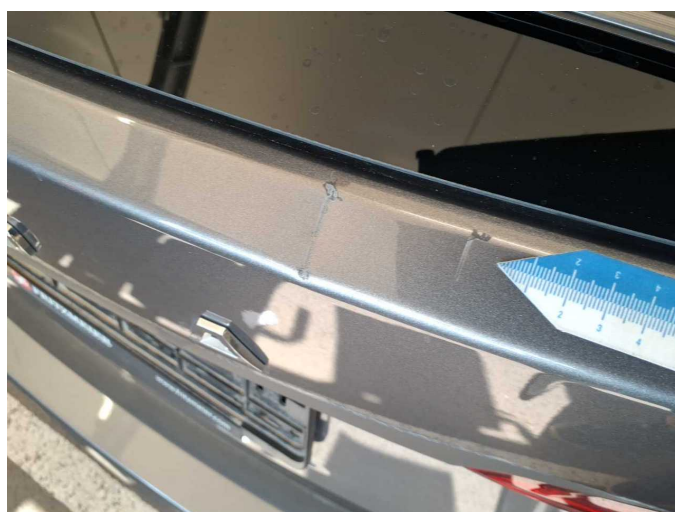
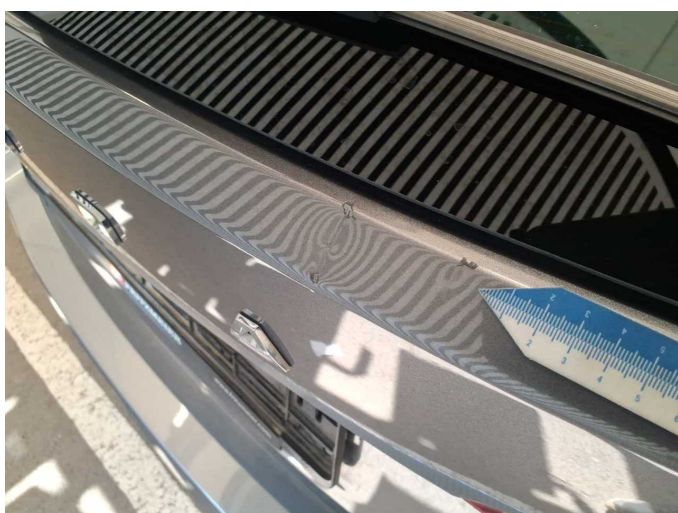
| No. | Component group | Description |
|---|---|---|
| 6 | Boot lid / rear door | Boot lid (& Lackschaden) - Deformed - Repair and paint |

**Damage 6:** Boot lid / rear door: Boot lid (& Lackschaden) - Deformed - Repair and paint
