Expertise

Protocol number: 46607479  
Order No. / Reference: 26697810  
Inspection date: 20 Jul 2026

Manufacturer: Ford

Model: S-Max 2.0 EcoBlue Aut. TITANIUM

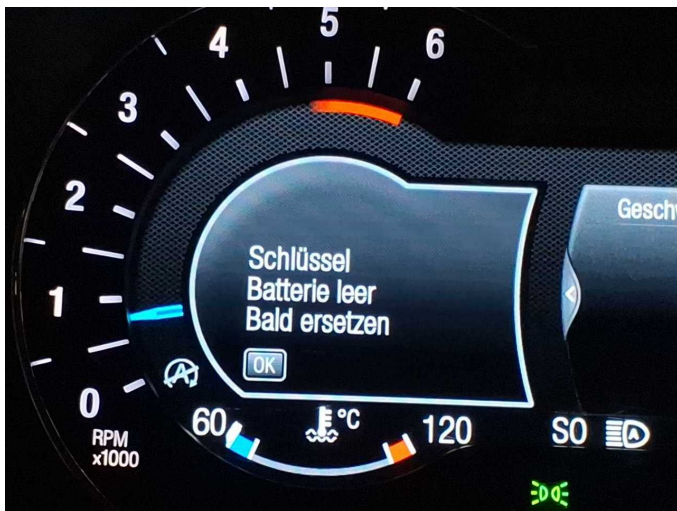
| No. | Component group | Description |
|---|---|---|
| 1 | Equipment | Vehicle key with remote control (Batterie) - Empty - Replace |

**Damage 1:** Equipment: Vehicle key with remote control (Batterie) - Empty  
- Replace

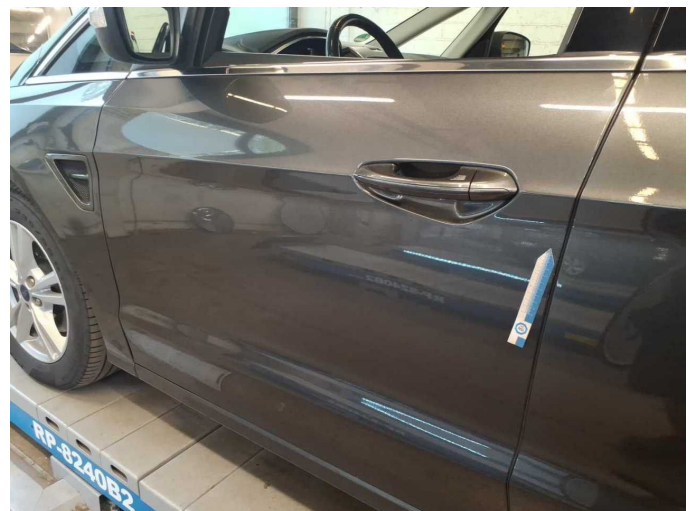
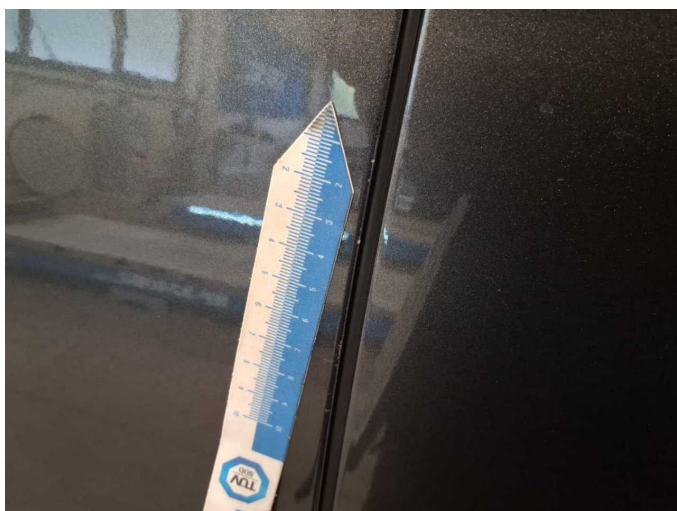
| No. | Component group | Description |
|---|---|---|
| 2 | Door - front left side | Door edge - Scratched - Smart repair |

**Damage 2:** Door - front left side: Door edge - Scratched - Smart repair

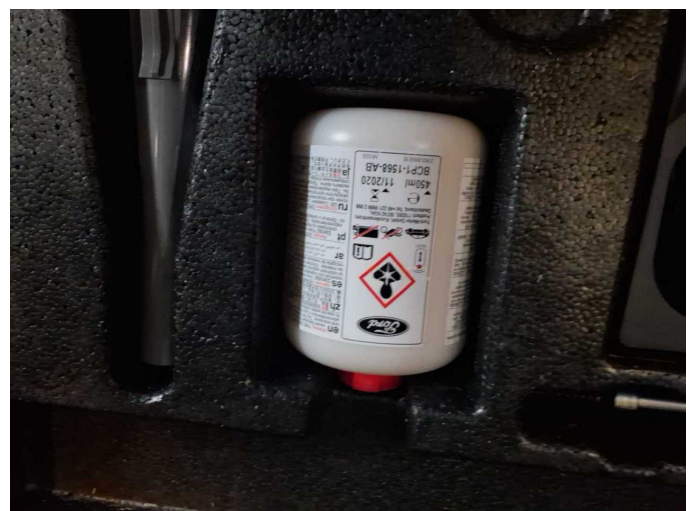
| No. | Component group | Description |
|---|---|---|
| 3 | Equipment | Tirefit filler - Expired - Replace |

**Damage 3:** Equipment: Tirefit filler - Expired - Replace

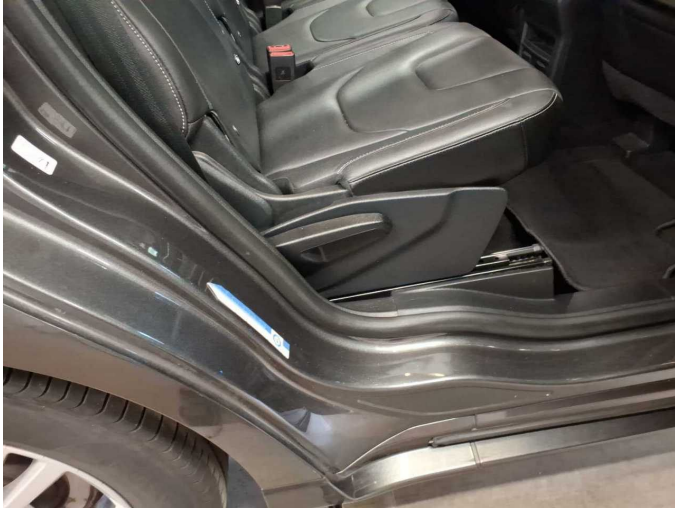
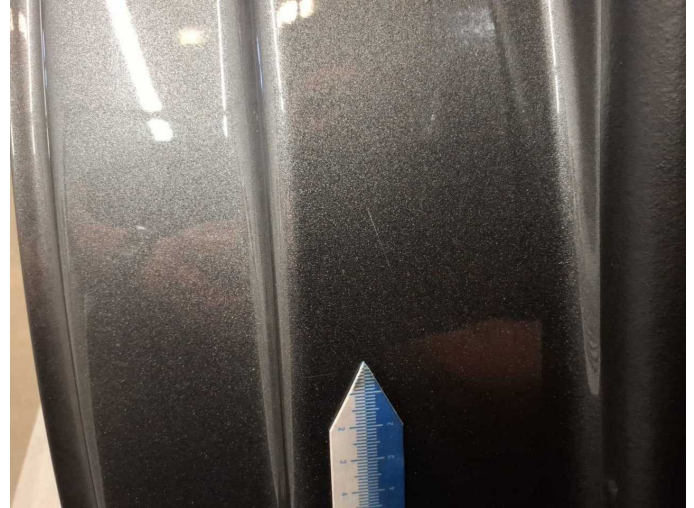
| No. | Component group | Description |
|---|---|---|
| 4 | Side panel - rear right side | Sill - Scratch(es) - Smart repair |

**Damage 4:** Side panel - rear right side: Sill - Scratch(es) - Smart repair

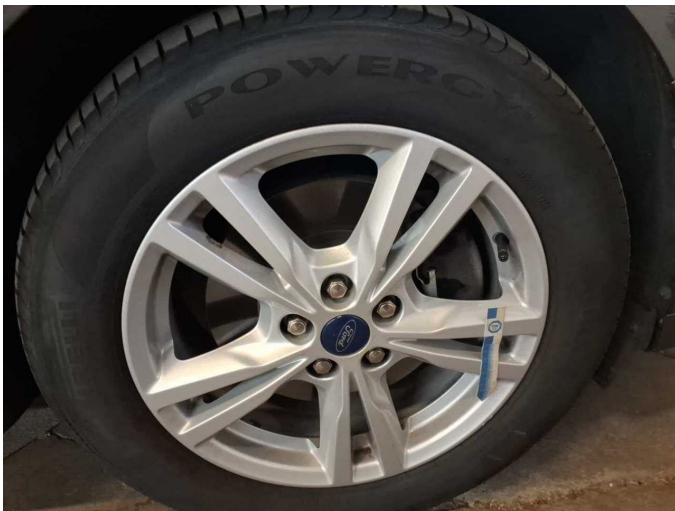
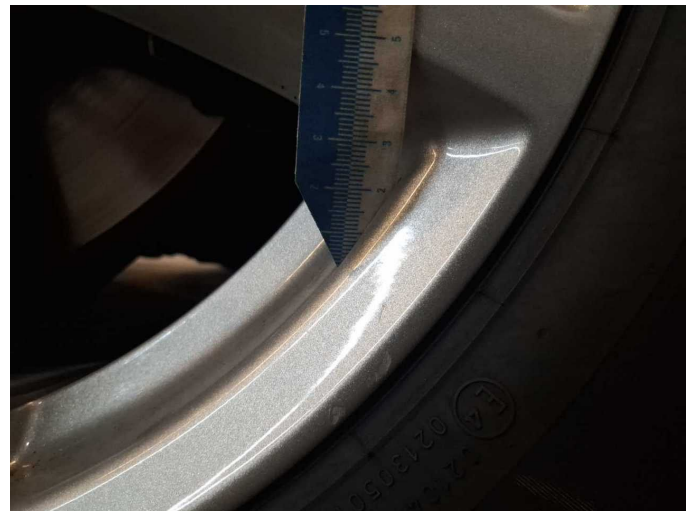
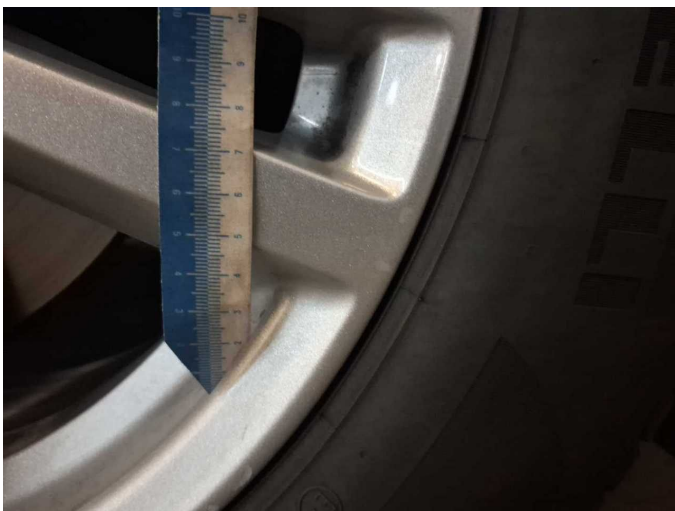
| No. | Component group | Description |
|---|---|---|
| 5 | Wheel / tyres | Alloy rim - front right side - Scratched - Loss in value |

**Damage 5:** Wheel / tyres: Alloy rim - front right side - Scratched - Loss in value

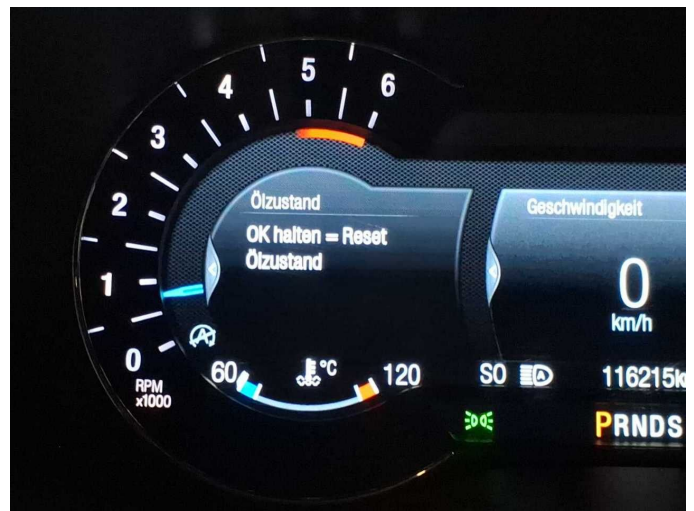
| No. | Component group | Description |
|---|---|---|
| 6 | Misc. | Inspection / maintenance - Due - Perform |

**Damage 6:** Misc.: Inspection / maintenance - Due - Perform

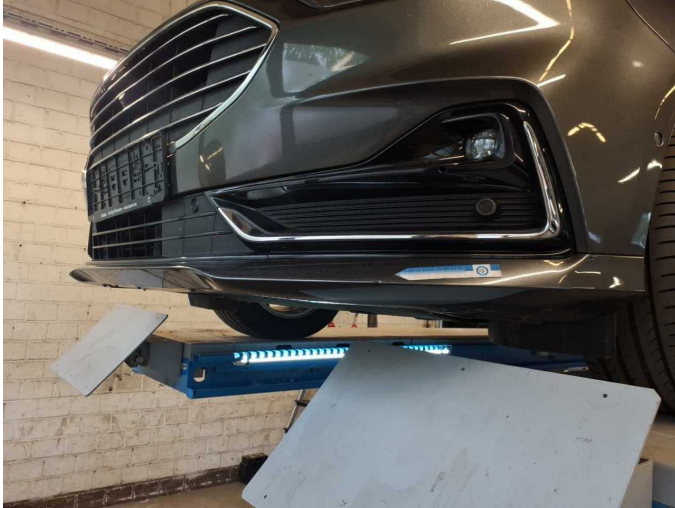
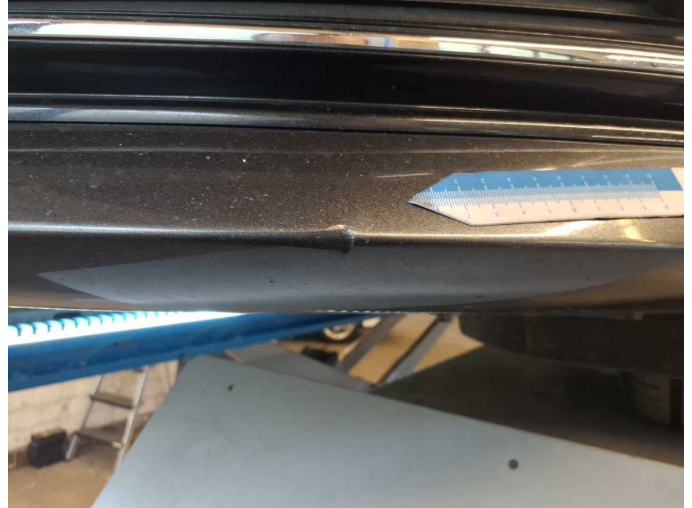
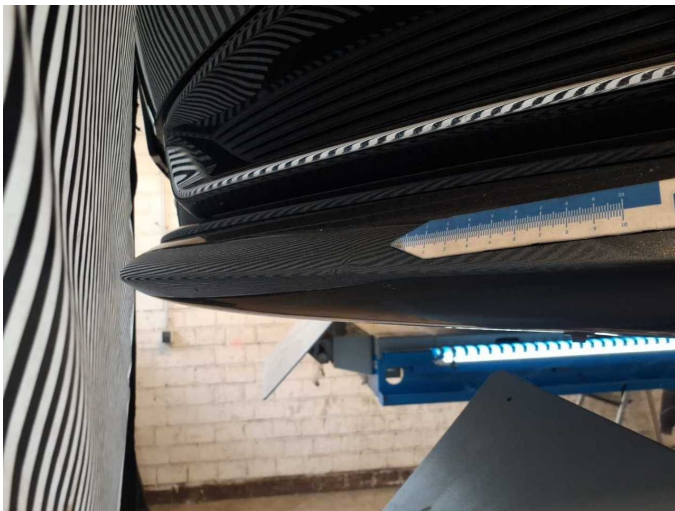
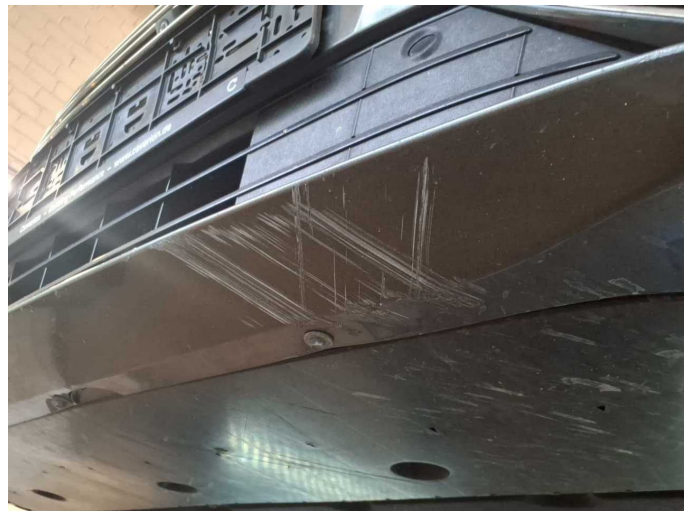
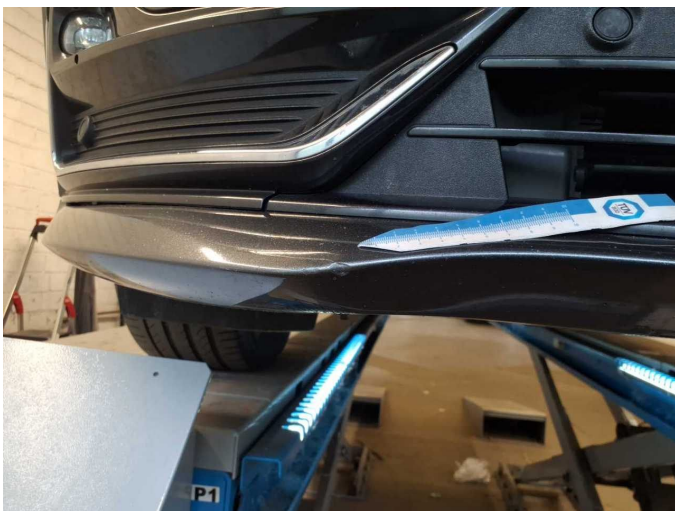
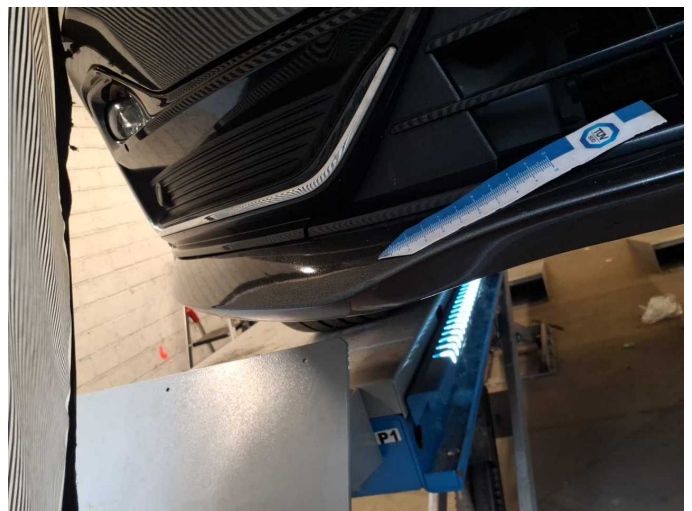
| No. | Component group | Description |
|---|---|---|
| 7 | Front bumper | Spoiler - Dent / paintcoat damage - Repair and paint |

**Damage 7:** Front bumper: Spoiler - Dent / paintcoat damage - Repair and paint

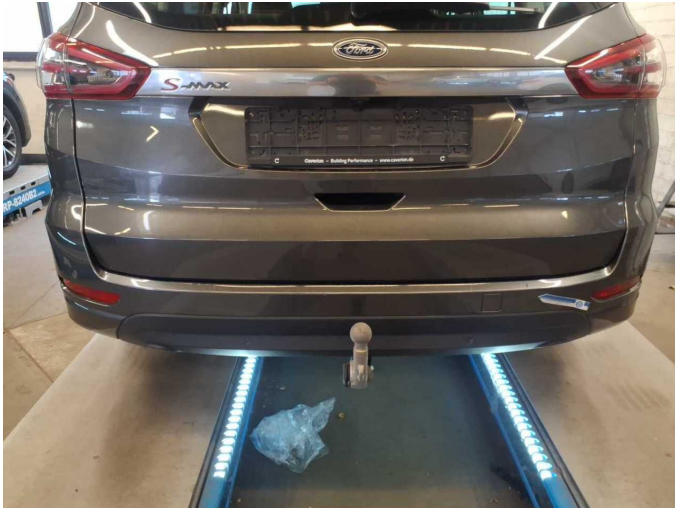
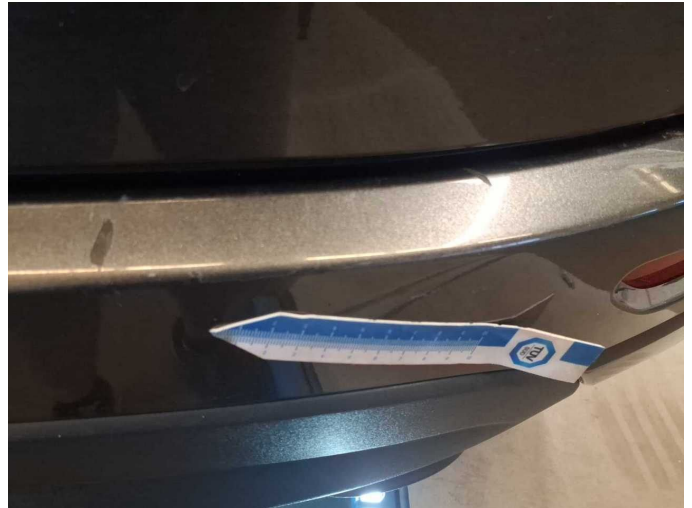
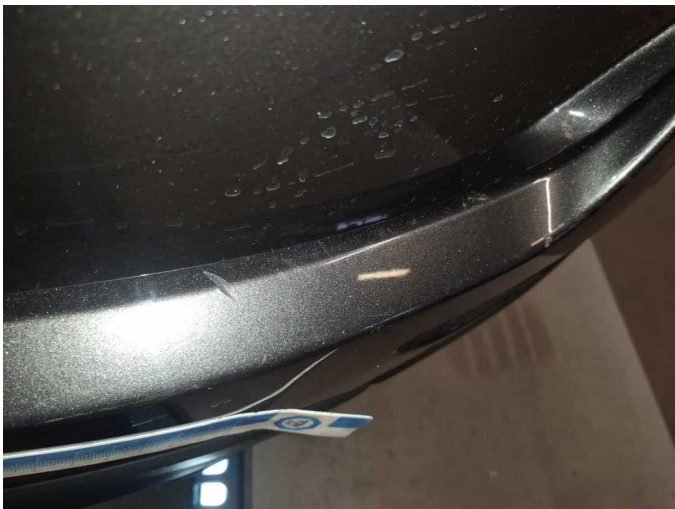
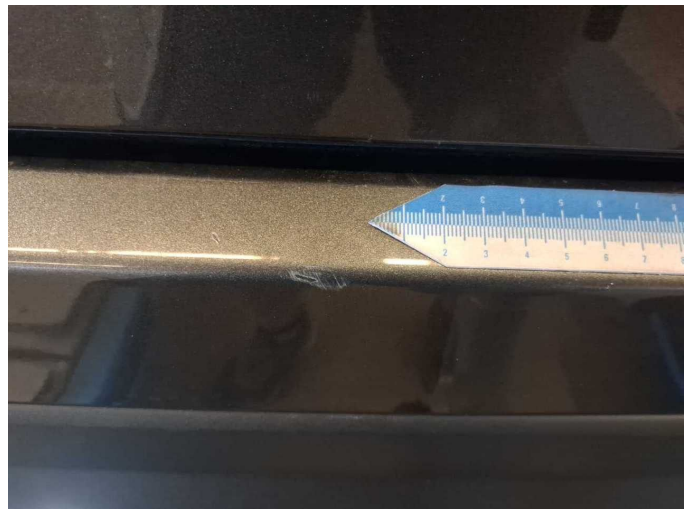
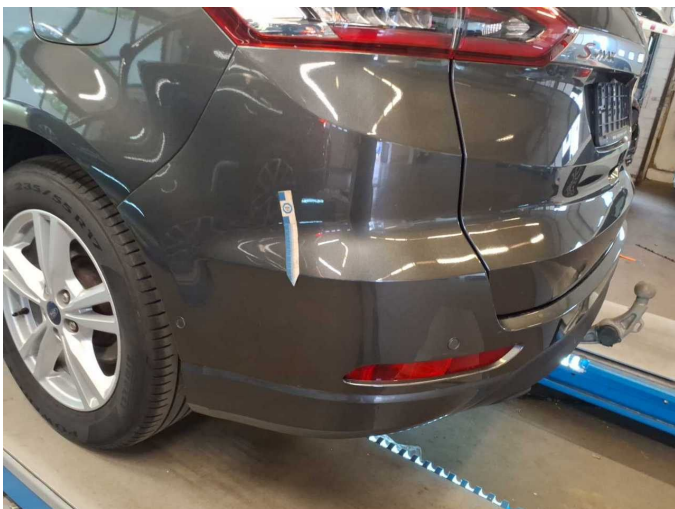
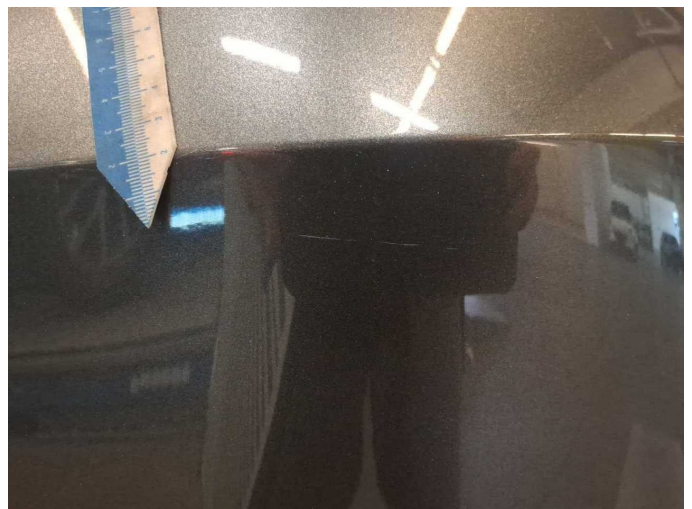
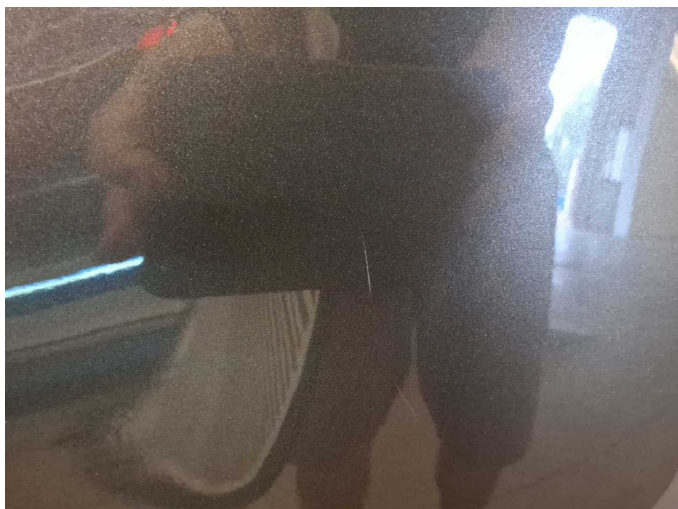
| No. | Component group | Description |
|---|---|---|
| 8 | Rear bumper | Rear bumper - Scratched - Paint |

**Damage 8:** Rear bumper: Rear bumper - Scratched - Paint

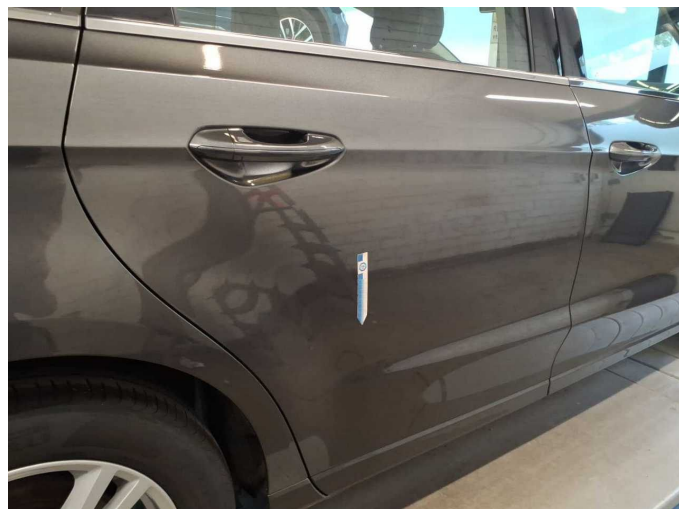
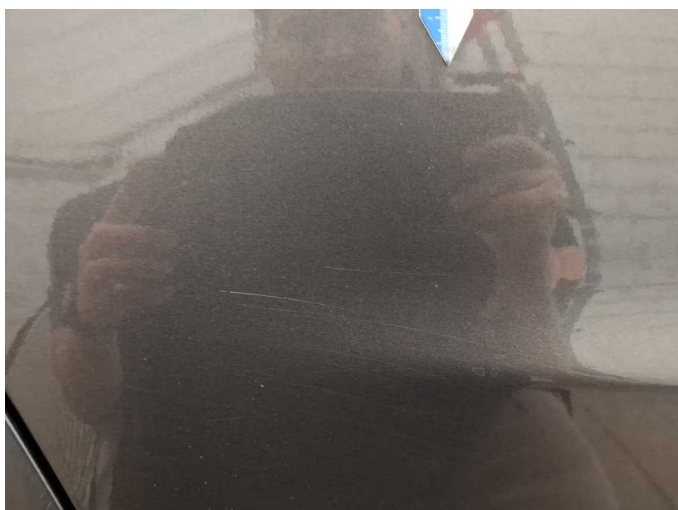
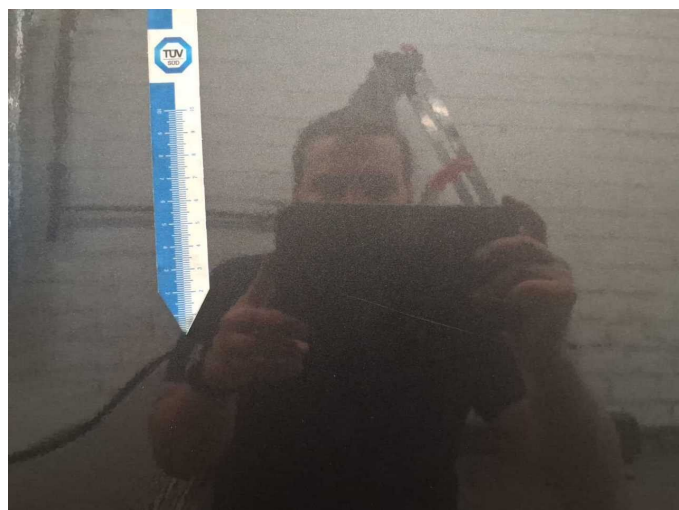
| No. | Component group | Description |
|---|---|---|
| 9 | Door - rear right side | Door - Scratched - Paint |

**Damage 9:** Door - rear right side: Door - Scratched - Paint

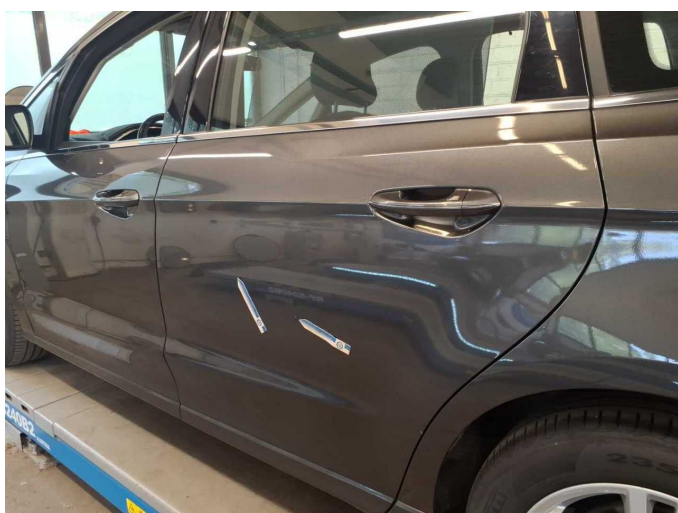
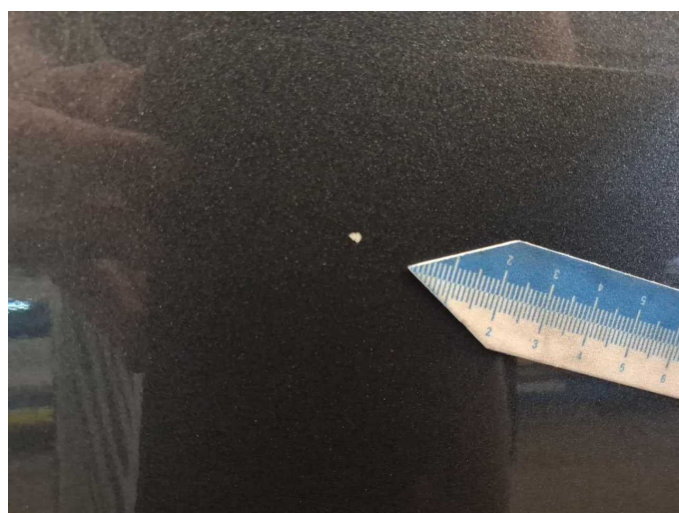
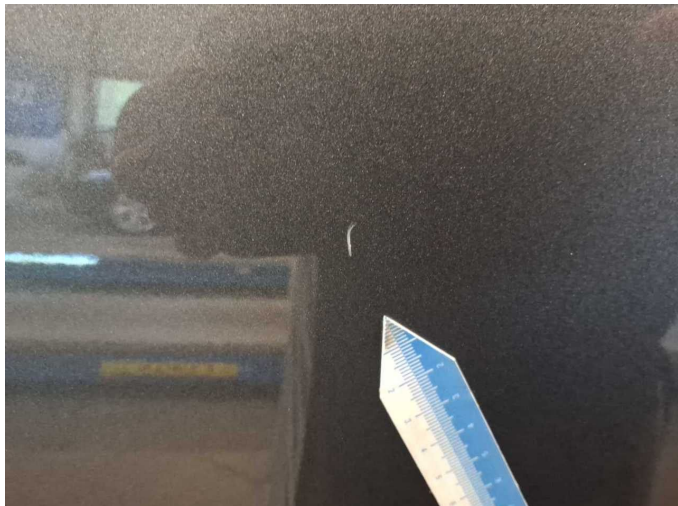
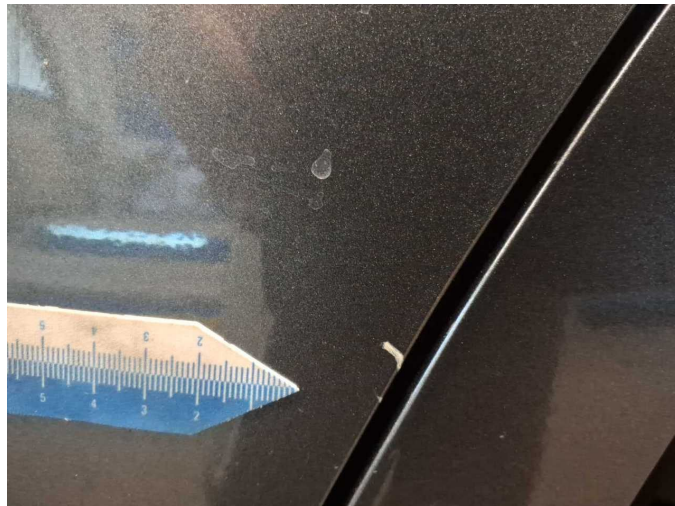
| No. | Component group | Description |
|---|---|---|
| 10 | Door - rear left side | Door - Scratched - Paint |

**Damage 10:** Door - rear left side: Door - Scratched - Paint

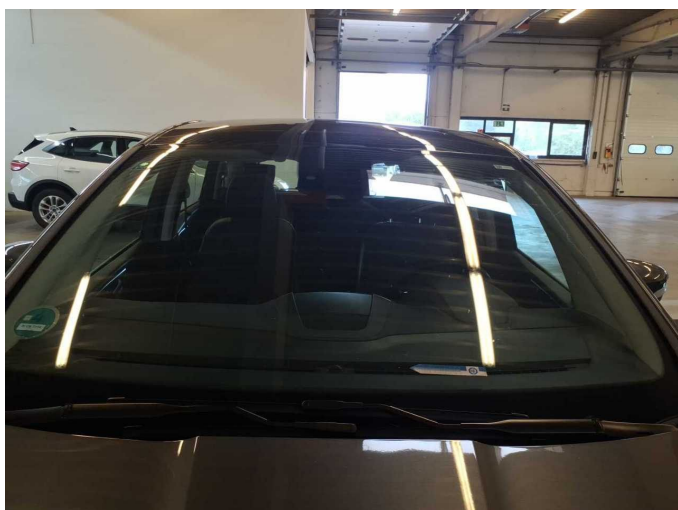
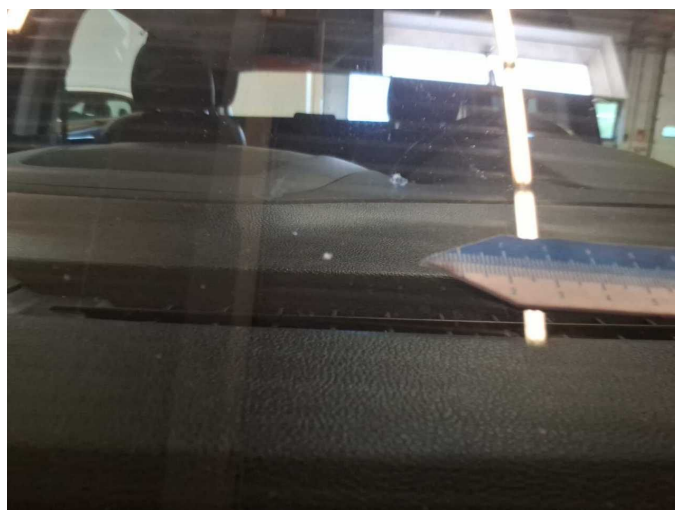
| No. | Component group | Description |
|---|---|---|
| 1 | Vehicle glazing | Windscreen - Stone chips - No deduction |

**Wear and tear 1:** Vehicle glazing: Windscreen - Stone chips - No deduction

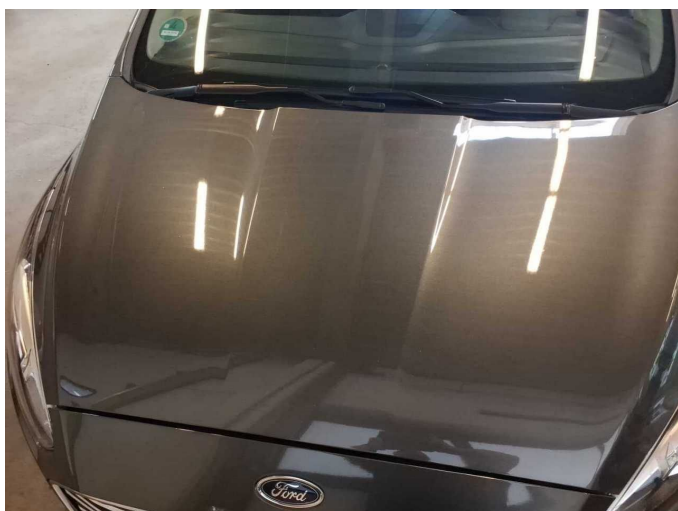
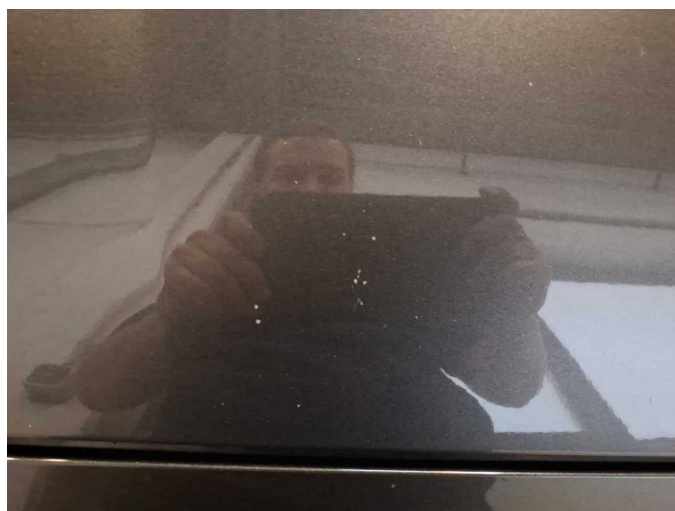
| No. | Component group | Description |
|---|---|---|
| 2 | Bonnet | Bonnet - Stone chips - No deduction |

**Wear and tear 2:** Bonnet: Bonnet - Stone chips - No deduction

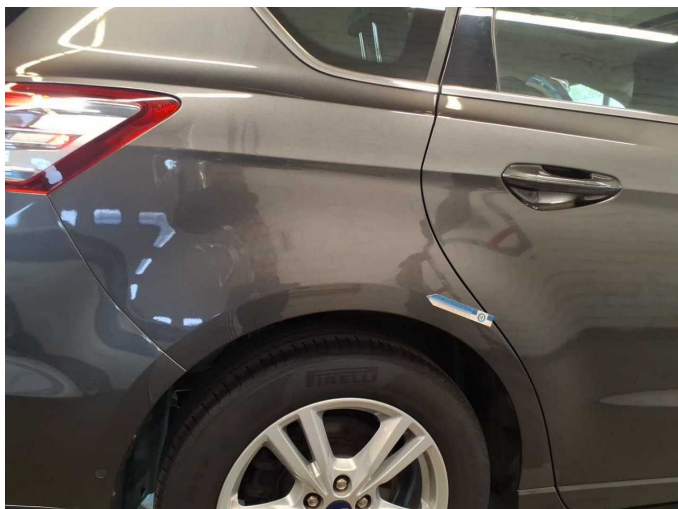
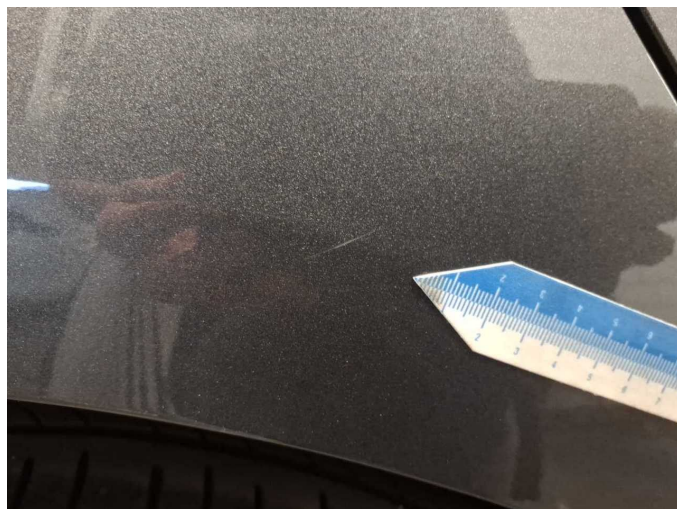
| No. | Component group | Description |
|---|---|---|
| 3 | Side panel - rear right side | Side panel (polierbar) - Scratch(es) - No deduction |

**Wear and tear 3:** Side panel - rear right side: Side panel (polierbar) - Scratch(es) - No deduction

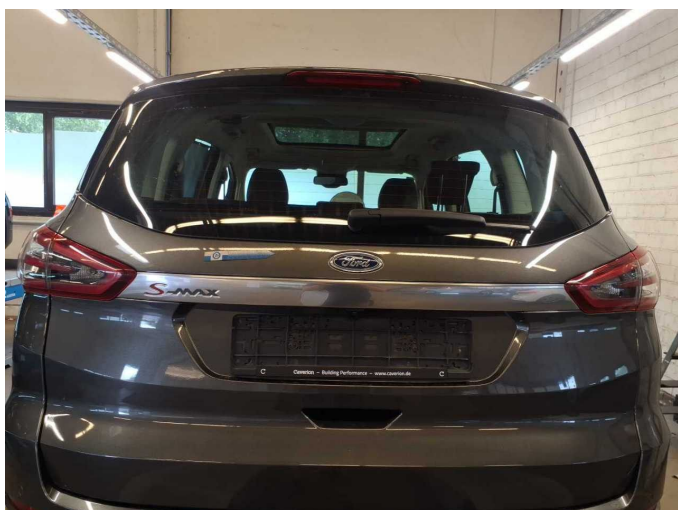
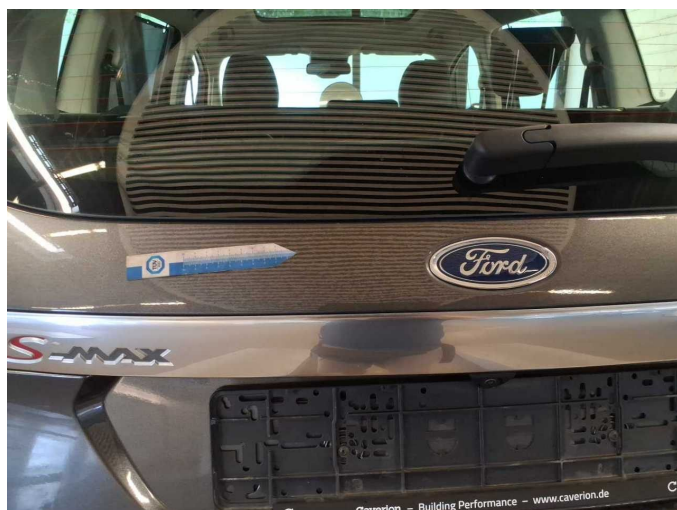
| No. | Component group | Description |
|---|---|---|
| 4 | Boot lid / rear door | Boot lid - dent(s) - No deduction |

**Wear and tear 4:** Boot lid / rear door: Boot lid - dent(s) - No deduction
