Expertise

Protocol number: 46883031  
Order No. / Reference: 26721012  
Inspection date: 4 Aug 2026

Manufacturer: Opel

Model: Astra 1.5 D Start/Stop Sports Tourer Business Edition

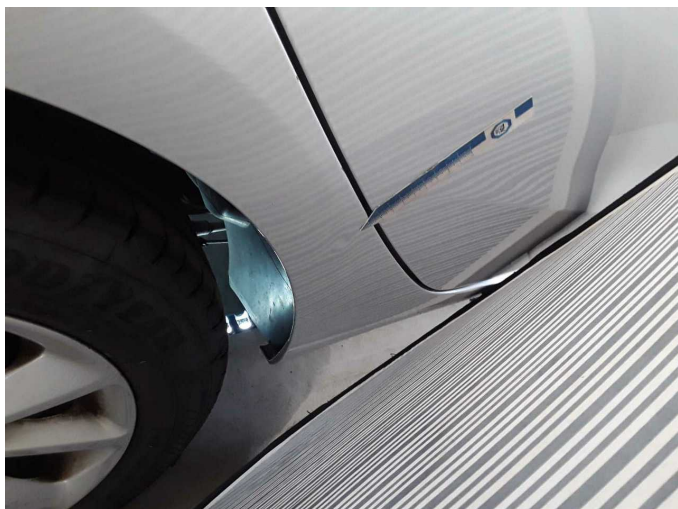
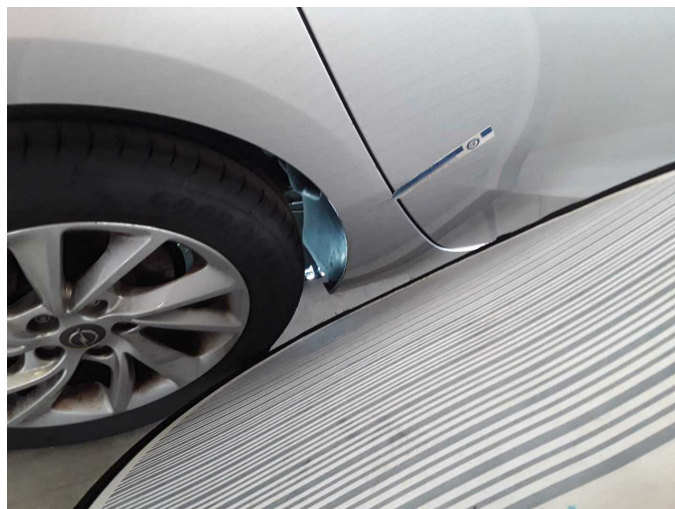
| No. | Component group | Description |
|---|---|---|
| 1 | Side panel - rear right side | Side panel - dent(s) - Smooth repair work |

**Damage 1:** Side panel - rear right side: Side panel - dent(s) - Smooth repair work

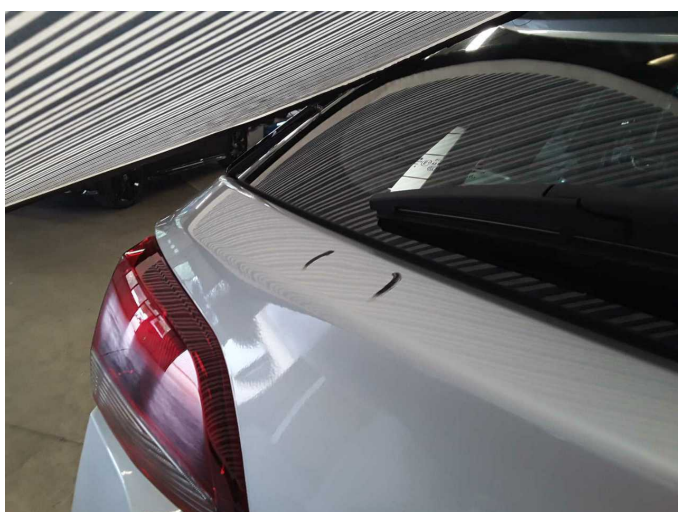
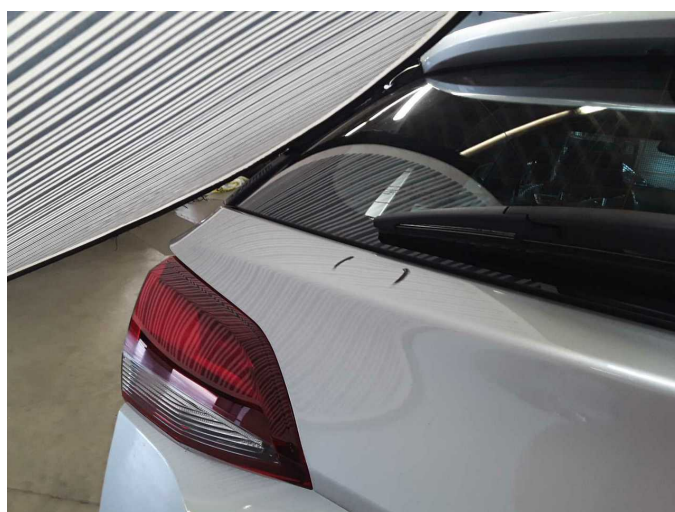
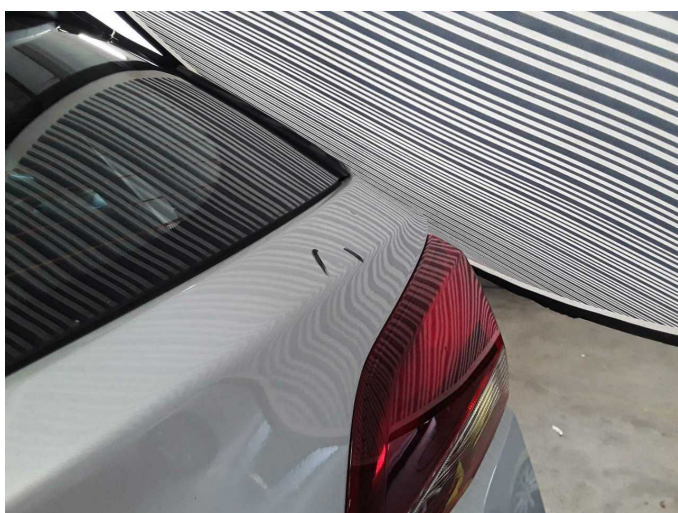
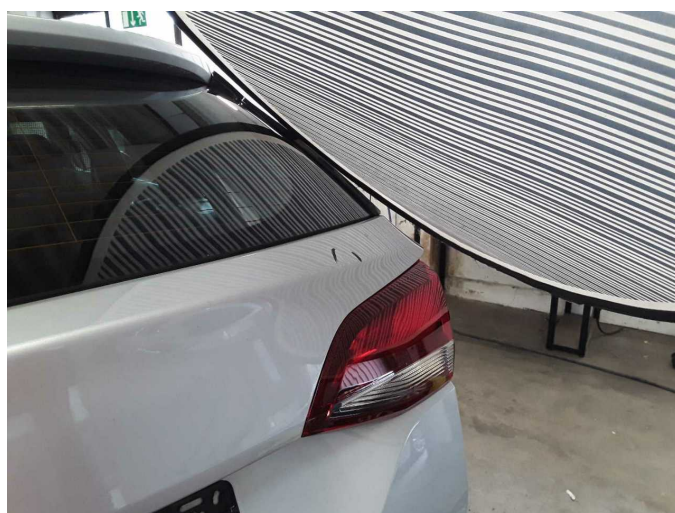
| No. | Component group | Description |
|---|---|---|
| 2 | Boot lid / rear door | Boot lid - dent(s) - Smooth repair work |

**Damage 2:** Boot lid / rear door: Boot lid - dent(s) - Smooth repair work

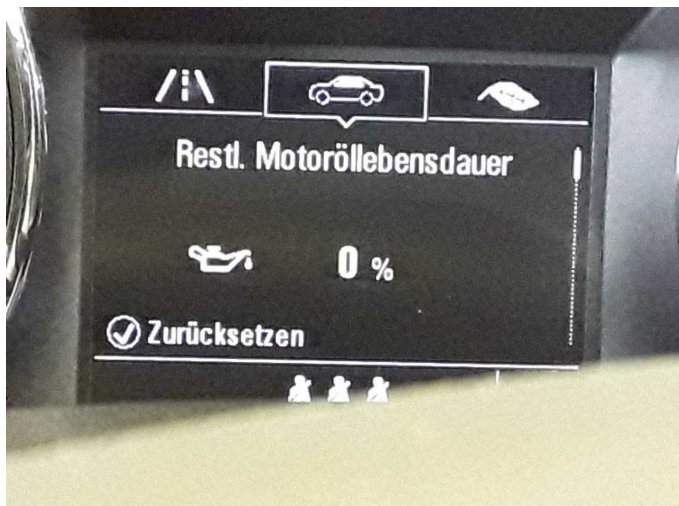
| No. | Component group | Description |
|---|---|---|
| 3 | Misc. | Inspection / maintenance - Due - Replace |

**Damage 3:** Misc.: Inspection / maintenance - Due - Replace

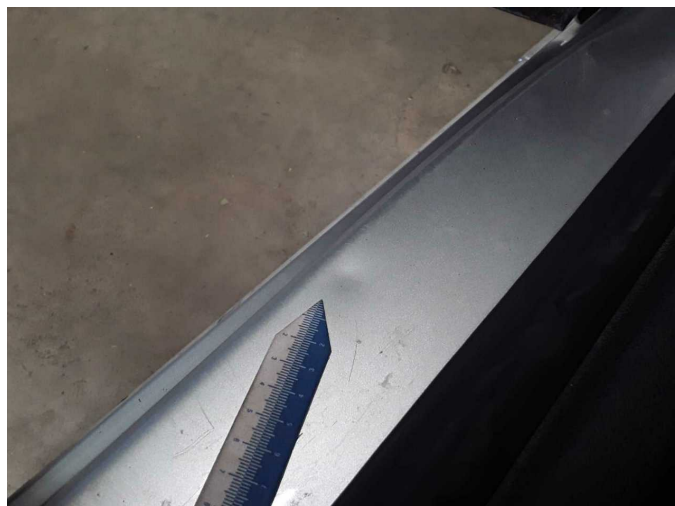
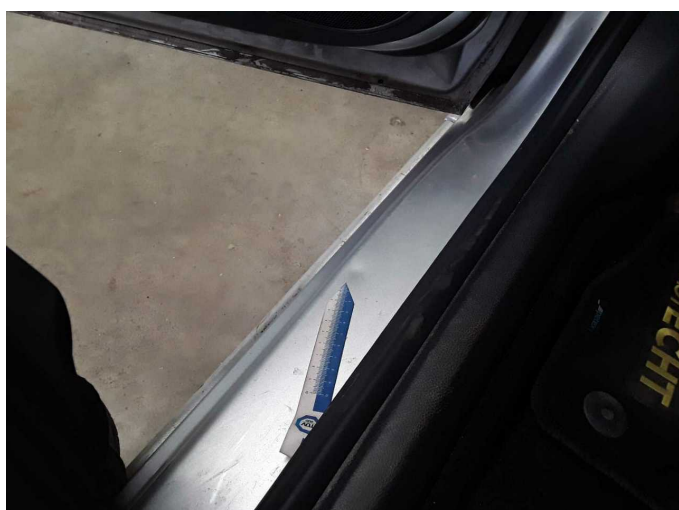
| No. | Component group | Description |
|---|---|---|
| 4 | Sill - left side | Sill (Einstieg vorn rechts + Kratzer) - dent(s) - Repair and paint |

**Damage 4:** Sill - left side: Sill (Einstieg vorn rechts + Kratzer) - dent(s) - Repair and paint

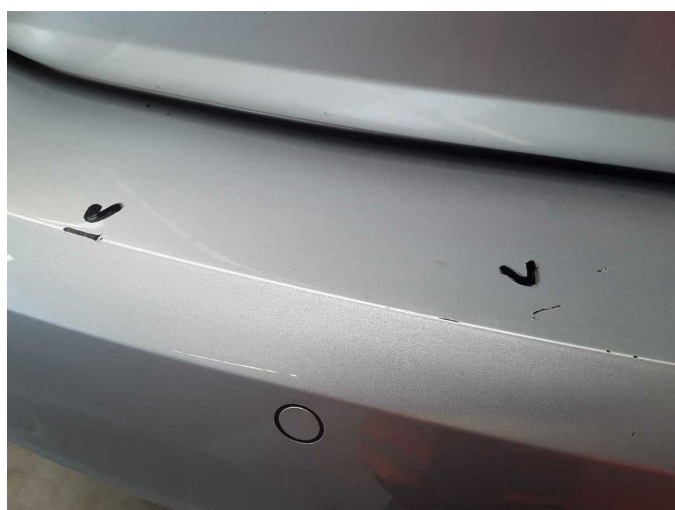
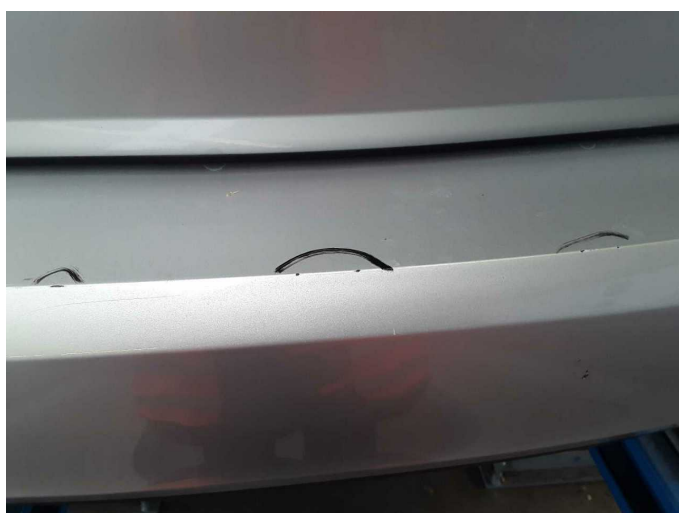
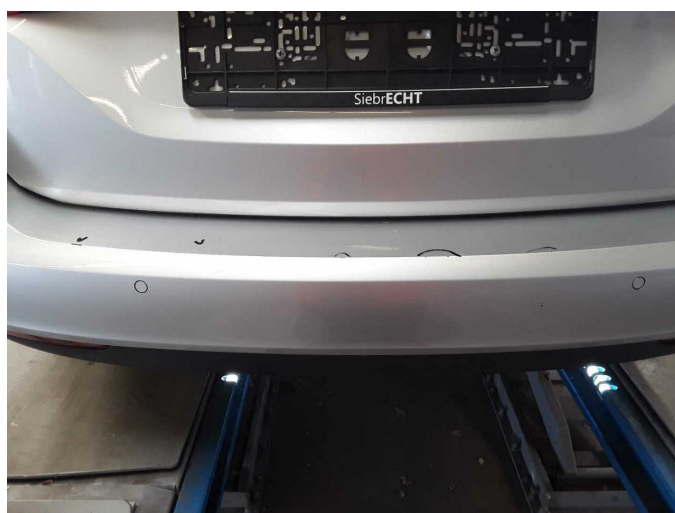
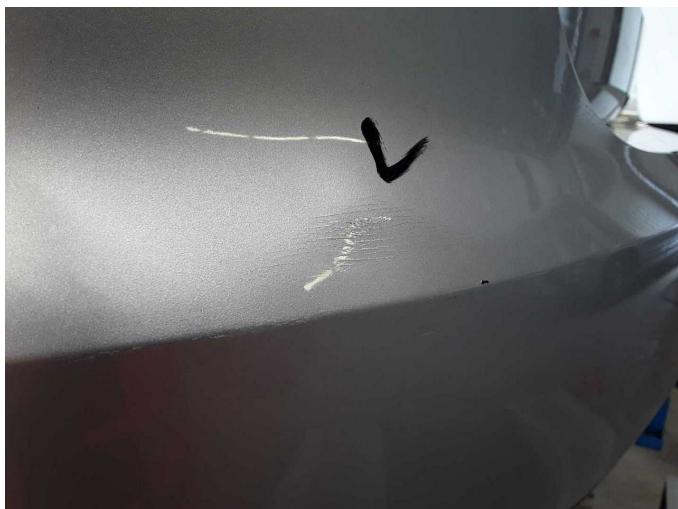
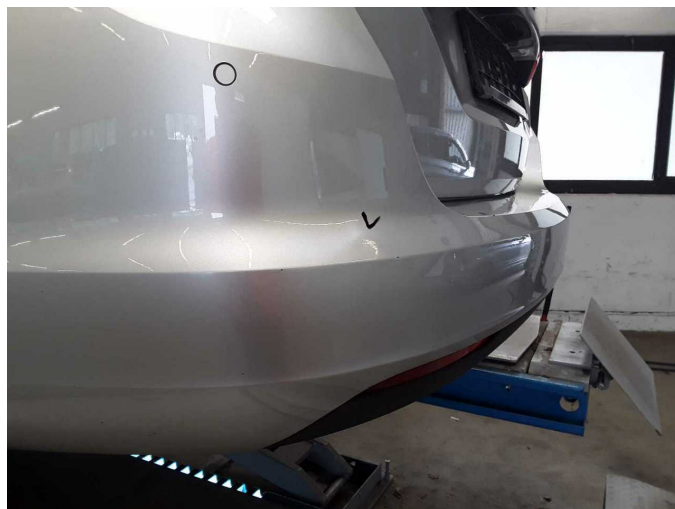
| No. | Component group | Description |
|---|---|---|
| 5 | Rear bumper | Rear bumper - Scratched - Repair and paint |

**Damage 5:** Rear bumper: Rear bumper - Scratched - Repair and paint

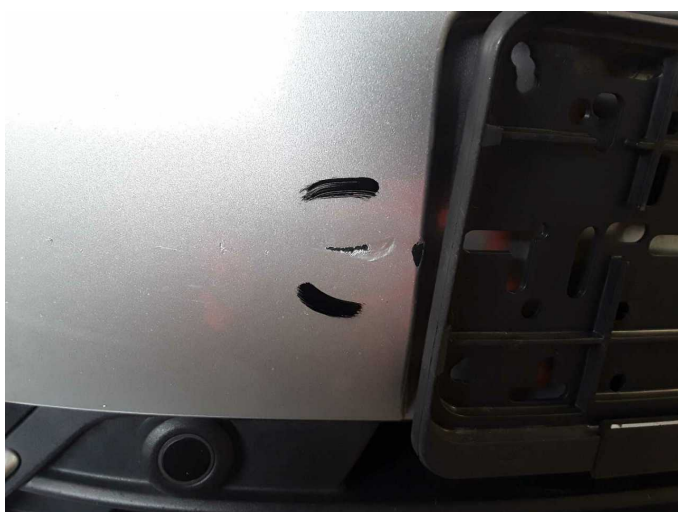
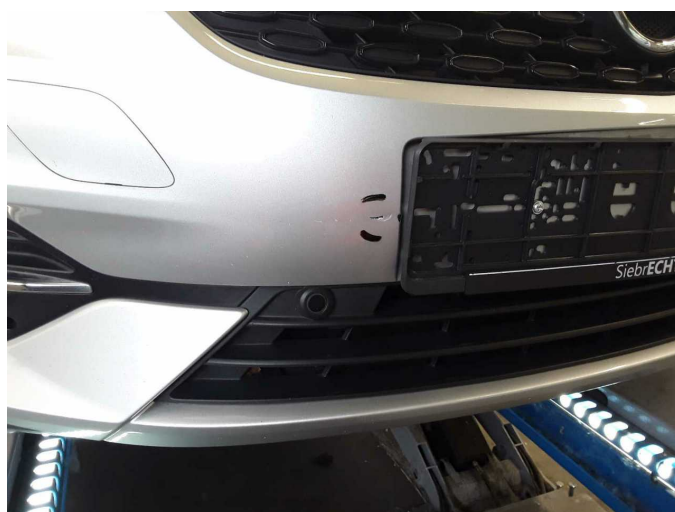
| No. | Component group | Description |
|---|---|---|
| 6 | Front bumper | Front bumper - Scratch(es) - Paint |

**Damage 6:** Front bumper: Front bumper - Scratch(es) - Paint

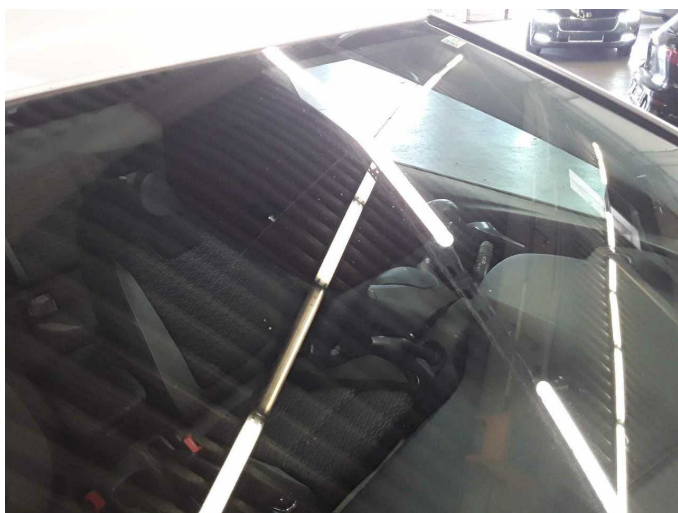
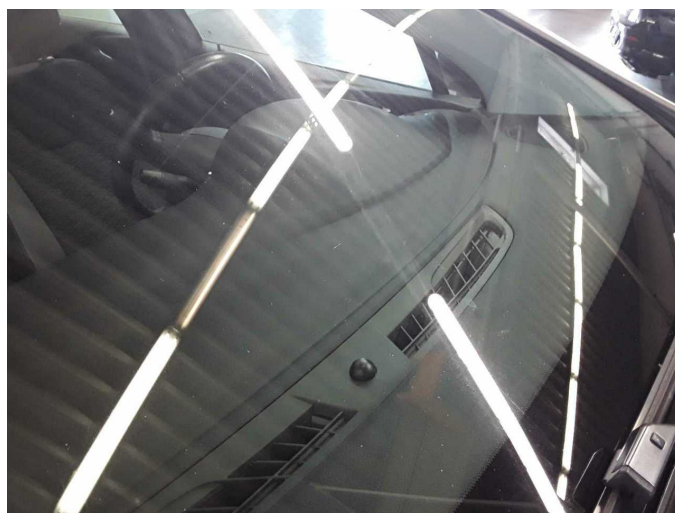
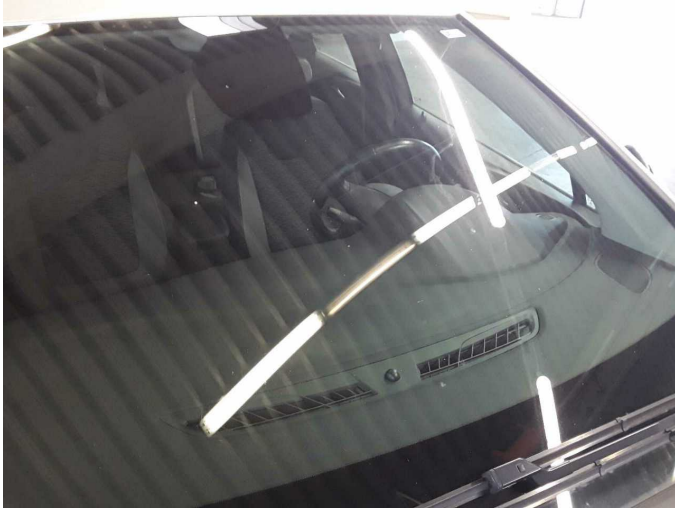
| No. | Component group | Description |
|---|---|---|
| 7 | Vehicle glazing | Windscreen (Zu viele Steinschläge) - Stone chips - Replace |

**Damage 7:** Vehicle glazing: Windscreen (Zu viele Steinschläge) - Stone chips - Replace
