Expertise

Protocol number: 46470443  
Order No. / Reference: 25930036  
Inspection date: 9 Jul 2026

Manufacturer: Mercedes-Benz  
VIN: W1VVLCEZXT4562032

Model: Vito 116 CDI KAWA Extralang HA Aut. PRO

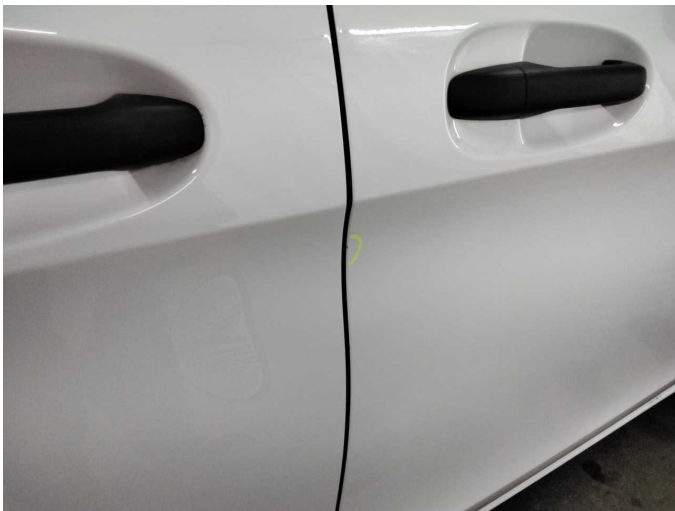
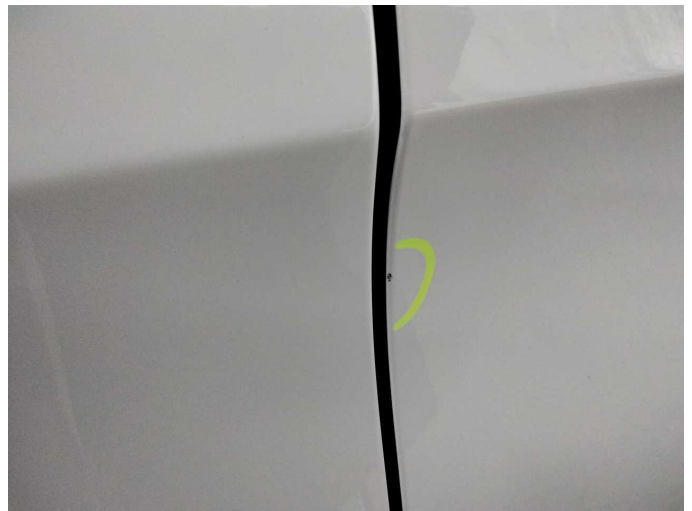
| No. | Component group | Description |
|---|---|---|
| 1 | Door - front right side | Door edge - Scratch(es) - Smart repair |

**Damage 1:** Door - front right side: Door edge - Scratch(es) - Smart repair

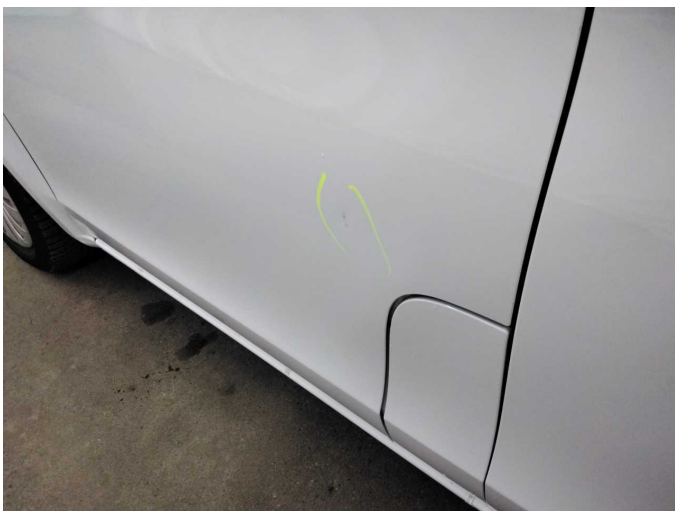
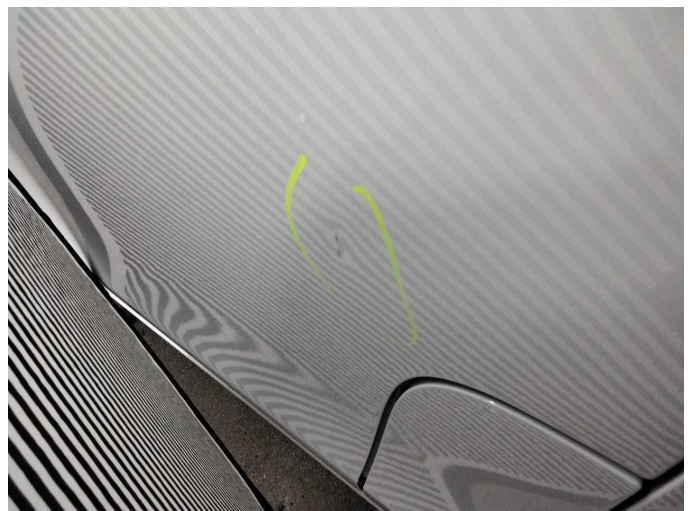
| No. | Component group | Description |
|---|---|---|
| 2 | Door - front left side | Door - Dent / paintcoat damage - Smart repair |

**Damage 2:** Door - front left side: Door - Dent / paintcoat damage - Smart repair
