Expertise

Protocol number: 46381034  
Order No. / Reference: 26503772  
Inspection date: 7 Jul 2026

Manufacturer: Skoda  
VIN: TMBJH9NPXL7058247

Model: Superb Combi 2.0 TDI DSG L&K

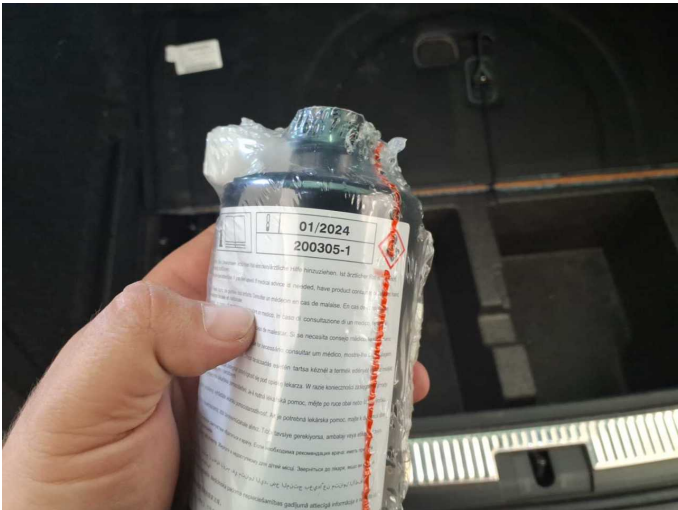
| No. | Component group | Description |
|---|---|---|
| 1 | Equipment | Tirefit filler - Expired - Replace |

Damage 1: Equipment: Tirefit filler - Expired - Replace

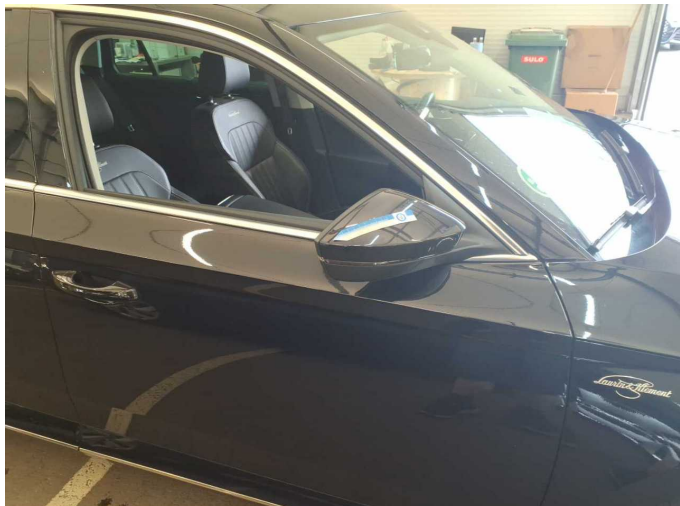
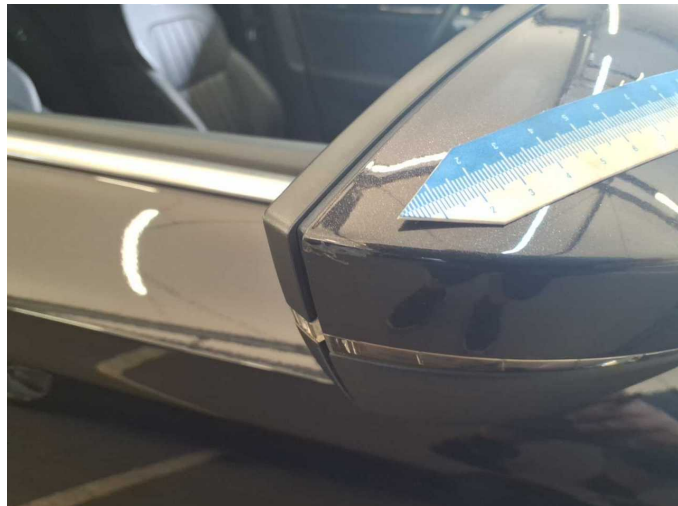
| No. | Component group | Description |
|---|---|---|
| 2 | Wing mirror - right side | Cap - Scratched - Smart repair |

**Damage 2:** Wing mirror - right side: Cap - Scratched - Smart repair

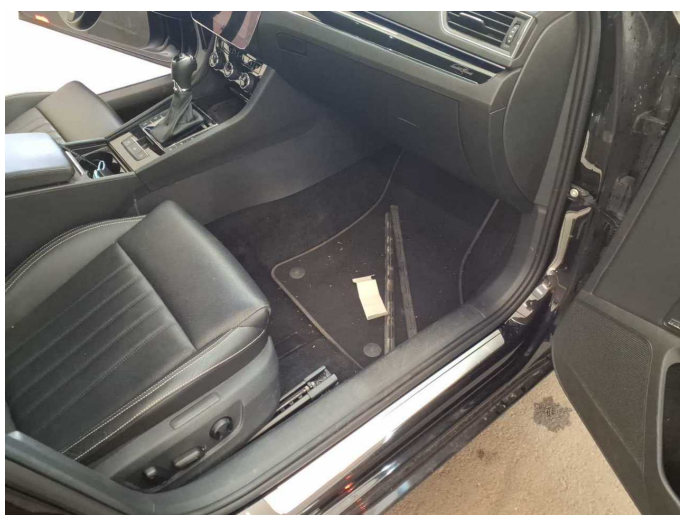
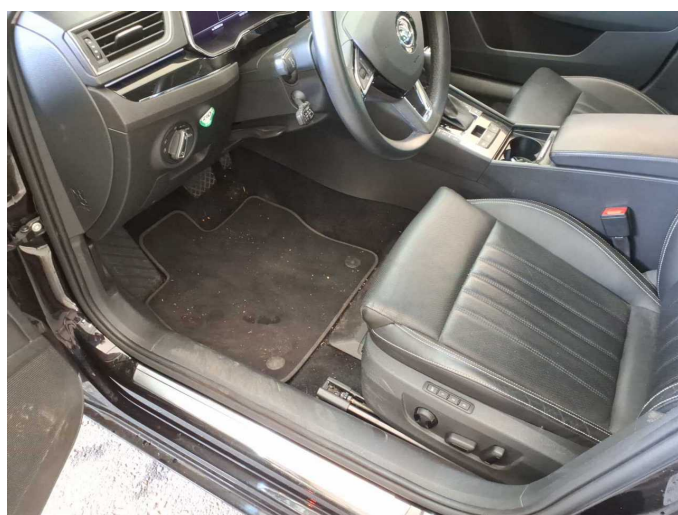
| No. | Component group | Description |
|---|---|---|
| 3 | Interior | Interior - Soiled - Clean |

**Damage 3:** Interior: Interior - Soiled - Clean

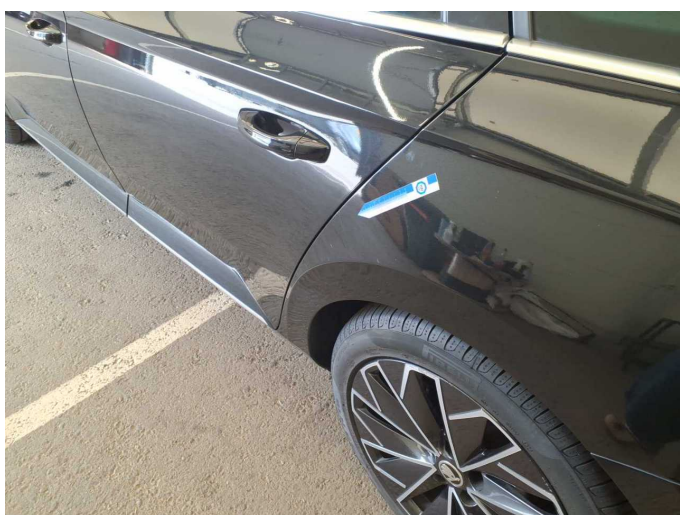
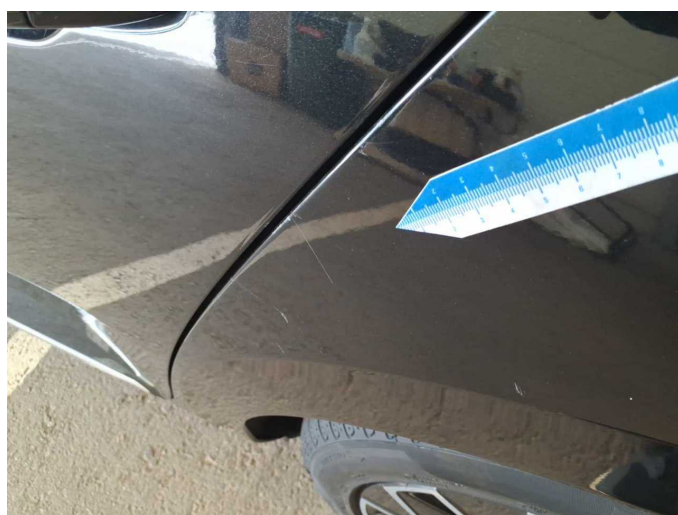
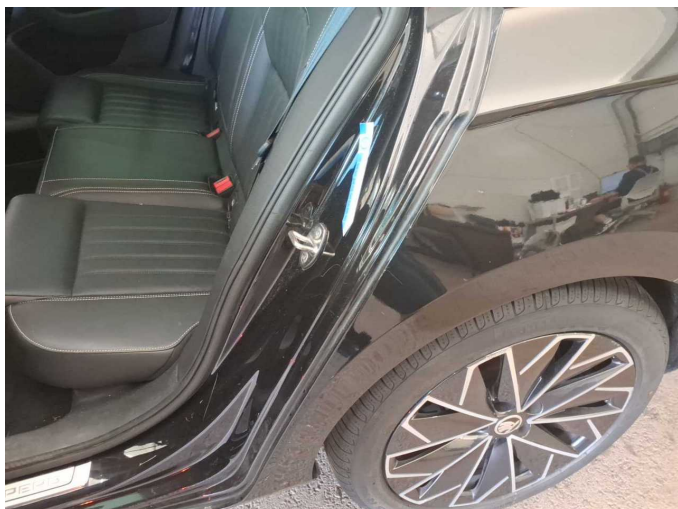
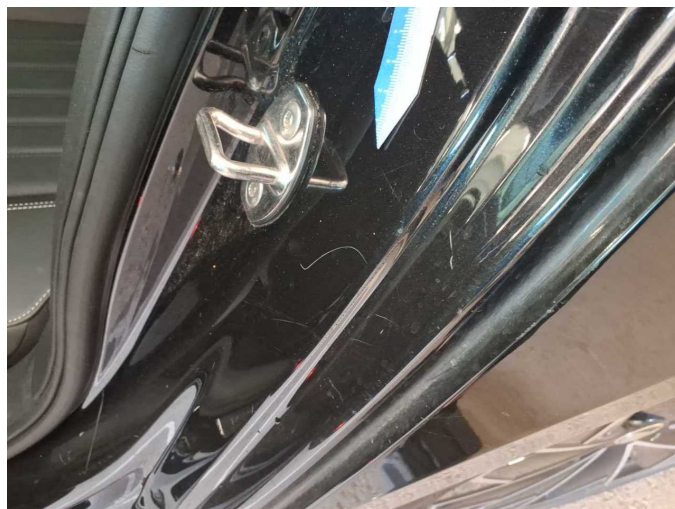
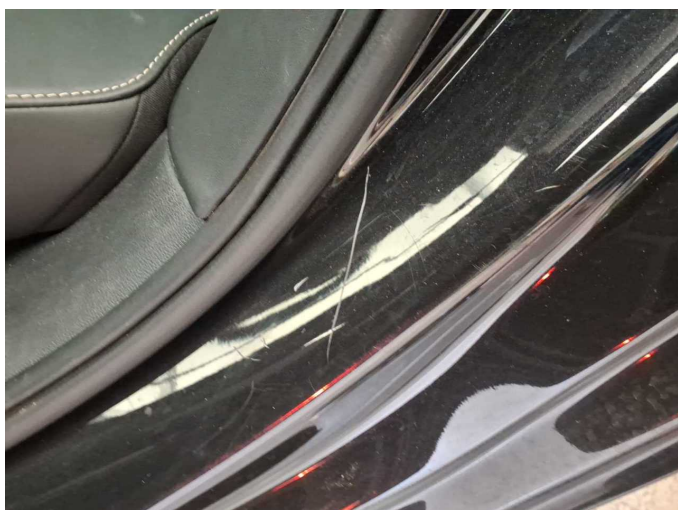
| No. | Component group | Description |
|---|---|---|
| 4 | Side panel - rear left side | Side panel (Inkl. Einstieg) - Scratched - Smart repair |

**Damage 4:** Side panel - rear left side: Side panel (Inkl. Einstieg) - Scratched - Smart repair

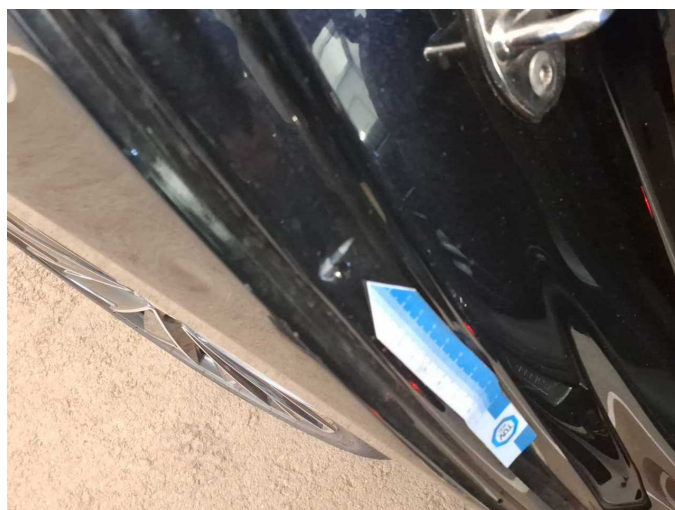
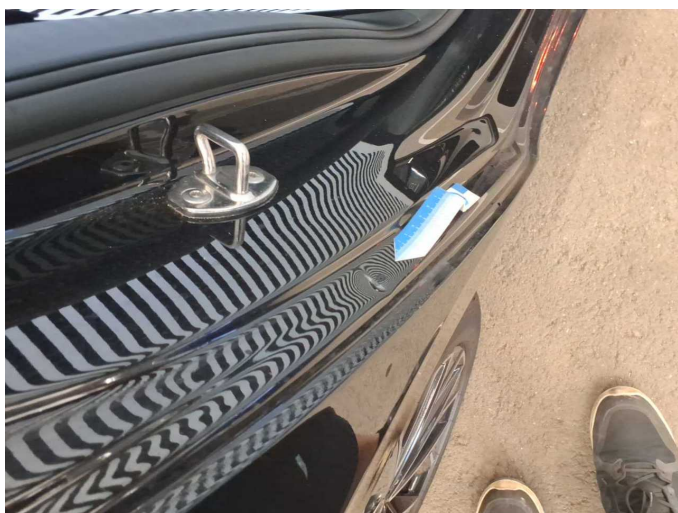
| No. | Component group | Description |
|---|---|---|
| 5 | Side panel - rear right side | Sill - Dent / paintcoat damage - Smart repair |

**Damage 5:** Side panel - rear right side: Sill - Dent / paintcoat damage - Smart repair

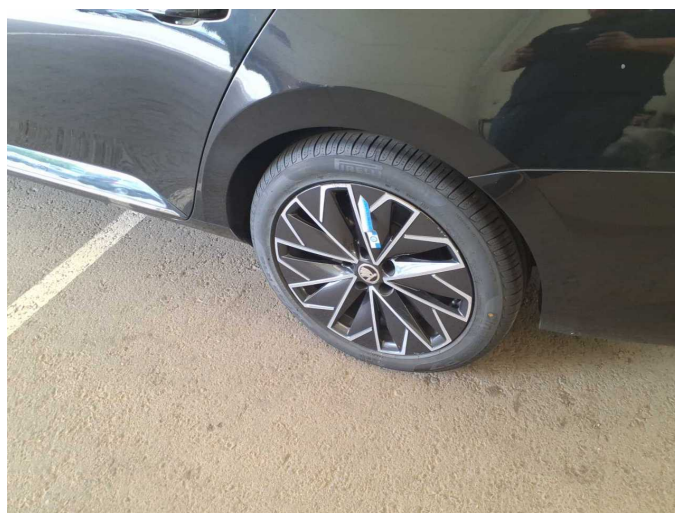
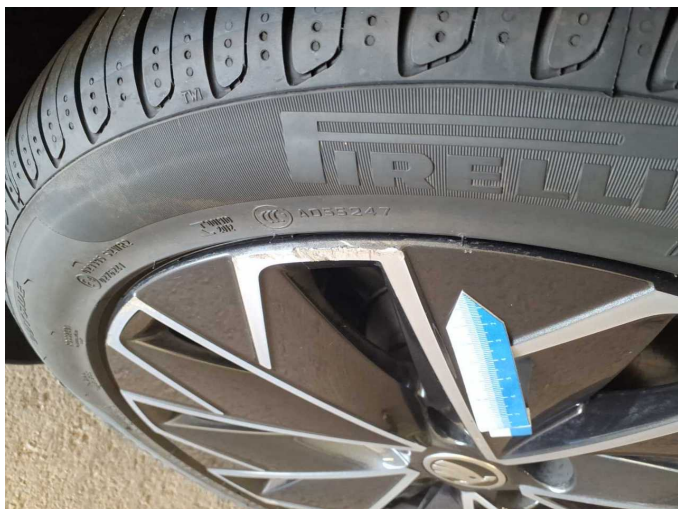
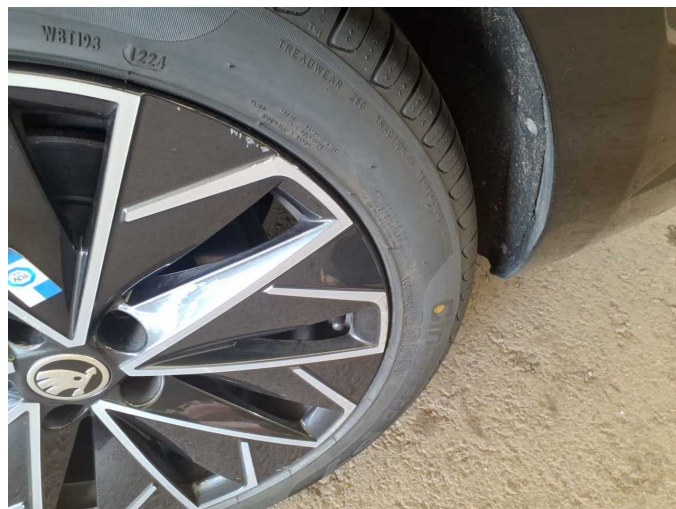
| No. | Component group | Description |
|---|---|---|
| 6 | Wheel / tyres | Alloy rim - rear left side - Scratched - Loss in value |

**Damage 6:** Wheel / tyres: Alloy rim - rear left side - Scratched - Loss in value

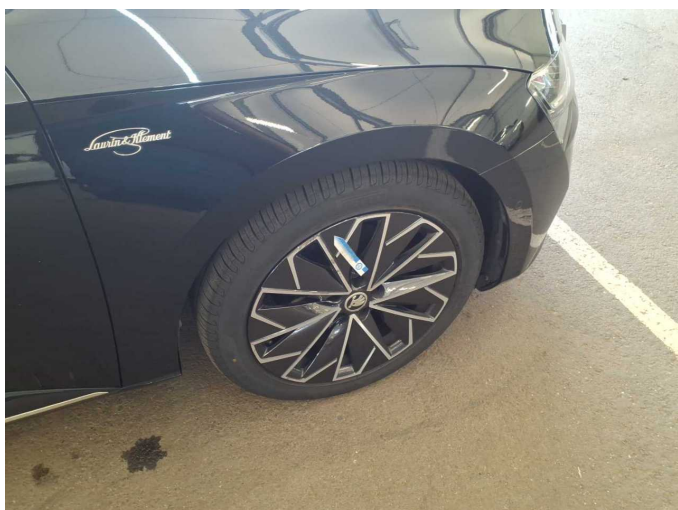
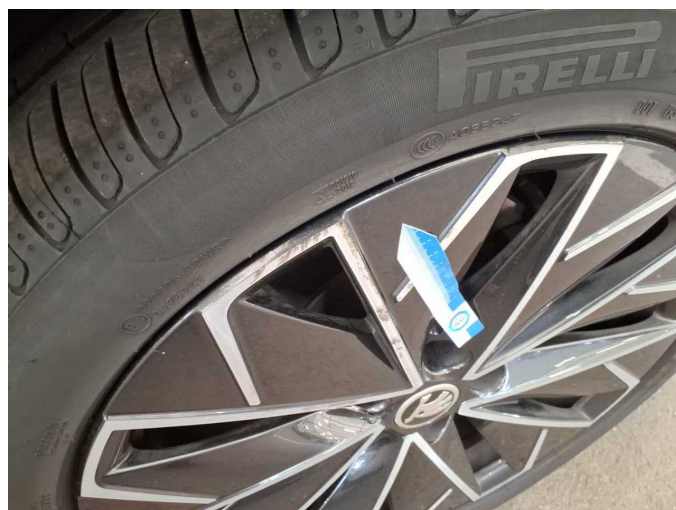
| No. | Component group | Description |
|---|---|---|
| 7 | Wheel / tyres | Alloy rim - front right side - Scratched - Loss in value |

**Damage 7:** Wheel / tyres: Alloy rim - front right side - Scratched - Loss in value

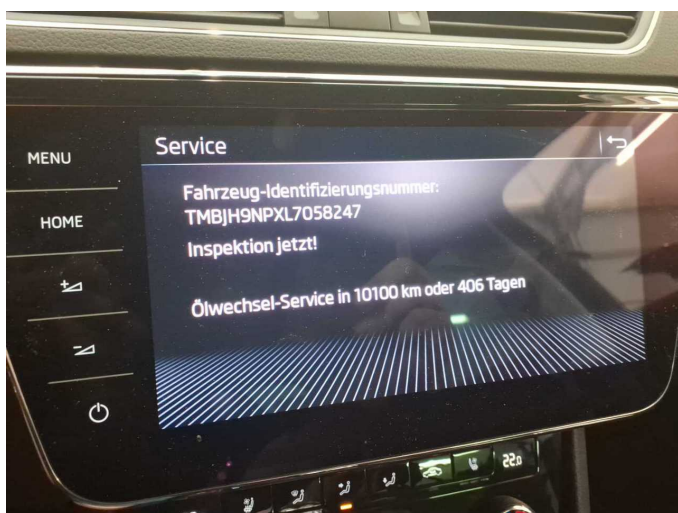
| No. | Component group | Description |
|---|---|---|
| 8 | Misc. | Inspection / maintenance - Due - Perform |

**Damage 8:** Misc.: Inspection / maintenance - Due - Perform

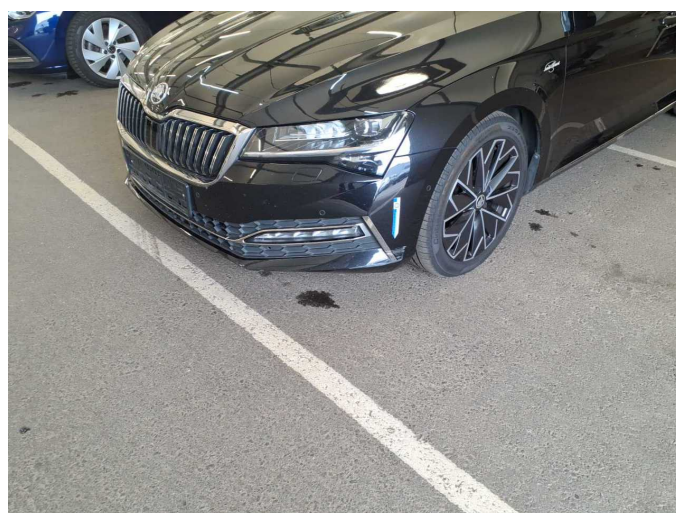
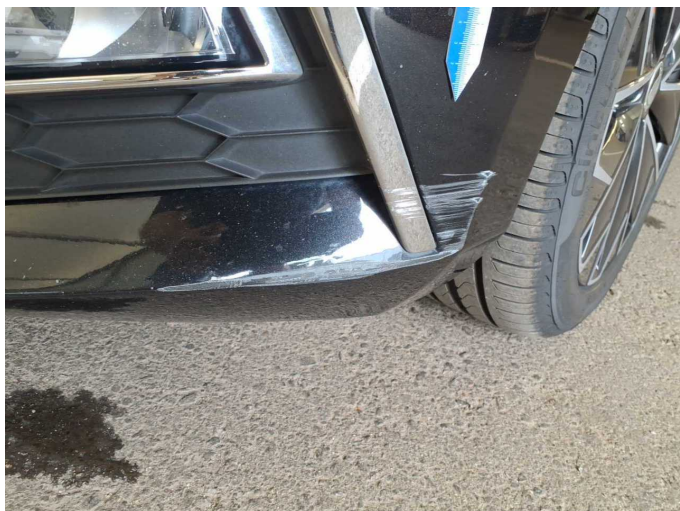
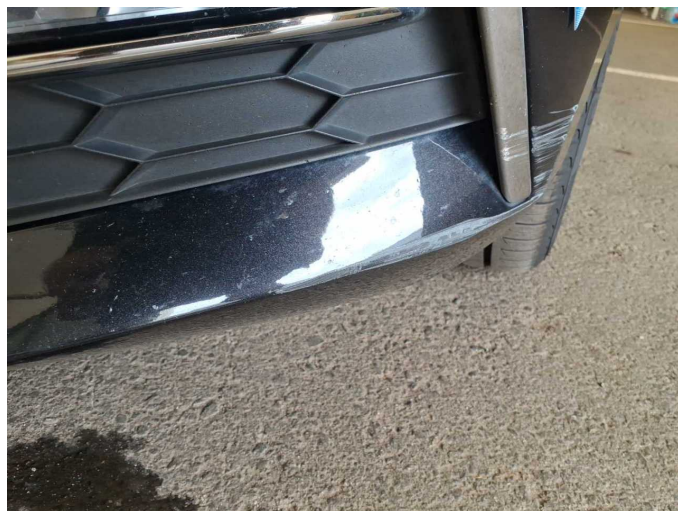
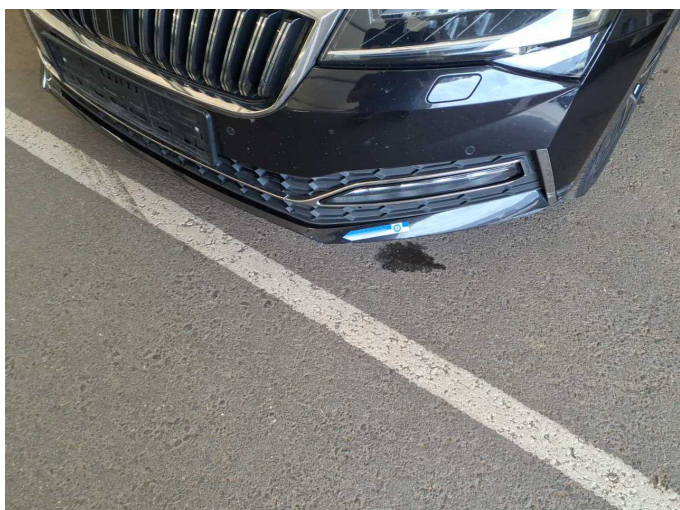
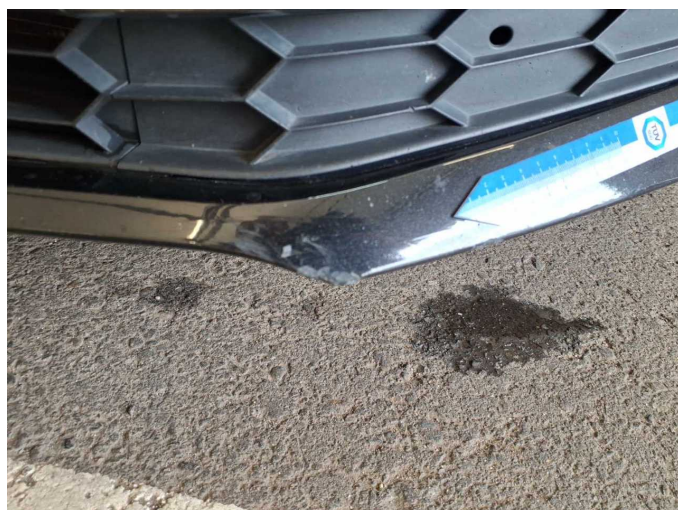
| No. | Component group | Description |
|---|---|---|
| 9 | Front bumper | Front bumper (+ Blende) - Scratched - Paint |

**Damage 9:** Front bumper: Front bumper (+ Blende) - Scratched - Paint

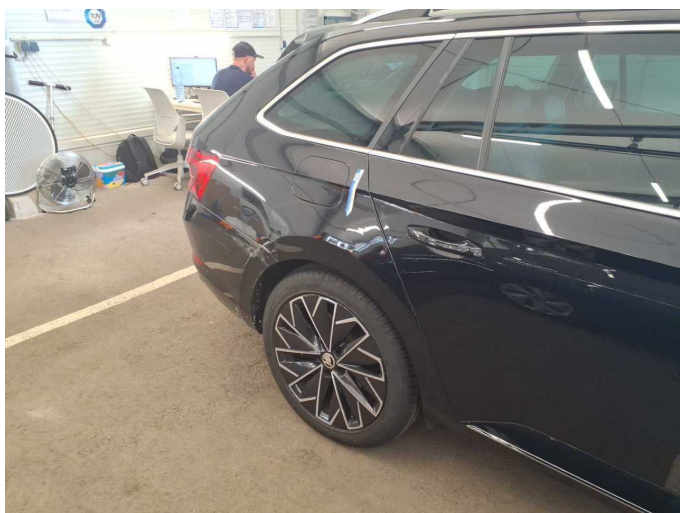
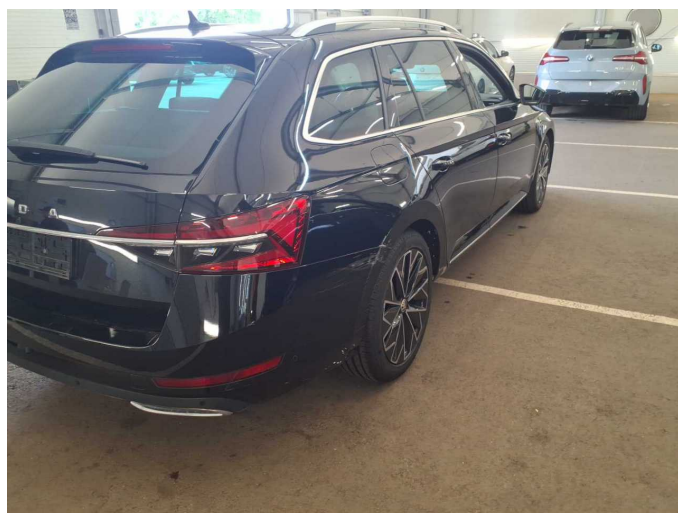
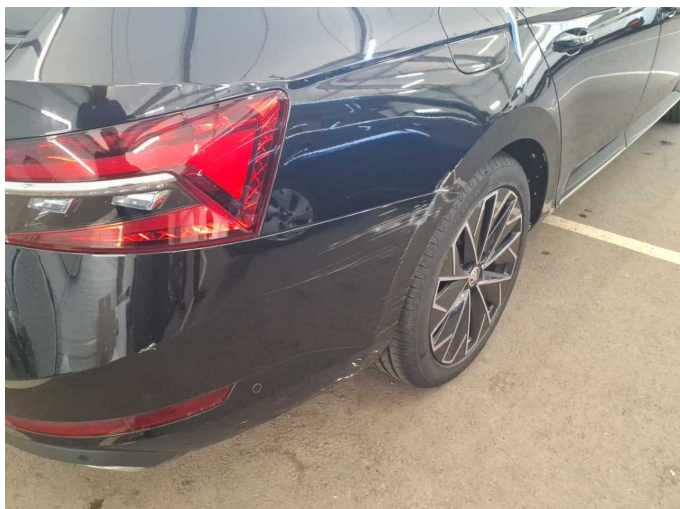
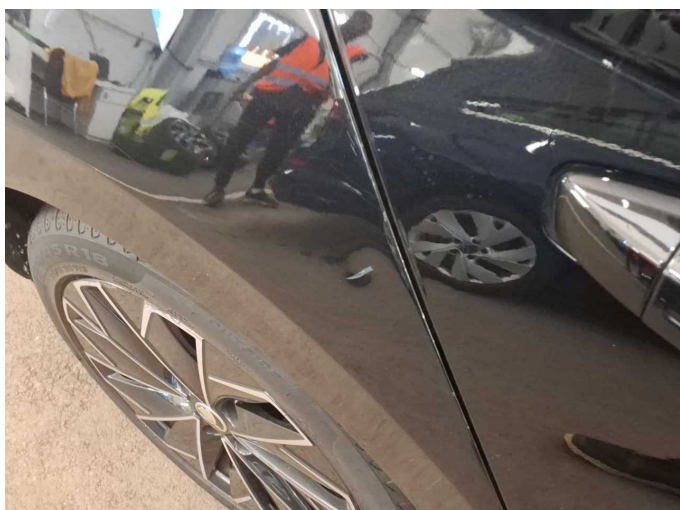
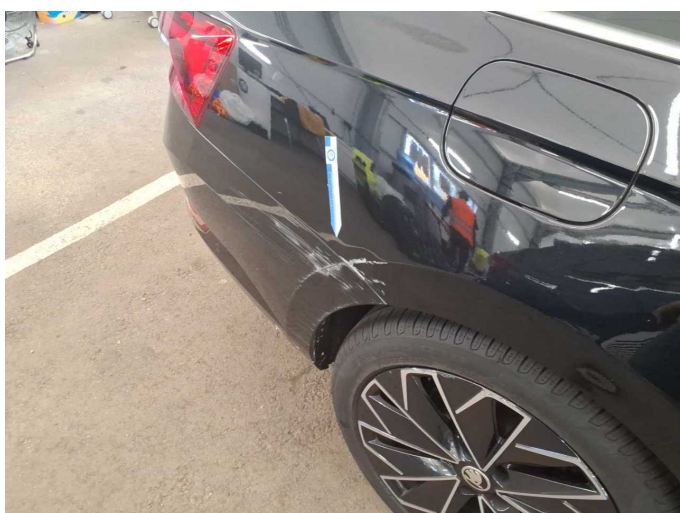
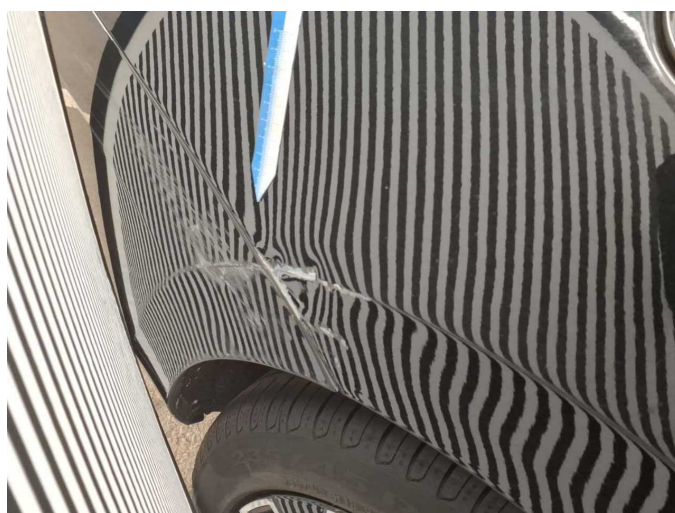
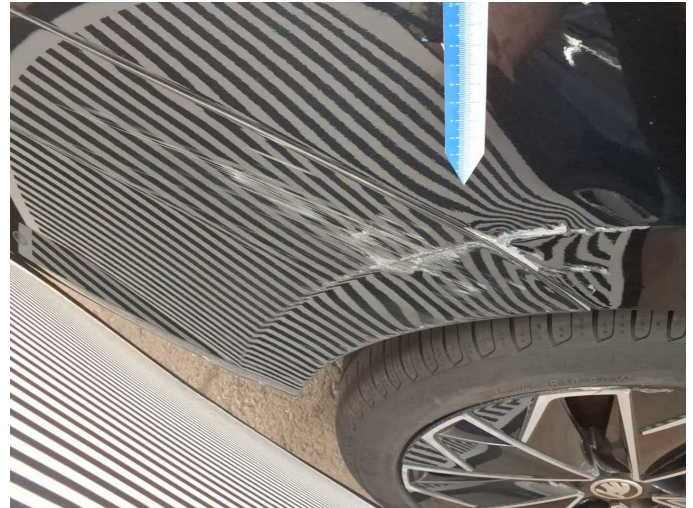
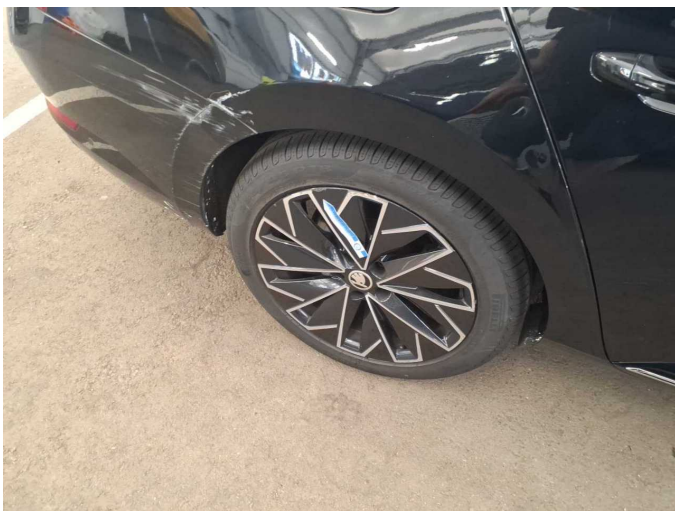
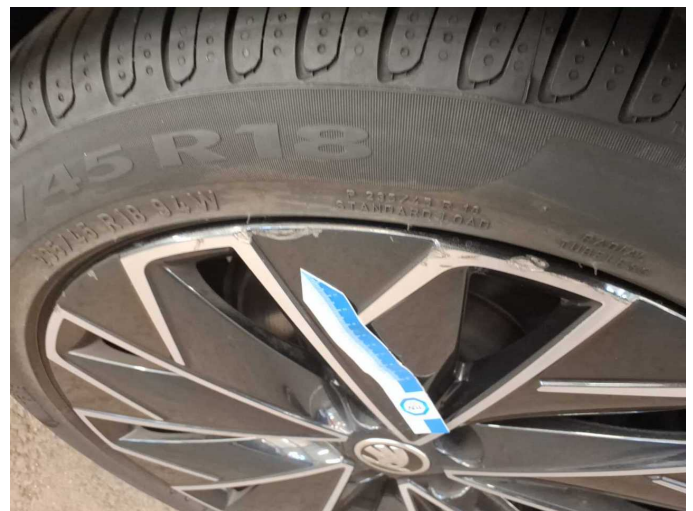
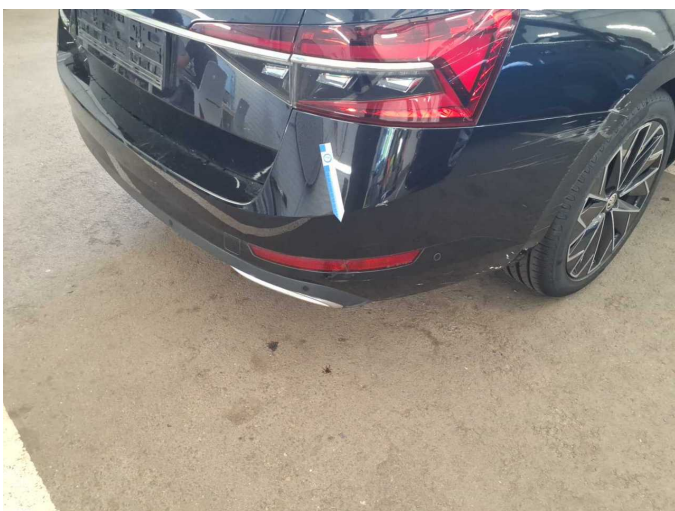
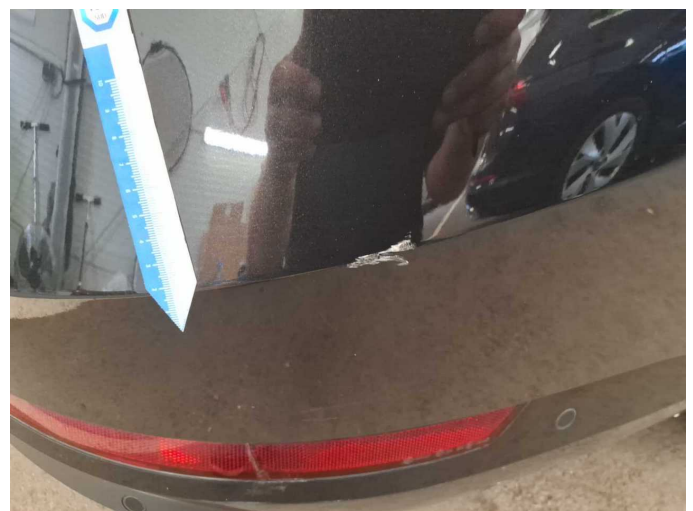
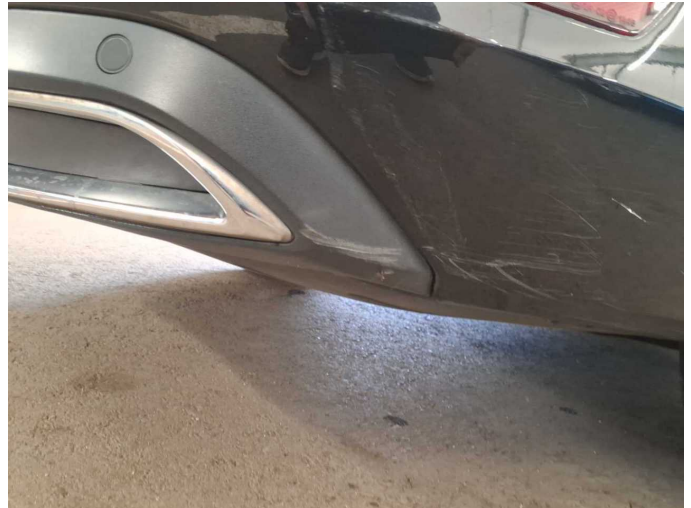
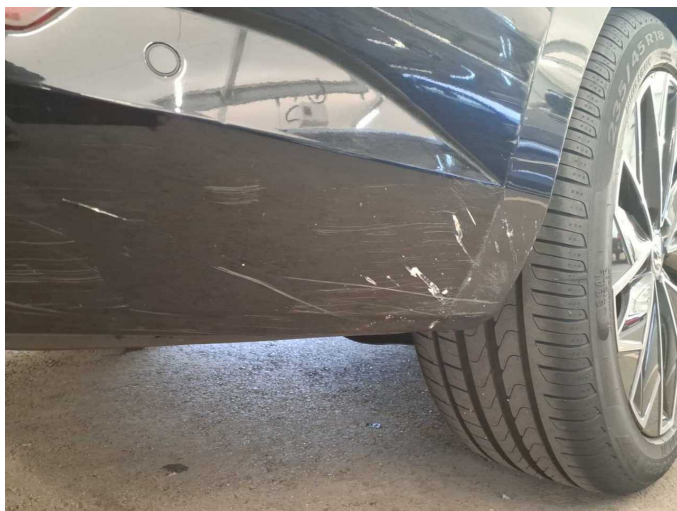
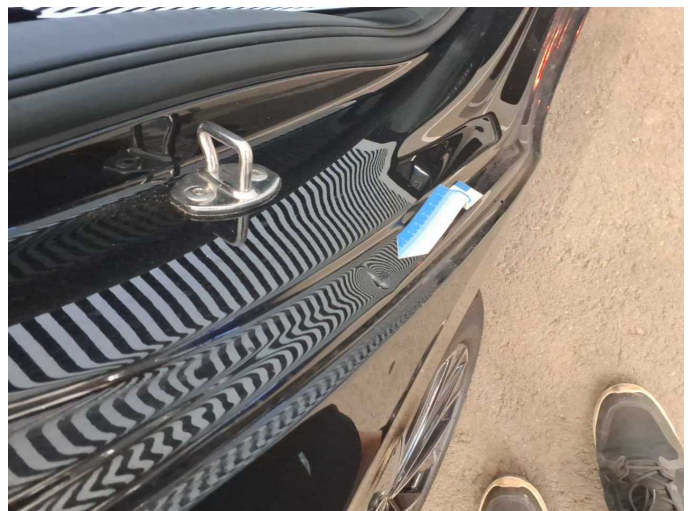
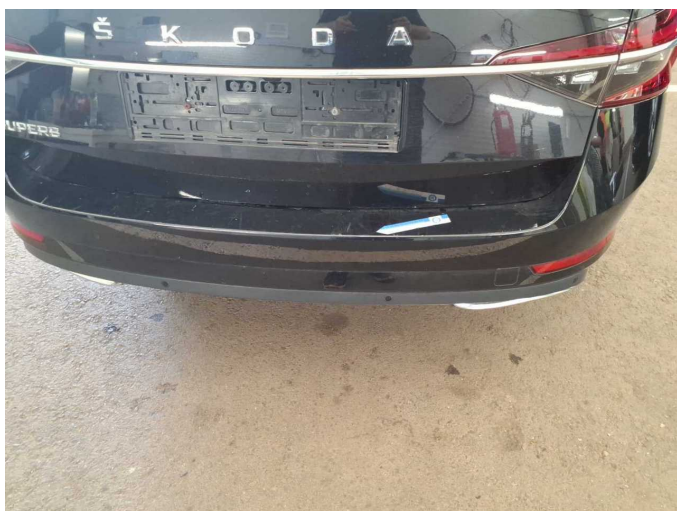
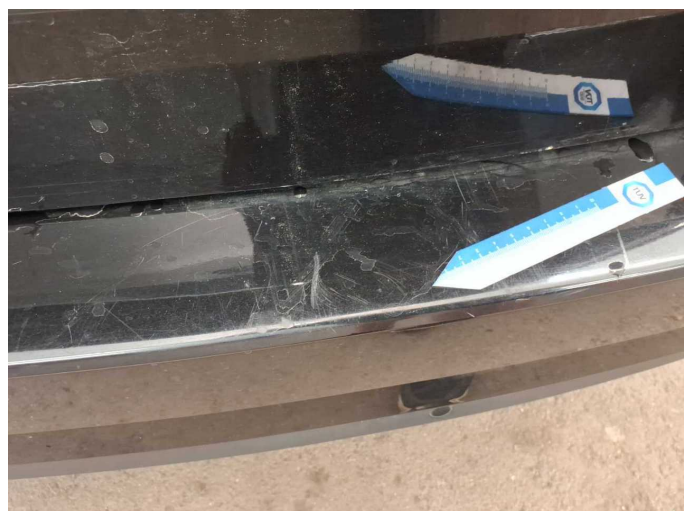
| No. | Accident |
|---|---|
| 1 | Rear, Side right |

**Accident 1:** Rear, Side right

**Accident 1: Rear, Side right**

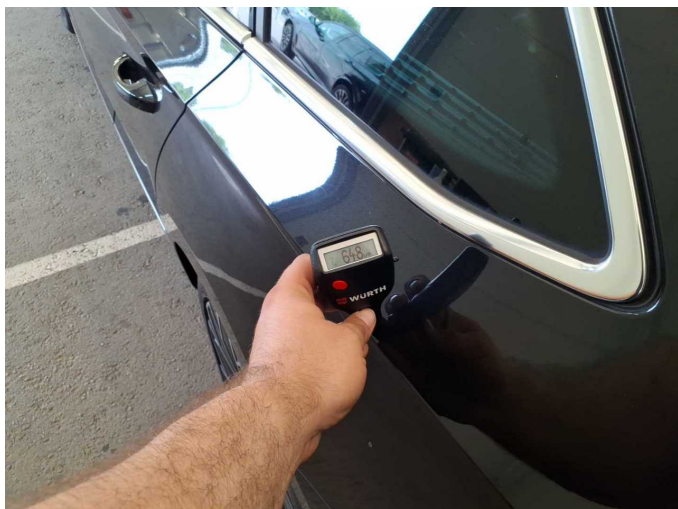
| No. | Repainting |
|---|---|
| 1 | Side panel - rear left side, Professionally carried out, Invoice of repair done Non-existent |

| Side panel - rear left side | 648 µm | Side panel - rear right side | 205 µm |

**Repainting 1:** Side panel - rear left side

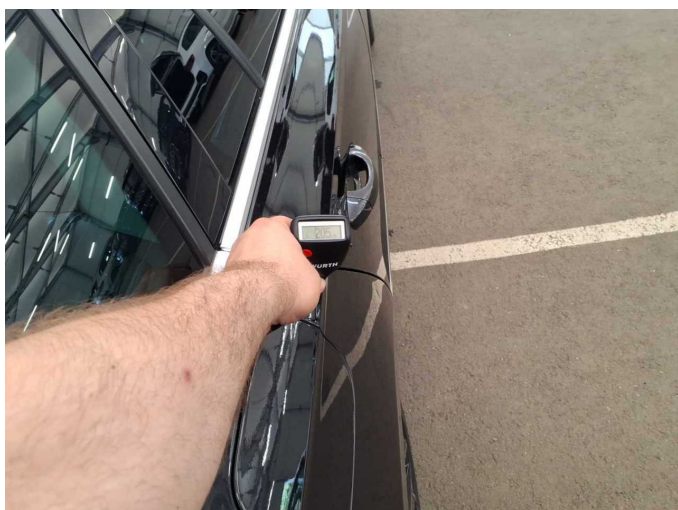
| No. | Repainting |
|---|---|
| 2 | Side panel - rear right side, Professionally carried out, Invoice of repair done Non-existent |

**Repainting 2:** Side panel - rear right side

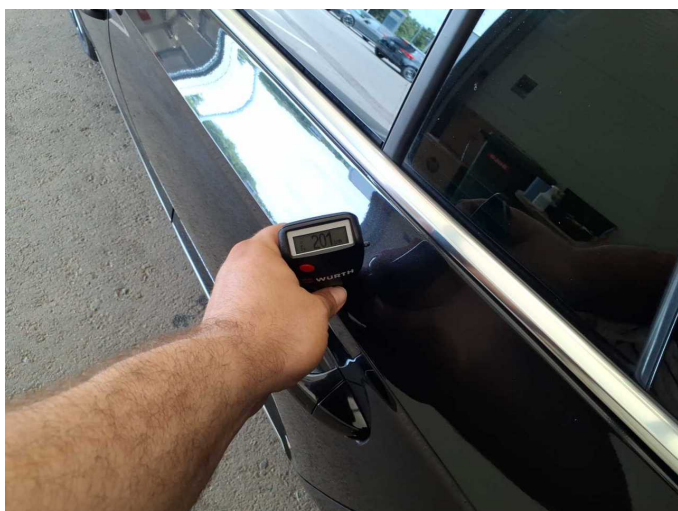
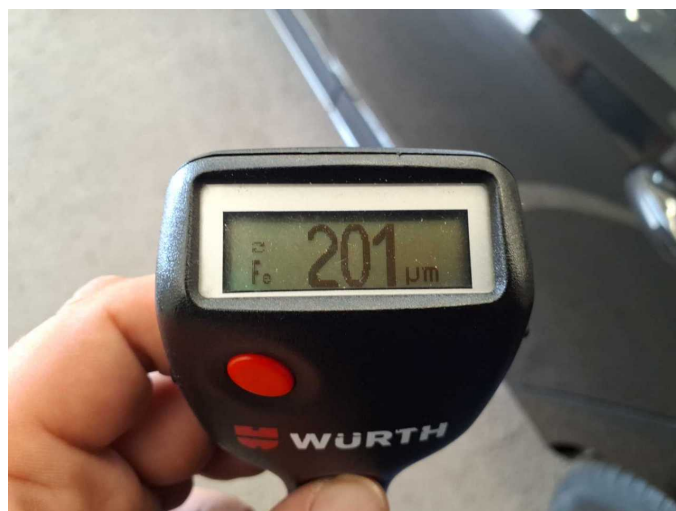
| No. | Repainting |
|---|---|
| 3 | Door - rear left side, Professionally carried out, Invoice of repair done Non-existent |

| Door - rear left side | 201 µm | Door - rear right side | 190 µm |

**Repainting 3:** Door - rear left side

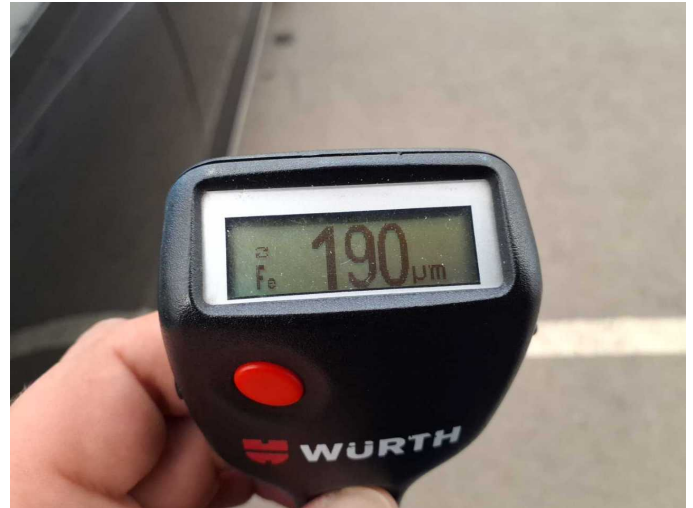
| No. | Repainting |
|---|---|
| 4 | Door - rear right side, Professionally carried out, Invoice of repair done Non-existent |

**Repainting 4:** Door - rear right side

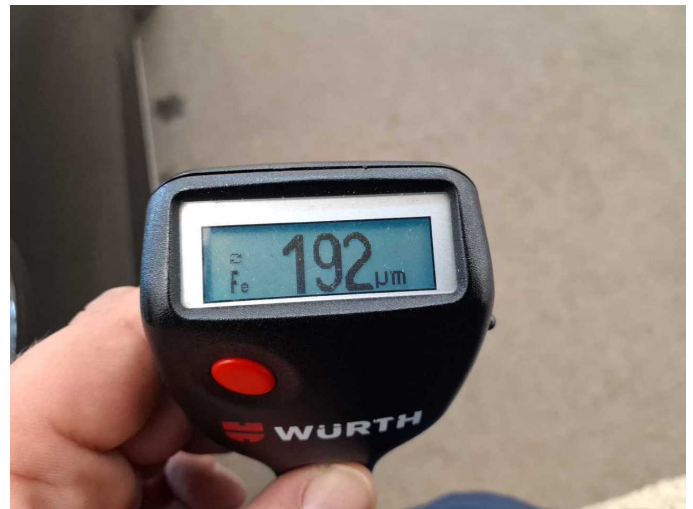
| No. | Repainting |
|---|---|
| 5 | Door - front right side, Professionally carried out, Invoice of repair done Non-existent |

| Door - front right side | 192 µm | | |

**Repainting 5:** Door - front right side
