Expertise

Protocol number: 45075017
Order No. / Reference: 26123787
Inspection date: 10 Apr 2026

Model: Kodiaq 2.0 TDI DSG Style

VIN: TMBJJ7NS2P8514741

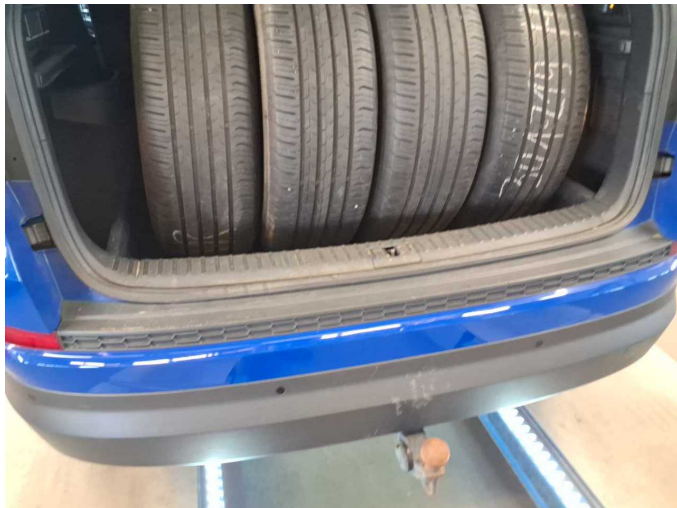
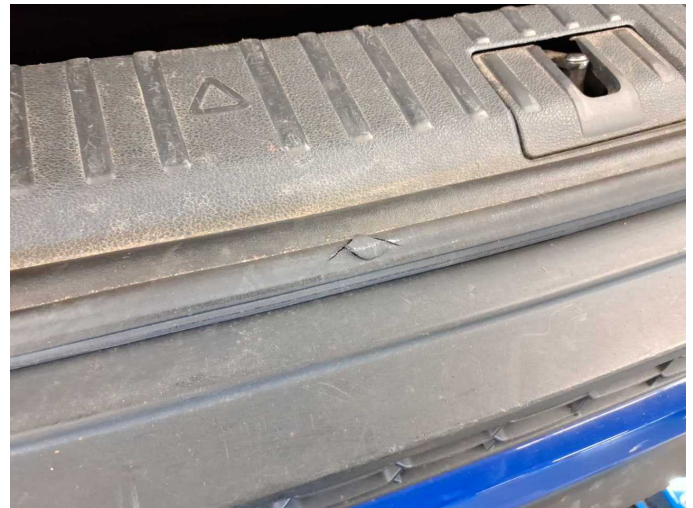
| No. | Component group | Description |
|---|---|---|
| 1 | Boot lid / rear door | Seal - Broken / torn - Replace |

Damage 1: Boot lid / rear door: Seal - Broken / torn - Replace

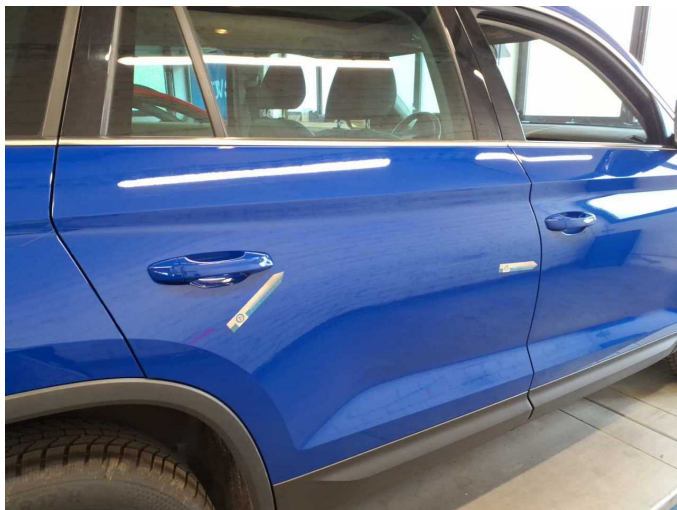
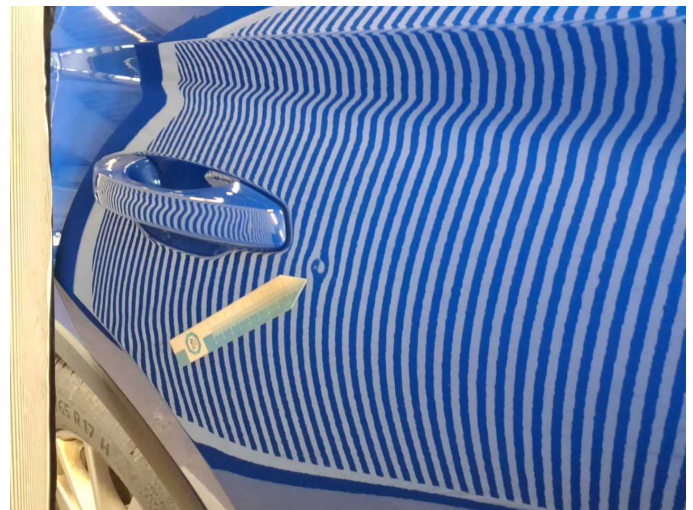
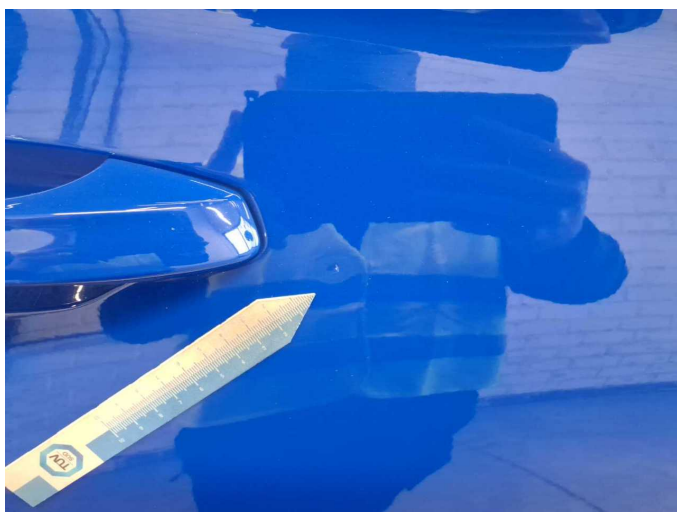
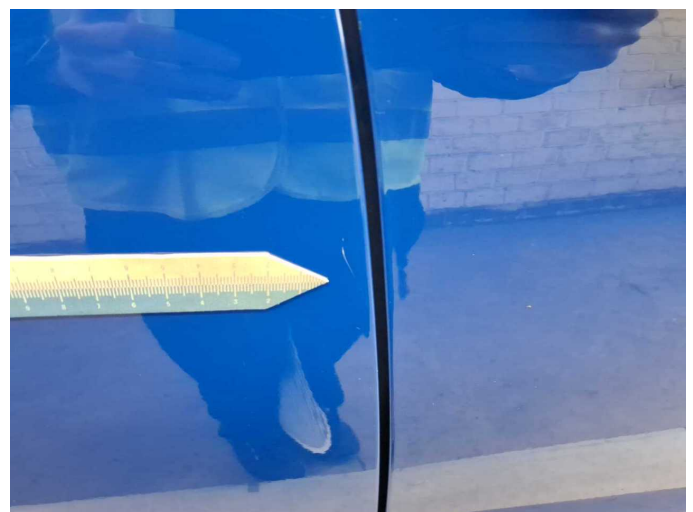
| No. | Component group | Description |
|---|---|---|
| 2 | Door - rear right side | Door - Dent / paintcoat damage - Smart repair |

Damage 2: Door - rear right side: Door - Dent / paintcoat damage - Smart repair

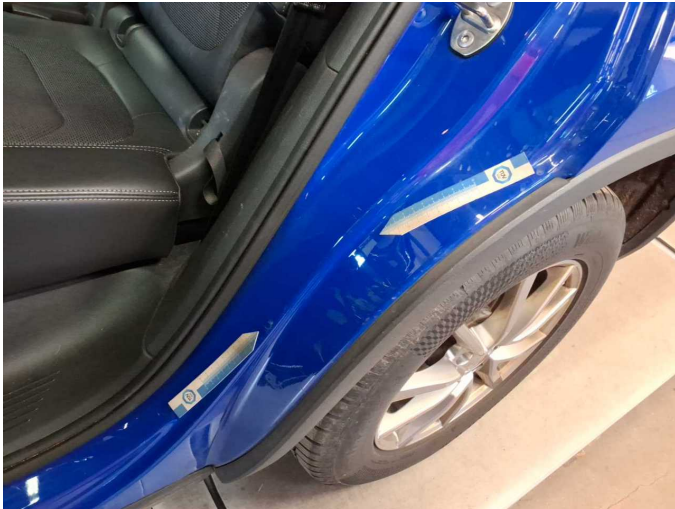
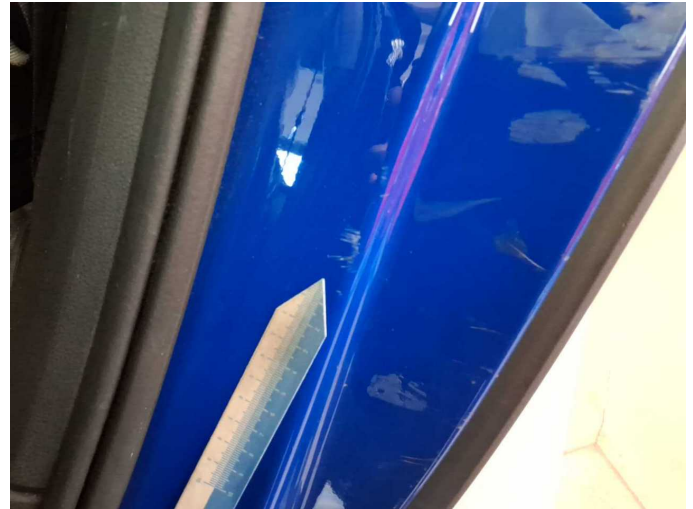
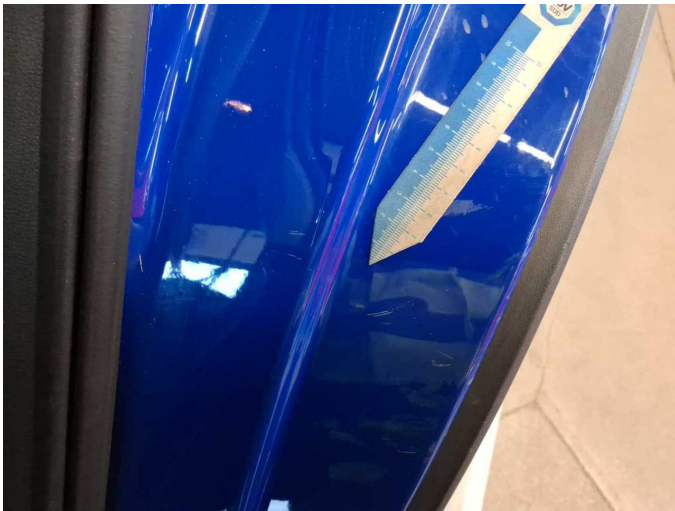
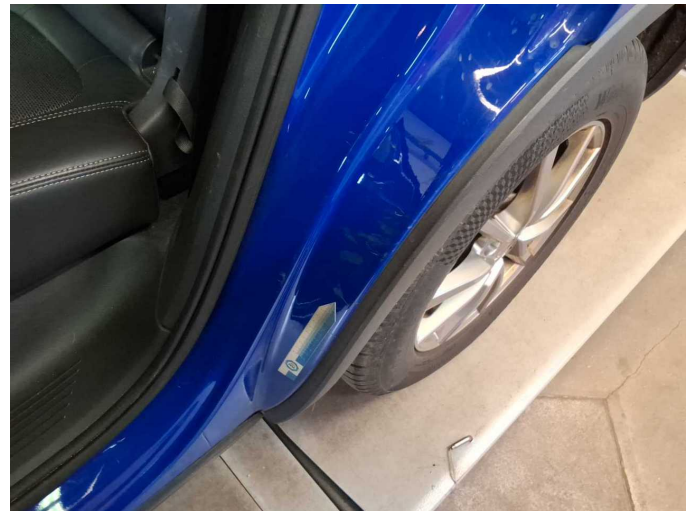
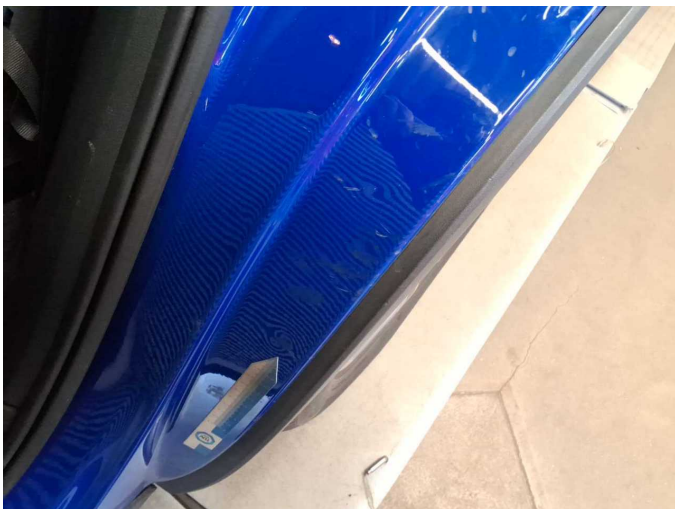
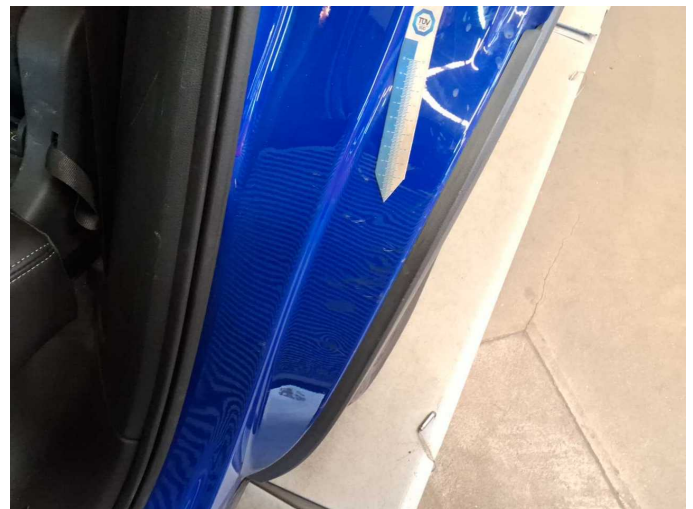
| No. | Component group | Description |
|---|---|---|
| 3 | Side panel - rear left side | Sill - Dent / paintcoat damage - Smart repair |

Damage 3: Side panel - rear left side: Sill - Dent / paintcoat damage - Smart repair

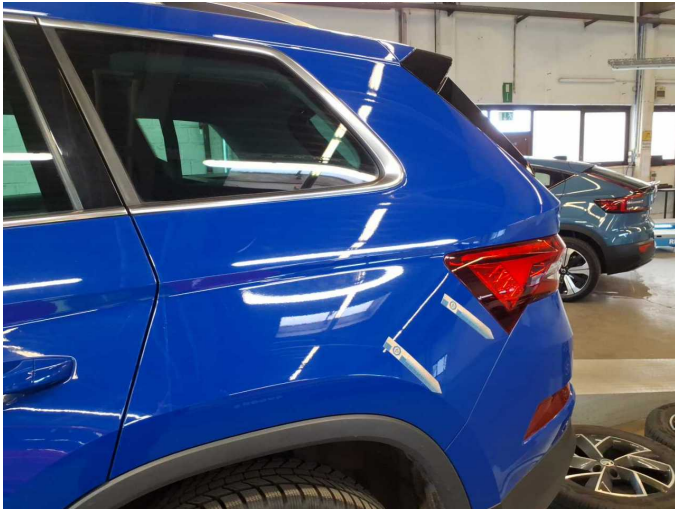
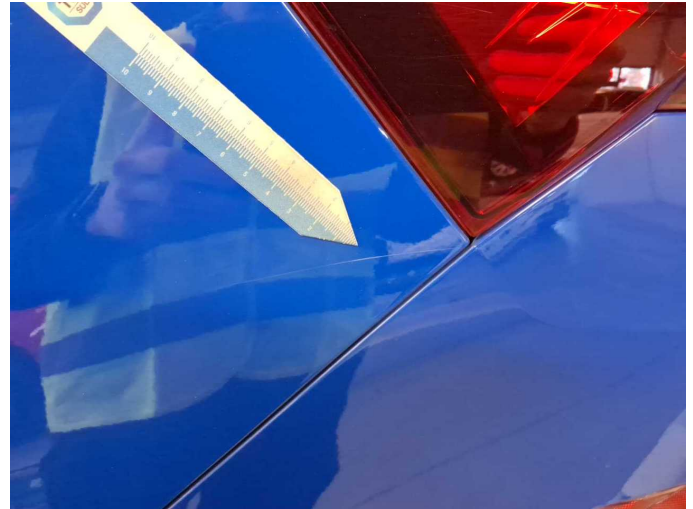
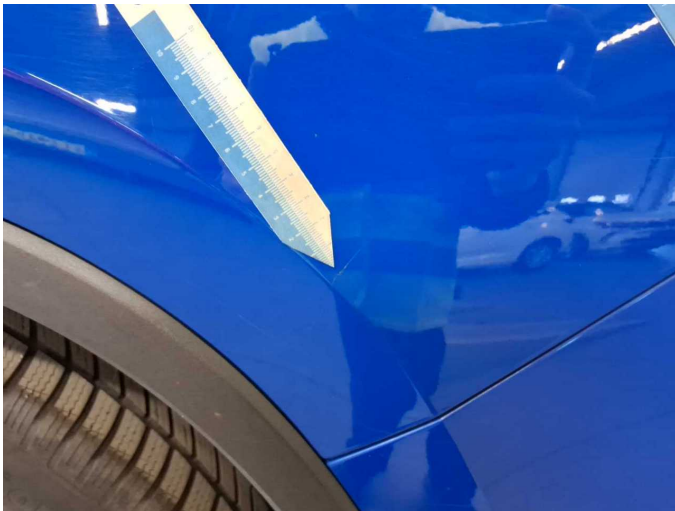
| No. | Component group | Description |
|---|---|---|
| 4 | Side panel - rear left side | Side panel - Scratch(es) - Smart repair |

Damage 4: Side panel - rear left side: Side panel - Scratch(es) - Smart repair

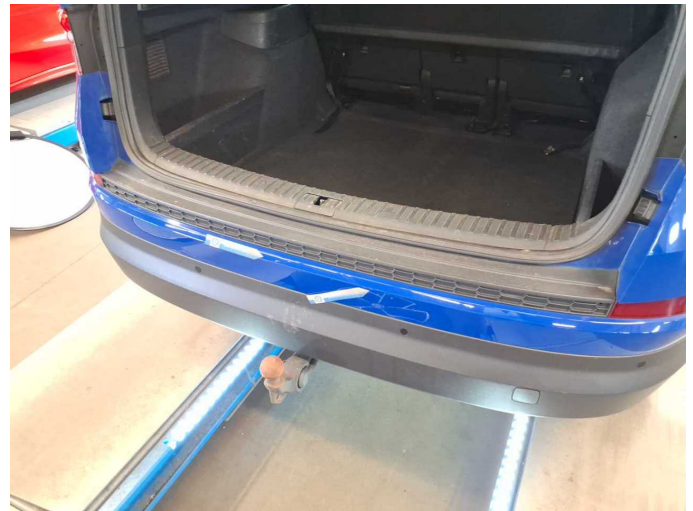
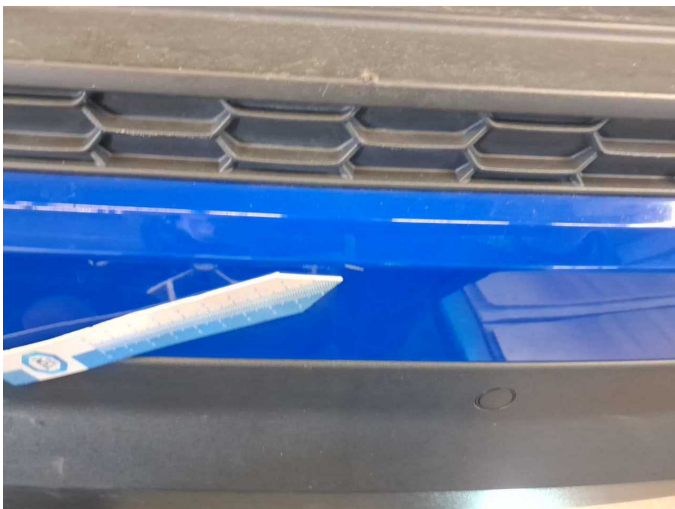
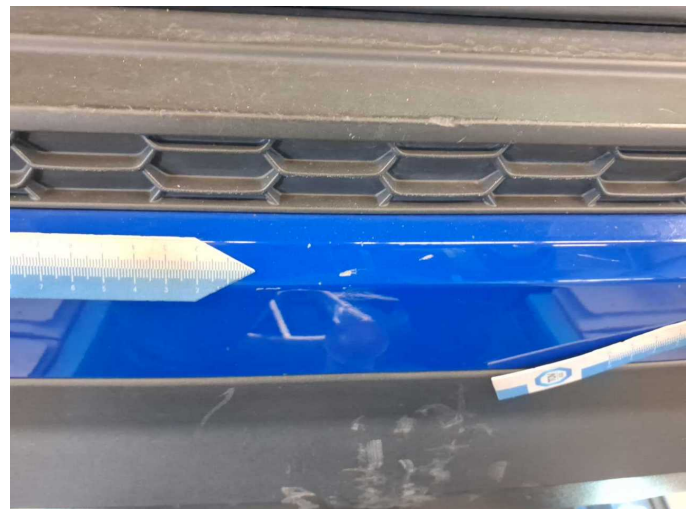
| No. | Component group | Description |
|---|---|---|
| 5 | Rear bumper | Rear bumper - Scratch(es) - Smart repair |

Damage 5: Rear bumper: Rear bumper - Scratch(es) - Smart repair

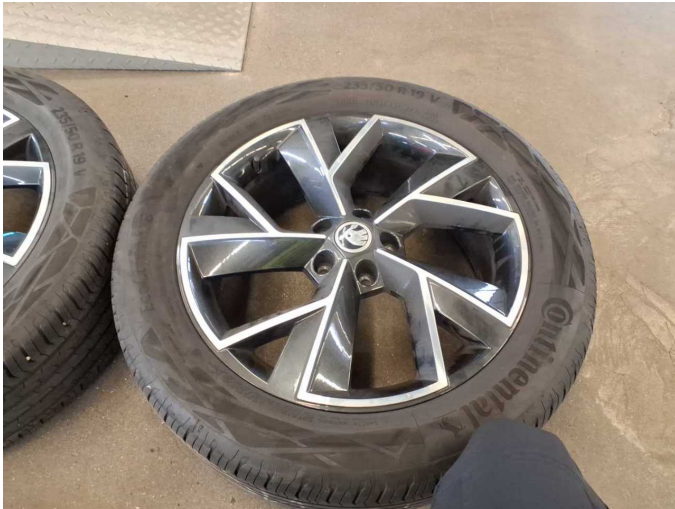
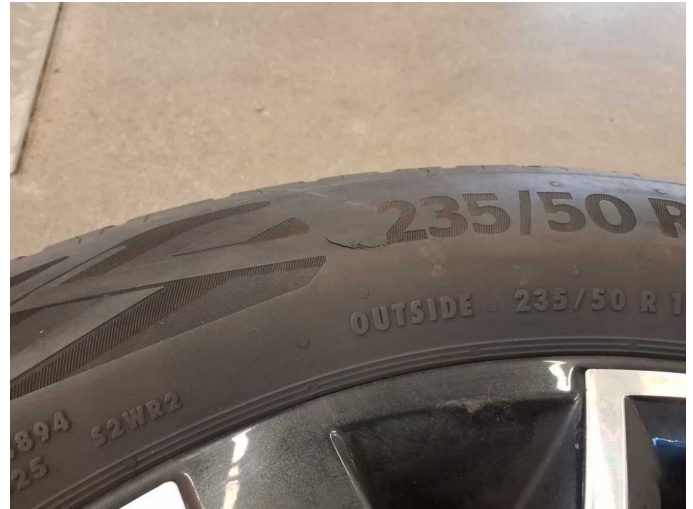
| No. | Component group | Description |
|---|---|---|
| 6 | 2nd wheel set | 1 tyre - Damaged - Replace |

Damage 6: 2nd wheel set: 1 tyre - Damaged - Replace

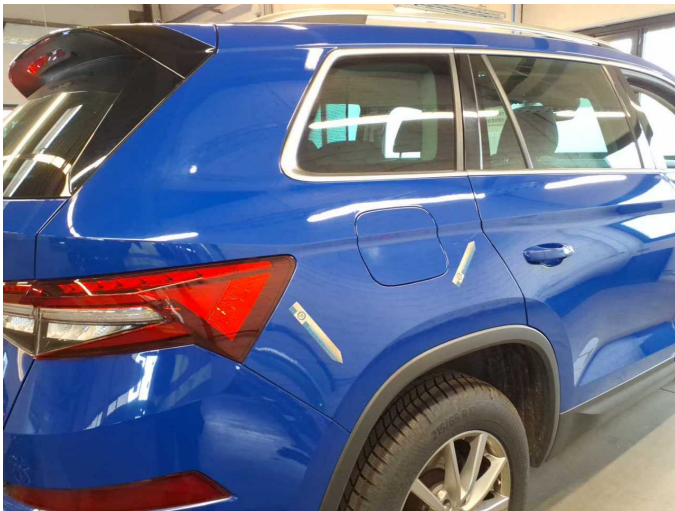
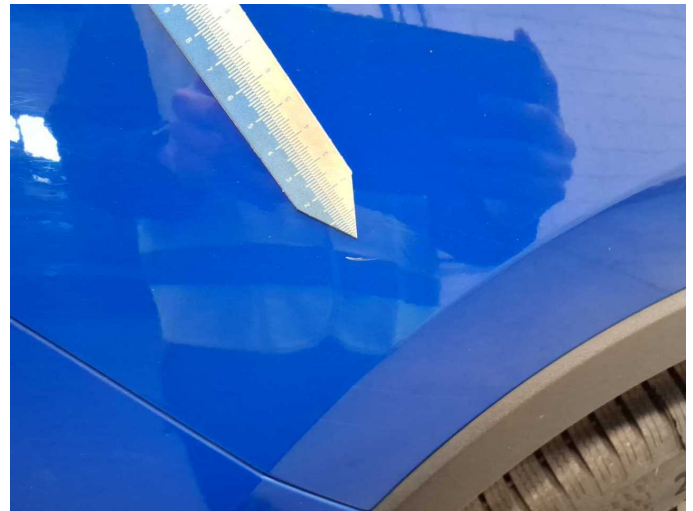
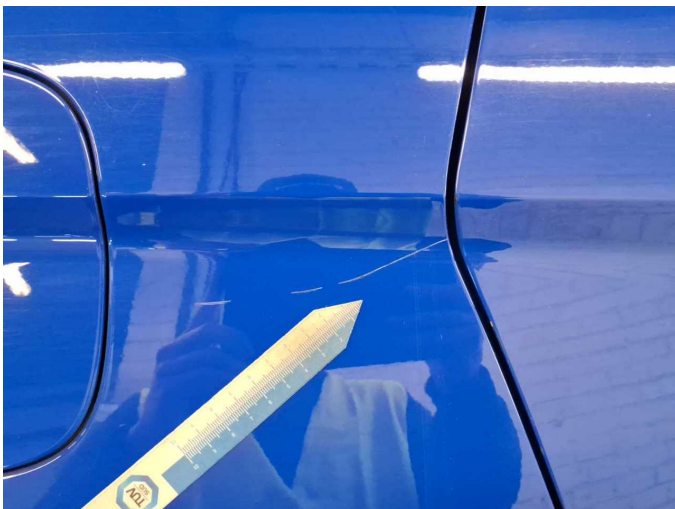
| No. | Component group | Description |
|---|---|---|
| 7 | Side panel - rear right side | Side panel - Scratch(es) - Paint |

Damage 7: Side panel - rear right side: Side panel - Scratch(es) - Paint

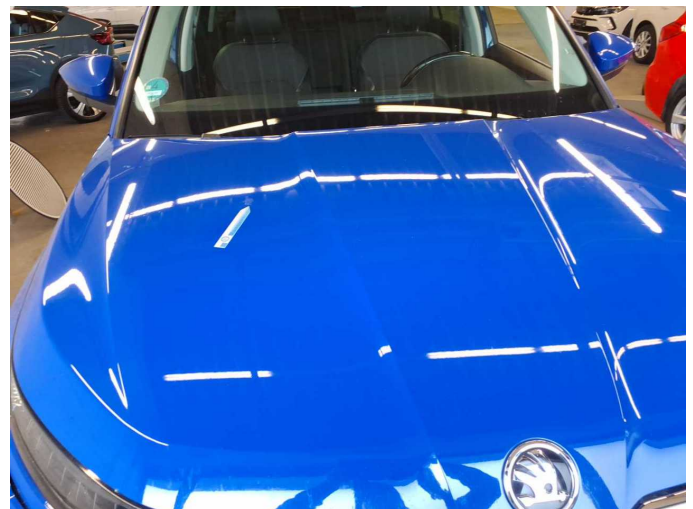
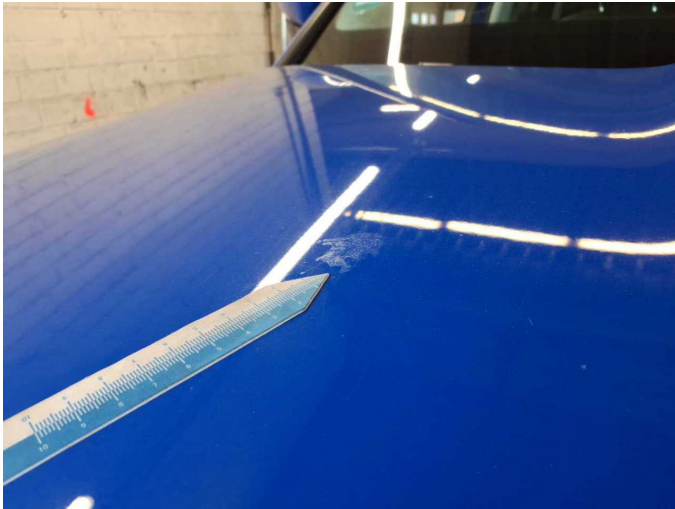
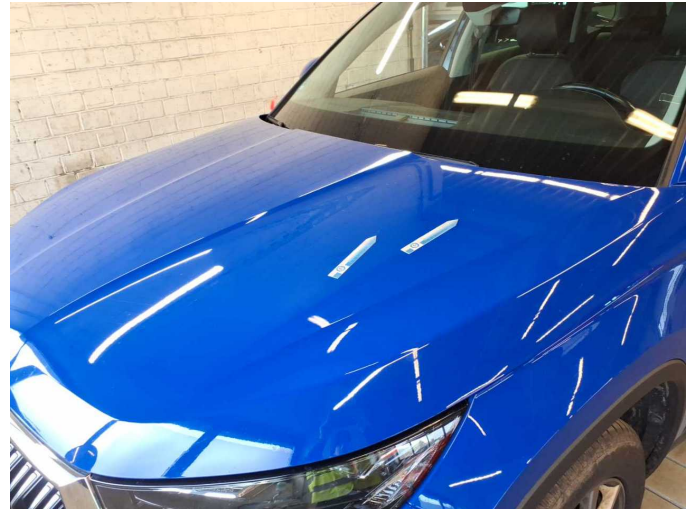
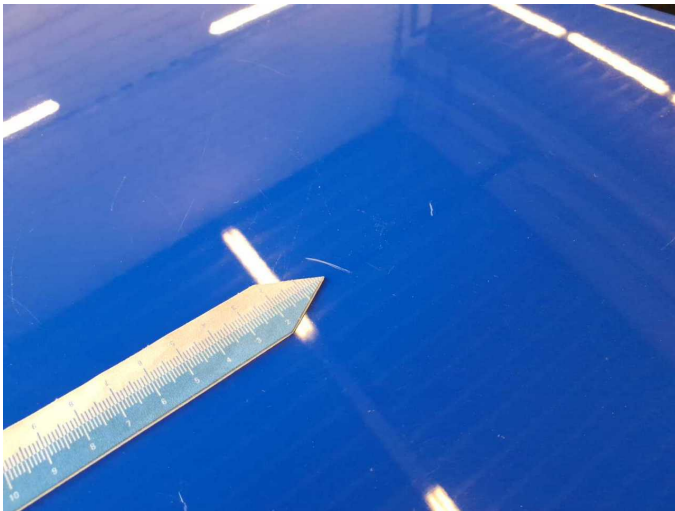
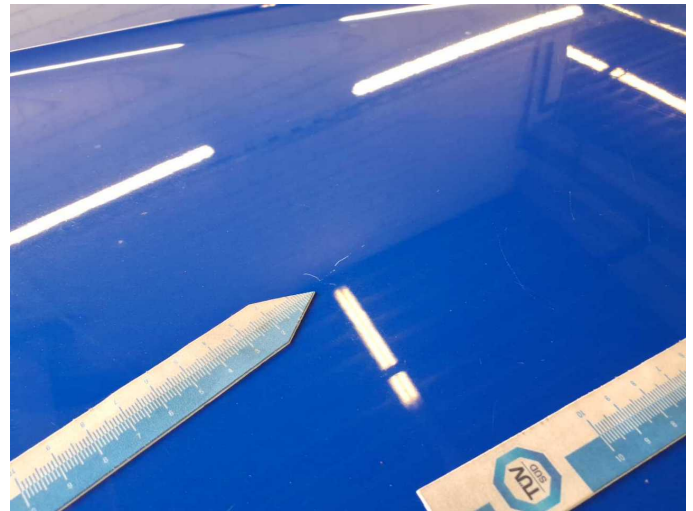
| No. | Component group | Description |
|---|---|---|
| 8 | Bonnet | Bonnet (Vogelkotverätzung eingebrannt + Kratzer) - Paint defect - Paint |

Damage 8: Bonnet: Bonnet (Vogelkotverätzung eingebraunt + Kratzer) - Paint defect - Paint

Damage 8: Bonnet: Bonnet (Vogelkotverätzung eingebrannt + Kratzer) - Paint defect - Paint

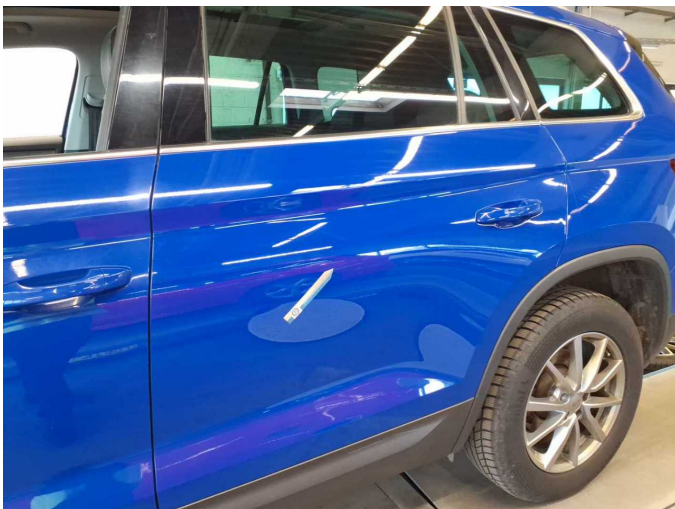
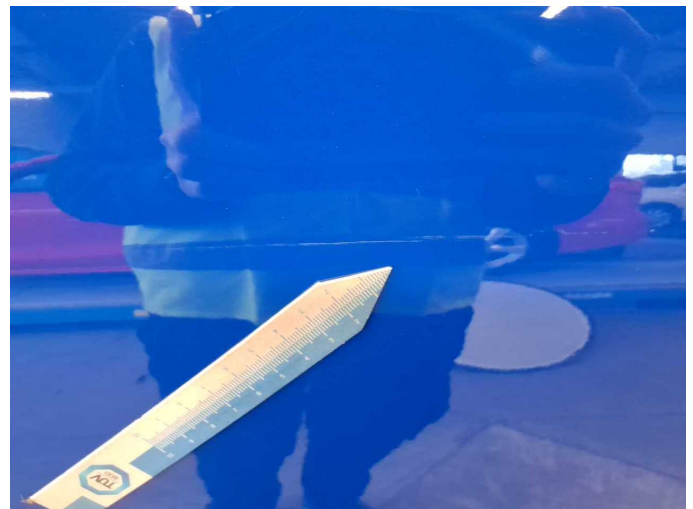
| No. | Component group | Description |
|---|---|---|
| 9 | Door - rear left side | Door - Scratch(es) - Paint |

Damage 9: Door - rear left side: Door - Scratch(es) - Paint

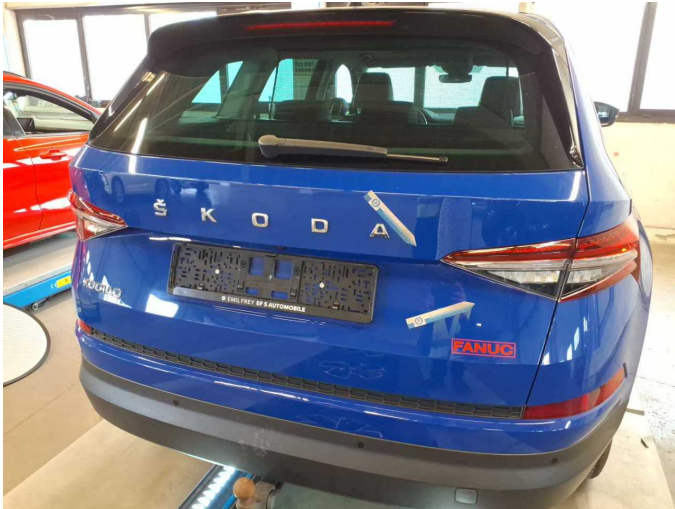
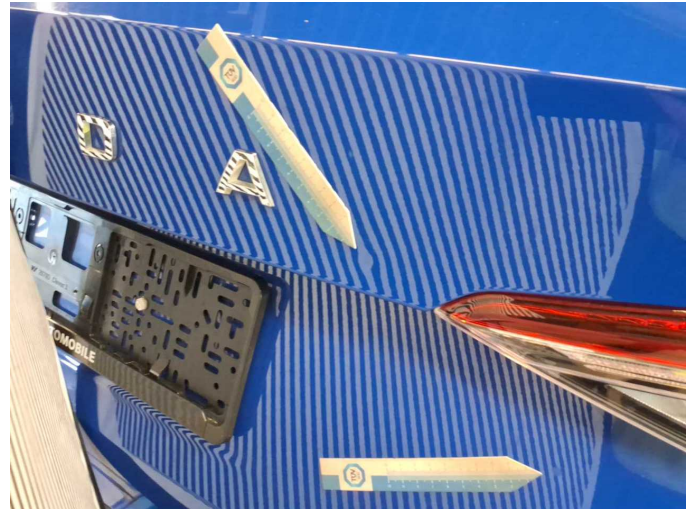
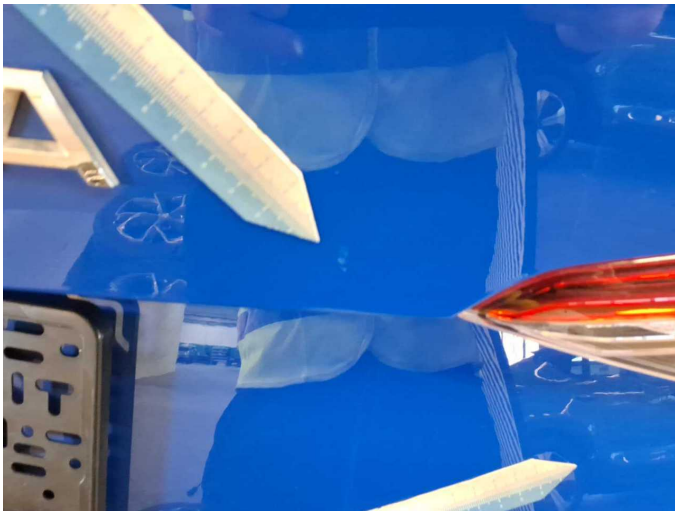
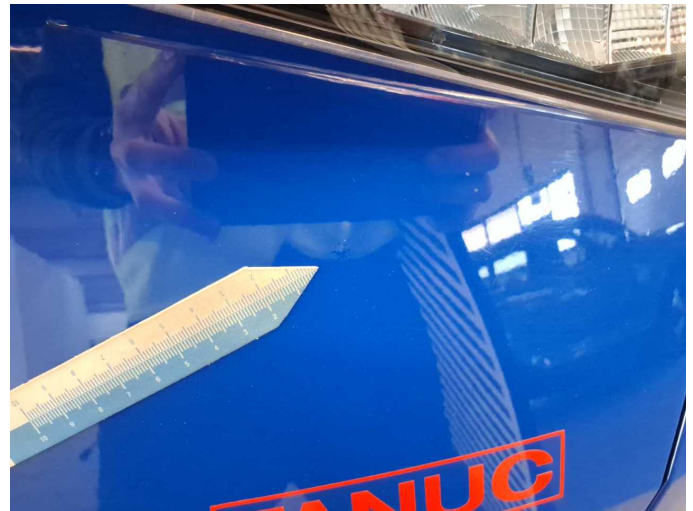
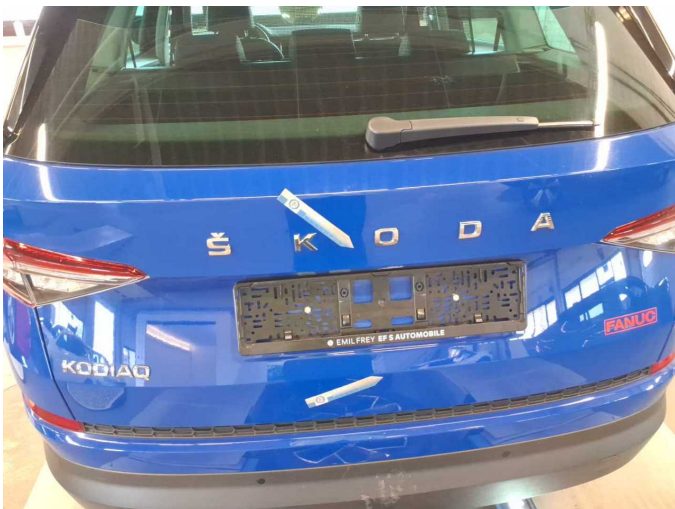
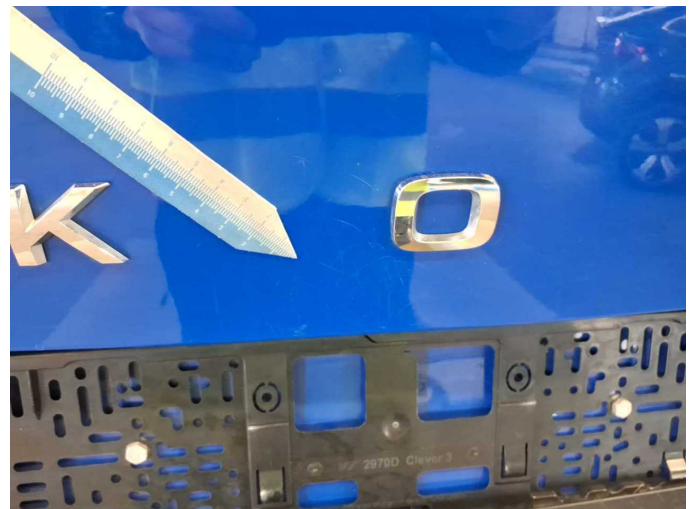
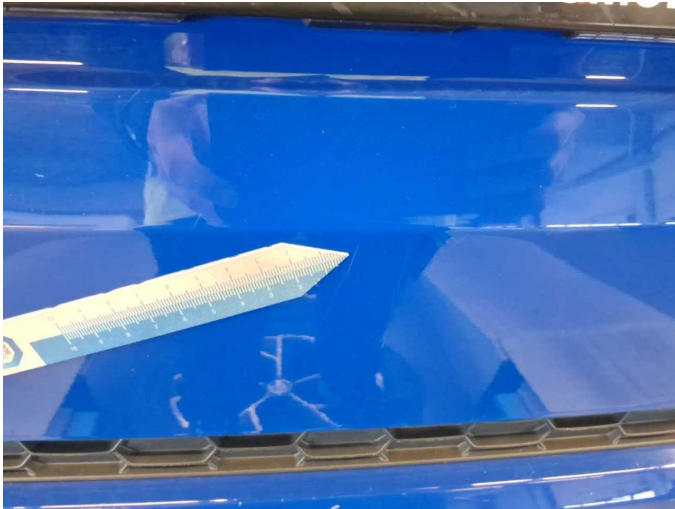
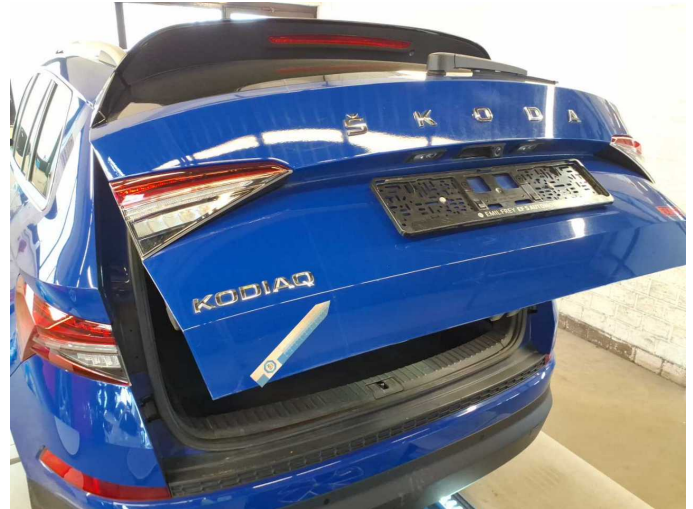
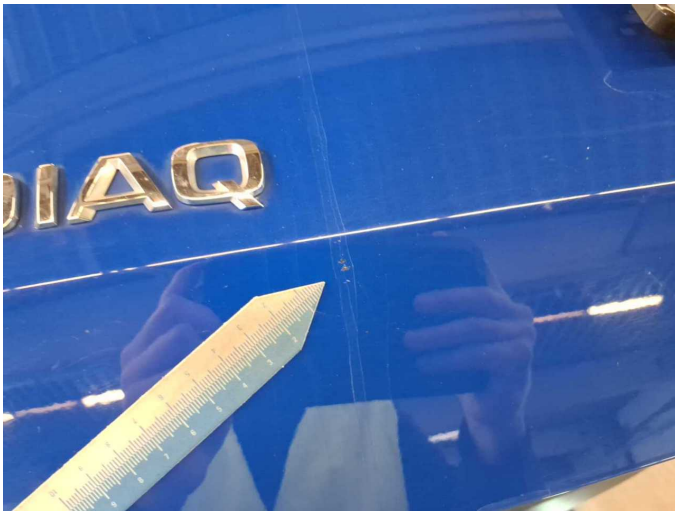
| No. | Component group | Description |
|---|---|---|
| 10 | Boot lid / rear door | Boot lid (+ Delle / Lackschaden) - Corrosion - Paint |

Damage 10: Boot lid / rear door: Boot lid (+ Delle / Lackschaden) - Corrosion - Paint

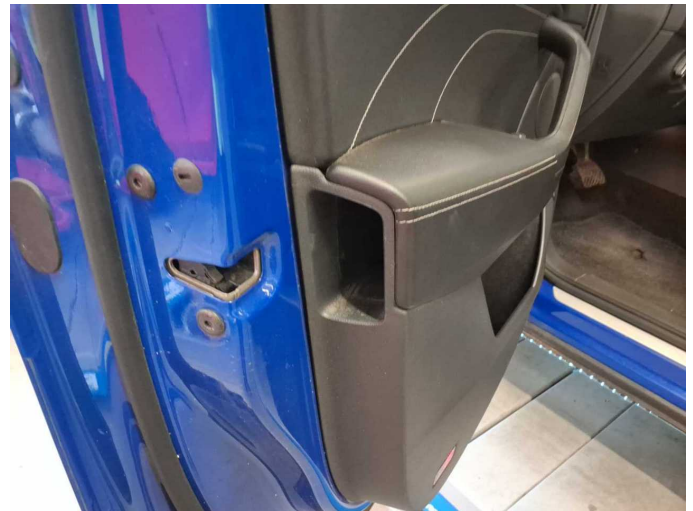
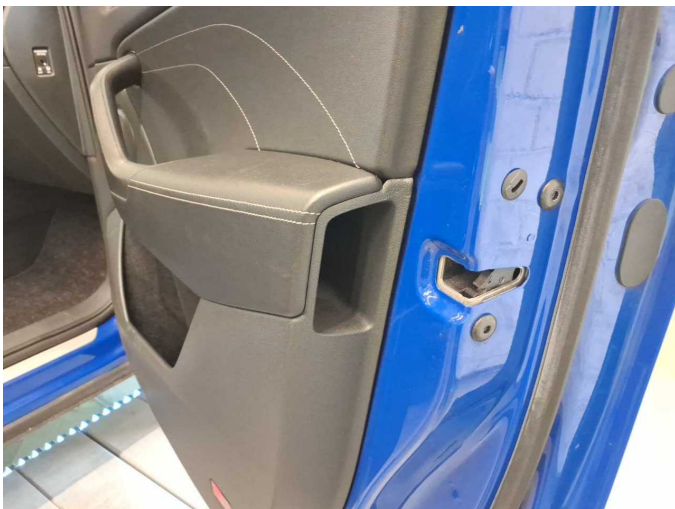
Equipment - Umbrella

Missing part 1: Equipment: Umbrella - Missing - Replace

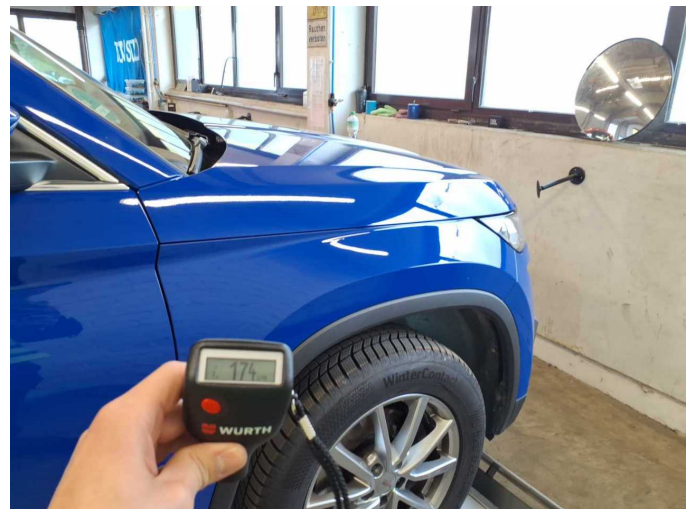
1 Mudguard - right side, Professionally carried out, Invoice of repair done Non-existent

Mudguard - right side 174 µm

Repainting 1: Mudguard - right side
