- Vehicle Inspection Report -

Number: 10078943
From: 19.02.2026

Order number: 1002320074
Order completed: 18.02.2026 12:05
Report number: 10078943
VIN: TMBLK0NX2MY187326

Vehicle category:	Passenger Car
Vehicle type:	EstateCar
Make:	Skoda
Model:	Octavia
Manufacturers and type code:	8004 / AVJ
Date of first registration:	16.12.2021
Mileage:	91,196 km
Proof of mileage:	ReadOff
Exterior colour:	Schwarz-Magic Perleffekt
Roof colour:	Schwarz-Magic Perleffekt
Propulsion:	4 Wheel-drive
Fuel:	Diesel
Engine size (cc):	2,000 ccm
Performance:	147 kW (200 PS)
Length:	4,702 mm
Height:	1,477 mm
Width:	1,829 mm
Permitted total weight:	2,141 kg
Wheelbase:	2,677 mm
Number of powered axles:	2
Cylinders:	4
Euronorm:	Euro 6
Number of doors:	4
Number of seats:	5
Gearbox:	Automatic 7-speed
Upholstery type:	Lining Alcantara
Interior colour:	RS Naht grau
Number of keys:	2

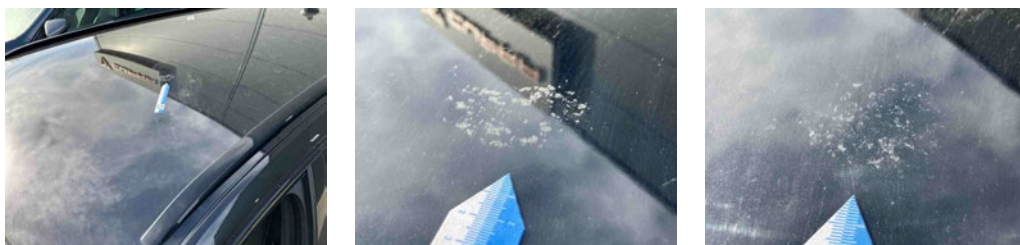
1 - Roof - Chemical pollution - Repair and paint (complete)

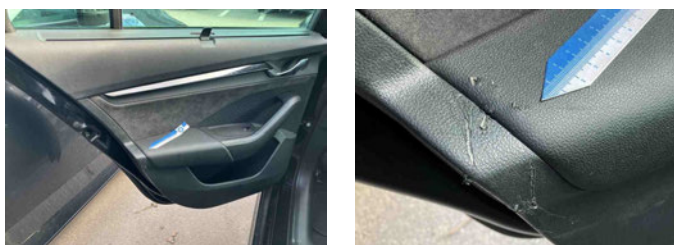
2 - Door panel RL - Tear - Replace

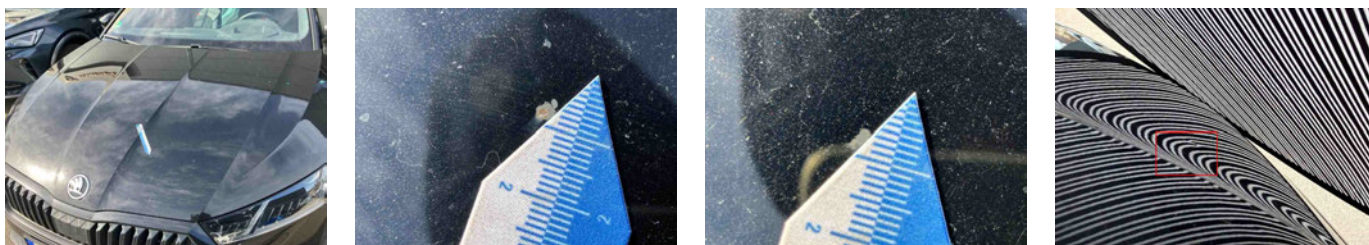
3 - Bonnet - Dent(s) and scratch(es) - Repair and paint (complete)

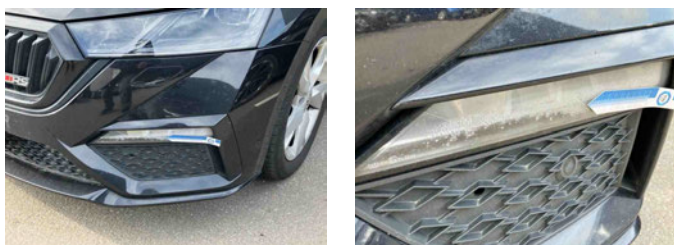
4 - Fog lamp L - Waterinfiltration - Replace

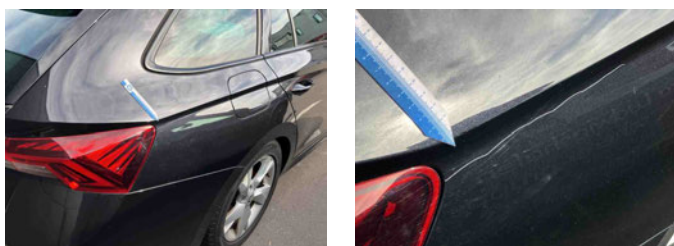
5 - Side wall RR - Scratch(es) - Repair and paint (complete)

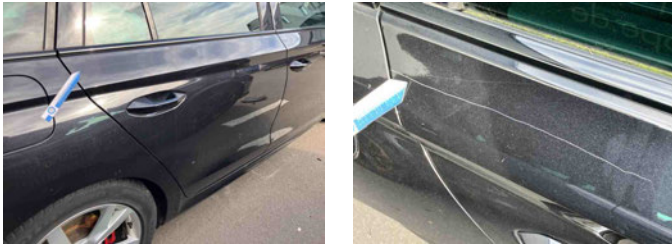
6 - Door RR - Scratch(es) - Repair and paint (complete)

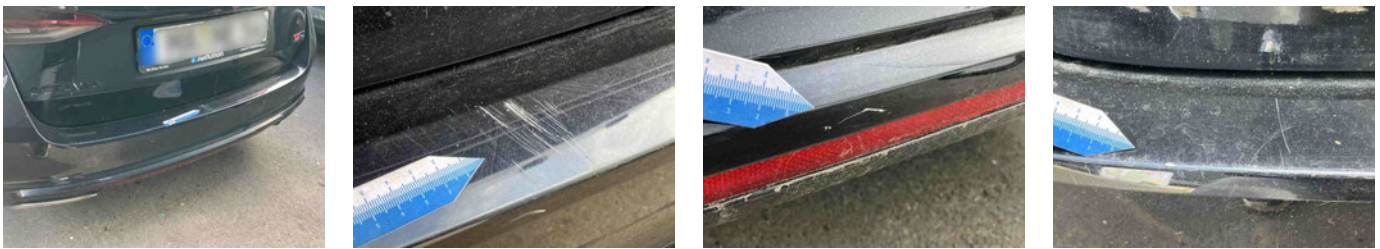
7 - Bumper R - Scratch(es) - Repair and paint (complete)

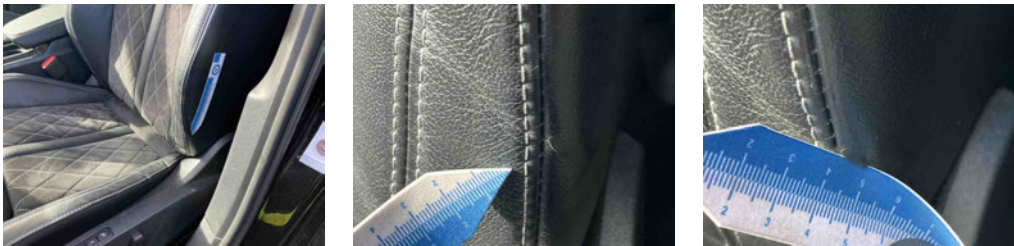
9 - Backrest cover FL - Tear - Smart repair LEATHER

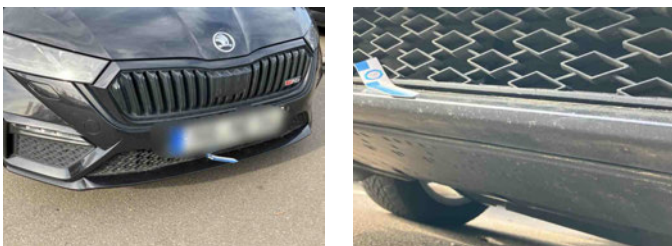
10 - Bumper F - Scratch(es) - Spot repair

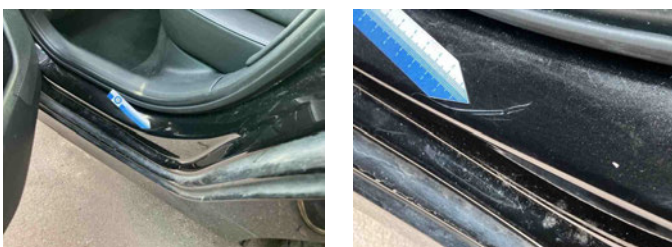
11 - Inner door sill RL - Scratch(es) - Smart repair
