Expertise

Protocol number: 46196354
Order No. / Reference: 25933964
Inspection date: 16 Jun 2026

Manufacturer: Mercedes-Benz

Model: Vito 116 CDI Tourer Lang Aut. SELECT

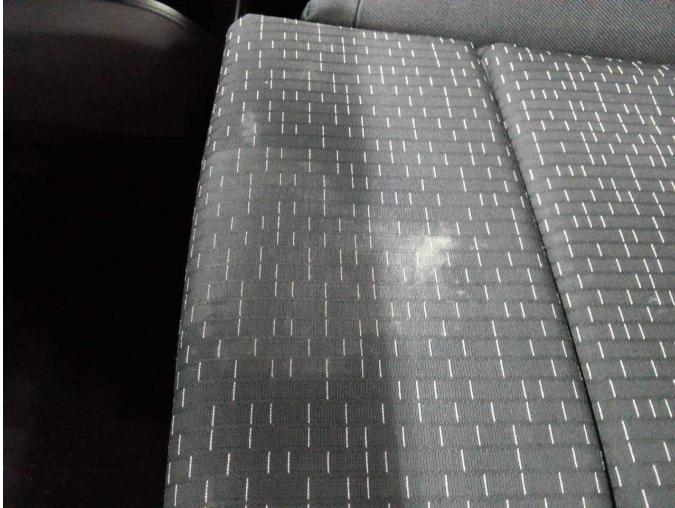
Damage 1: Seat - front: Seat cover - left side (Fleck) - Soiled - Clean

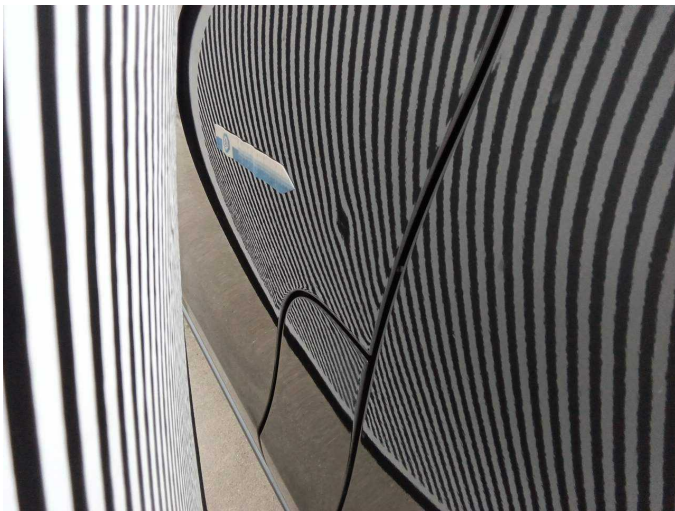
Damage 2: Door - front left side: Door (1) - dent(s) - Smooth repair work

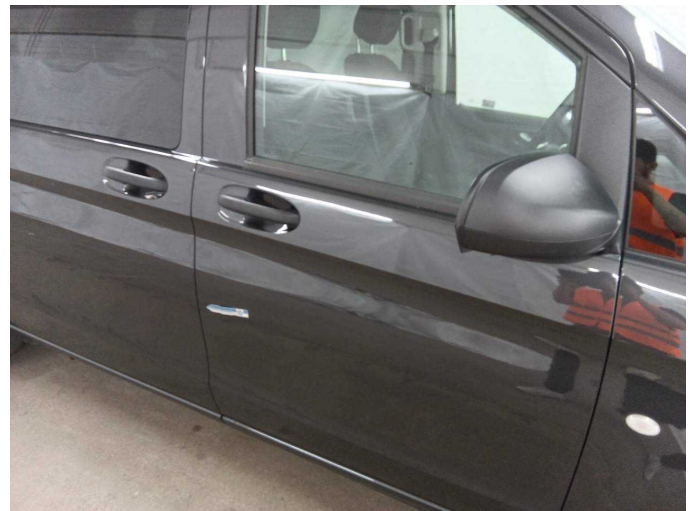
Damage 2: Door - front left side: Door (1) - dent(s) - Smooth repair work

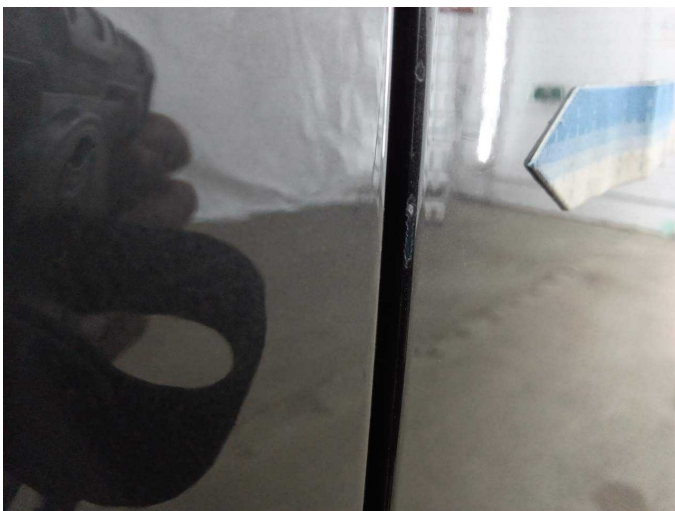
Damage 3: Door - front right side: Door - Scratch(es) - Paint

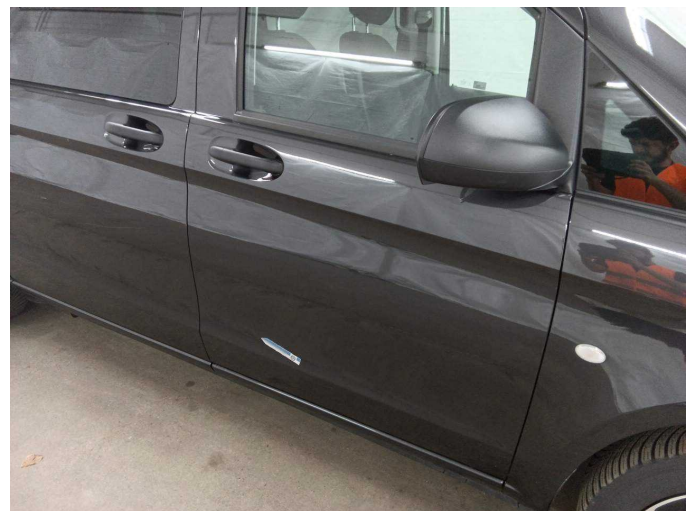
Damage 3: Door - front right side: Door - Scratch(es) - Paint

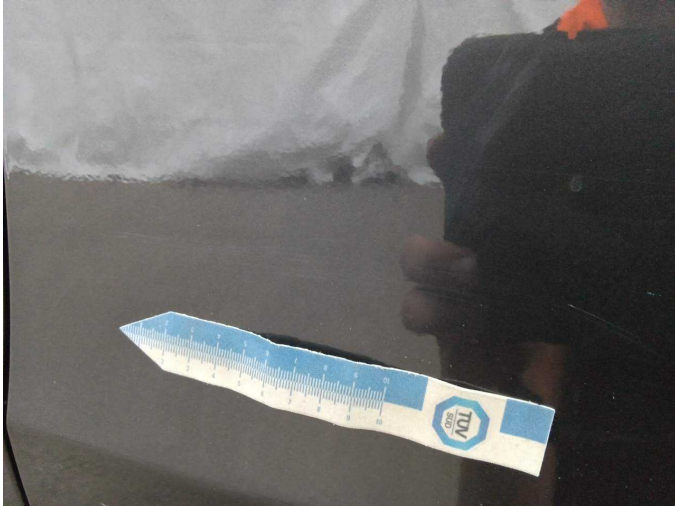
Damage 3: Door - front right side: Door - Scratch(es) - Paint

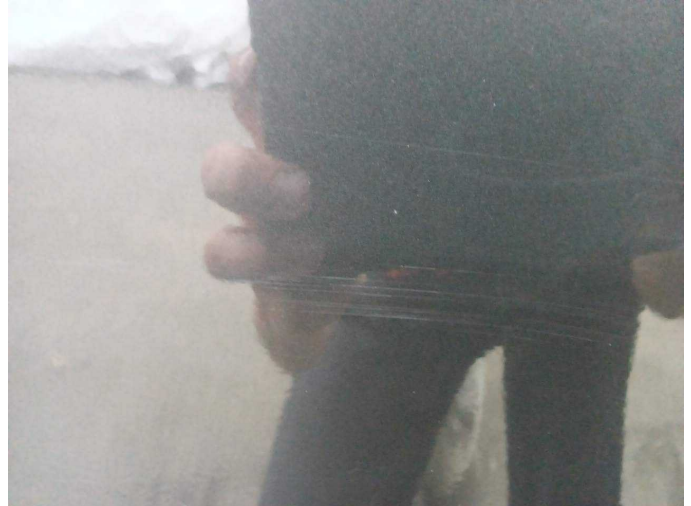
Damage 3: Door - front right side: Door - Scratch(es) - Paint

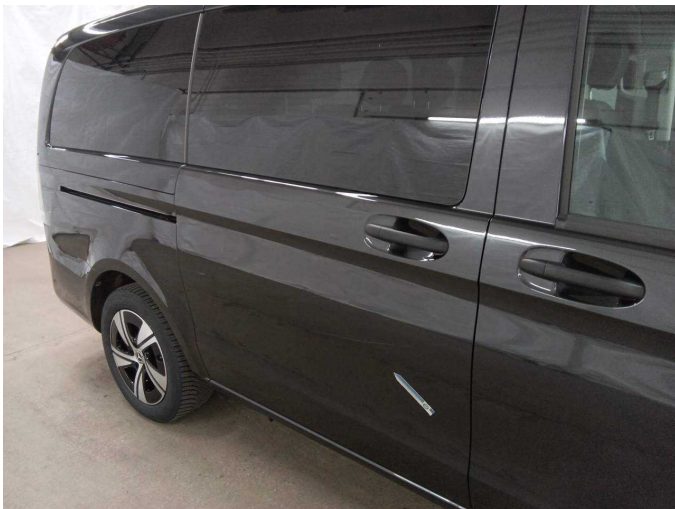
Damage 3: Door - front right side: Door - Scratch(es) - Paint

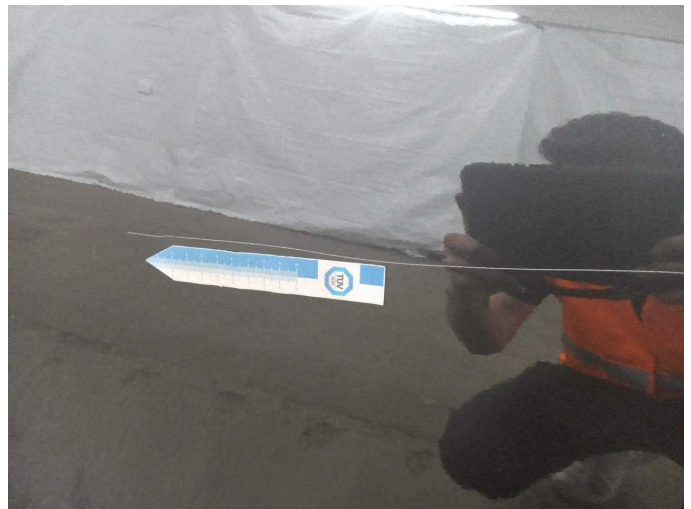
Damage 4: Sliding door, right: Sliding door - Scratch(es) - Paint

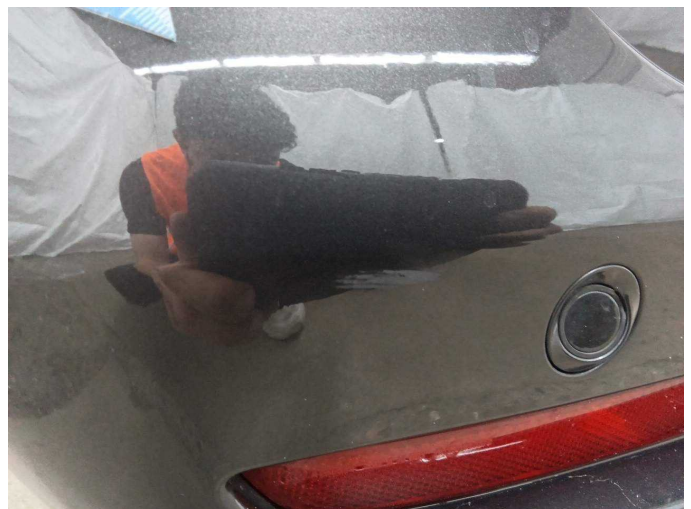
Damage 5: Rear bumper: Rear bumper - Scratch(es) - Paint

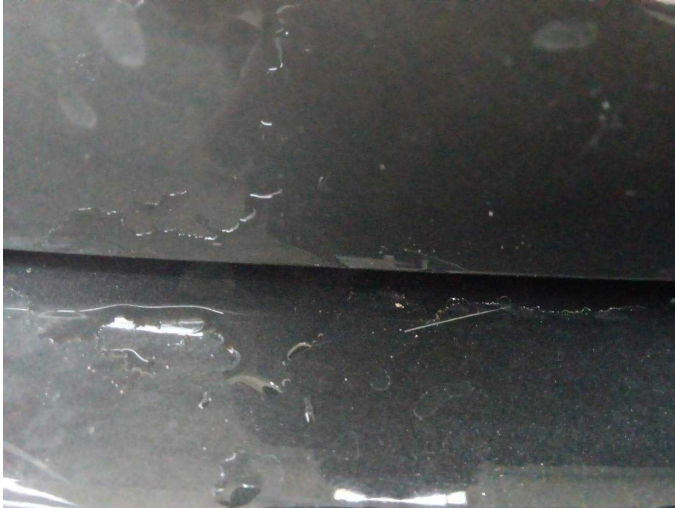
Damage 5: Rear bumper: Rear bumper - Scratch(es) - Paint

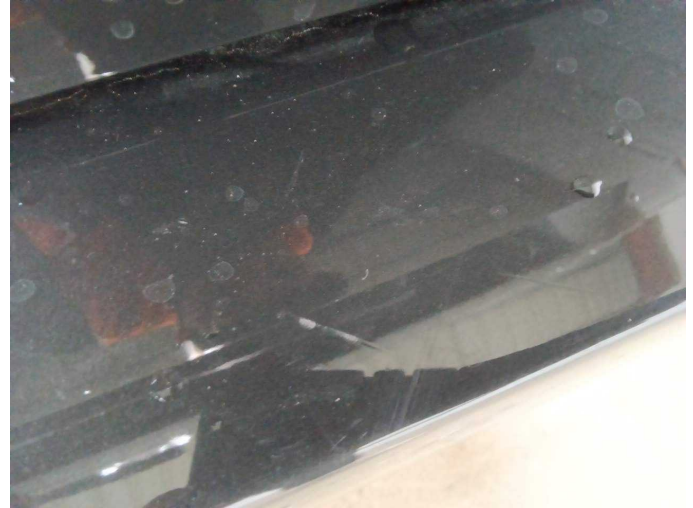
Damage 5: Rear bumper: Rear bumper - Scratch(es) - Paint

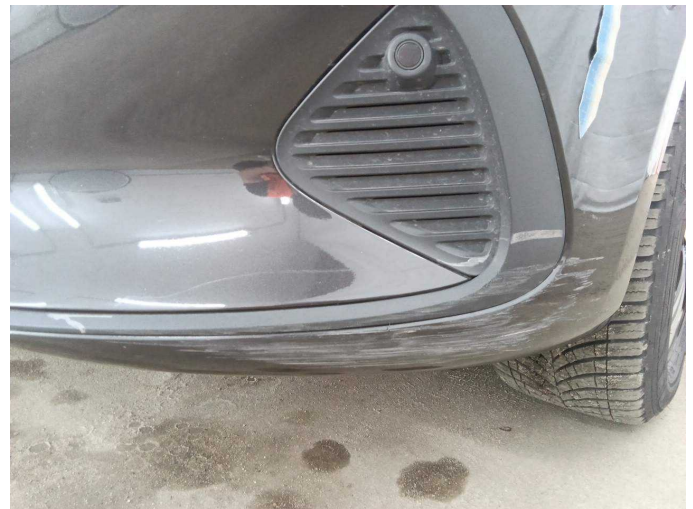
Damage 6: Front bumper: Front bumper (inkl. Blende erneuern) - Scratch(es) - Paint

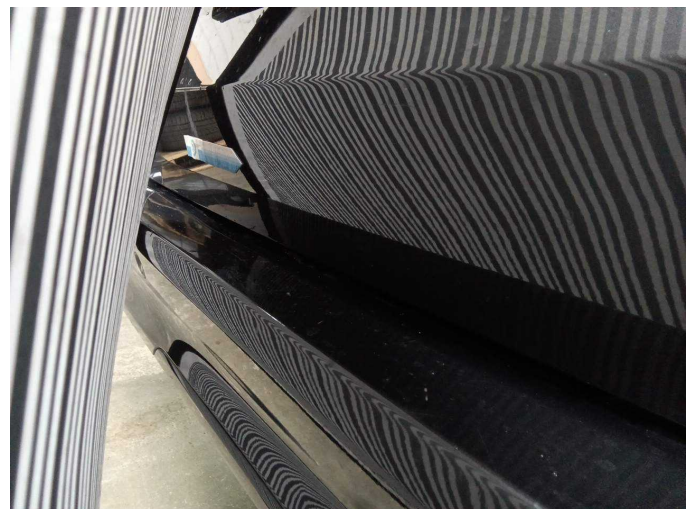
Wear and tear 3: Boot lid / rear door: Boot lid - dent(s) - No deduction
