Expertise

Protocol number: 46652776  
Order No. / Reference: 26701687  
Inspection date: 22 Jul 2026

Manufacturer: Opel

Model: Corsa 1.2 Start/Stop Elegance

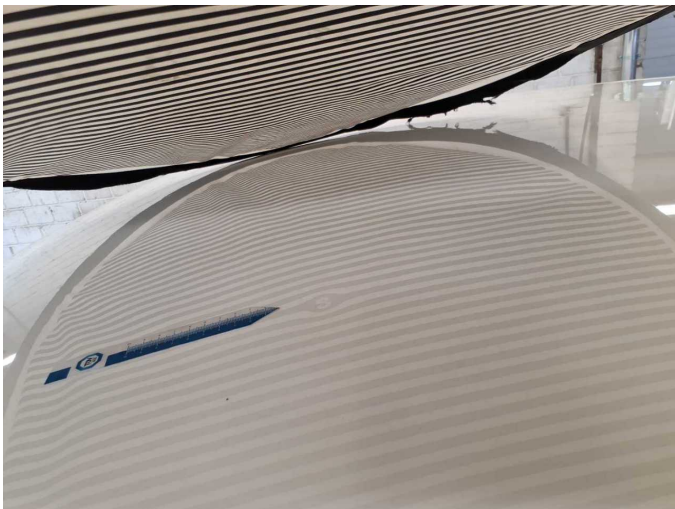
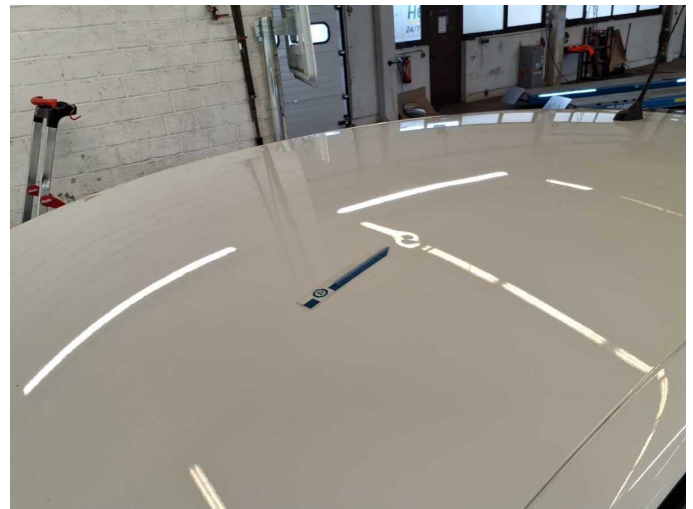
| No. | Component group | Description |
|---|---|---|
| 1 | Roof | Roof - dent(s) - Smooth repair work |

Damage 1: Roof: Roof - dent(s) - Smooth repair work

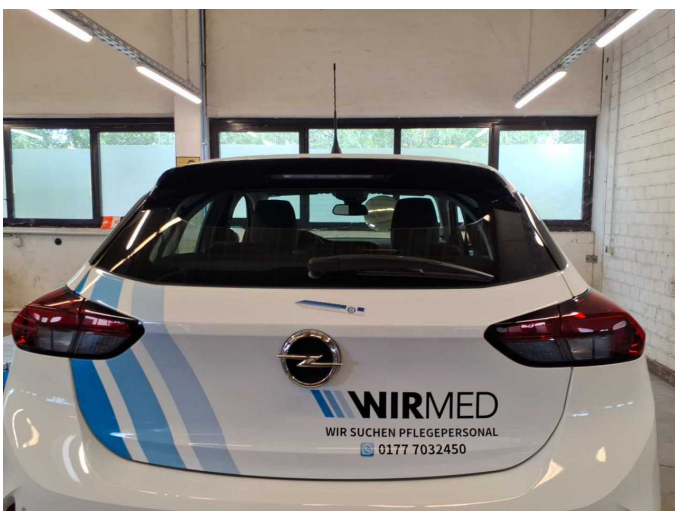
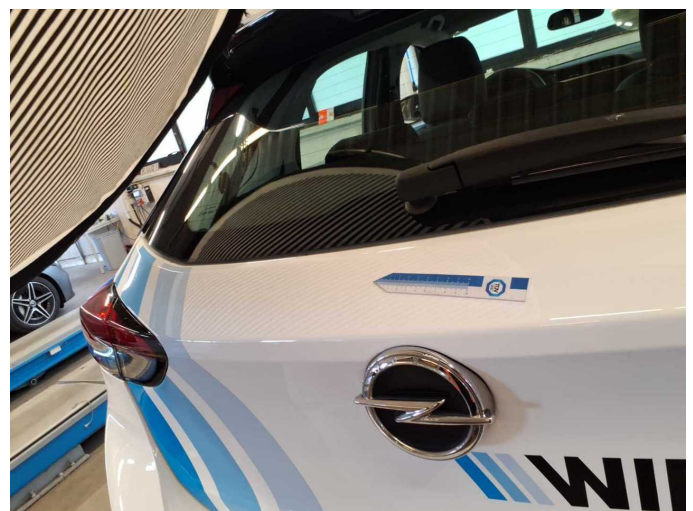
| No. | Component group | Description |
|---|---|---|
| 2 | Boot lid / rear door | Boot lid - dent(s) - Smooth repair work |

Damage 2: Boot lid / rear door: Boot lid - dent(s) - Smooth repair work

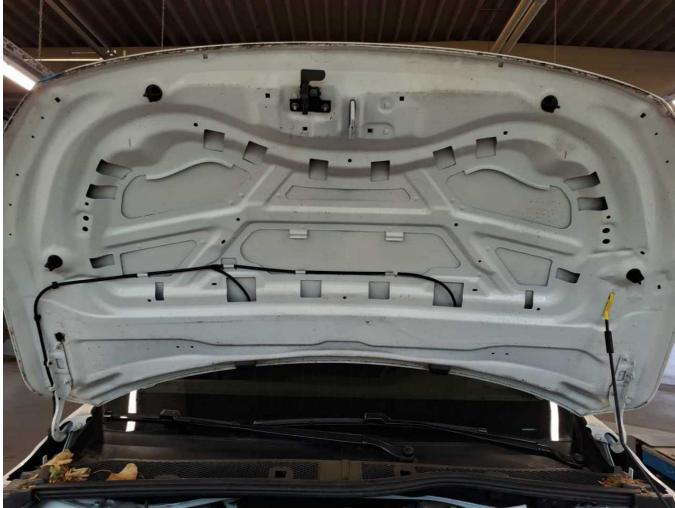
| No. | Component group | Description |
|---|---|---|
| 3 | Bonnet | Insulation lining - Missing - Replace |

**Damage 3:** Bonnet: Insulation lining - Missing - Replace

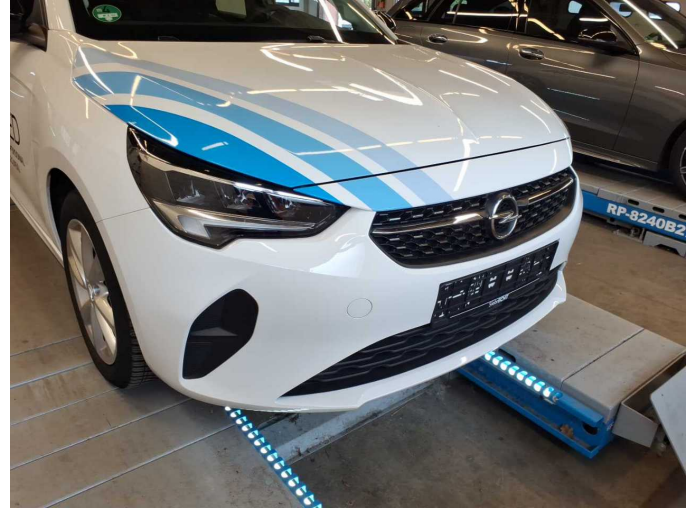
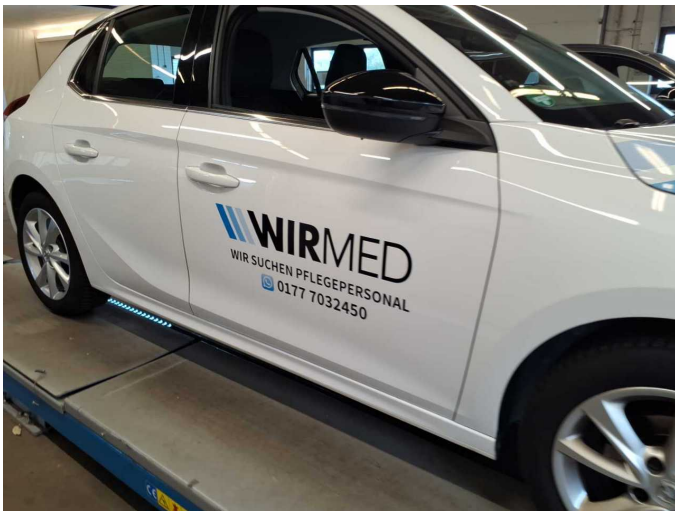
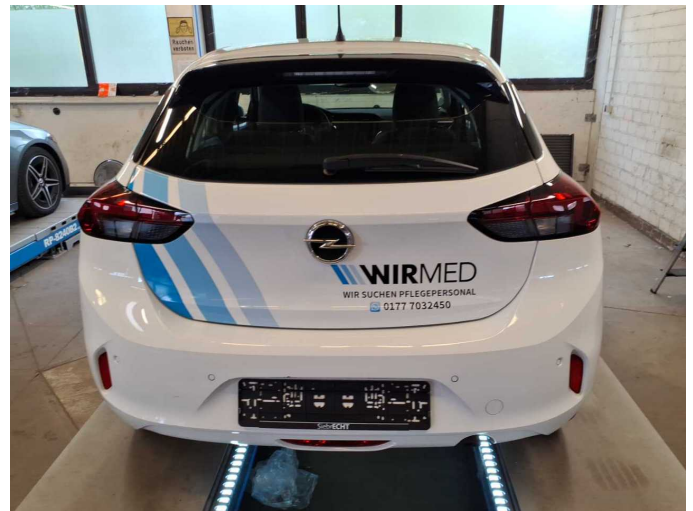
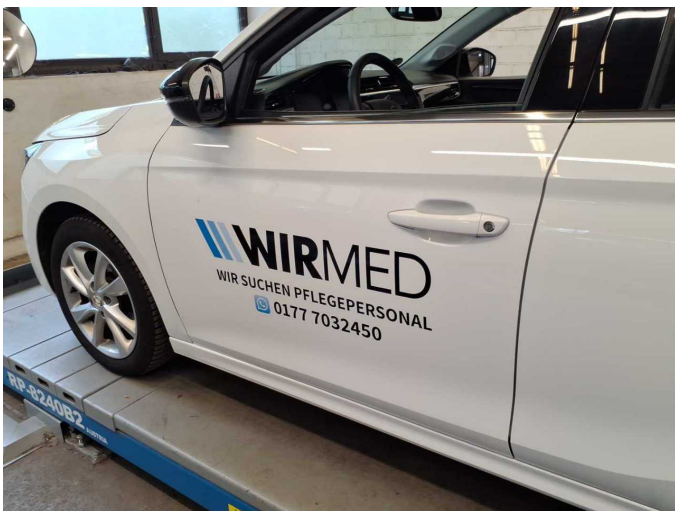
| No. | Component group | Description |
|---|---|---|
| 4 | Body | Body - Glued / labelled - De-glue / neutralise |

**Damage 4:** Body: Body - Glued / labelled - De-glue / neutralise

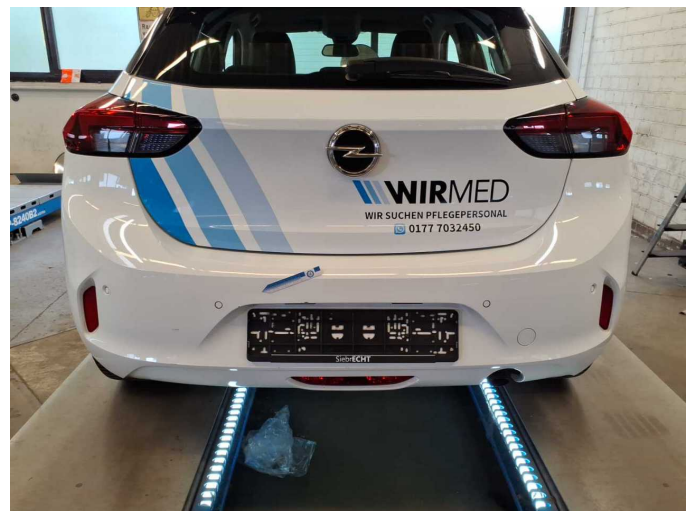
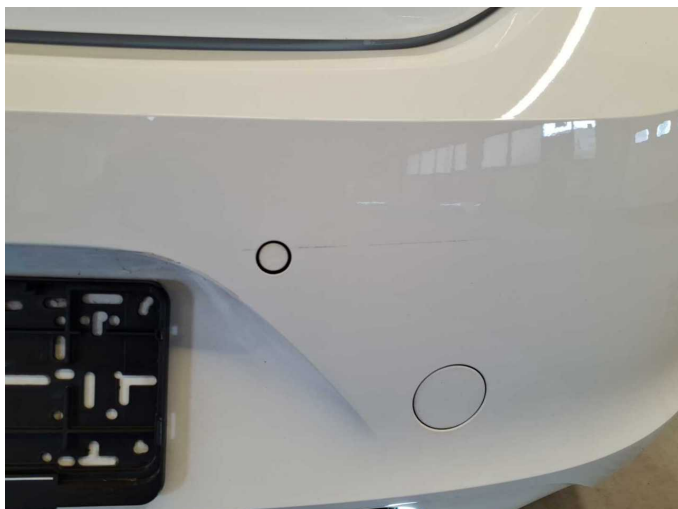
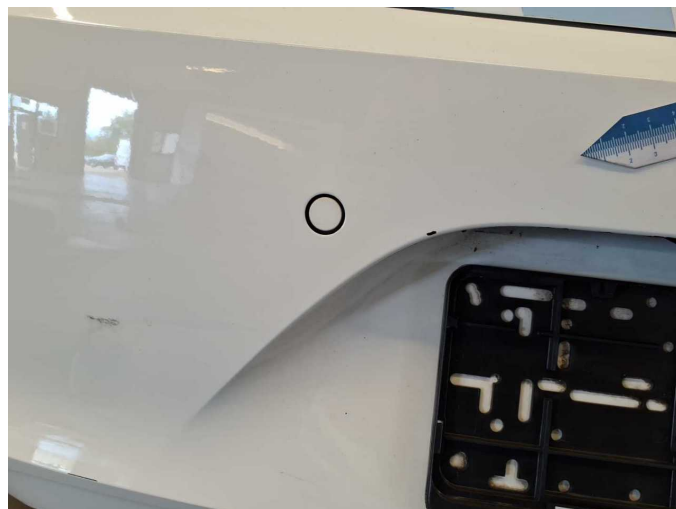
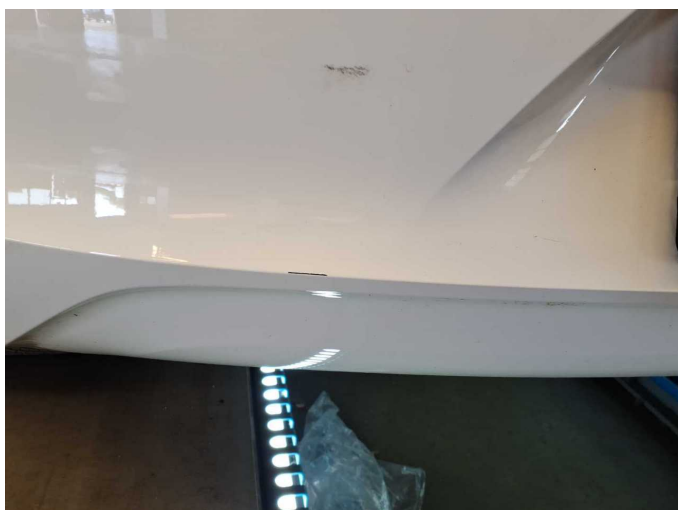
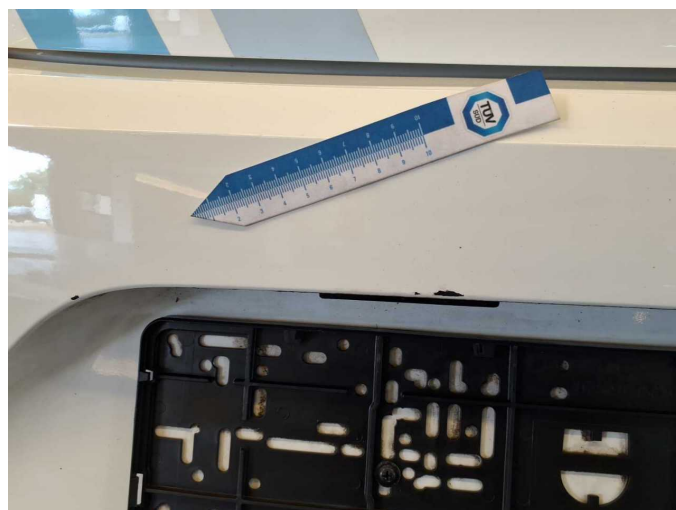
| No. | Component group | Description |
|---|---|---|
| 5 | Rear bumper | Rear bumper - Scratched - Paint |

**Damage 5:** Rear bumper: Rear bumper - Scratched - Paint

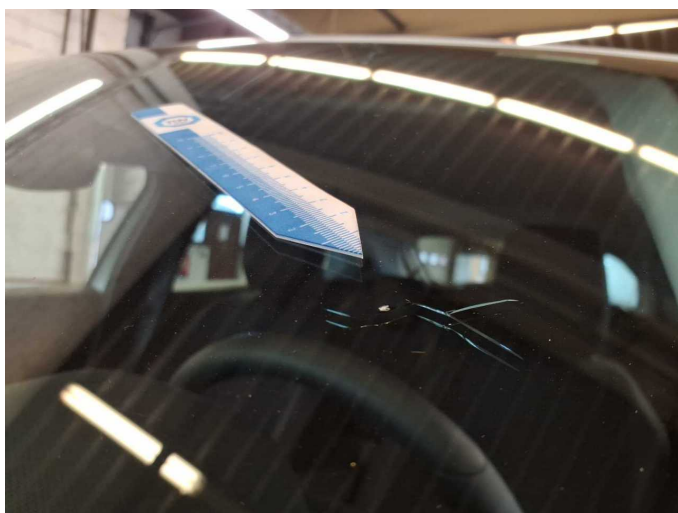
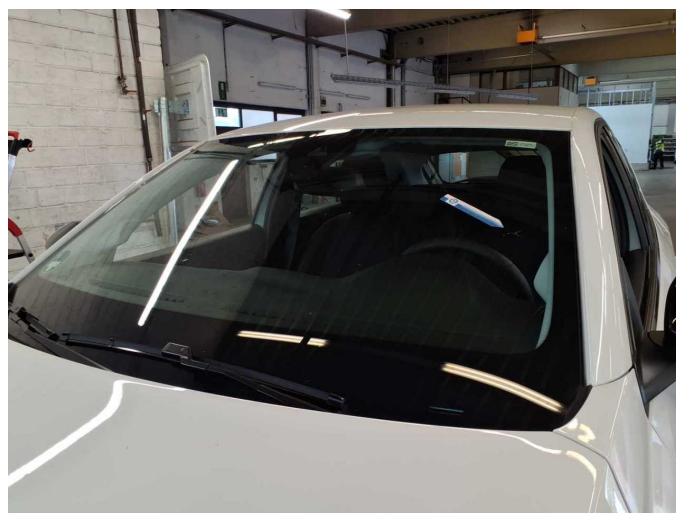
| No. | Component group | Description |
|---|---|---|
| 6 | Vehicle glazing | Windscreen - Broken / torn - Replace |

**Damage 6:** Vehicle glazing: Windscreen - Broken / torn - Replace

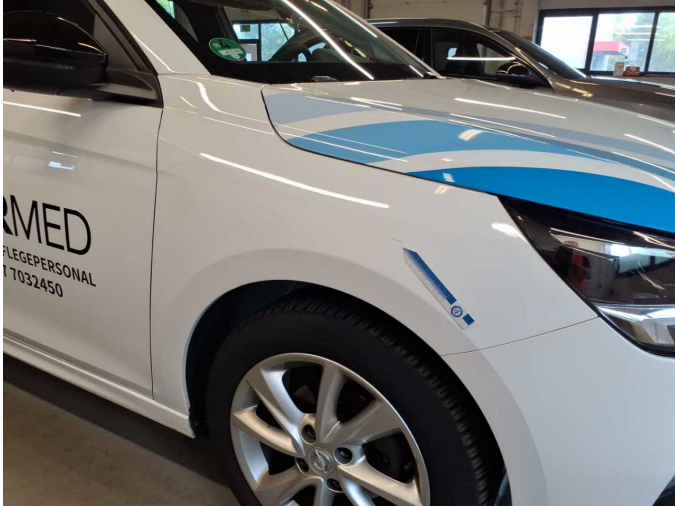
| No. | Component group | Description |
|---|---|---|
| 1 | Mudguard - right side | Mudguard - right side - Soiled - No deduction |

**Wear and tear 1:** Mudguard - right side: Mudguard - right side - Soiled - No deduction

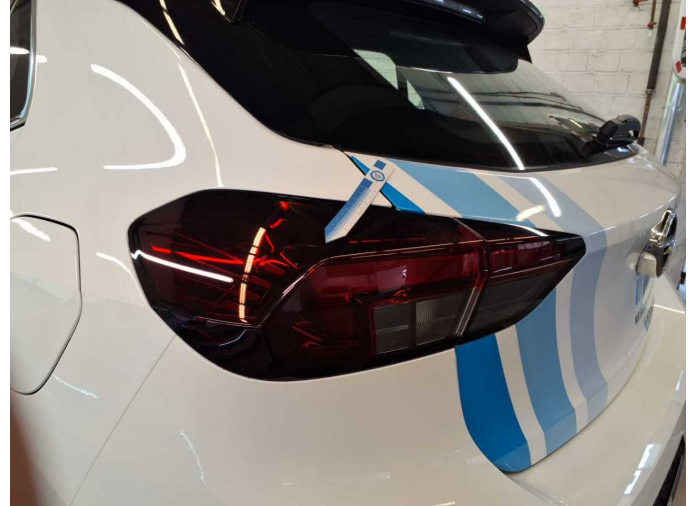
| No. | Component group | Description |
|---|---|---|
| 2 | Tail light | Tail lamp - left side - Scratch(es) - No deduction |

**Wear and tear 2:** Tail light: Tail lamp - left side - Scratch(es) - No deduction
