Expertise

Protocol number: 46655583  
Order No. / Reference: 26657690  
Inspection date: 22 Jul 2026

Manufacturer: Mazda

Model: 2 SKYACTIV-G 90 M HYBRID Homura

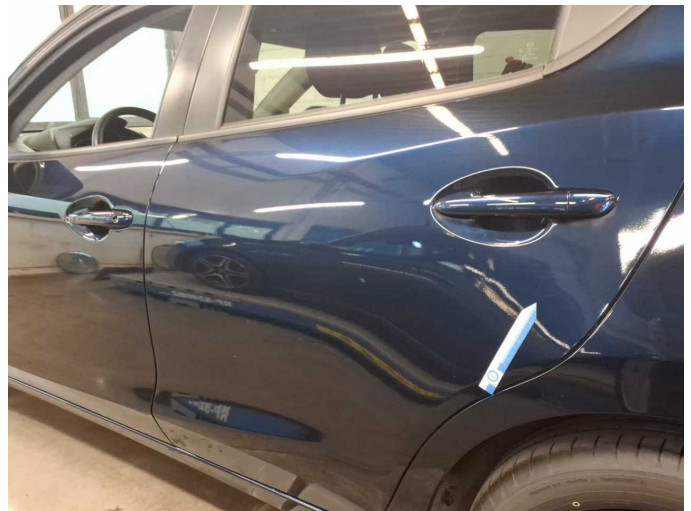
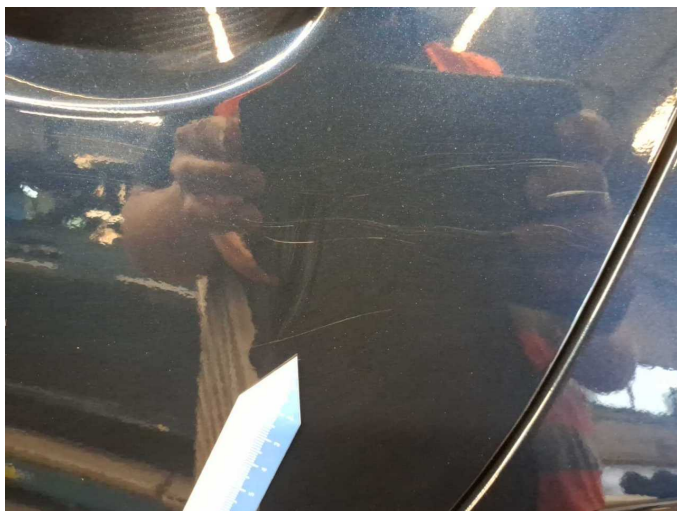
| No. | Component group | Description |
|---|---|---|
| 1 | Door - rear left side | Door - Scratched - Cover / polish |

Damage 1: Door - rear left side: Door - Scratched - Cover / polish

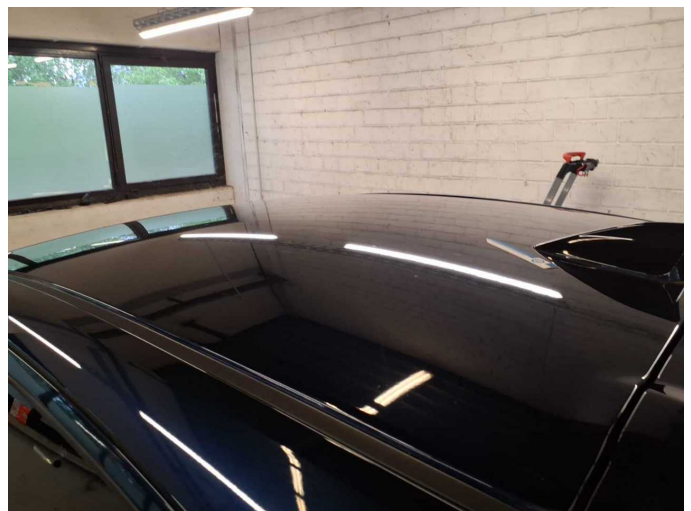
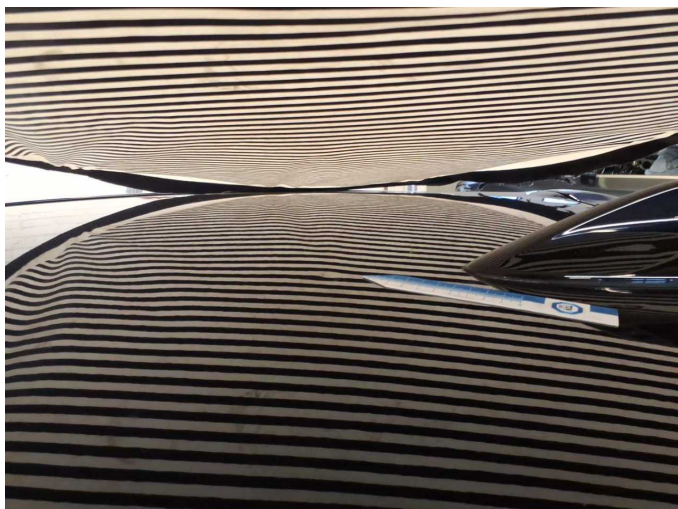
| No. | Component group | Description |
|---|---|---|
| 2 | Roof | Roof - dent(s) - Smooth repair work |

Damage 2: Roof: Roof - dent(s) - Smooth repair work

**Damage 2:** Roof: Roof - dent(s) - Smooth repair work

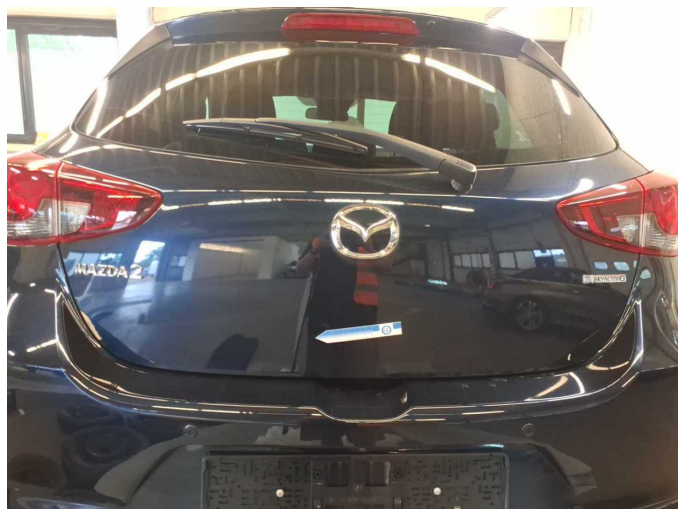
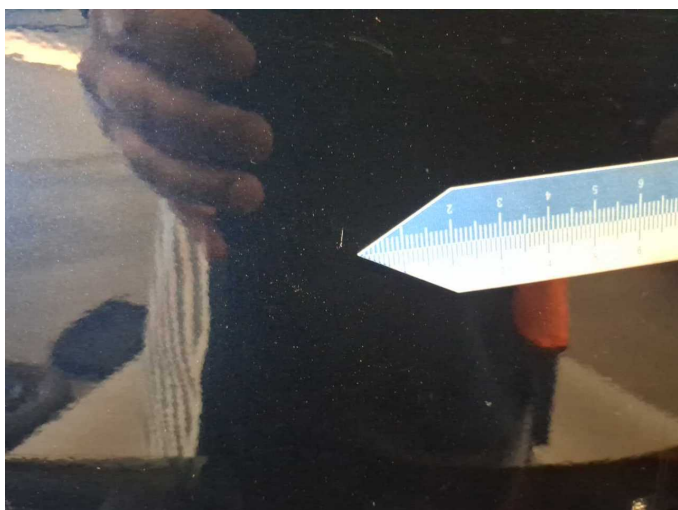
| No. | Component group | Description |
|---|---|---|
| 3 | Boot lid / rear door | Boot lid - Scratch(es) - Smart repair |

**Damage 3:** Boot lid / rear door: Boot lid - Scratch(es) - Smart repair

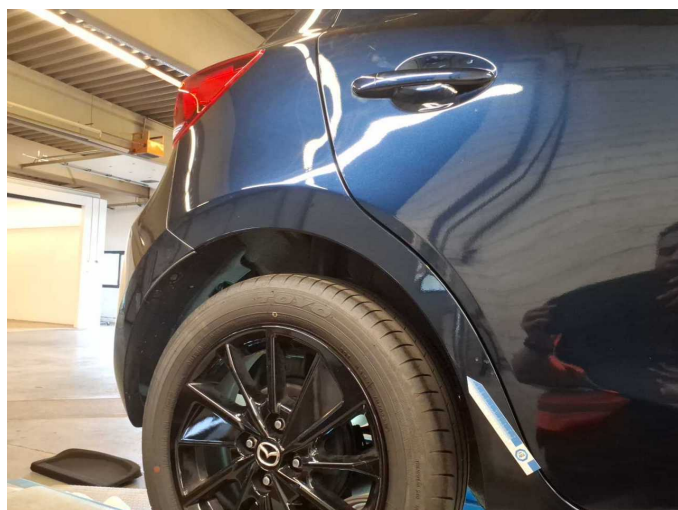
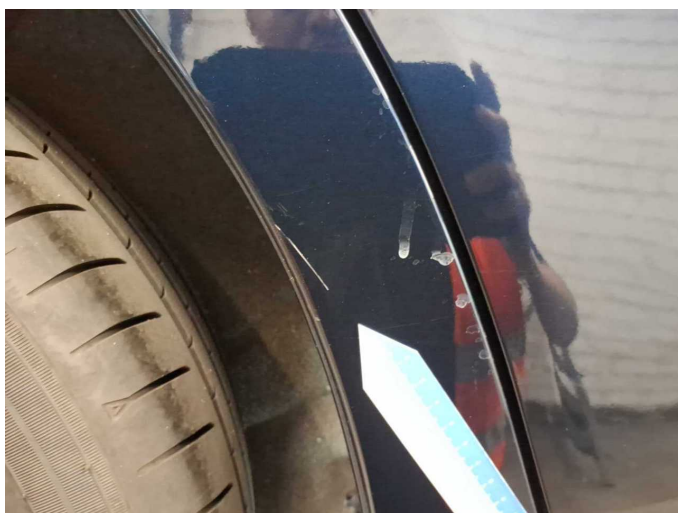
| No. | Component group | Description |
|---|---|---|
| 4 | Side panel - rear right side | Side panel - Scratch(es) - Smart repair |

**Damage 4:** Side panel - rear right side: Side panel - Scratch(es) - Smart repair

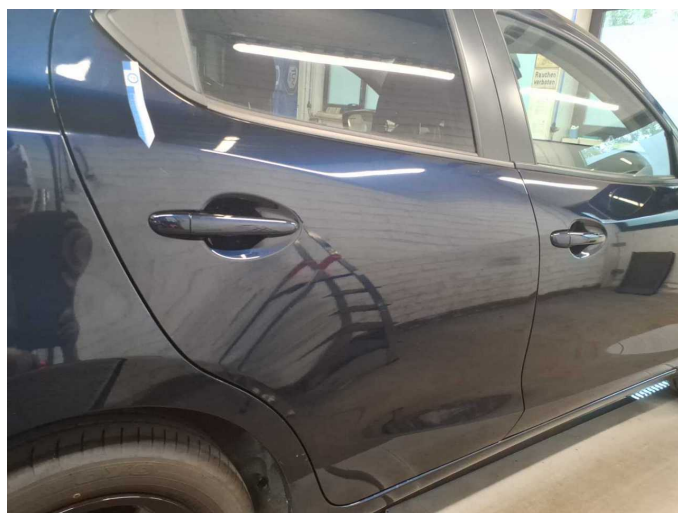
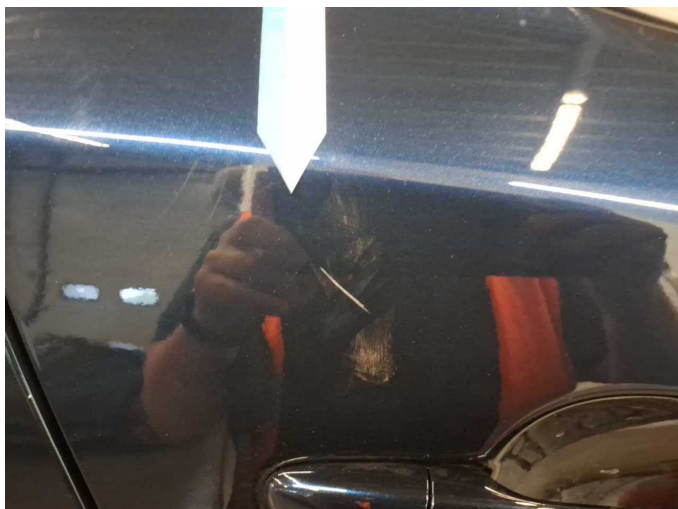
| No. | Component group | Description |
|---|---|---|
| 5 | Door - rear right side | Door - Scratch(es) - Smart repair |

**Damage 5:** Door - rear right side: Door - Scratch(es) - Smart repair
