Expertise

Protocol number: 46644092  
Order No. / Reference: 26589039  
Inspection date: 21 Jul 2026

Manufacturer: MAN  
VIN: WMA03VUY8P9009509

Model: TGE 3,5T 4x2F

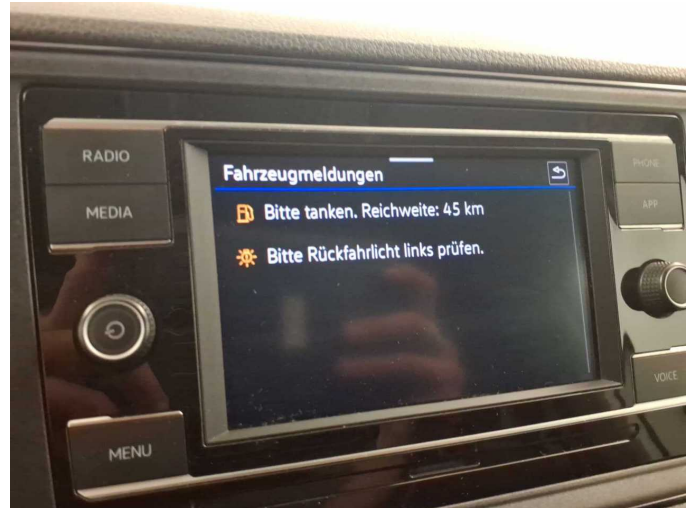
| No. | Component group | Description |
|---|---|---|
| 1 | Electrical system | Lighting system - on - Perform diagnosis |

**Damage 1:** Electrical system: Lighting system - on - Perform diagnosis

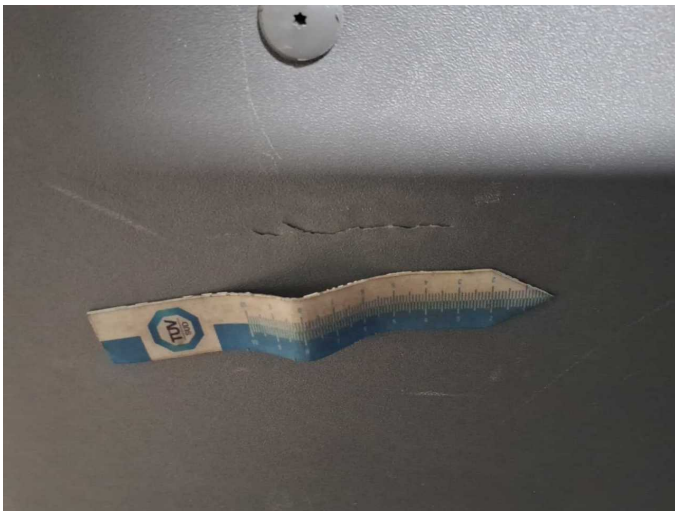
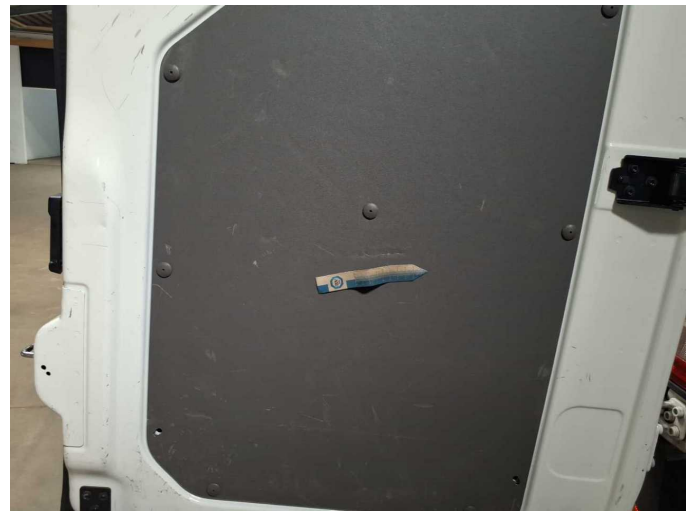
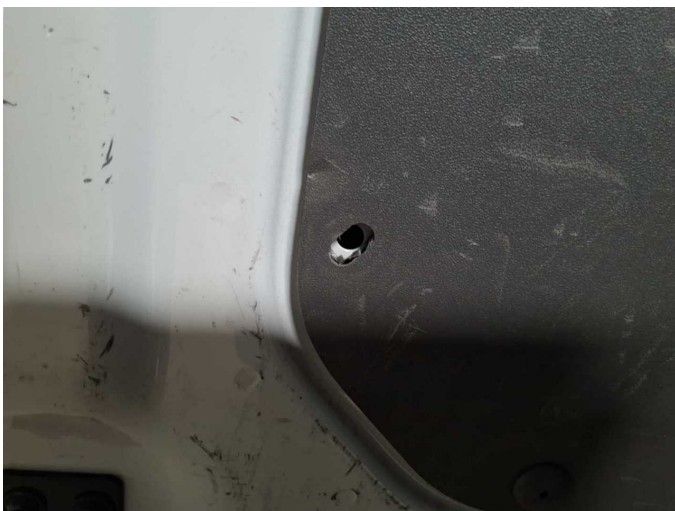
| No. | Component group | Description |
|---|---|---|
| 2 | Boot lid / rear door | Rear door - left side (Verkleidung) - Broken / torn - Replace |

**Damage 2:** Boot lid / rear door: Rear door - left side (Verkleidung) - Broken / torn - Replace

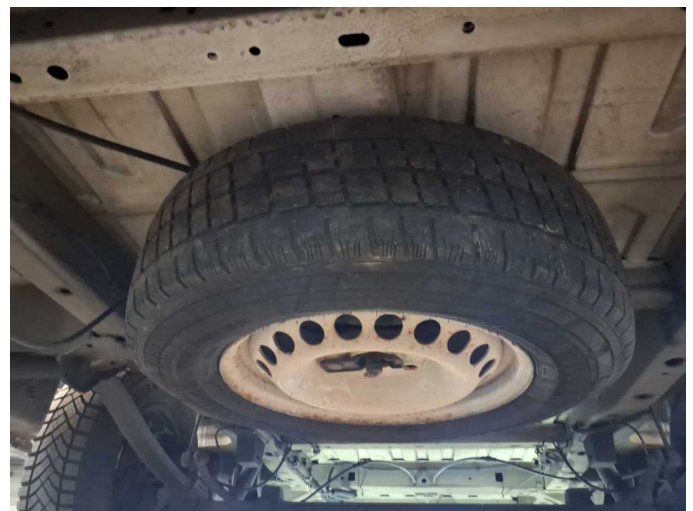
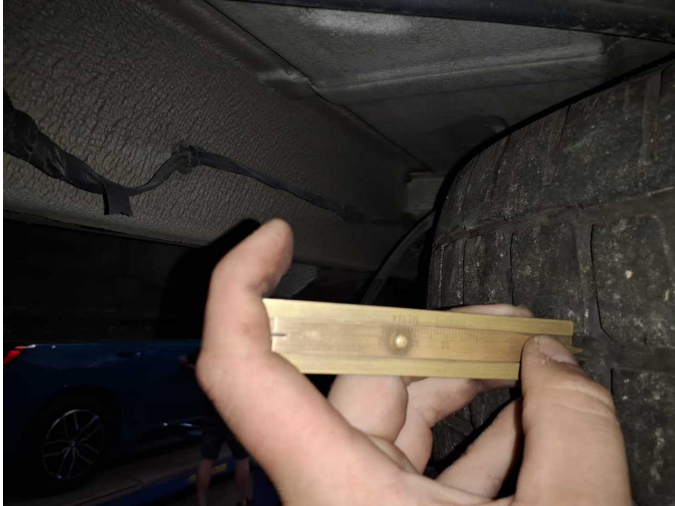
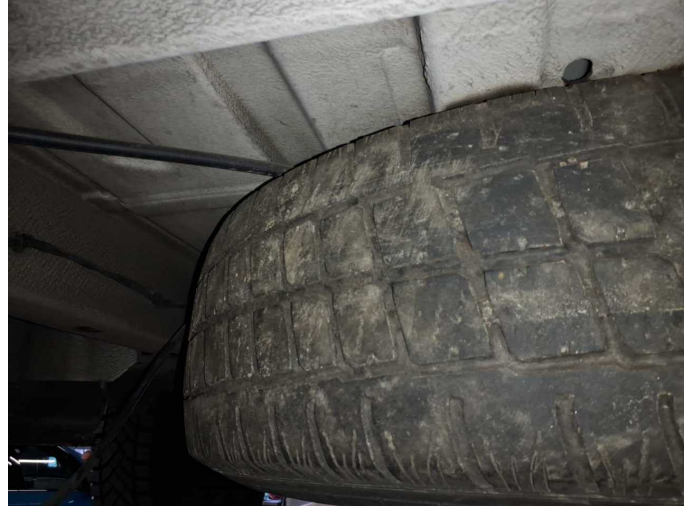
| No. | Component group | Description |
|---|---|---|
| 3 | Wheel / tyres | Spare wheel - Worn - Replace |

**Damage 3:** Wheel / tyres: Spare wheel - Worn - Replace

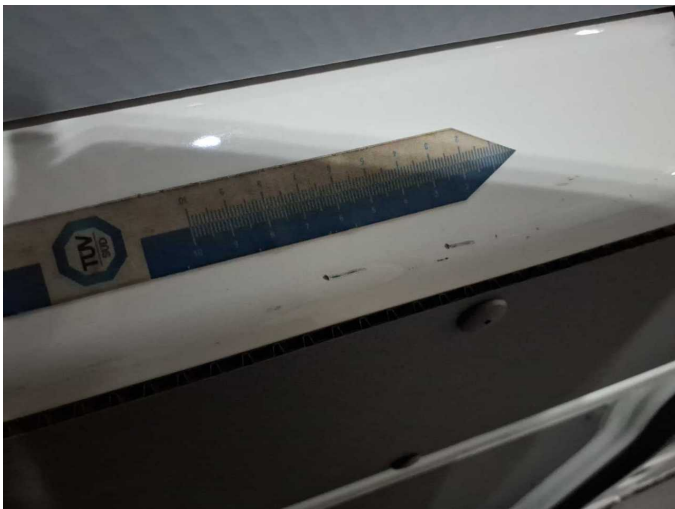
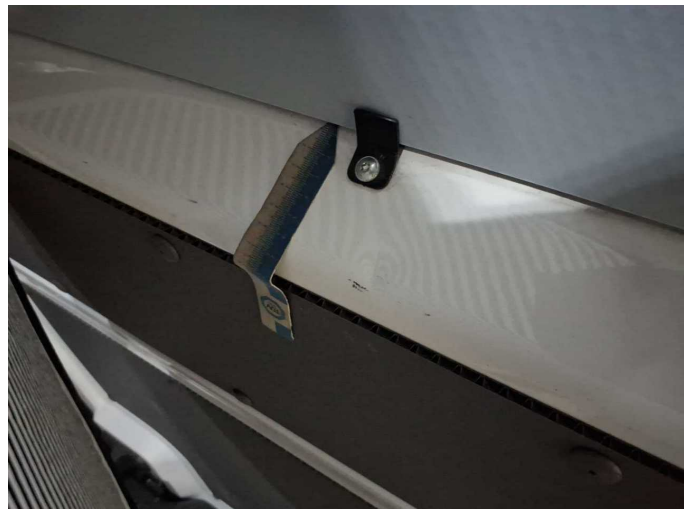
| No. | Component group | Description |
|---|---|---|
| 4 | Sliding door, right | Sliding door - Dent / paintcoat damage - Repair and paint |

**Damage 4:** Sliding door, right: Sliding door - Dent / paintcoat damage - Repair and paint

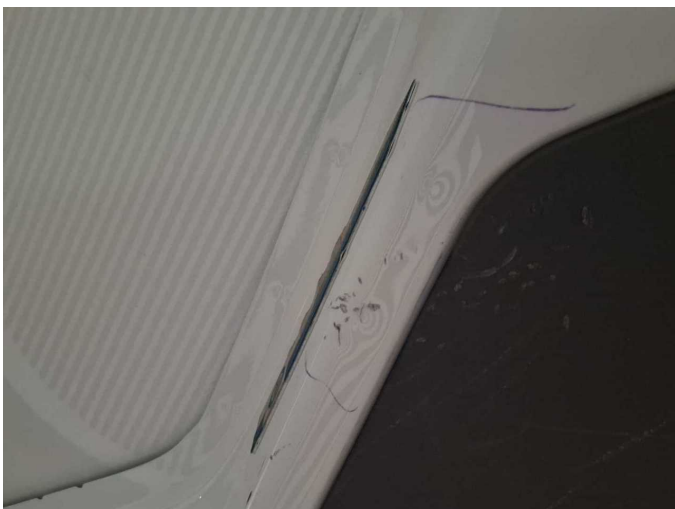
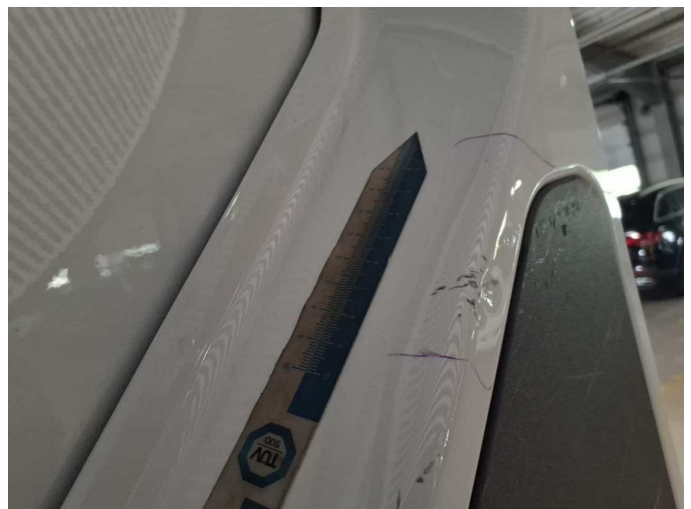
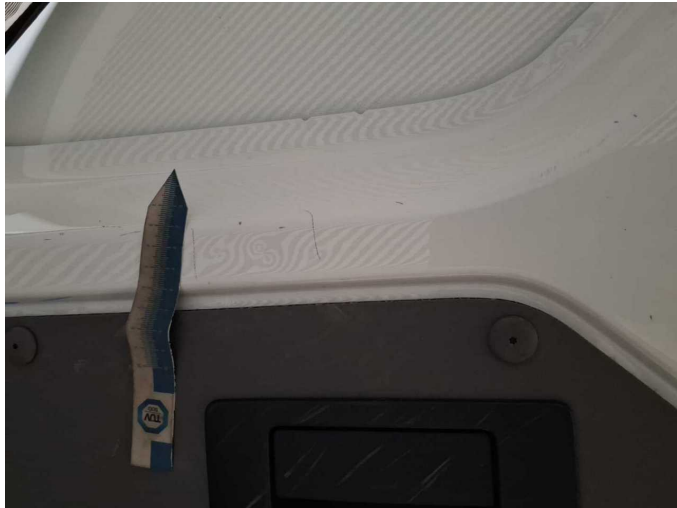
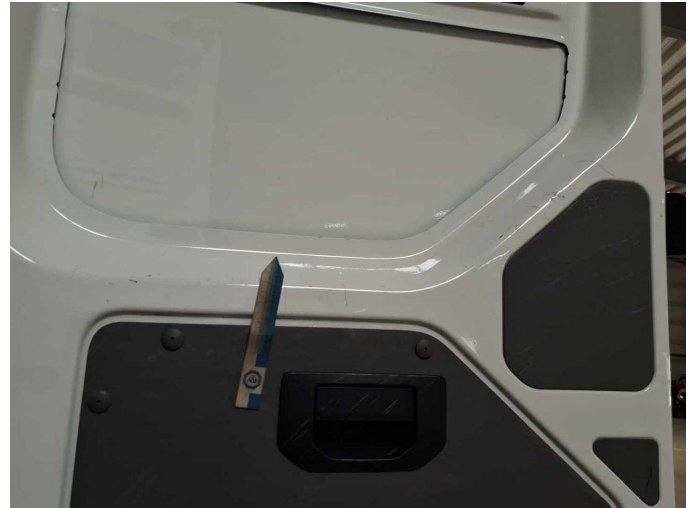
| No. | Component group | Description |
|---|---|---|
| 5 | Boot lid / rear door | Rear door - right side - Dent / paintcoat damage - Repair and paint |

**Damage 5:** Boot lid / rear door: Rear door - right side - Dent / paintcoat damage - Repair and paint

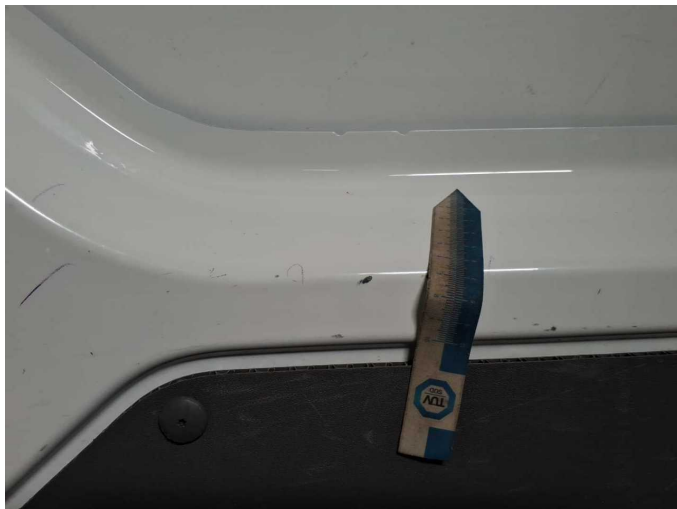
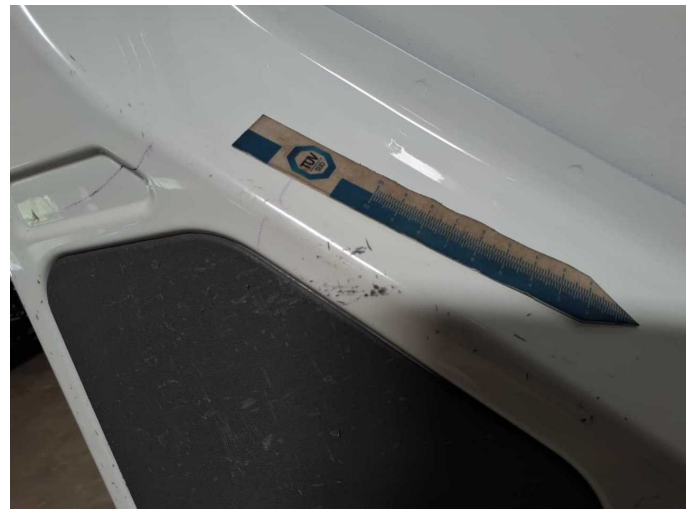
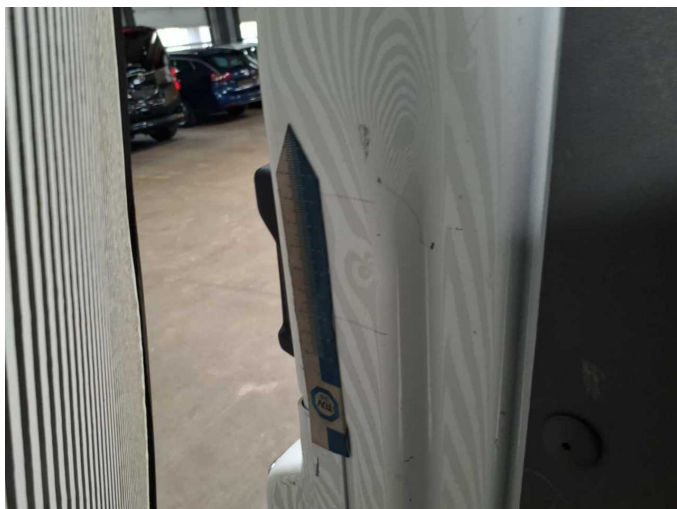
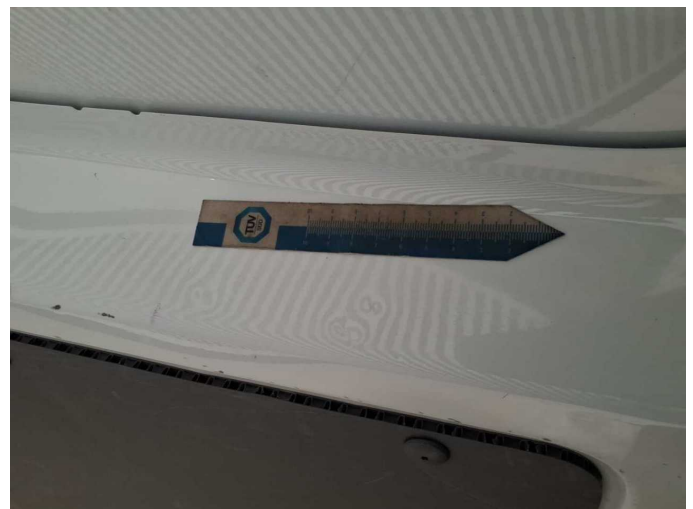
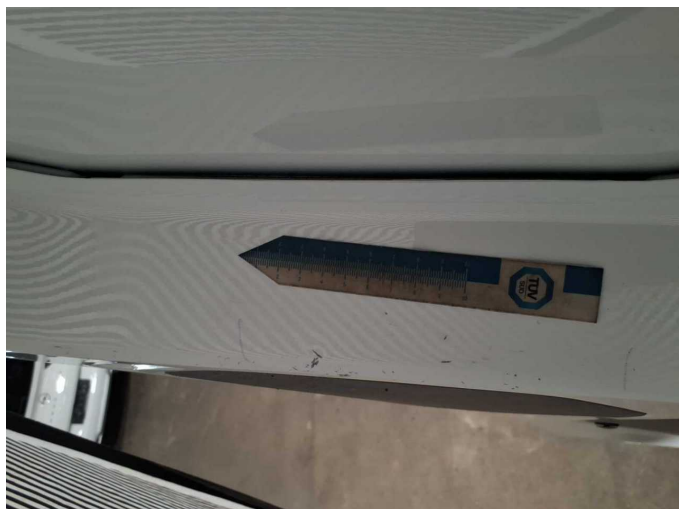
| No. | Component group | Description |
|---|---|---|
| 6 | Boot lid / rear door | Rear door - left side - Dent / paintcoat damage - Repair and paint |

**Damage 6:** Boot lid / rear door: Rear door - left side - Dent / paintcoat damage - Repair and paint

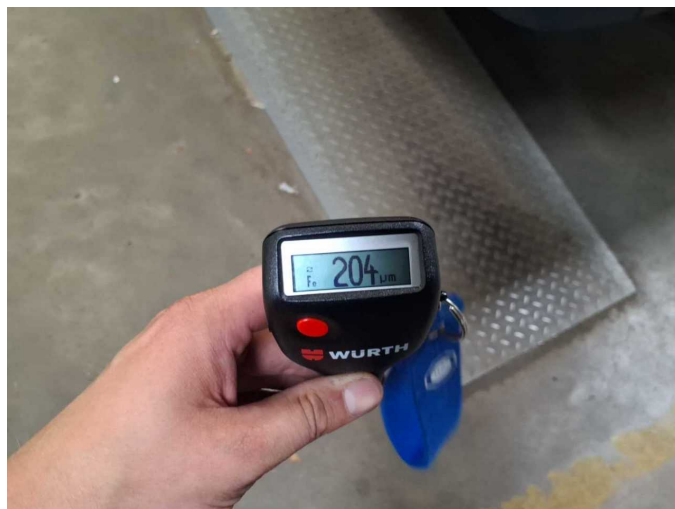
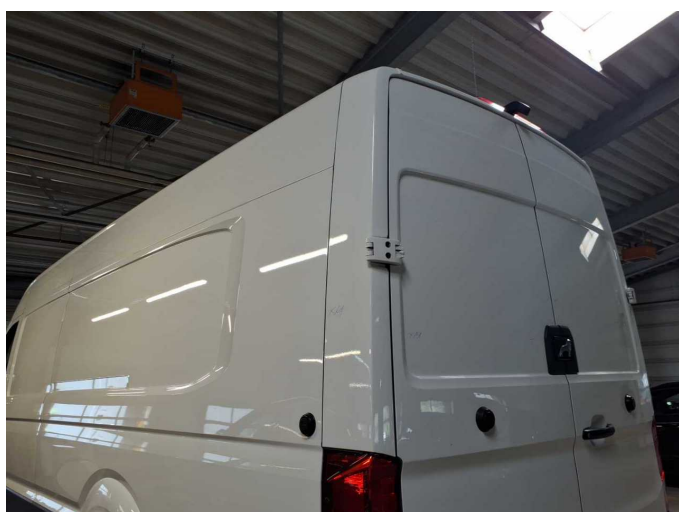
- 1 Side panel - rear left side, Professionally carried out, Invoice of repair done Non-existent
- 2 Door - rear left side

**Repainting 1:** Side panel - rear left side

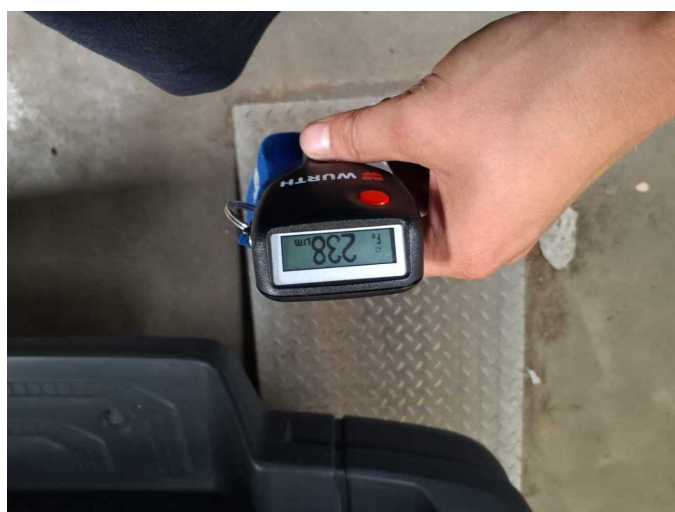
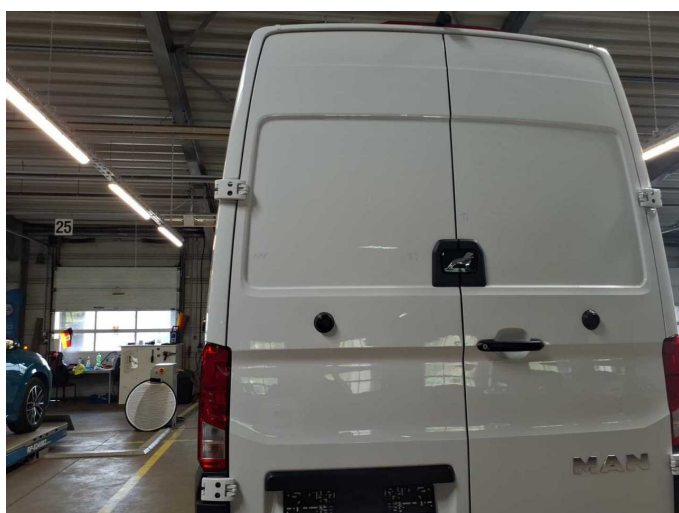
**Repainting 2:** Door - rear left side

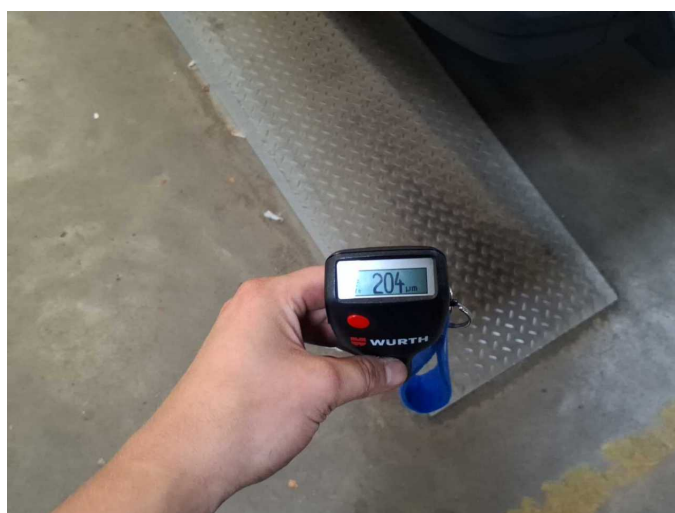
| Side panel - rear left side | 204 µm | Door - rear left side | 238 µm |

**Side panel - rear left side: 204 µm**

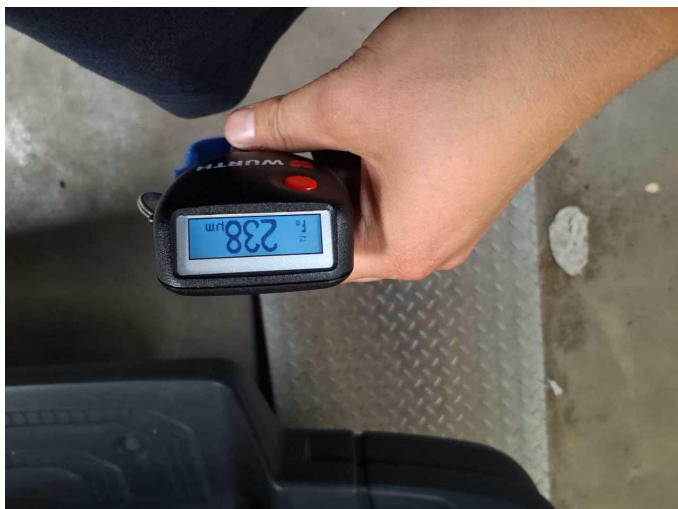
**Door - rear left side: 238 µm**
