Expertise

Protocol number: 46695902  
Order No. / Reference: 26631085  
Inspection date: 22 Jul 2026

Manufacturer: Opel

Model: Insignia Sports Tourer 1.5 Diesel Automatik Elegance

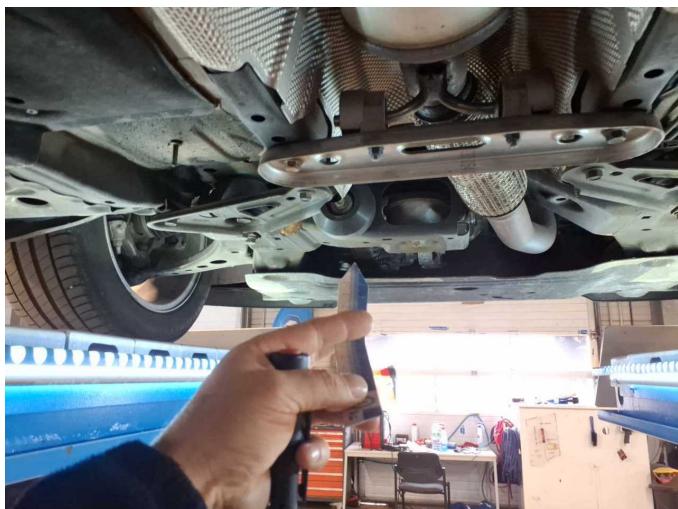
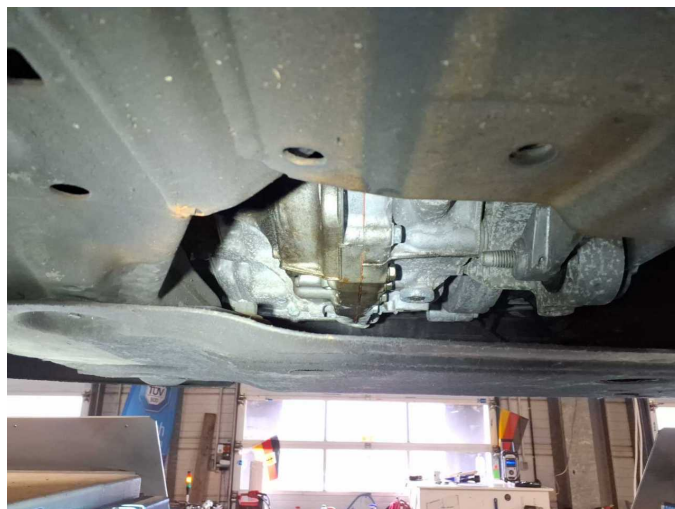
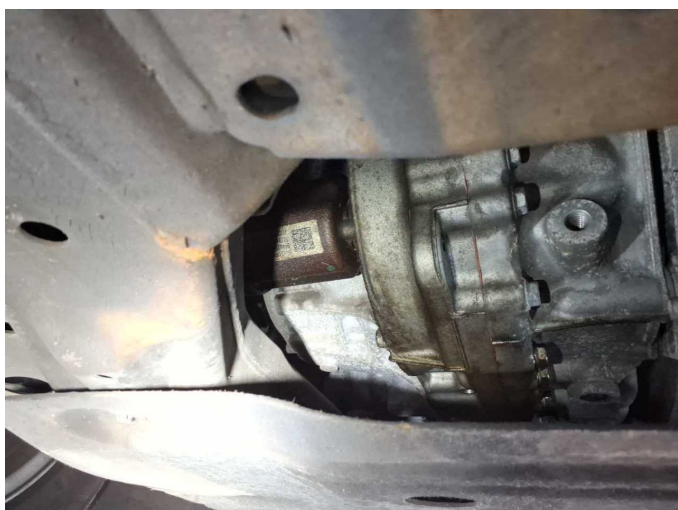
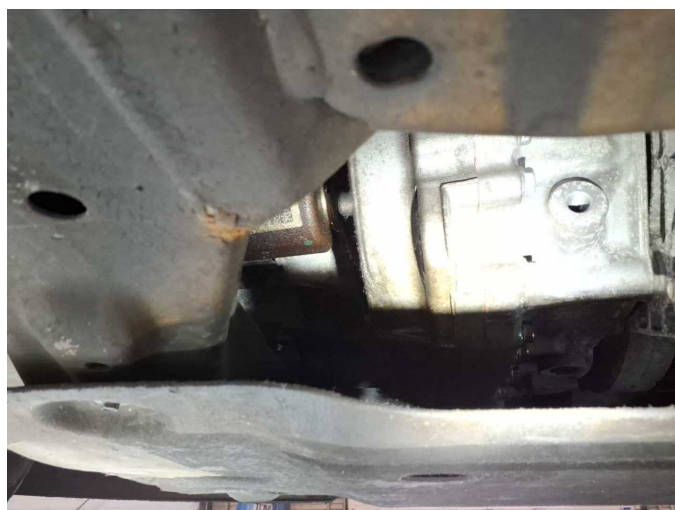
| No. | Component group | Description |
|---|---|---|
| 1 | Gearbox | Gearbox - Leaking - Perform diagnosis |

**Damage 1:** Gearbox: Gearbox - Leaking - Perform diagnosis

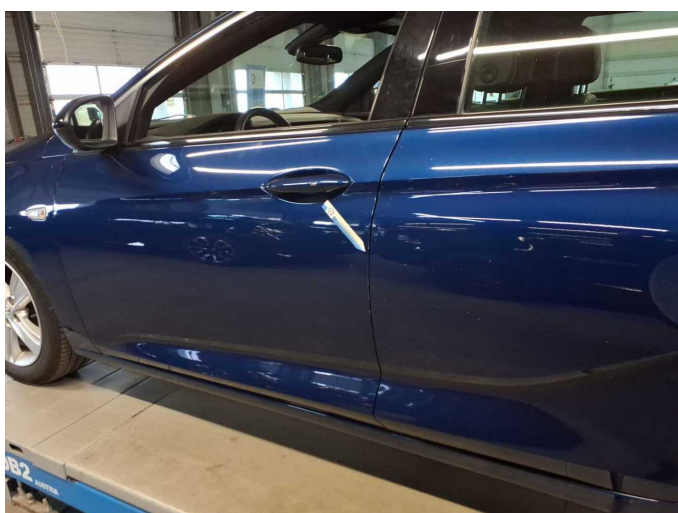
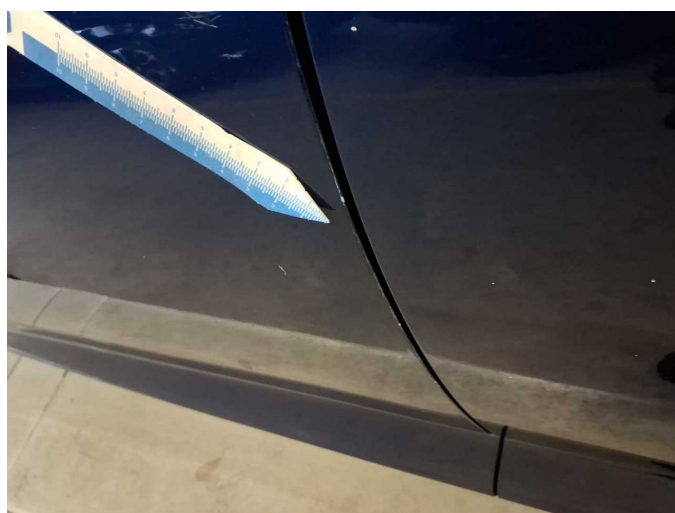
| No. | Component group | Description |
|---|---|---|
| 2 | Door - front left side | Door edge - Scratch(es) - Smart repair |

**Damage 2:** Door - front left side: Door edge - Scratch(es) - Smart repair

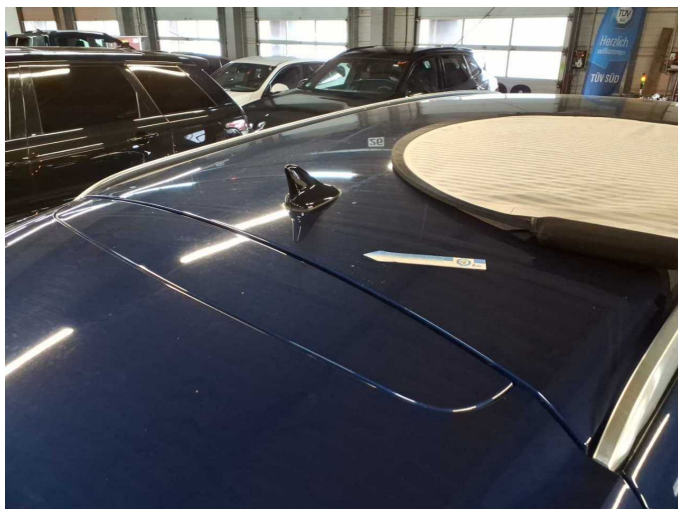
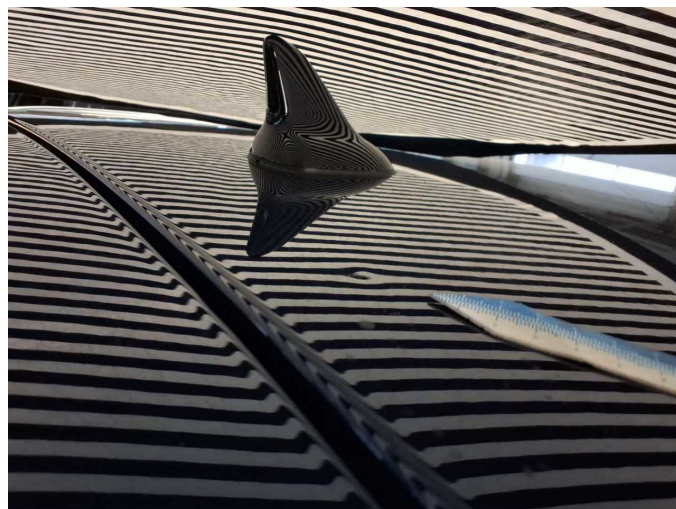
| No. | Component group | Description |
|---|---|---|
| 3 | Roof | Roof - dent(s) - Smart repair |

**Damage 3:** Roof: Roof - dent(s) - Smart repair

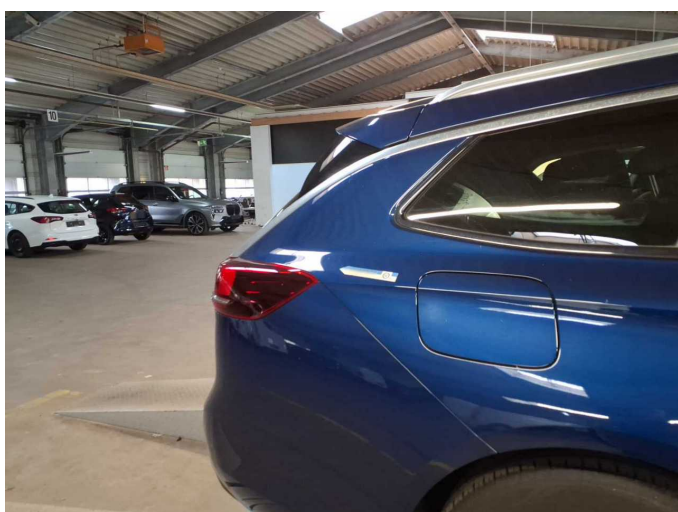
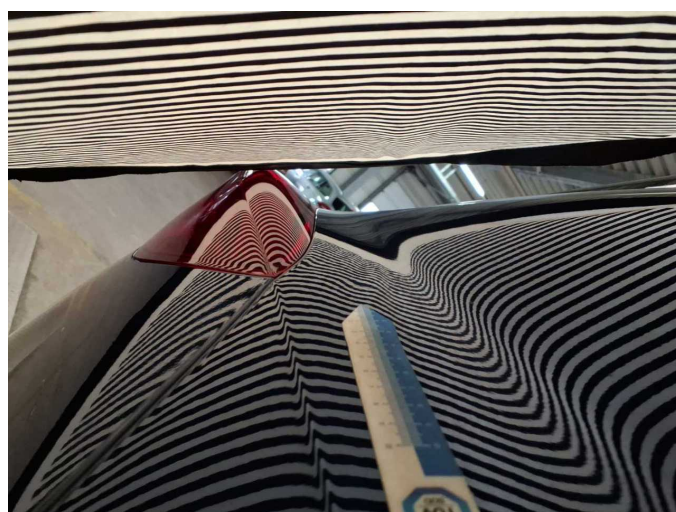
| No. | Component group | Description |
|---|---|---|
| 4 | Side panel - rear right side | Side panel - dent(s) - Smooth repair work |

**Damage 4:** Side panel - rear right side: Side panel - dent(s) - Smooth repair work

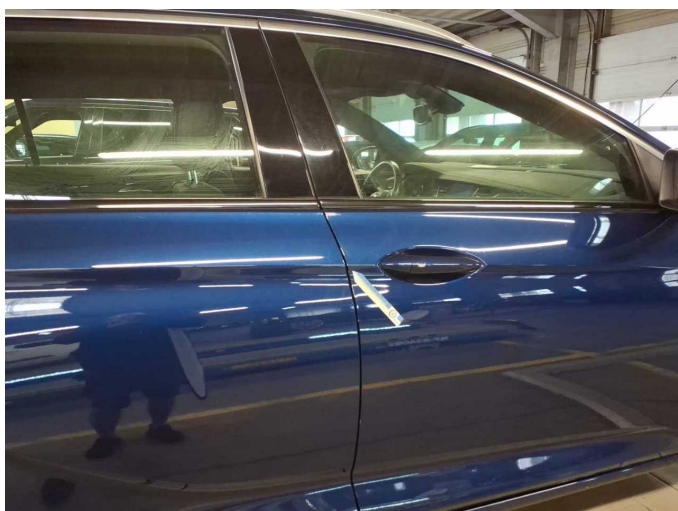
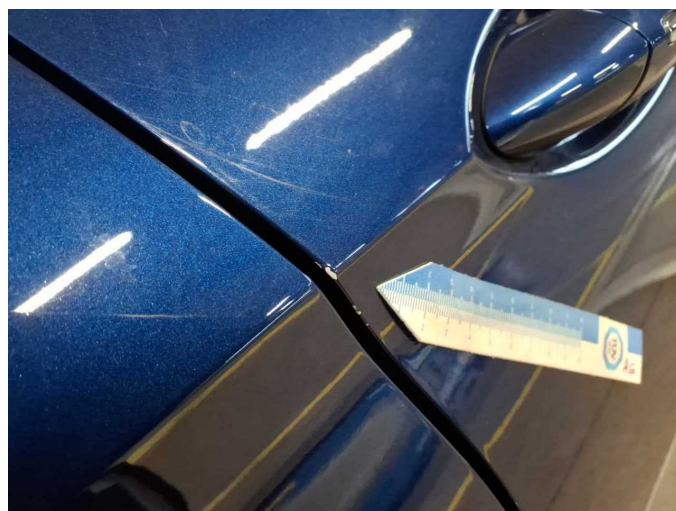
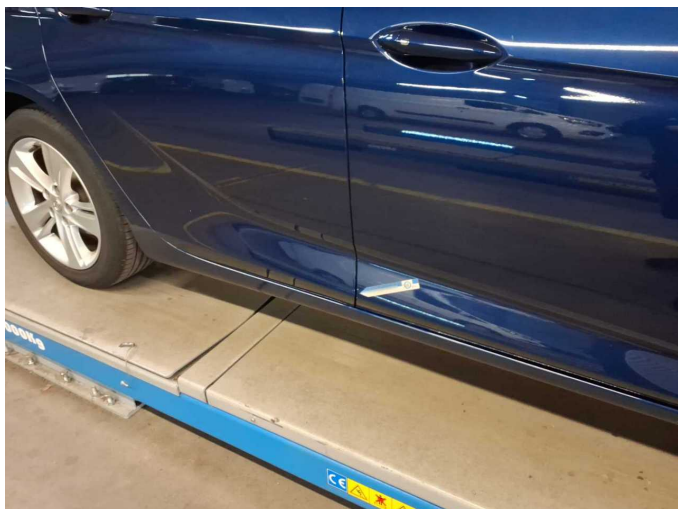
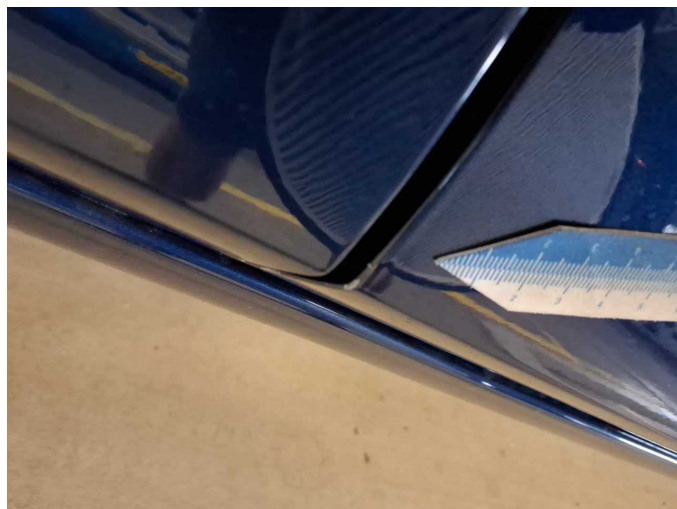
| No. | Component group | Description |
|---|---|---|
| 5 | Door - front right side | Door edge - Scratch(es) - Smart repair |

**Damage 5:** Door - front right side: Door edge - Scratch(es) - Smart repair

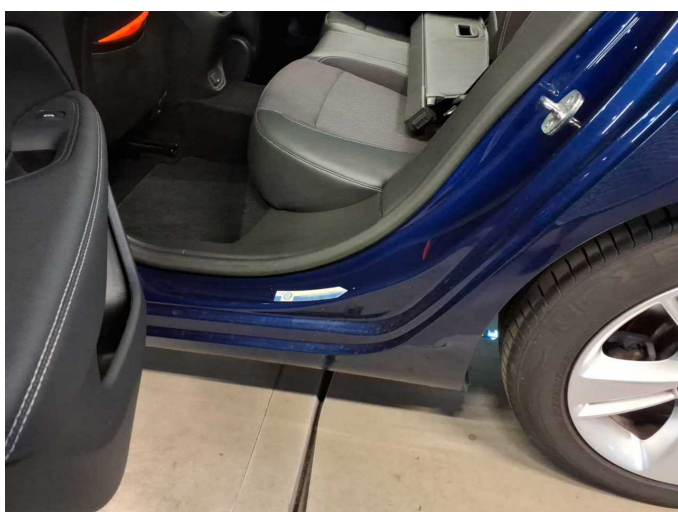
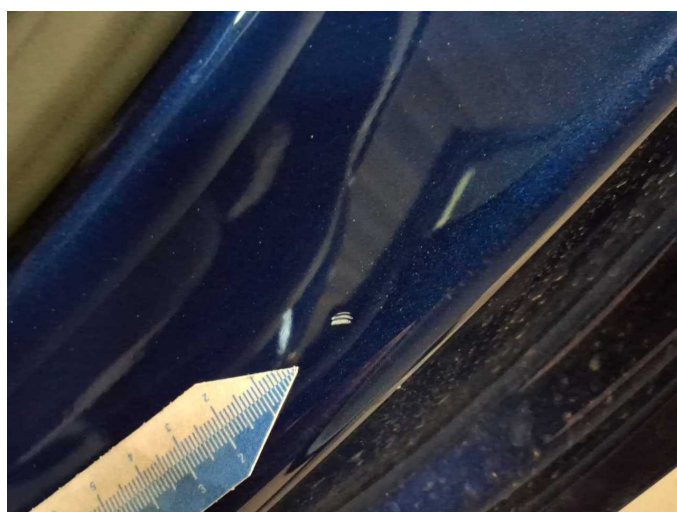
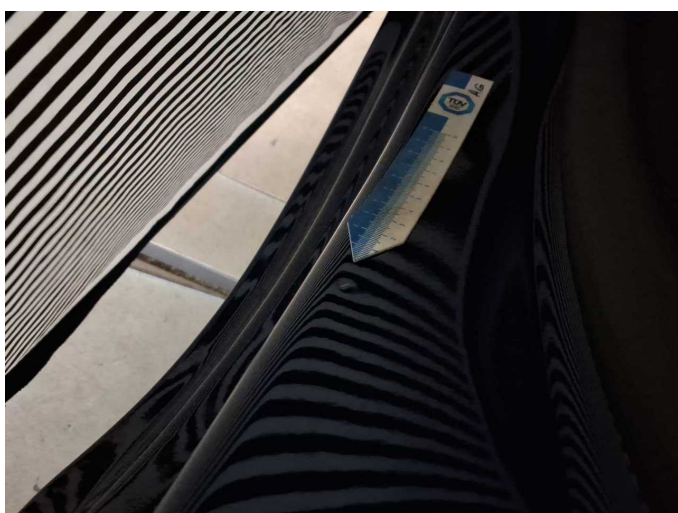
| No. | Component group | Description |
|---|---|---|
| 6 | Side panel - rear left side | Sill - Dent / paintcoat damage - Smart repair |

**Damage 6:** Side panel - rear left side: Sill - Dent / paintcoat damage - Smart repair

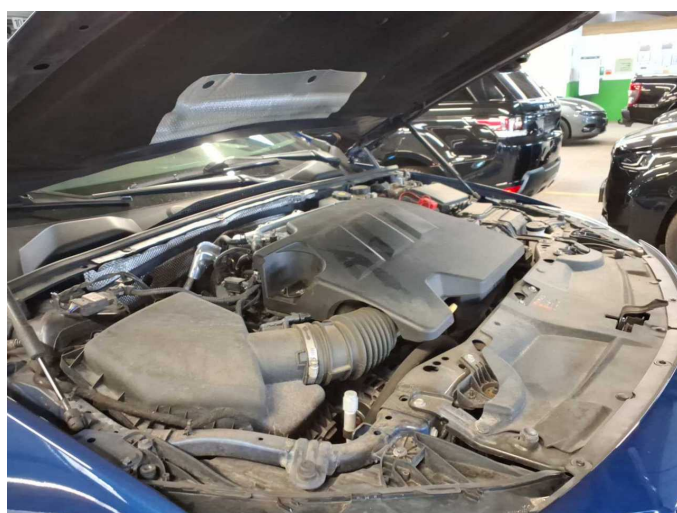
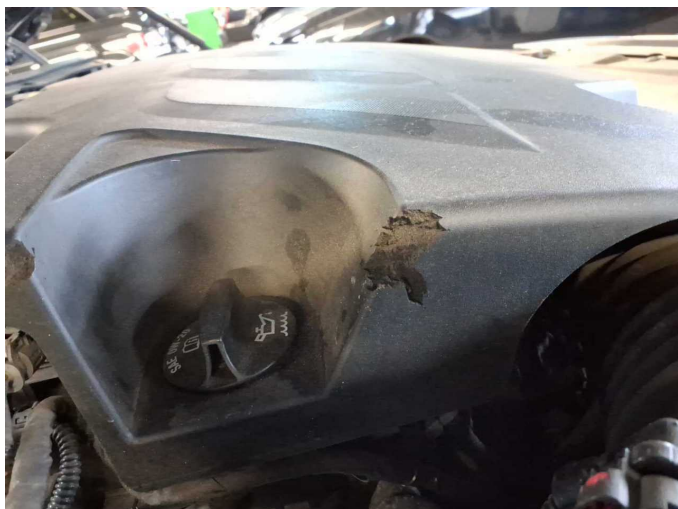
| No. | Component group | Description |
|---|---|---|
| 7 | Engine | Engine cover - Damage caused by marten / rodent - Replace |

**Damage 7:** Engine: Engine cover - Damage caused by marten / rodent - Replace

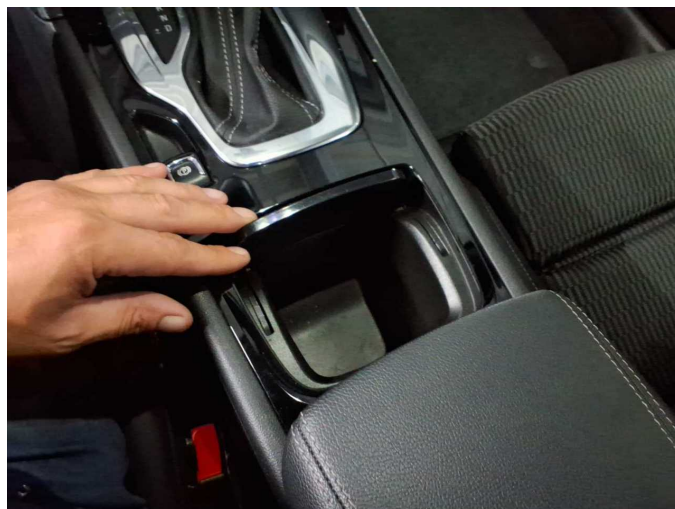
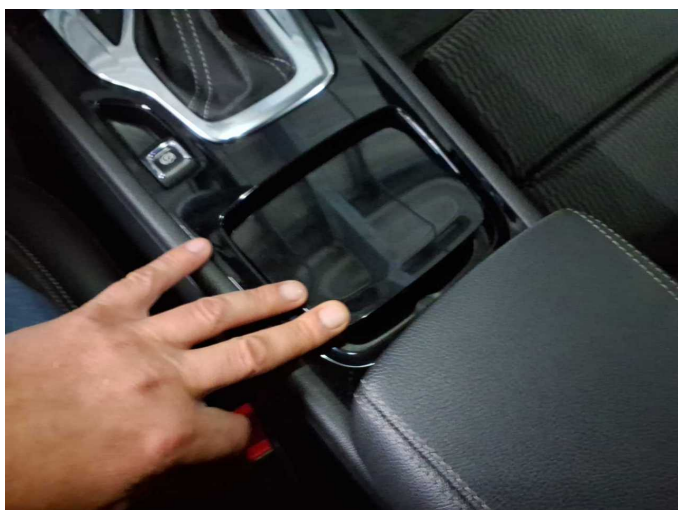
| No. | Component group | Description |
|---|---|---|
| 8 | Instrument panel | Centre console - front (Ablagefachdeckel schließt nicht) - Malposition - Replace |

**Damage 8:** Instrument panel: Centre console - front (Ablagefachdeckel schließt nicht) - Malposition - Replace

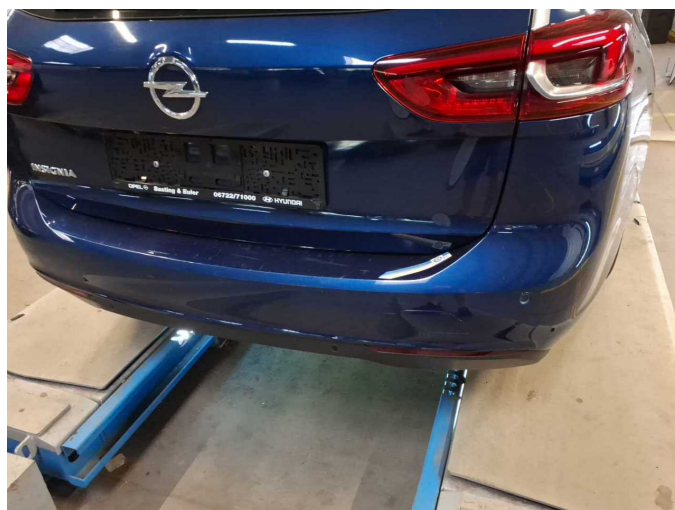
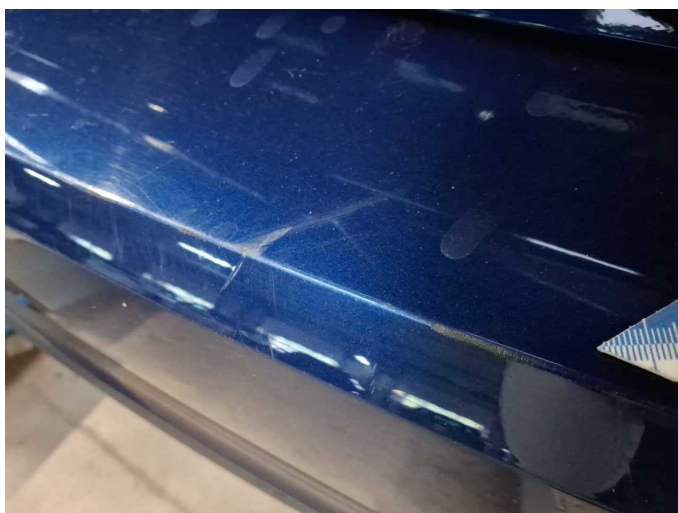
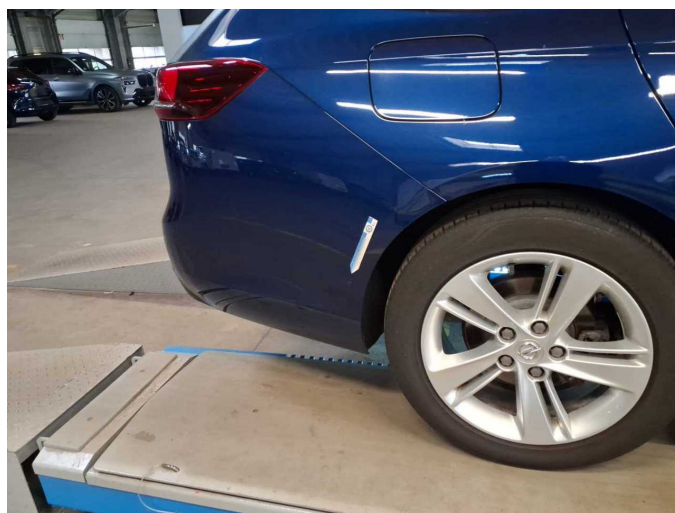
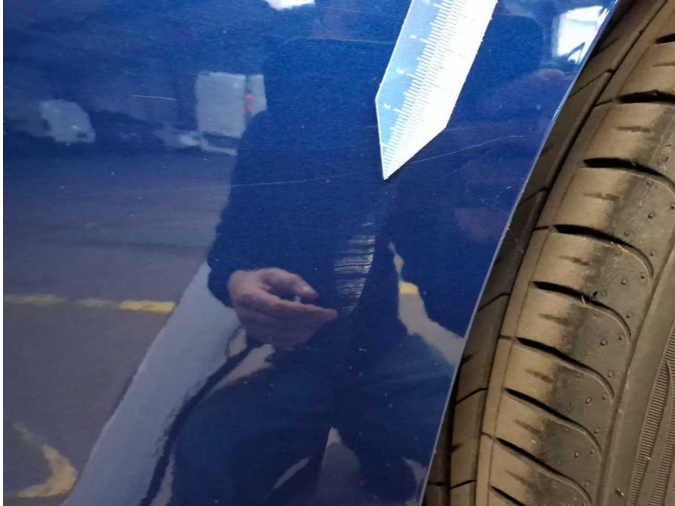
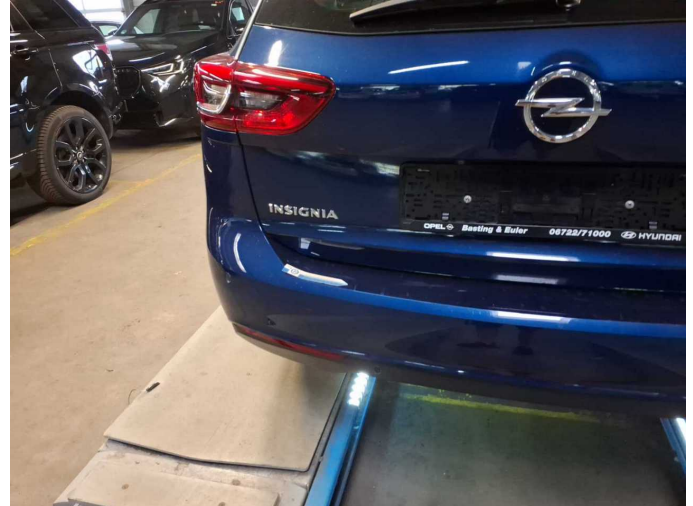
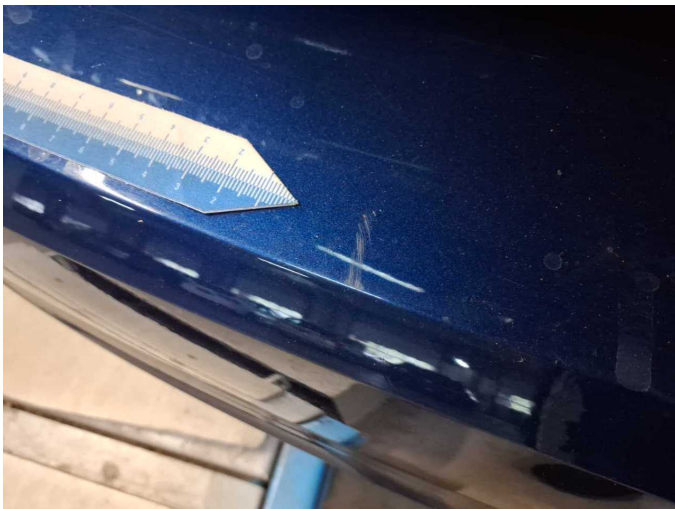
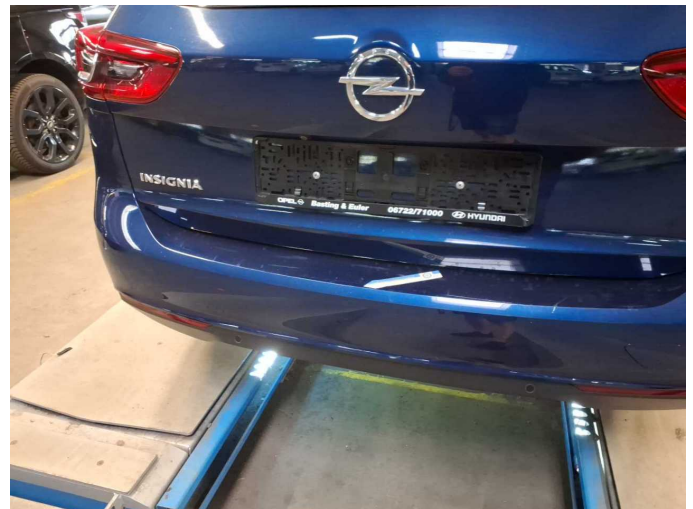
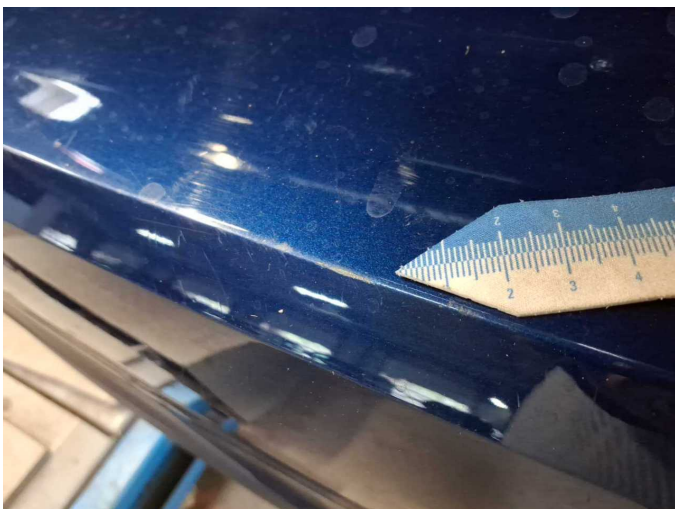
| No. | Component group | Description |
|---|---|---|
| 9 | Rear bumper | Rear bumper - Scratched - Paint |

**Damage 9:** Rear bumper: Rear bumper - Scratched - Paint

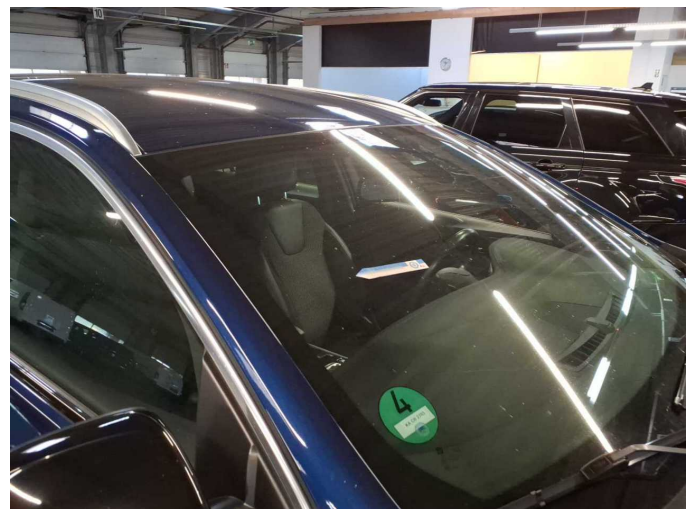
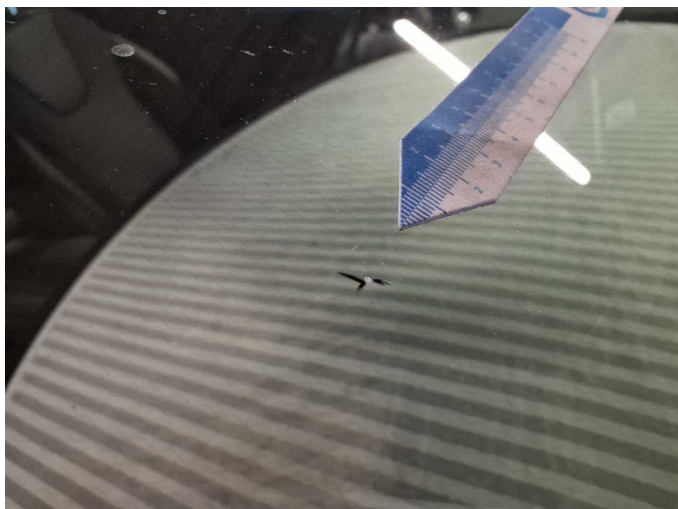
| No. | Component group | Description |
|---|---|---|
| 10 | Vehicle glazing | Windscreen (Rissbildung) - Stone chips - Replace |

**Damage 10:** Vehicle glazing: Windscreen (Rissbildung) - Stone chips - Replace

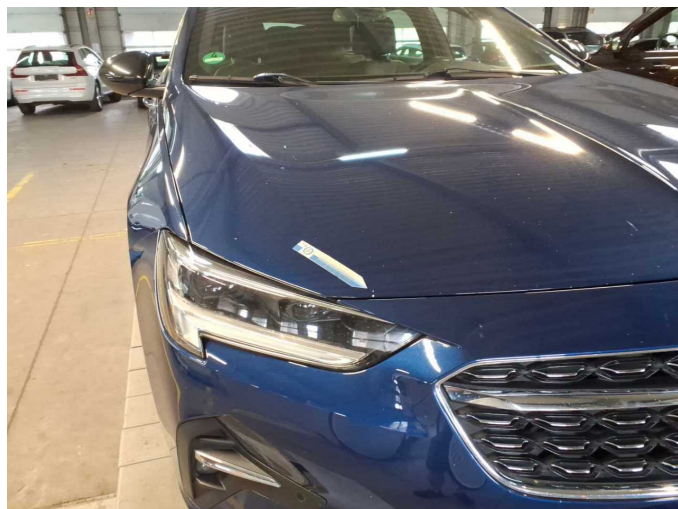
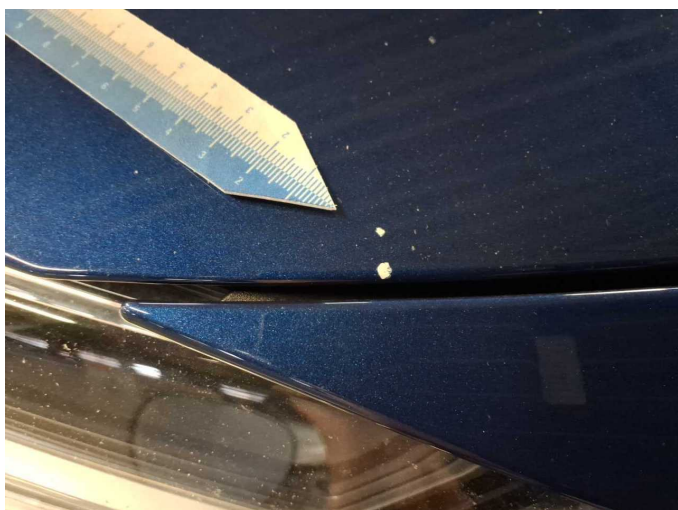
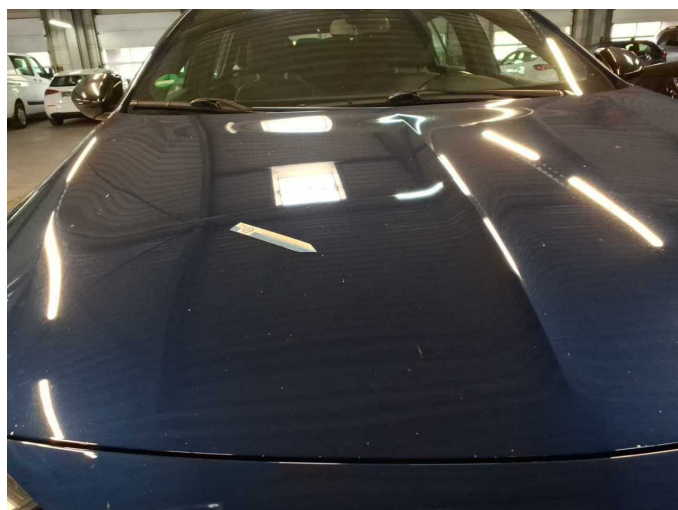
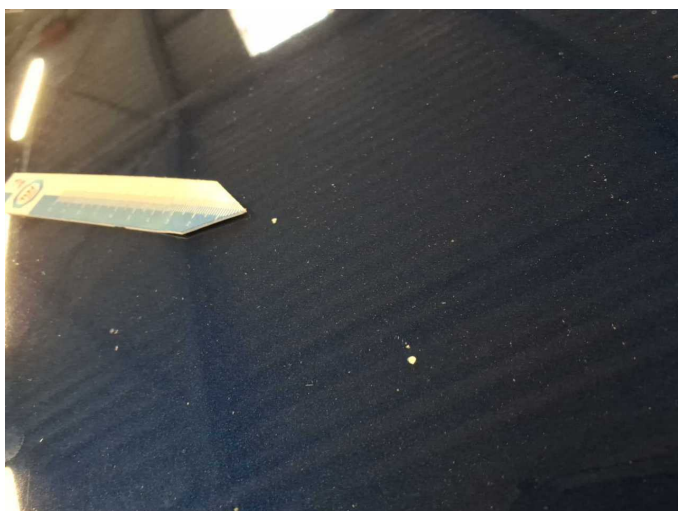
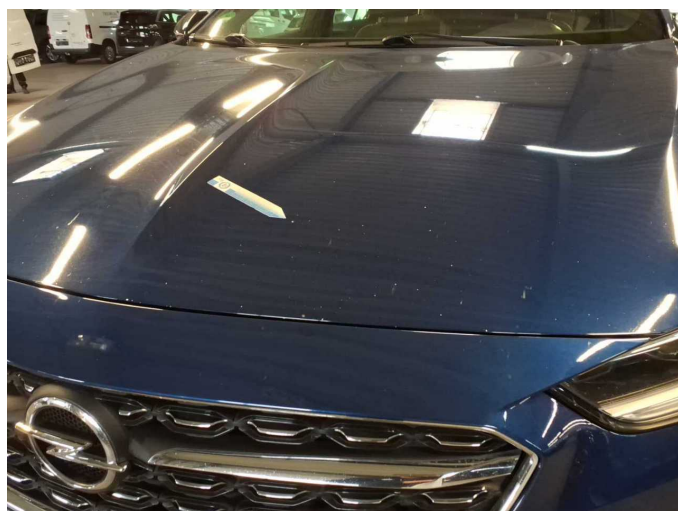
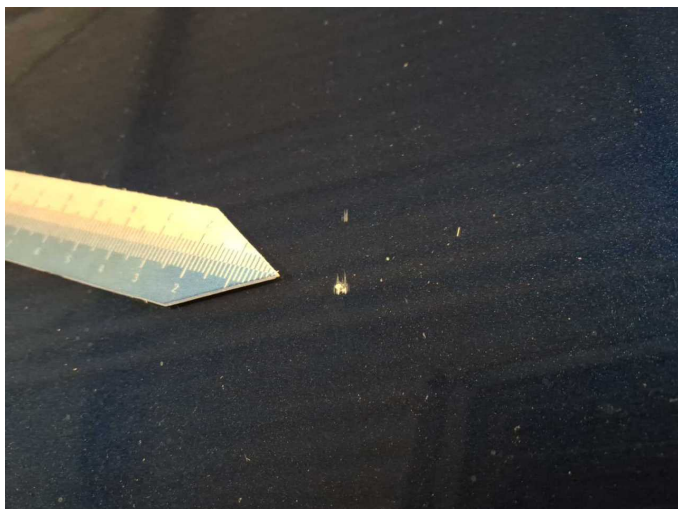
| No. | Component group | Description |
|---|---|---|
| 11 | Bonnet | Bonnet (Sandstrahleffekt) - Stone chips - Paint |

**Damage 11:** Bonnet: Bonnet (Sandstrahleffekt) - Stone chips - Paint
