## Expertise

Protocol number: 44645003  
Order number / reference: 26062900  
Inspection date: 25 Mar 2026

Manufacturer: Volkswagen

Model: Tiguan Allspace 2.0 TDI SCR Comfortline

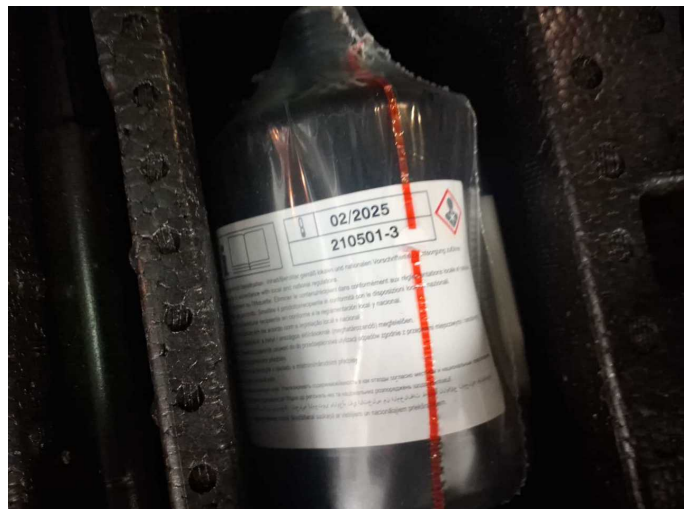
No.	Component group	Description
1	Equipment	Tirefit filler - Expired - Replace
2	Boot lid / rear door	Boot lid - dent(s) - Smooth repair work
3	Door - rear left side	Door - dent(s) - Smooth repair work
4	2nd wheel set	1 alloy rim - Scratch(es) - Loss in value
5	2nd wheel set	1 alloy rim - Scratch(es) - Loss in value
6	2nd wheel set	1 alloy rim - Scratch(es) - Loss in value
7	2nd wheel set	1 alloy rim - Scratch(es) - Loss in value

Damage 1: Equipment: Tirefit filler - Expired - Replace

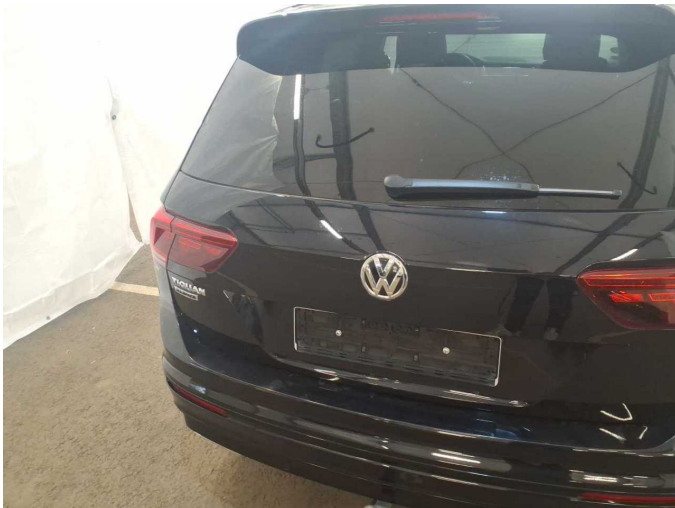
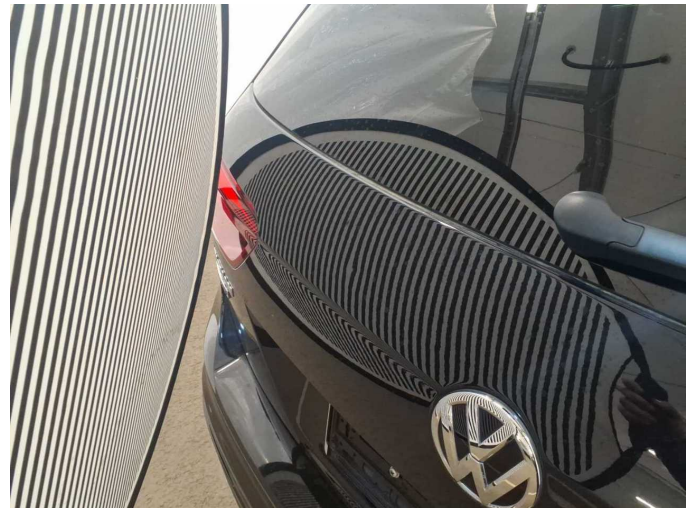
**Damage 2:** Boot lid / rear door: Boot lid - dent(s) - Smooth repair work

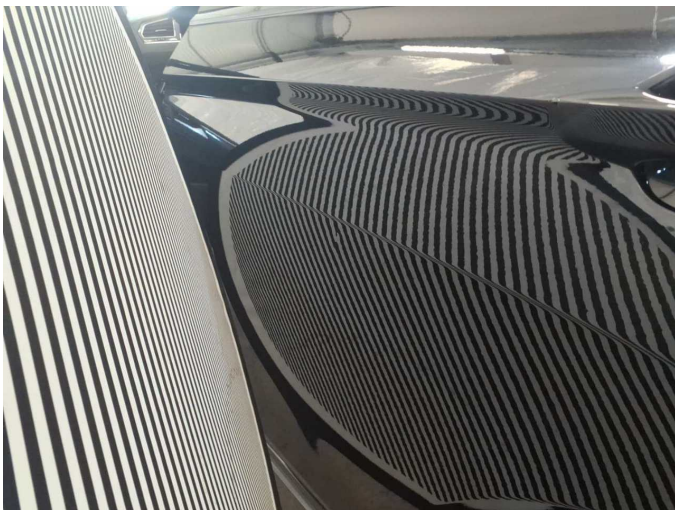
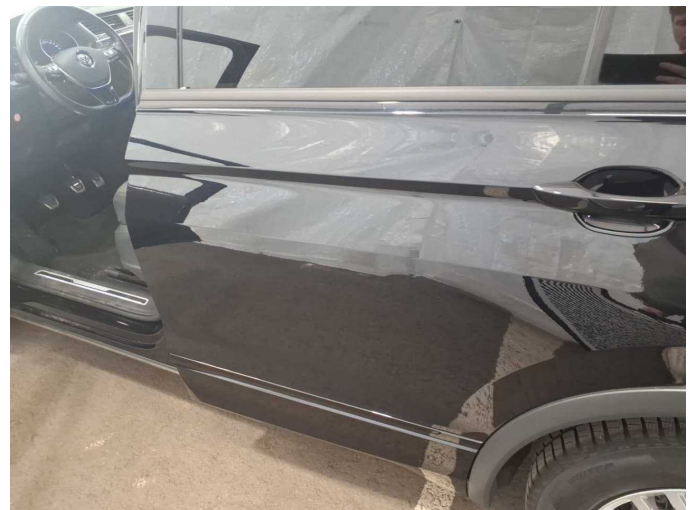
**Damage 3:** Door - rear left side: Door - dent(s) - Smooth repair work

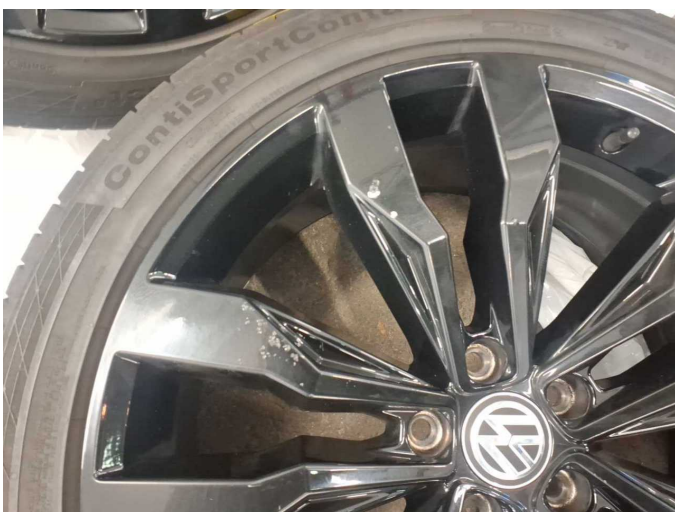
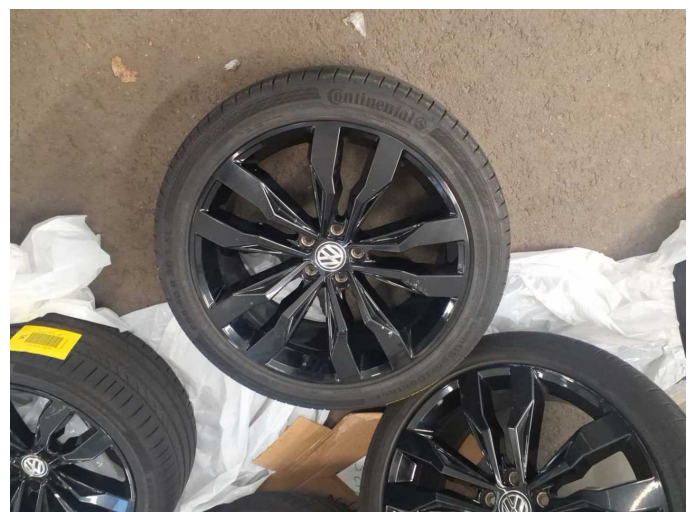
**Damage 4:** 2nd wheel set: 1 alloy rim - Scratch(es) - Loss in value

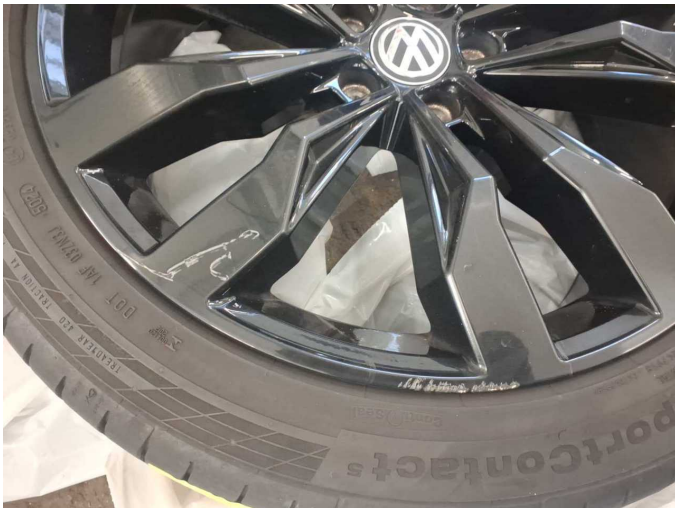
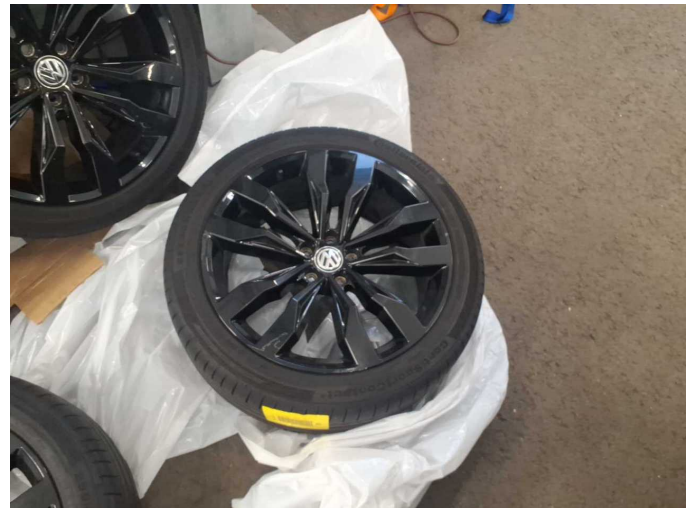
**Damage 5:** 2nd wheel set: 1 alloy rim - Scratch(es) - Loss in value

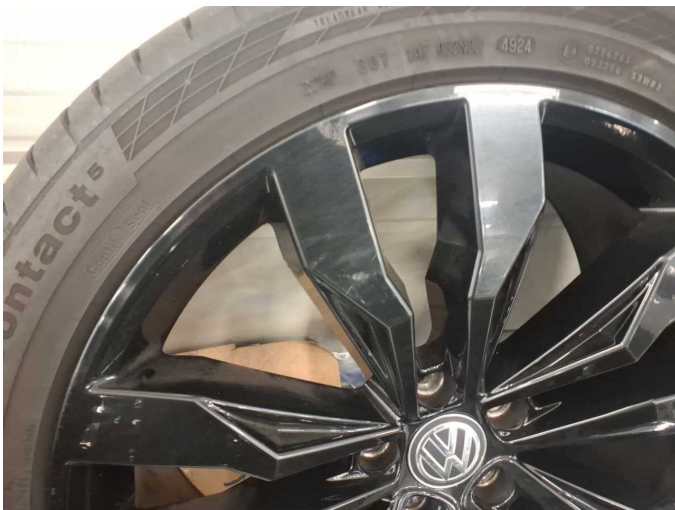
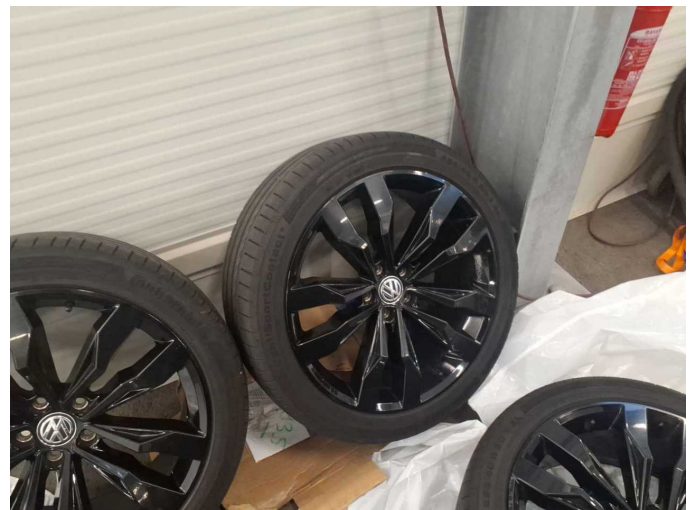
**Damage 6:** 2nd wheel set: 1 alloy rim - Scratch(es) - Loss in value

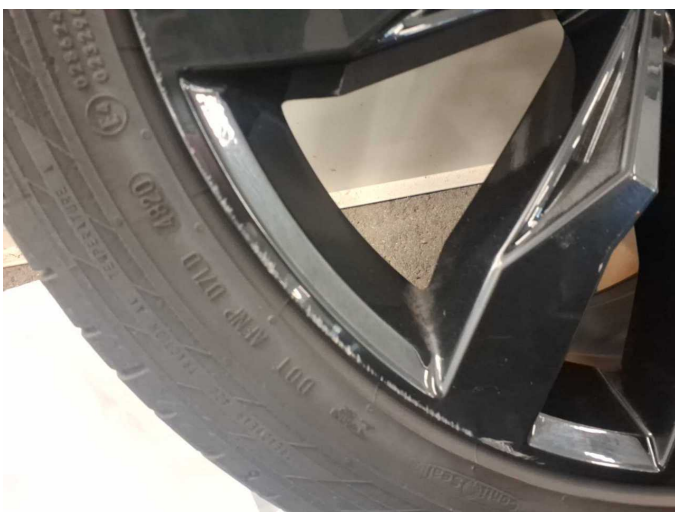
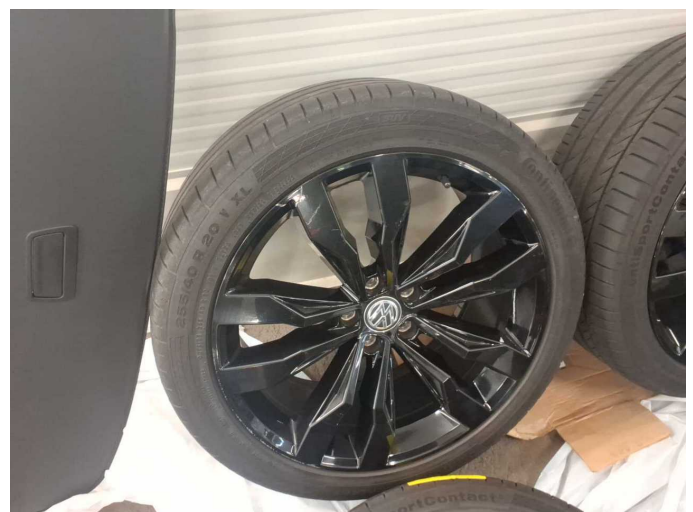
**Damage 7:** 2nd wheel set: 1 alloy rim - Scratch(es) - Loss in value
