2-FHA-986

2-FHA-986 · ST Line 1.0i EcoBoost 125pk M6 · 22 June 2026 · Zaventem (BE)

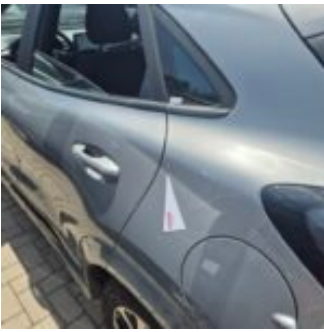
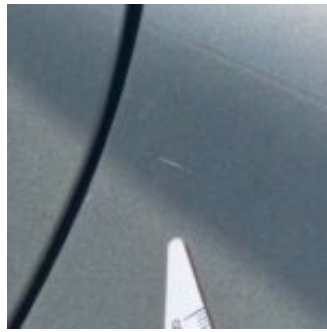
Fender - Rear Left

Small scratch(es)

No

Touch-up / Polish

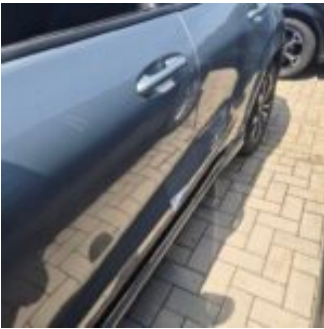
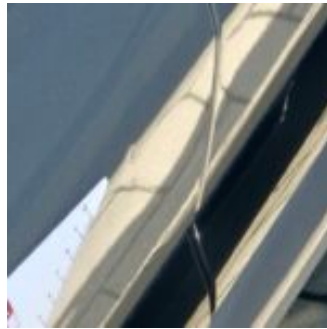
Frontdoor - Left

Small dent(s)

No

Restyle

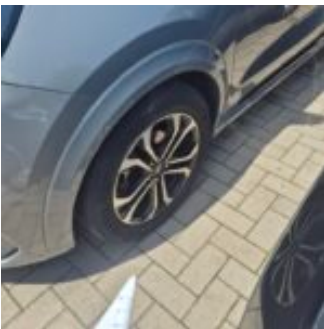
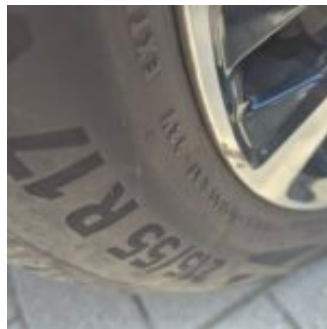
Alloy - Left Front

Damaged

Yes

Acceptable

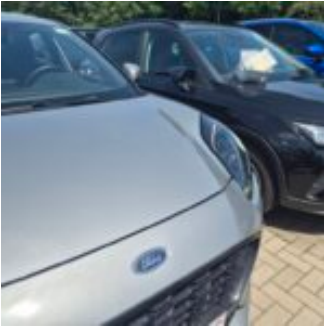
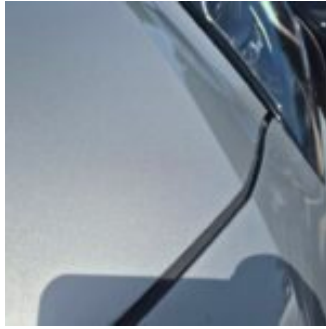
Hood

Stonechipping

Yes

Acceptable

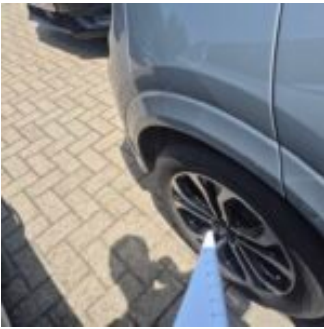
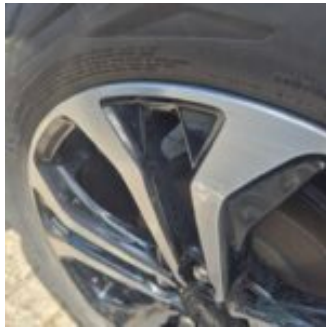
Alloy - Right Rear

Damaged

No

Rim repair

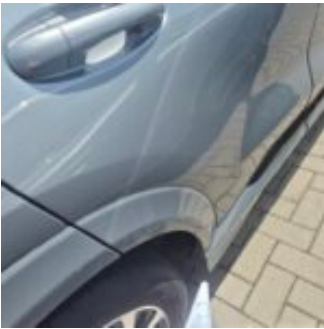
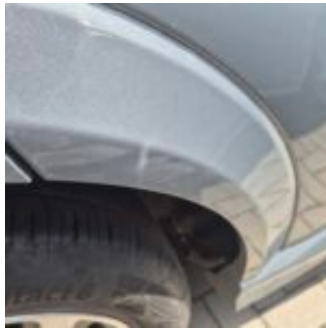
Overfender

Small scratch(es)

No

Spray

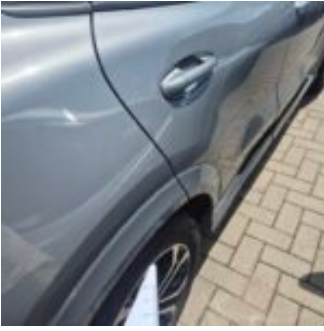
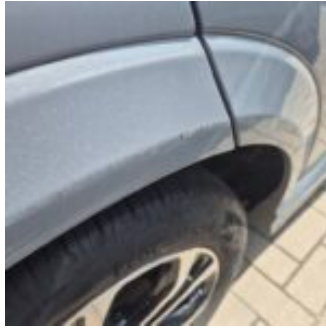
Overfender

Small scratch(es)

No

Spray
