Expertise

Protocol number: 46323022  
Order No. / Reference: 26547211  
Inspection date: 3 Jul 2026

Model: Zafira Life 2.0 D M Edition

VIN: VXEEVHTMNZ072625

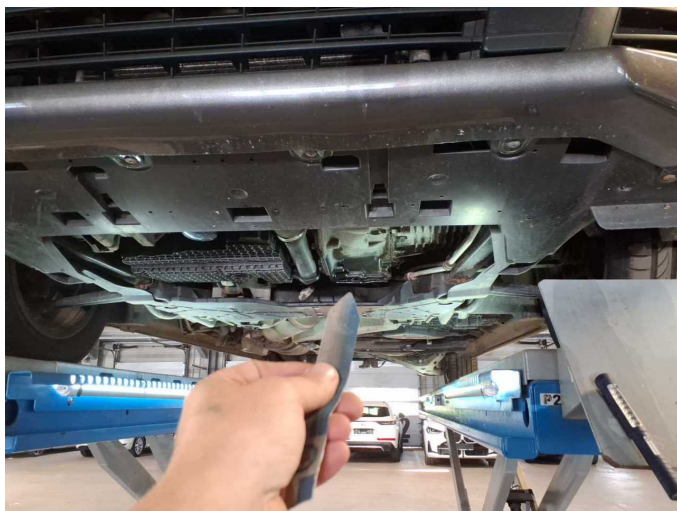
| No. | Component group | Description |
|---|---|---|
| 1 | Gearbox | Gearbox (Tröpfchenbildung, Umweltbelastung) - Leaking - Perform diagnosis |

**Damage 1:** Gearbox: Gearbox (Tröpfchenbildung, Umweltbelastung) - Leaking - Perform diagnosis

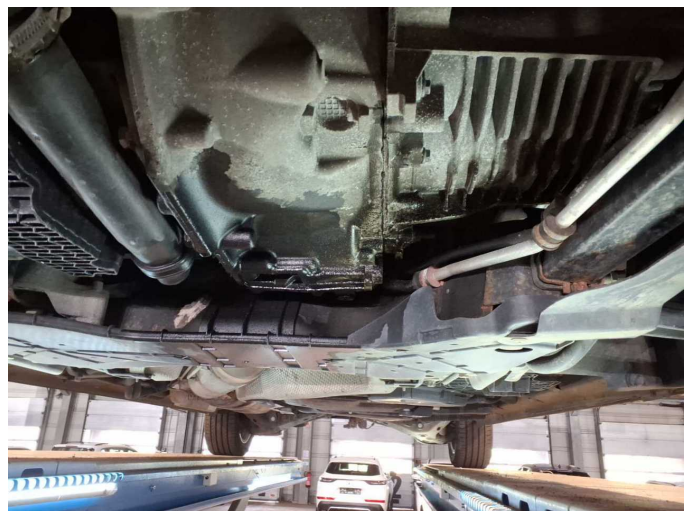
**Damage 1:** Gearbox: Gearbox (Tröpfchenbildung, Umweltbelastung) - Leaking - Perform diagnosis

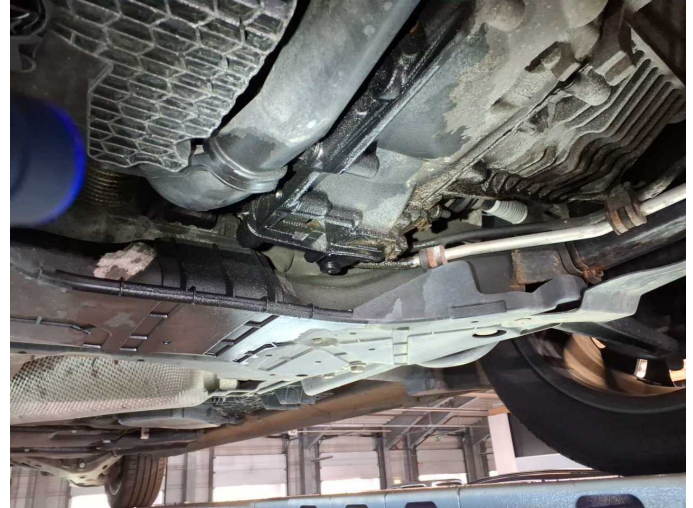
**Damage 1:** Gearbox: Gearbox (Tröpfchenbildung, Umweltbelastung) - Leaking - Perform diagnosis

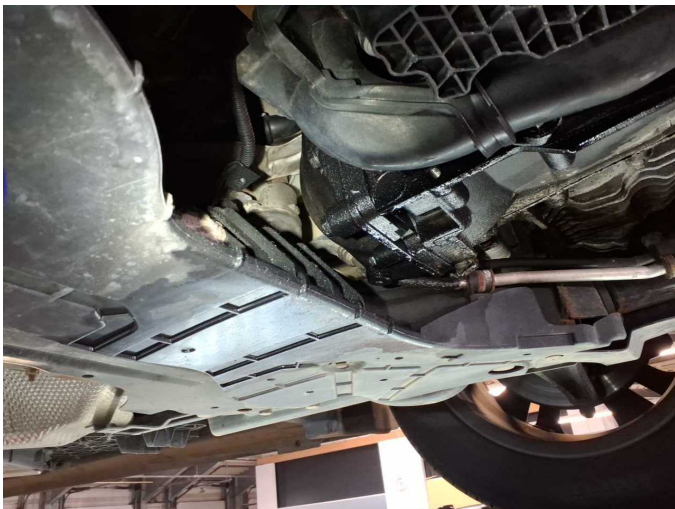
**Damage 1:** Gearbox: Gearbox (Tröpfchenbildung, Umweltbelastung) - Leaking - Perform diagnosis

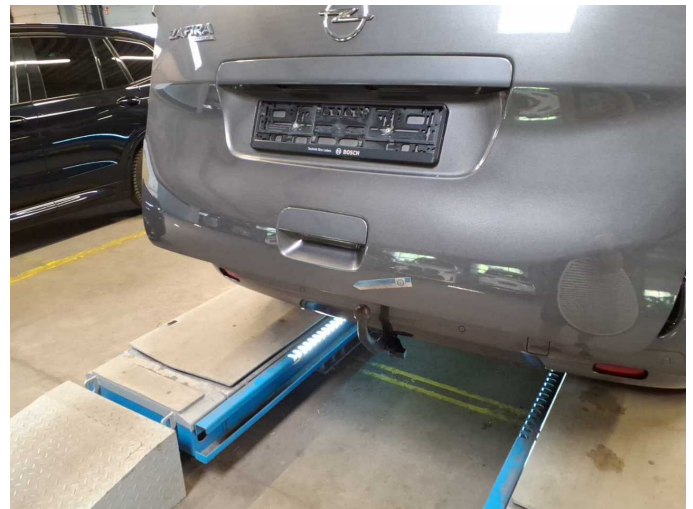
| No. | Component group | Description |
|---|---|---|
| 2 | Boot lid / rear door | Boot lid - dent(s) - Smooth repair work |

**Damage 2:** Boot lid / rear door: Boot lid - dent(s) - Smooth repair work

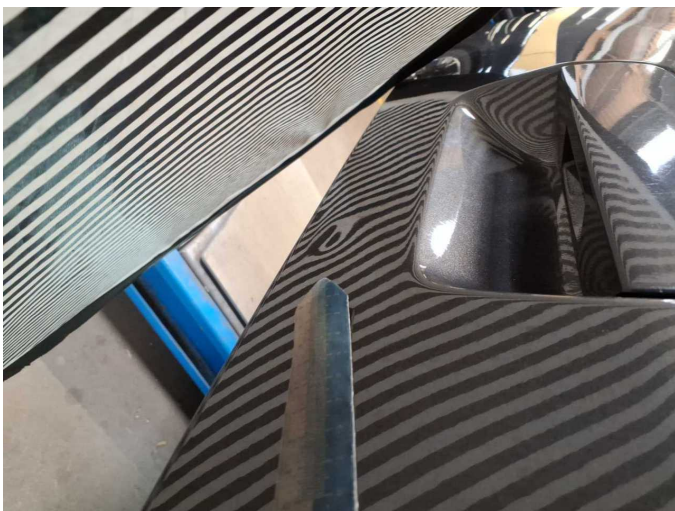
**Damage 2:** Boot lid / rear door: Boot lid - dent(s) - Smooth repair work

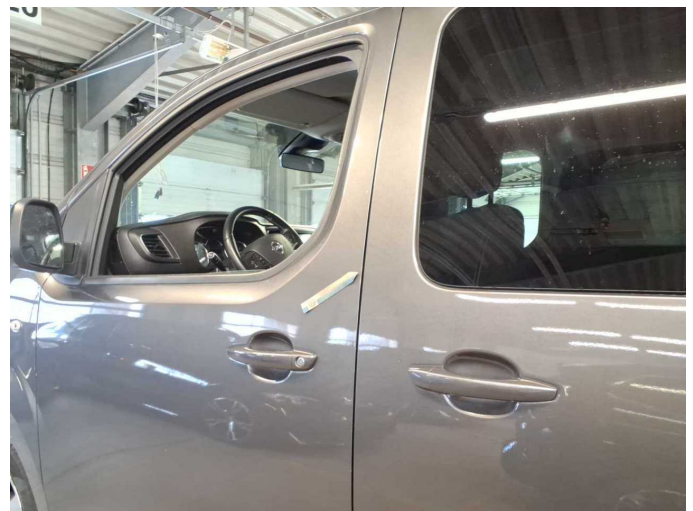
| No. | Component group | Description |
|---|---|---|
| 3 | Door - front left side | Door edge - Scratch(es) - Smart repair |

**Damage 3:** Door - front left side: Door edge - Scratch(es) - Smart repair

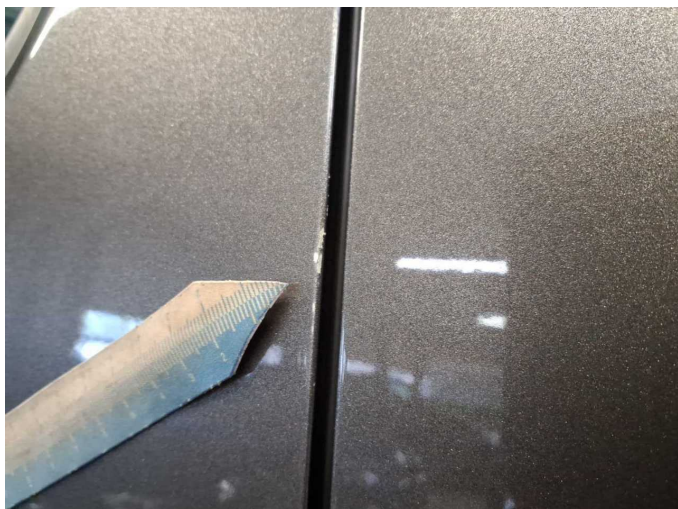
**Damage 3:** Door - front left side: Door edge - Scratch(es) - Smart repair

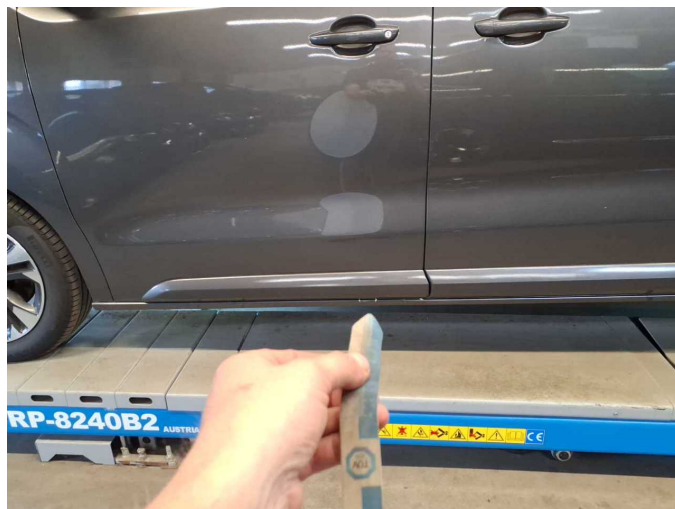
| No. | Component group | Description |
|---|---|---|
| 4 | Sill - left side | Sill - Scratch(es) - Smart repair |

**Damage 4:** Sill - left side: Sill - Scratch(es) - Smart repair

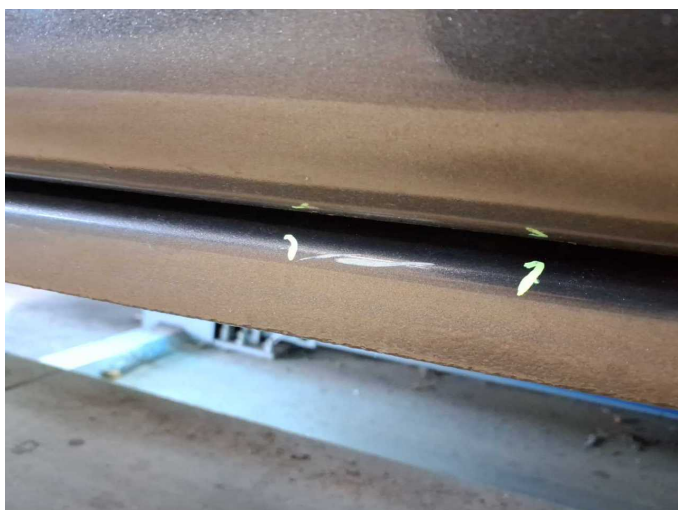
**Damage 4:** Sill - left side: Sill - Scratch(es) - Smart repair

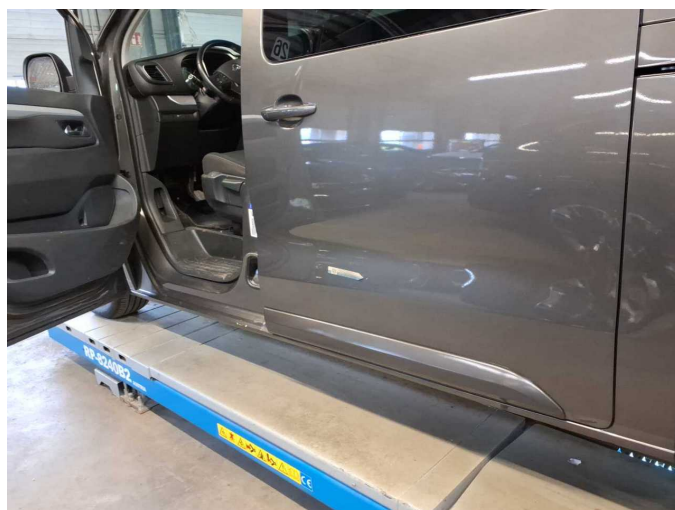
| No. | Component group | Description |
|---|---|---|
| 5 | Sliding door - left side | Sliding door with glass panel (Bis an Grund) - Scratch(es) - Smart repair |

**Damage 5:** Sliding door - left side: Sliding door with glass panel (Bis an Grund) - Scratch(es) - Smart repair

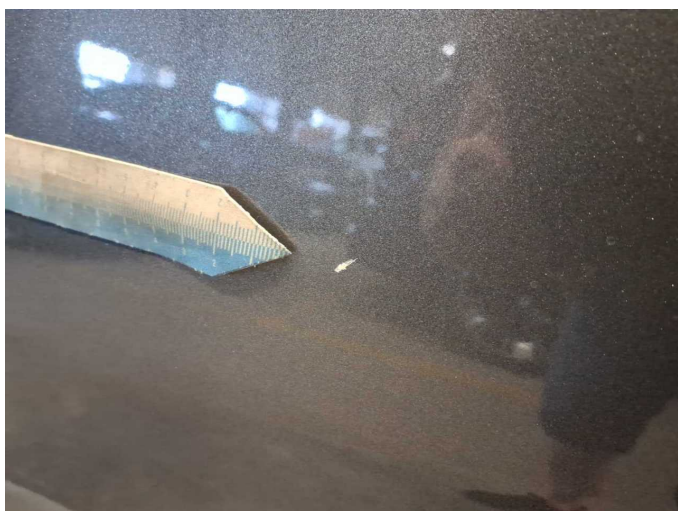
**Damage 5:** Sliding door - left side: Sliding door with glass panel (Bis an Grund) - Scratch(es) - Smart repair

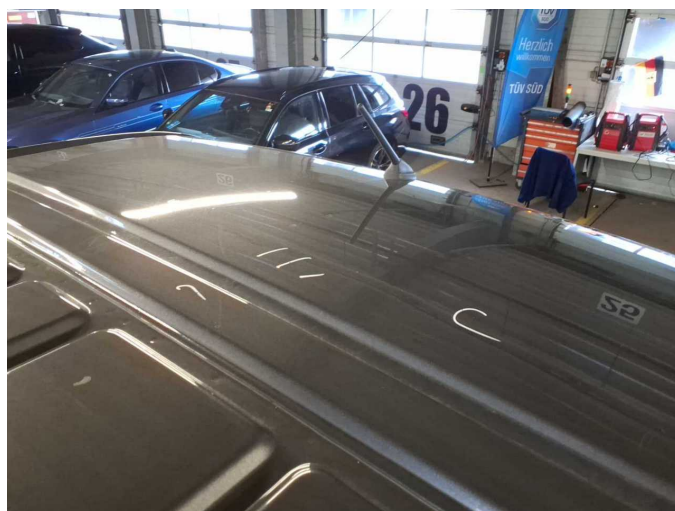
| No. | Component group | Description |
|---|---|---|
| 6 | Roof | Roof (vorne) - dent(s) - Smooth repair work |

**Damage 6:** Roof: Roof (vorne) - dent(s) - Smooth repair work

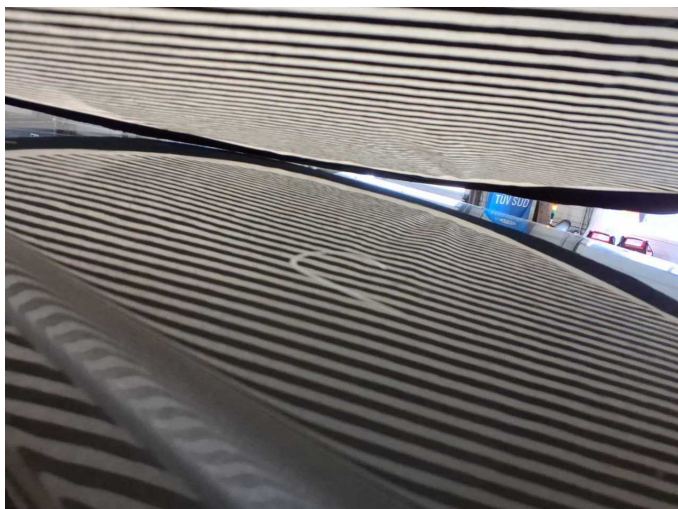
**Damage 6:** Roof: Roof (vorne) - dent(s) - Smooth repair work

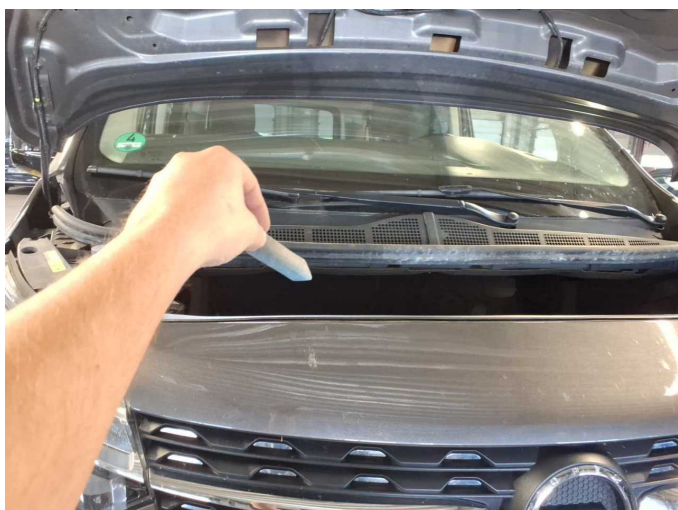
| No. | Component group | Description |
|---|---|---|
| 7 | Misc. | Misc. (Stirnwand Dämmung) - Broken / torn - Replace |

**Damage 7:** Misc.: Misc. (Stirnwand Dämmung) - Broken / torn - Replace

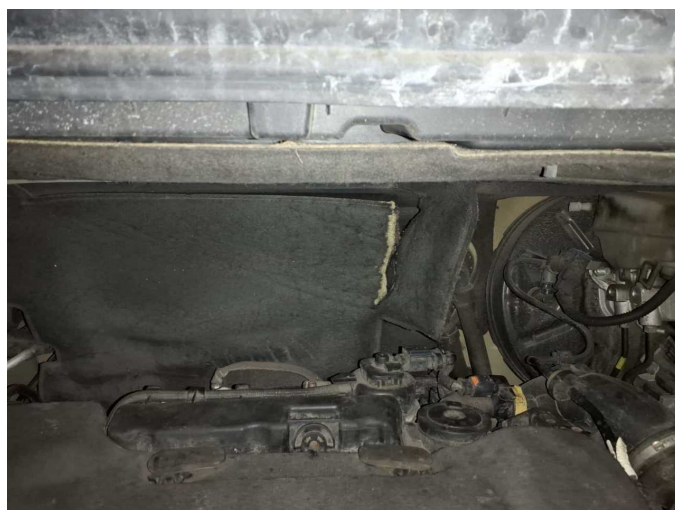
**Damage 7:** Misc.: Misc. (Stirnwand Dämmung) - Broken / torn - Replace

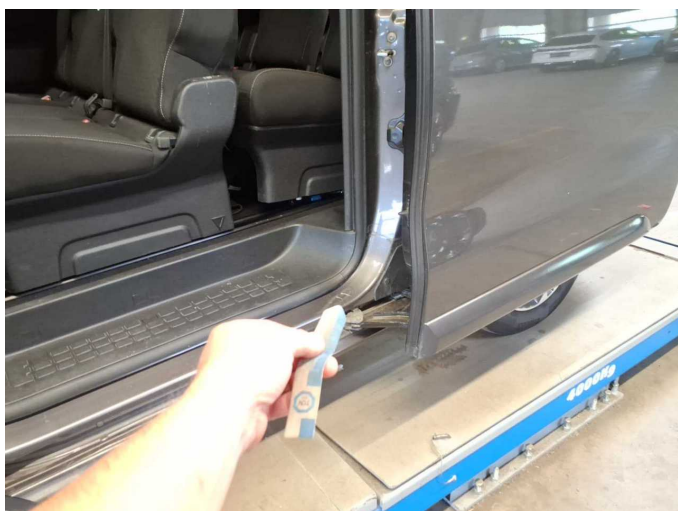
| No. | Component group | Description |
|---|---|---|
| 8 | Side panel - rear left side | Sill - Dent / paintcoat damage - Smart repair |

**Damage 8:** Side panel - rear left side: Sill - Dent / paintcoat damage - Smart repair

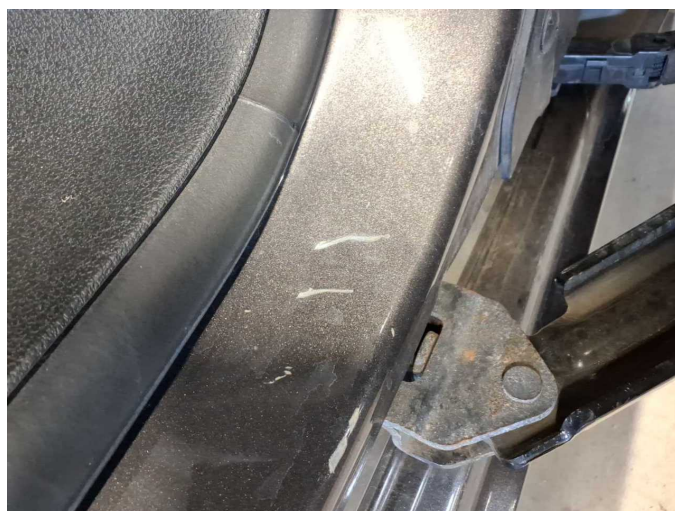
**Damage 8:** Side panel - rear left side: Sill - Dent / paintcoat damage - Smart repair

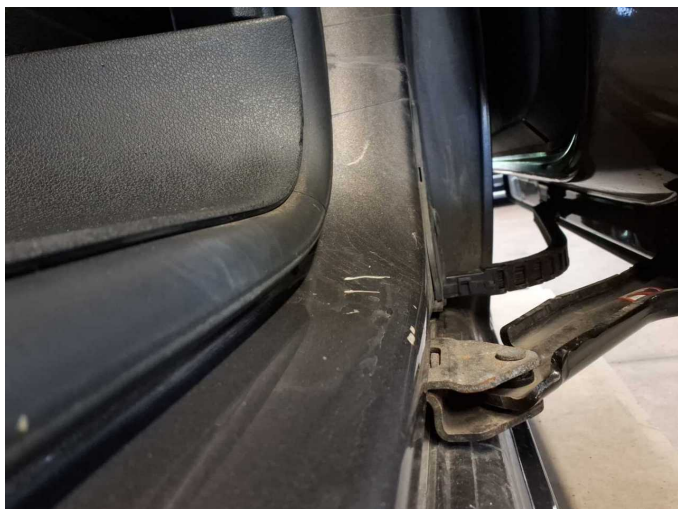
**Damage 8:** Side panel - rear left side: Sill - Dent / paintcoat damage - Smart repair

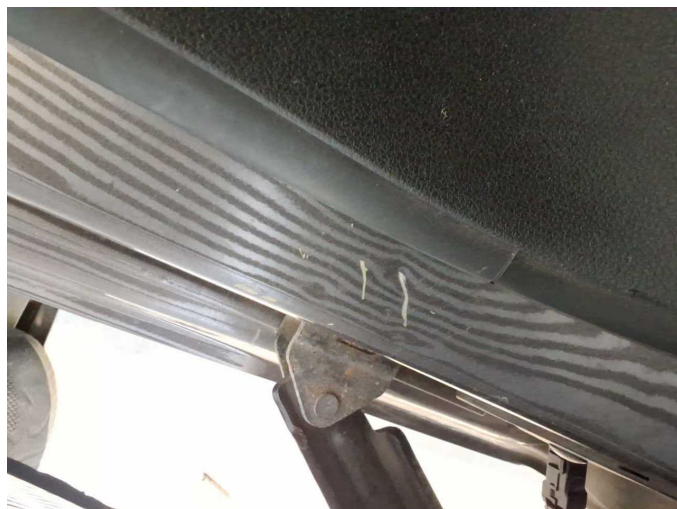
**Damage 8:** Side panel - rear left side: Sill - Dent / paintcoat damage - Smart repair

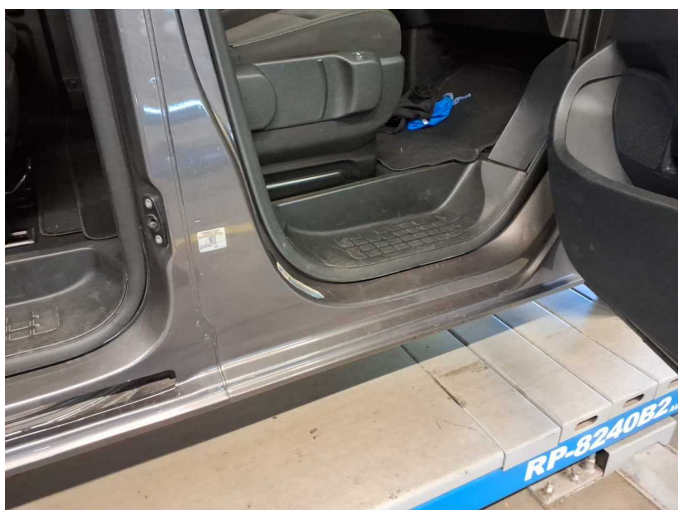
| No. | Component group | Description |
|---|---|---|
| 9 | Sill - right side | Sill - Dent / paintcoat damage - Smart repair |

**Damage 9:** Sill - right side: Sill - Dent / paintcoat damage - Smart repair

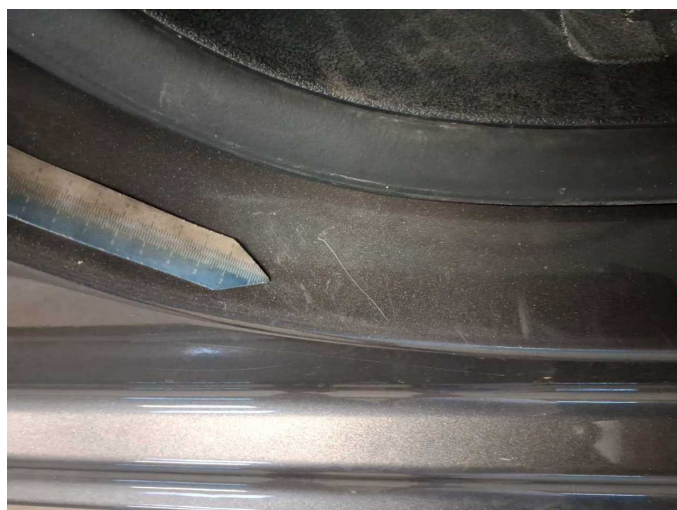
**Damage 9:** Sill - right side: Sill - Dent / paintcoat damage - Smart repair

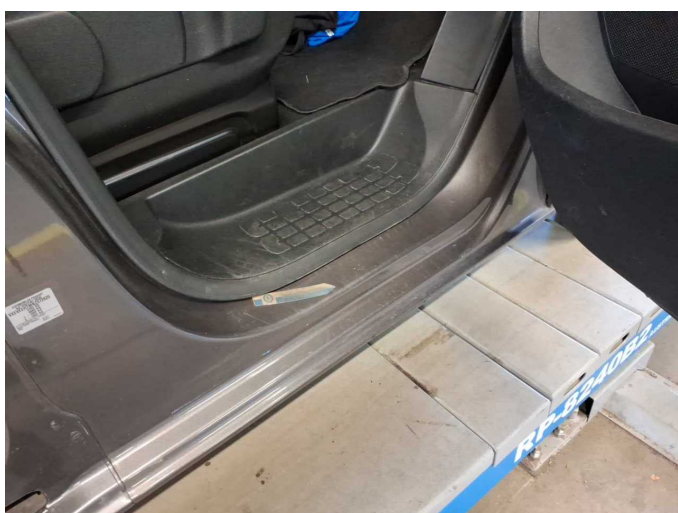
**Damage 9:** Sill - right side: Sill - Dent / paintcoat damage - Smart repair

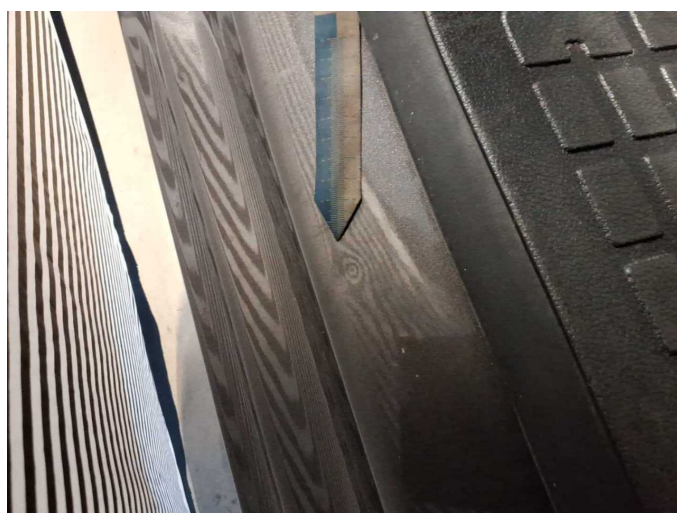
**Damage 9:** Sill - right side: Sill - Dent / paintcoat damage - Smart repair

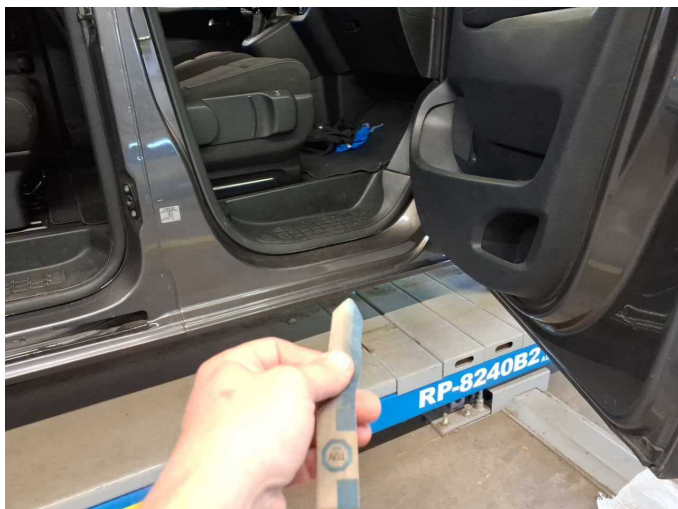
| No. | Component group | Description |
|---|---|---|
| 10 | Sill - right side | Sill - Dent / paintcoat damage - Smart repair |

**Damage 10:** Sill - right side: Sill - Dent / paintcoat damage - Smart repair

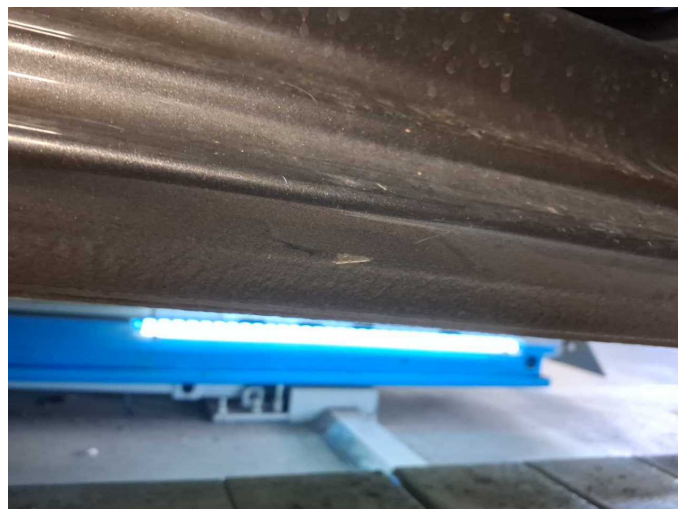
**Damage 10:** Sill - right side: Sill - Dent / paintcoat damage - Smart repair

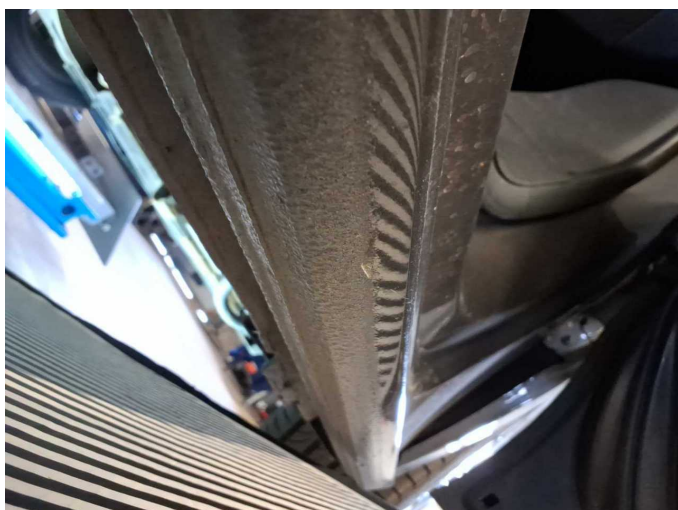
**Damage 10:** Sill - right side: Sill - Dent / paintcoat damage - Smart repair

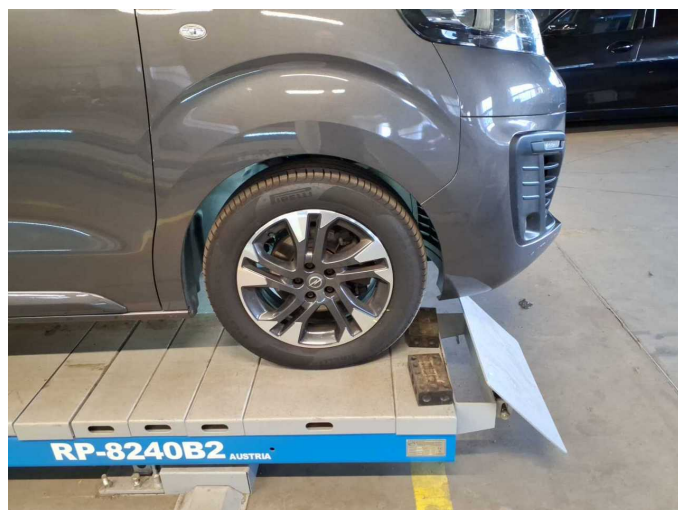
| No. | Component group | Description |
|---|---|---|
| 11 | Wheel / tyres | Alloy rim - front right side - Scratch(es) - Loss in value |

**Damage 11:** Wheel / tyres: Alloy rim - front right side - Scratch(es) - Loss in value

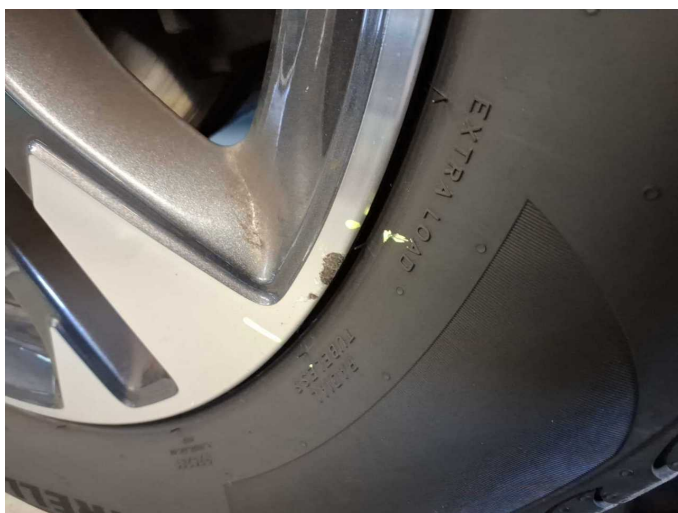
**Damage 11:** Wheel / tyres: Alloy rim - front right side - Scratch(es) - Loss in value

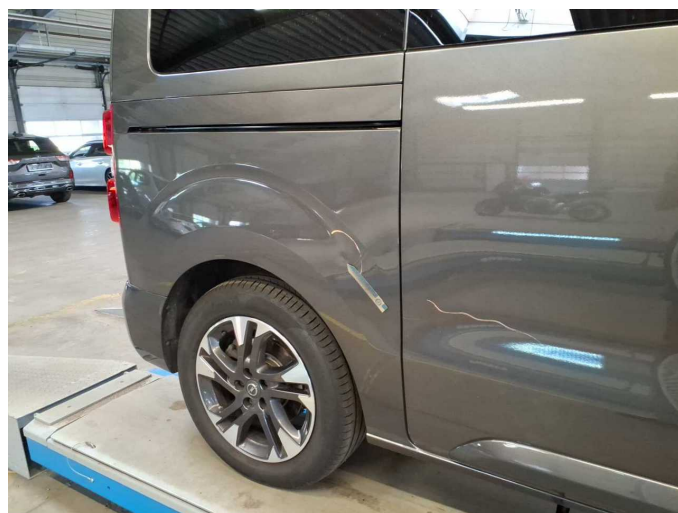
| No. | Component group | Description |
|---|---|---|
| 12 | Side panel - rear right side | Side panel - Dent / paintcoat damage - Smart repair |

**Damage 12:** Side panel - rear right side: Side panel - Dent / paintcoat damage - Smart repair

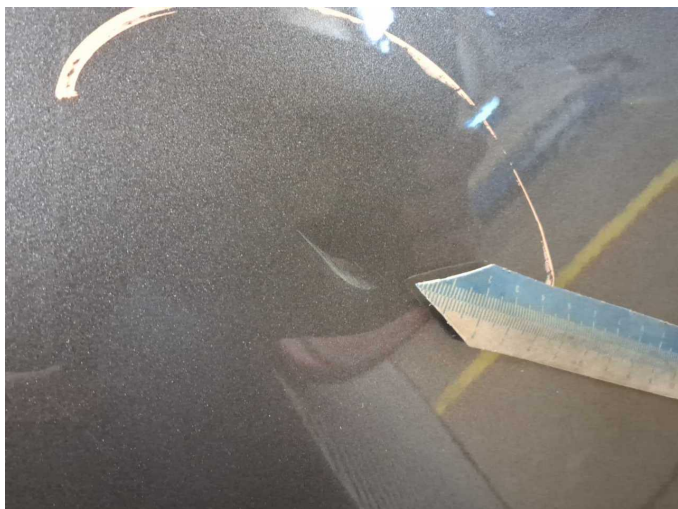
**Damage 12:** Side panel - rear right side: Side panel - Dent / paintcoat damage - Smart repair

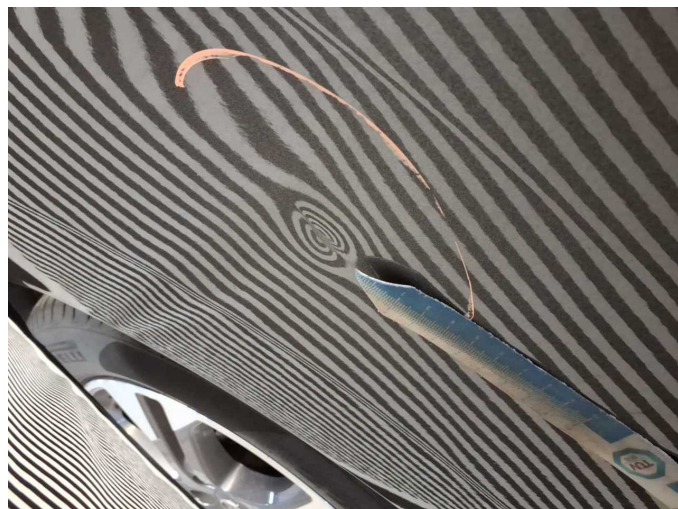
**Damage 12:** Side panel - rear right side: Side panel - Dent / paintcoat damage - Smart repair

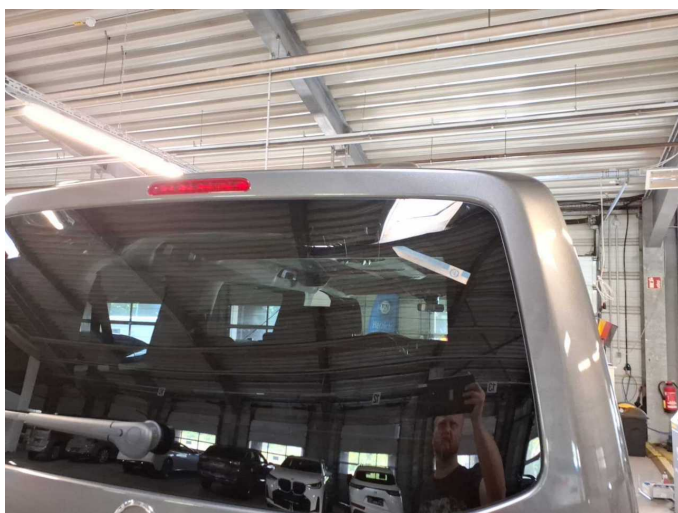
| No. | Component group | Description |
|---|---|---|
| 13 | Vehicle glazing | Rear window - Scratched - Replace |

**Damage 13:** Vehicle glazing: Rear window - Scratched - Replace

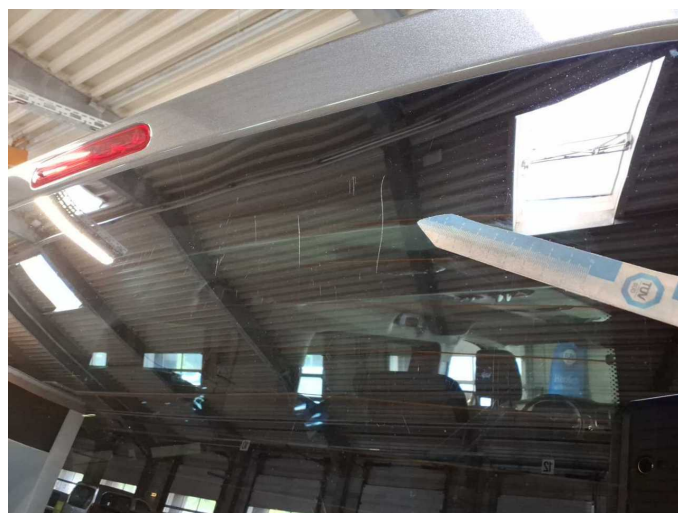
**Damage 13:** Vehicle glazing: Rear window - Scratched - Replace

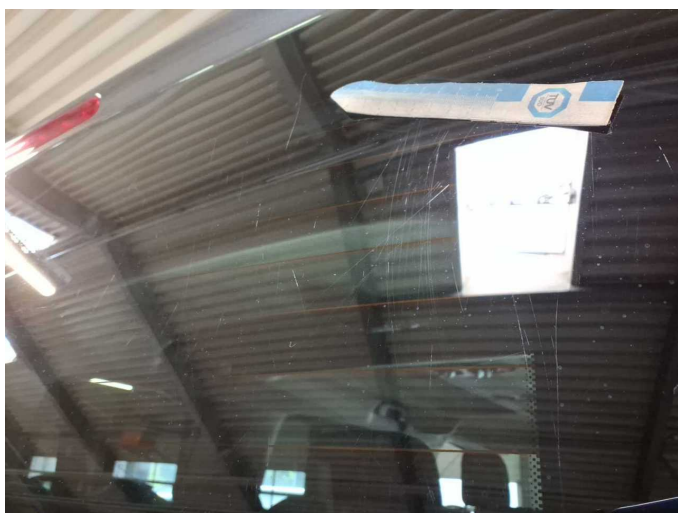
**Damage 13:** Vehicle glazing: Rear window - Scratched - Replace

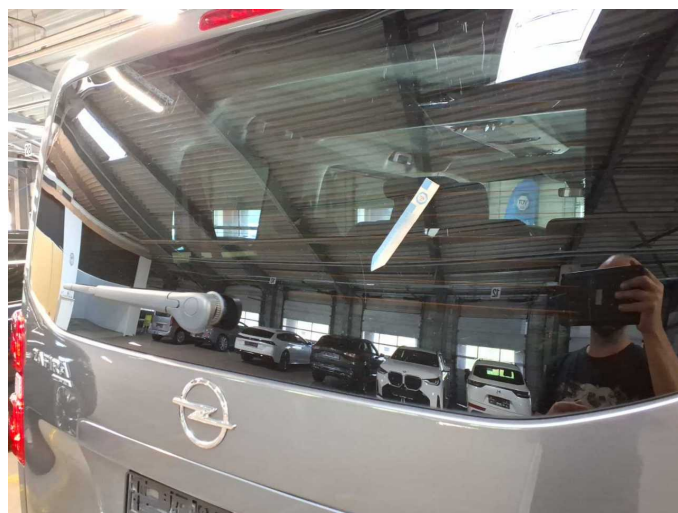
**Damage 13:** Vehicle glazing: Rear window - Scratched - Replace

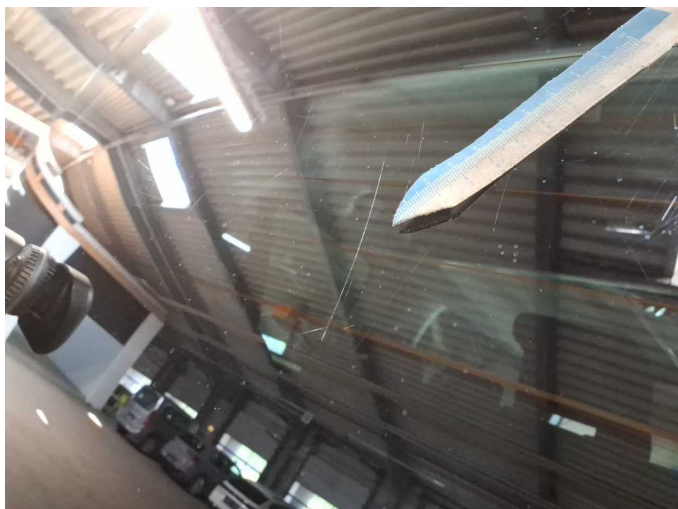
**Damage 13:** Vehicle glazing: Rear window - Scratched - Replace

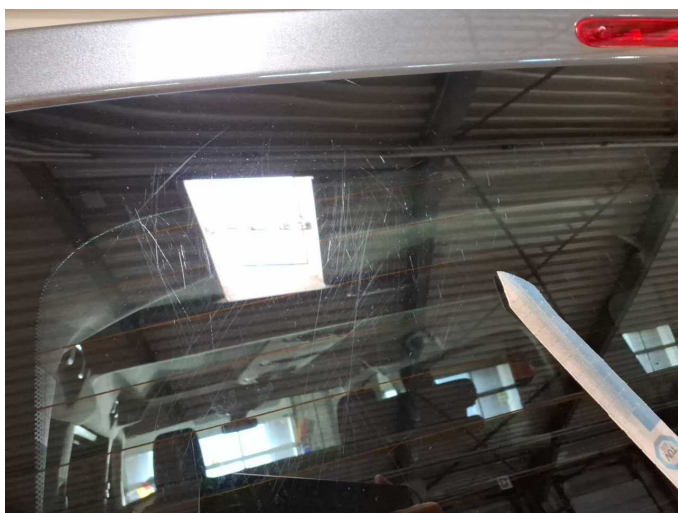
**Damage 13:** Vehicle glazing: Rear window - Scratched - Replace

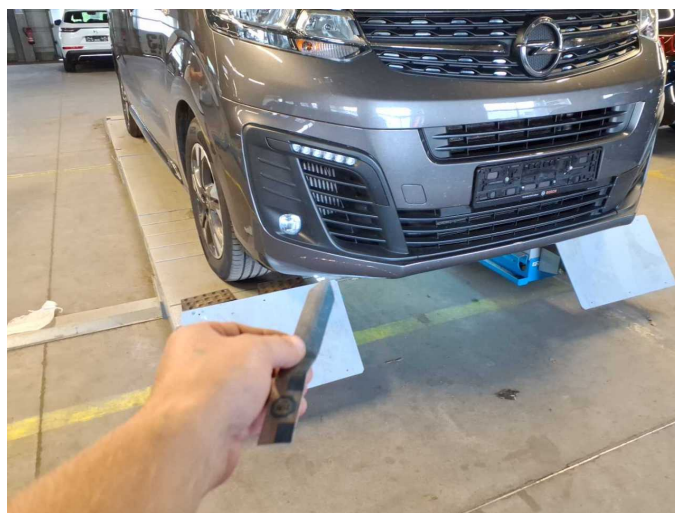
| No. | Component group | Description |
|---|---|---|
| 14 | Front bumper | Front bumper - Scratched - Repair and paint |

**Damage 14:** Front bumper: Front bumper - Scratched - Repair and paint

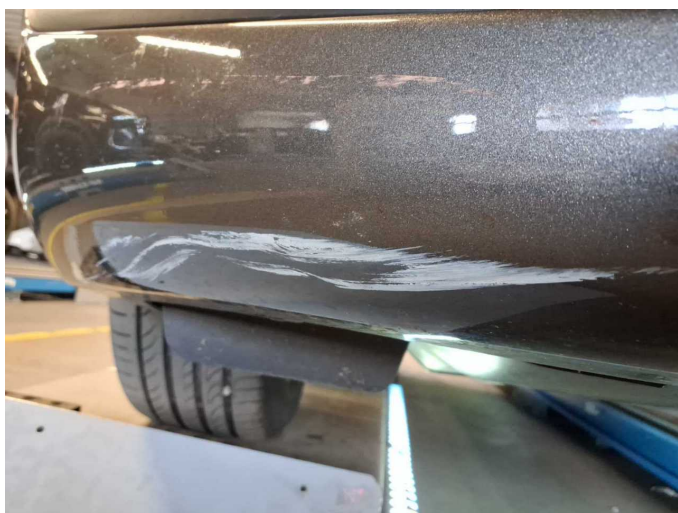
**Damage 14:** Front bumper: Front bumper - Scratched - Repair and paint

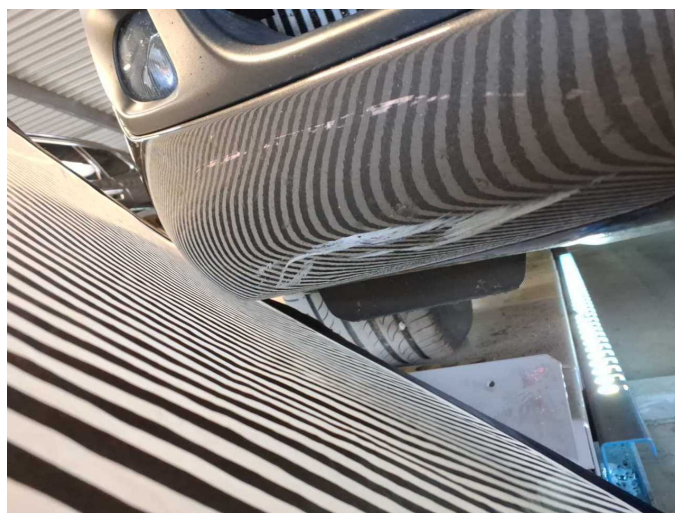
**Damage 14:** Front bumper: Front bumper - Scratched - Repair and paint

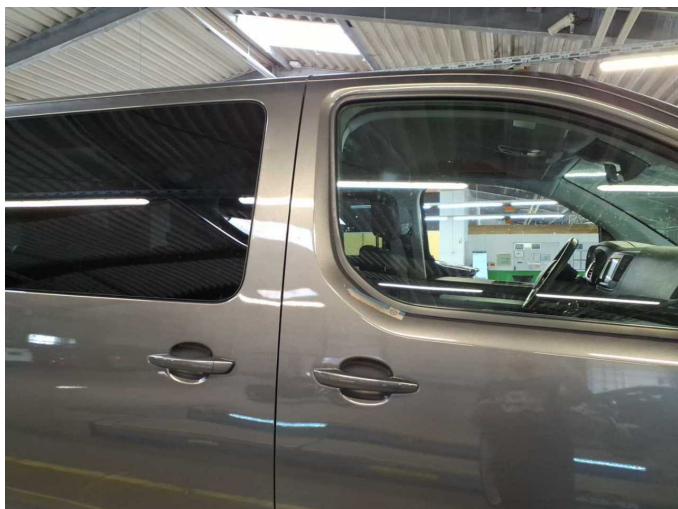
| No. | Component group | Description |
|---|---|---|
| 15 | Door - front right side | Door - Scratched - Repair and paint |

**Damage 15:** Door - front right side: Door - Scratched - Repair and paint

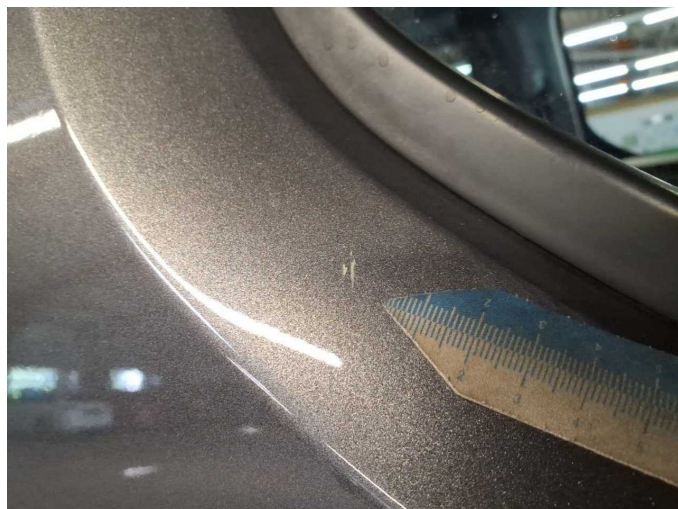
**Damage 15:** Door - front right side: Door - Scratched - Repair and paint

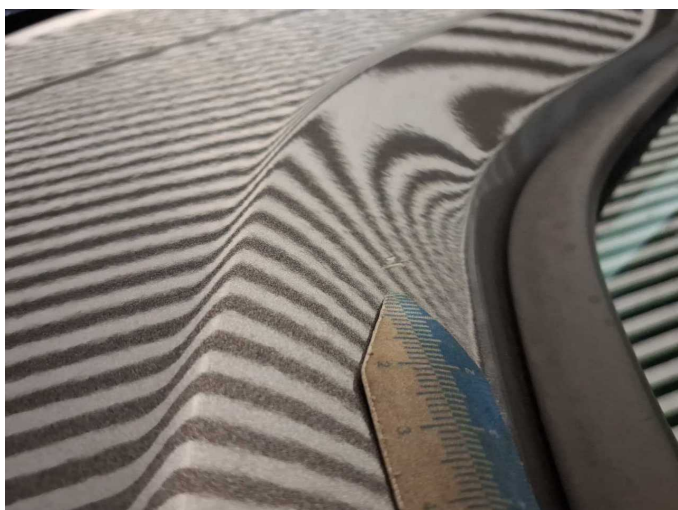
**Damage 15:** Door - front right side: Door - Scratched - Repair and paint

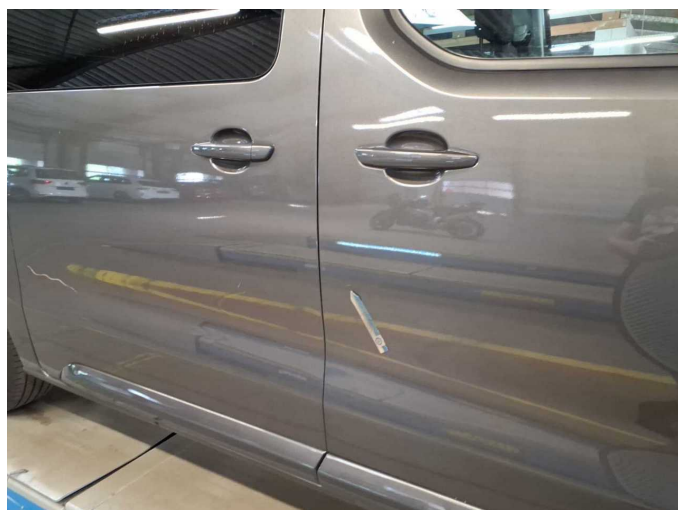
**Damage 15:** Door - front right side: Door - Scratched - Repair and paint

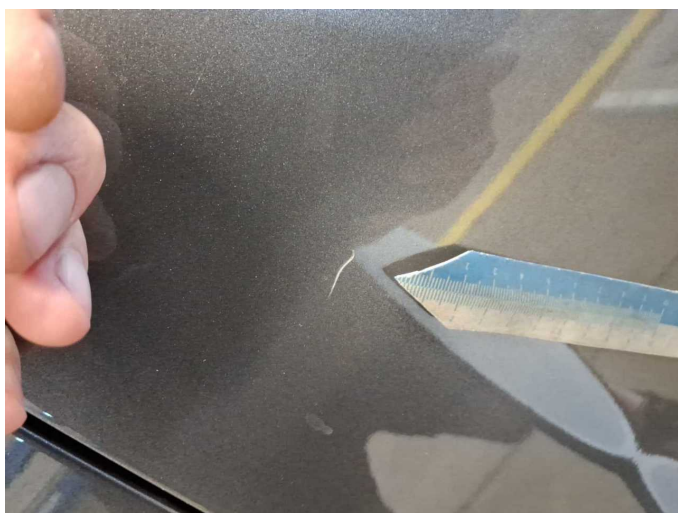
**Damage 15:** Door - front right side: Door - Scratched - Repair and paint

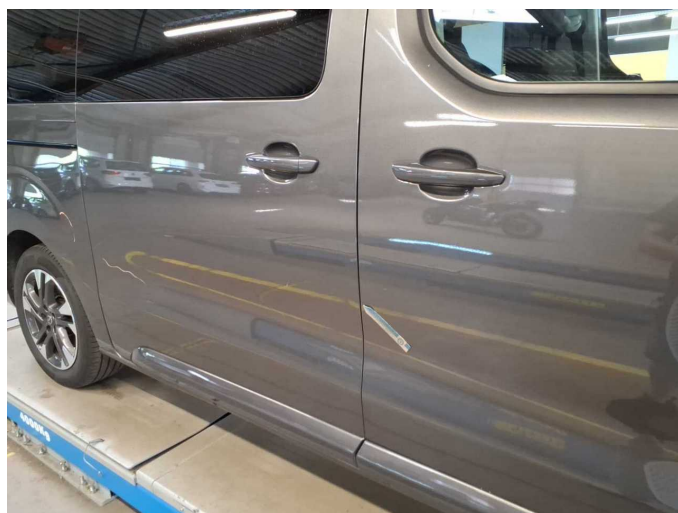
**Damage 15:** Door - front right side: Door - Scratched - Repair and paint

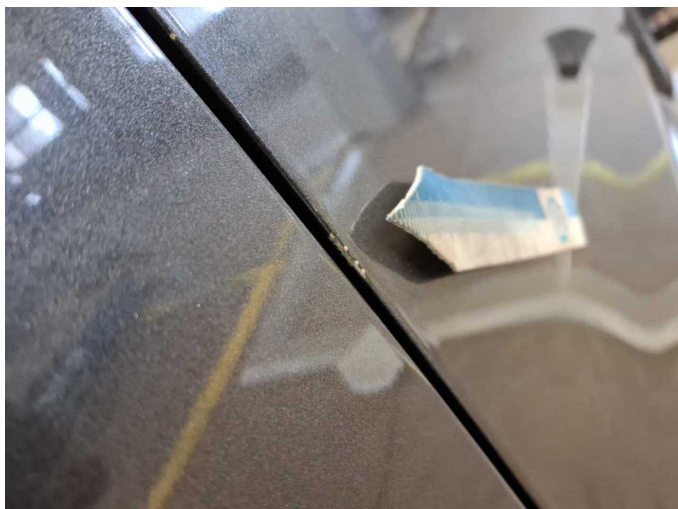
**Damage 15:** Door - front right side: Door - Scratched - Repair and paint

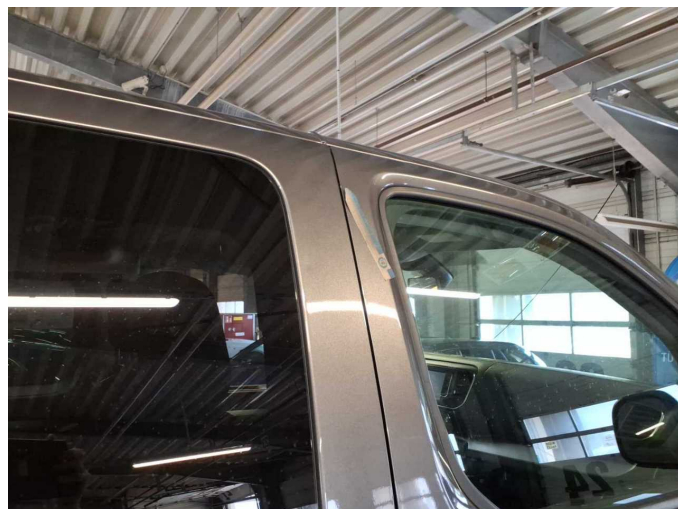
**Damage 15:** Door - front right side: Door - Scratched - Repair and paint

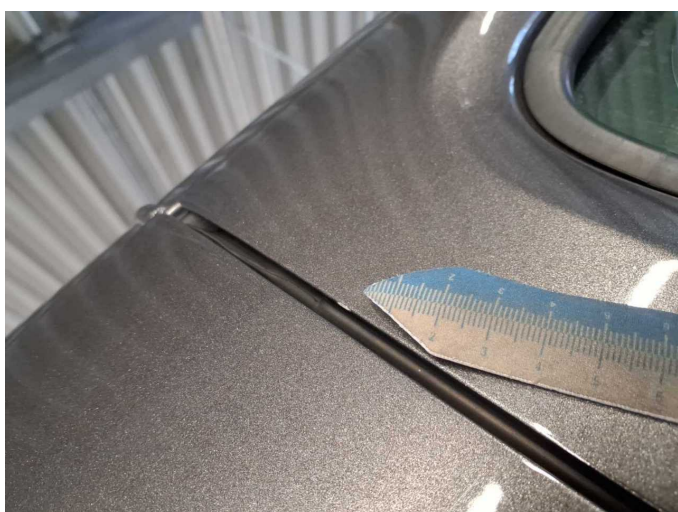
**Damage 15:** Door - front right side: Door - Scratched - Repair and paint

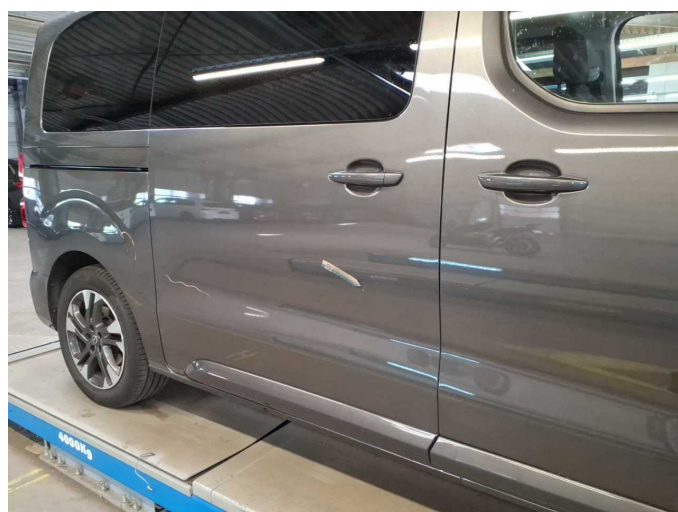
| No. | Component group | Description |
|---|---|---|
| 16 | Sliding door, right | Sliding door (Delle) - Scratched - Repair and paint |

**Damage 16:** Sliding door, right: Sliding door (Delle) - Scratched - Repair and paint

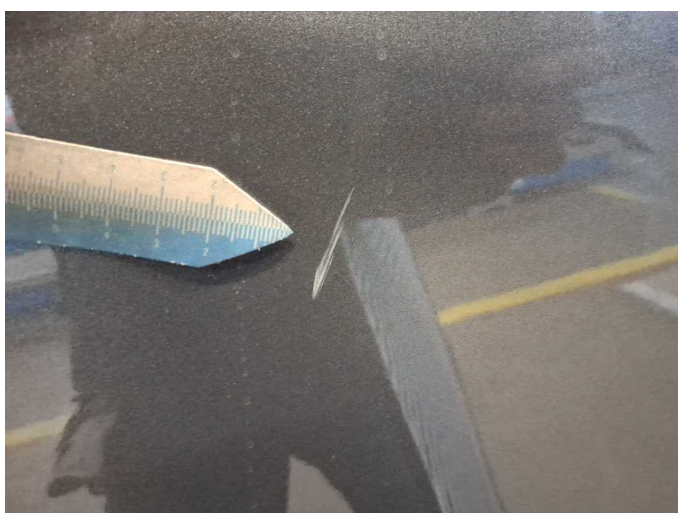
**Damage 16:** Sliding door, right: Sliding door (Delle) - Scratched - Repair and paint

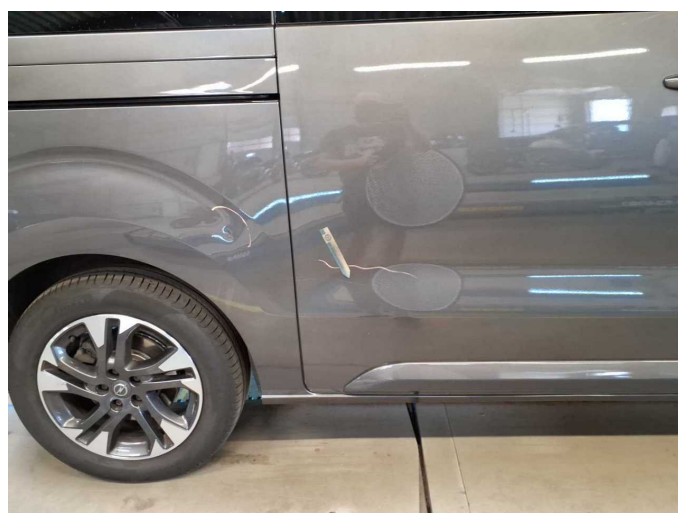
**Damage 16:** Sliding door, right: Sliding door (Delle) - Scratched - Repair and paint

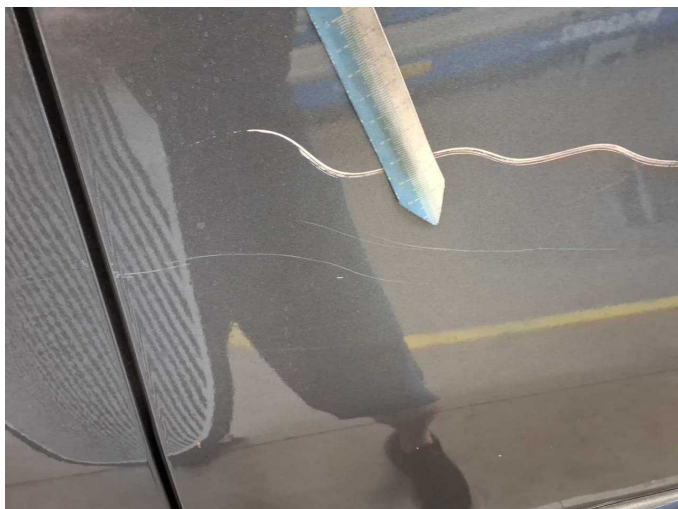
**Damage 16:** Sliding door, right: Sliding door (Delle) - Scratched - Repair and paint

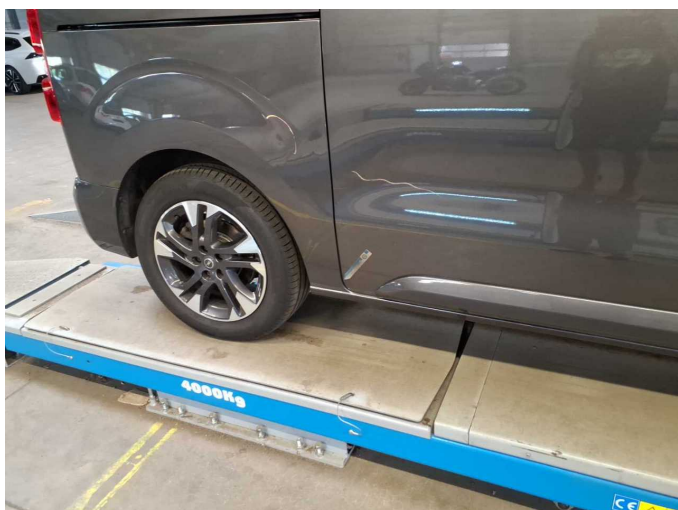
**Damage 16:** Sliding door, right: Sliding door (Delle) - Scratched - Repair and paint

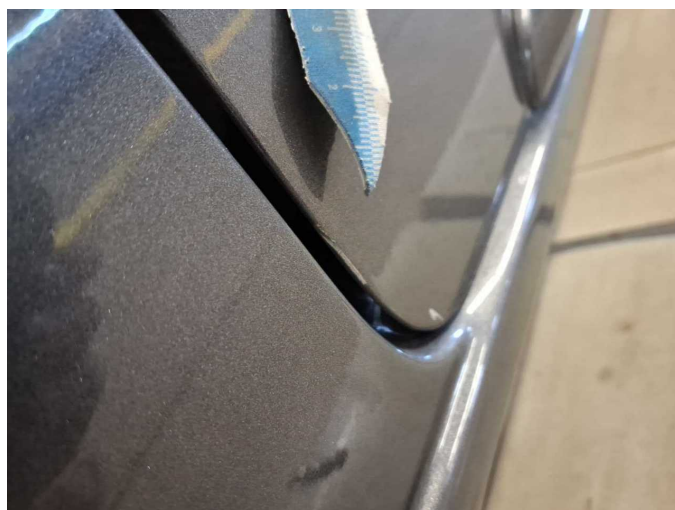
**Damage 16:** Sliding door, right: Sliding door (Delle) - Scratched - Repair and paint

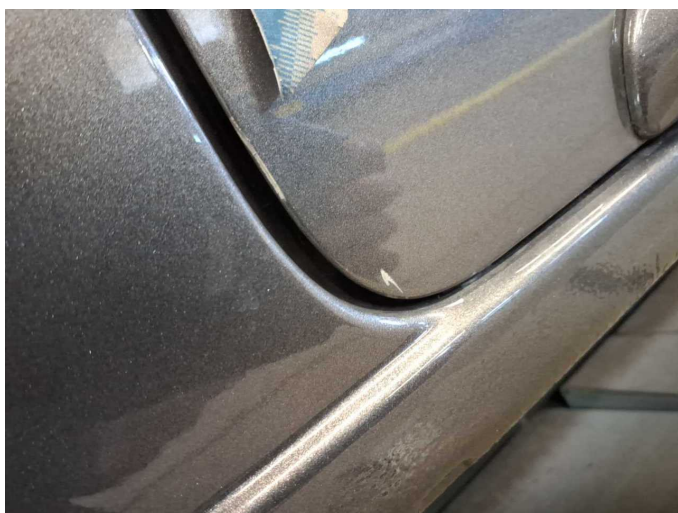
**Damage 16:** Sliding door, right: Sliding door (Delle) - Scratched - Repair and paint

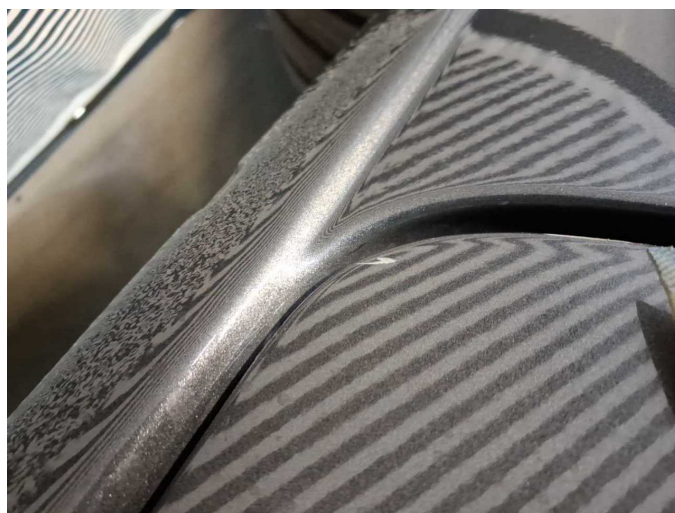
**Damage 16:** Sliding door, right: Sliding door (Delle) - Scratched - Repair and paint

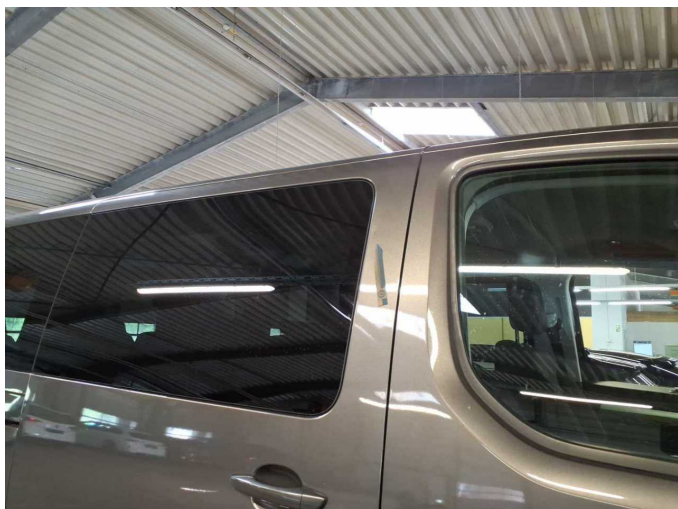
**Damage 16:** Sliding door, right: Sliding door (Delle) - Scratched - Repair and paint

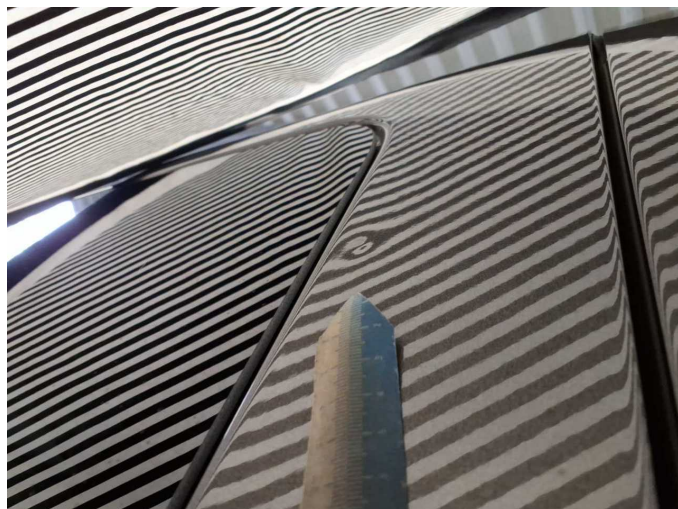
**Damage 16:** Sliding door, right: Sliding door (Delle) - Scratched - Repair and paint

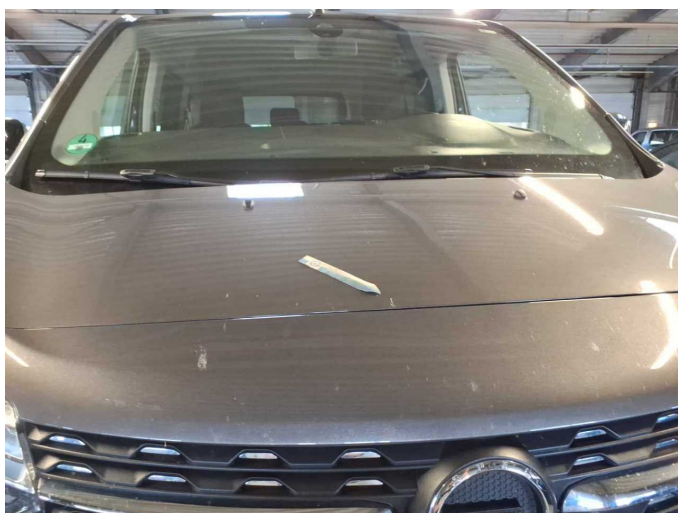
| No. | Component group | Description |
|---|---|---|
| 17 | Bonnet | Bonnet - Scratch(es) - Repair and paint |

**Damage 17:** Bonnet: Bonnet - Scratch(es) - Repair and paint
