Expertise

Protocol number: 46323022  
Order No. / Reference: 26547211  
Inspection date: 3 Jul 2026

Model: Zafira Life 2.0 D M Edition

VIN: VXEEVHTMNZ072625

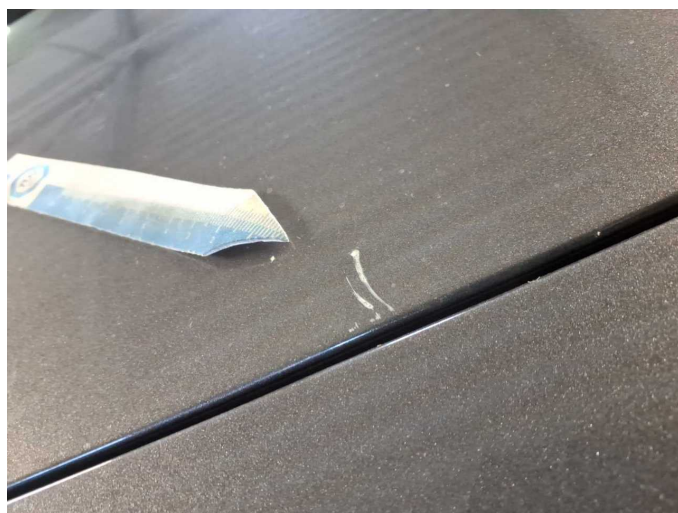
**Damage 17:** Bonnet: Bonnet - Scratch(es) - Repair and paint

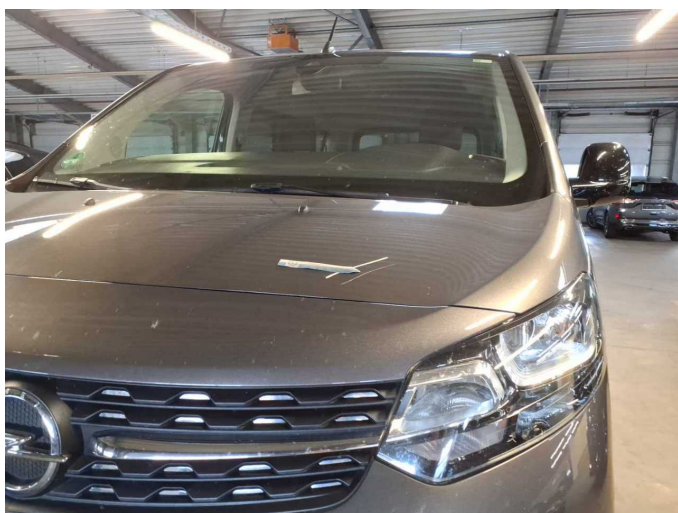
**Damage 17:** Bonnet: Bonnet - Scratch(es) - Repair and paint

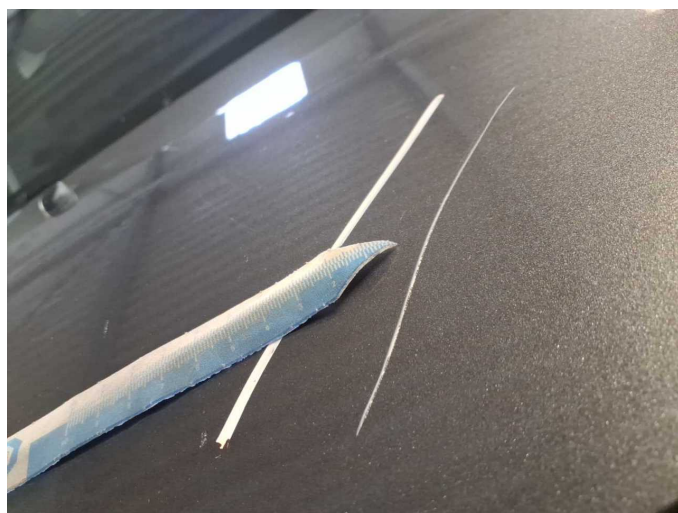
**Damage 17:** Bonnet: Bonnet - Scratch(es) - Repair and paint

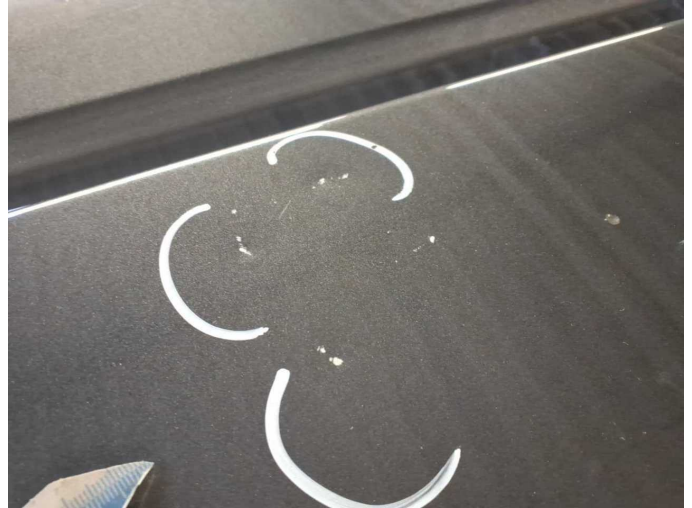
| No. | Component group | Description |
|---|---|---|
| 18 | Roof | Roof (Mitte) - Dent / paintcoat damage - Repair and paint |

**Damage 18:** Roof: Roof (Mitte) - Dent / paintcoat damage - Repair and paint

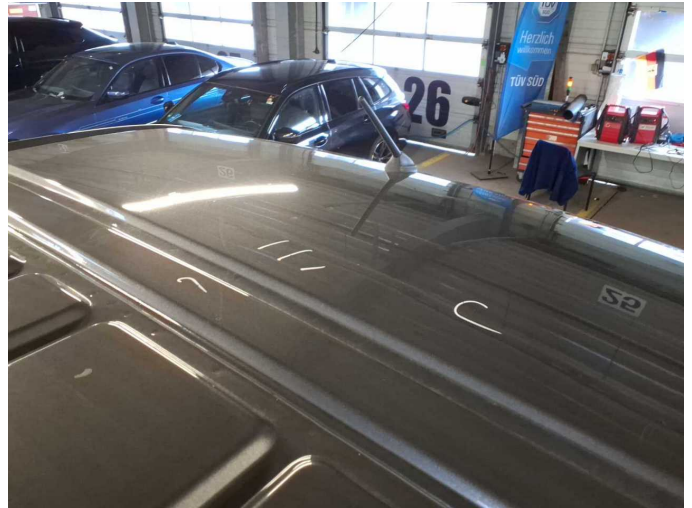
**Damage 18:** Roof: Roof (Mitte) - Dent / paintcoat damage - Repair and paint

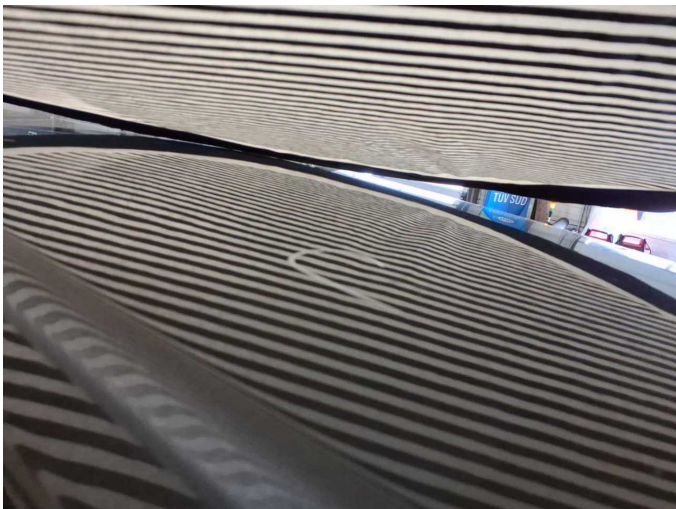
**Damage 18:** Roof: Roof (Mitte) - Dent / paintcoat damage - Repair and paint

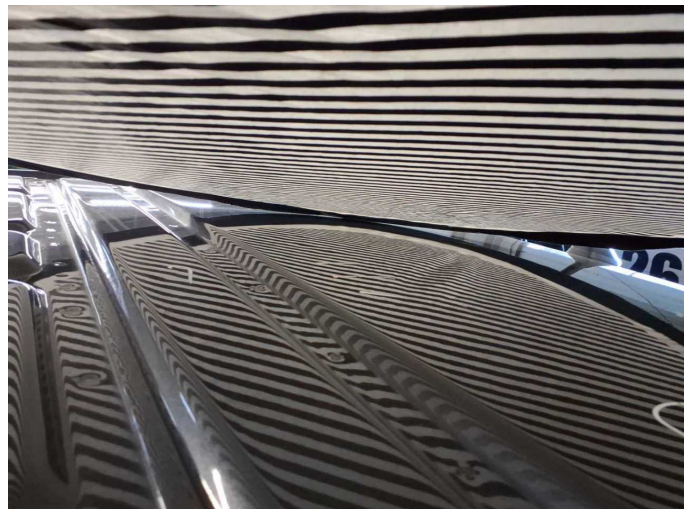
**Damage 18:** Roof: Roof (Mitte) - Dent / paintcoat damage - Repair and paint

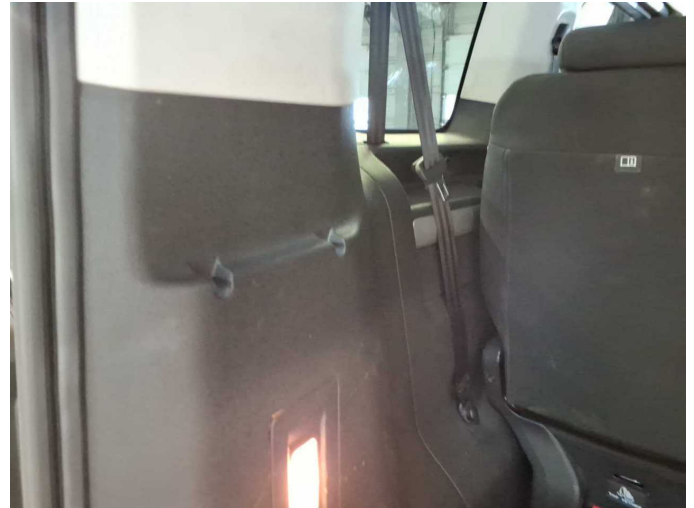
Interior - Rear shelf

**Missing part 1:** Interior: Rear shelf - Missing - Replace

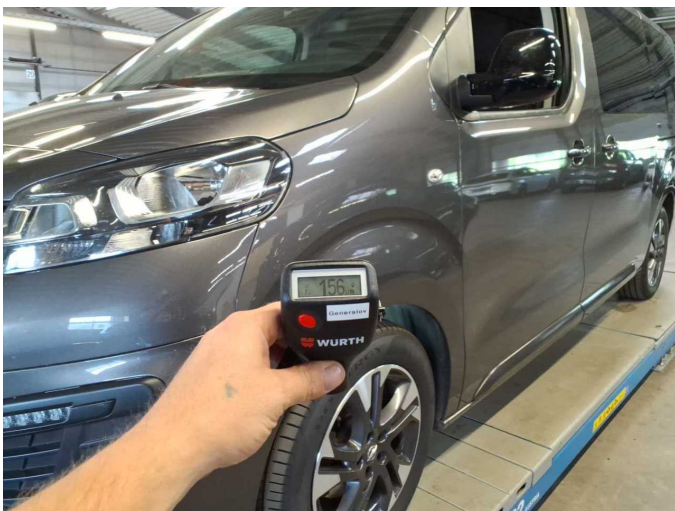
- 1 Mudguard - left side, Professionally carried out, Invoice of repair done Non-existent

Mudguard - left side 156 µm |

**Repainting 1:** Mudguard - left side
