Expertise

Protocol number: 46627076  
Order No. / Reference: 26761051  
Inspection date: 15 Jul 2026

Manufacturer: Ford

Model: Focus Turnier 1.0 EcoBoost Start-Stopp-System  
COOL&CONNECT

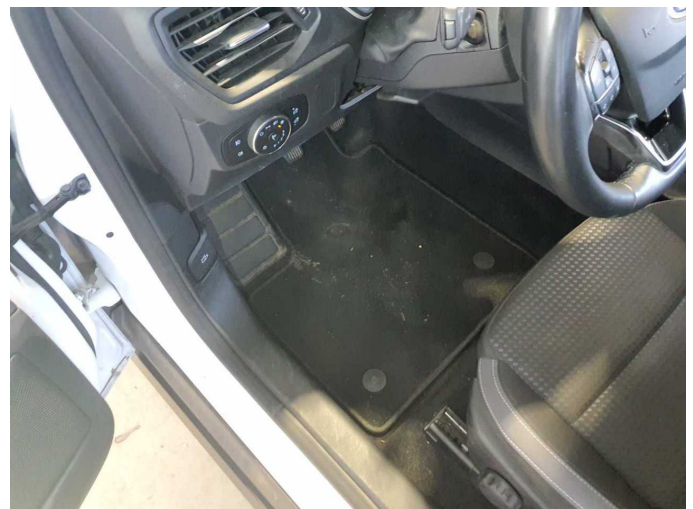
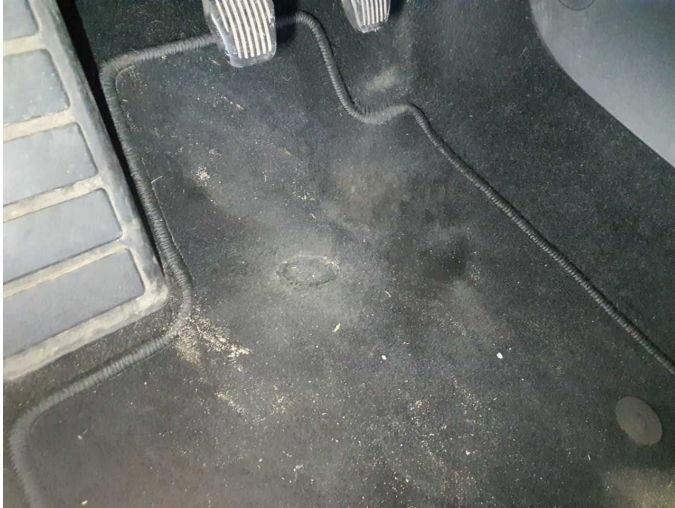
| No. | Component group | Description |
|---|---|---|
| 1 | Trim / covers | Floor mats - Broken / torn - Replace |

Damage 1: Trim / covers: Floor mats - Broken / torn - Replace

**Damage 1:** Trim / covers: Floor mats - Broken / torn - Replace

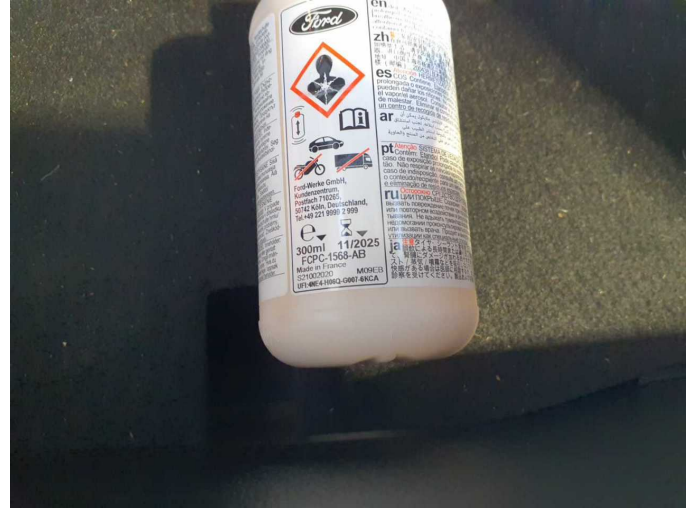
| No. | Component group | Description |
|---|---|---|
| 2 | Equipment | Tirefit filler - Expired - Replace |

**Damage 2:** Equipment: Tirefit filler - Expired - Replace

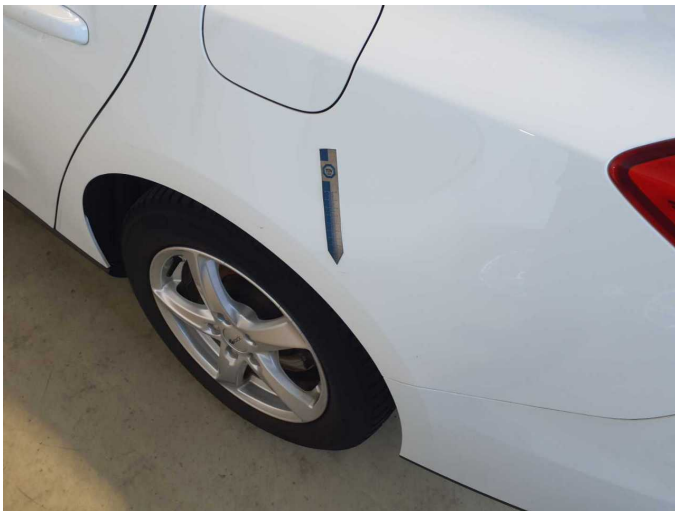
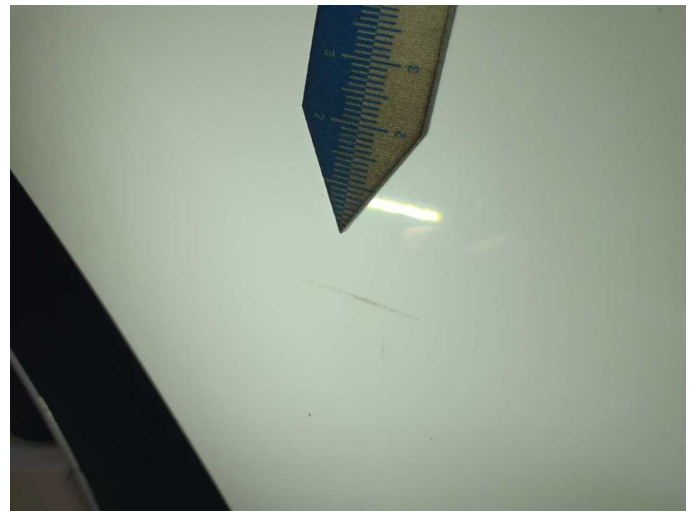
| No. | Component group | Description |
|---|---|---|
| 3 | Side panel - rear left side | Side panel - Scratch(es) - Smart repair |

**Damage 3:** Side panel - rear left side: Side panel - Scratch(es) - Smart repair

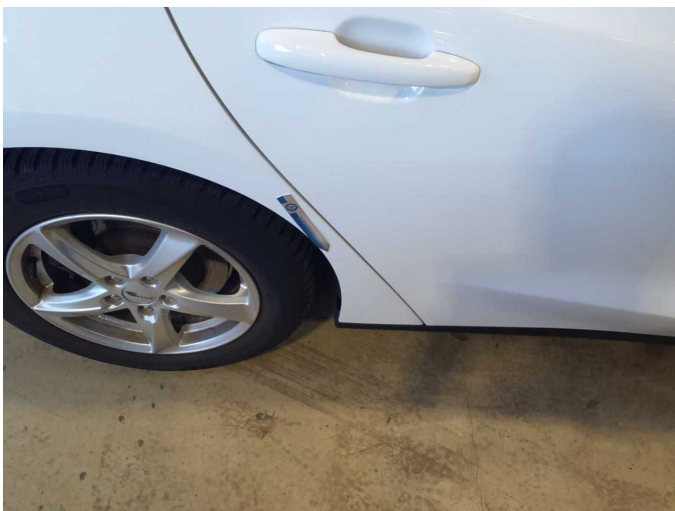
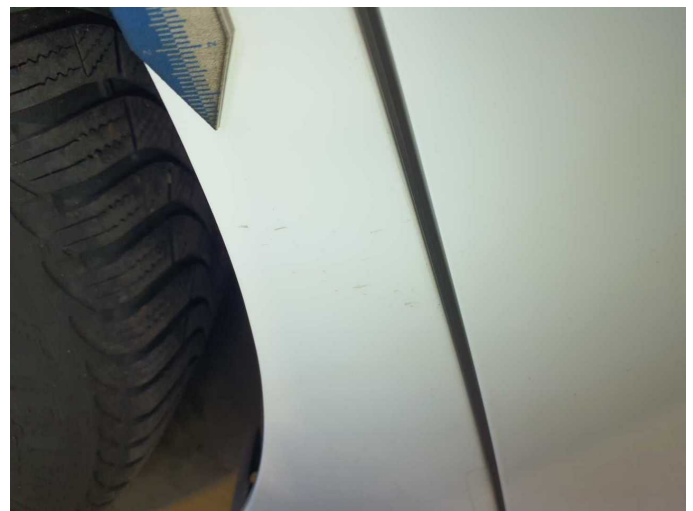
| No. | Component group | Description |
|---|---|---|
| 4 | Side panel - rear right side | Side panel - Scratch(es) - Smart repair |

**Damage 4:** Side panel - rear right side: Side panel - Scratch(es) - Smart repair

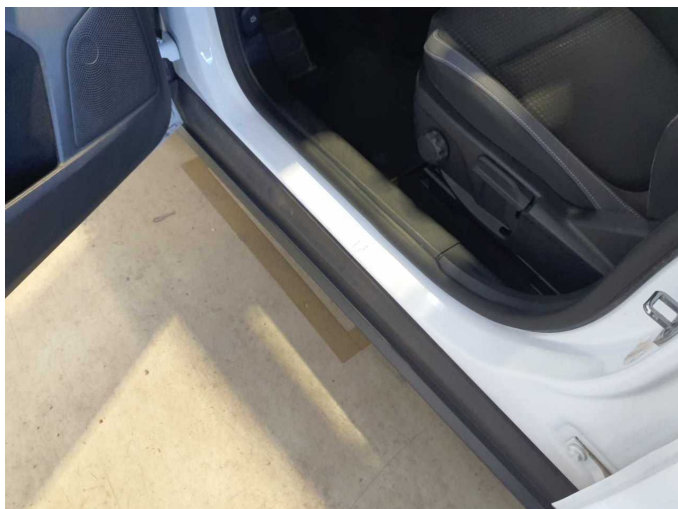
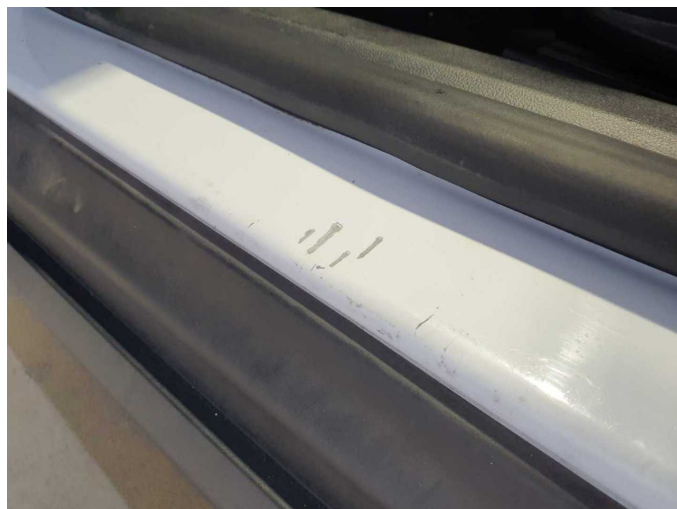
| No. | Component group | Description |
|---|---|---|
| 5 | Sill - left side | Sill - Dent / paintcoat damage - Smart repair |

**Damage 5:** Sill - left side: Sill - Dent / paintcoat damage - Smart repair

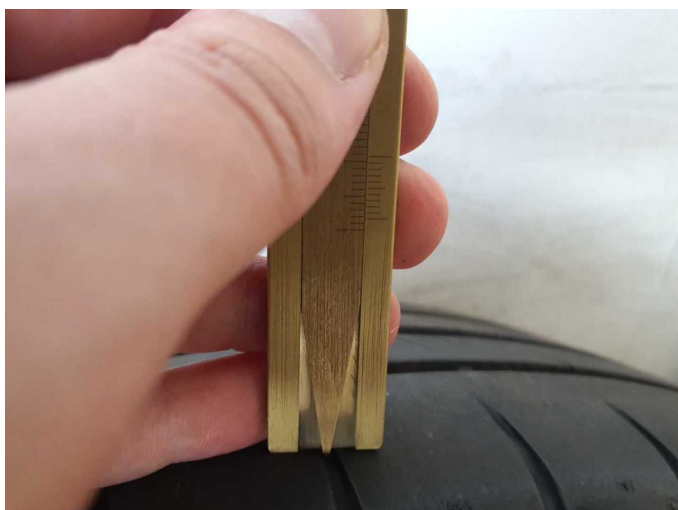
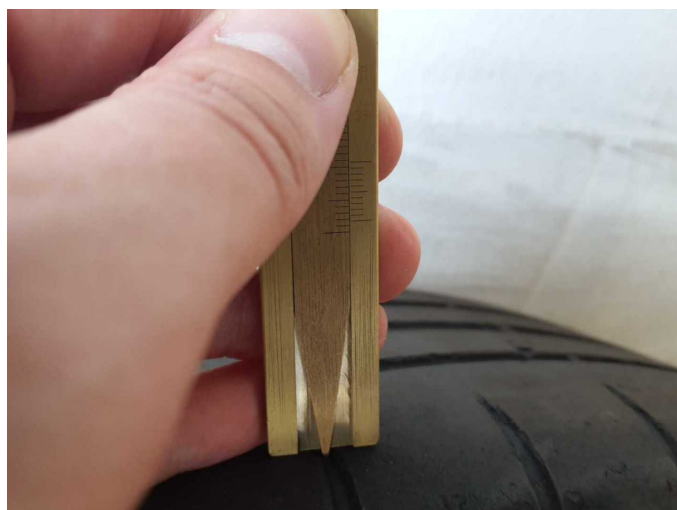
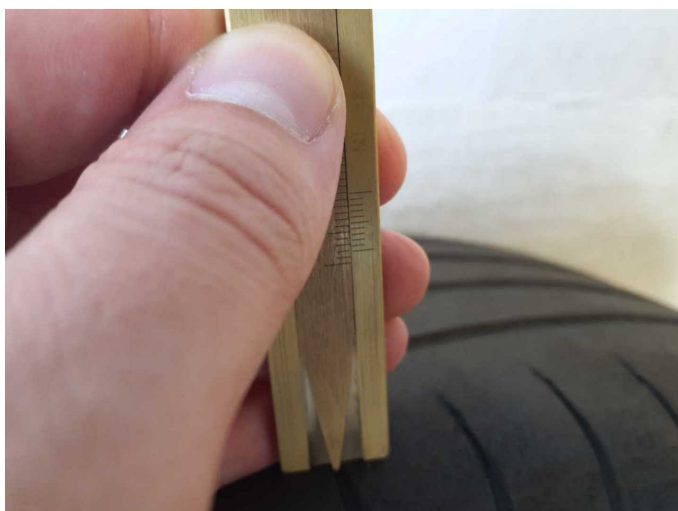
| Tyres | | | | |
|---|---|---|---|---|
| 1) | 205/60 R16 92V | Summer tyres on Light alloy | Goodyear | 3mm / 1mm |
| 2) | 205/60 R16 92V | Summer tyres on Light alloy | Goodyear | 1mm / 1mm |

| No. | Component group | Description |
|---|---|---|
| 6 | 2nd wheel set | 3 tyres - Worn - Replace |

**Damage 6:** 2nd wheel set: 3 tyres - Worn - Replace

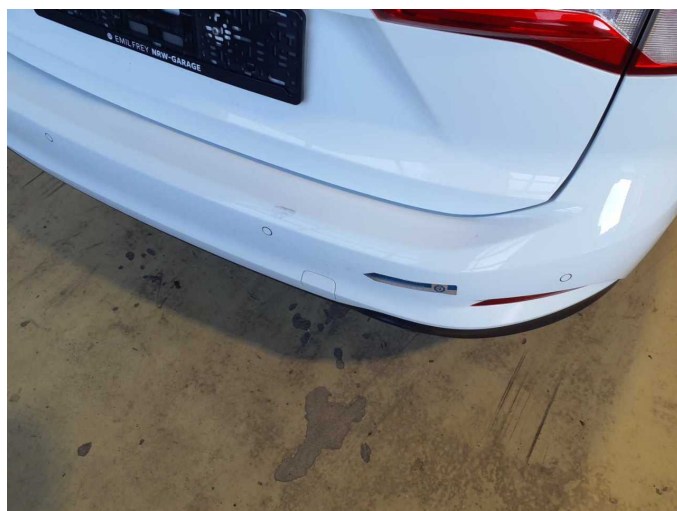
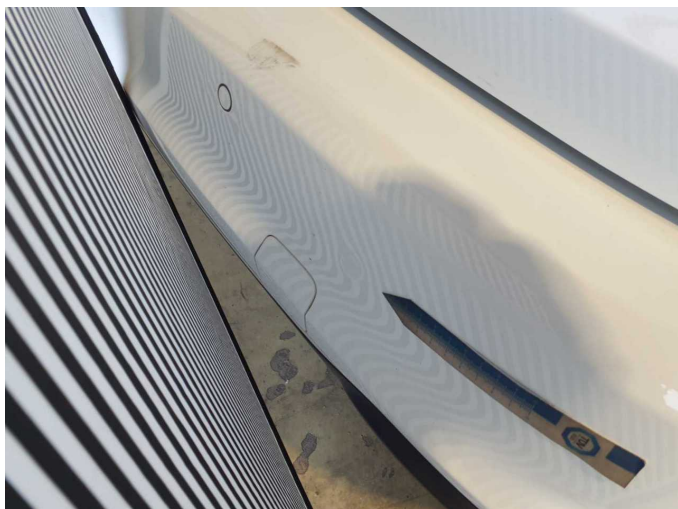
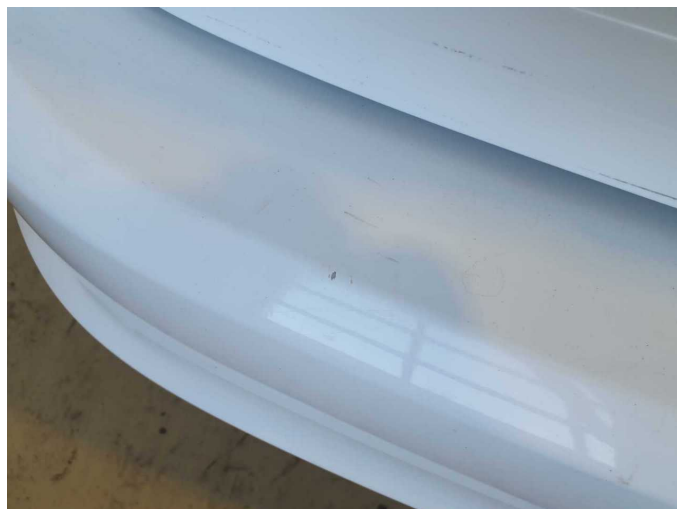
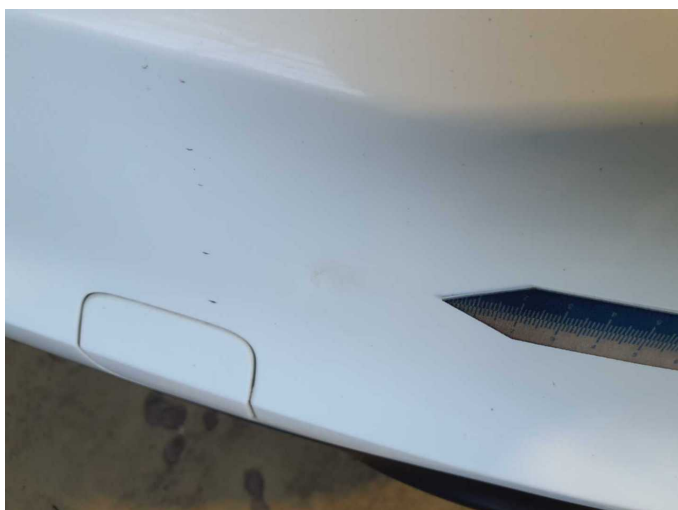
| No. | Component group | Description |
|---|---|---|
| 7 | Rear bumper | Rear bumper - Dent / paintcoat damage - Repair and paint |

**Damage 7:** Rear bumper: Rear bumper - Dent / paintcoat damage - Repair and paint

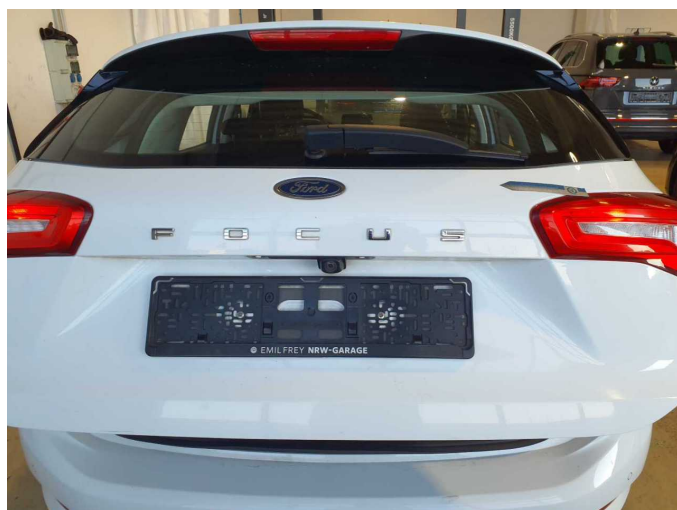
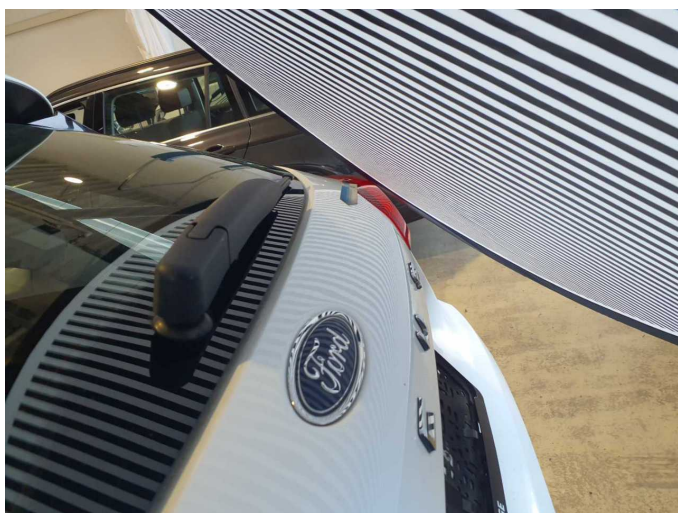
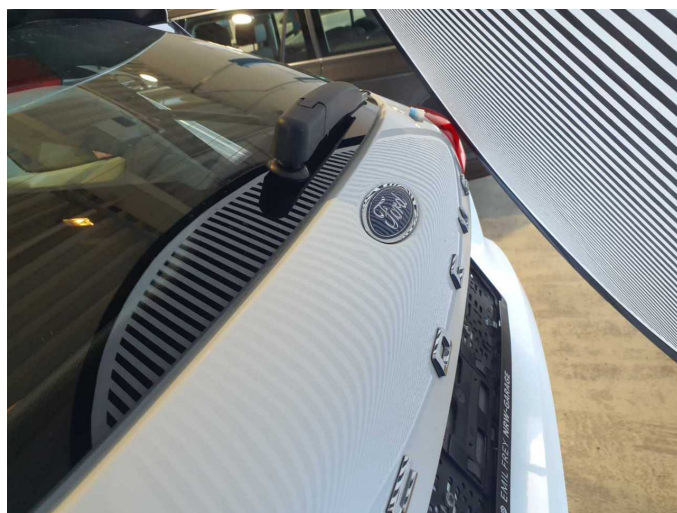
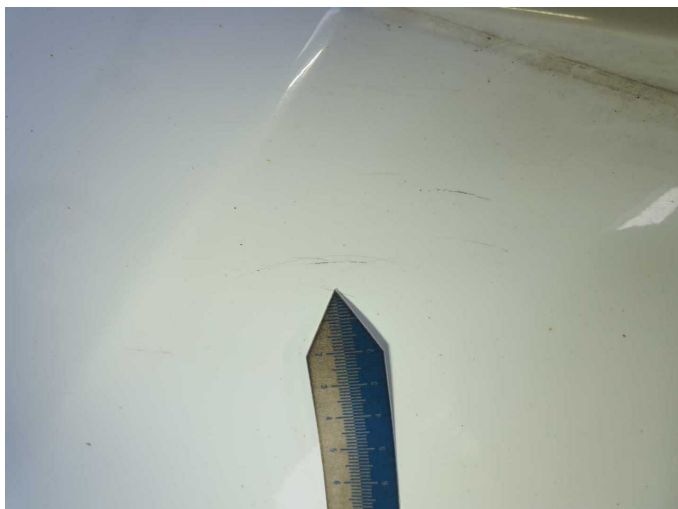
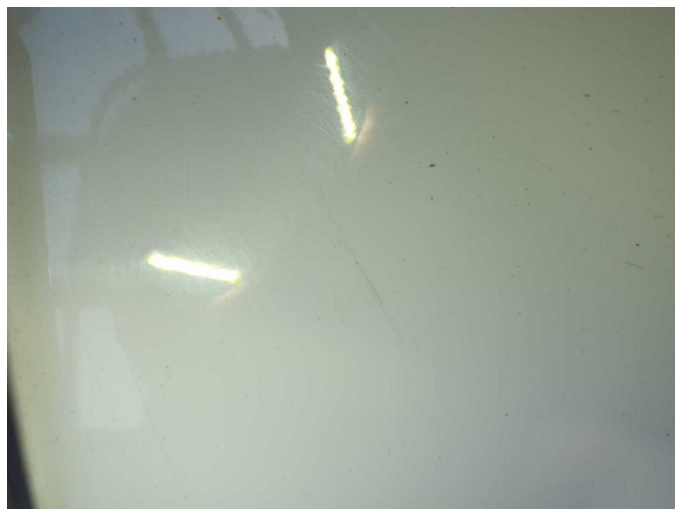
| No. | Component group | Description |
|---|---|---|
| 8 | Boot lid / rear door | Boot lid - Dent / paintcoat damage - Repair and paint |

**Damage 8:** Boot lid / rear door: Boot lid - Dent / paintcoat damage - Repair and paint

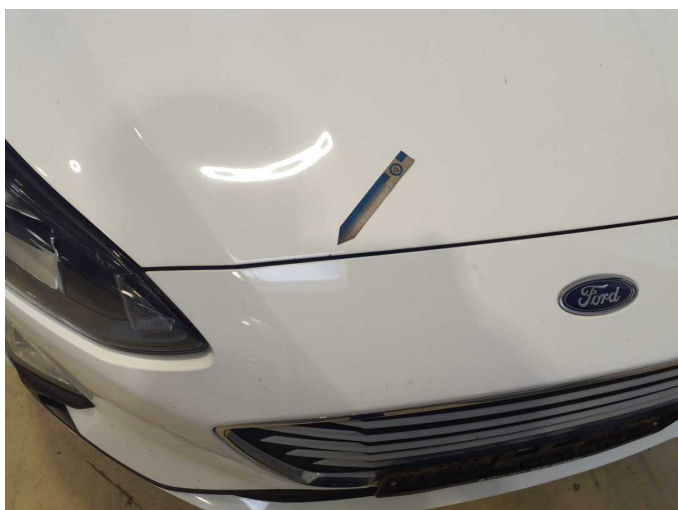
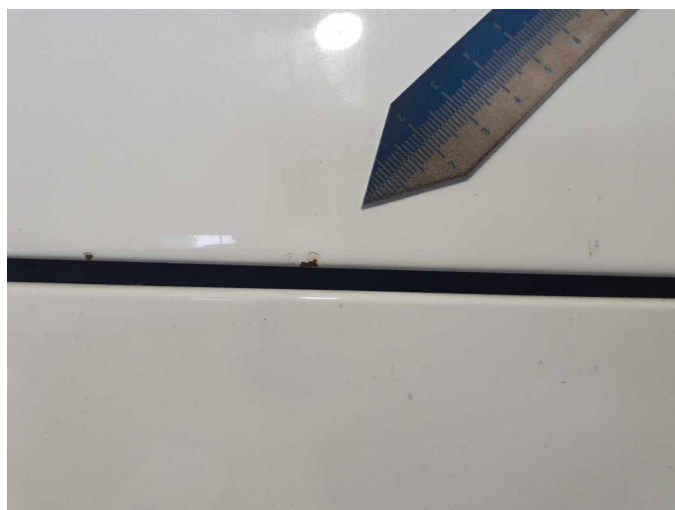
| No. | Component group | Description |
|---|---|---|
| 9 | Bonnet | Bonnet - Corrosion - Repair and paint |

**Damage 9:** Bonnet: Bonnet - Corrosion - Repair and paint

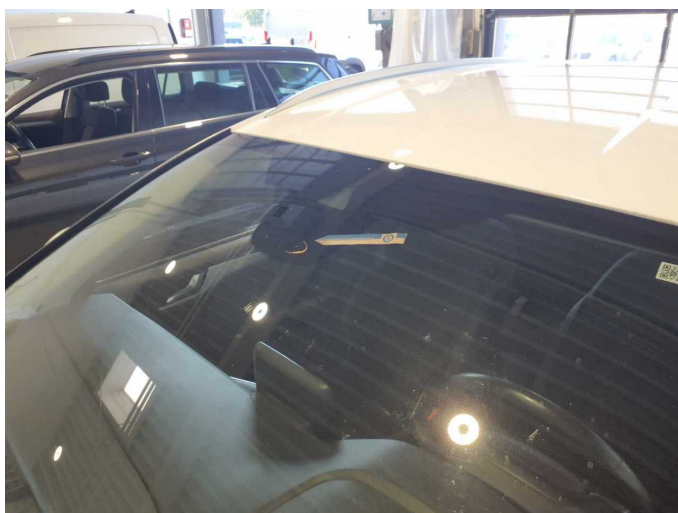
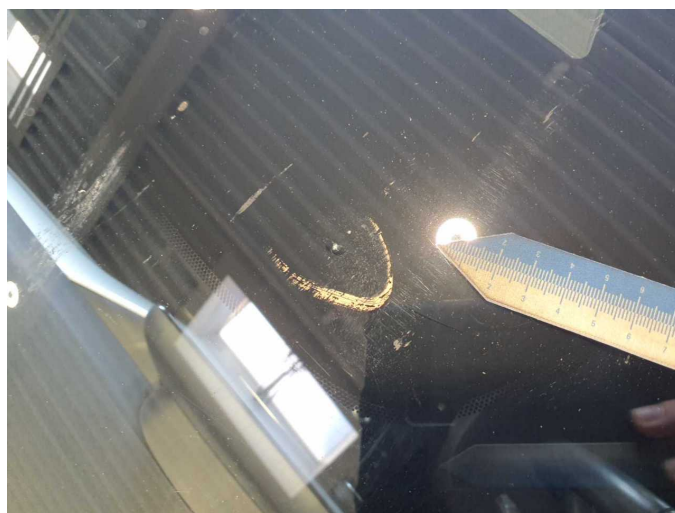
| No. | Component group | Description |
|---|---|---|
| 10 | Vehicle glazing | Windscreen - Broken / torn - Replace |

**Damage 10:** Vehicle glazing: Windscreen - Broken / torn - Replace

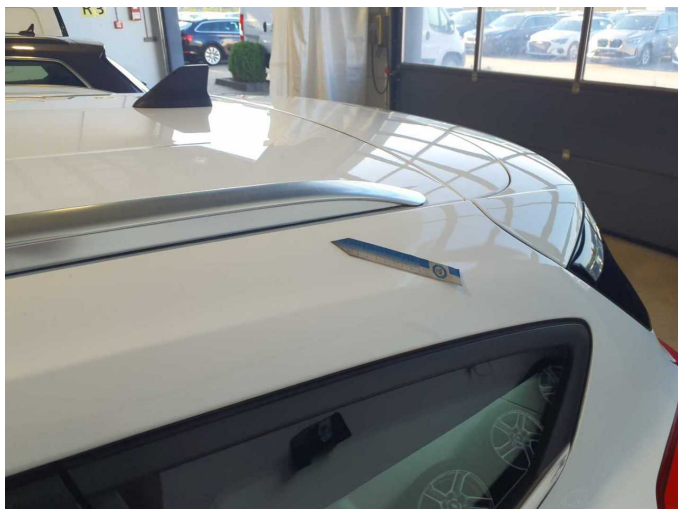
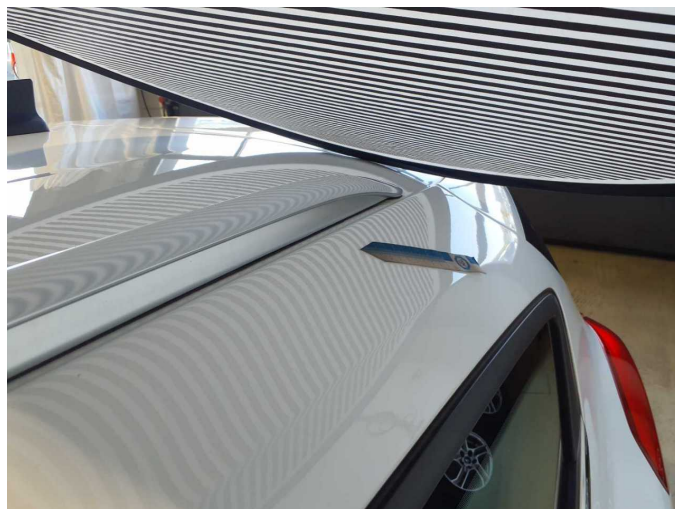
| No. | Component group | Description |
|---|---|---|
| 6 | Roof | Roof rail - left side - dent(s) - No deduction |

**Wear and tear 6:** Roof: Roof rail - left side - dent(s) - No deduction

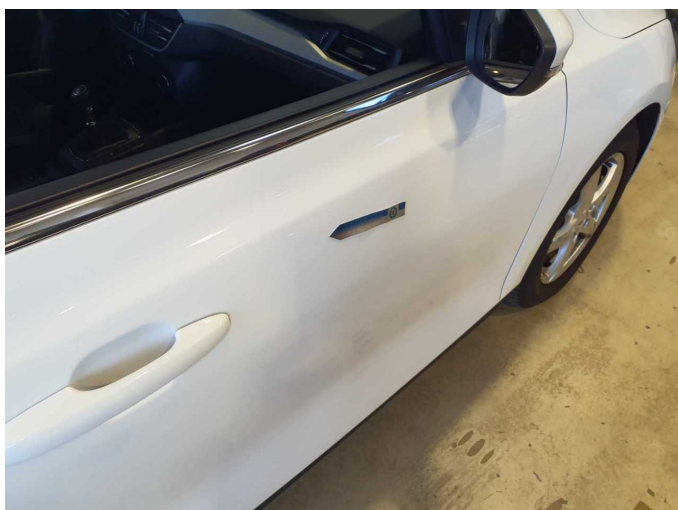
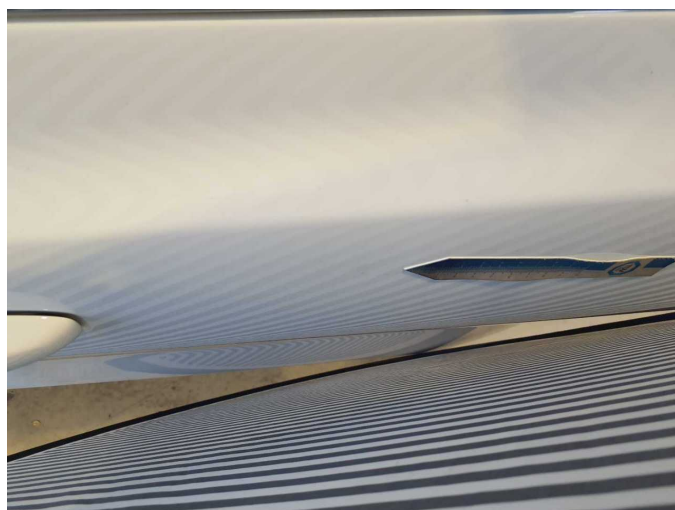
| No. | Component group | Description |
|---|---|---|
| 7 | Door - front right side | Door - Dent / paintcoat damage - No deduction |

**Wear and tear 7:** Door - front right side: Door - Dent / paintcoat damage - No deduction

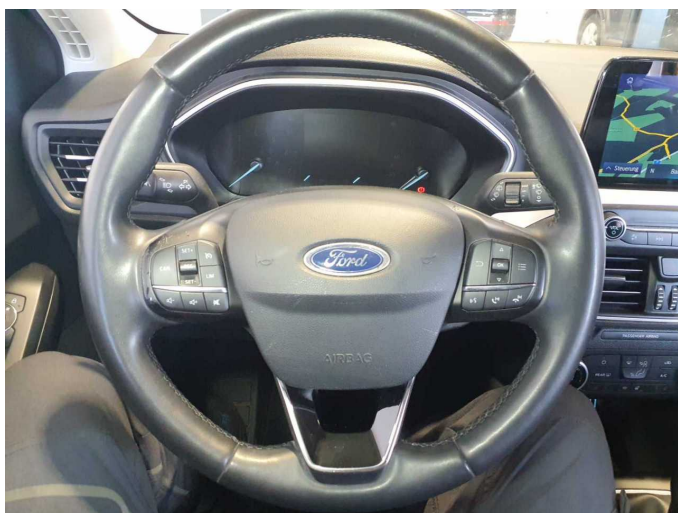
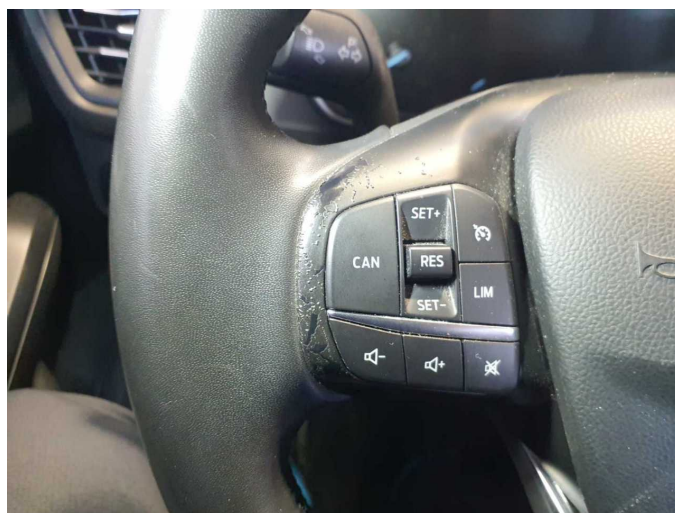
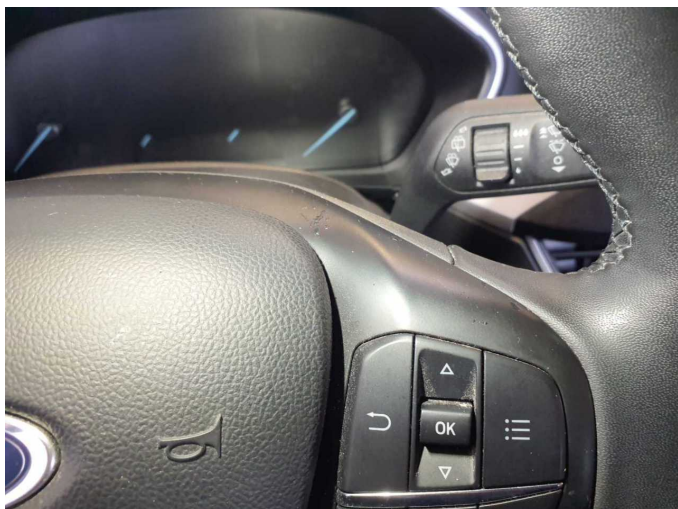
| No. | Component group | Description |
|---|---|---|
| 8 | Steering system | Steering wheel - Scratch(es) - No deduction |

**Wear and tear 8:** Steering system: Steering wheel - Scratch(es) - No deduction

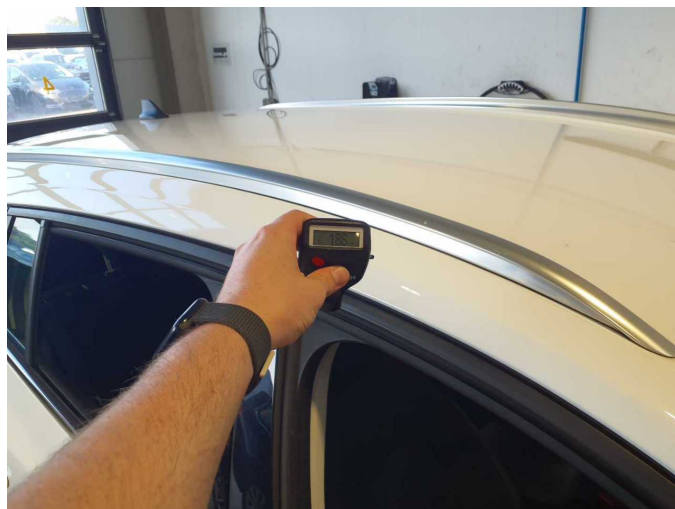
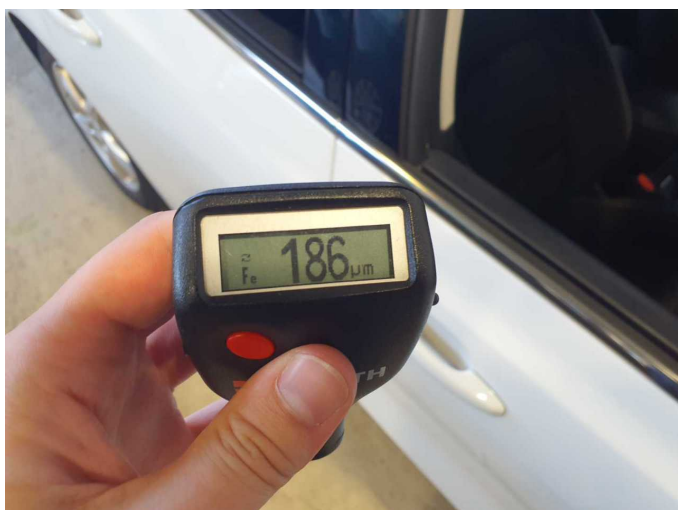
| Roof rail - right side | 186 µm | Bonnet | 279 µm |

**Repainting 1:** Roof rail - right side

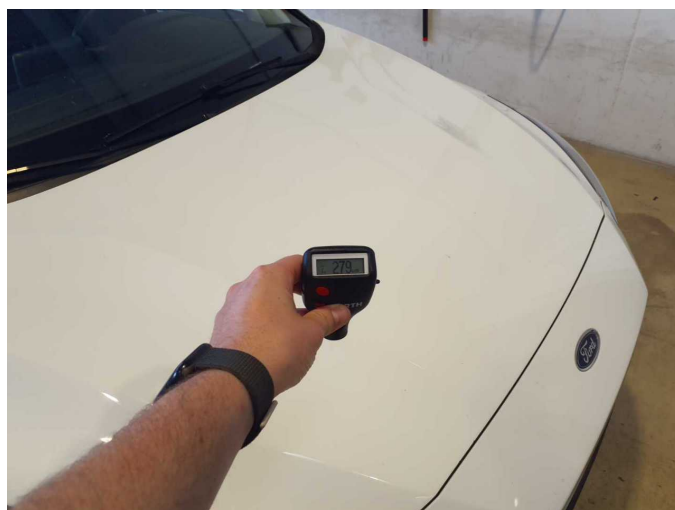
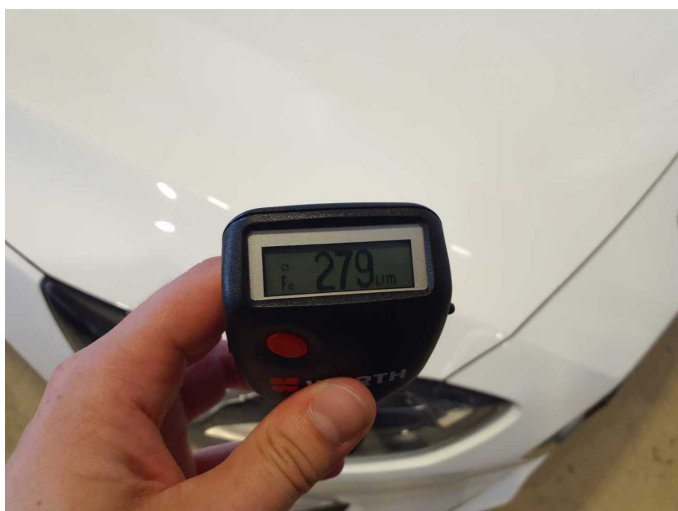
**Repainting 2:** Bonnet

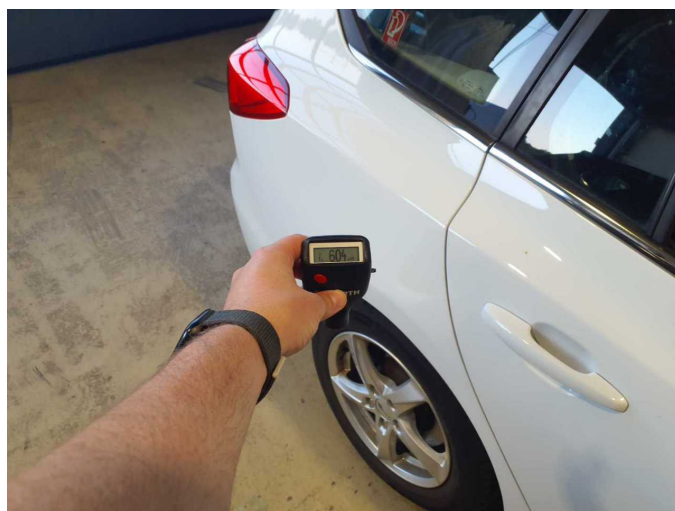
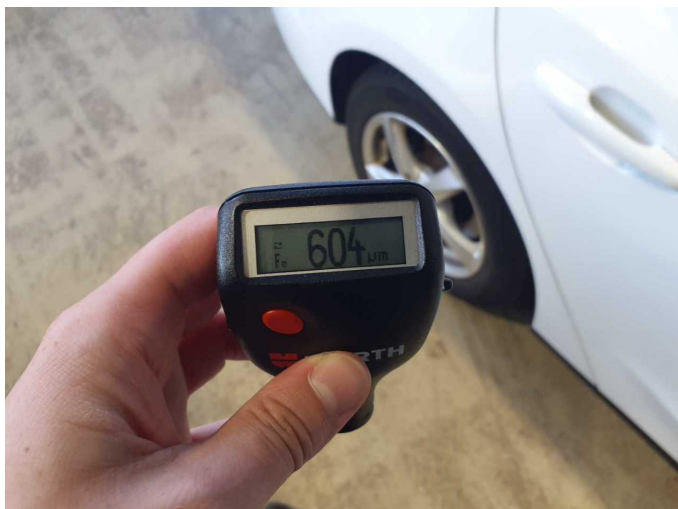
| Side panel - rear right side | 604 µm | Door - rear right side | 324 µm |

**Repainting 3:** Side panel - rear right side

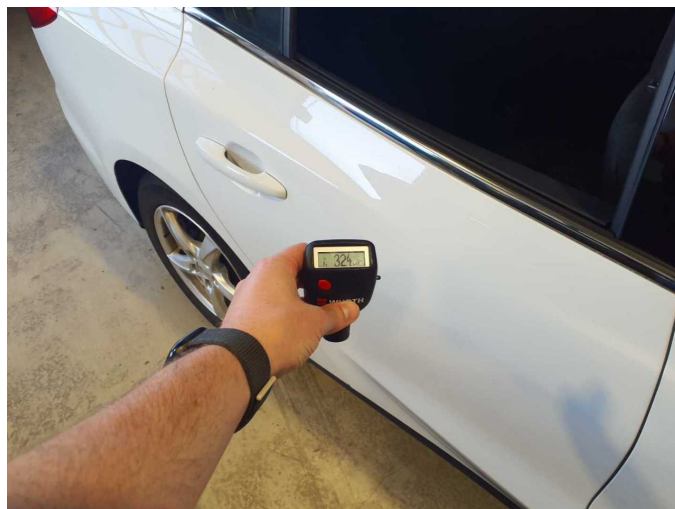
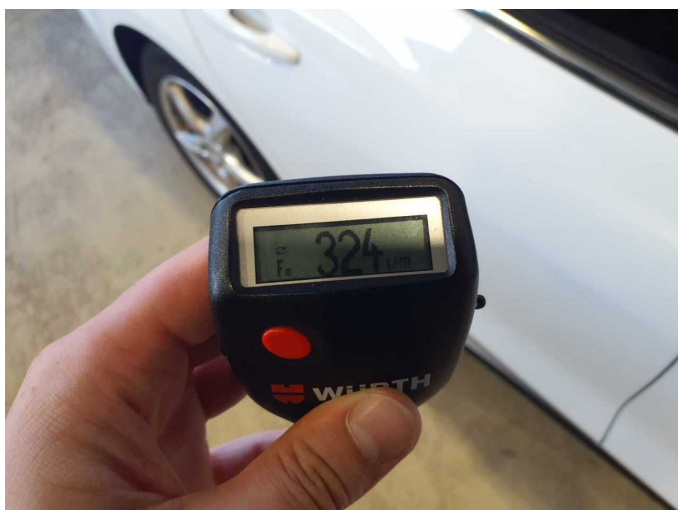
**Repainting 4:** Door - rear right side
