Expertise

Protocol number: 45526603
Order No. / Reference: 26362117
Inspection date: 18 May 2026

Model: Focus Turnier 2.0 EcoBlue Start-Stopp-System Aut. ACTIVE

VIN: WF0PXXGCHPLY71171

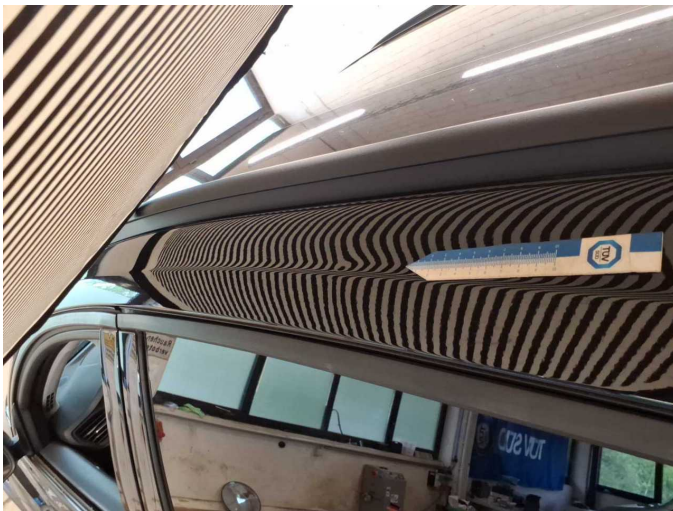
Damage 1: Roof: Roof rail - left side - dent(s) - Smooth repair work

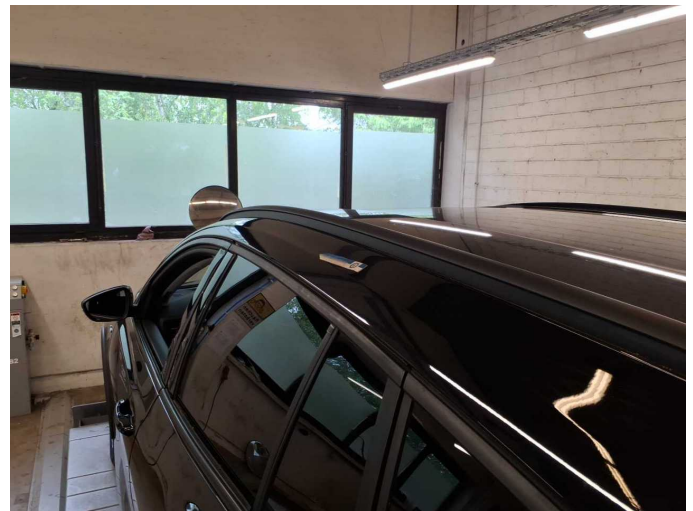
Damage 1: Roof: Roof rail - left side - dent(s) - Smooth repair work

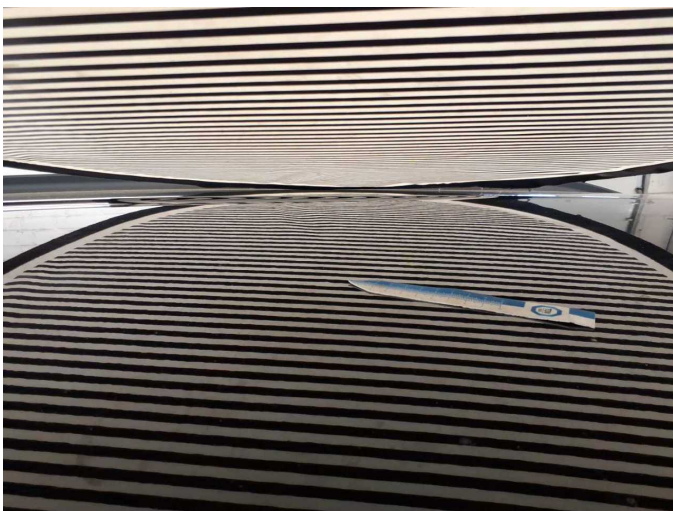
Damage 2: Roof: Roof - dent(s) - Smooth repair work

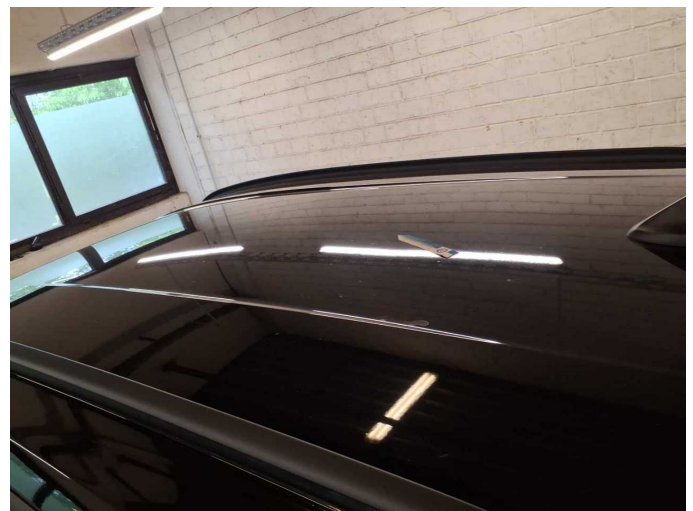
Damage 2: Roof: Roof - dent(s) - Smooth repair work

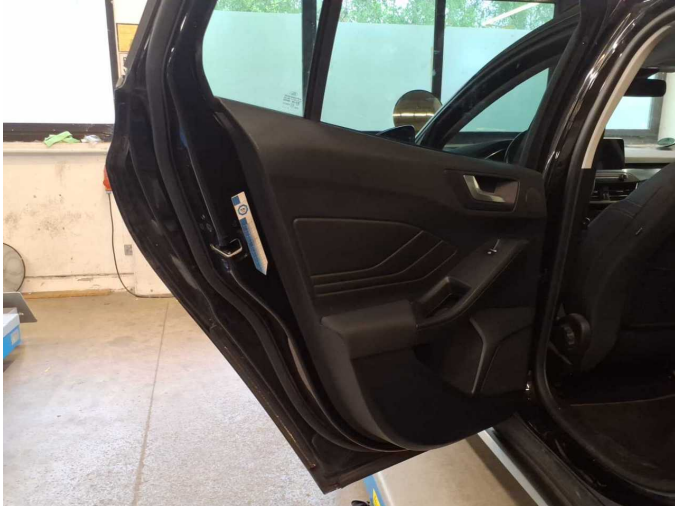
Damage 3: Door - rear left side: Door (Innen Rahmen) - dent(s) - Smooth repair work

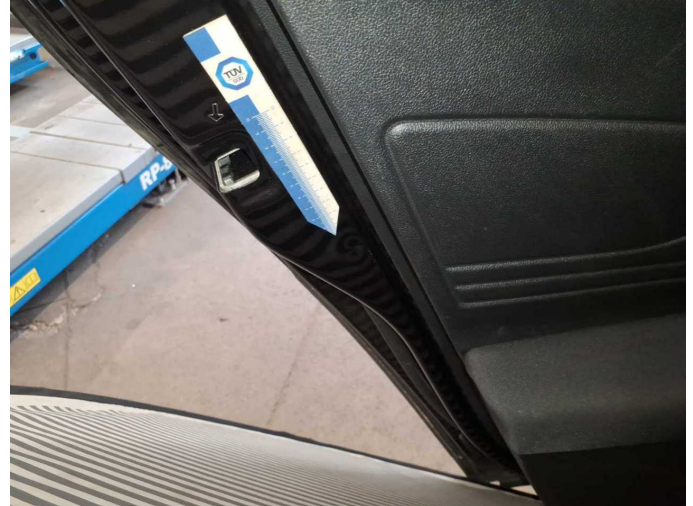
Damage 3: Door - rear left side: Door (Innen Rahmen) - dent(s) - Smooth repair work

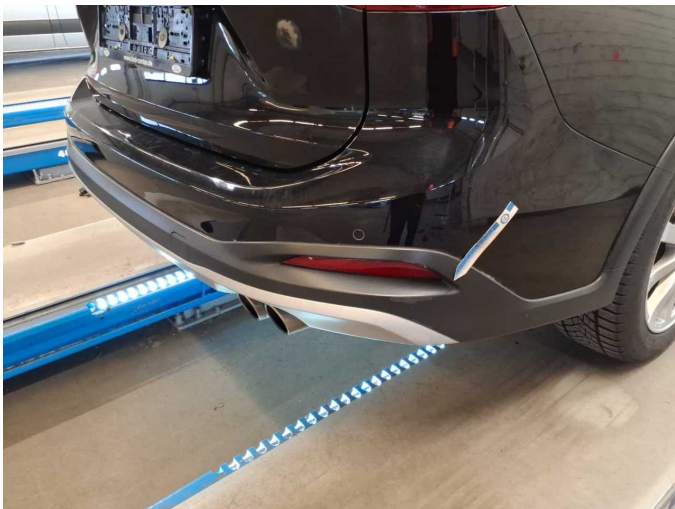
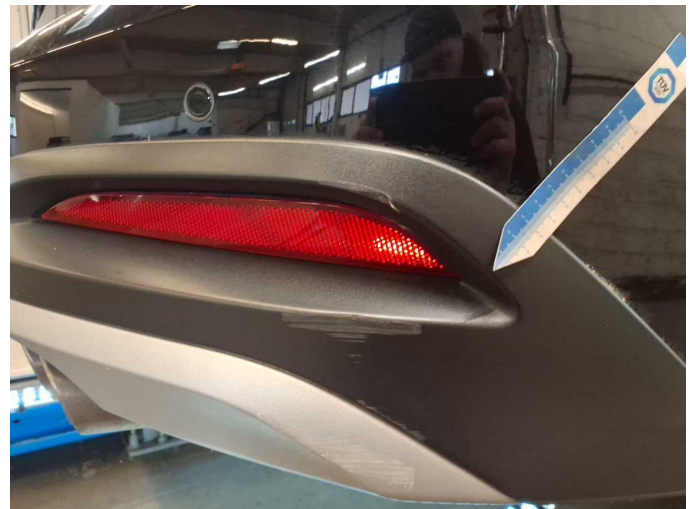
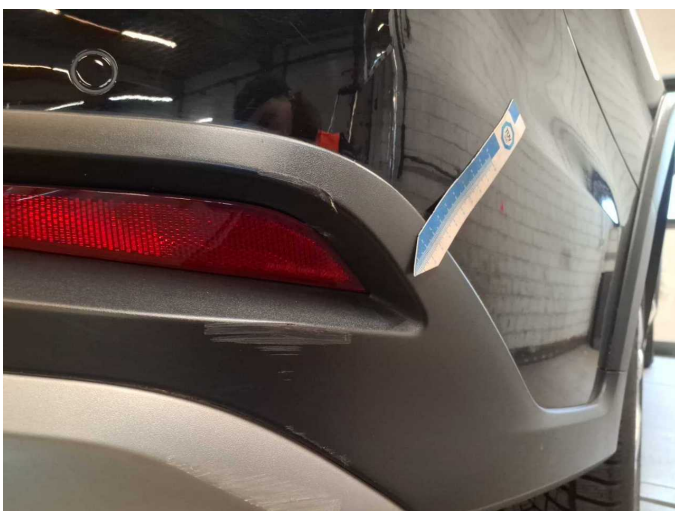
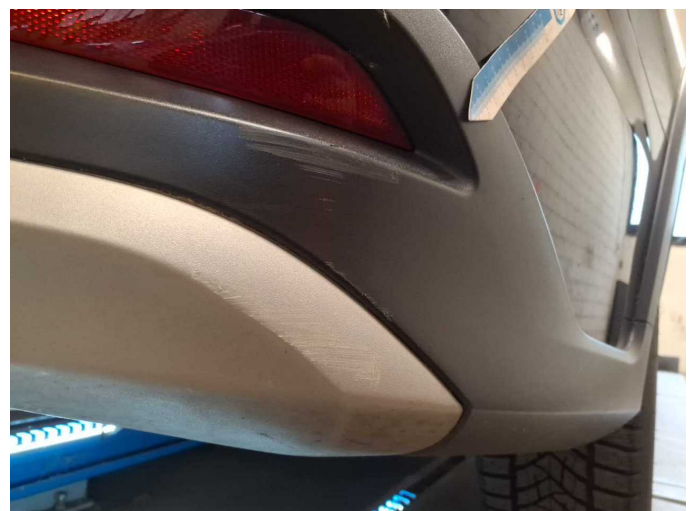
Damage 4: Rear bumper: Spoiler - Scratched - Loss in value

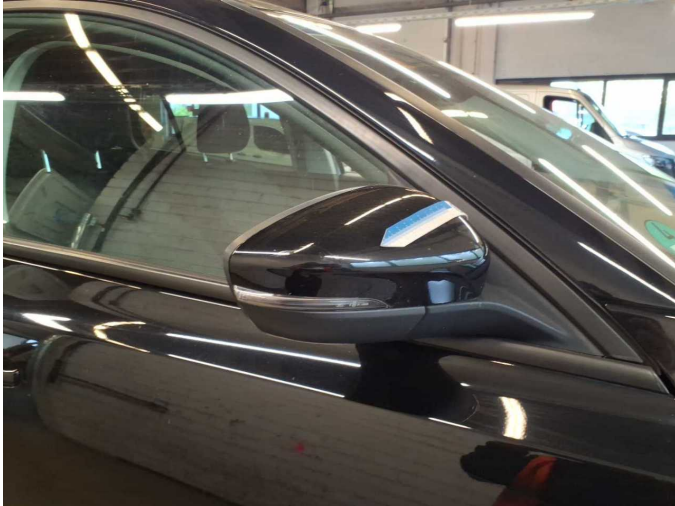
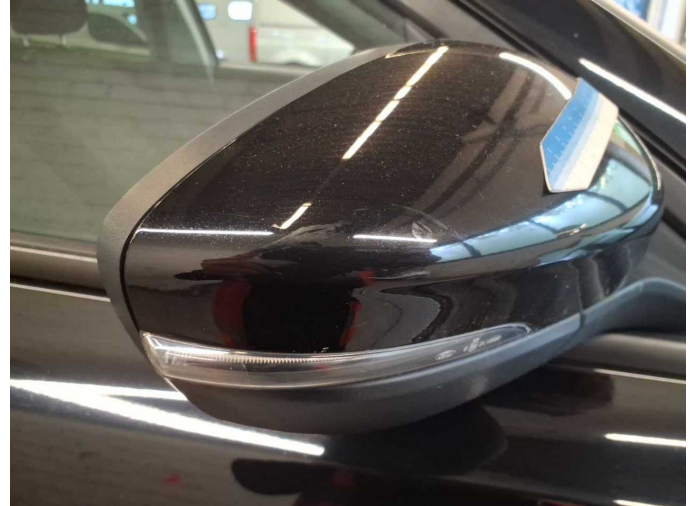
Damage 5: Wing mirror - right side: Cap - Scratched - Smart repair

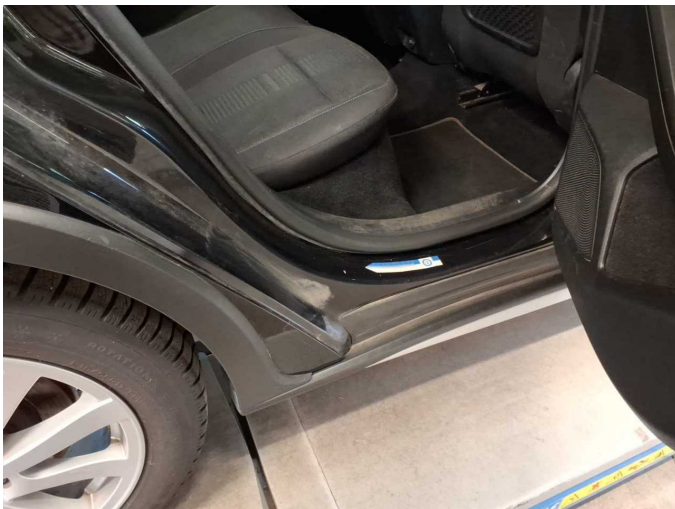
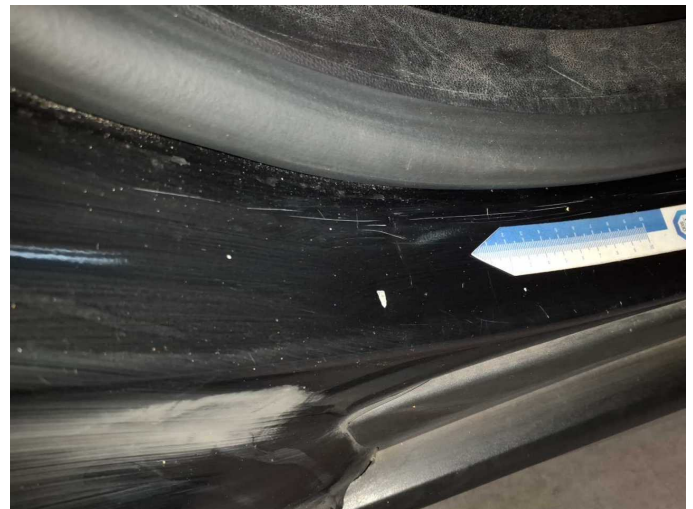
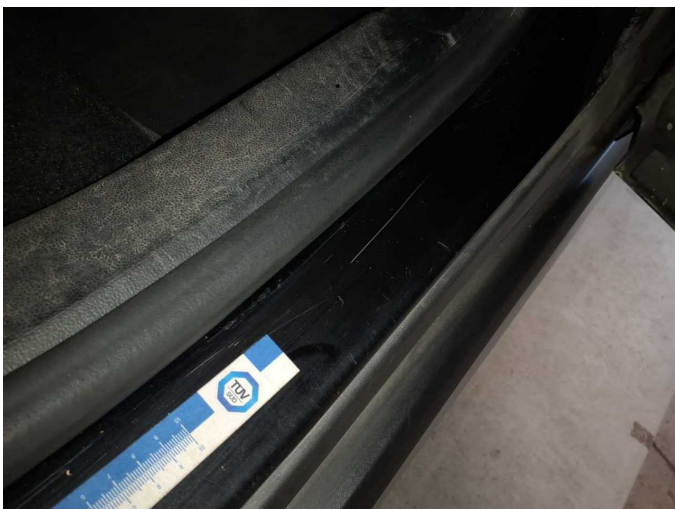
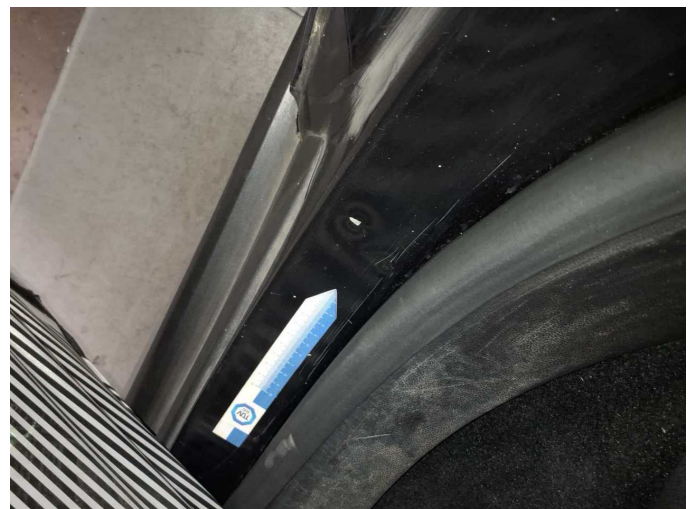
Damage 6: Side panel - rear right side: Sill - Dent / paintcoat damage - Smart repair

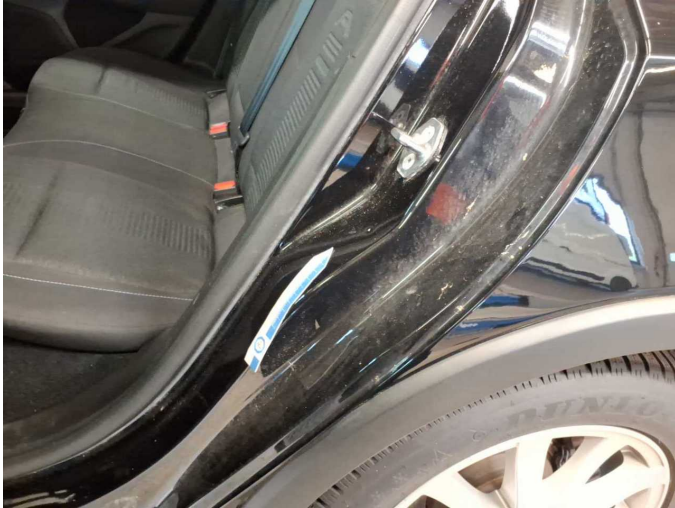
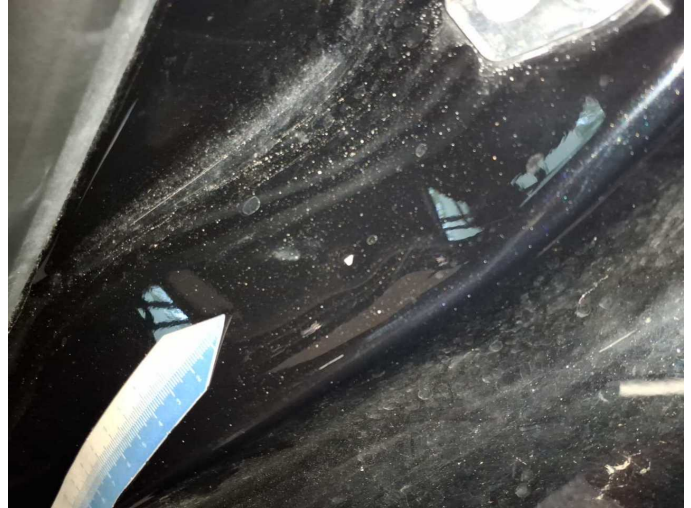
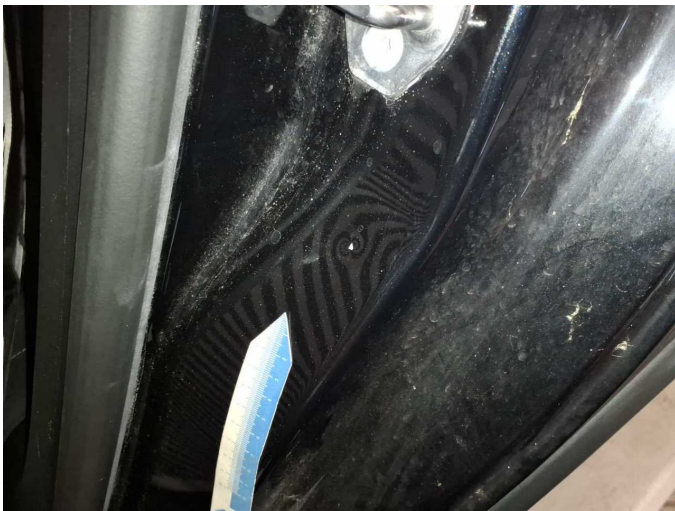
Damage 7: Side panel - rear left side: Sill - Dent / paintcoat damage - Smart repair

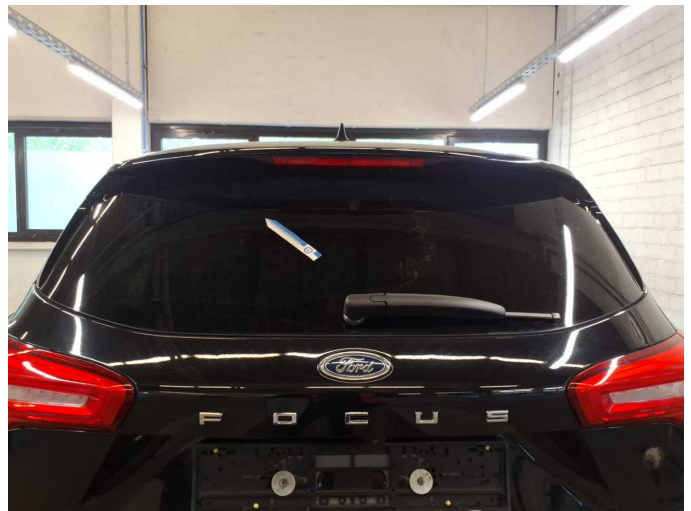
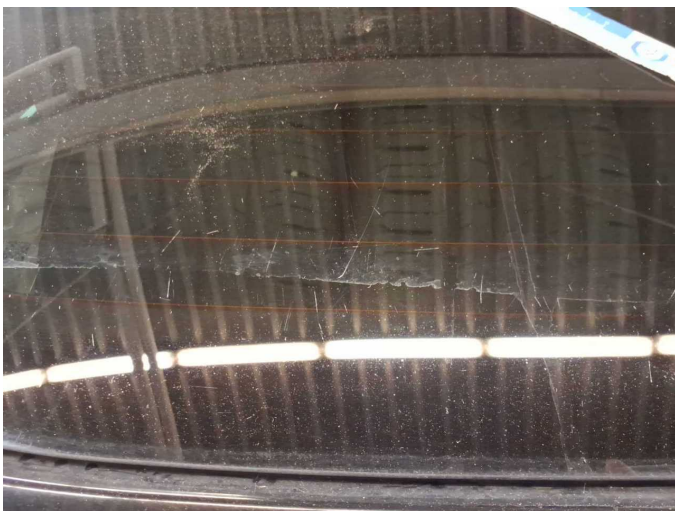
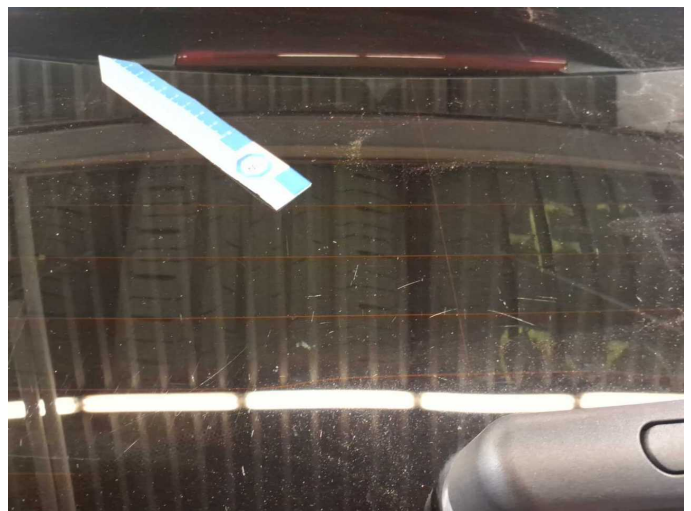
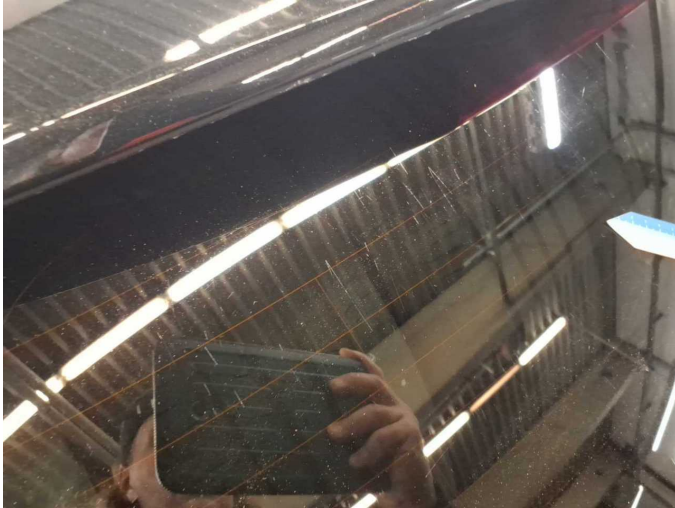
Damage 8: Vehicle glazing: Rear window - Scratched - Loss in value

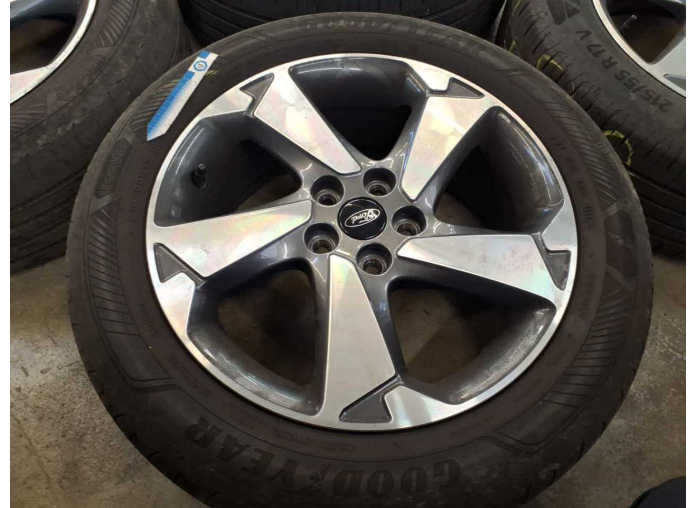
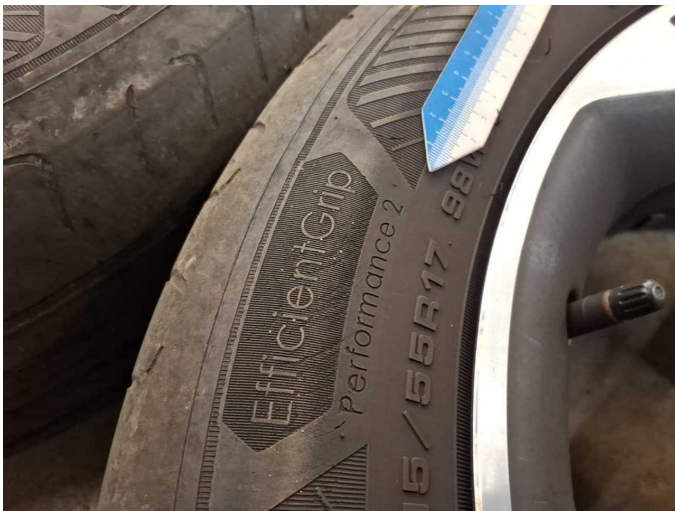
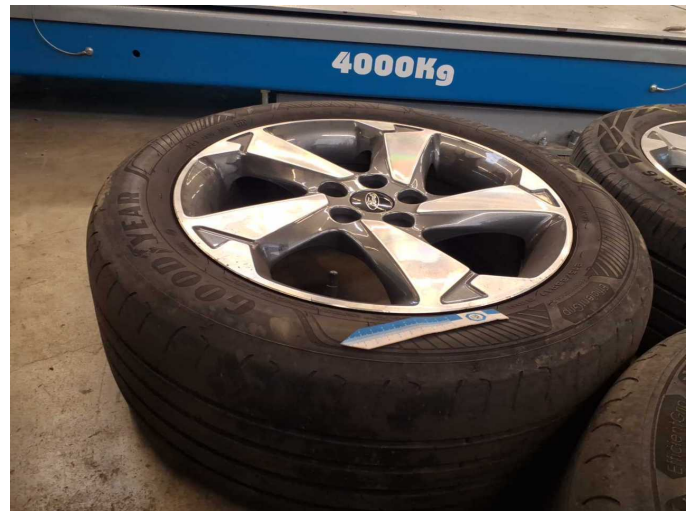
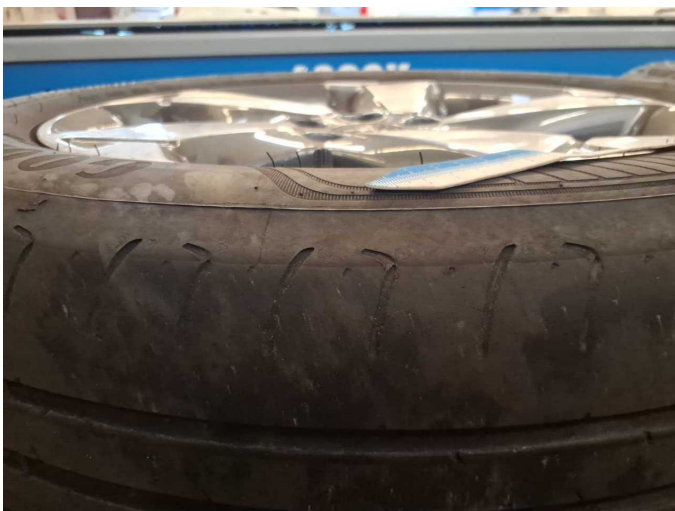
Damage 9: 2nd wheel set: 2 tyres - Damaged - Replace

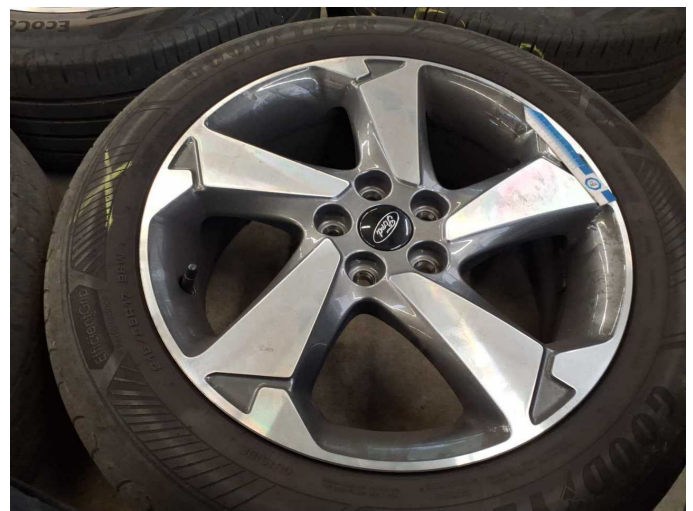
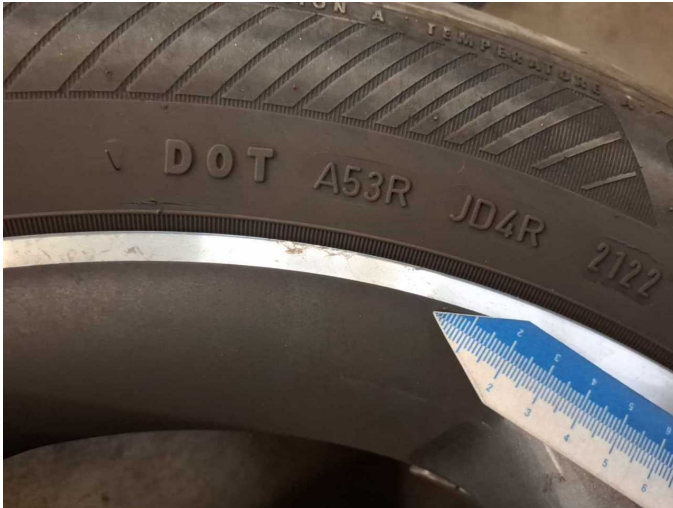
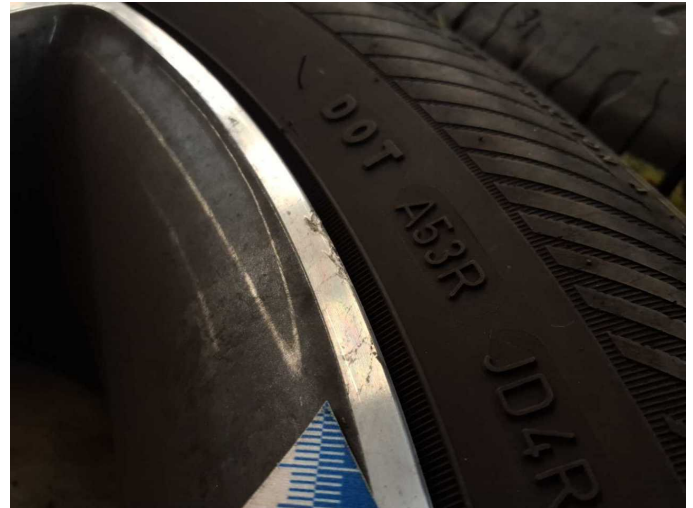
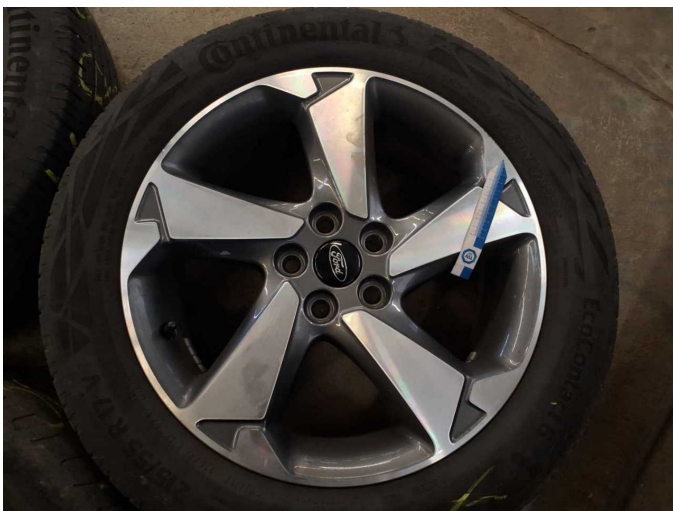
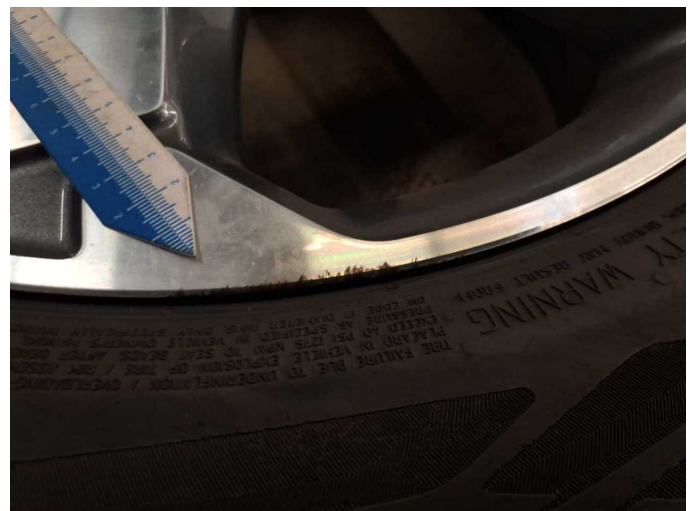
Damage 10: 2nd wheel set: 2 alloy rims - Scratched - Loss in value

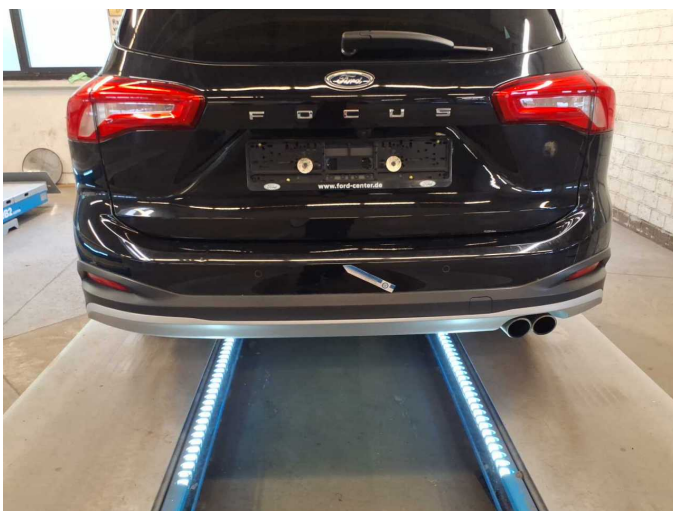
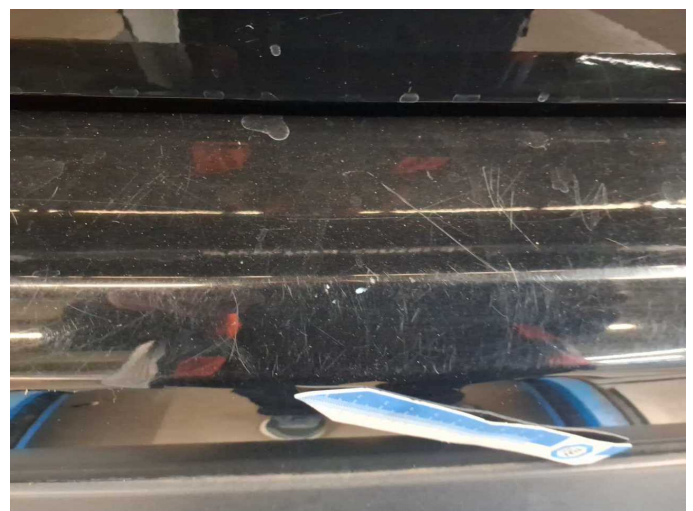
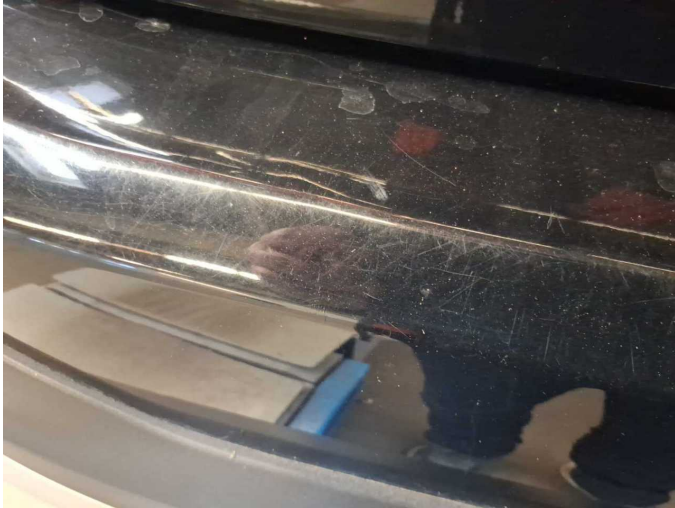
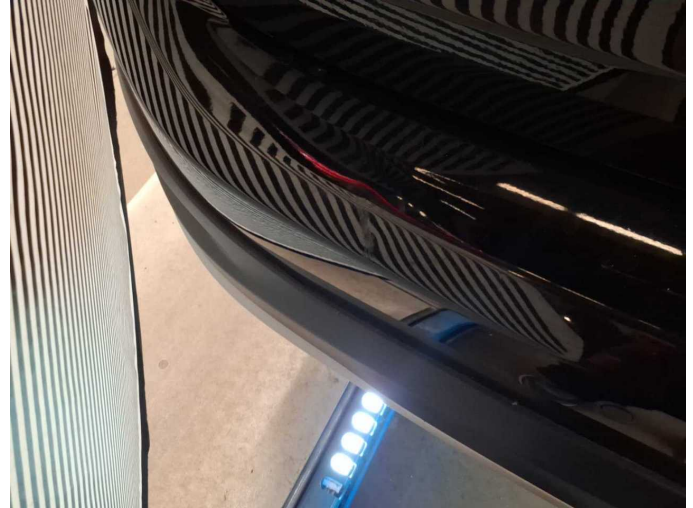
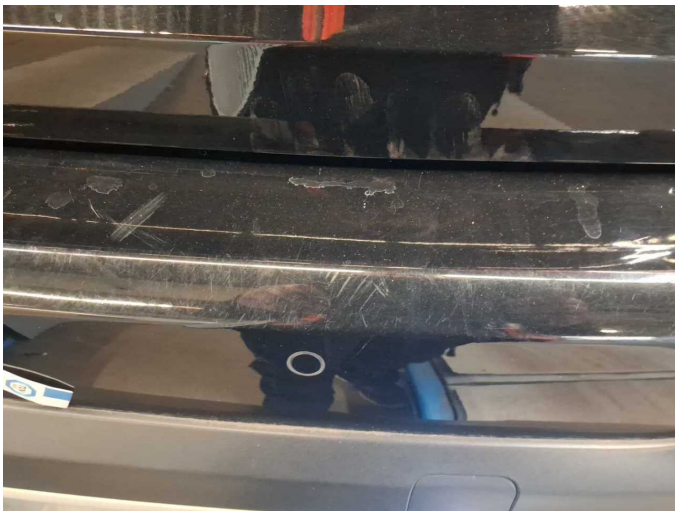
Damage 11: Rear bumper: Rear bumper - Dent / paintcoat damage - Repair and paint

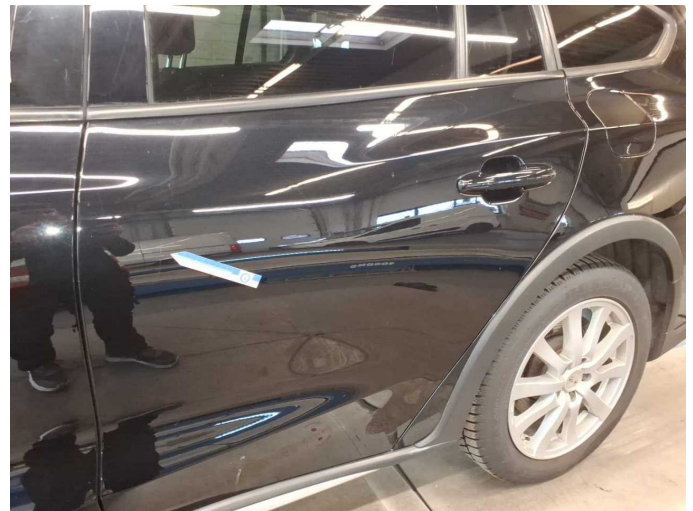
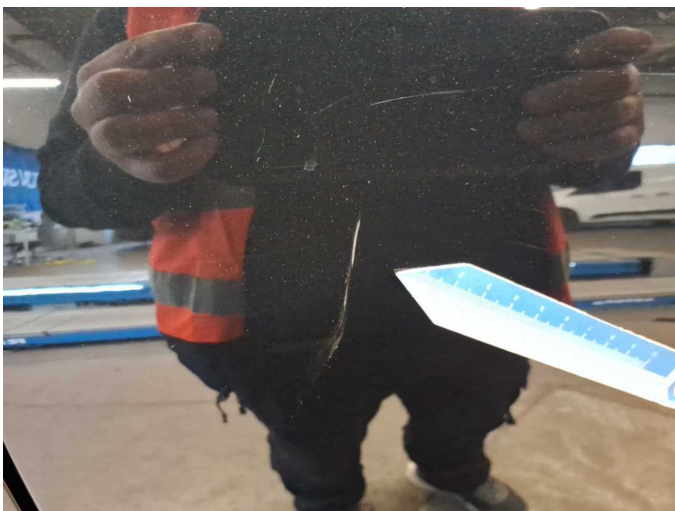
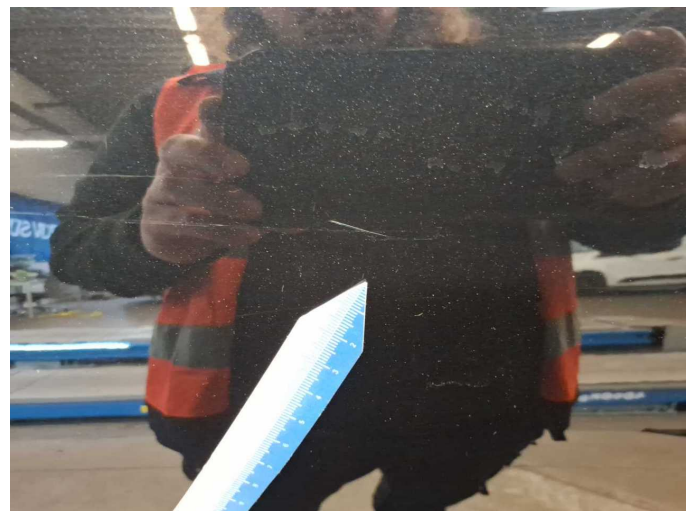
Damage 12: Door - rear left side: Door - Scratched - Paint

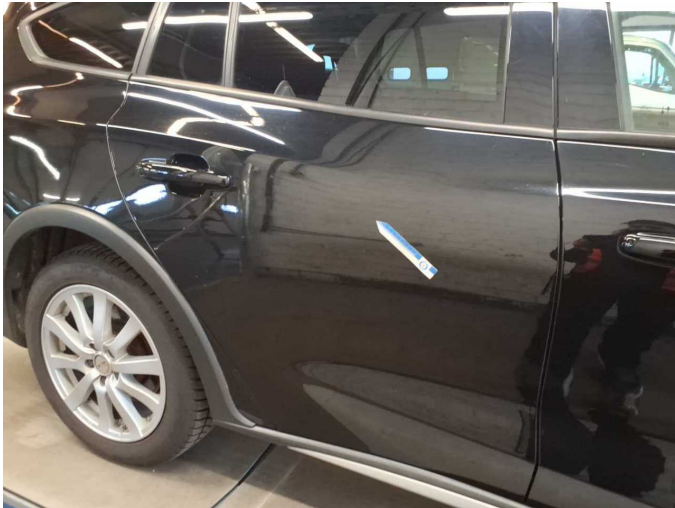
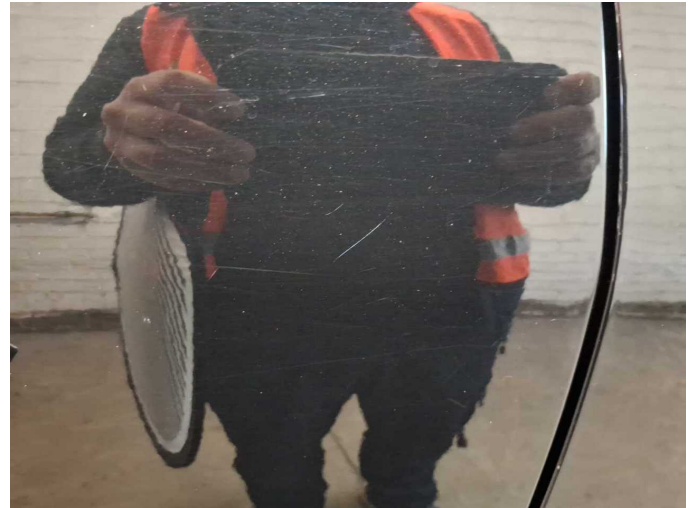
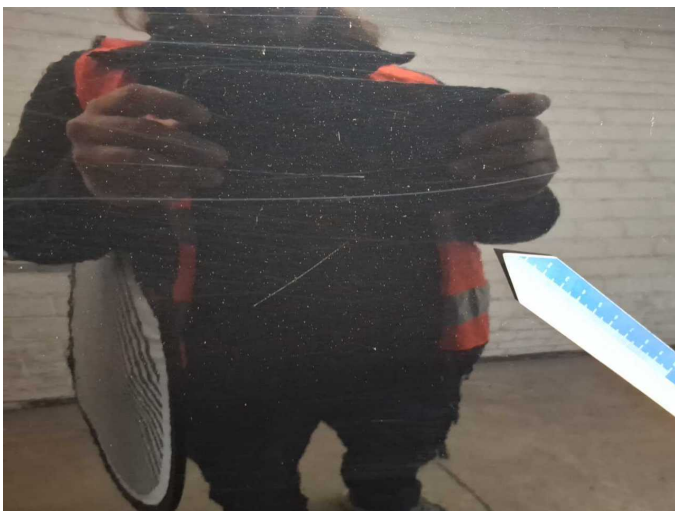
Damage 13: Door - rear right side: Door - Scratched - Paint

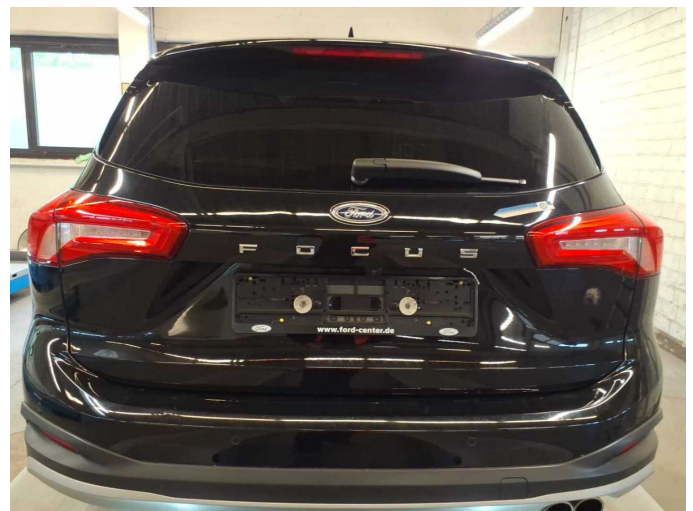
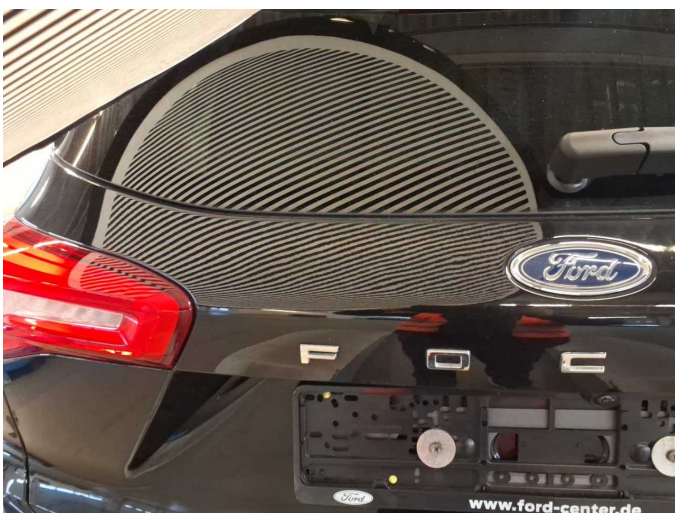
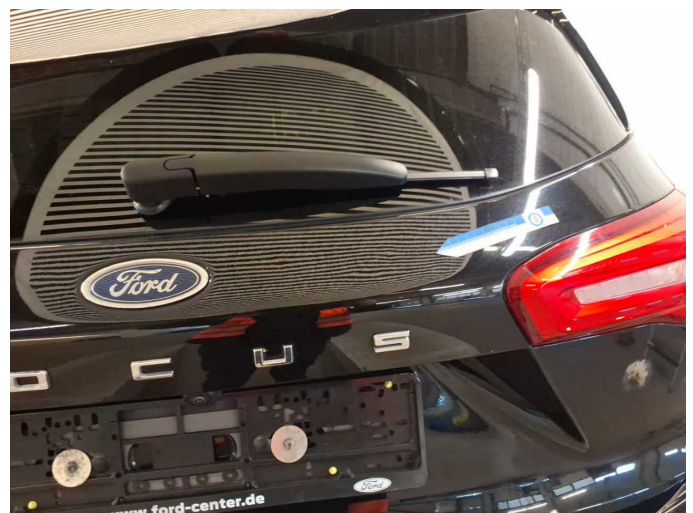
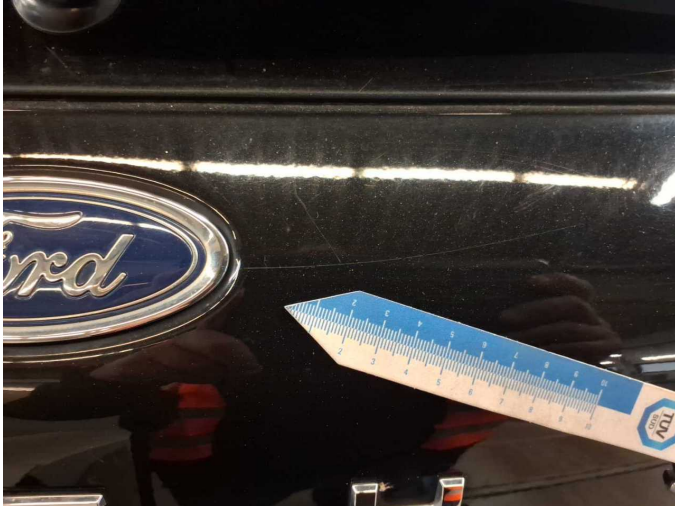
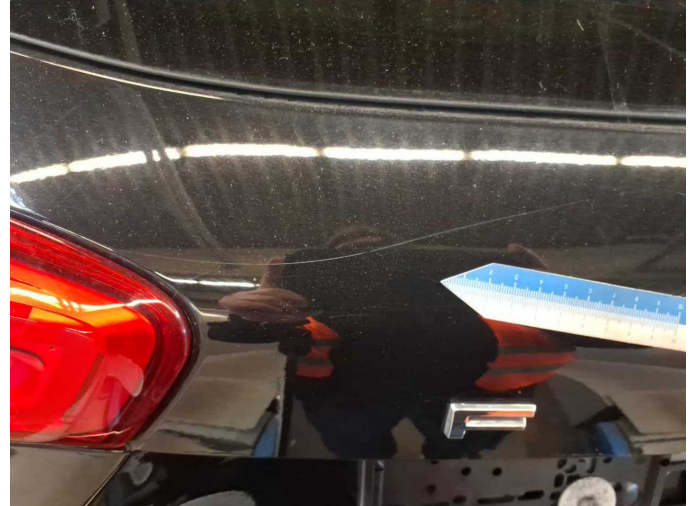
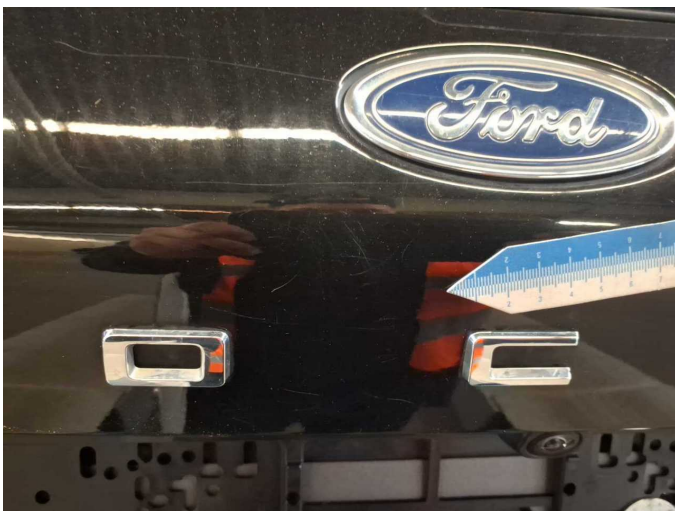
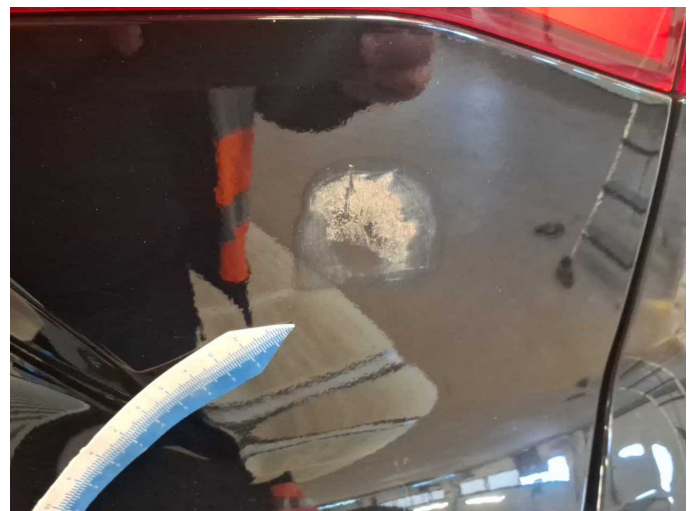
Damage 14: Boot lid / rear door: Boot lid - Dent / paintcoat damage - Repair and paint

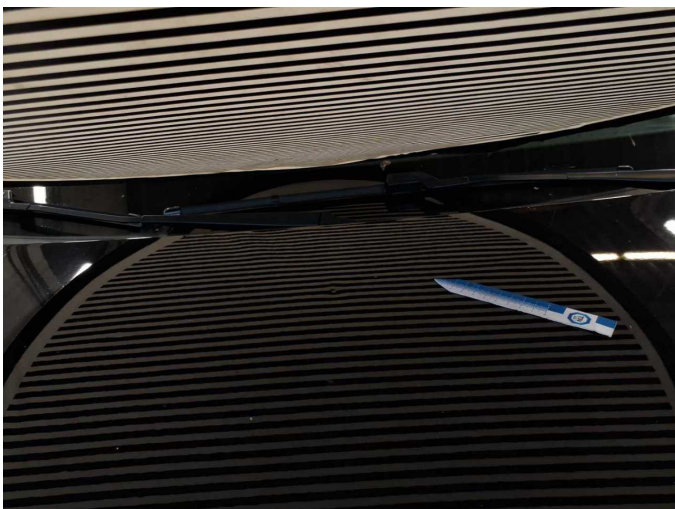
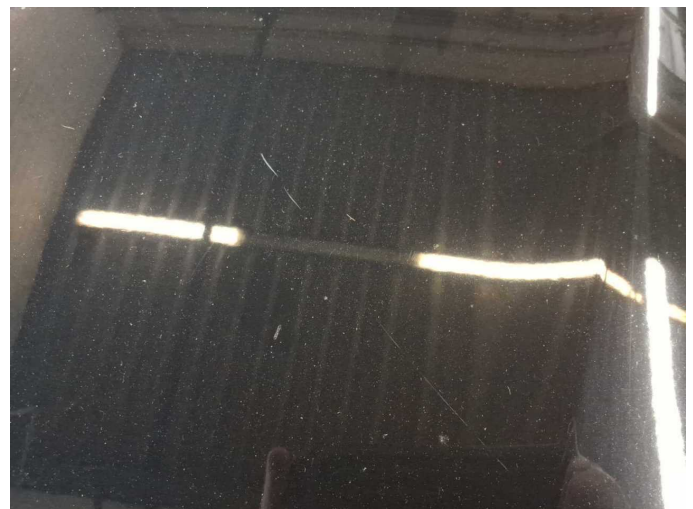
Damage 15: Bonnet: Bonnet - Dent / paintcoat damage - Repair and paint

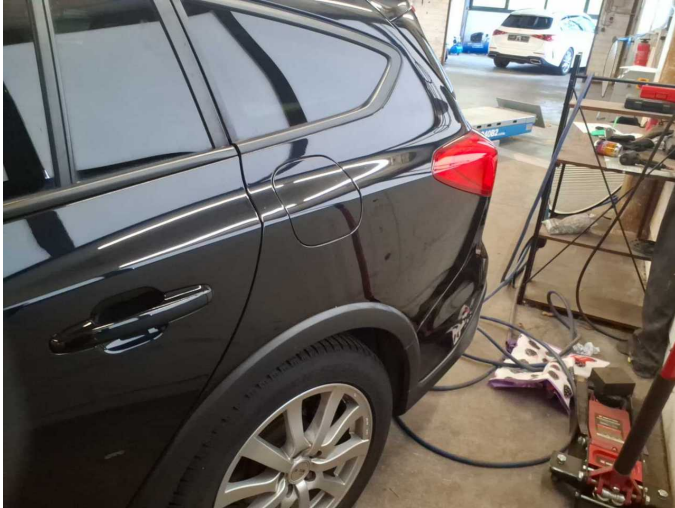
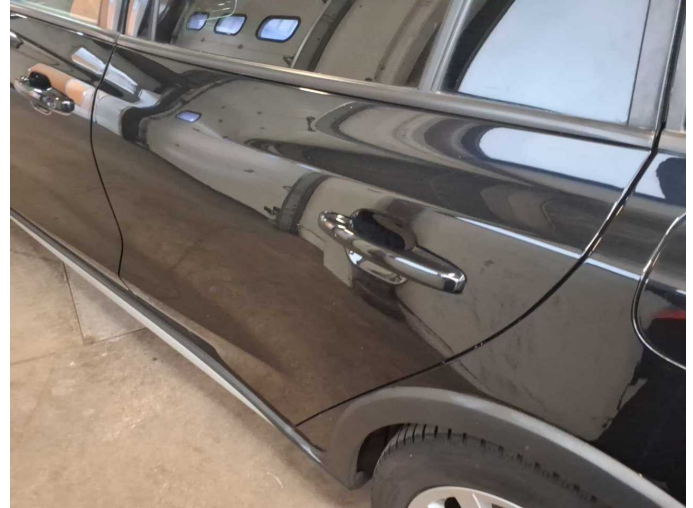
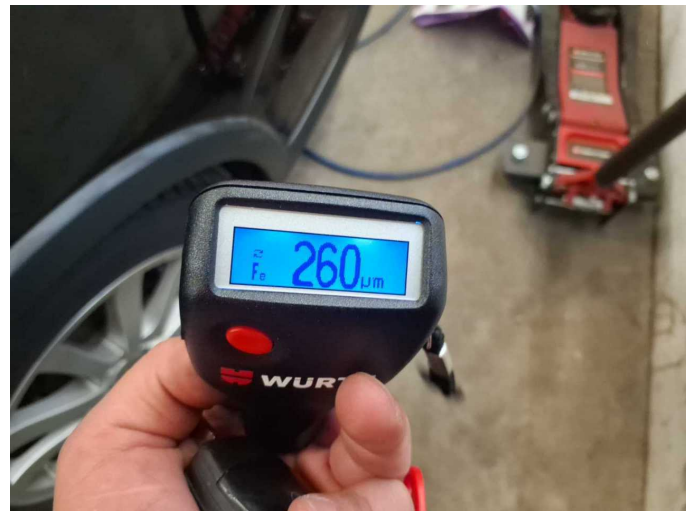
Side panel - rear left side	249 µm	Door - rear left side	174 µm
-----------------------------	--------	-----------------------	--------

Repainting 1: Side panel - rear left side, Door - rear left side
