Expertise

Protocol number: 46267064  
Order No. / Reference: 26605855  
Inspection date: 29 Jun 2026

| Manufacturer: Opel | Model: Astra Sports Tourer 1.5 D Automatik Business Elegance |
| VIN: VXXKFCYHZTP1099363 | |

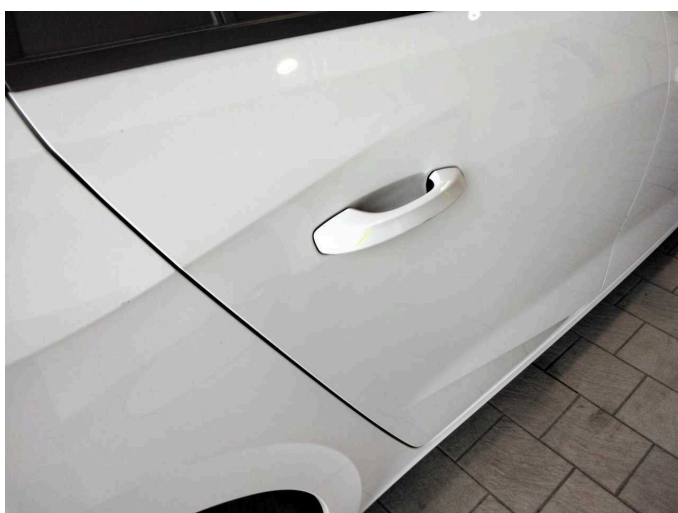
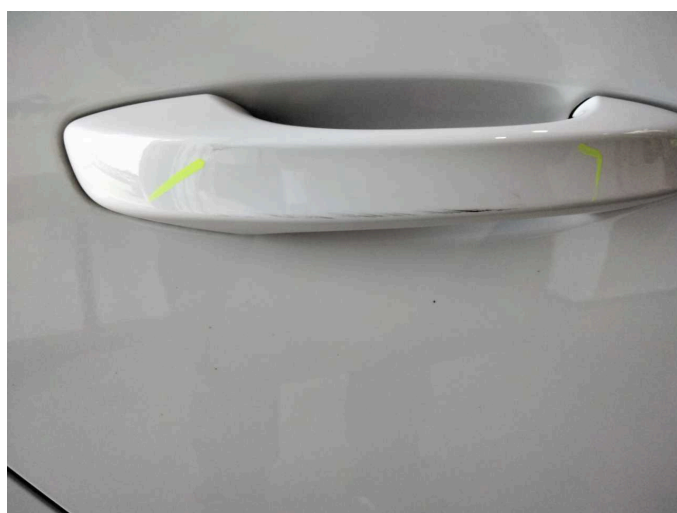
| No. | Component group | Description |
|---|---|---|
| 1 | Door - rear right side | Door handle - outside - Scratch(es) - Smart repair |

**Damage 1:** Door - rear right side: Door handle - outside - Scratch(es) - Smart repair

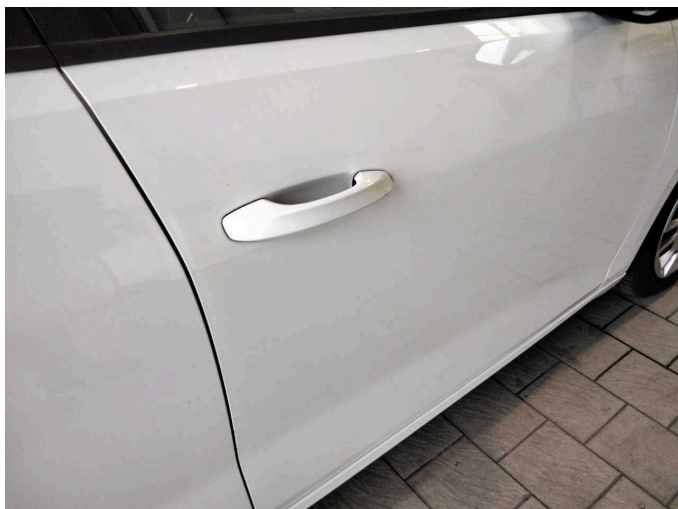
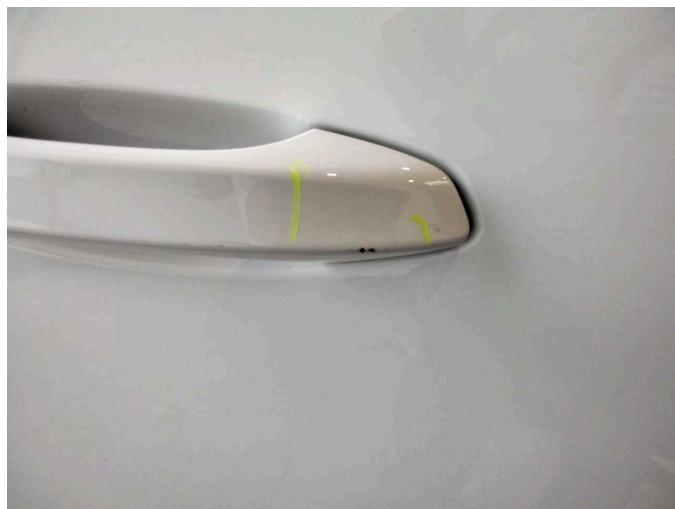
| No. | Component group | Description |
|---|---|---|
| 2 | Door - front right side | Door handle - outside - Scratch(es) - Smart repair |

**Damage 2:** Door - front right side: Door handle - outside - Scratch(es) - Smart repair

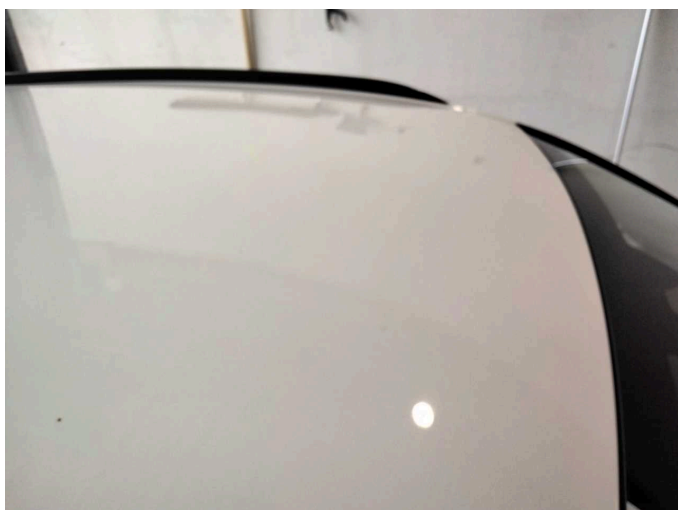
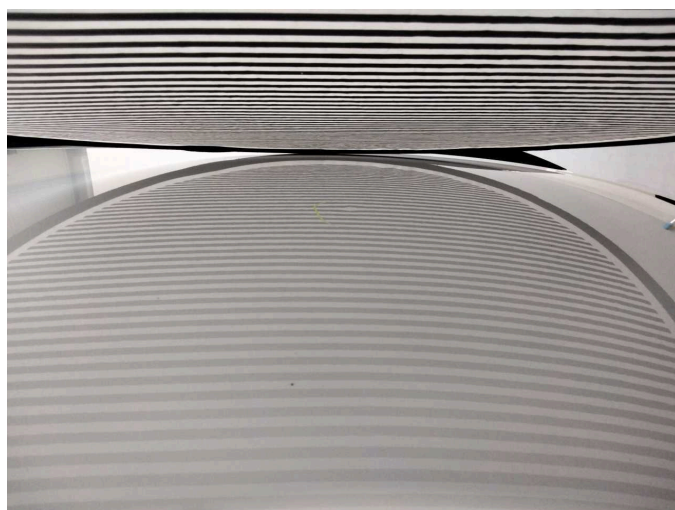
| No. | Component group | Description |
|---|---|---|
| 3 | Roof | Roof - dent(s) - Smooth repair work |

**Damage 3:** Roof: Roof - dent(s) - Smooth repair work

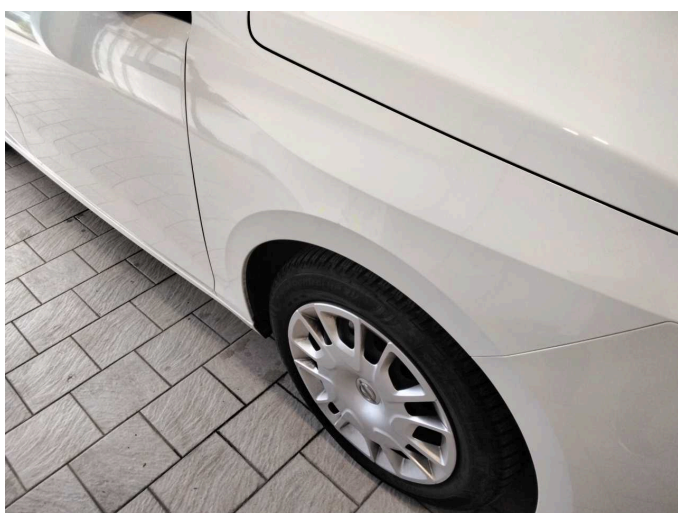
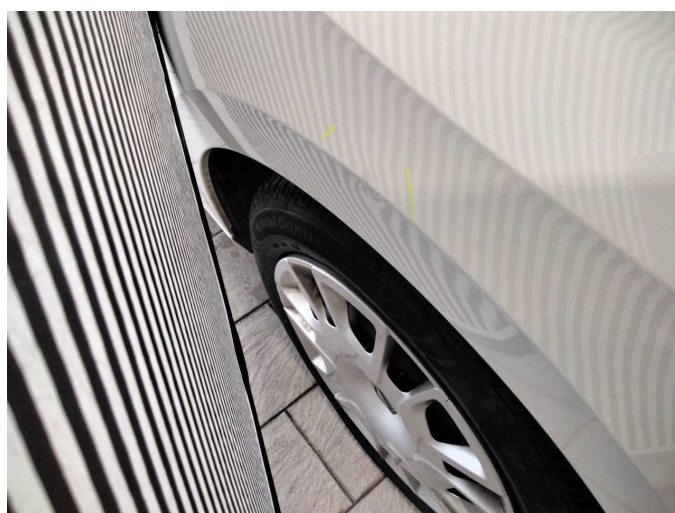
| No. | Component group | Description |
|---|---|---|
| 4 | Mudguard - right side | Mudguard - right side - Dent / paintcoat damage - Smart repair |

**Damage 4:** Mudguard - right side: Mudguard - right side - Dent / paintcoat damage - Smart repair

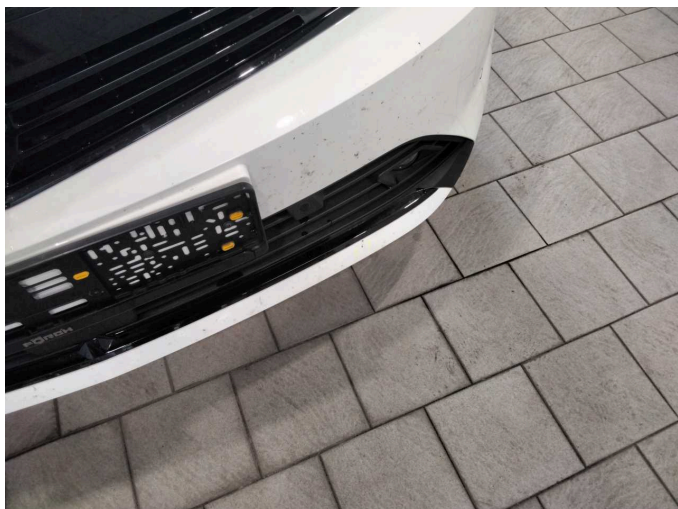
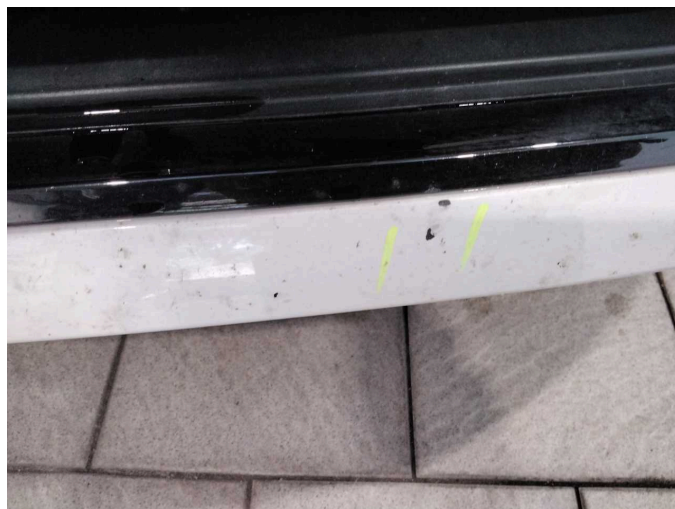
| No. | Component group | Description |
|---|---|---|
| 5 | Front bumper | Front bumper - Scratch(es) - Smart repair |

**Damage 5:** Front bumper: Front bumper - Scratch(es) - Smart repair

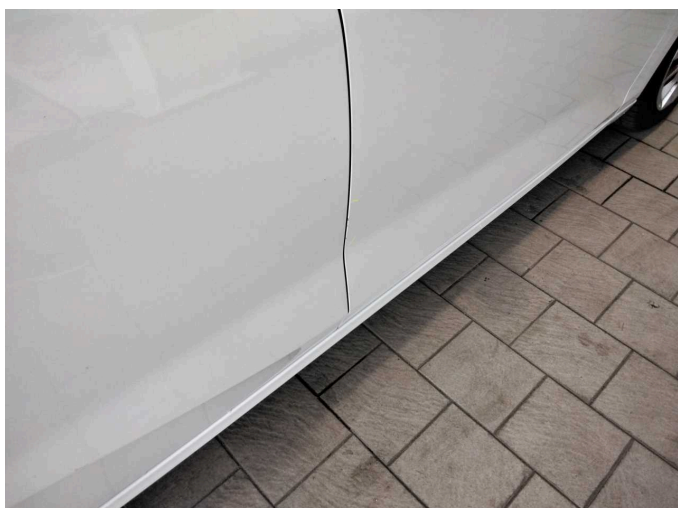
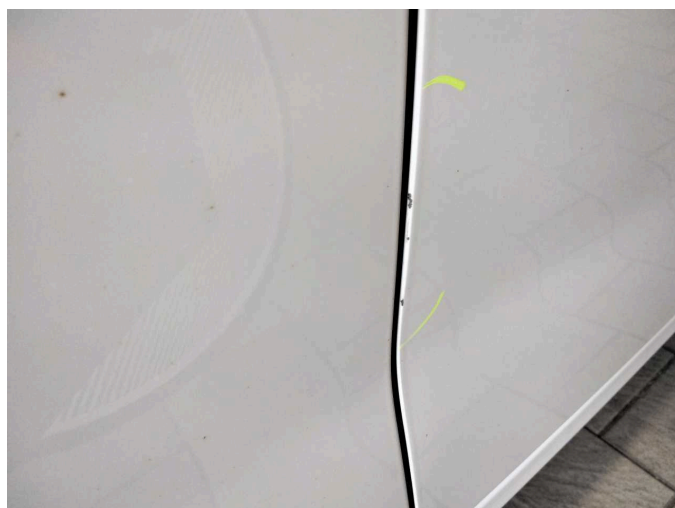
| No. | Component group | Description |
|---|---|---|
| 6 | Door - front right side | Door edge - Scratch(es) - Smart repair |

**Damage 6:** Door - front right side: Door edge - Scratch(es) - Smart repair

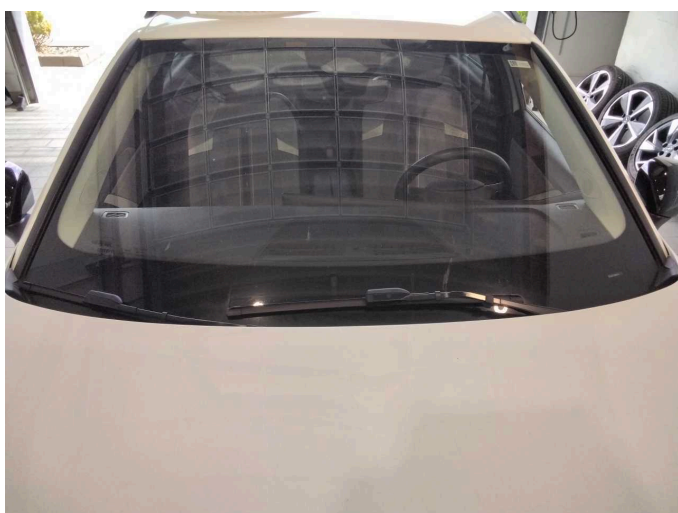
| No. | Component group | Description |
|---|---|---|
| 1 | Vehicle glazing | Windscreen - Stone chips - No deduction |

**Wear and tear 1:** Vehicle glazing: Windscreen - Stone chips - No deduction

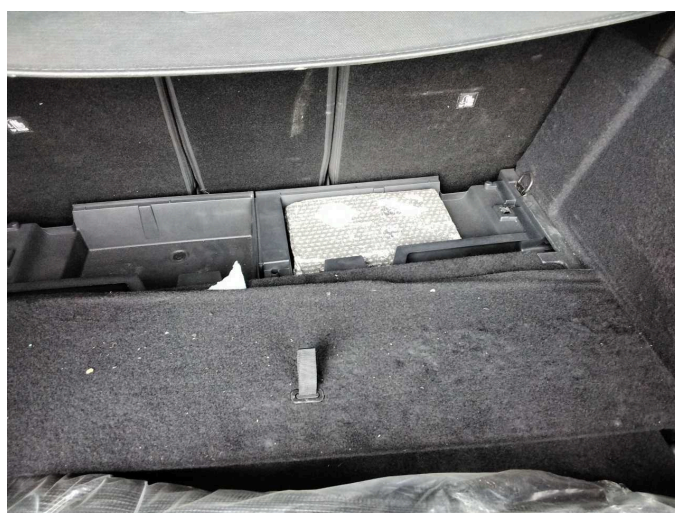
**Missing part 1:** Equipment: Tirefit filler - Missing - Replace

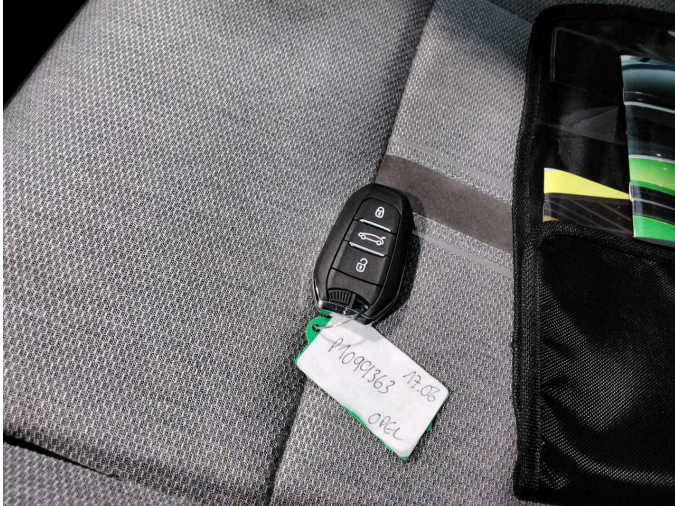
Missing part 2: Equipment: Vehicle key - Missing - Replace

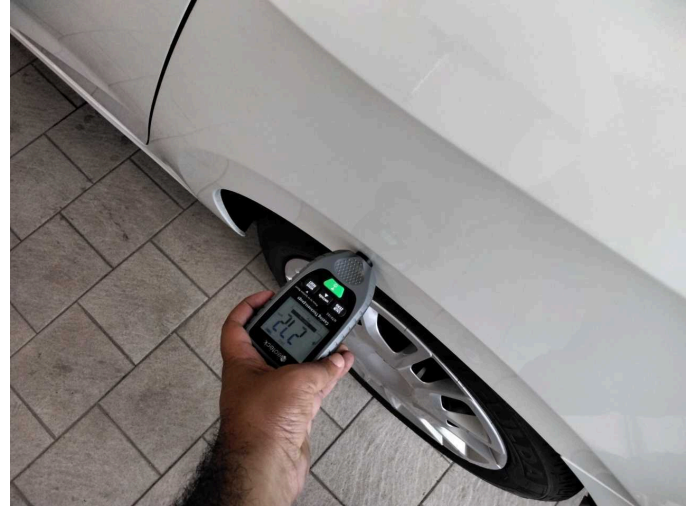
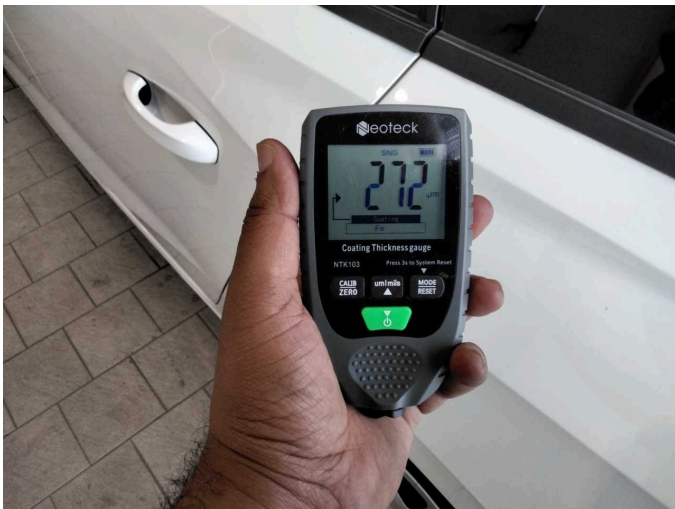
| Side panel - rear left side | 272 µm | Door - front left side | 223 µm |

Side panel - rear left side: 272  $\mu\text{m}$

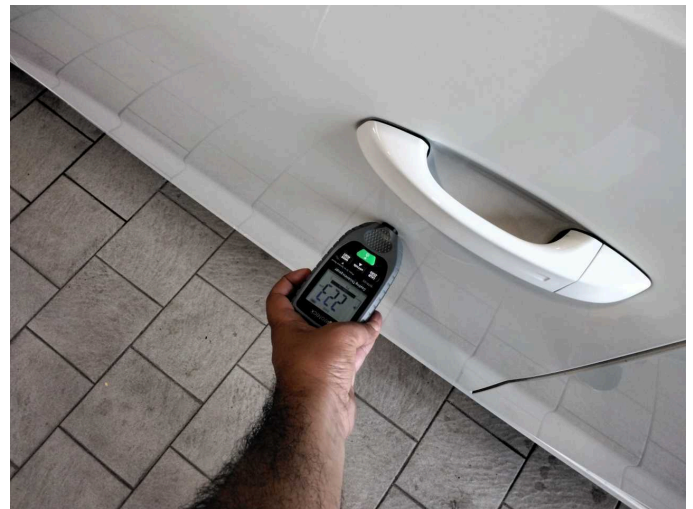
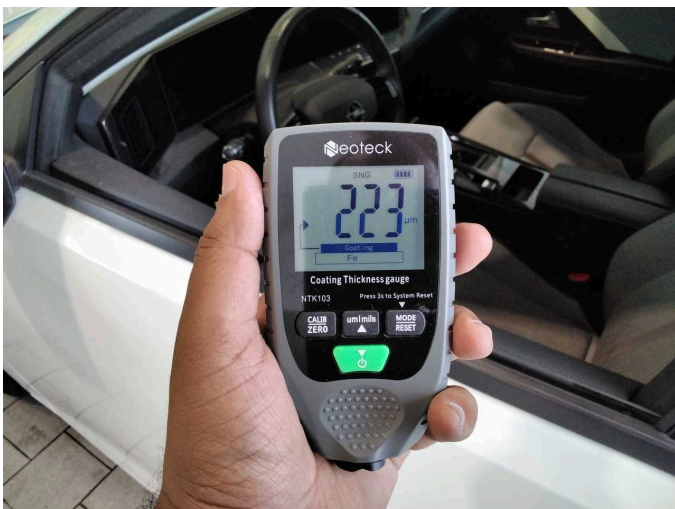
Door - front left side: 223  $\mu\text{m}$
