Expertise

Protocol number: 46765144  
Order No. / Reference: 26812652  
Inspection date: 28 Jul 2026

Manufacturer: Volkswagen

Model: Caddy Cargo 2.0 TDI BMT

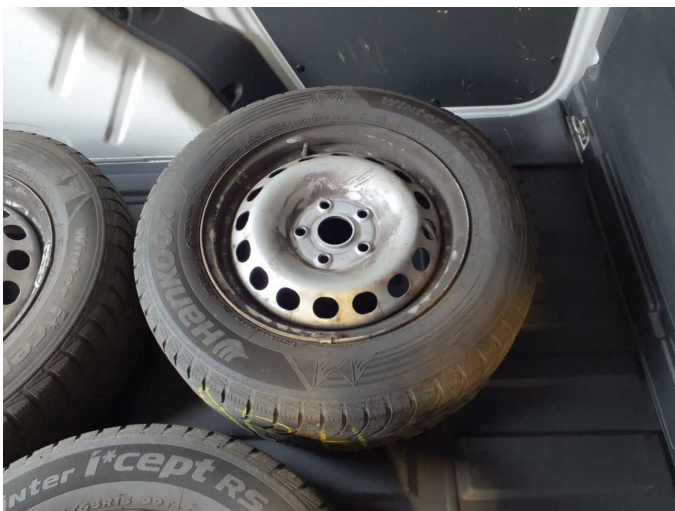
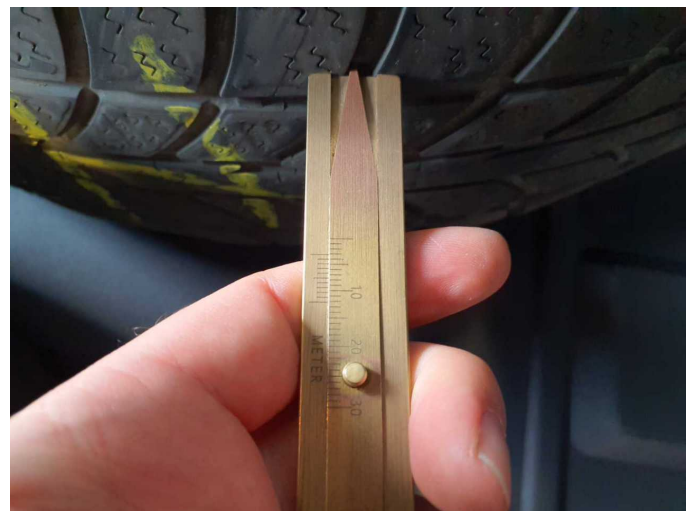
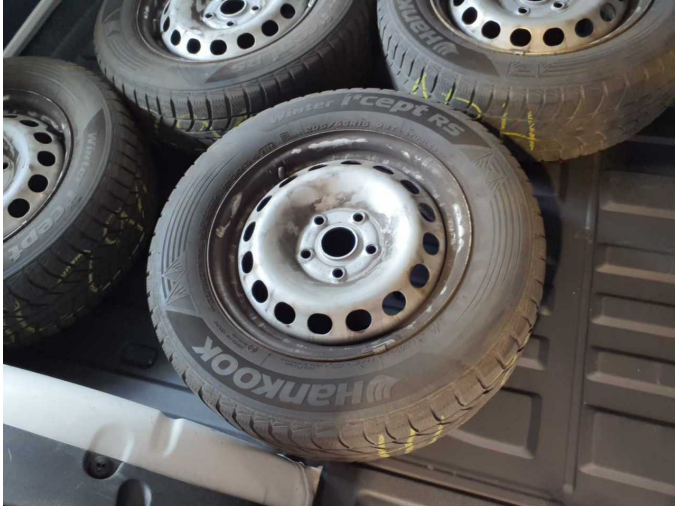
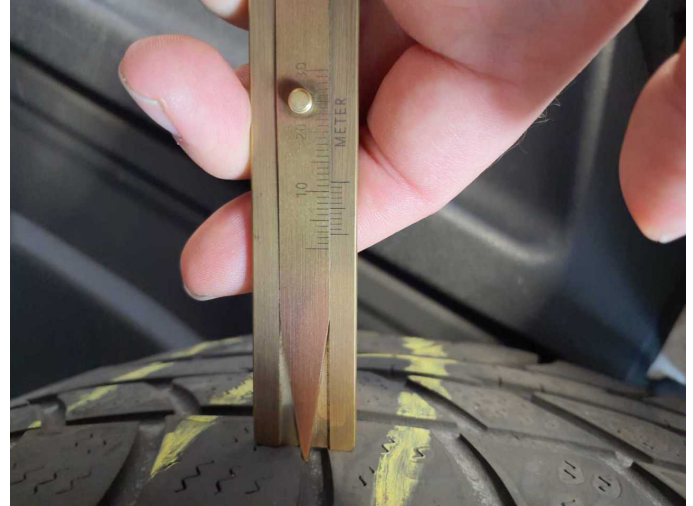
| No. | Component group | Description |
|---|---|---|
| 1 | 2nd wheel set | 2 tyres (nicht Teil der Ausstattung) - Worn - No deduction |

**Damage 1:** 2nd wheel set: 2 tyres (nicht Teil der Ausstattung) - Worn - No deduction

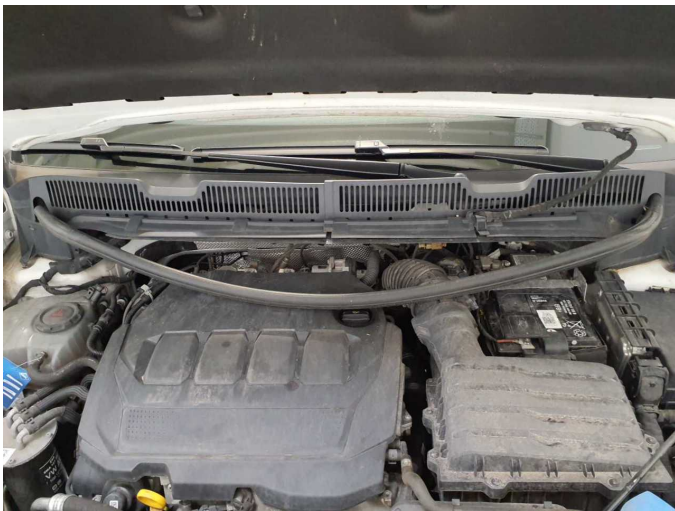
| No. | Component group | Description |
|---|---|---|
| 2 | Bonnet | Bonnet (Dichtung) - Loose - Un- / install |

**Damage 2:** Bonnet: Bonnet (Dichtung) - Loose - Un- / install

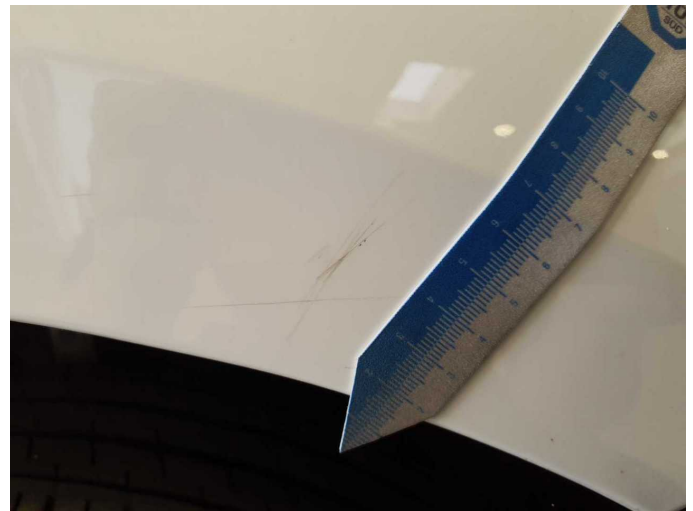
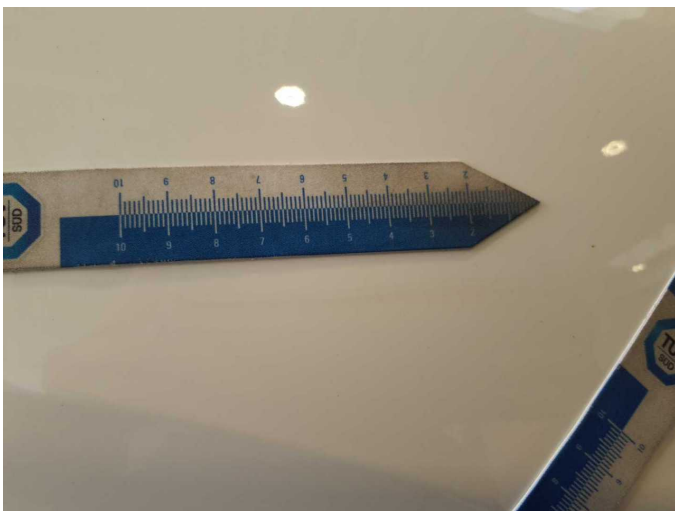
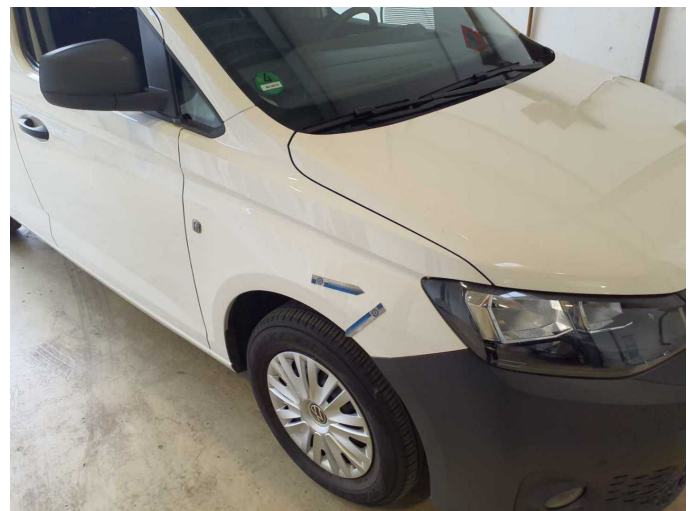
| No. | Component group | Description |
|---|---|---|
| 3 | Mudguard - right side | Mudguard - right side - Scratch(es) - Smart repair |

**Damage 3:** Mudguard - right side: Mudguard - right side - Scratch(es) - Smart repair

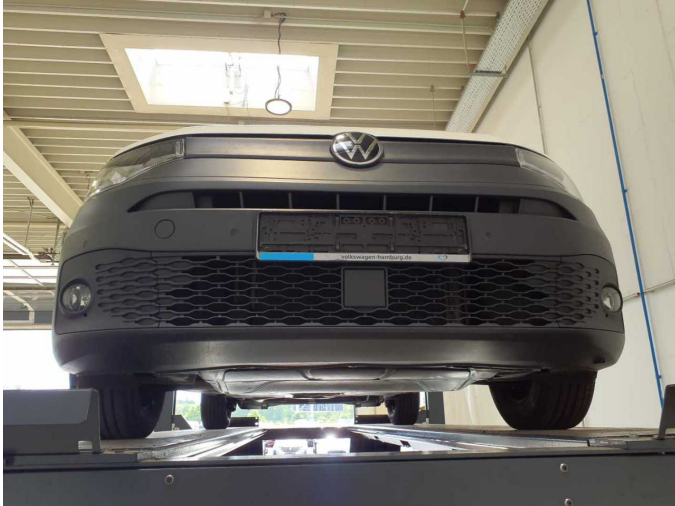
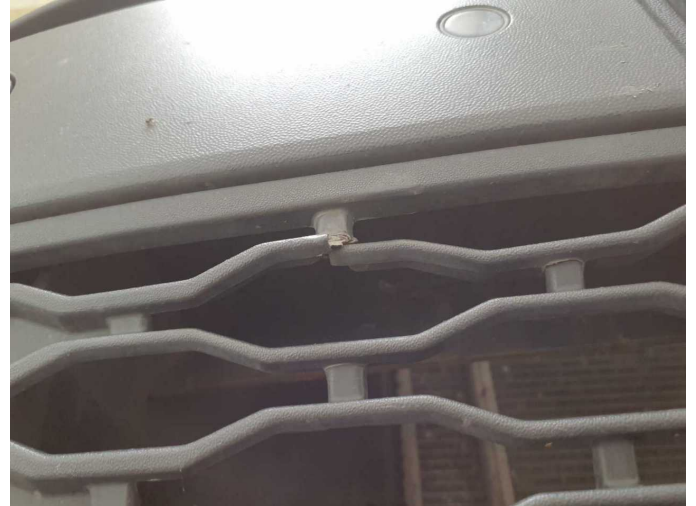
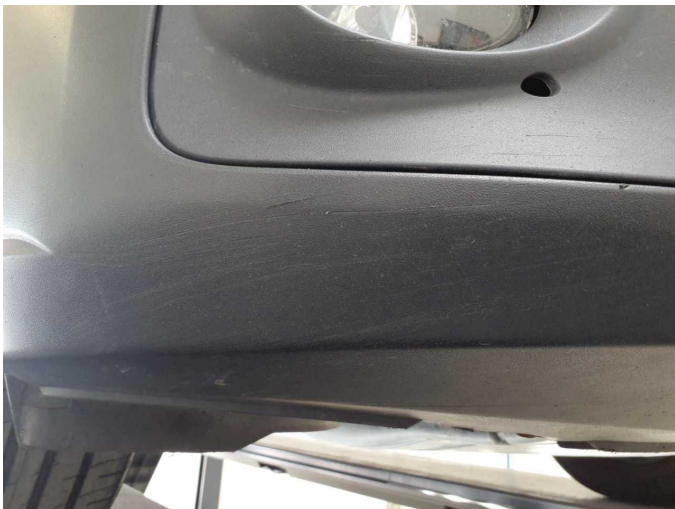
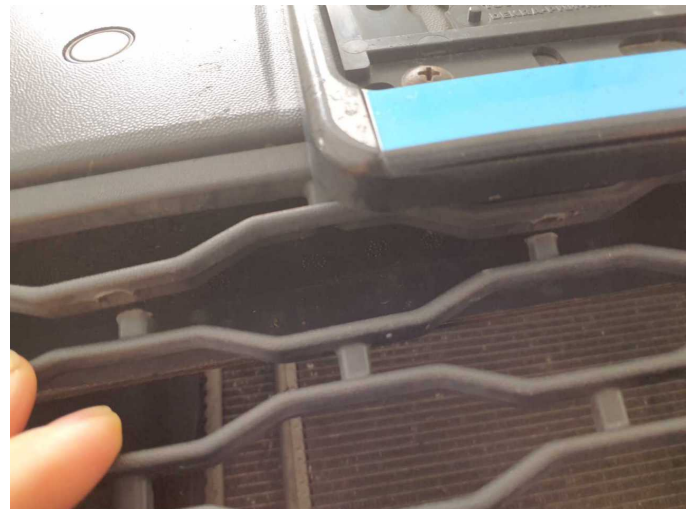
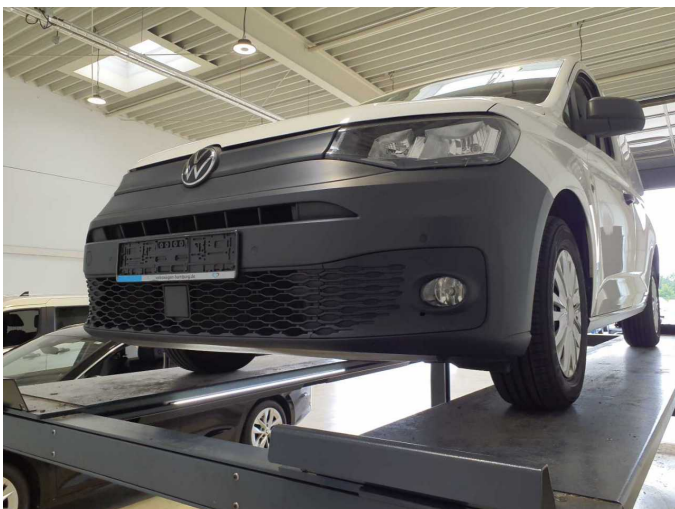
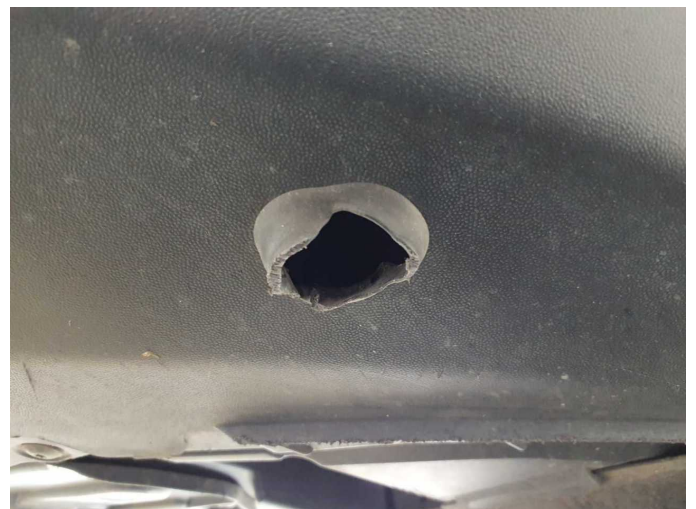
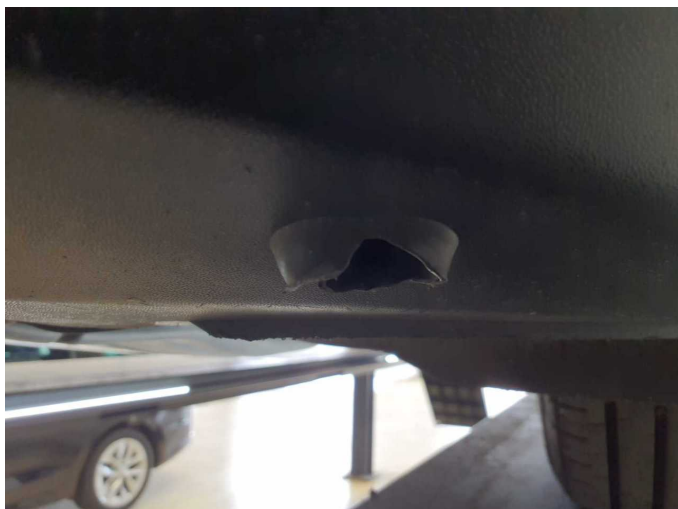
| No. | Component group | Description |
|---|---|---|
| 5 | Front bumper | Front bumper - Damaged - Replace |

**Damage 5:** Front bumper: Front bumper - Damaged - Replace

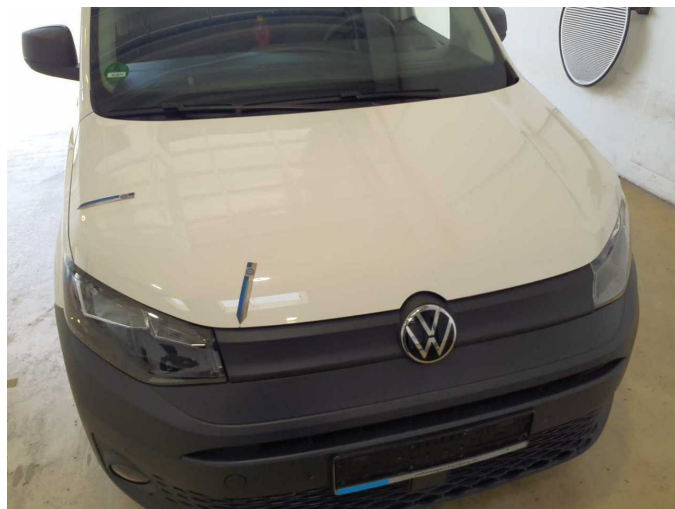
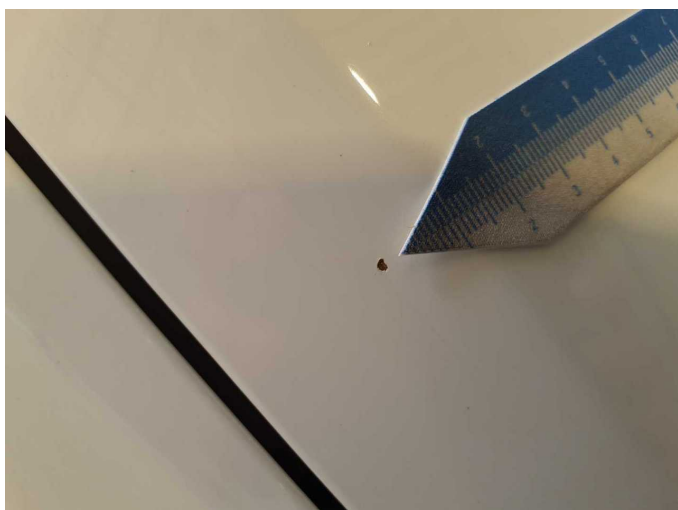
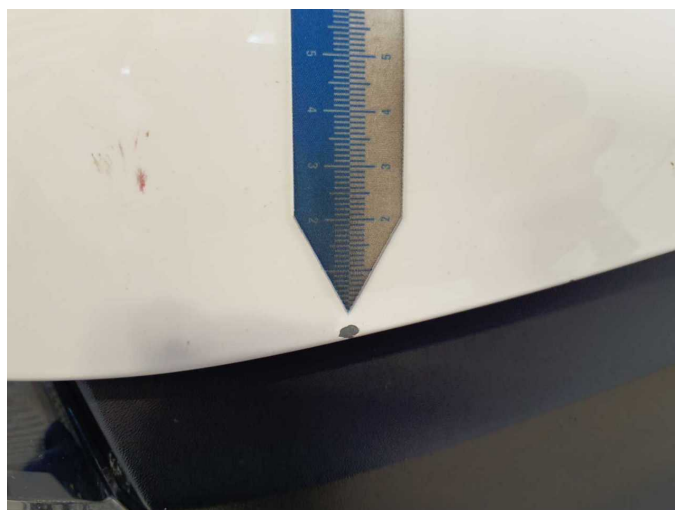
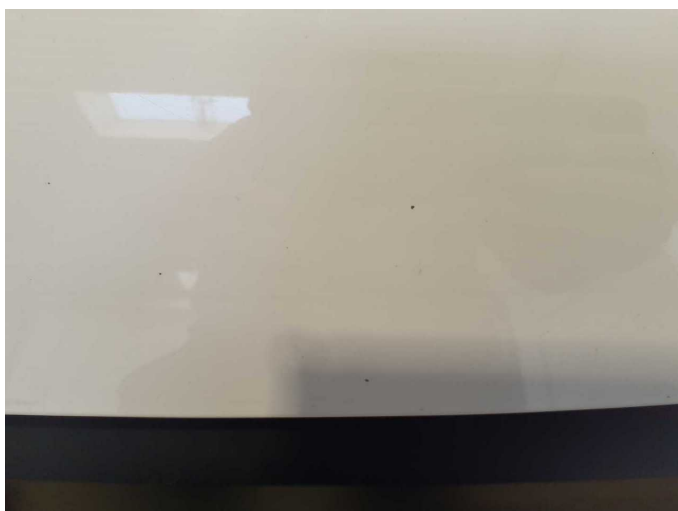
| No. | Component group | Description |
|---|---|---|
| 6 | Bonnet | Bonnet - Corrosion - Paint |

**Damage 6:** Bonnet: Bonnet - Corrosion - Paint

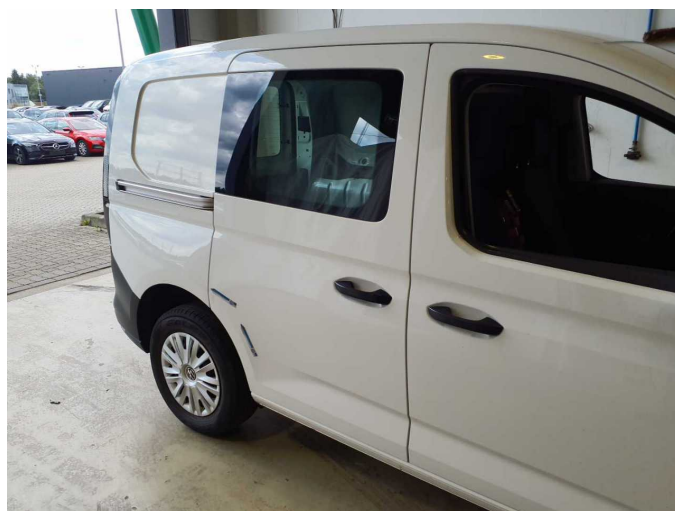
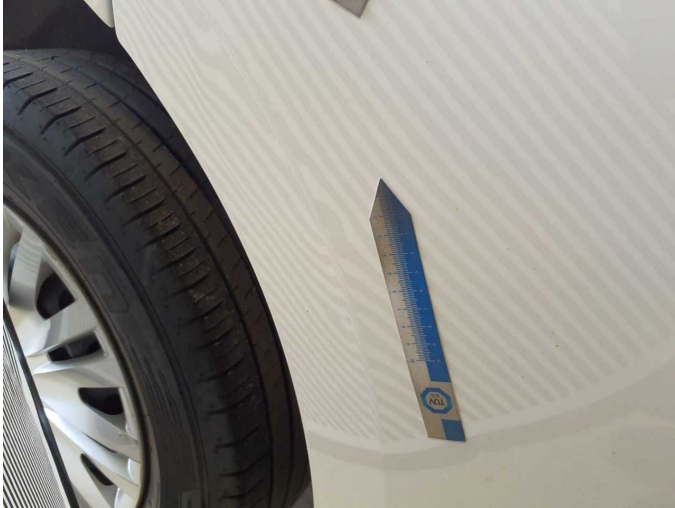
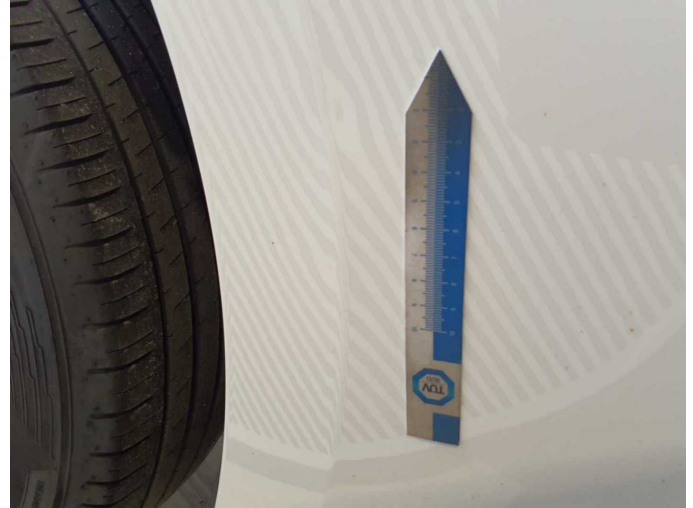
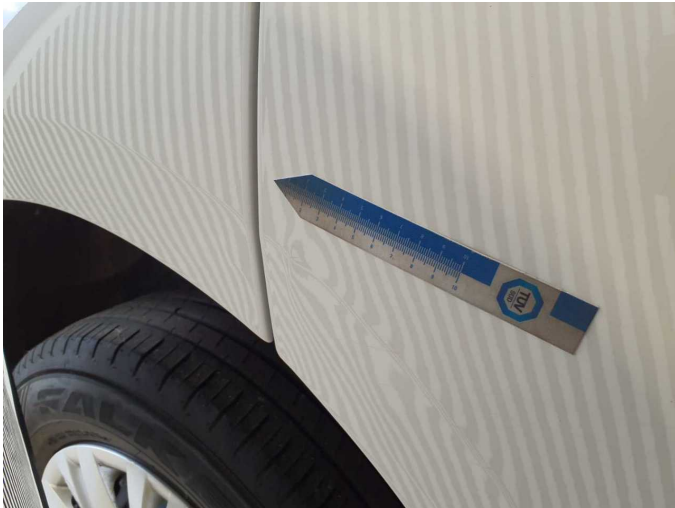
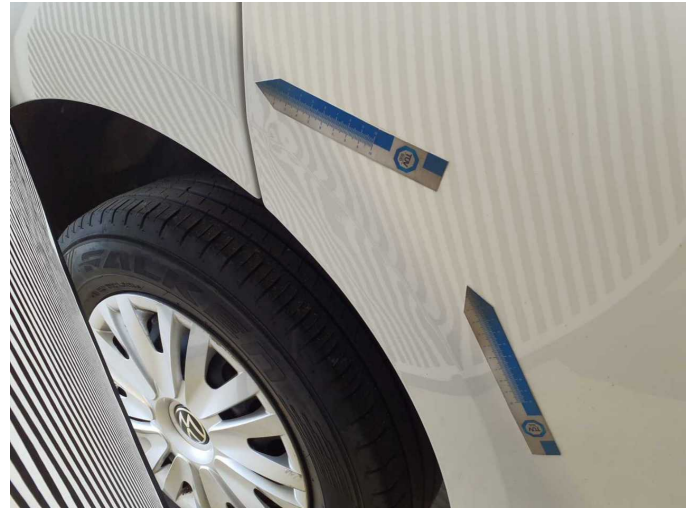
| No. | Component group | Description |
|---|---|---|
| 7 | Sliding door, right | Sliding door - Deformed - Repair and paint |

**Damage 7:** Sliding door, right: Sliding door - Deformed - Repair and paint

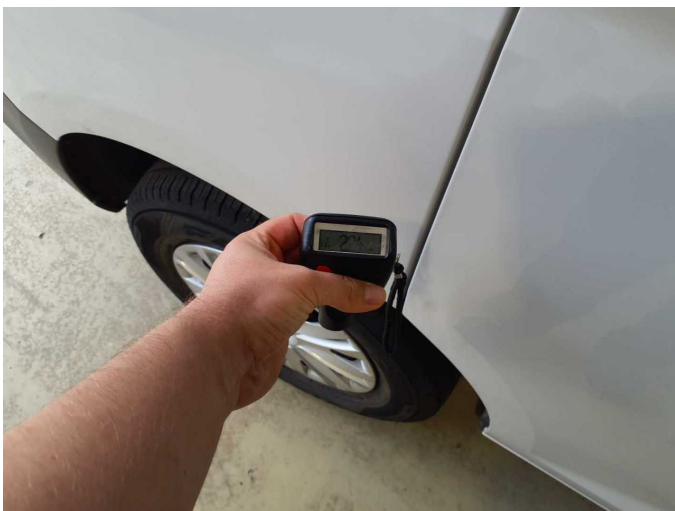
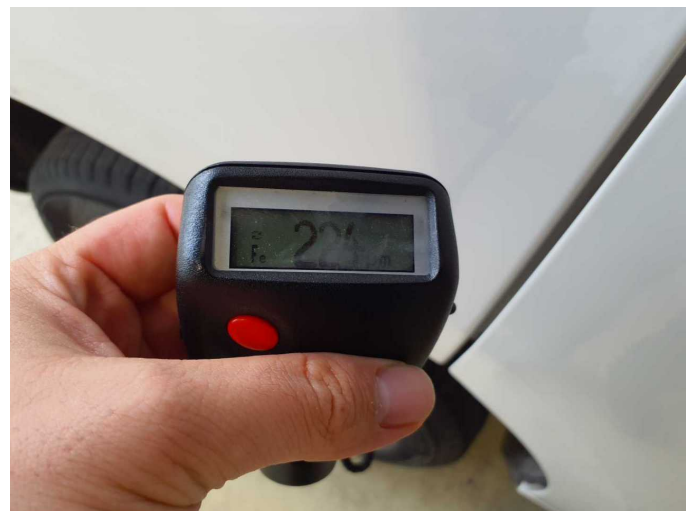
| Side panel - rear right side | 224 µm | Door - front left side | 226 µm |

**Repainting 1:** Side panel - rear right side

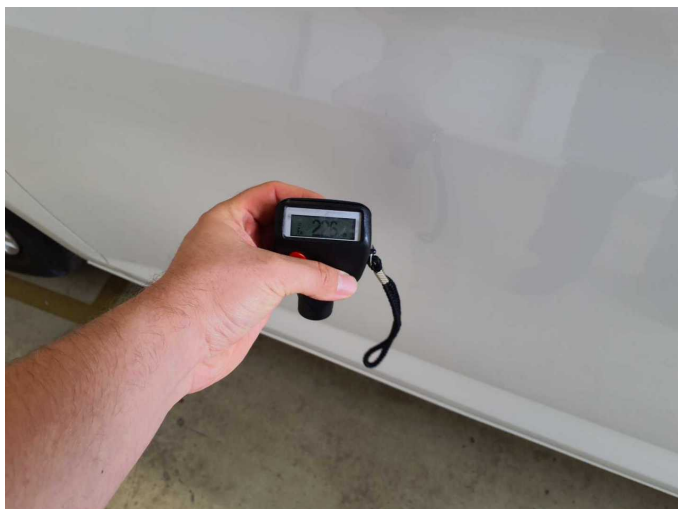
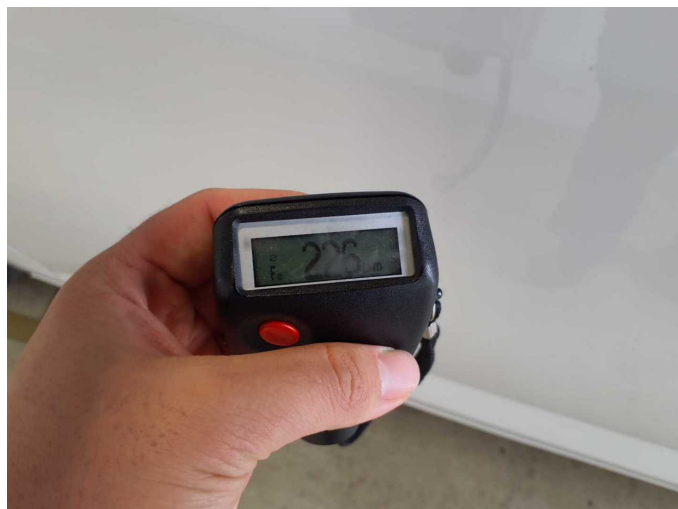
**Repainting 2:** Door - front left side
