## Expertise

Protocol number: 45868540  
Order No. / Reference: 26153155  
Inspection date: 1 Jun 2026

Model: 317 CDI Sprinter Standard HA 9G-TRONIC PRO

VIN: W1V3KBFZ8TP864758

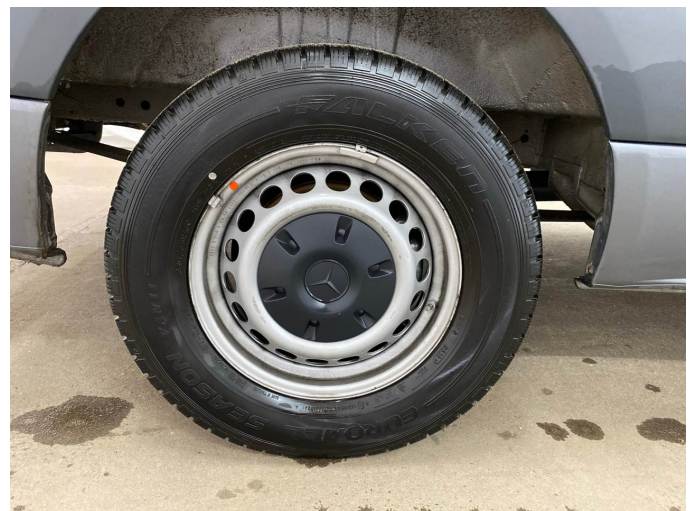
Figure 12: Mounted tyres

#	Tyre size	Type of tyre	Manufacturer	Tread depth
1)	235/65 R16 115R	All-season tyres on Steel rim with wheel cover	Falken	9mm / 9mm
2)	235/65 R16 115R	All-season tyres on Steel rim with wheel cover	Falken	6mm / 6mm

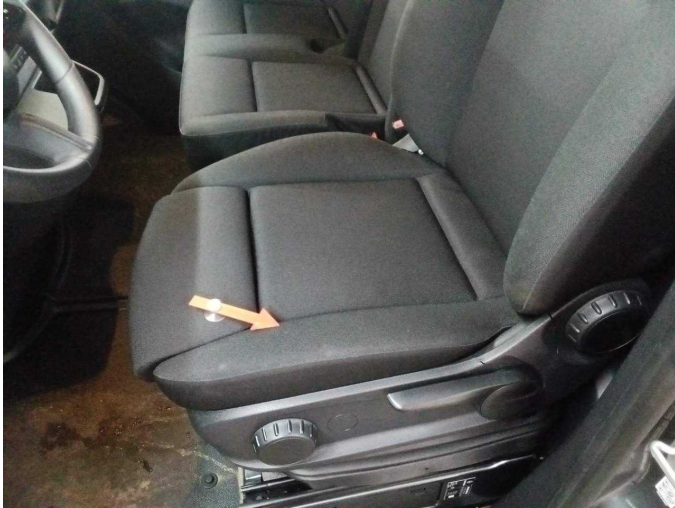
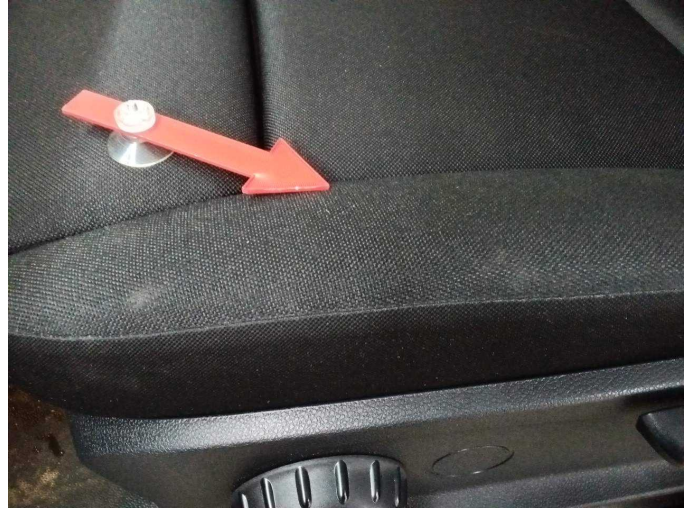
**Damage 3:** Seat - front: Seat cover - left side - Clean

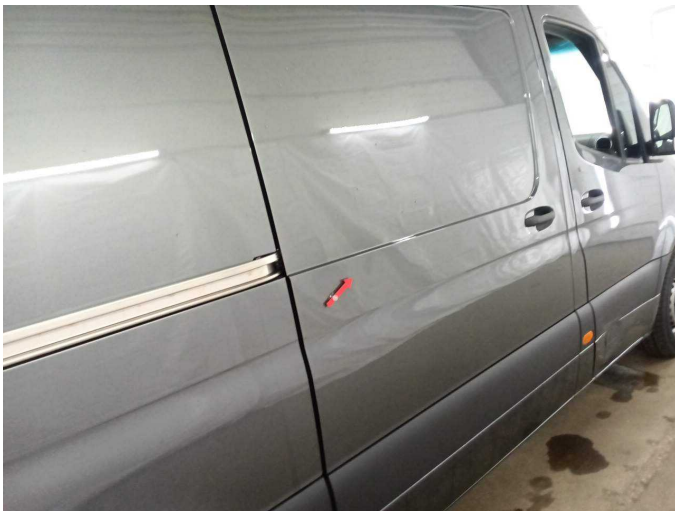
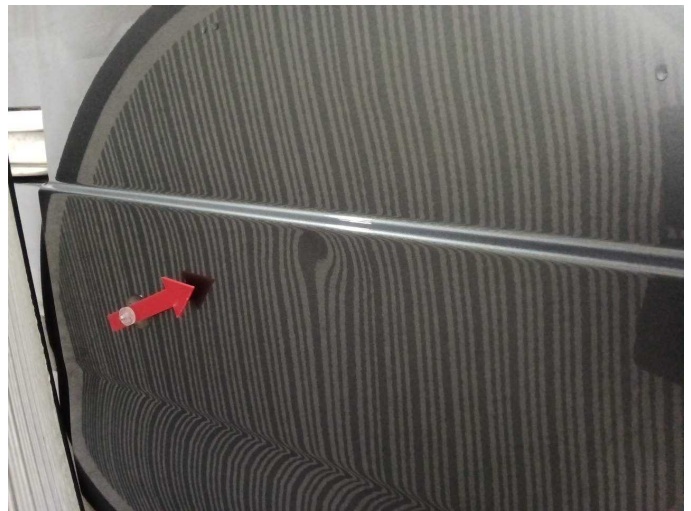
**Damage 4:** Sliding door, right: Sliding door - dent(s) - Repair

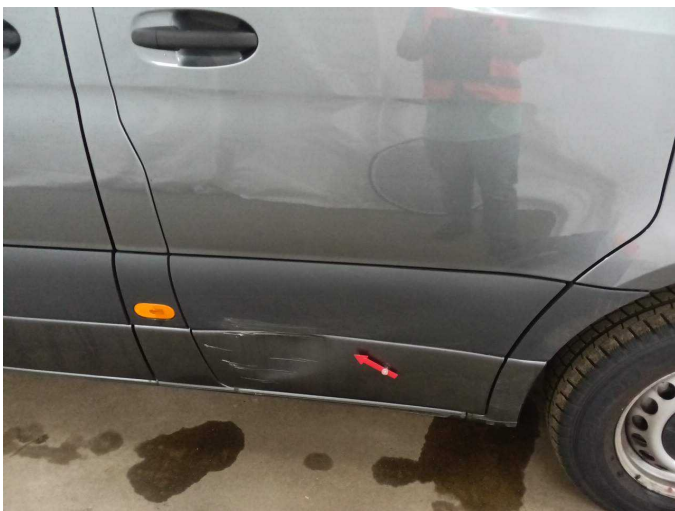
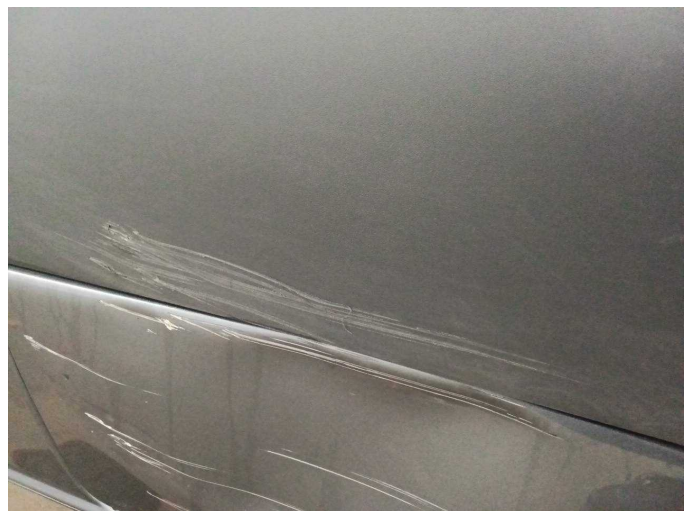
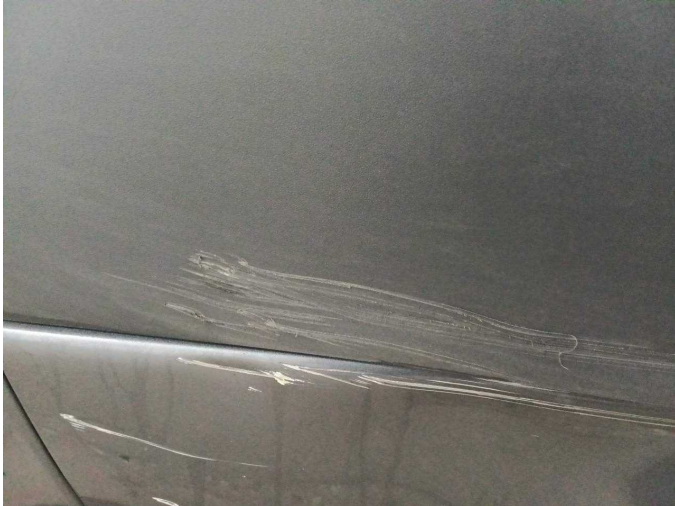
**Damage 5:** Door - front right side: Brightware - lower - Scratched - Replace

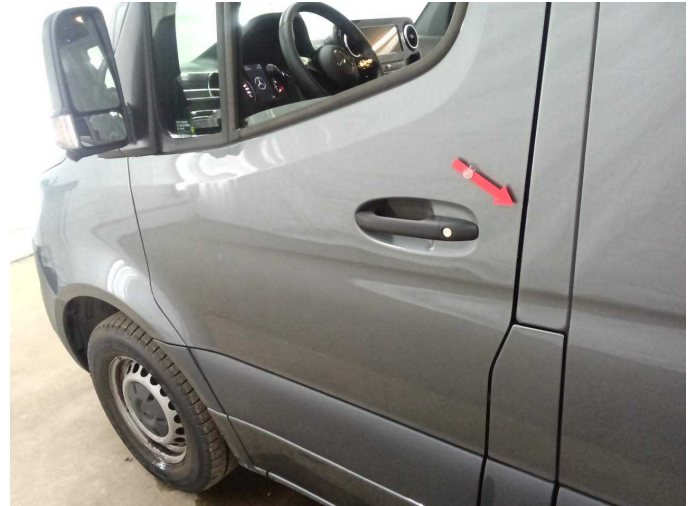
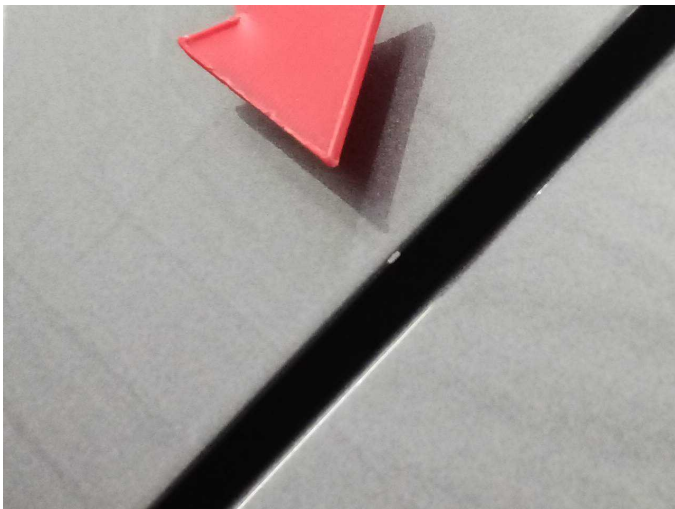
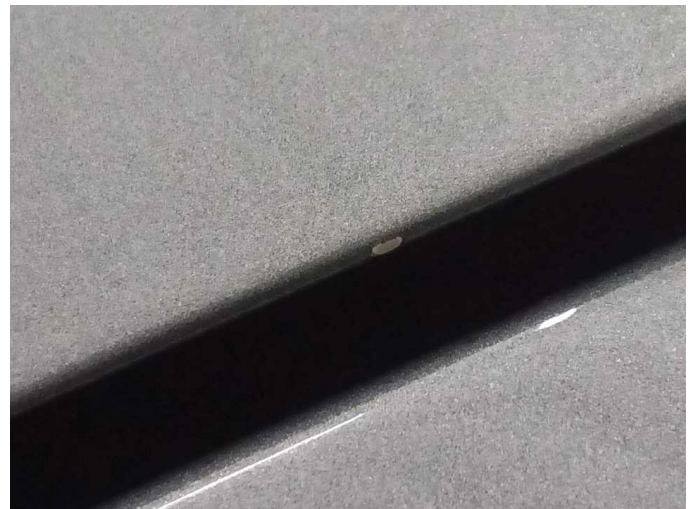
**Damage 6:** Door - front left side: Door edge - Scratch(es) - Smart repair

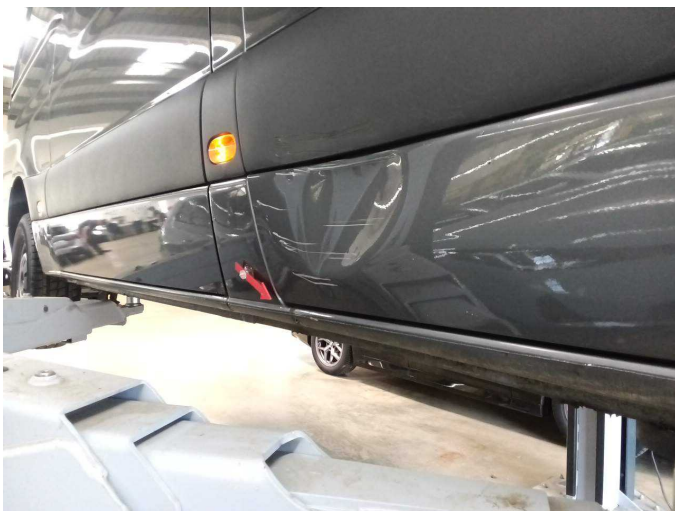
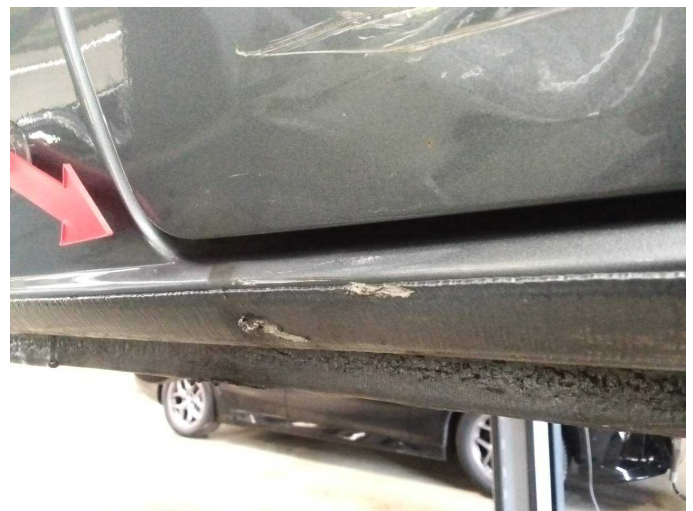
**Damage 7:** Sill - right side: Sill - Scratched - Smart repair

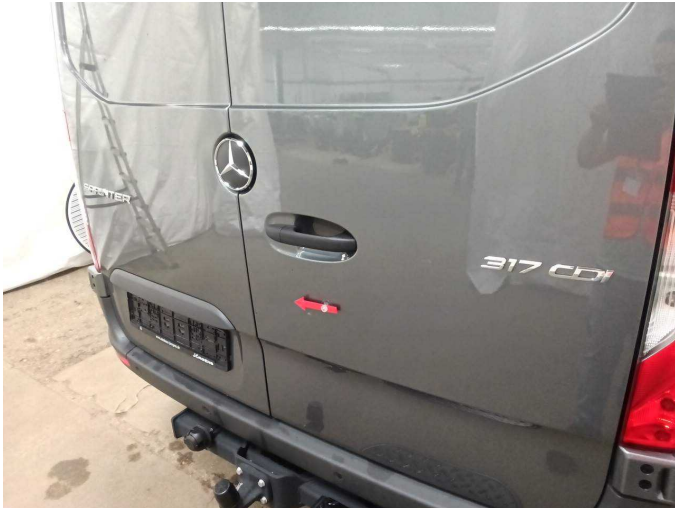
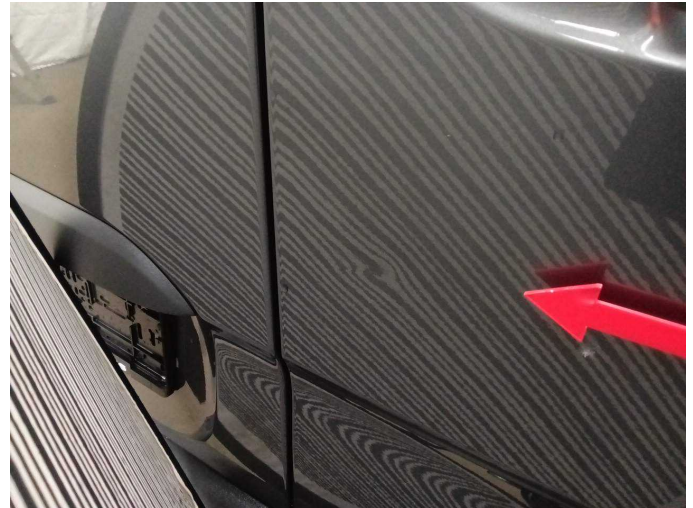
**Damage 8:** Boot lid / rear door: Rear door - right side - Dent / paintcoat damage - Smart repair

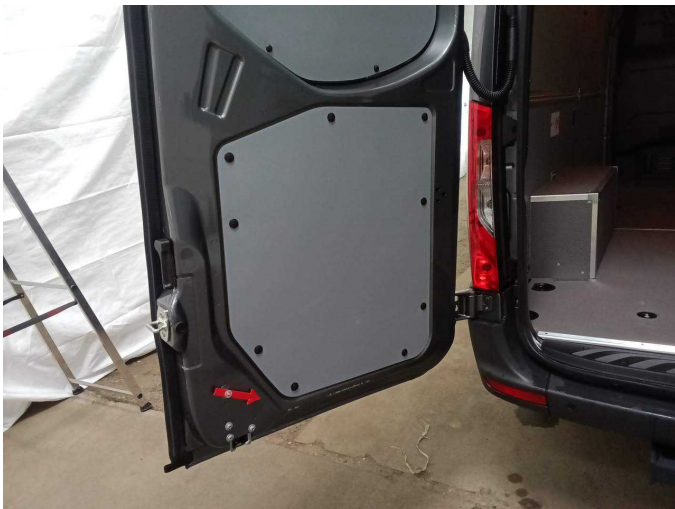
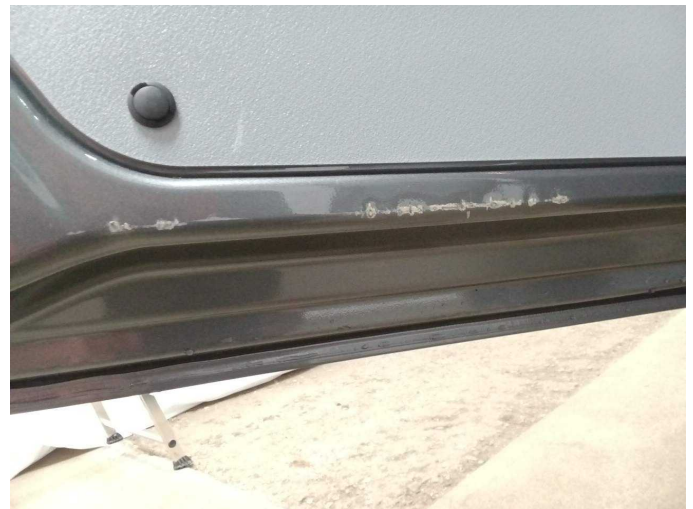
**Damage 9:** Boot lid / rear door: Rear door - left side (innen) - Dent / paintcoat damage - Smart repair

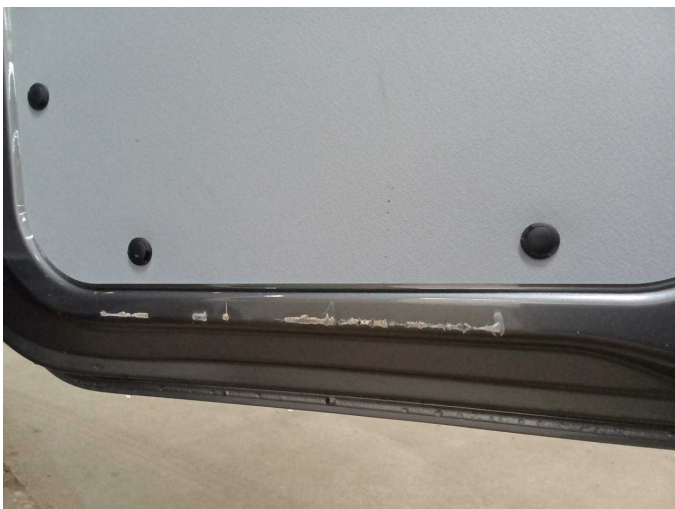
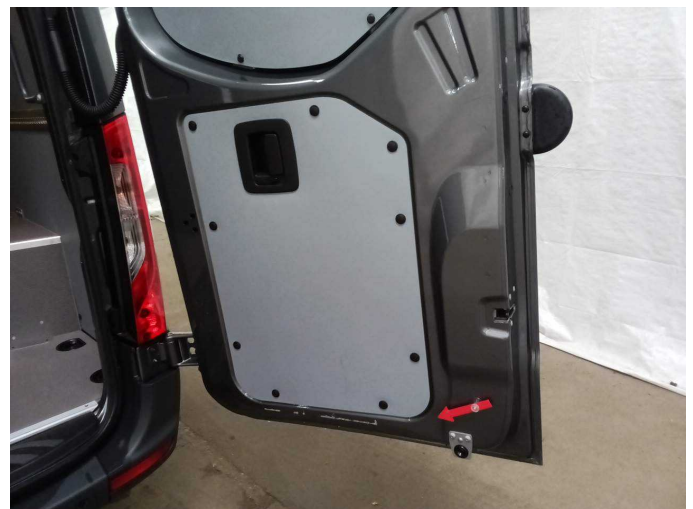
**Damage 10:** Boot lid / rear door: Rear door - right side (innen) - Dent / paintcoat damage - Smart repair

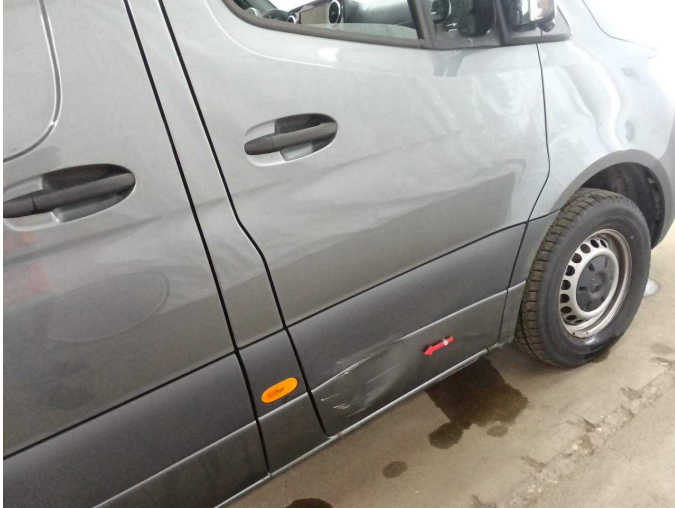
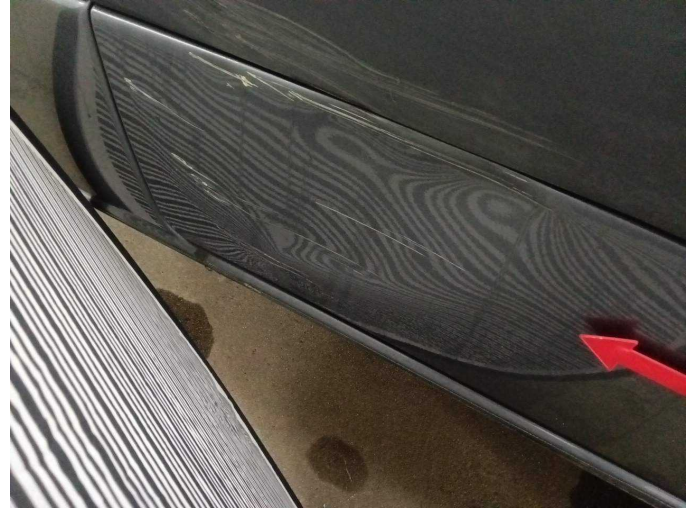
**Damage 11:** Door - front right side: Door - Dent / paintcoat damage - Smart repair

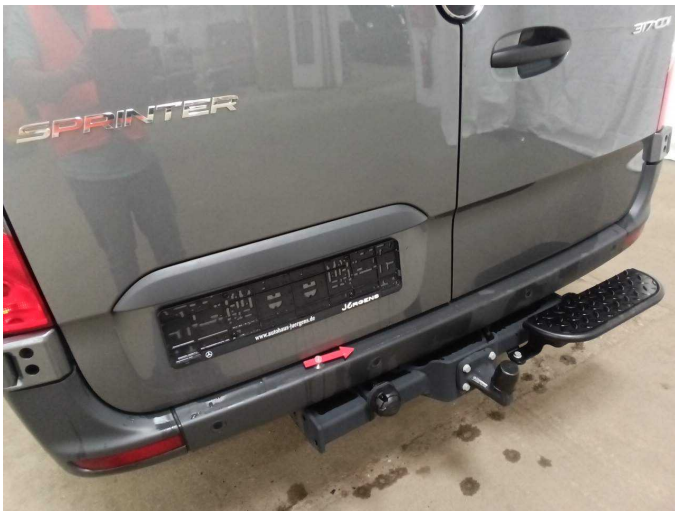
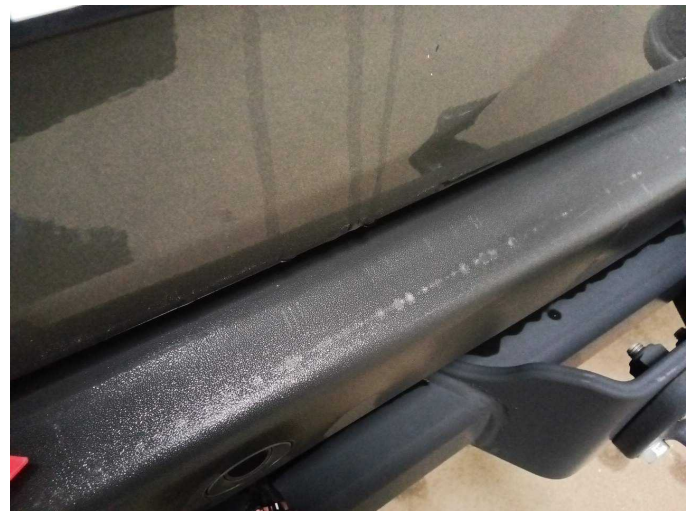
**Wear and tear 6:** Rear bumper: Rear bumper - Scratched - Loss in value
