Expertise

Protocol number: 46193226
Order No. / Reference: 25933475
Inspection date: 22 May 2026

Model: Vito 116 CDI Tourer Lang Aut. PRO

VIN: W1VVLFEZ3T4559247

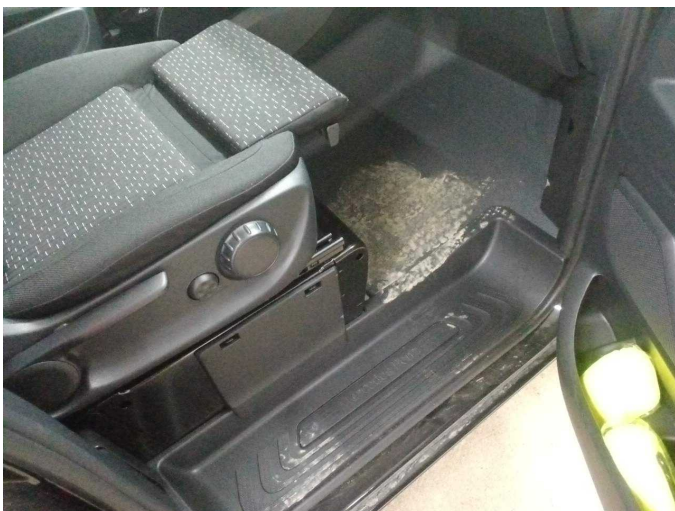
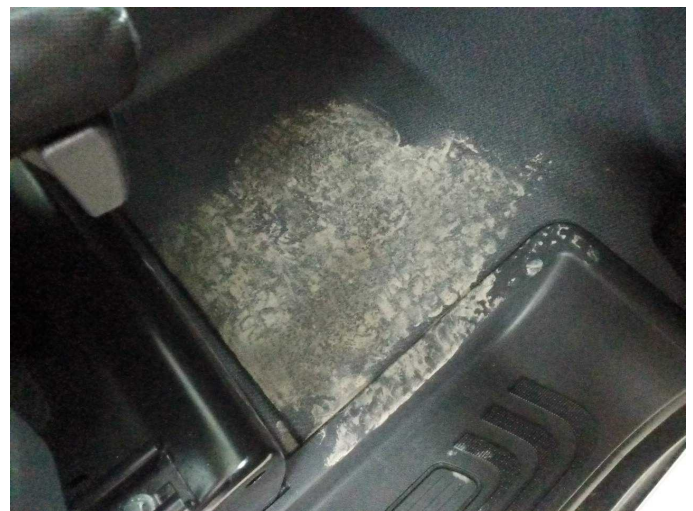
Damage 2: Interior: Interior - Soiled - Clean

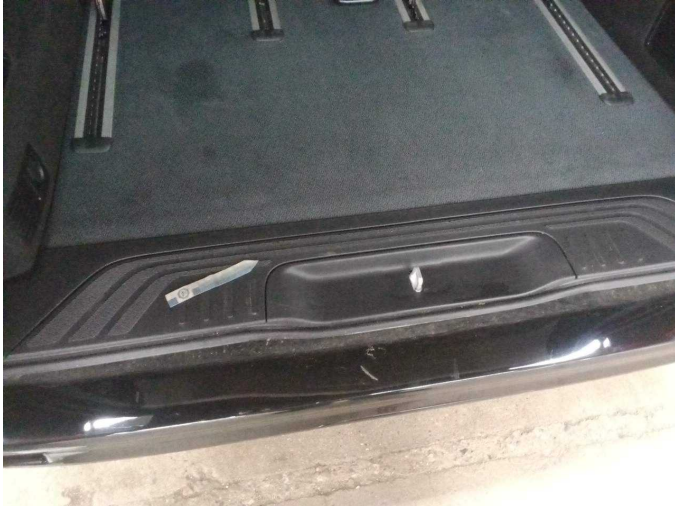
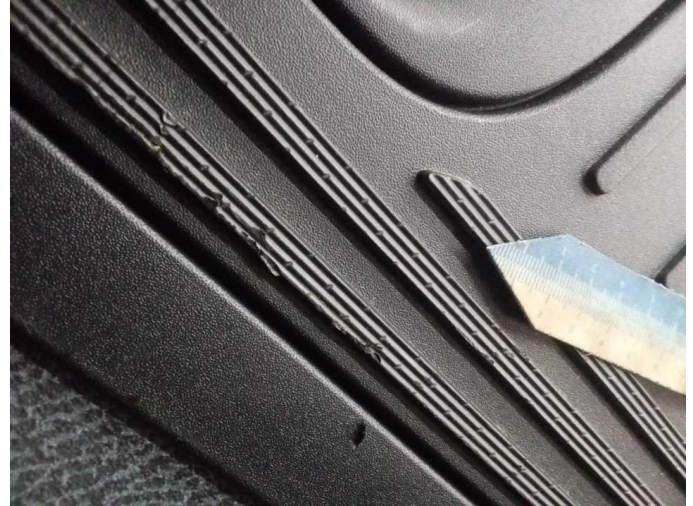
Damage 3: Trim / covers: Boot sill cover - Scratched - Loss in value

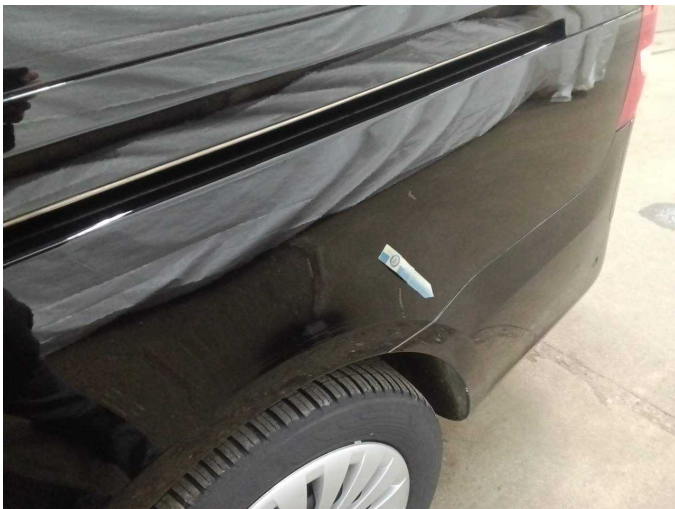
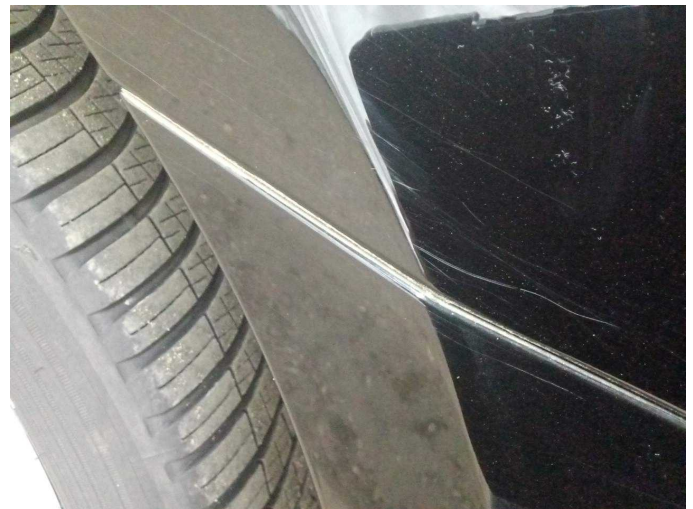
Damage 4: Side panel - rear left side: Side panel - Scratch(es) - Smart repair

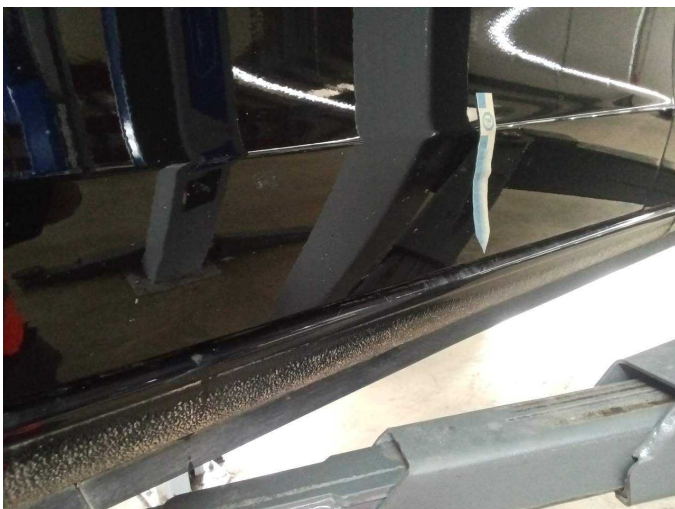
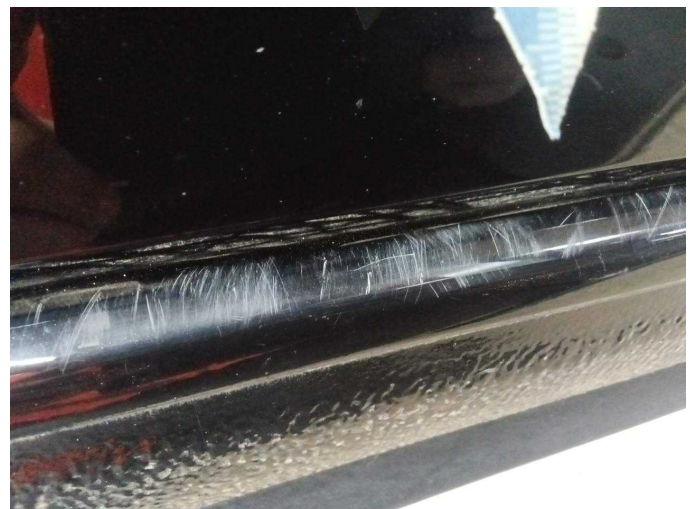
Damage 5: Sill - left side: Sill - Scratch(es) - Smart repair

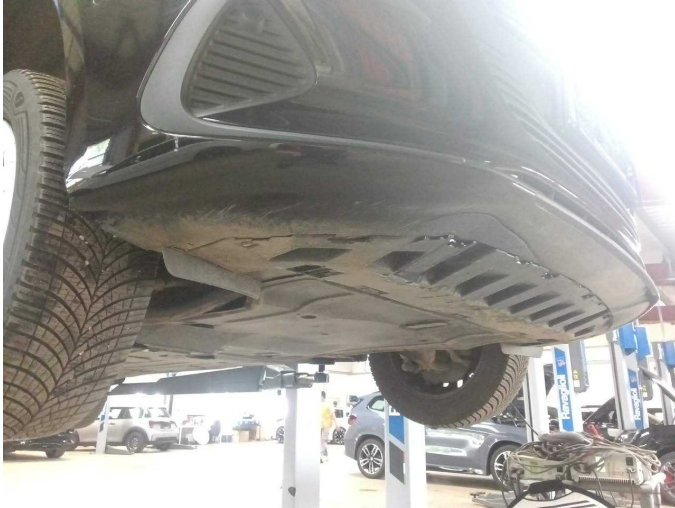
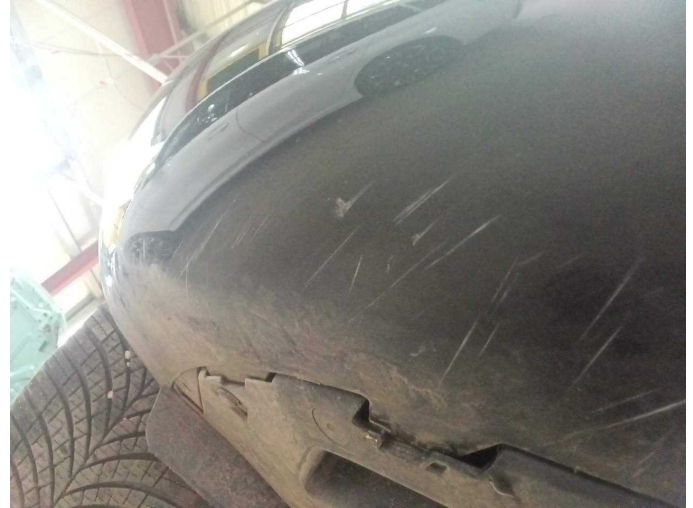
Damage 6: Front bumper: Front bumper - Scratched - Smart repair

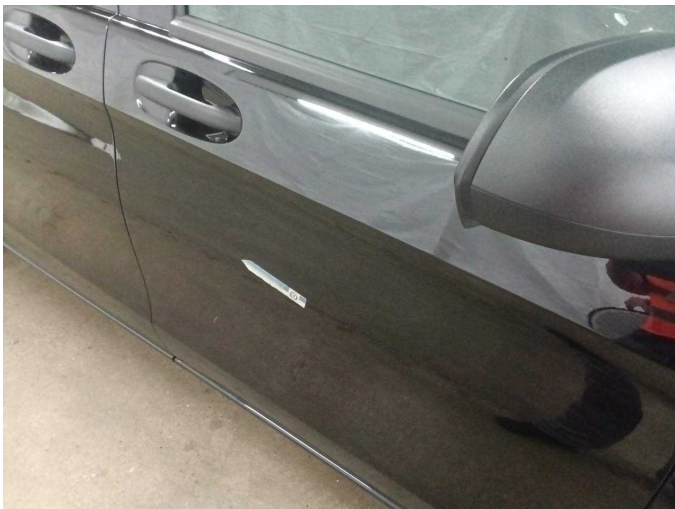
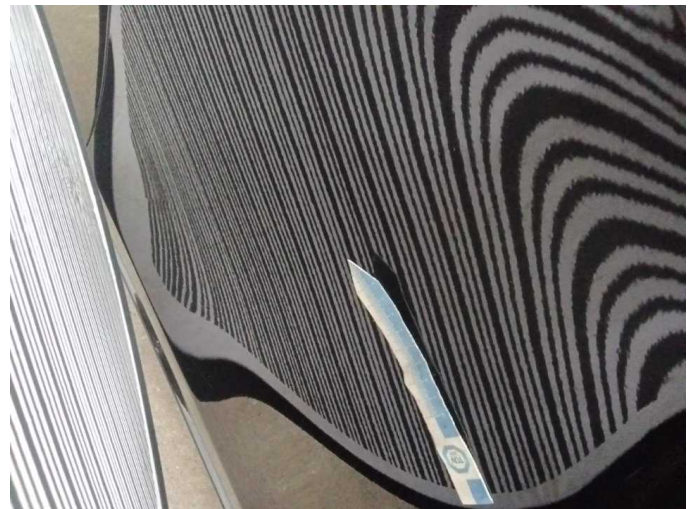
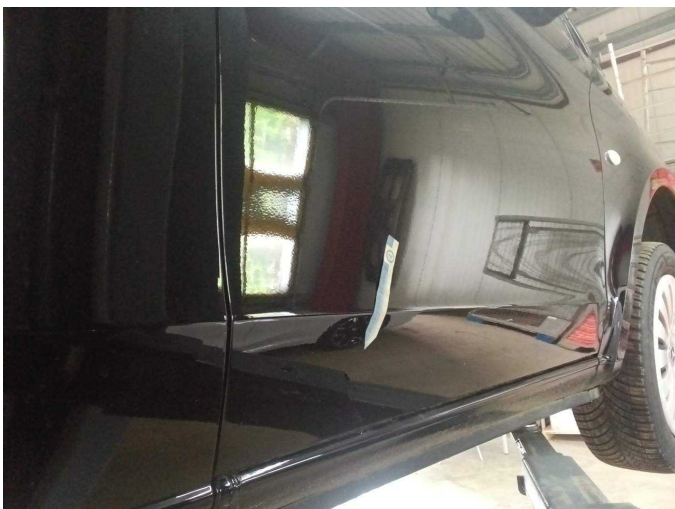
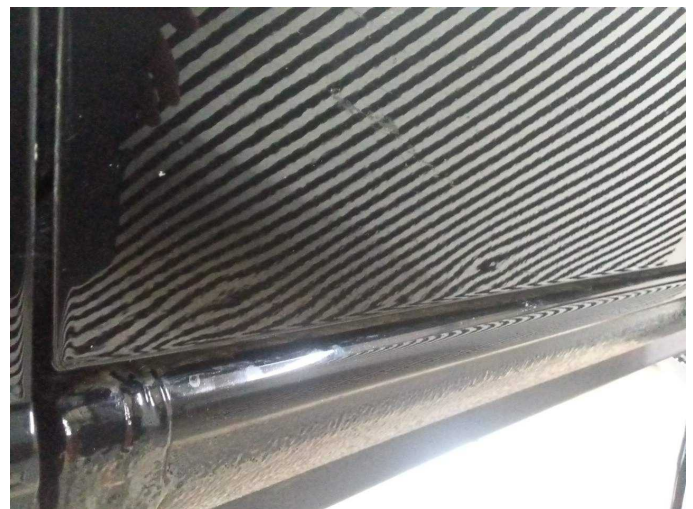
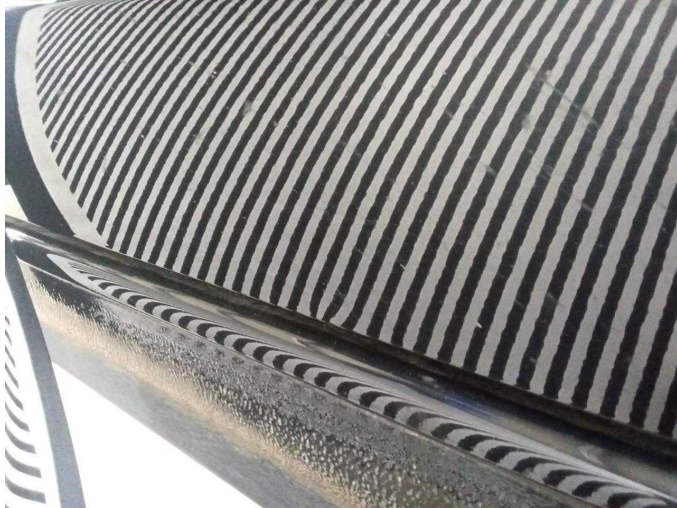
Damage 7: Door - front right side: Door - dent(s) - Smooth repair work

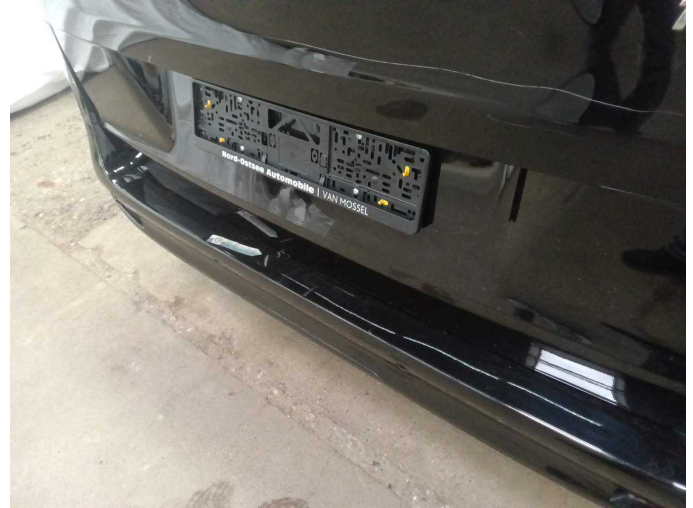
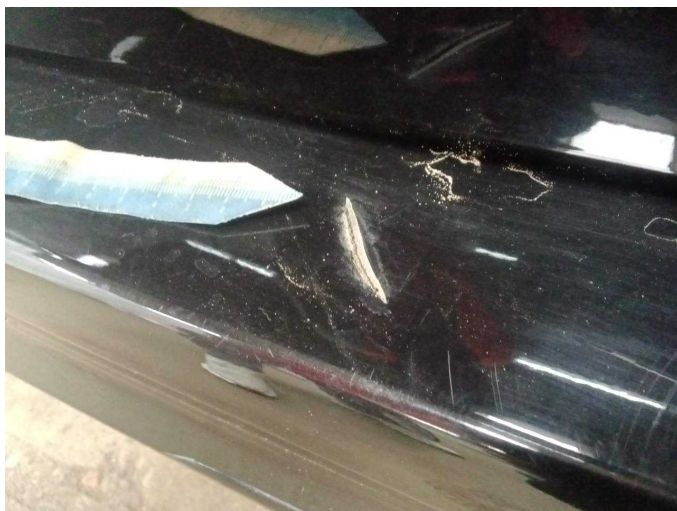
Damage 8: Rear bumper: Rear bumper - Scratched - Repair and paint

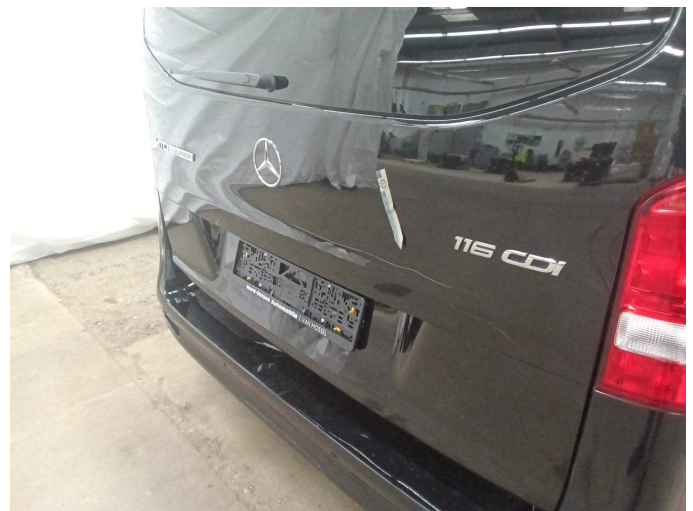
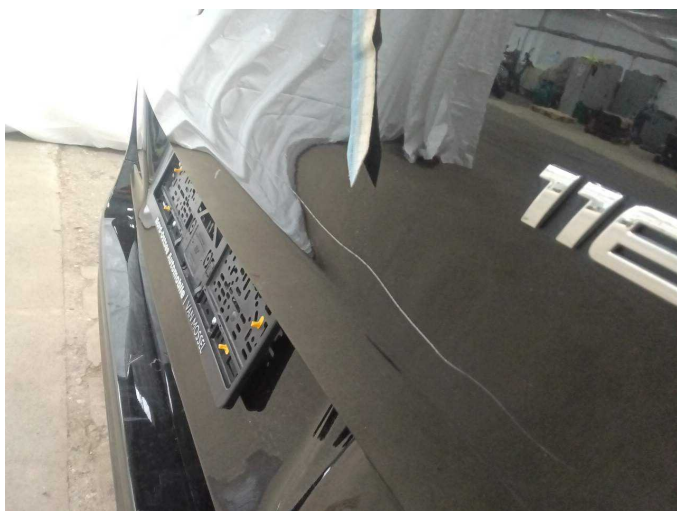
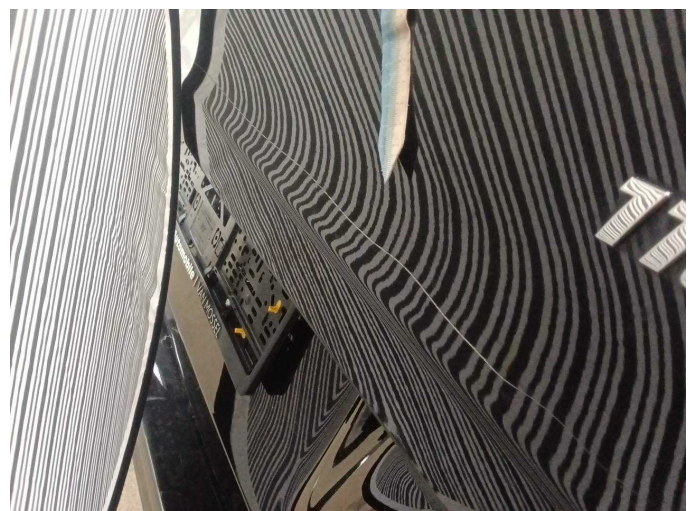
Damage 9: Boot lid / rear door: Boot lid - Scratch(es) - Paint

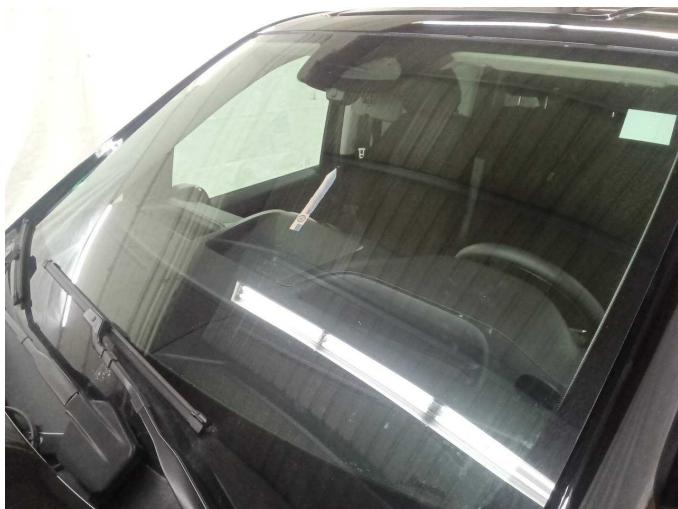
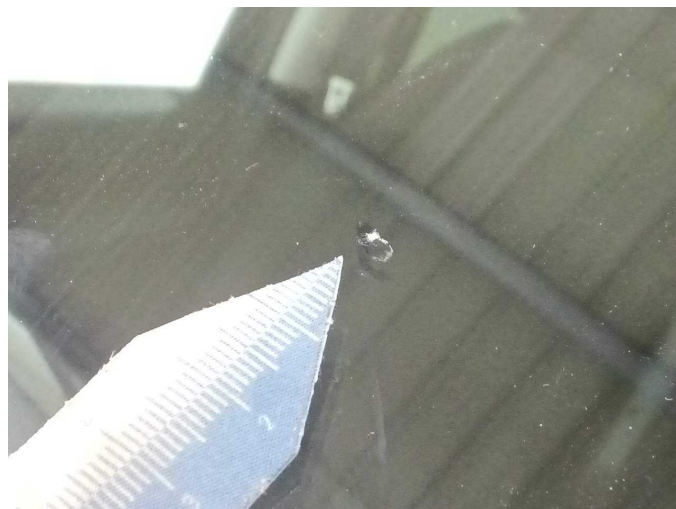
Damage 10: Vehicle glazing: Windscreen - Stone chips - Replace
