## Expertise

Protocol number: 45777300  
Order No. / Reference: 26529394  
Inspection date: 5 Jun 2026

Model: Focus Turnier 1.5 EcoBlue Start-Stopp-System Aut. TITANIUM

VIN: WF0PXXGCHPPL83995

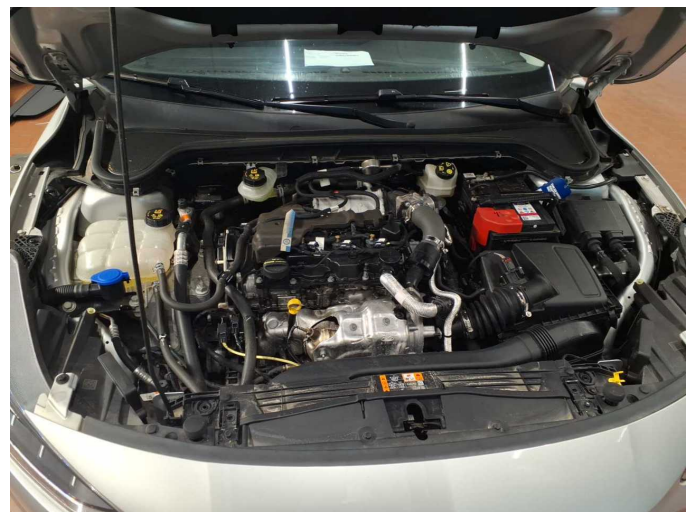
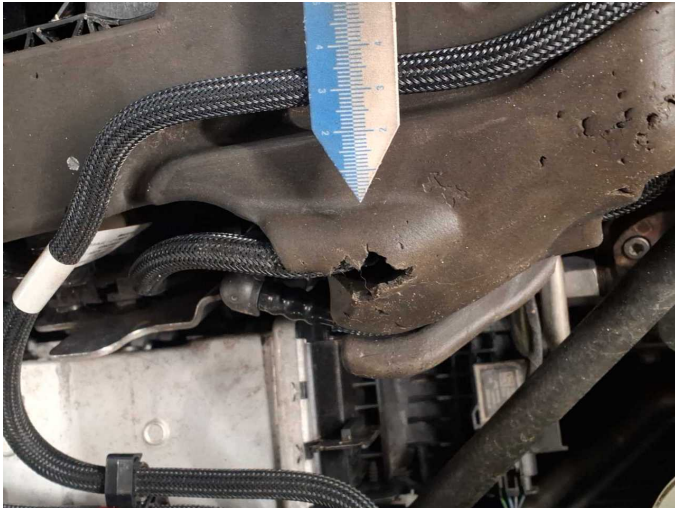
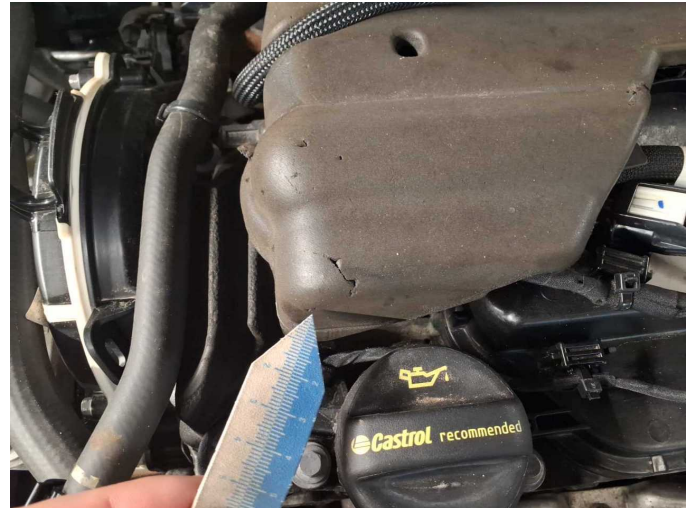
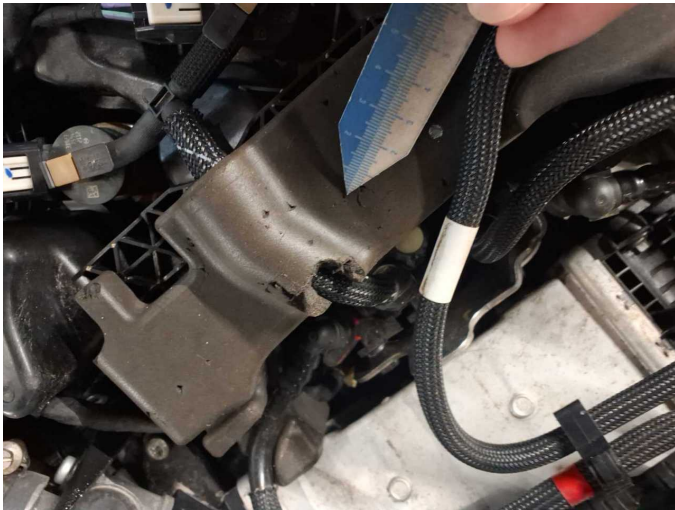
No.	Component group	Description
1	Misc.	Misc. (Isolierung Motor) - Damage caused by marten / rodent - Replace
2	Door - front right side	Door - dent(s) - Smooth repair work
3	Roof	Roof - dent(s) - Smooth repair work
4	Bonnet	Bonnet - dent(s) - Smooth repair work
5	Door - front left side	Door - Scratch(es) - Smart repair
6	Rear bumper	Rear bumper - Scratched - Paint
7	Front bumper	Front bumper (+ Steinschläge) - Dent / paintcoat damage - Repair and paint
8	Side panel - rear right side	Side panel - Dent / paintcoat damage - Repair and paint
9	Vehicle glazing	Windscreen (mit Heizung) - Stone chips - Replace
10	Trim / covers	Roof lining - Burn hole (cigarettes) - Replace

Damage 1: Misc.: Misc. (Isolierung Motor) - Damage caused by marten / rodent - Replace

**Damage 1:** Misc.: Misc. (Isolierung Motor) - Damage caused by marten / rodent - Replace

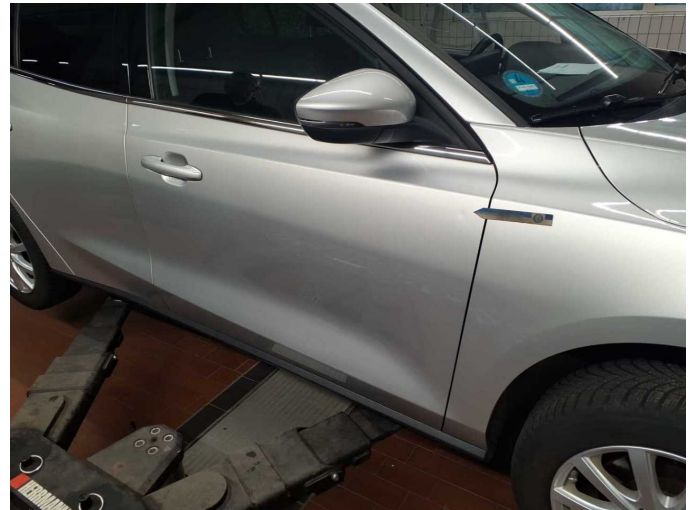
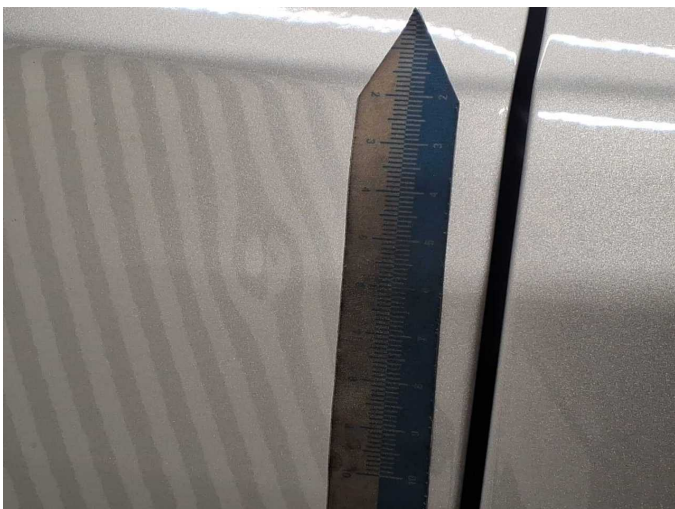
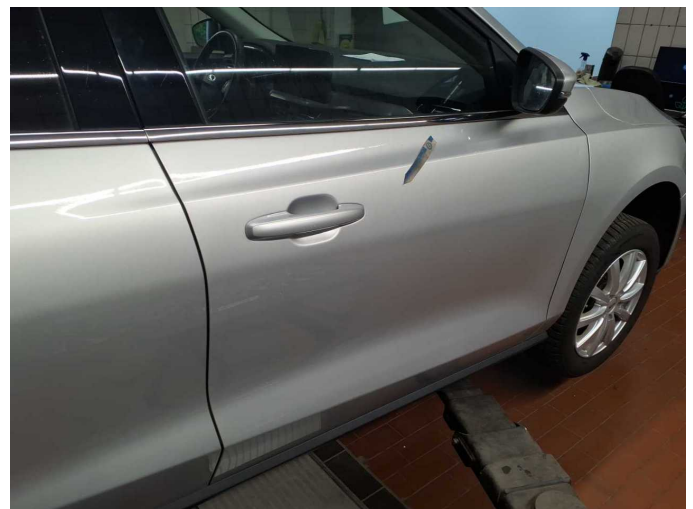
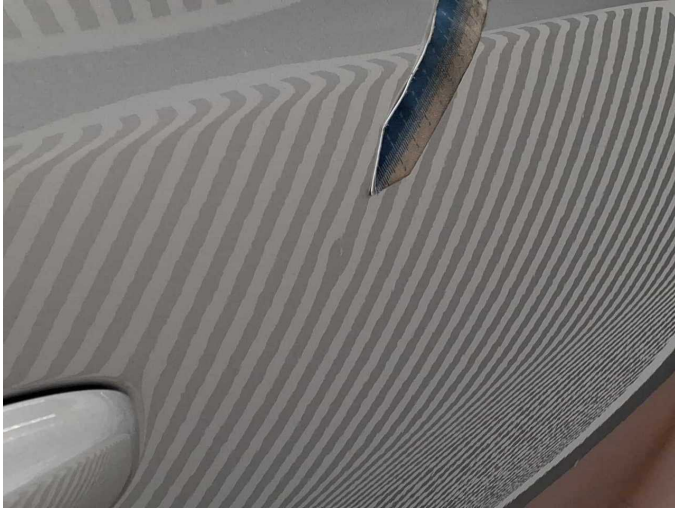
**Damage 2:** Door - front right side: Door - dent(s) - Smooth repair work

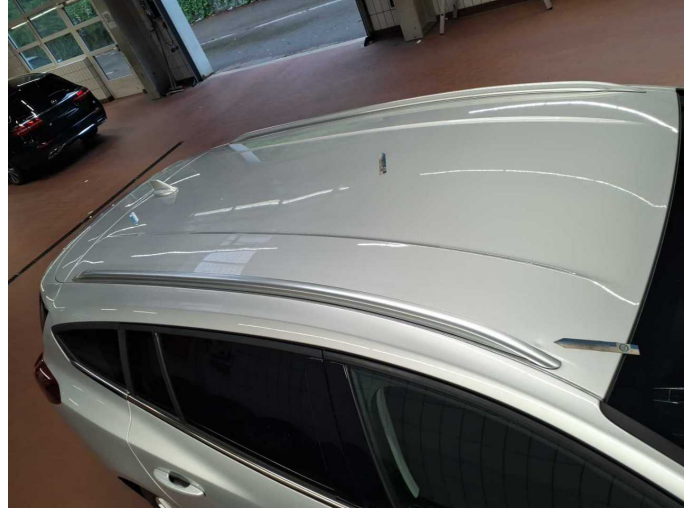
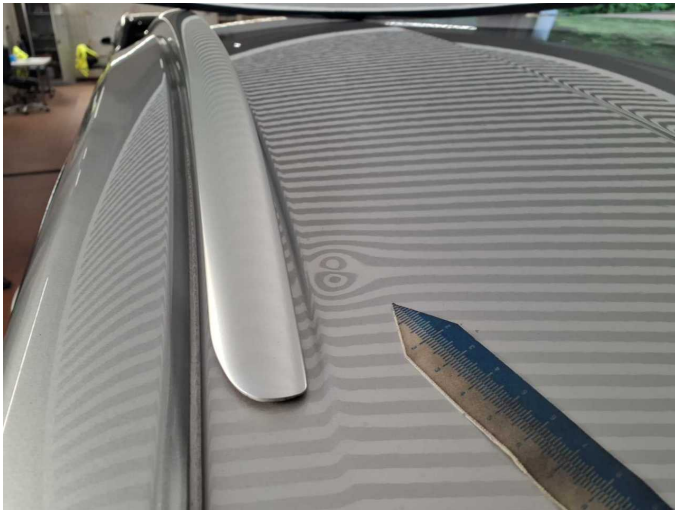
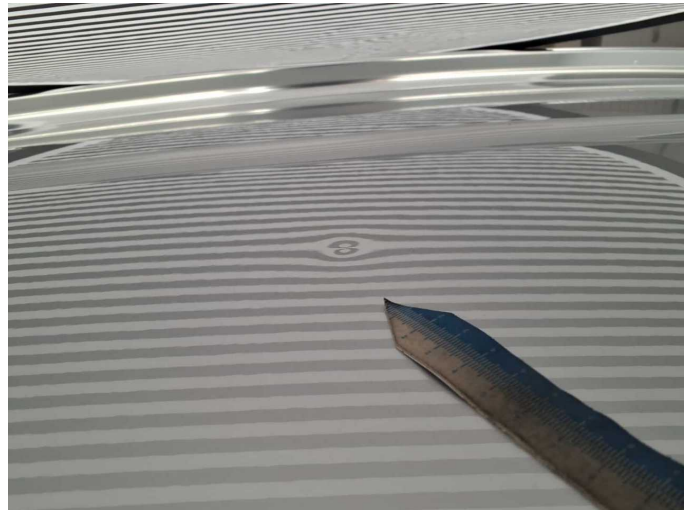
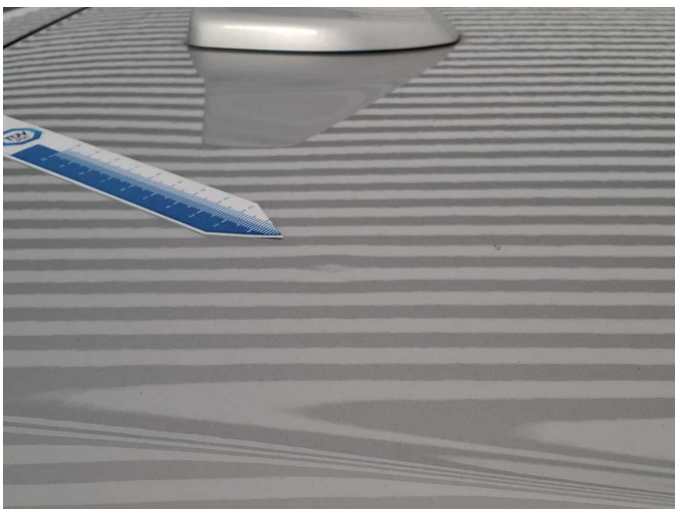
**Damage 3:** Roof: Roof - dent(s) - Smooth repair work

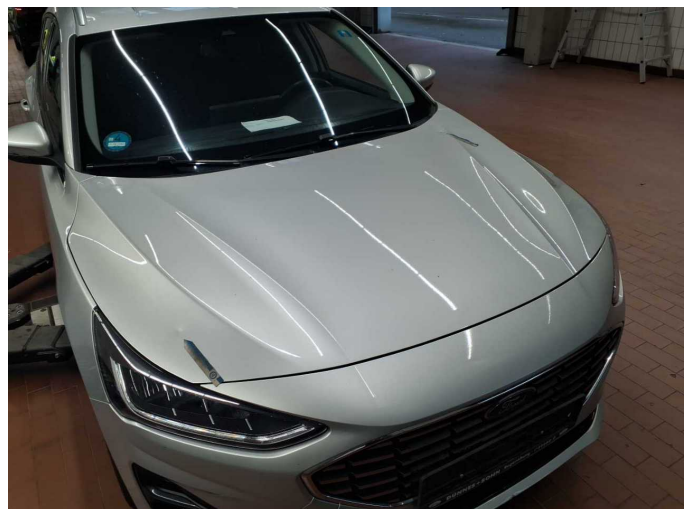
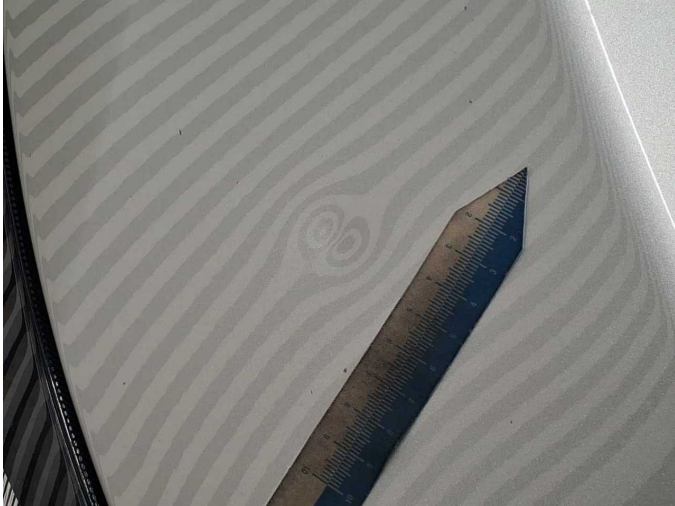
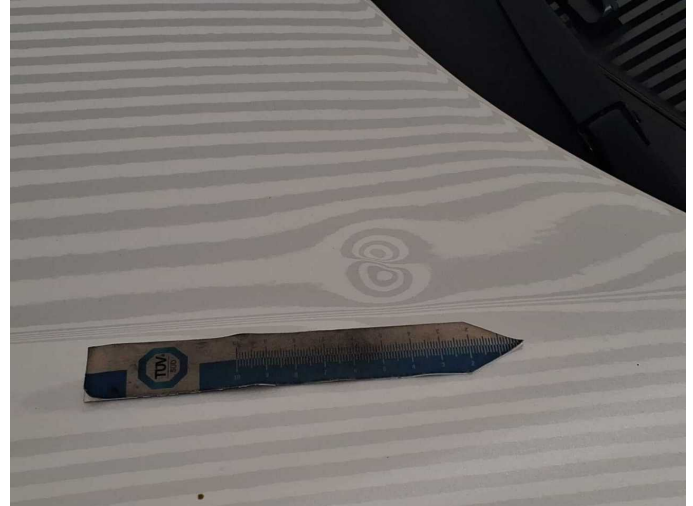
**Damage 4:** Bonnet: Bonnet - dent(s) - Smooth repair work

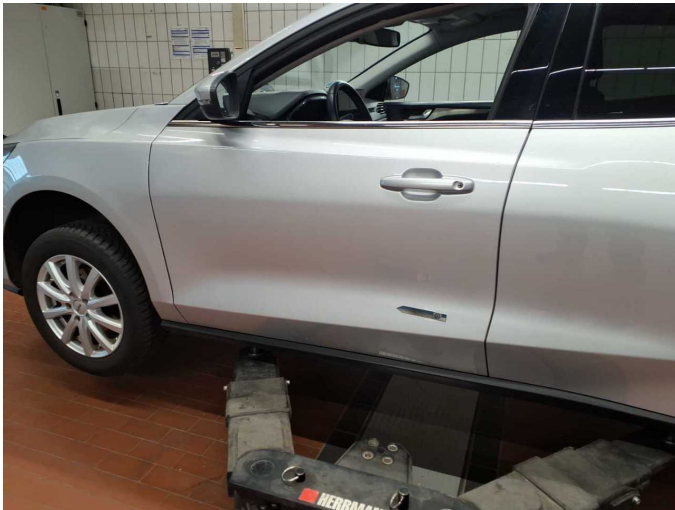
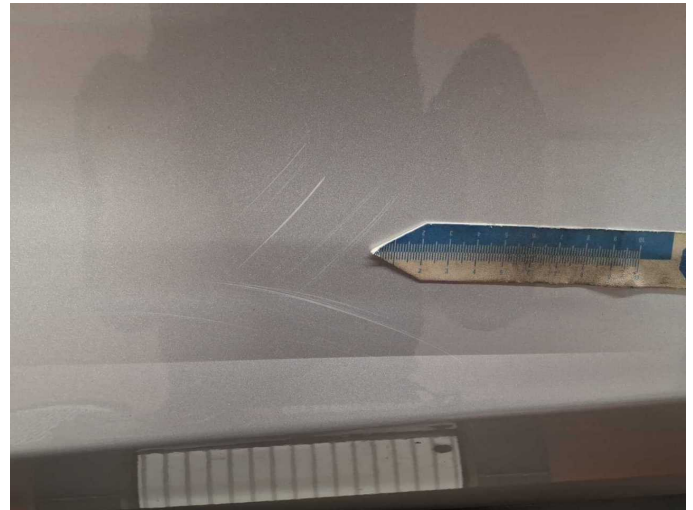
**Damage 5:** Door - front left side: Door - Scratch(es) - Smart repair

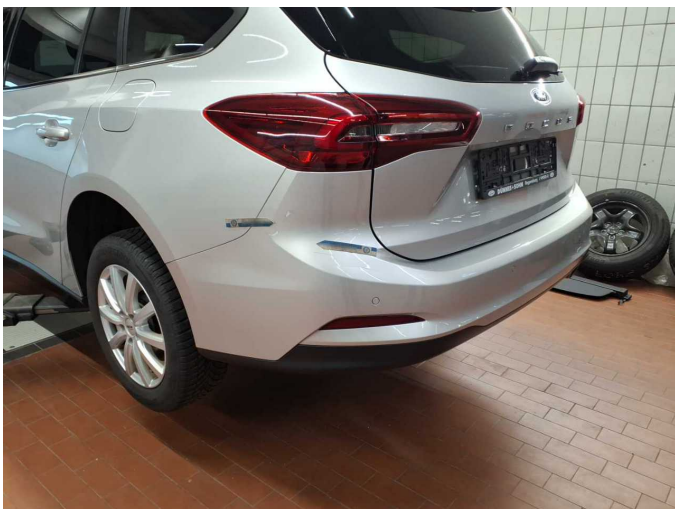
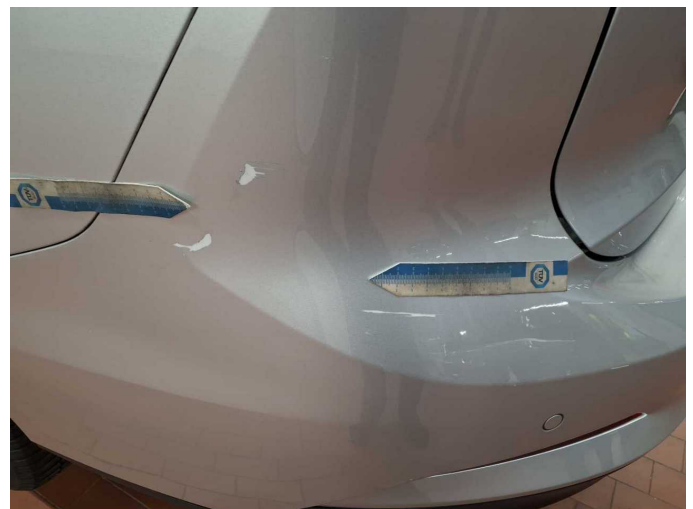
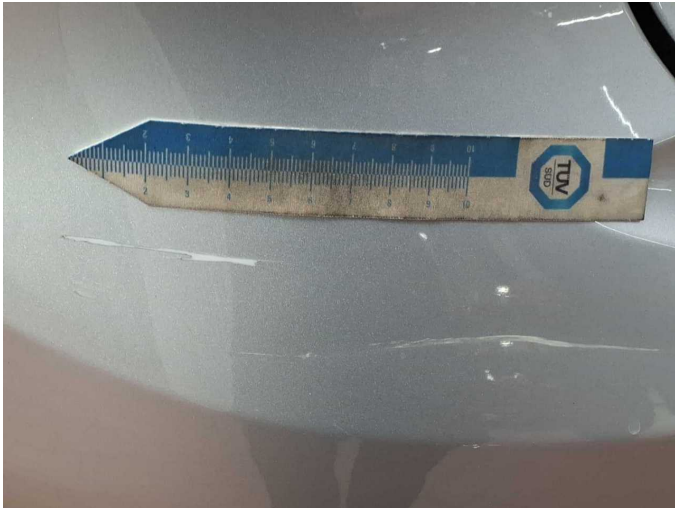
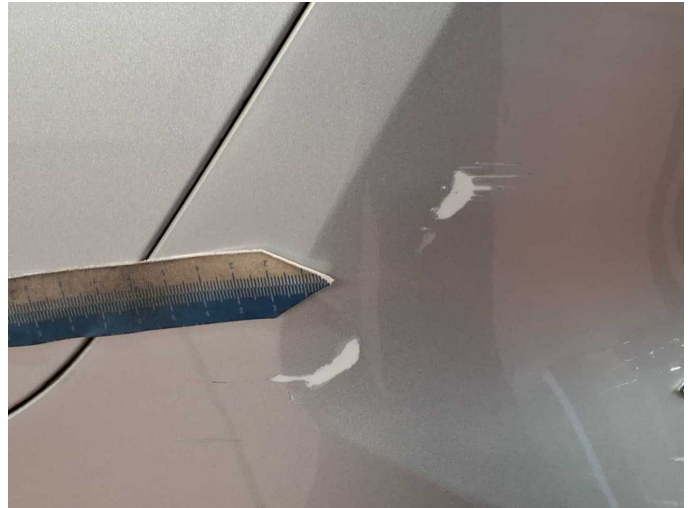
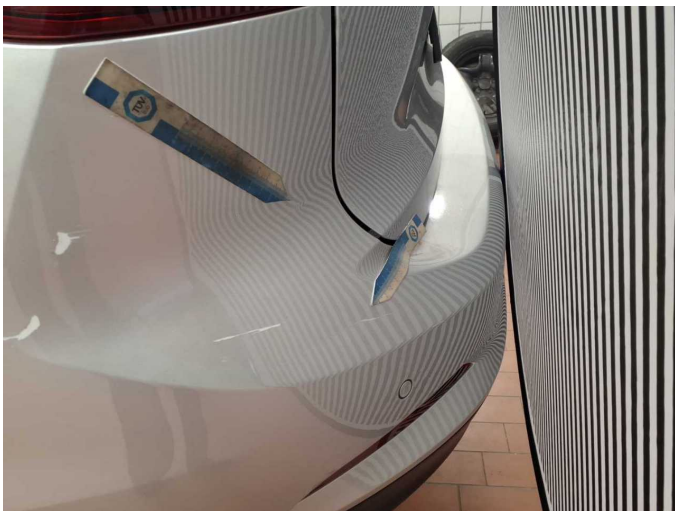
**Damage 6:** Rear bumper: Rear bumper - Scratched - Paint

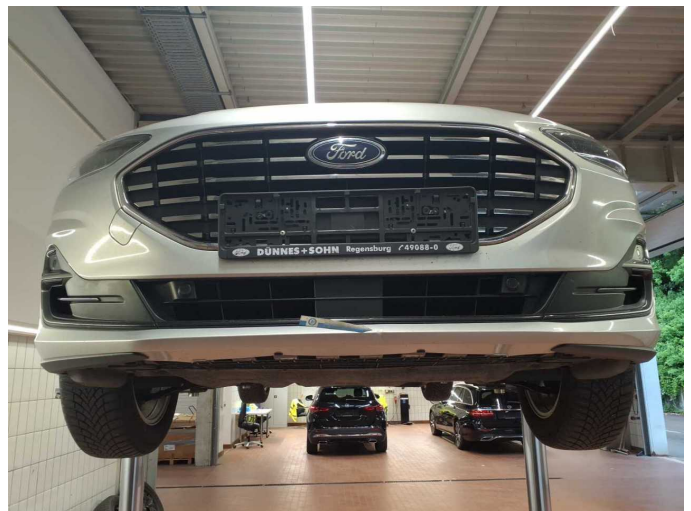
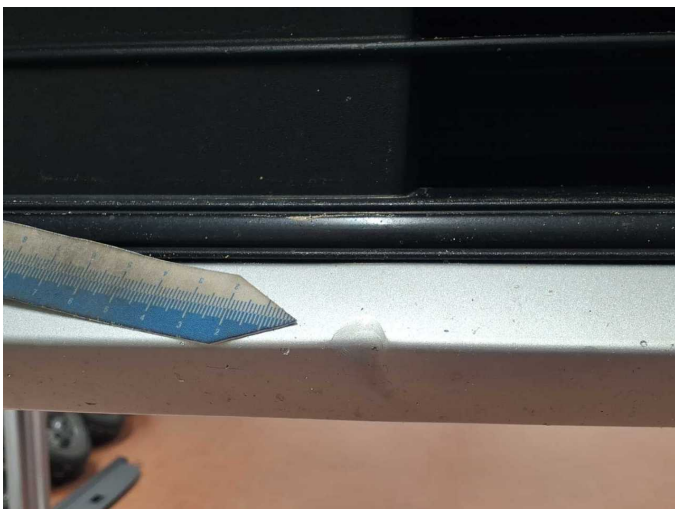
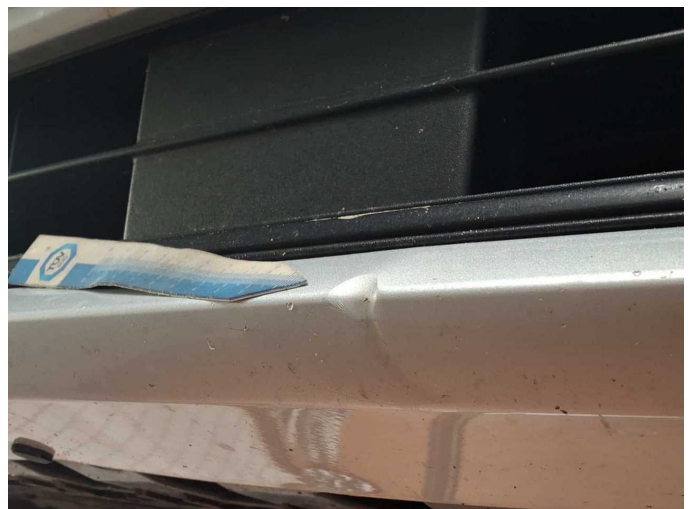
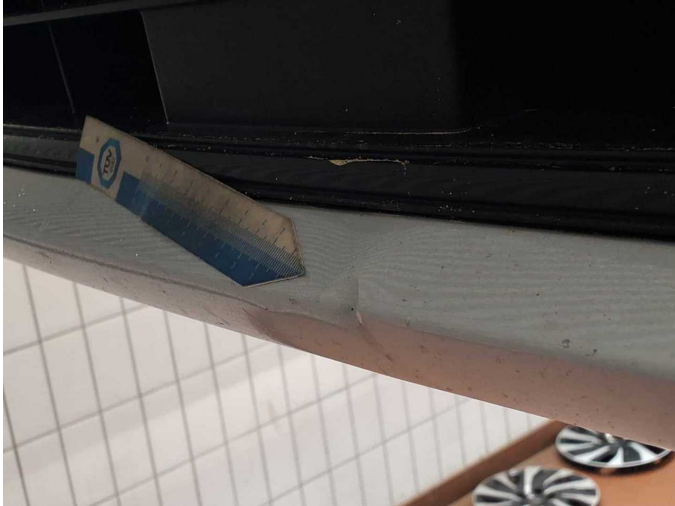
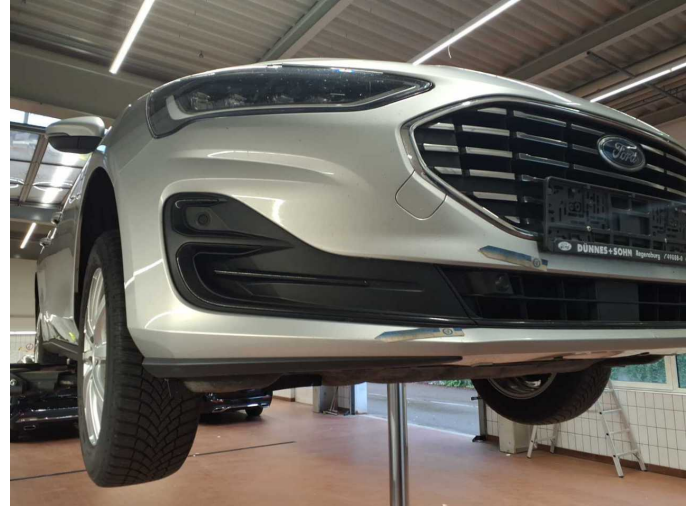
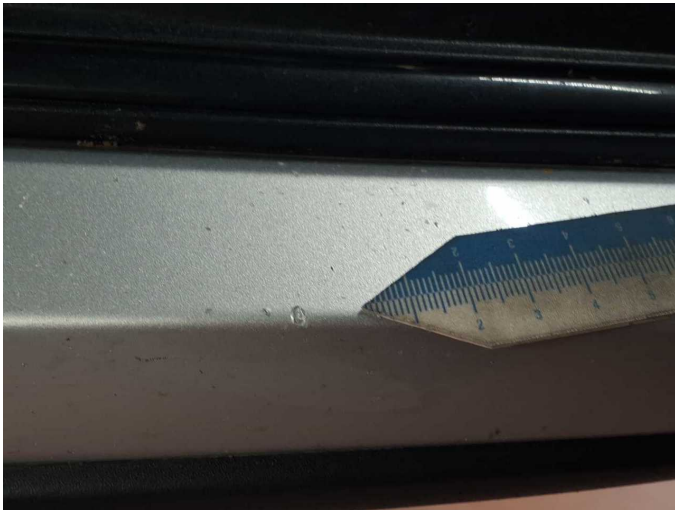
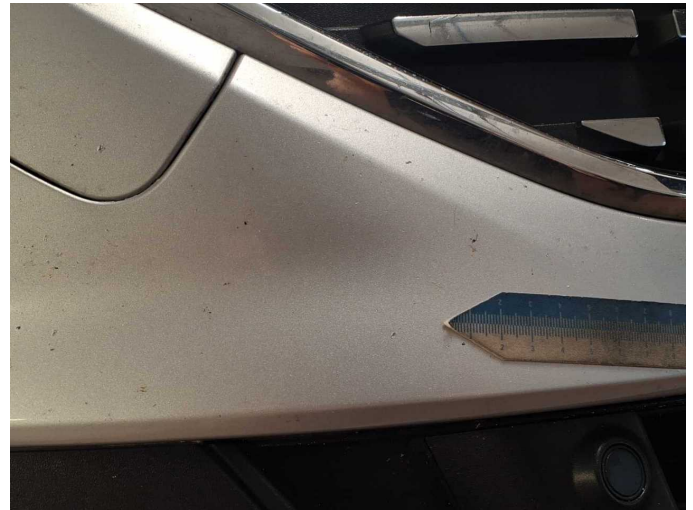
**Damage 7:** Front bumper: Front bumper (+ Steinschläge) - Dent / paintcoat damage - Repair and paint

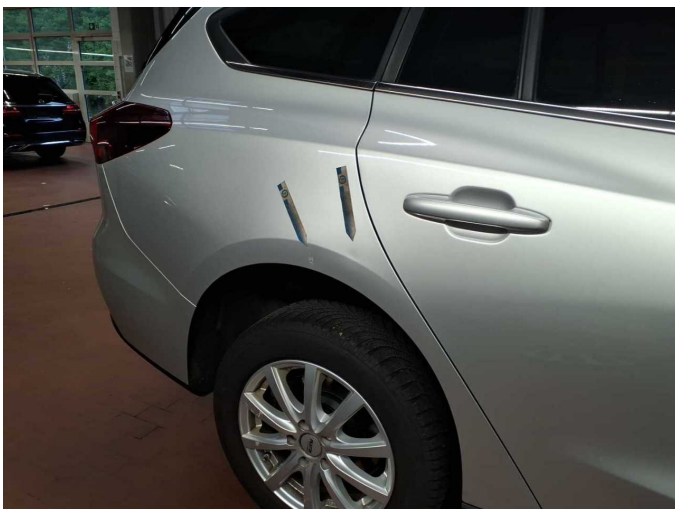
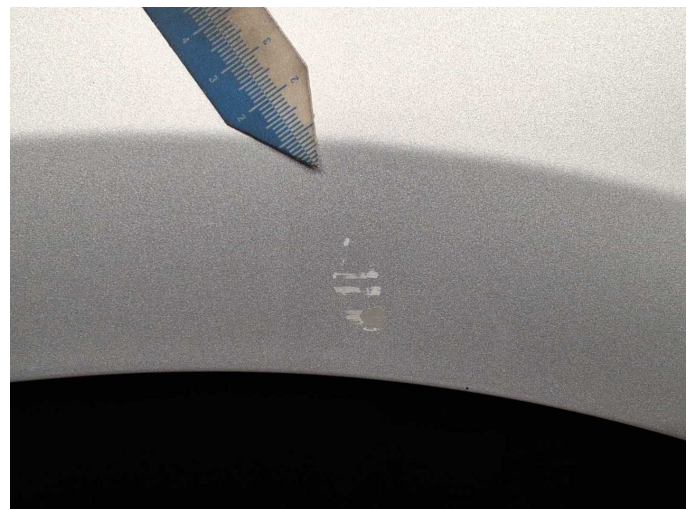
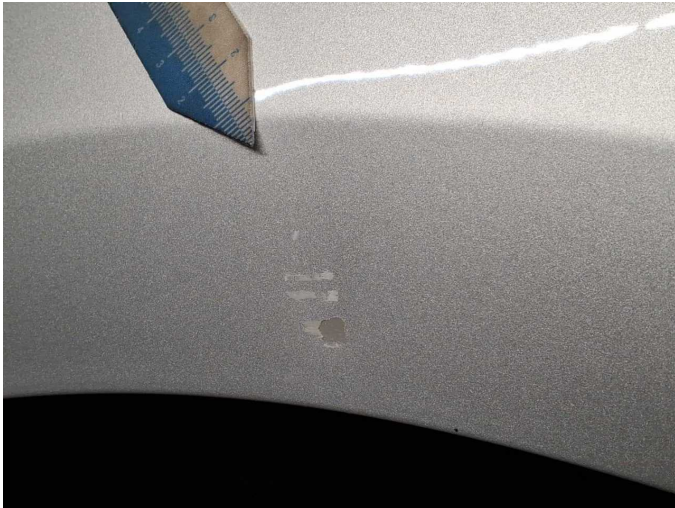
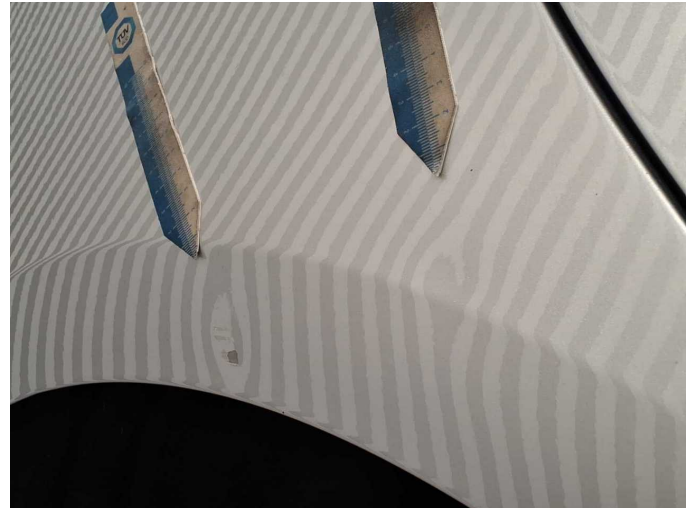
**Damage 8:** Side panel - rear right side: Side panel - Dent / paintcoat damage - Repair and paint

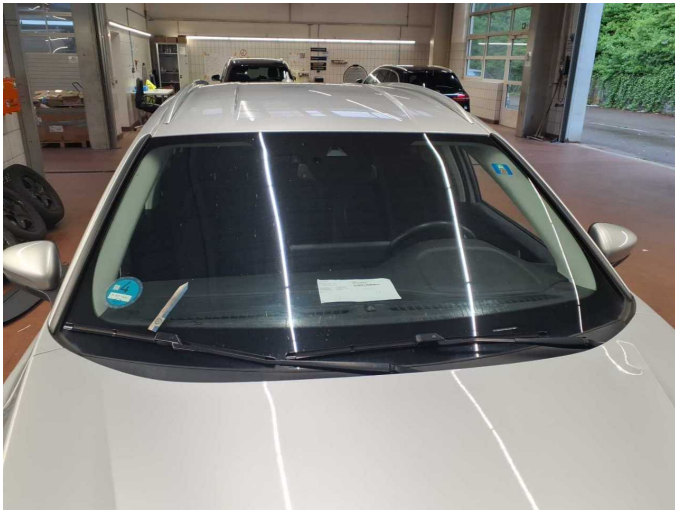
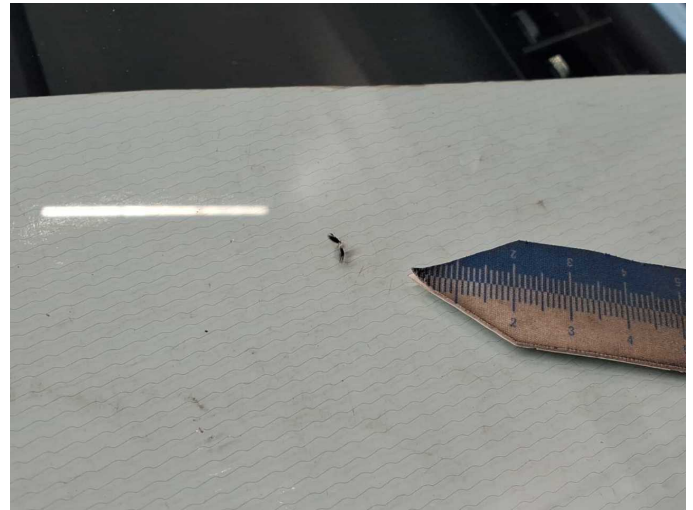
**Damage 9:** Vehicle glazing: Windscreen (mit Heizung) - Stone chips - Replace

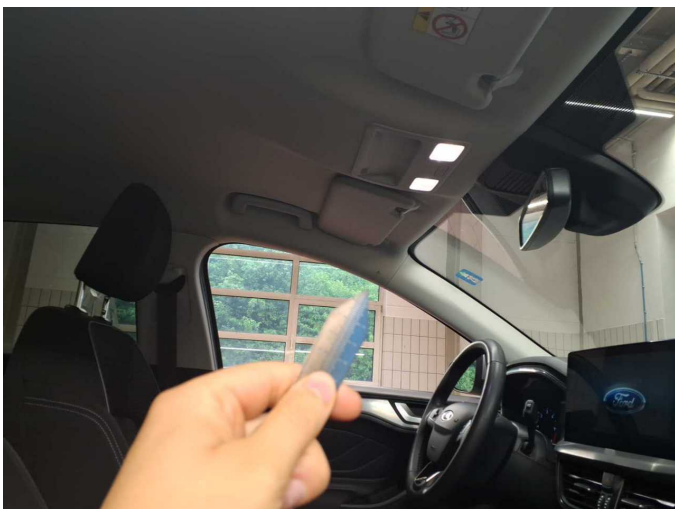
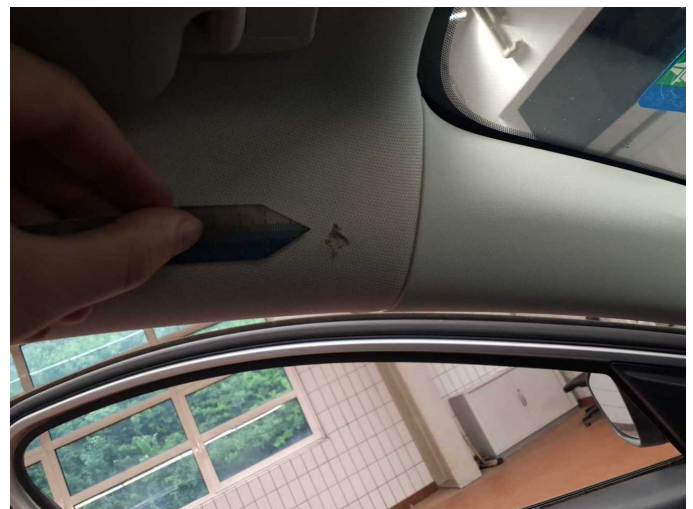
**Damage 10:** Trim / covers: Roof lining - Burn hole (cigarettes) - Replace

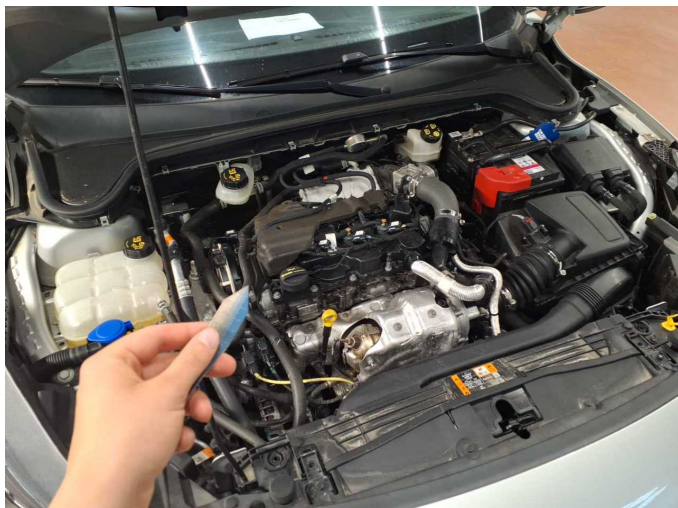
Engine - Engine cover

**Missing part 1:** Engine: Engine cover - Missing - Replace
