Expertise

Protocol number: 46347284  
Order No. / Reference: 26612033  
Inspection date: 6 Jul 2026

Manufacturer: Opel

Model: Astra 1.2 Turbo Business Elegance

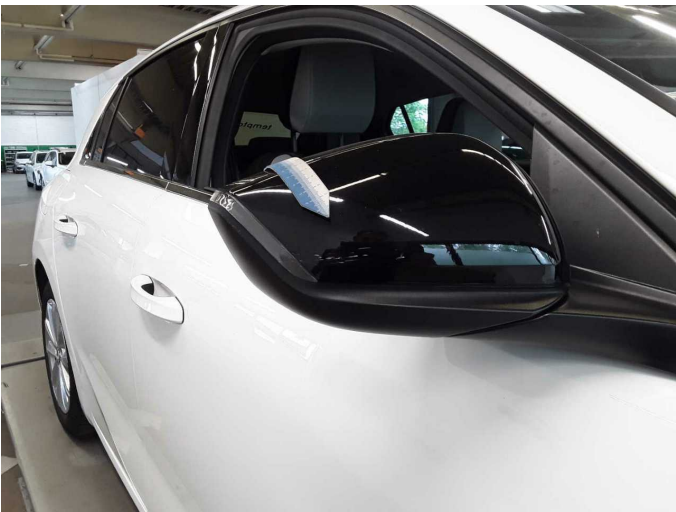
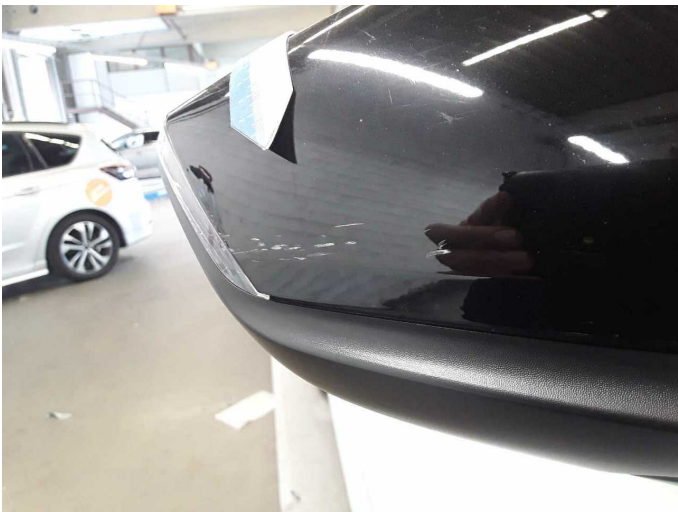
| No. | Component group | Description |
|---|---|---|
| 2 | Wing mirror - right side | Cap - Scratch(es) - Smart repair |

Damage 2: Wing mirror - right side: Cap - Scratch(es) - Smart repair

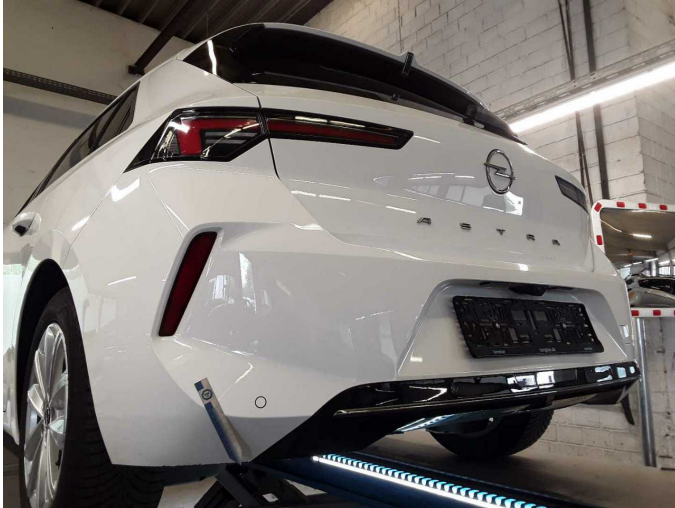
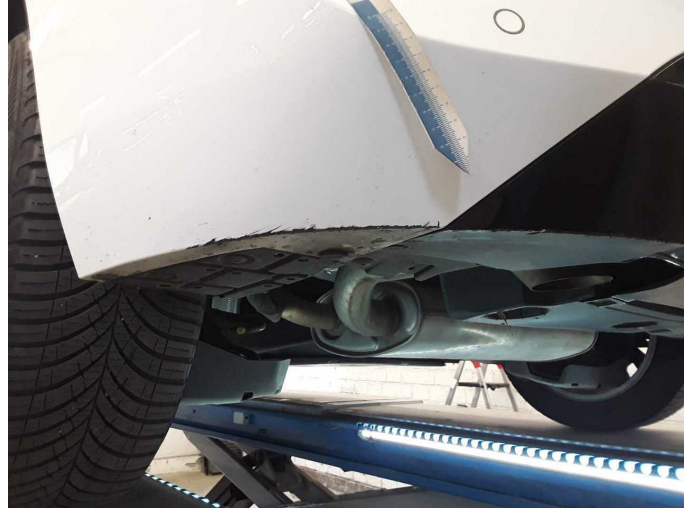
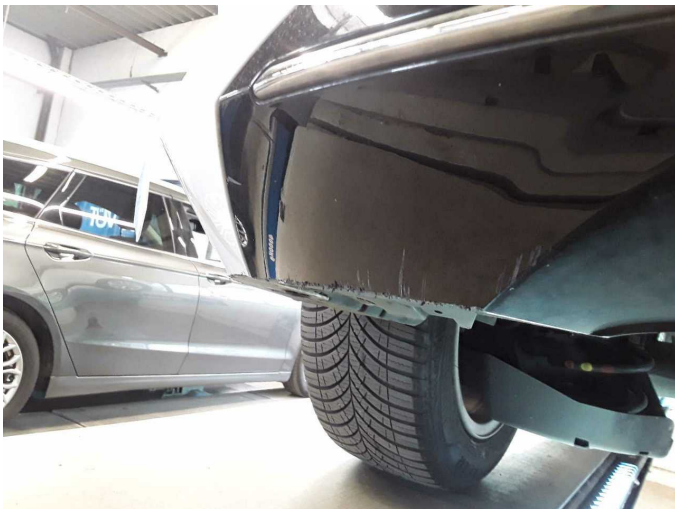
| No. | Component group | Description |
|---|---|---|
| 4 | Rear bumper | Rear bumper (unterhalb) - Scratched - Smart repair |

**Damage 4:** Rear bumper: Rear bumper (unterhalb) - Scratched - Smart repair

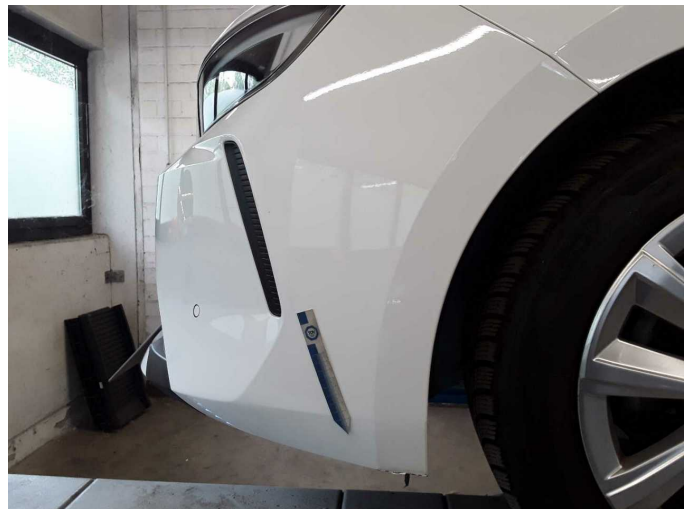
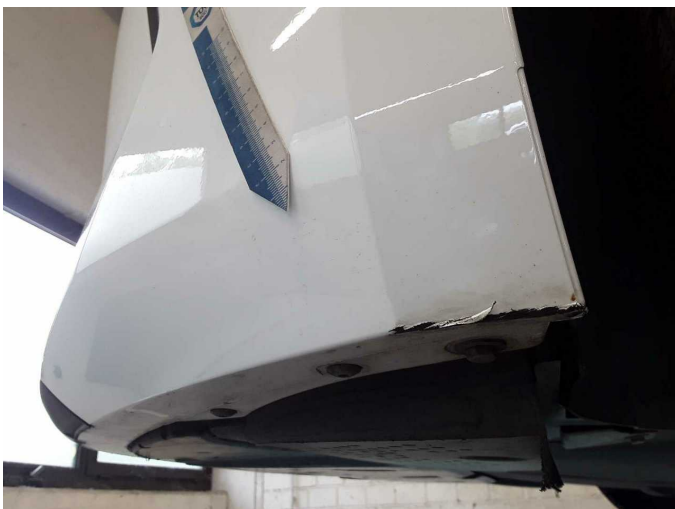
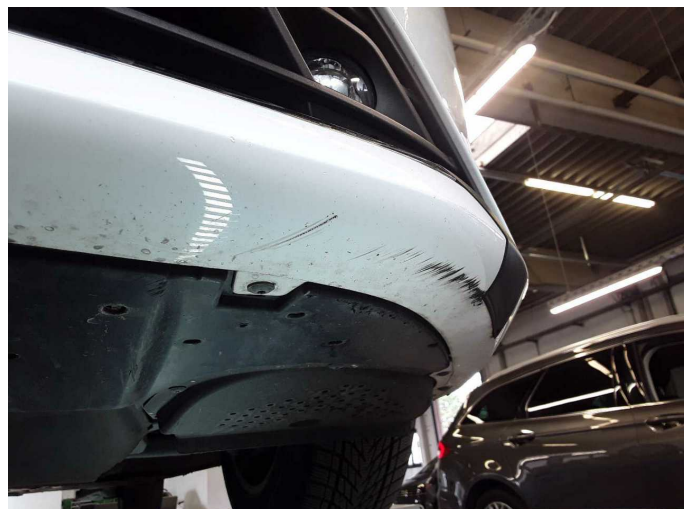
| No. | Component group | Description |
|---|---|---|
| 5 | Front bumper | Front bumper (unterhalb) - Scratched - Smart repair |

**Damage 5:** Front bumper: Front bumper (unterhalb) - Scratched - Smart repair

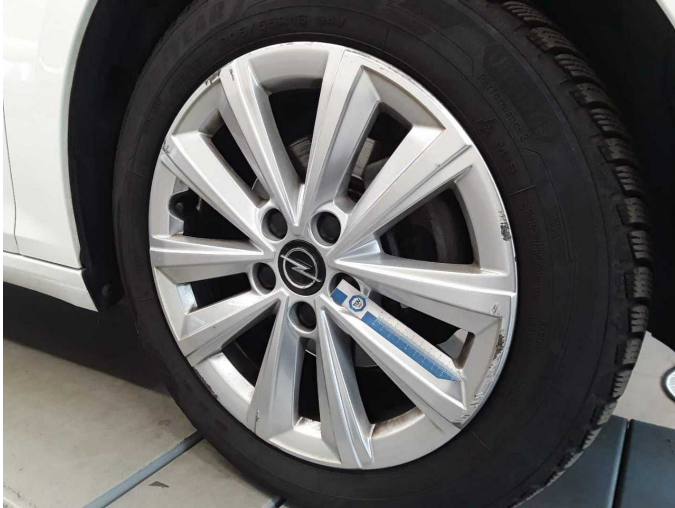
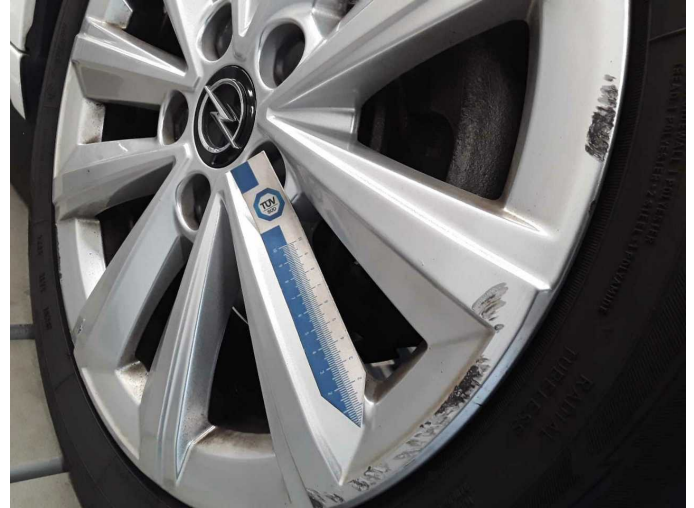
| No. | Component group | Description |
|---|---|---|
| 6 | Wheel / tyres | Alloy rim - front right side - Scratched - Loss in value |

**Damage 6:** Wheel / tyres: Alloy rim - front right side - Scratched - Loss in value

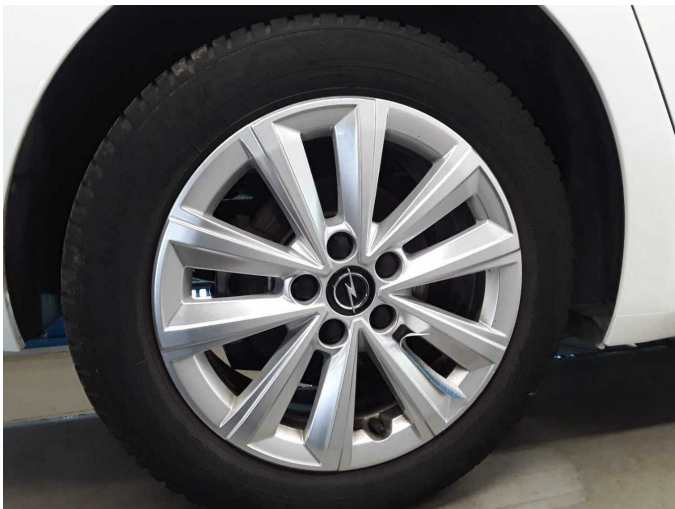
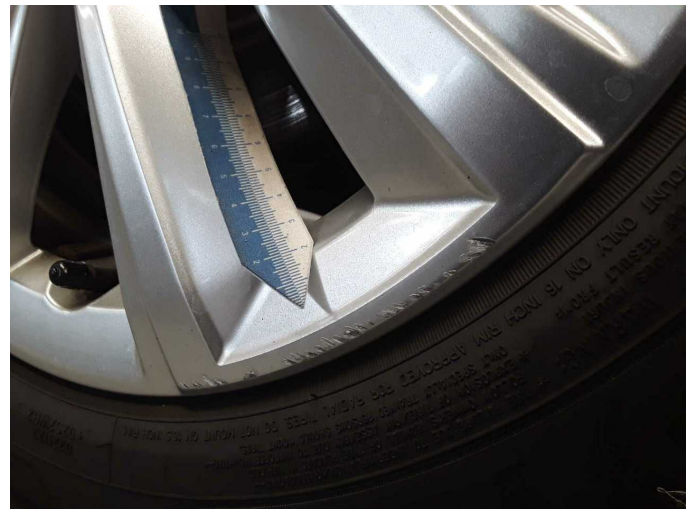
| No. | Component group | Description |
|---|---|---|
| 7 | Wheel / tyres | Alloy rim - rear right side - Scratched - Loss in value |

**Damage 7:** Wheel / tyres: Alloy rim - rear right side - Scratched - Loss in value

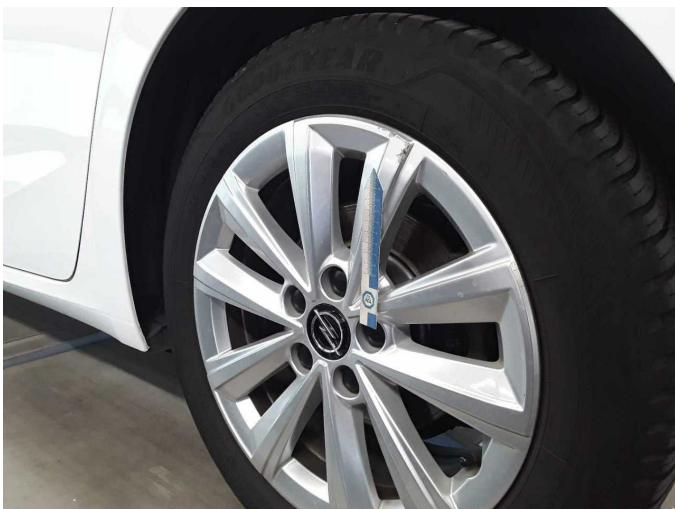
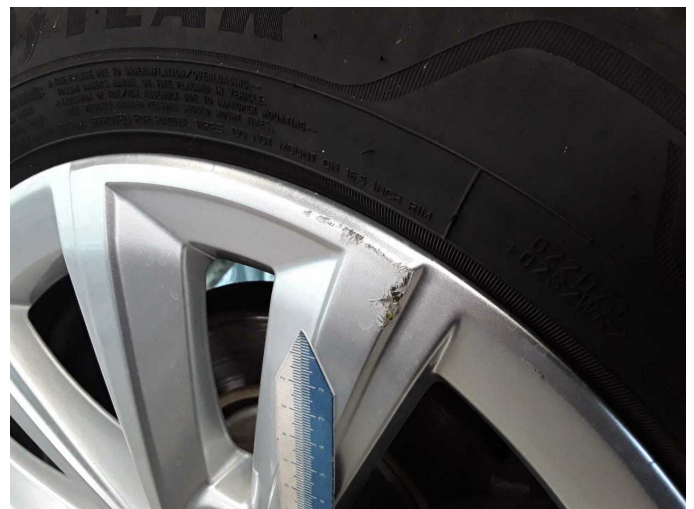
| No. | Component group | Description |
|---|---|---|
| 8 | Wheel / tyres | Alloy rim - rear left side - Scratched - Loss in value |

**Damage 8:** Wheel / tyres: Alloy rim - rear left side - Scratched - Loss in value

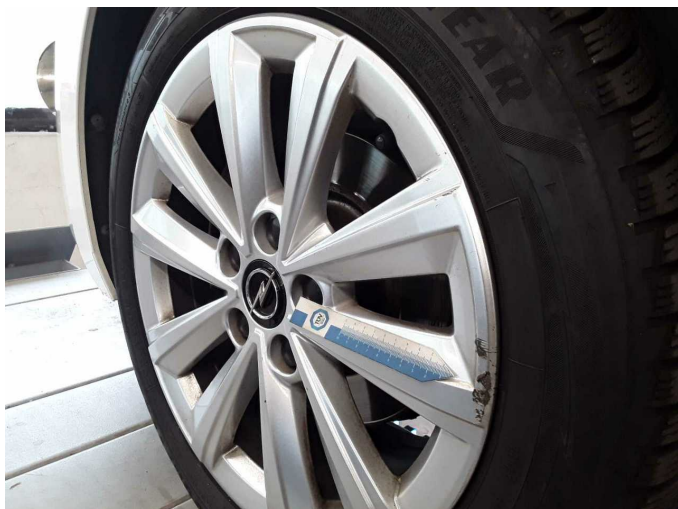
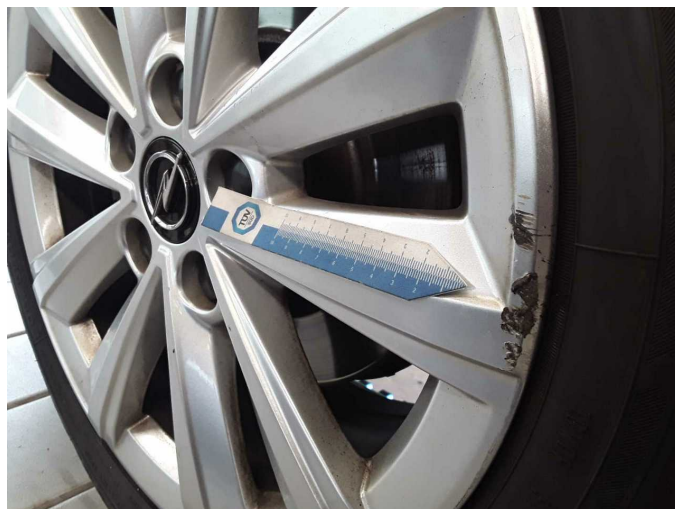
| No. | Component group | Description |
|---|---|---|
| 9 | Wheel / tyres | Alloy rim - front left side - Scratch(es) - Loss in value |

**Damage 9:** Wheel / tyres: Alloy rim - front left side - Scratch(es) - Loss in value

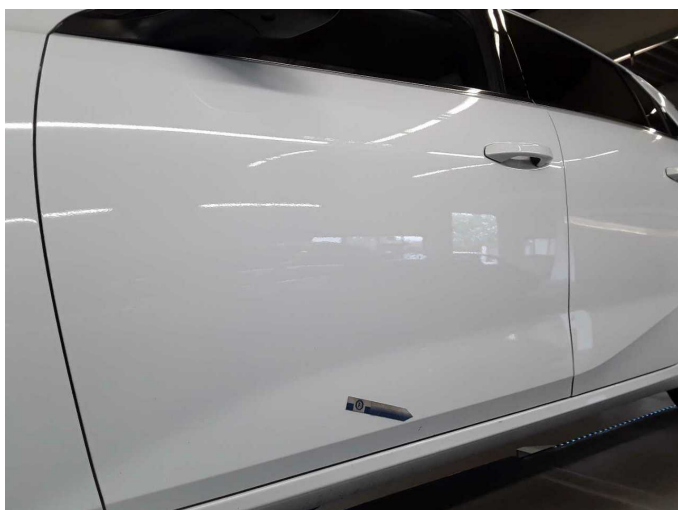
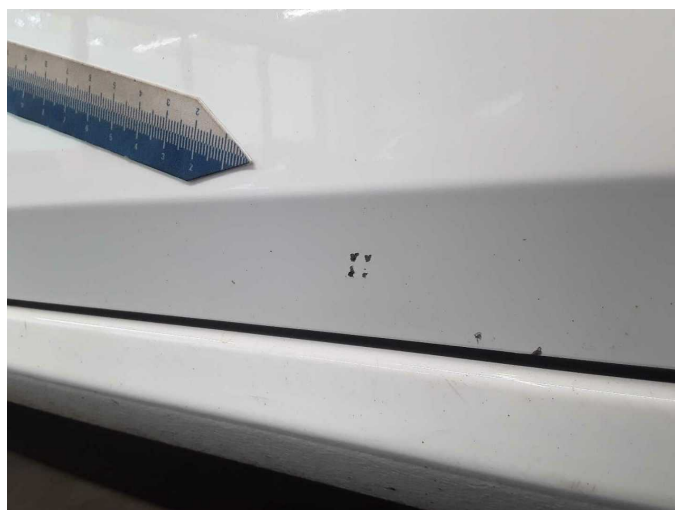
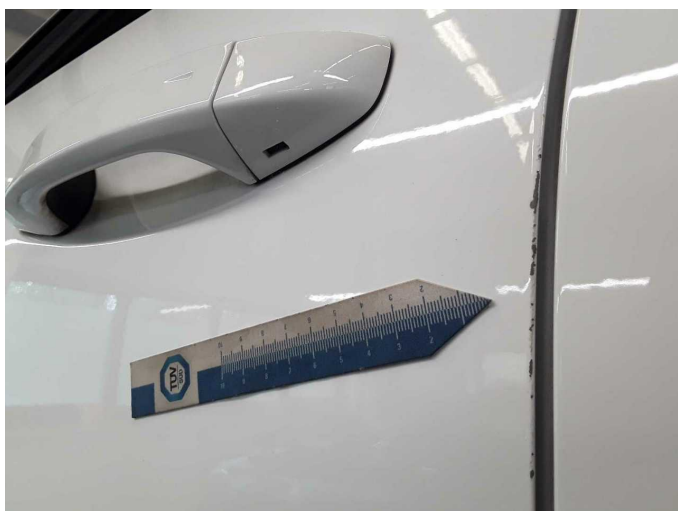
| No. | Component group | Description |
|---|---|---|
| 10 | Door - front left side | Door - Scratch(es) - Paint |

**Damage 10:** Door - front left side: Door - Scratch(es) - Paint

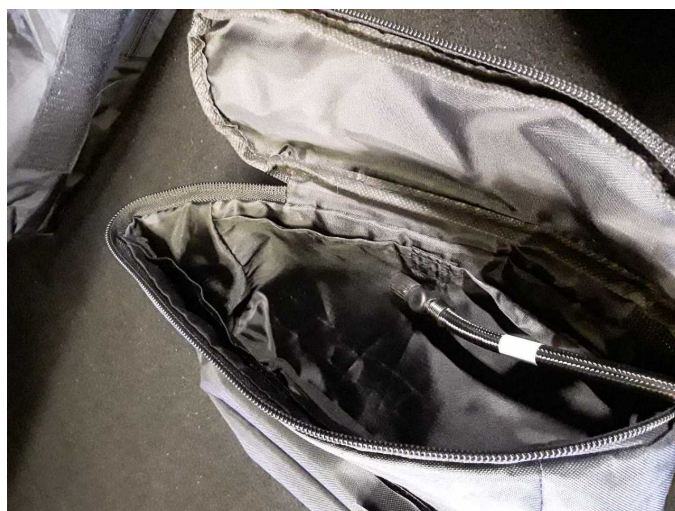
| Description |
|---|
| Equipment - Tirefit filler |

**Missing part 1:** Equipment: Tirefit filler - Missing - Replace

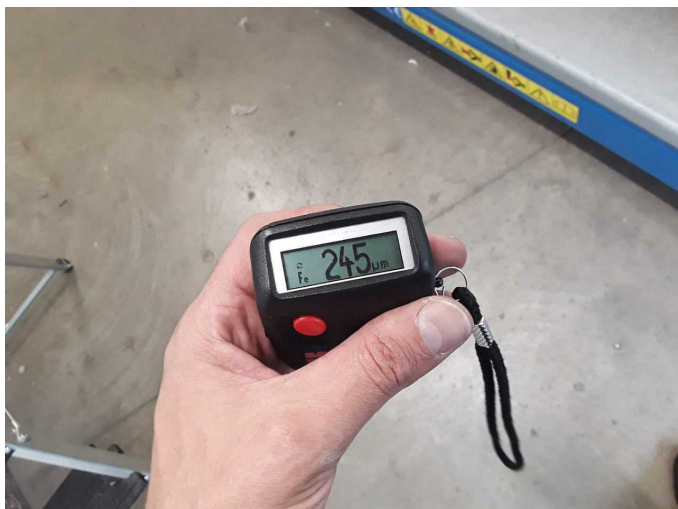
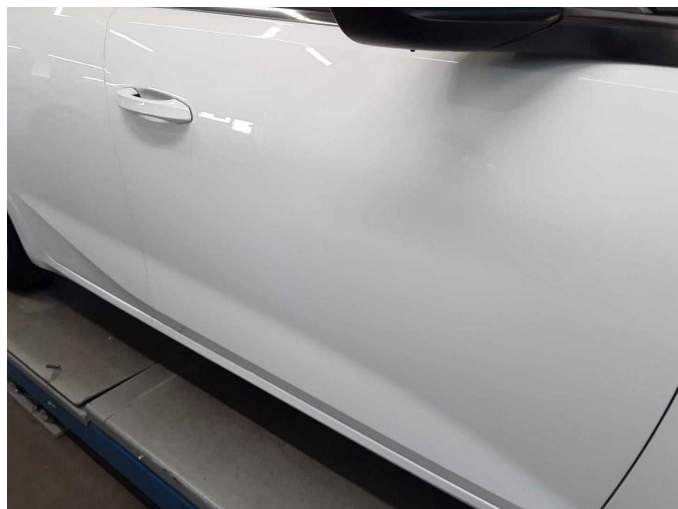
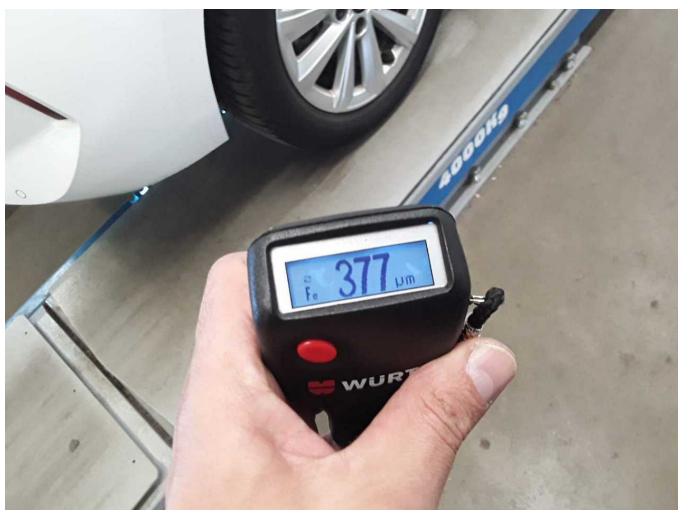
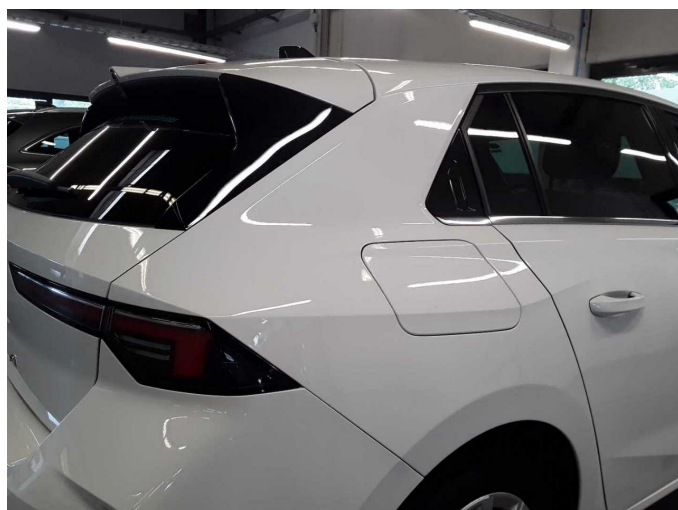
| No. | Repainting |
|---|---|
| 1 | Side panel - rear right side, Door - front right side, Professionally carried out, Invoice of repair done Non-existent |

**Repainting 1:** Side panel - rear right side, Door - front right side
