## Expertise

Protocol number: 46184185  
Order No. / Reference: 26639358  
Inspection date: 25 Jun 2026

Manufacturer: Volkswagen

Model: ID.4 Performance Upgrade Pro

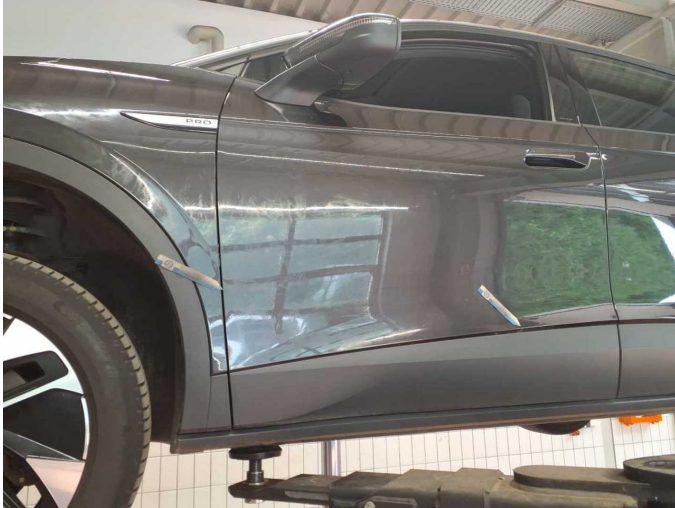
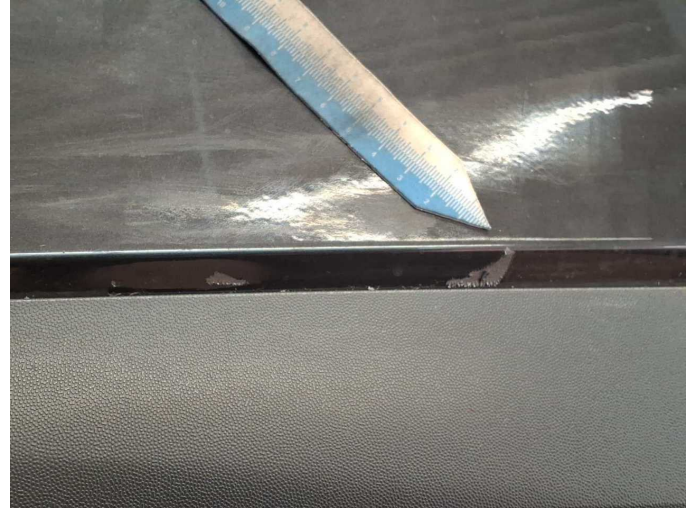
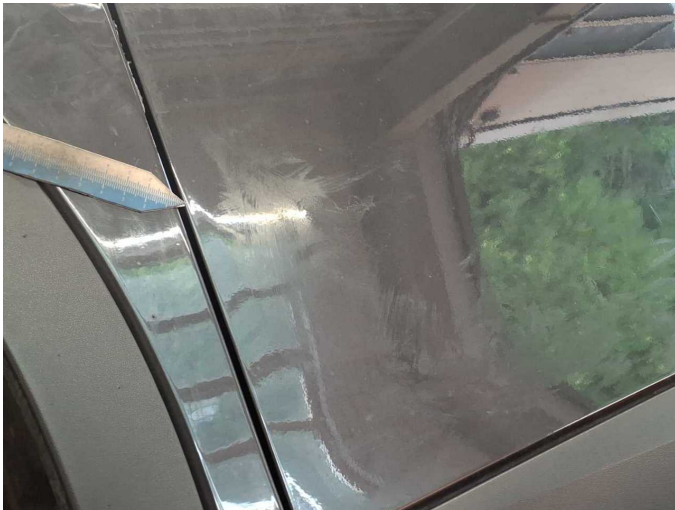
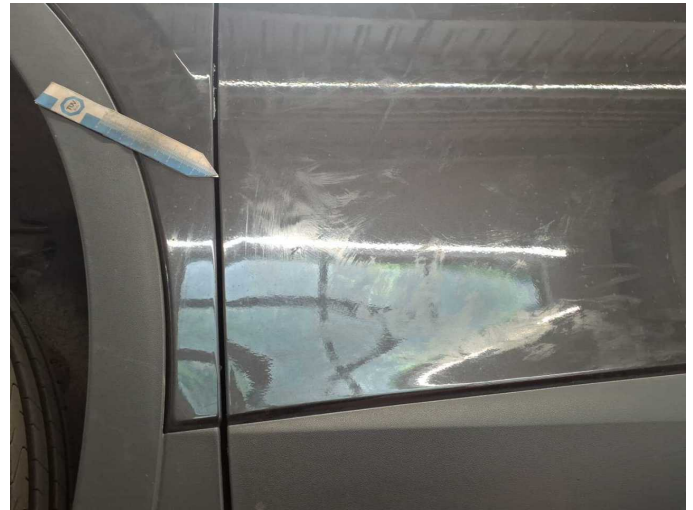
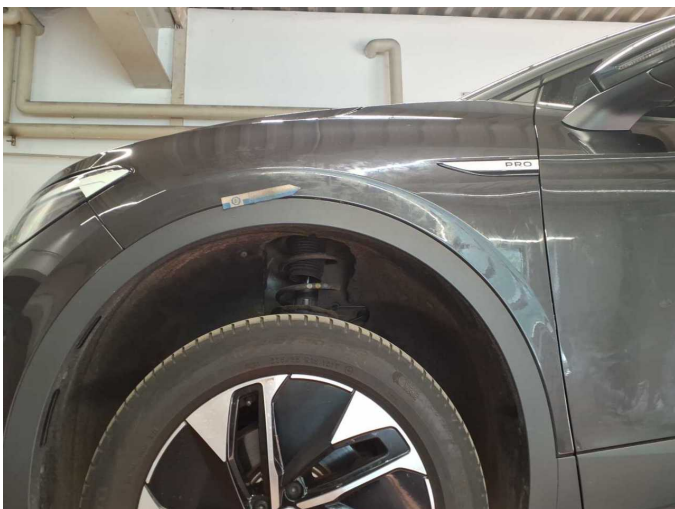
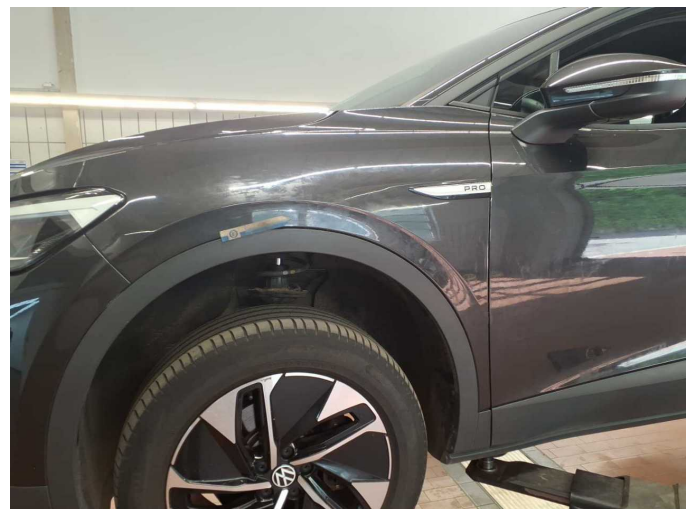
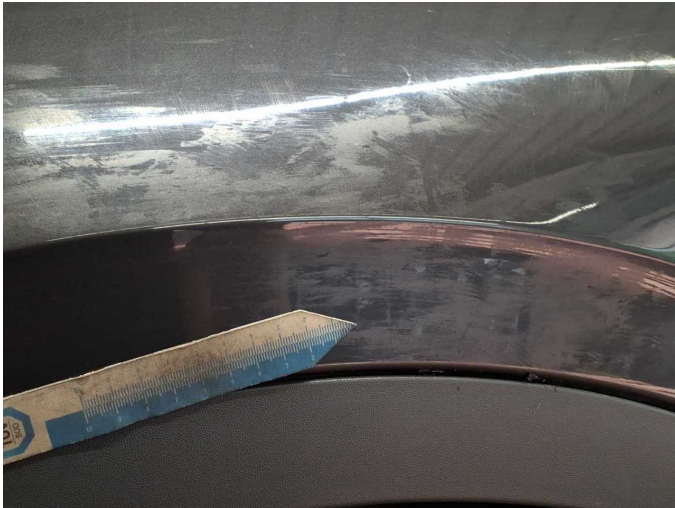
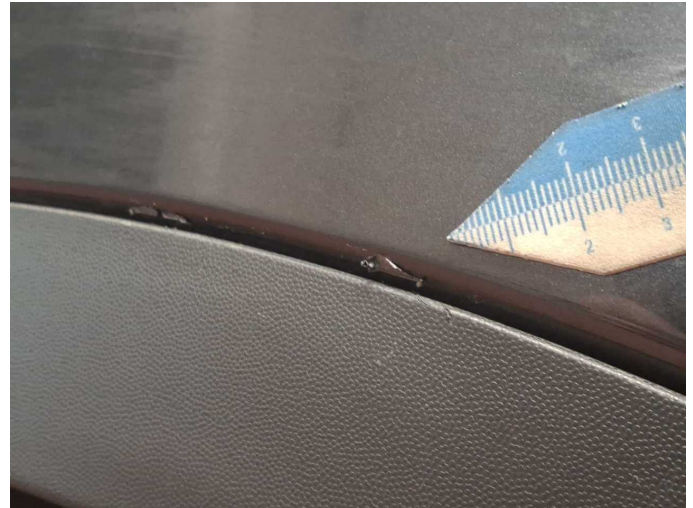
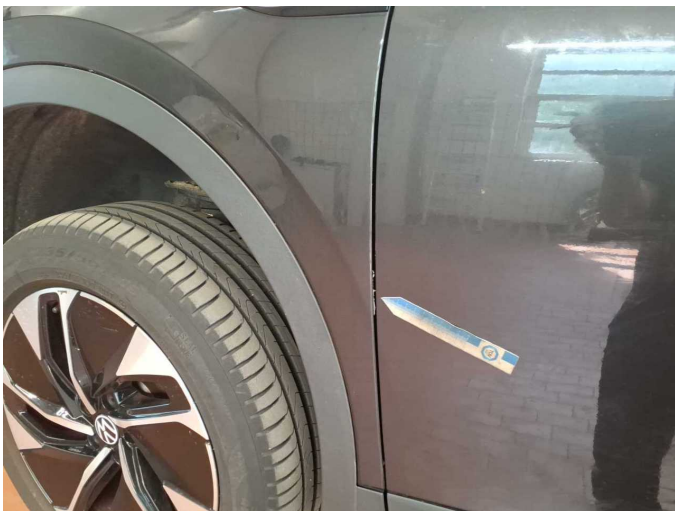
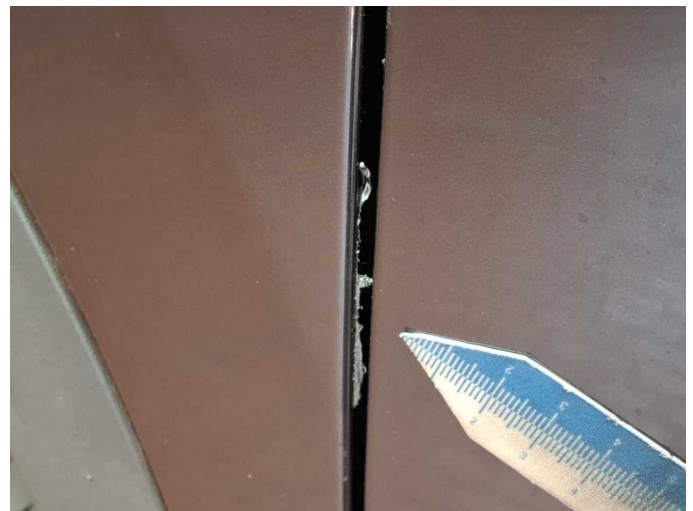
**Damage 1:** Body: Body (Klebereste) - Glued / labelled - De-glue / neutralise

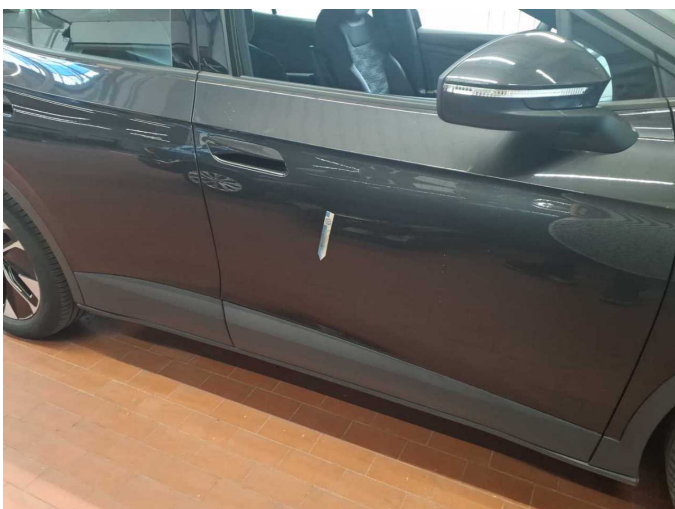
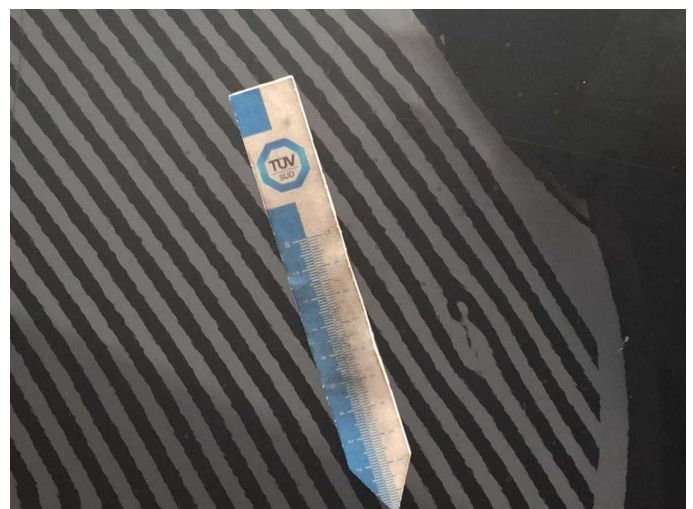
**Damage 2:** Door - front right side: Door - dent(s) - Smooth repair work

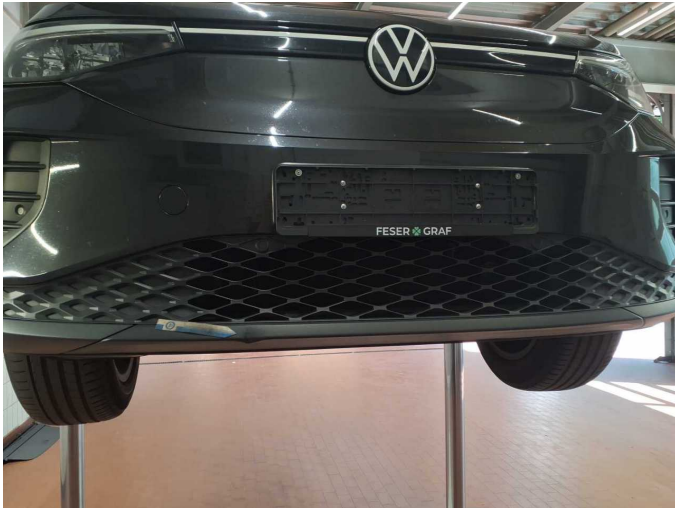
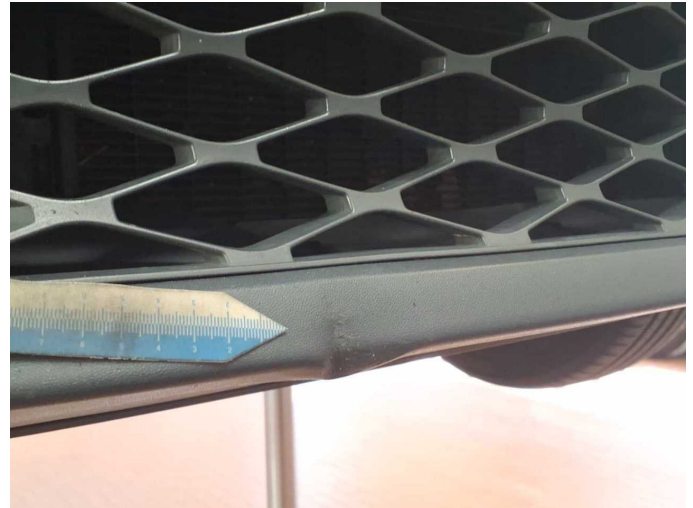
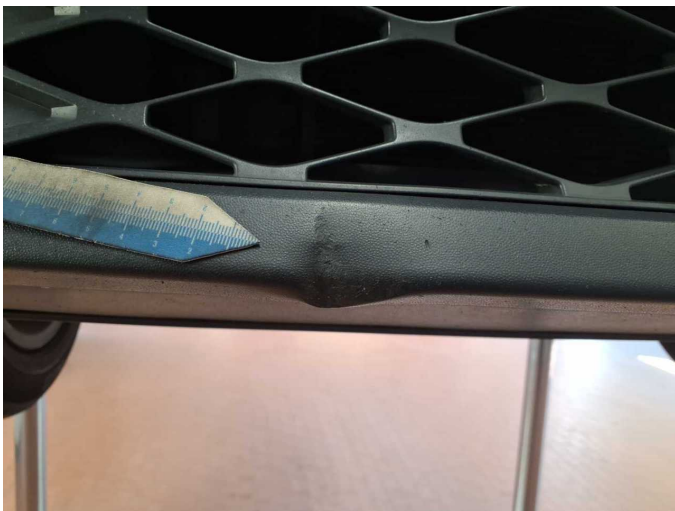
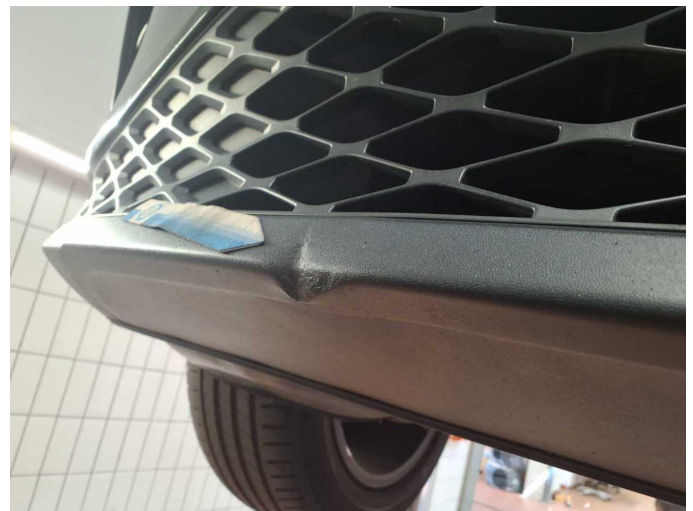
**Damage 3:** Front bumper: Spoiler - Deformed - Replace

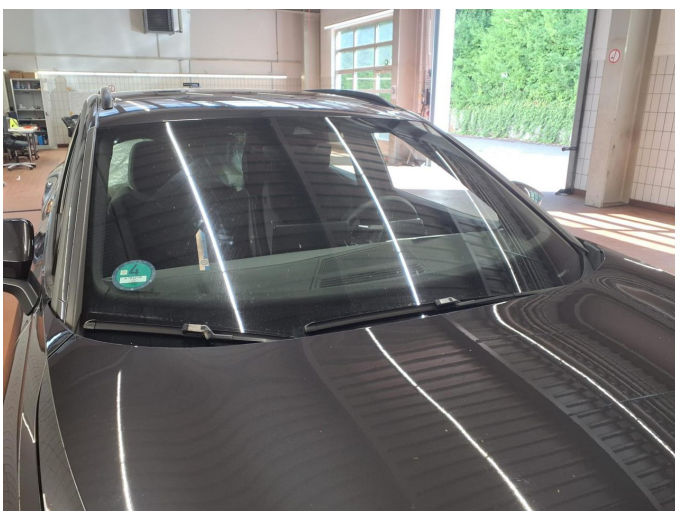
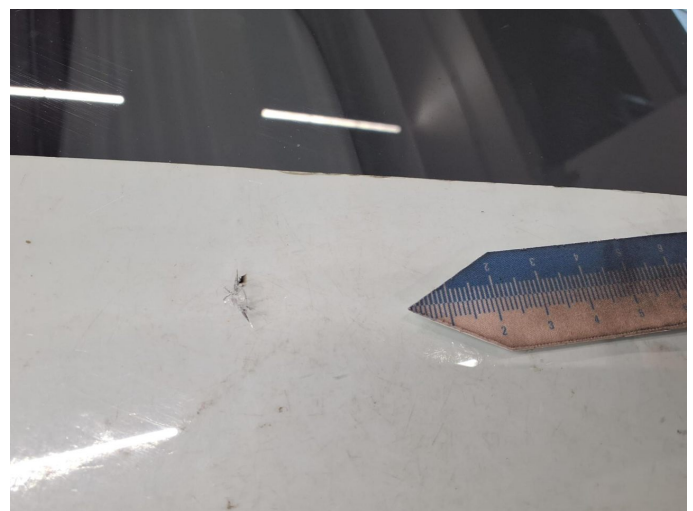
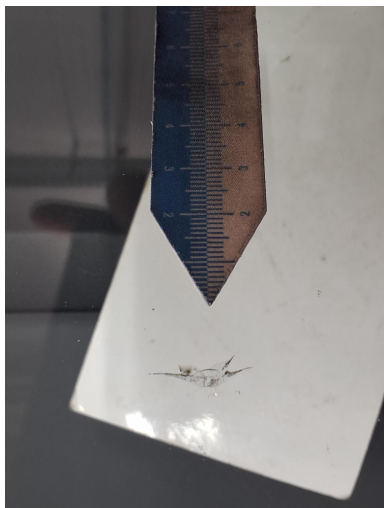
**Damage 4:** Vehicle glazing: Windscreen (reparierter Steinschlag) - Unprofessionally repaired - Replace

**Damage 4:** Vehicle glazing: Windscreen (reparierter Steinschlag) -  
Unprofessionally repaired - Replace

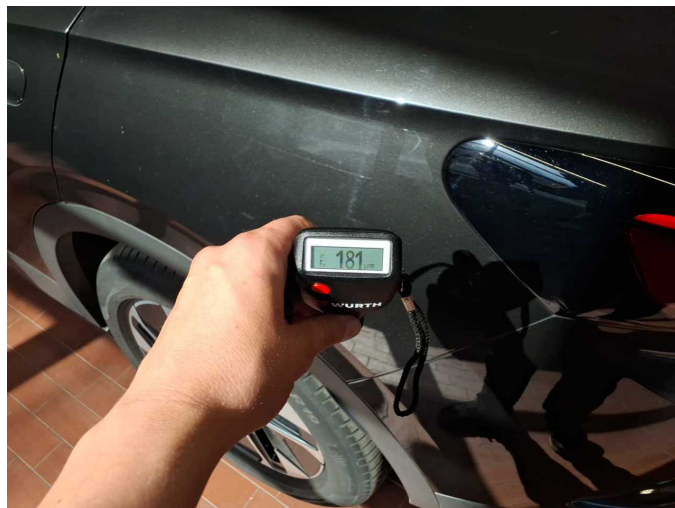
No.	Repainting
1	Side panel - rear left side, Professionally carried out, Invoice of repair done Non-existent
2	Door - front left side, Professionally carried out, Invoice of repair done Non-existent

Side panel - rear left side	181 µm	Door - front left side	168 µm
-----------------------------	--------	------------------------	--------

**Repainting 1:** Side panel - rear left side

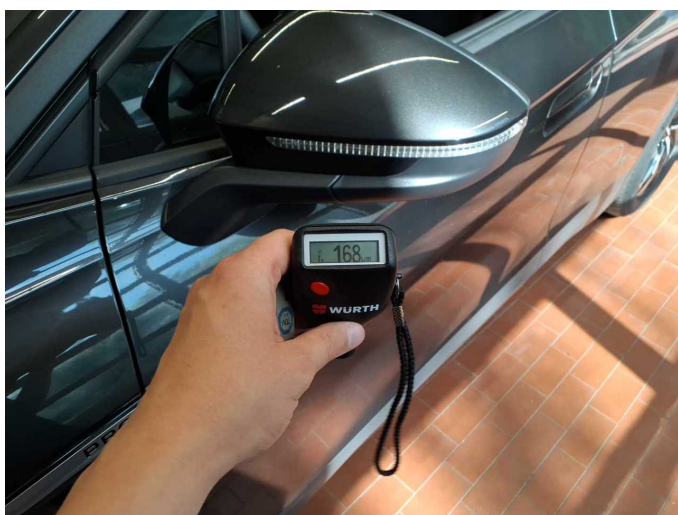
**Repainting 2:** Door - front left side
