Expertise

Protocol number: 46710040  
Order No. / Reference: 26699257  
Inspection date: 21 Jul 2026

Manufacturer: Fiat

Model: Scudo L2 Basis AT

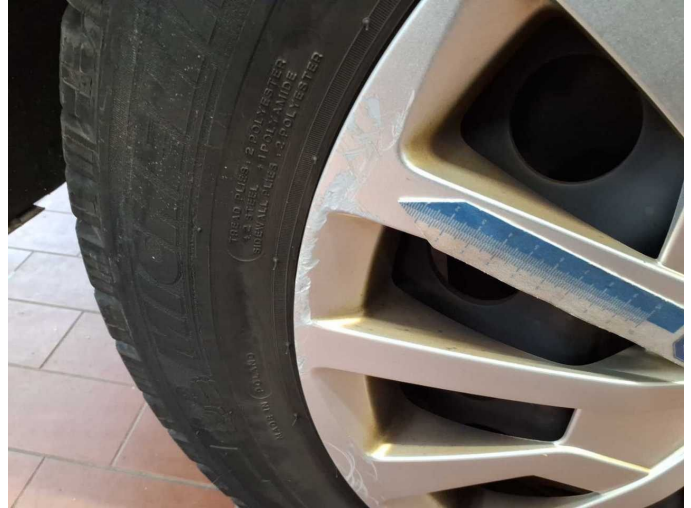
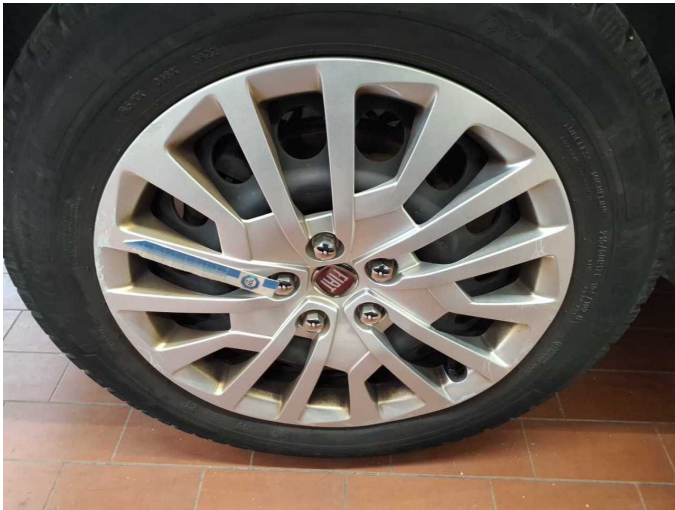
| No. | Component group | Description |
|---|---|---|
| 1 | Wheel / tyres | Wheel cover - rear right side - Scratched - Replace |

**Damage 1:** Wheel / tyres: Wheel cover - rear right side - Scratched - Replace

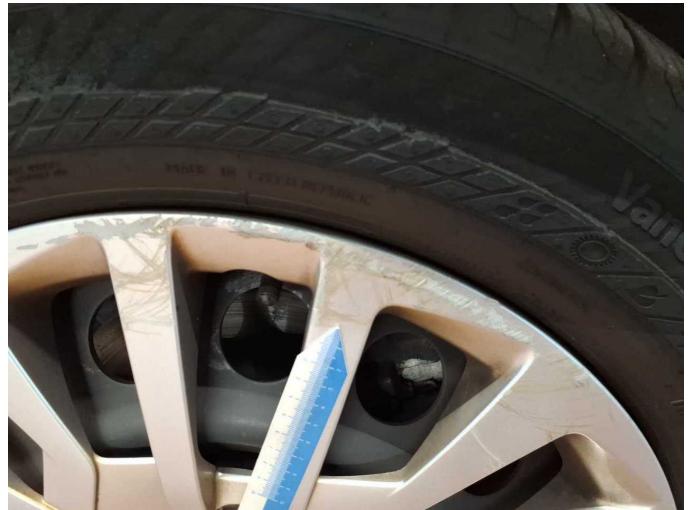
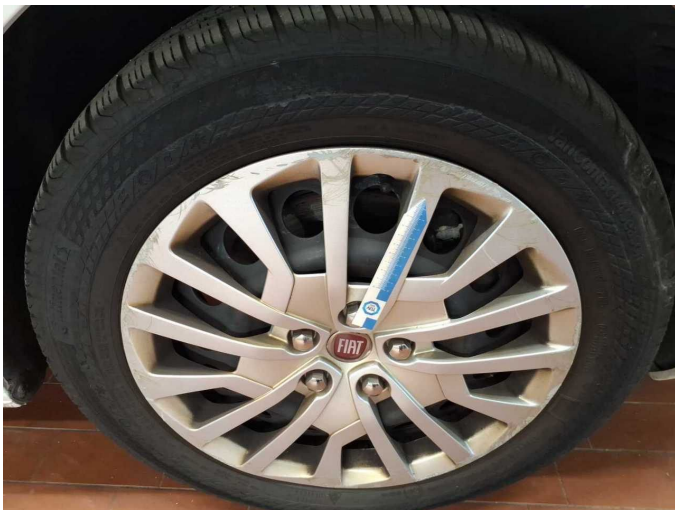
| No. | Component group | Description |
|---|---|---|
| 2 | Wheel / tyres | Wheel cover - front right side - Scratched - Replace |

**Damage 2:** Wheel / tyres: Wheel cover - front right side - Scratched - Replace

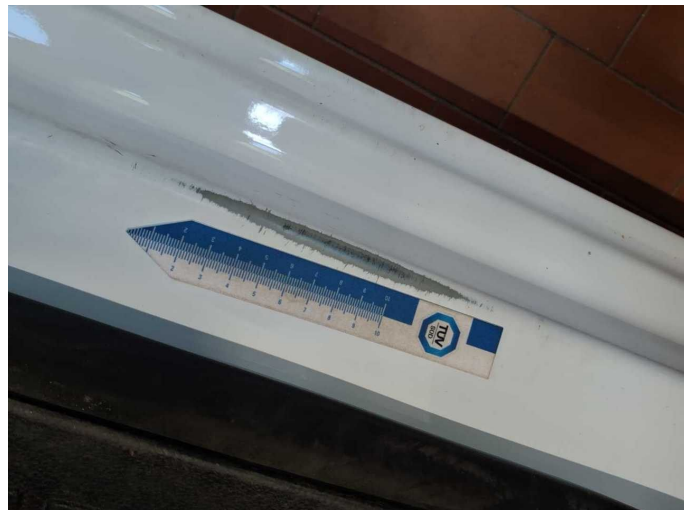
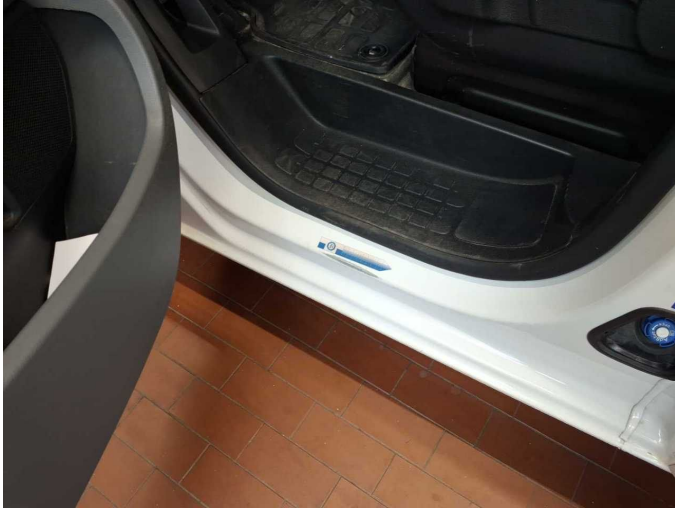
| No. | Component group | Description |
|---|---|---|
| 3 | Sill - left side | Sill - Scratch(es) - Smart repair |

**Damage 3:** Sill - left side: Sill - Scratch(es) - Smart repair

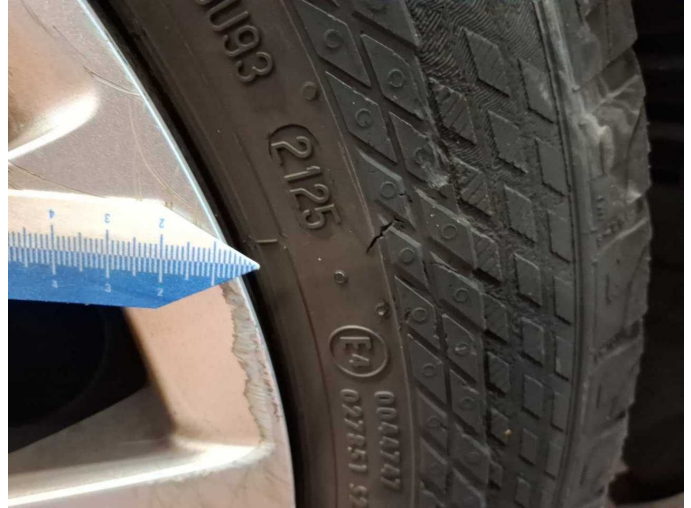
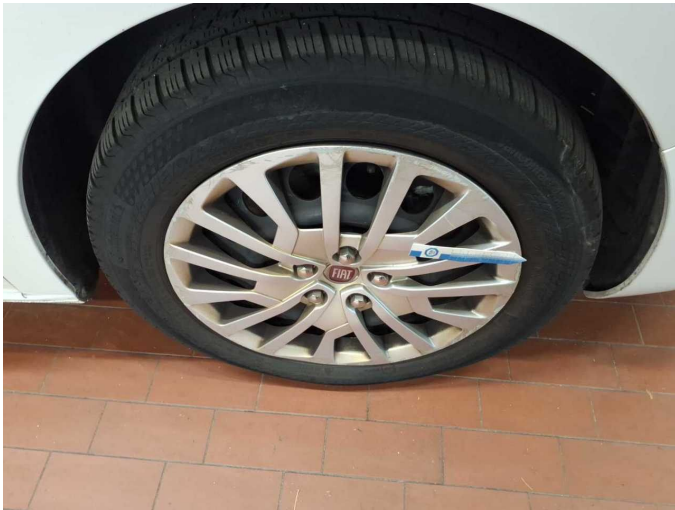
| No. | Component group | Description |
|---|---|---|
| 4 | Wheel / tyres | Tyre - front right side - Broken / torn - Replace |

**Damage 4:** Wheel / tyres: Tyre - front right side - Broken / torn - Replace

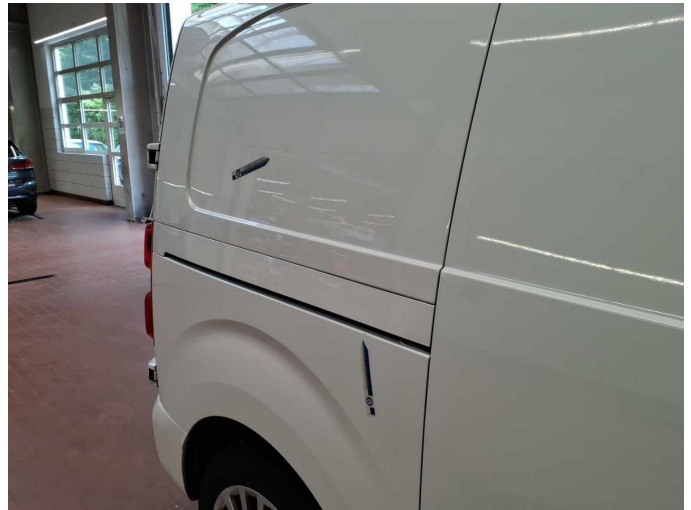
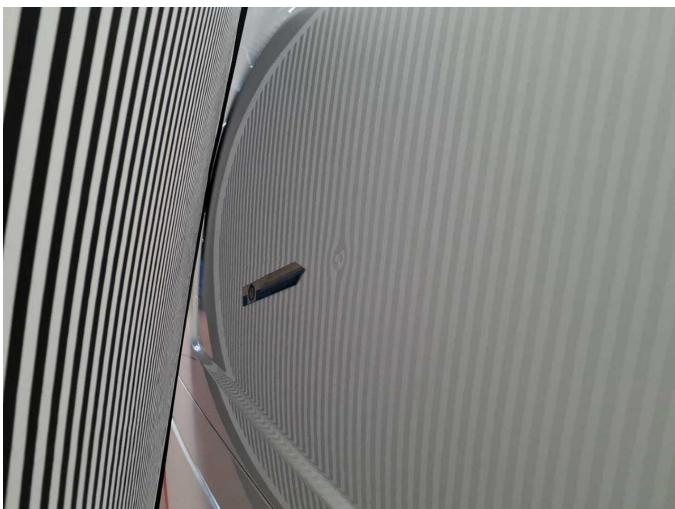
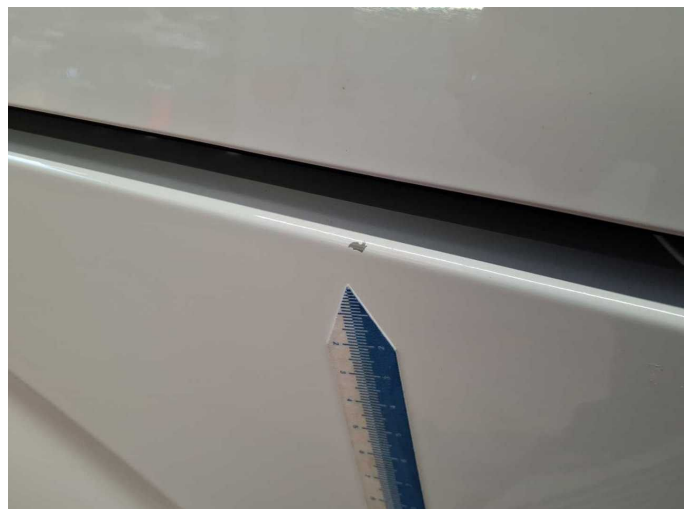
| No. | Component group | Description |
|---|---|---|
| 5 | Side panel - rear right side | Side panel (+ Kratzer) - dent(s) - Smart repair |

**Damage 5:** Side panel - rear right side: Side panel (+ Kratzer) - dent(s) - Smart repair

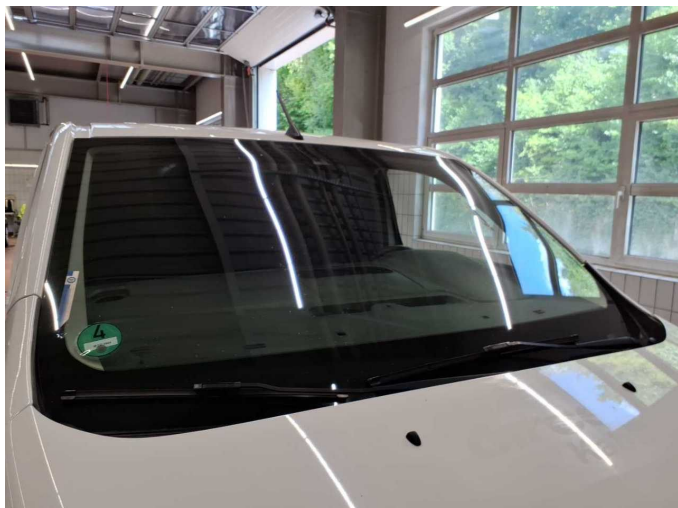
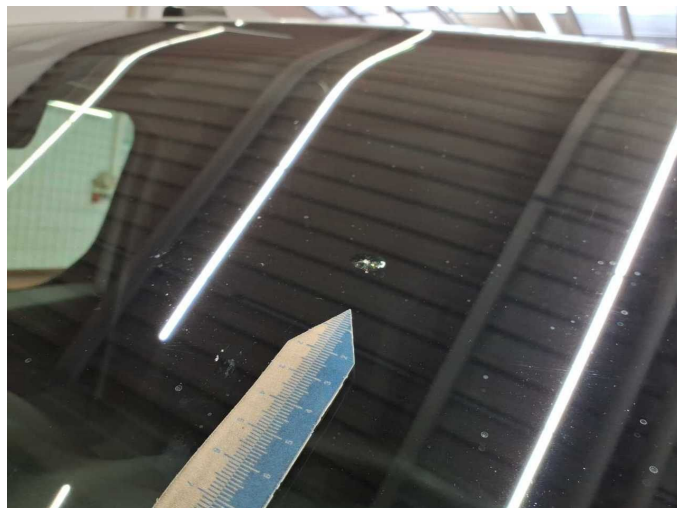
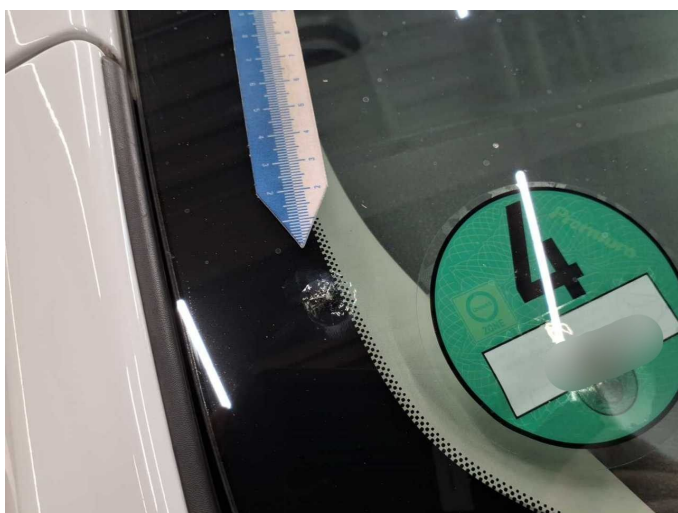
| No. | Component group | Description |
|---|---|---|
| 6 | Vehicle glazing | Windscreen - Stone chips - Replace |

**Damage 6:** Vehicle glazing: Windscreen - Stone chips - Replace

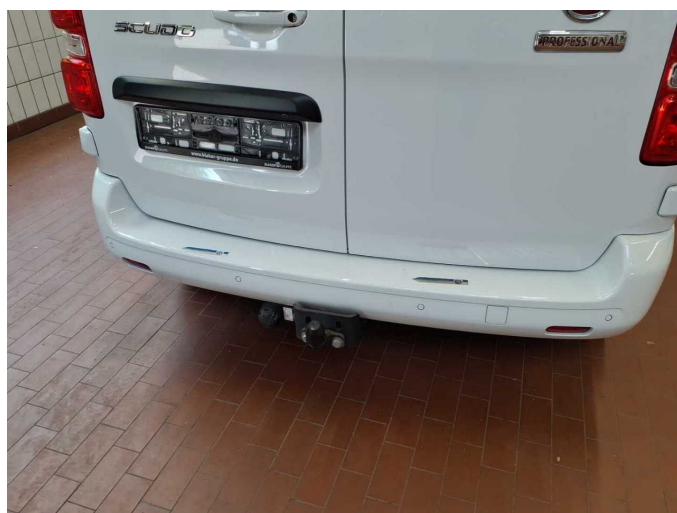
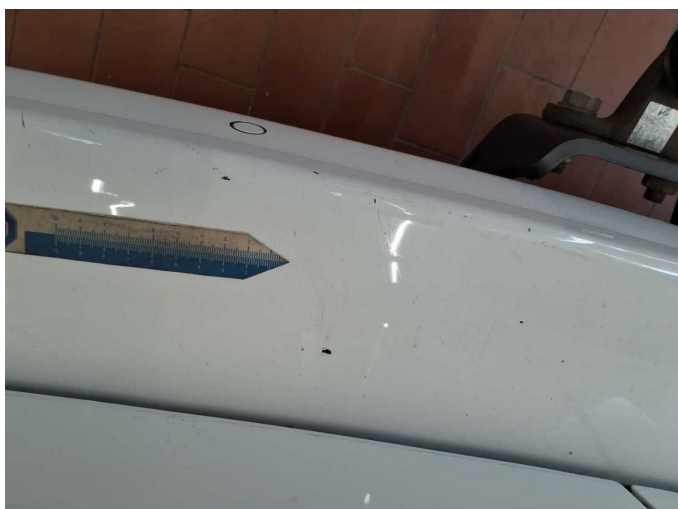
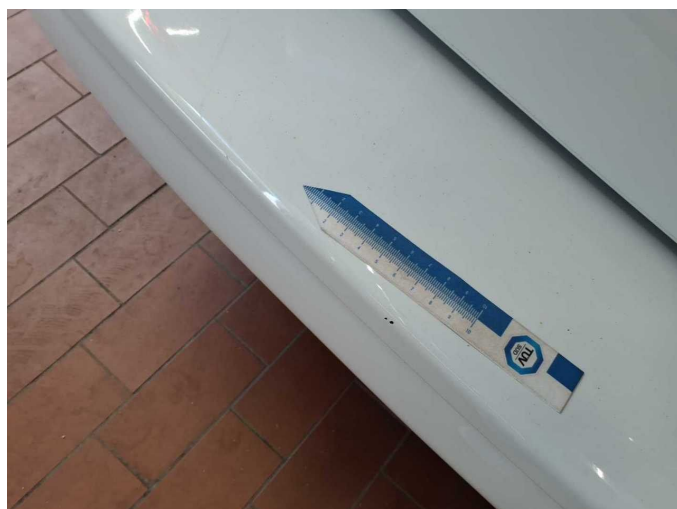
| No. | Component group | Description |
|---|---|---|
| 7 | Rear bumper | Rear bumper - Scratch(es) - Paint |

**Damage 7:** Rear bumper: Rear bumper - Scratch(es) - Paint

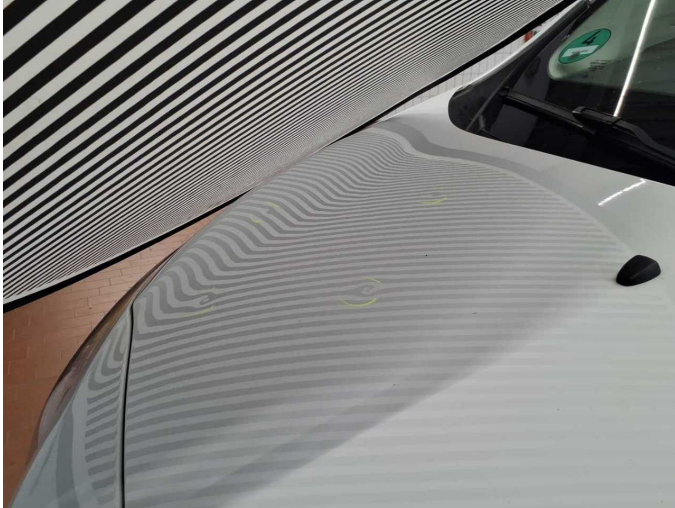
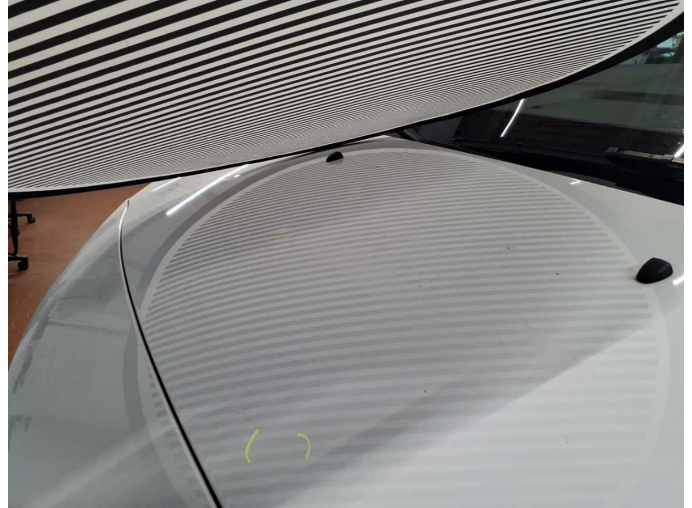
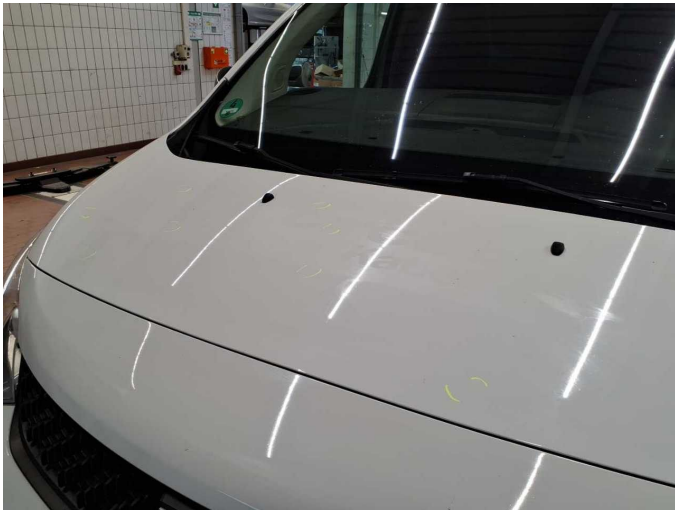
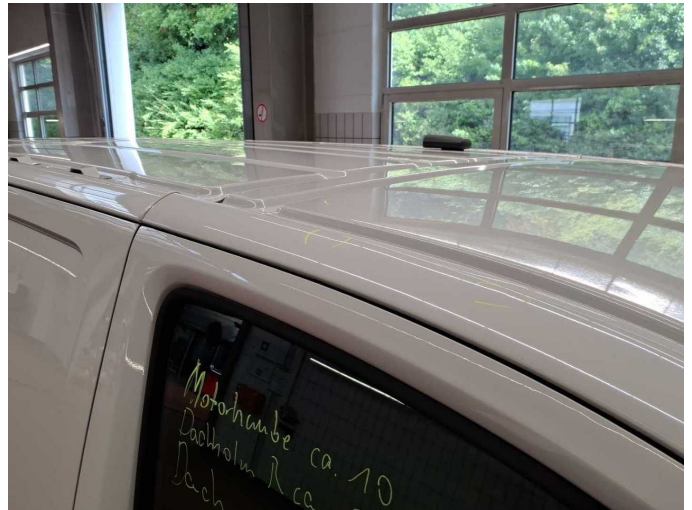
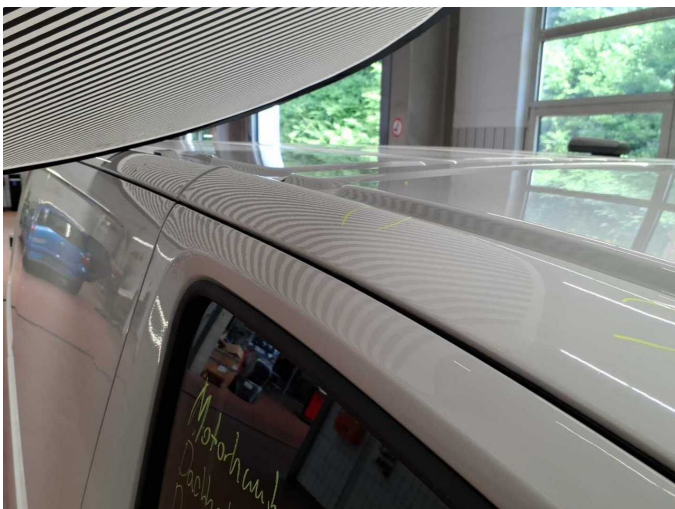
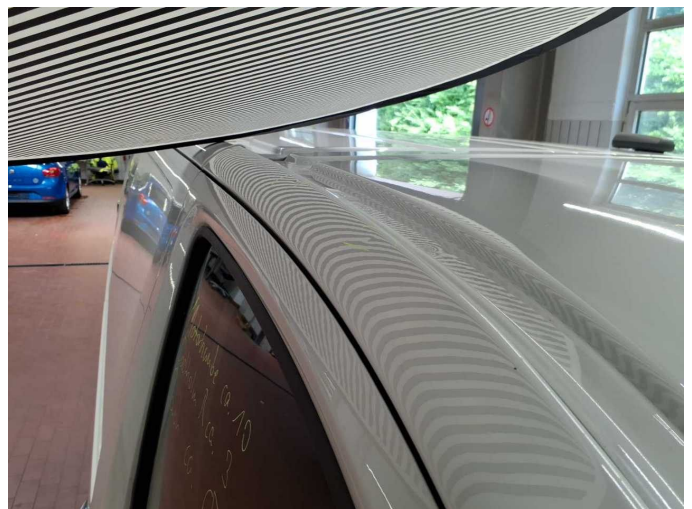
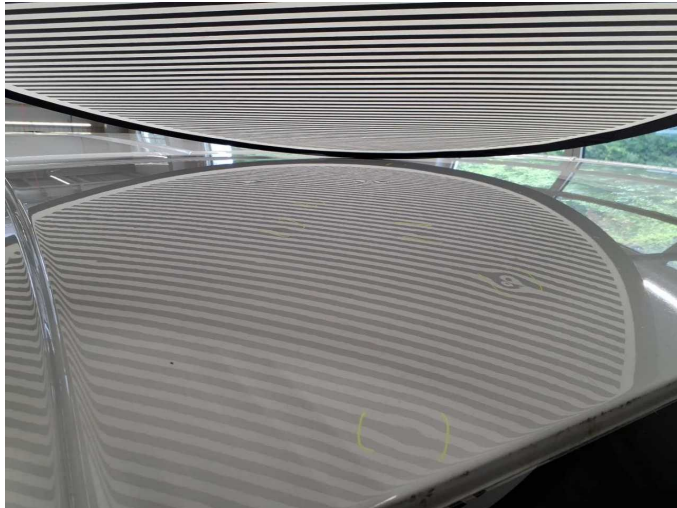
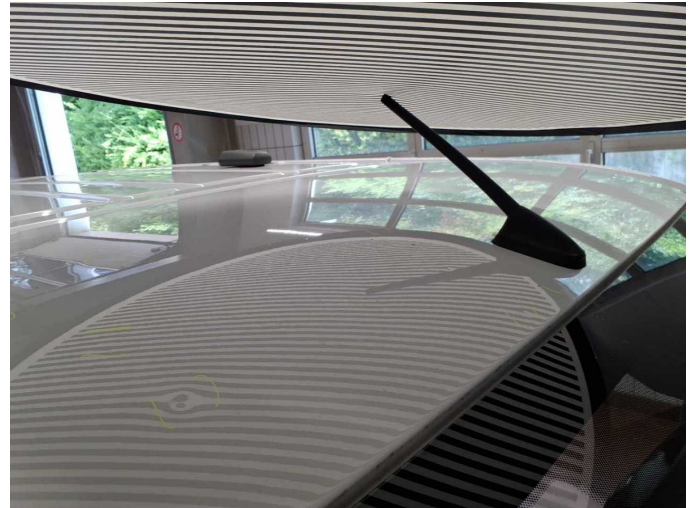
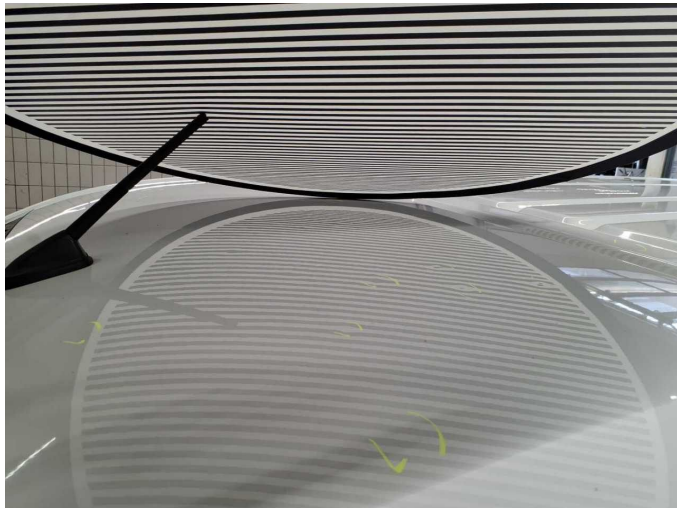
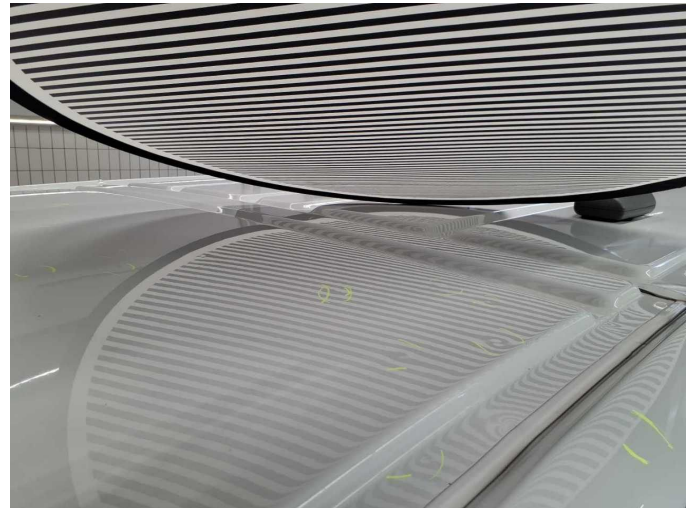
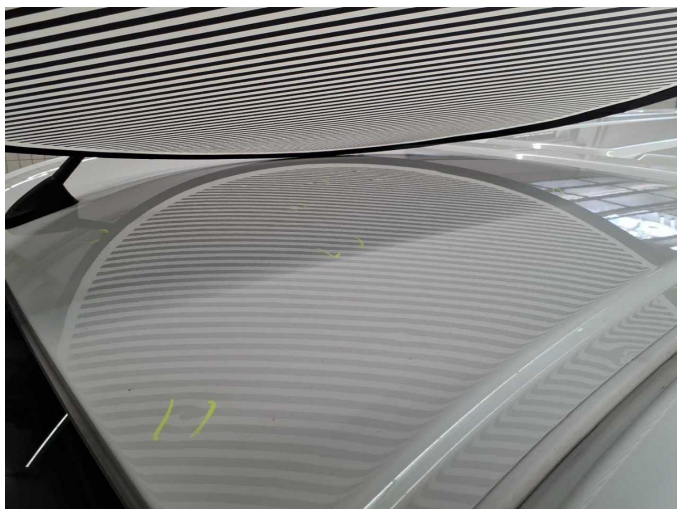
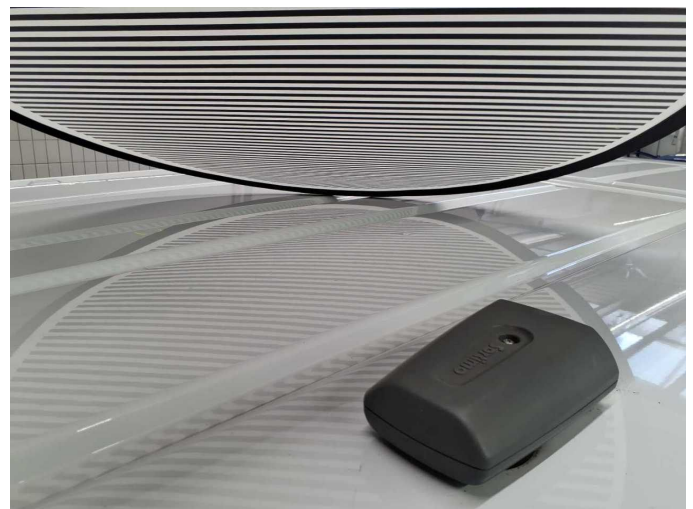
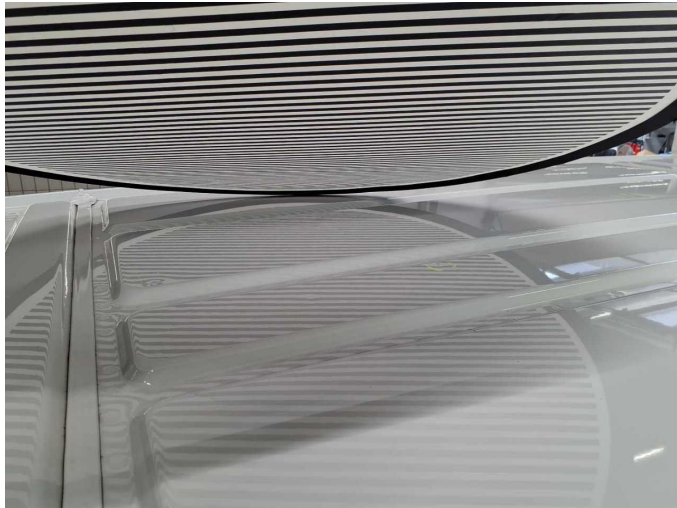
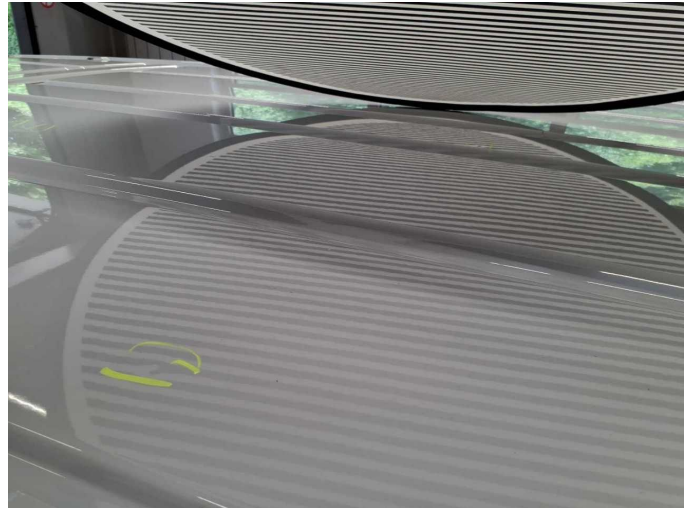
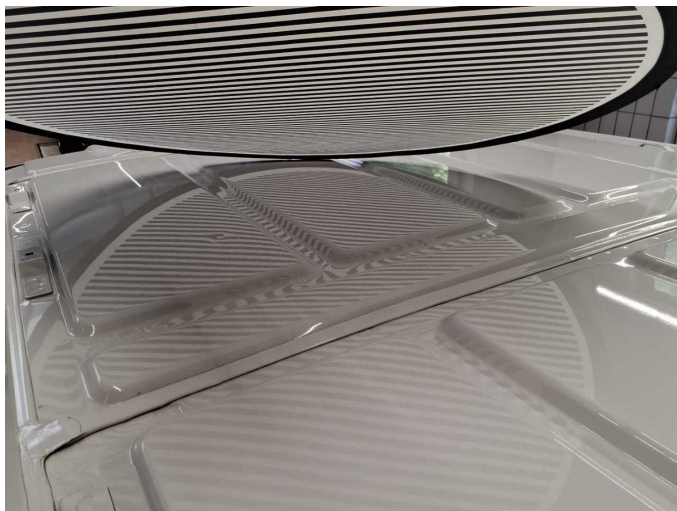
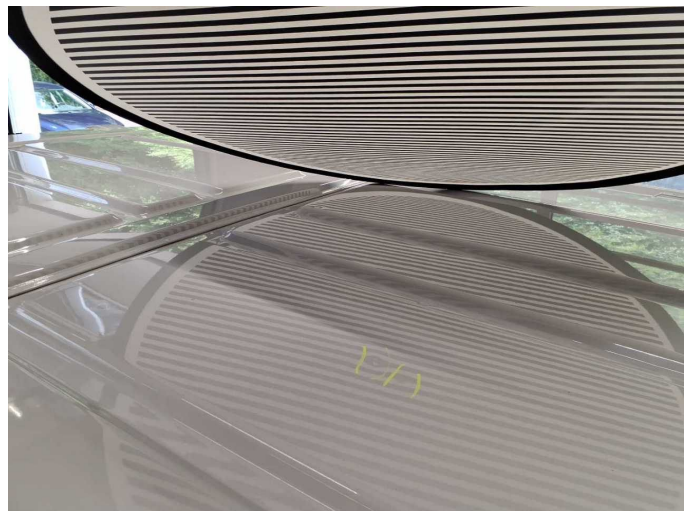
| No. | Component group | Description |
|---|---|---|
| 8 | Body | Body - Damage by hail - Smooth repair work |

**Damage 8:** Body: Body - Damage by hail - Smooth repair work
