Expertise

Protocol number: 45890795
Order No. / Reference: 26389772
Inspection date: 9 Jun 2026

Model: 317 CDI Sprinter Standard HA 9G-Tronic

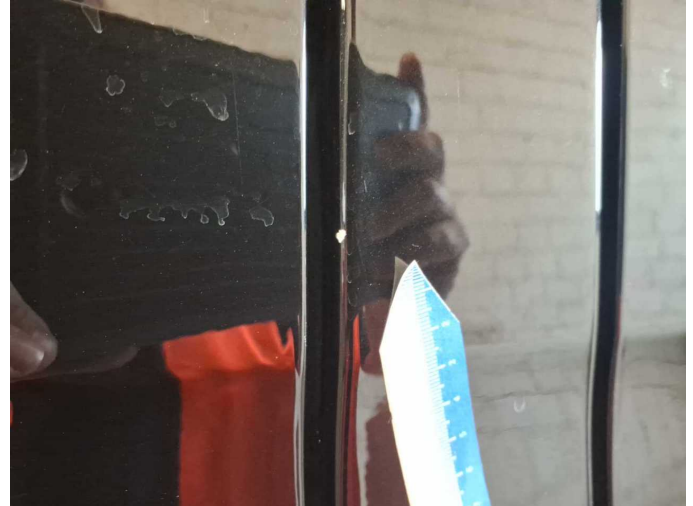
| No. | Component group | Description |
|---|---|---|
| 1 | Body | B-pillar - right side - Scratch(es) - Smart repair |

Damage 1: Body: B-pillar - right side - Scratch(es) - Smart repair

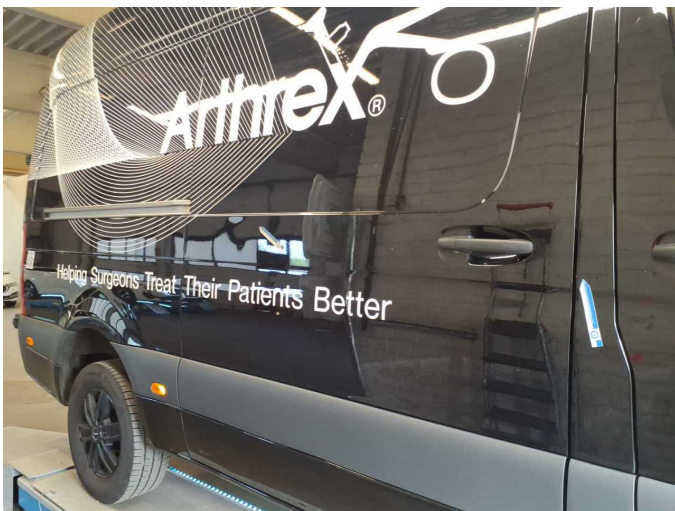
Damage 1: Body: B-pillar - right side - Scratch(es) - Smart repair

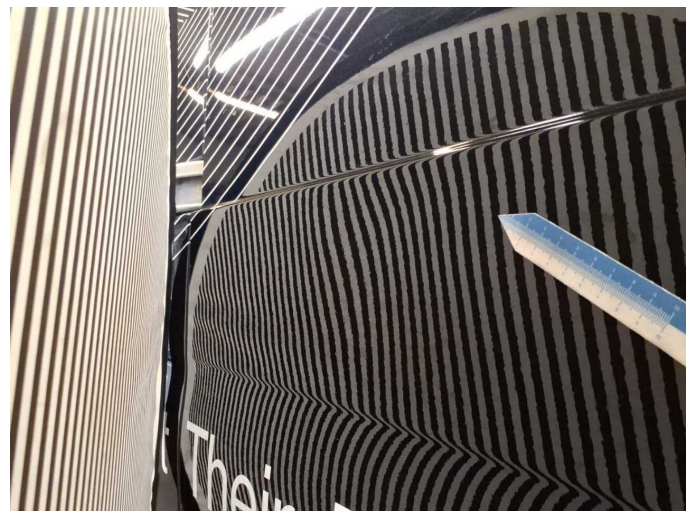
| No. | Component group | Description |
|---|---|---|
| 2 | Sliding door, right | Sliding door - dent(s) - Smooth repair work |

Damage 2: Sliding door, right: Sliding door - dent(s) - Smooth repair work

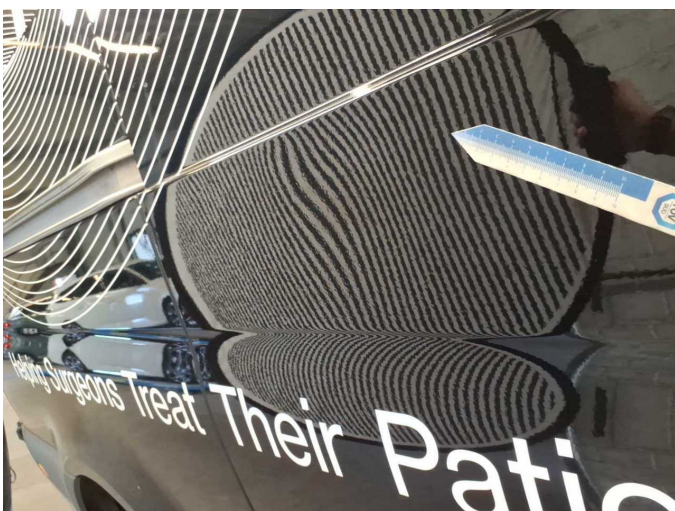
Damage 2: Sliding door, right: Sliding door - dent(s) - Smooth repair work

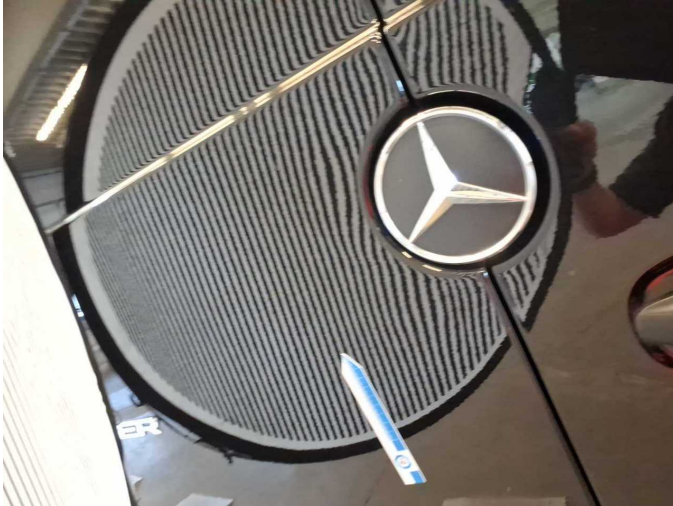
| No. | Component group | Description |
|---|---|---|
| 3 | Boot lid / rear door | Rear door - left side - dent(s) - Smooth repair work |

Damage 3: Boot lid / rear door: Rear door - left side - dent(s) - Smooth repair work

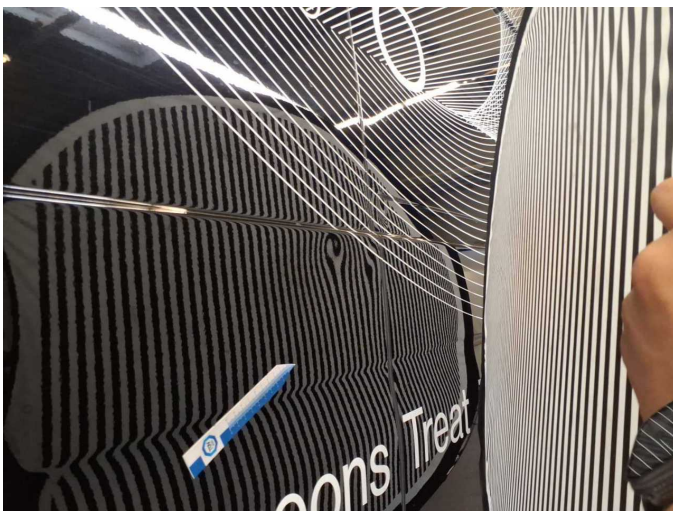
| No. | Component group | Description |
|---|---|---|
| 4 | Side panel - rear left side | Side panel - dent(s) - Smooth repair work |

Damage 4: Side panel - rear left side: Side panel - dent(s) - Smooth repair work

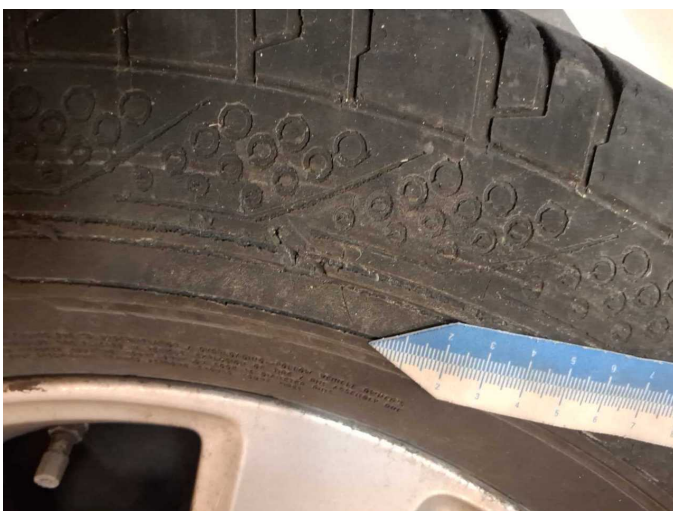
| No. | Component group | Description |
|---|---|---|
| 5 | 2nd wheel set | 1 tyre (Sommerreifen) - Broken / torn - Replace |

Damage 5: 2nd wheel set: 1 tyre (Sommerreifen) - Broken / torn - Replace

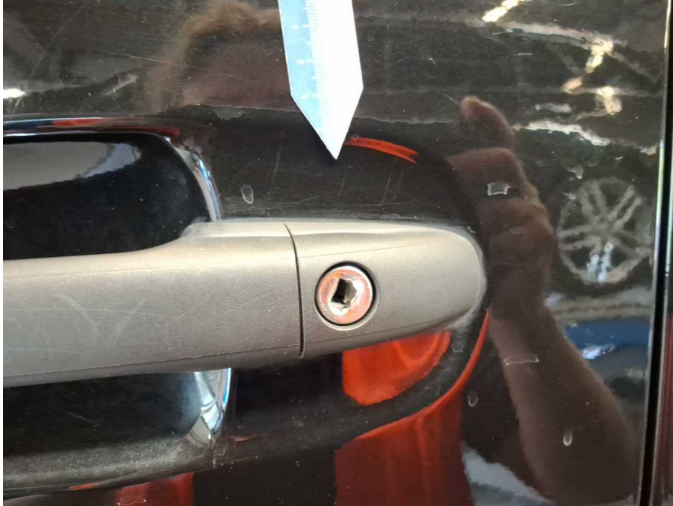
| No. | Component group | Description |
|---|---|---|
| 6 | Door - front left side | Lock / Locking mechanism (Zylinder) - Broken / torn - Replace |

Damage 6: Door - front left side: Lock / Locking mechanism (Zylinder) - Broken / torn - Replace

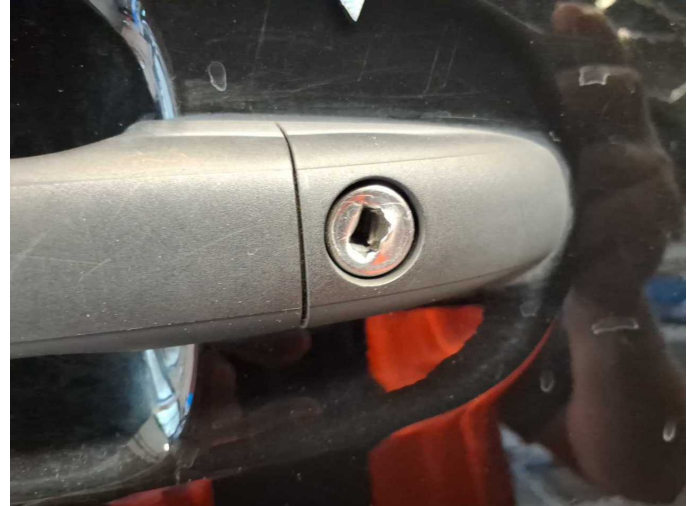
Damage 6: Door - front left side: Lock / Locking mechanism (Zylinder) - Broken / torn - Replace

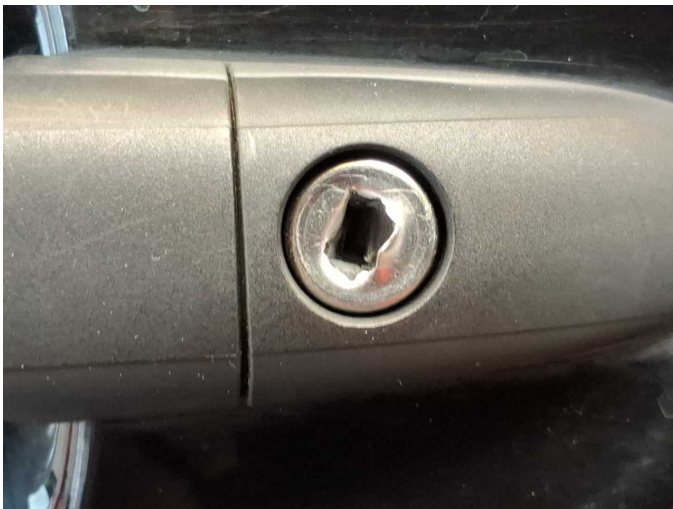
Damage 6: Door - front left side: Lock / Locking mechanism (Zylinder) - Broken / torn - Replace

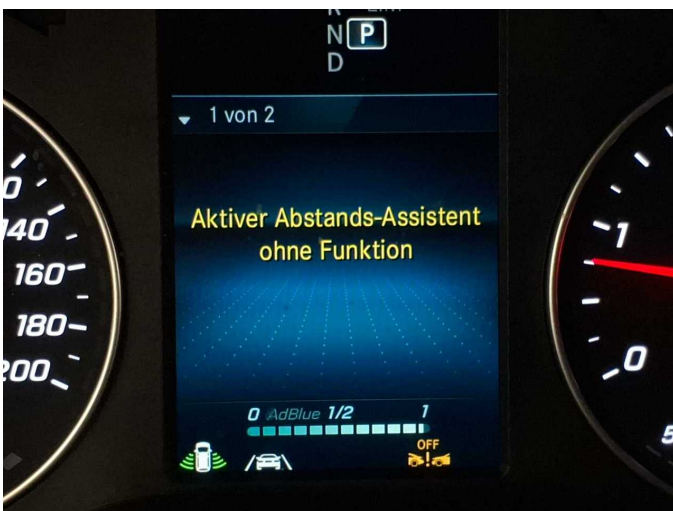
| No. | Component group | Description |
|---|---|---|
| 7 | Electronic systems | Electronic systems (Assistensysteme) - Electrical fault - Perform diagnosis |

Damage 7: Electronic systems: Electronic systems (Assistensysteme) - Electrical fault - Perform diagnosis

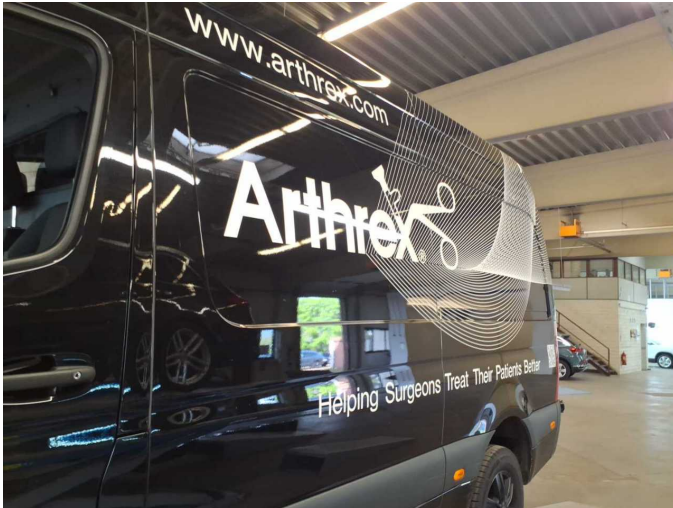
| No. | Component group | Description |
|---|---|---|
| 8 | Body | Body - Glued / labelled - De-glue / neutralise |

Damage 8: Body: Body - Glued / labelled - De-glue / neutralise

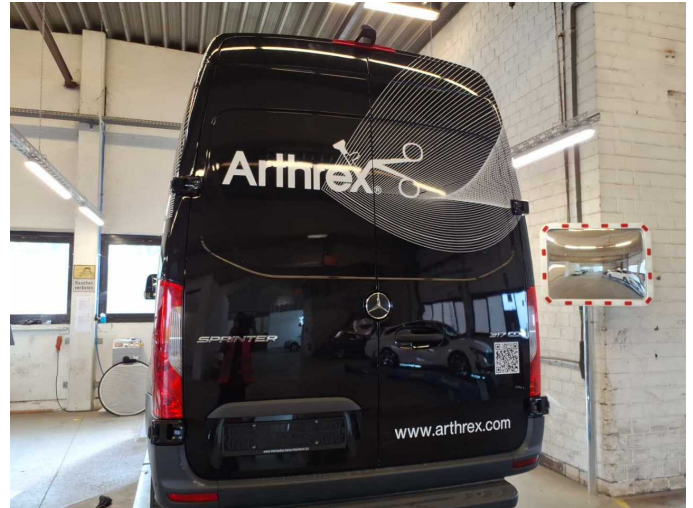
Damage 8: Body: Body - Glued / labelled - De-glu / neutralise

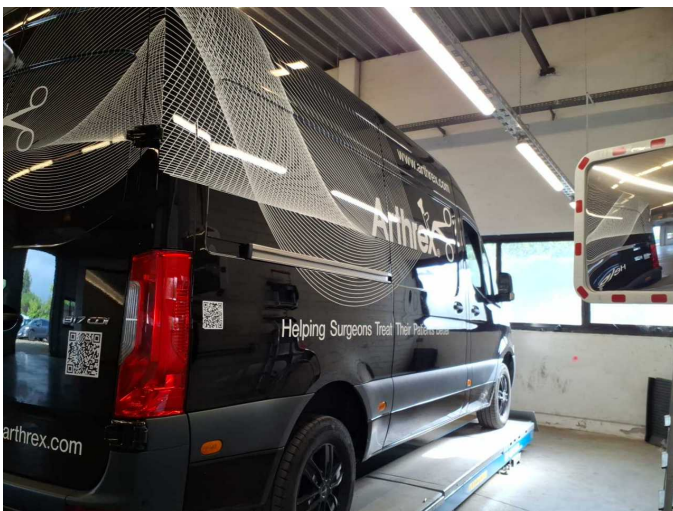
Damage 8: Body: Body - Glued / labelled - De-glu / neutralise

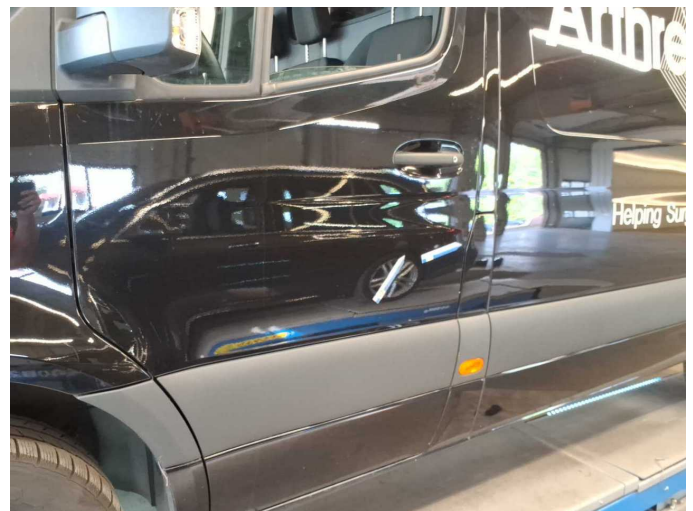
Damage 8: Body: Body - Glued / labelled - De-glu / neutralise

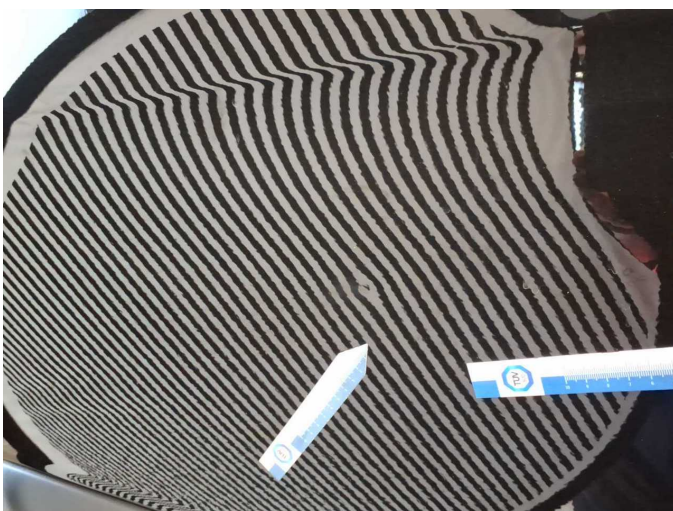
| No. | Component group | Description |
|---|---|---|
| 9 | Door - front left side | Door - Dent / paintcoat damage - Paint |

Damage 9: Door - front left side: Door - Dent / paintcoat damage - Paint

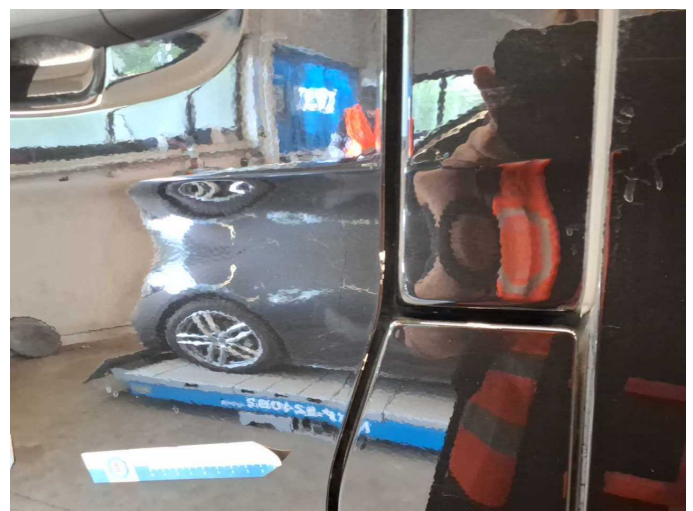
Damage 9: Door - front left side: Door - Dent / paintcoat damage - Paint

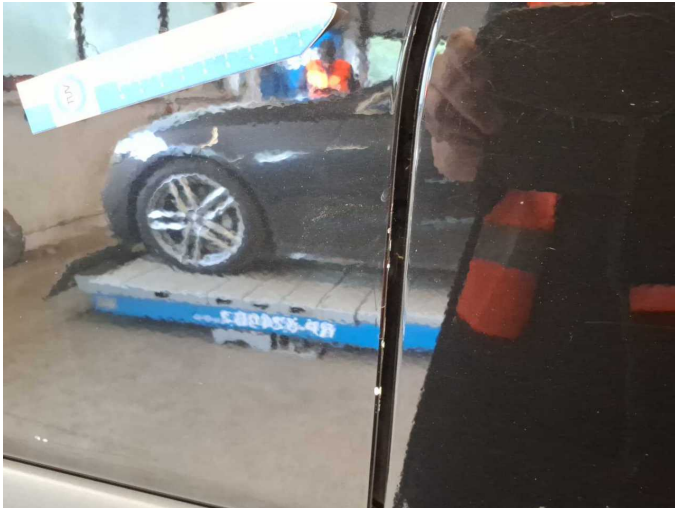
Damage 9: Door - front left side: Door - Dent / paintcoat damage - Paint

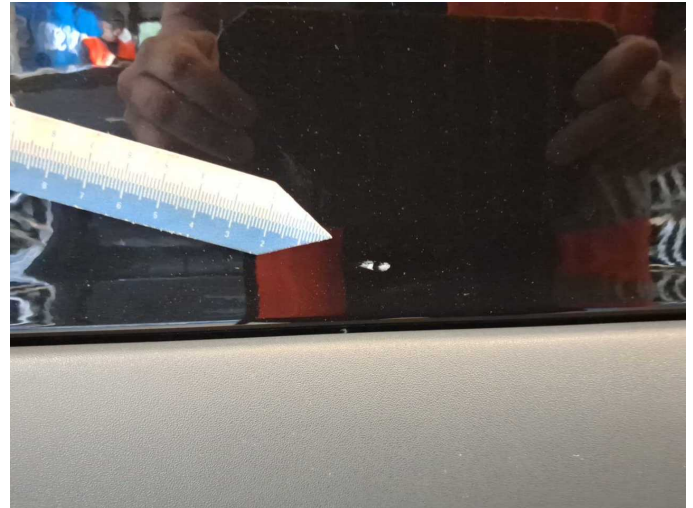
Damage 9: Door - front left side: Door - Dent / paintcoat damage - Paint

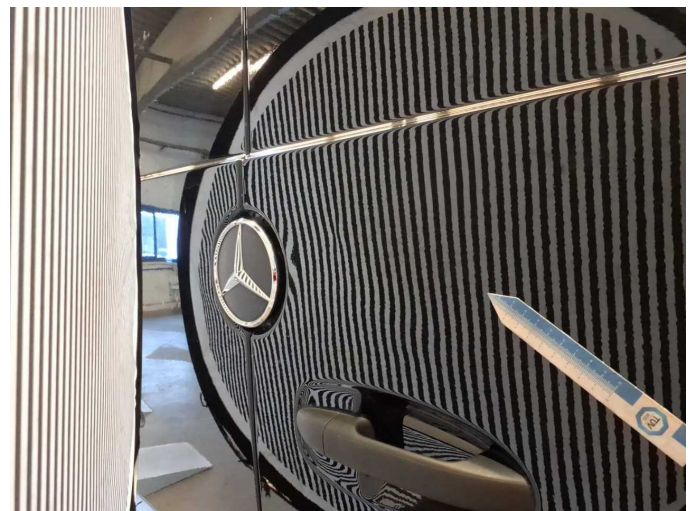
| No. | Component group | Description |
|---|---|---|
| 10 | Boot lid / rear door | Rear door - right side - Dent / paintcoat damage - Paint |

Damage 10: Boot lid / rear door: Rear door - right side - Dent / paintcoat damage - Paint

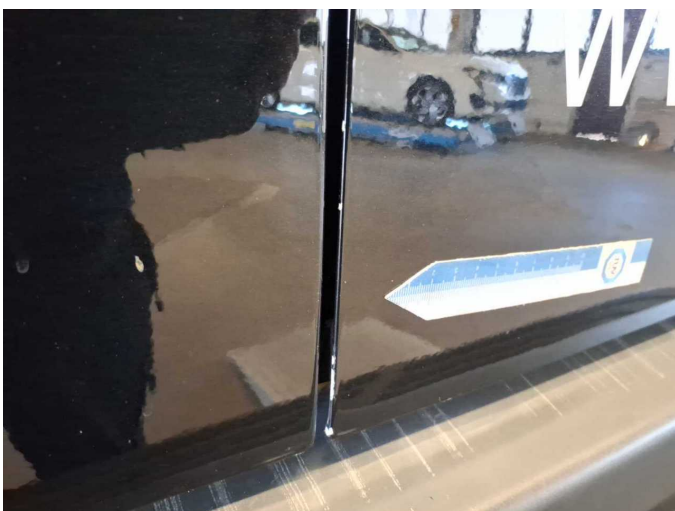
Damage 10: Boot lid / rear door: Rear door - right side - Dent / paintcoat damage - Paint

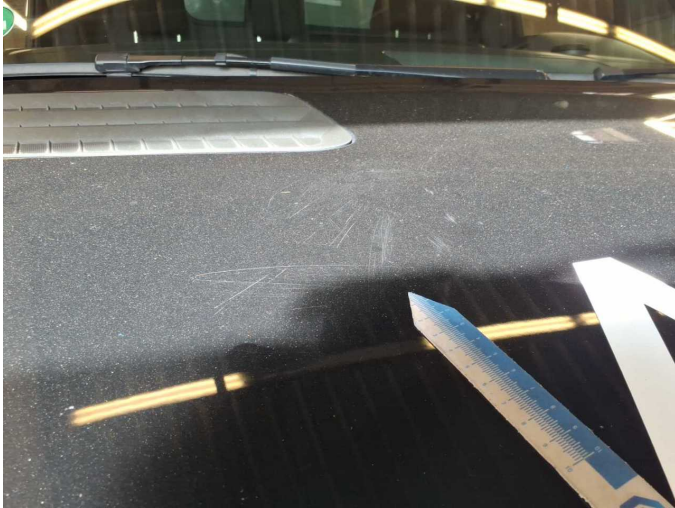
| No. | Component group | Description |
|---|---|---|
| 11 | Bonnet | Bonnet - Scratch(es) - Paint |

Damage 11: Bonnet: Bonnet - Scratch(es) - Paint

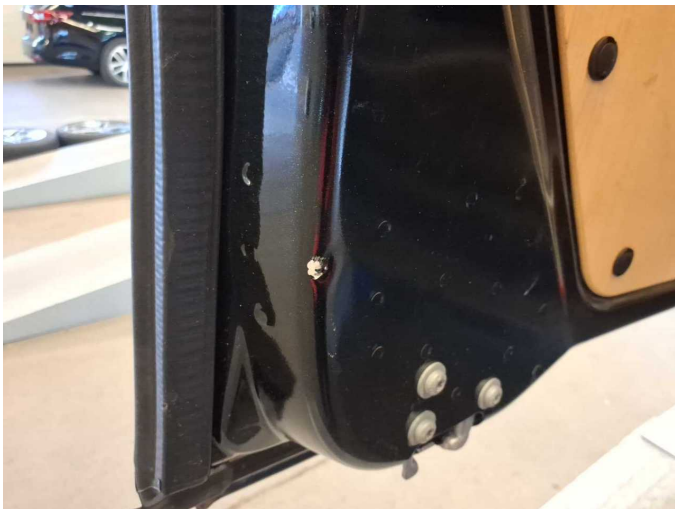
| No. | Component group | Description |
|---|---|---|
| 1 | Boot lid / rear door | Rear door - left side (Innenraum) - Scratched - No deduction |

Wear and tear 1: Boot lid / rear door: Rear door - left side (Innenraum) - Scratched - No deduction

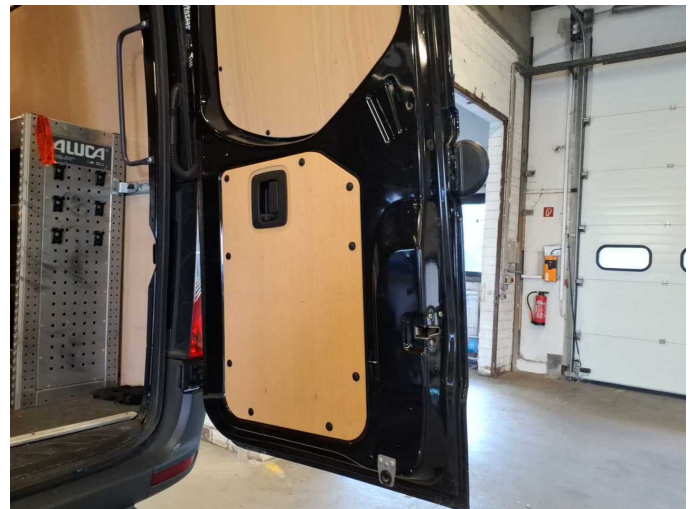
Wear and tear 1: Boot lid / rear door: Rear door - left side (Innenraum) - Scratched - No deduction

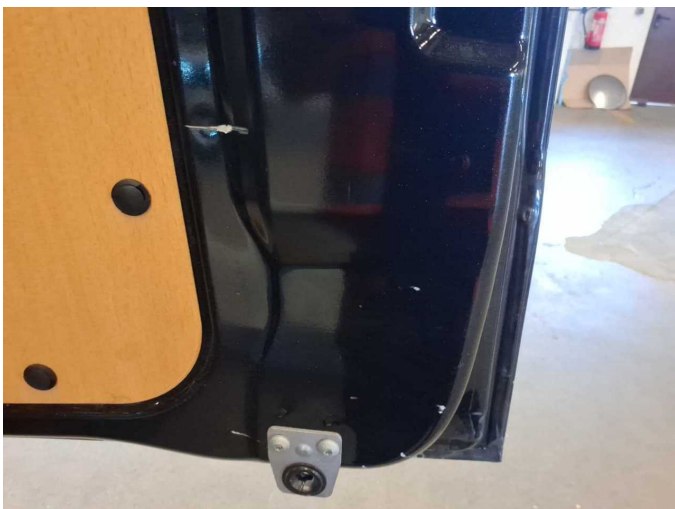
| No. | Component group | Description |
|---|---|---|
| 2 | Boot lid / rear door | Rear door - right side (Innenraum) - Scratched - No deduction |

Wear and tear 2: Boot lid / rear door: Rear door - right side (Innenraum) - Scratched - No deduction

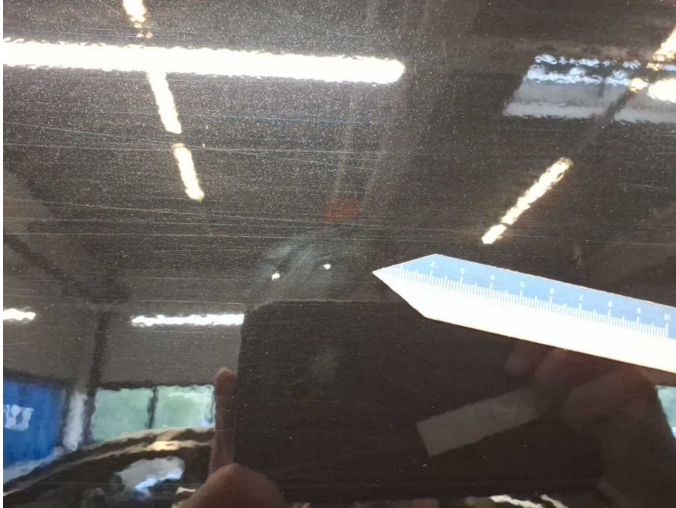
| No. | Component group | Description |
|---|---|---|
| 3 | Side panel - rear left side | Side panel - Stone chips - No deduction |

Wear and tear 3: Side panel - rear left side: Side panel - Stone chips - No deduction

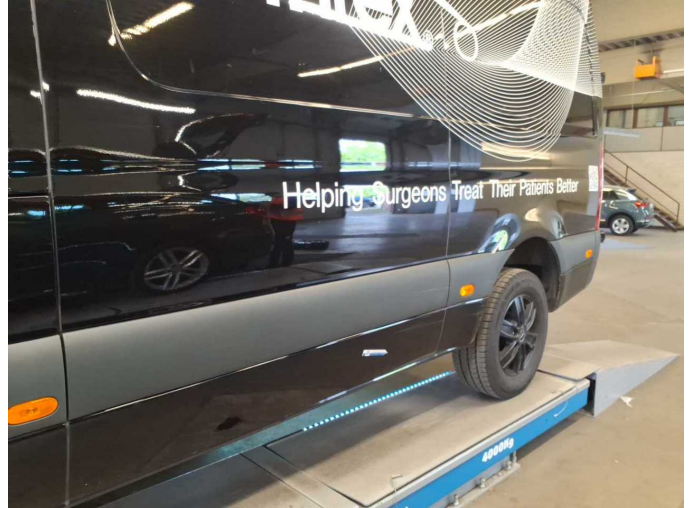
Wear and tear 3: Side panel - rear left side: Side panel - Stone chips - No deduction

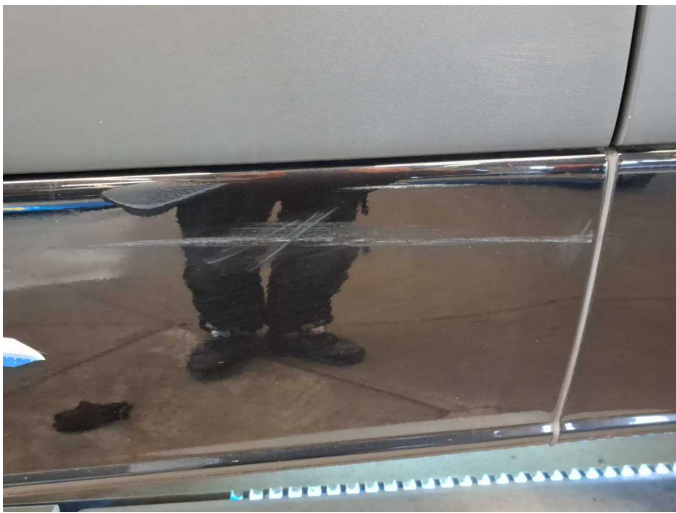
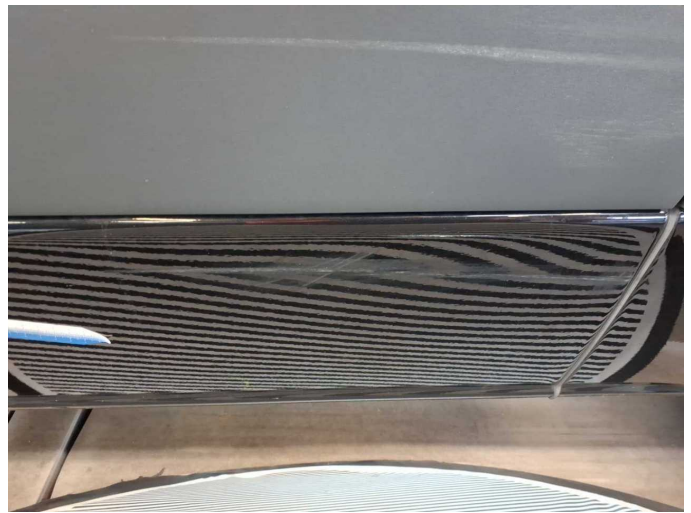
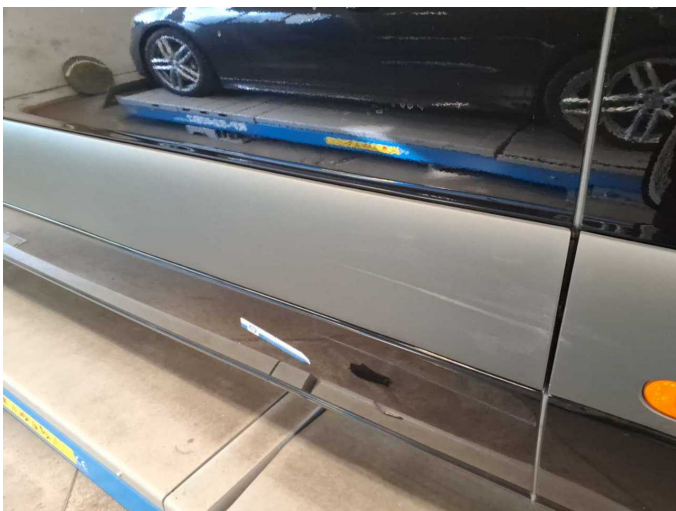
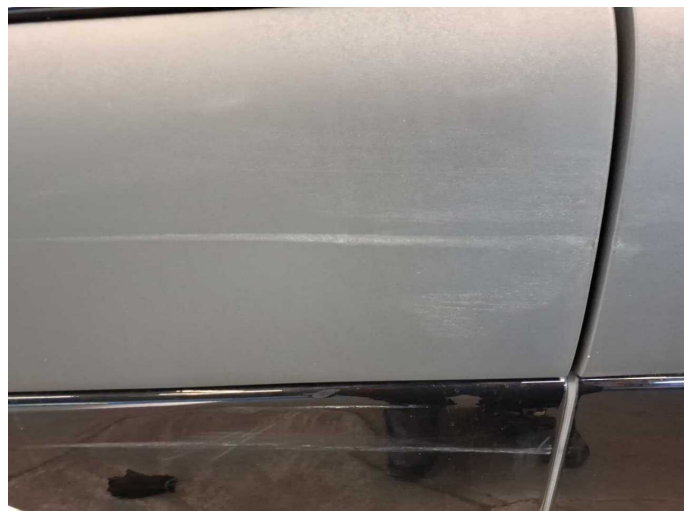
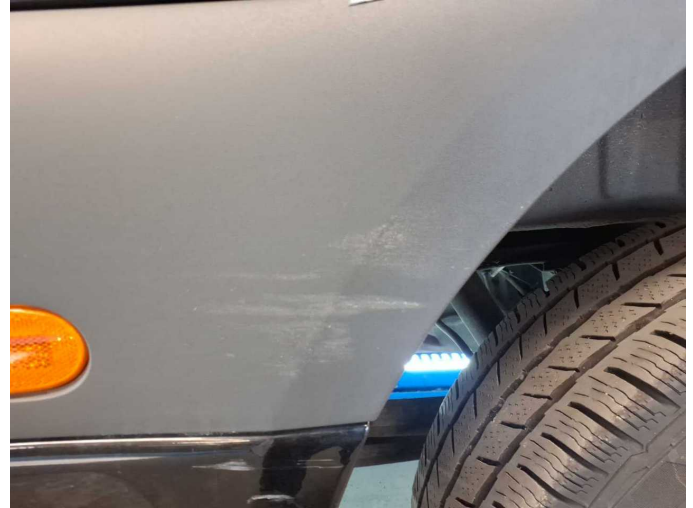
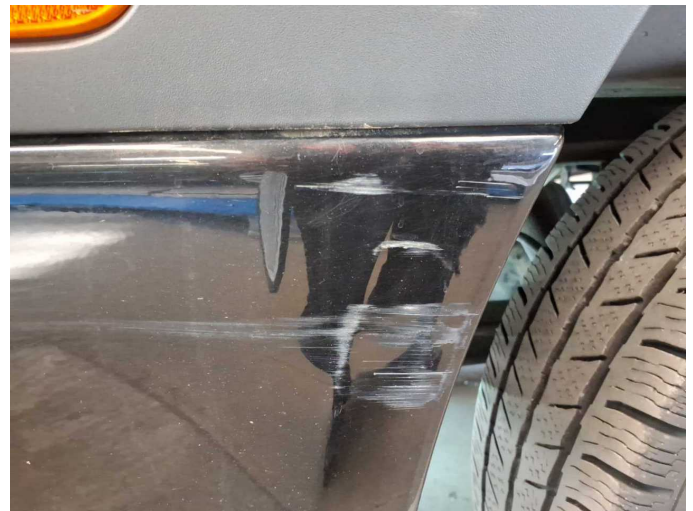
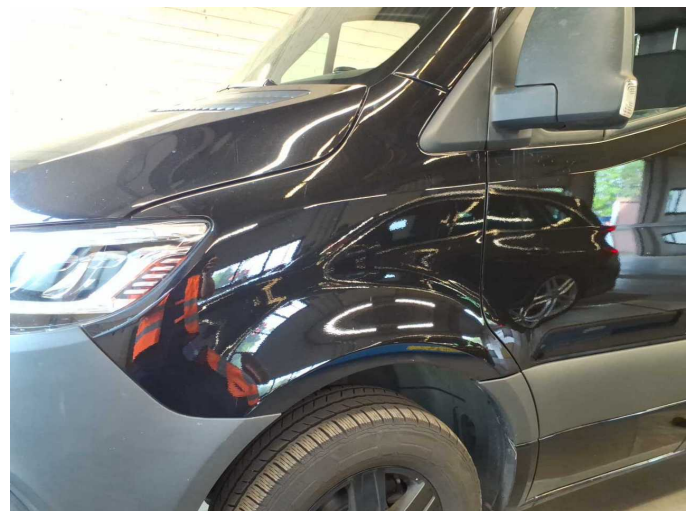
Accident 1: Side - left

| No. | Accident |
|---|---|
| 1 | Side - left |

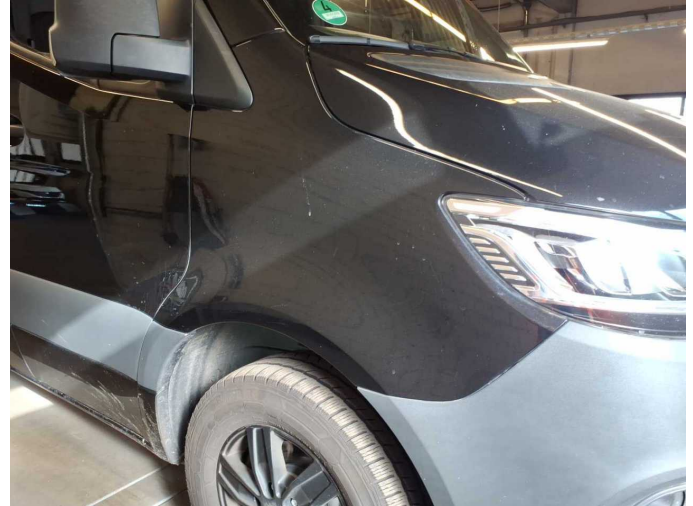
Repainting 1: Mudguard - left side, Mudguard - right side

| No. | Repainting |
|---|---|
| 1 | Mudguard - left side, Mudguard - right side |

| Mudguard - left side | 197 µm | Mudguard - right side | 217 µm |
