Expertise

Protocol number: 46275888
Order No. / Reference: 26652927
Inspection date: 2 Jul 2026

Model: 308 SW BlueHDi 130 EAT8 Stop & Start GT

VIN: VF3LCYHZKLS293138

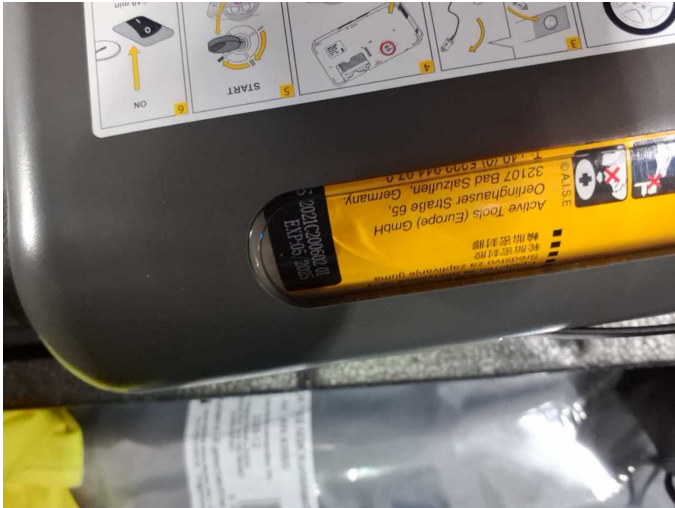
Damage 1: Equipment: Tirefit filler - Due - Replace

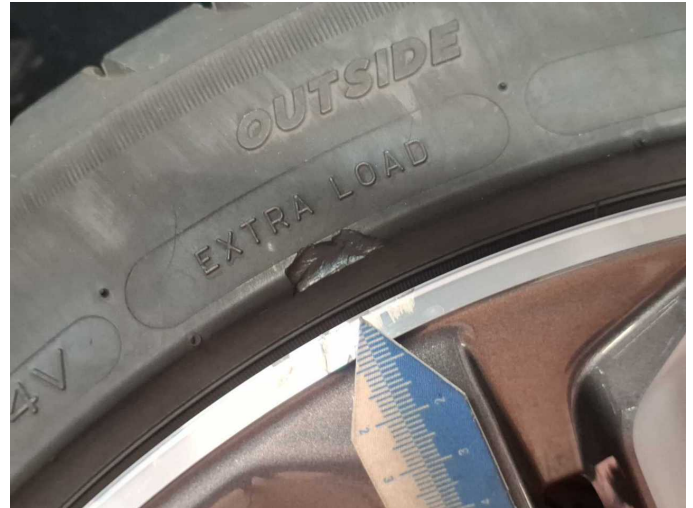
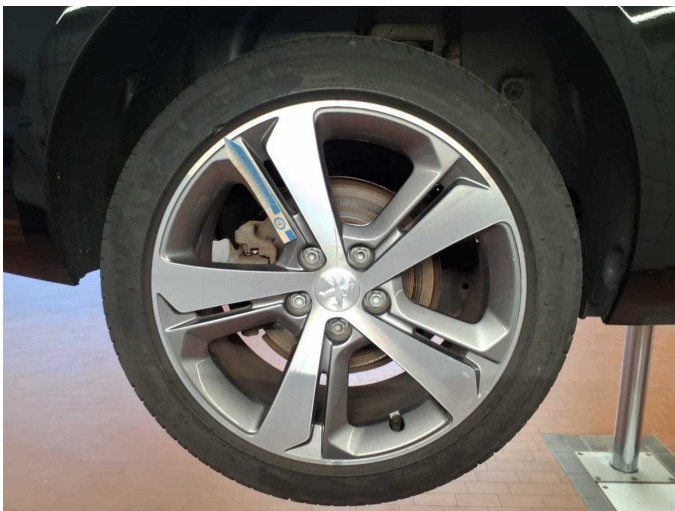
Damage 2: Wheel / tyres: Tyre - rear right side - Broken / torn - Replace

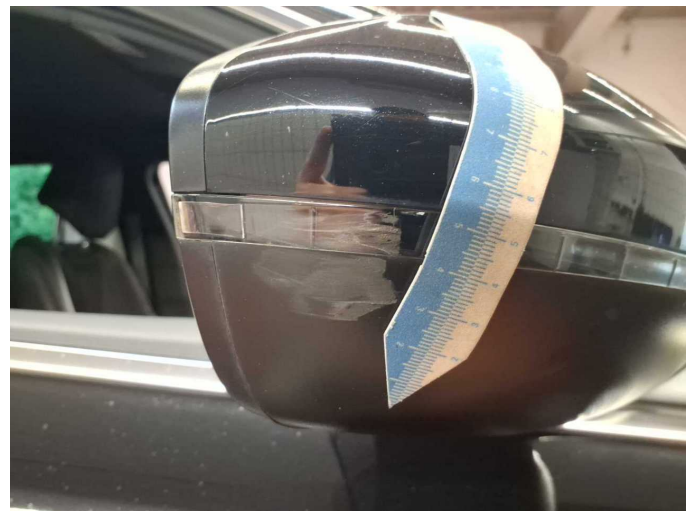
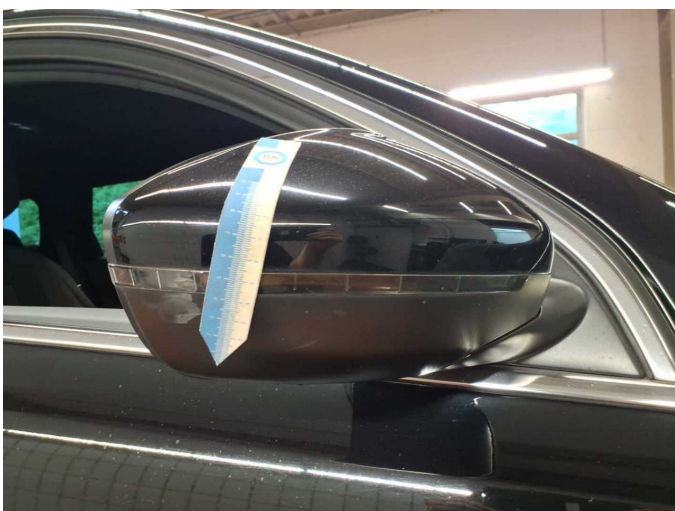
Damage 3: Indicator - front: Mirror - right side - Scratch(es) - Replace

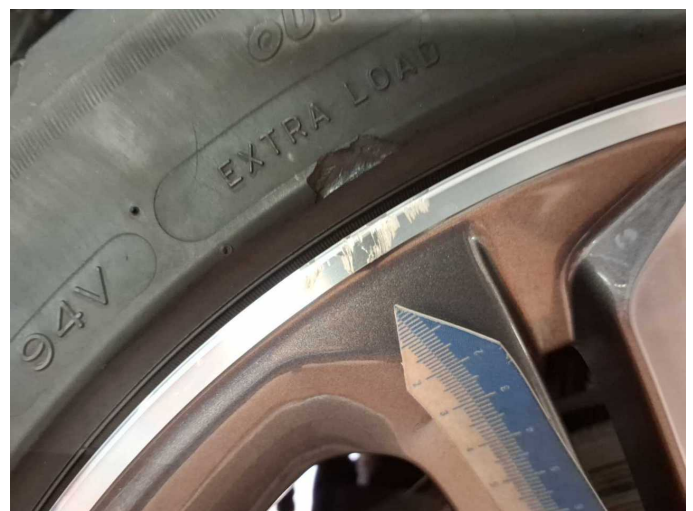
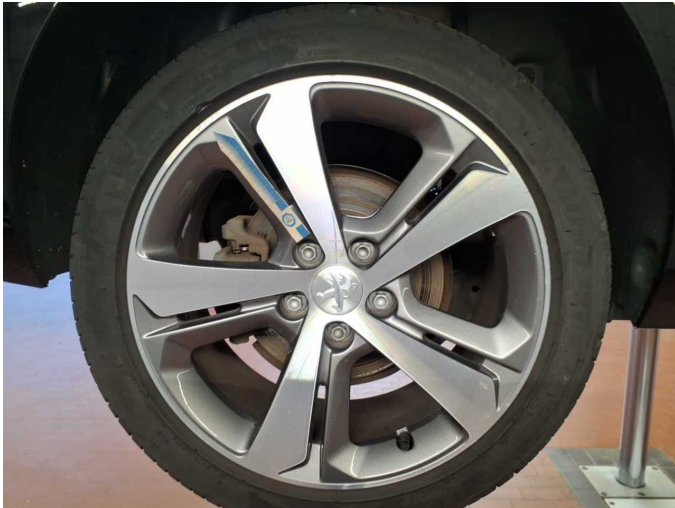
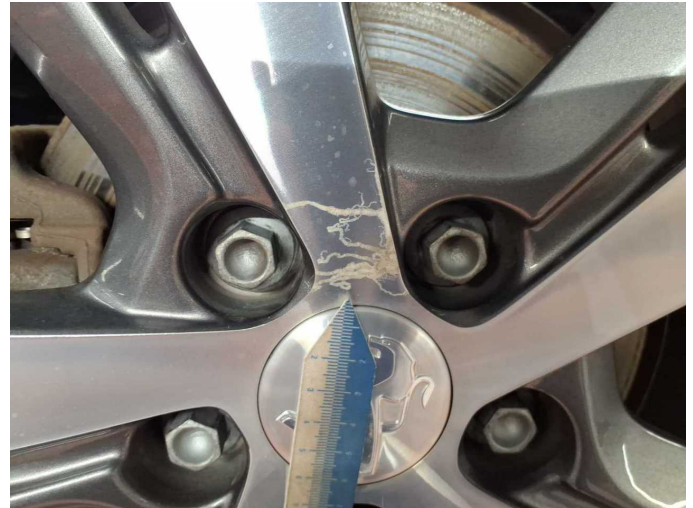
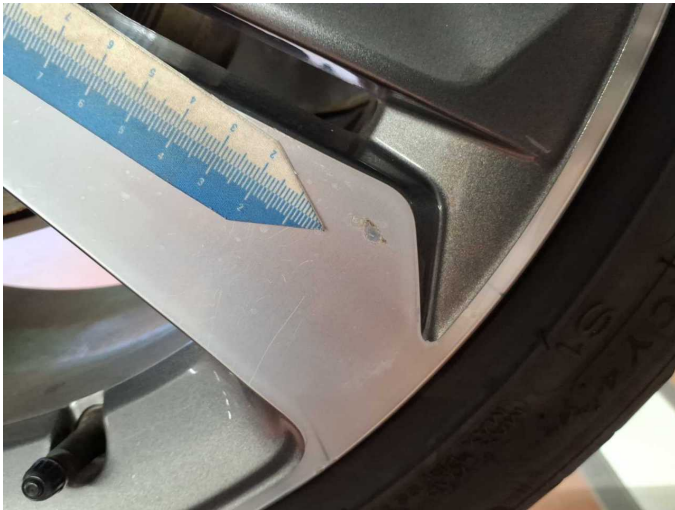
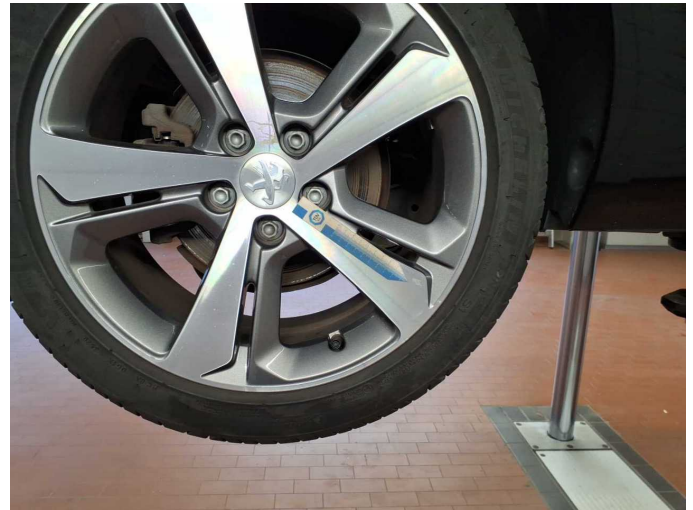
Damage 4: Wheel / tyres: Alloy rim - rear right side - Scratched - Loss in value

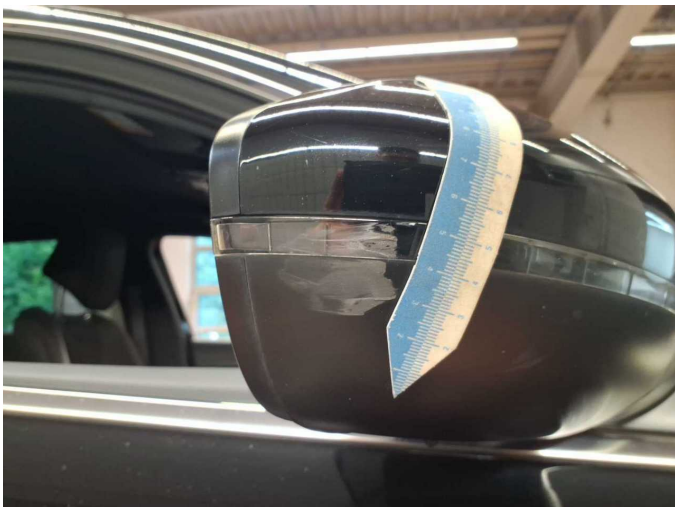
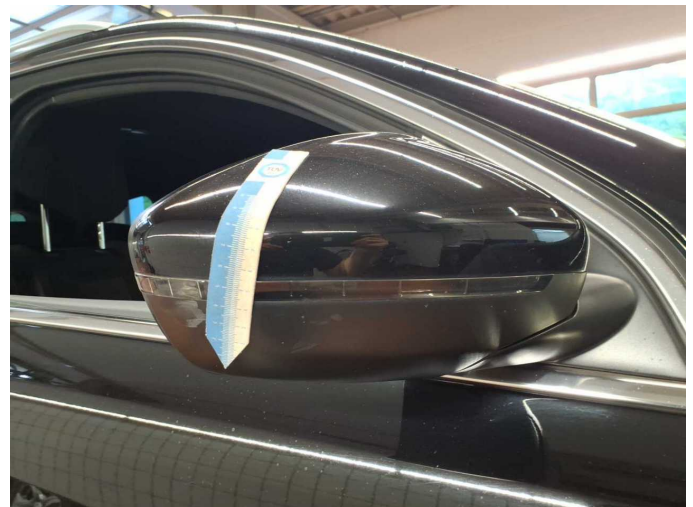
Damage 5: Wing mirror - right side: Mirror housing - Scratch(es) - Replace

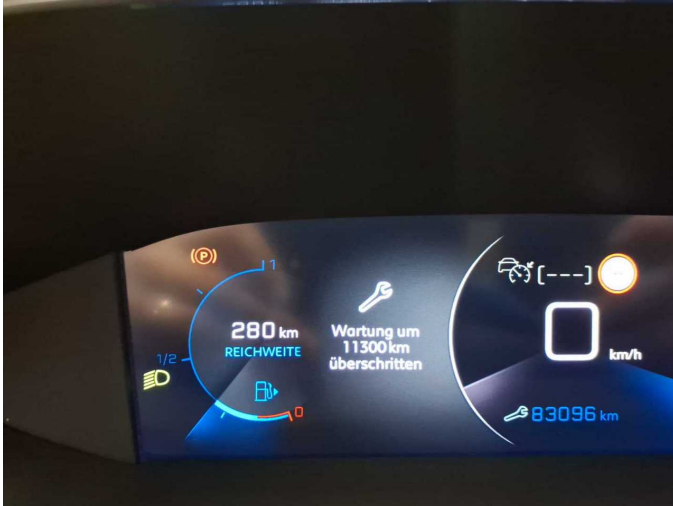
Damage 6: Misc.: Inspection / maintenance - Due - Perform

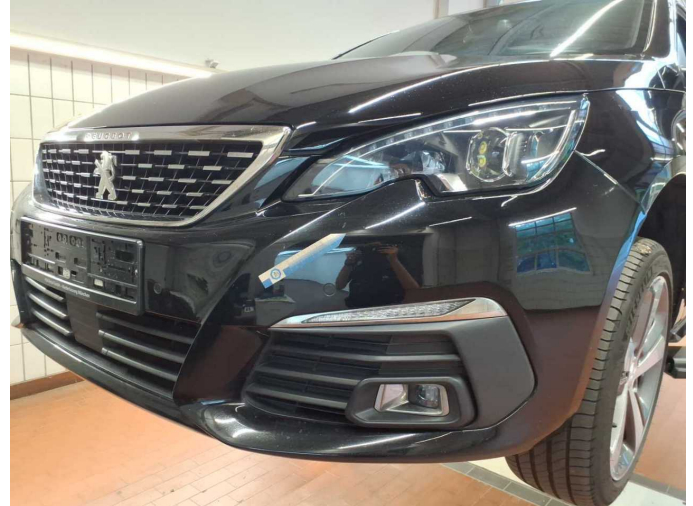
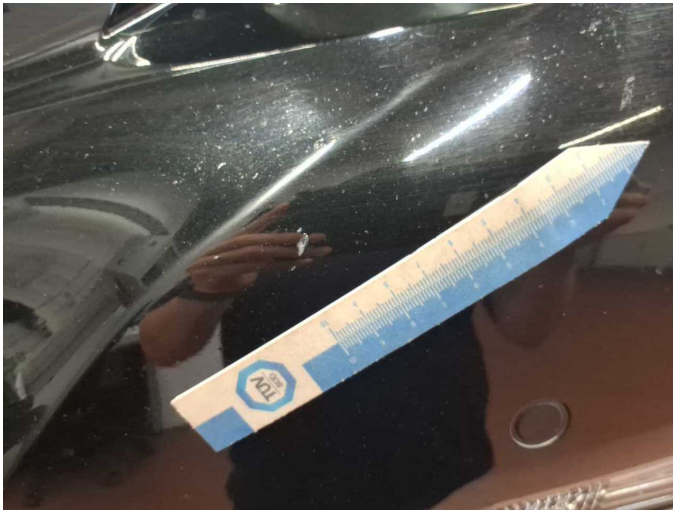
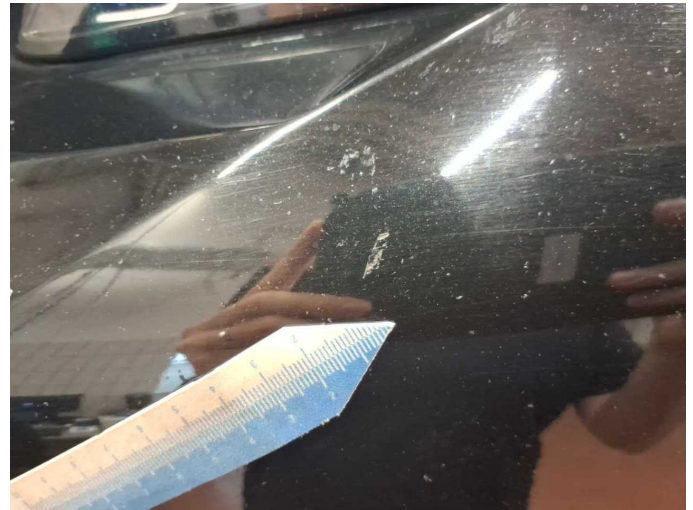
Wear and tear 2: Front bumper: Front bumper - Stone chips - No deduction

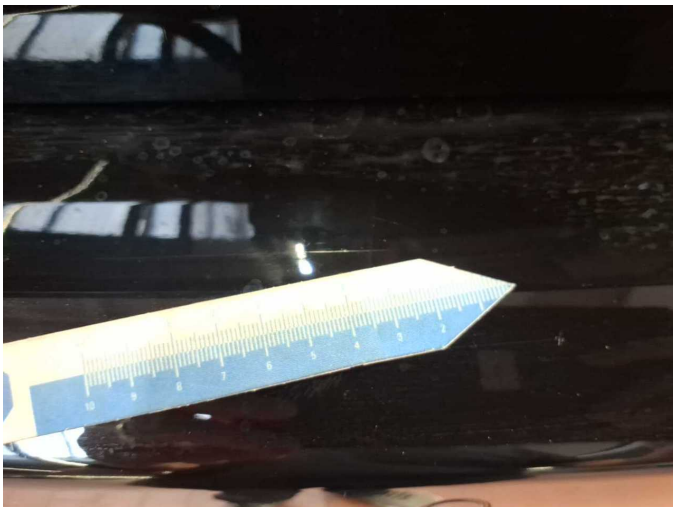
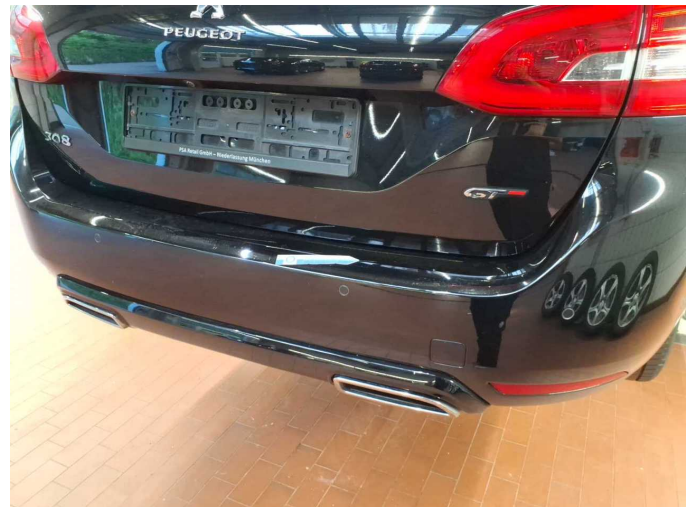
Wear and tear 3: Rear bumper: Rear bumper - Scratch(es) - No deduction

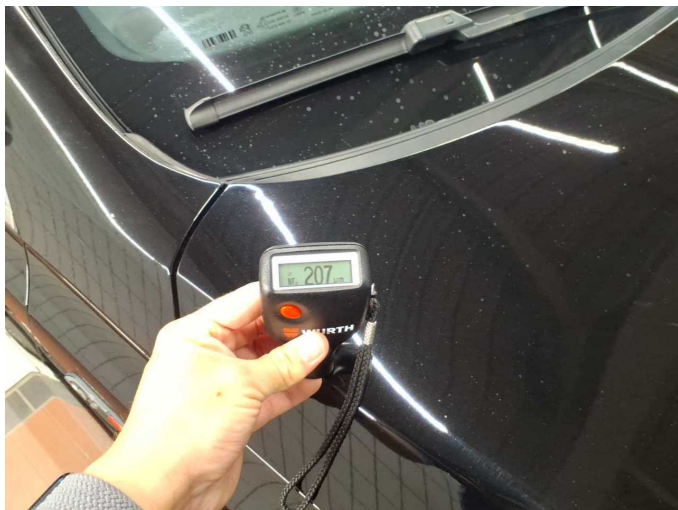
No.	Repainting
1	Bonnet, Professionally carried out, Invoice of repair done Non-existent

Bonnet	207 µm
--------	--------

Repainting 1: Bonnet
