Expertise

Protocol number: 46104689
Order No. / Reference: 26467023
Inspection date: 23 Jun 2026

Model: Focus Turnier 2.0 EcoBlue Start-Stopp-System Aut. ACTIVE

VIN: WF0PXXGCHPLB18849

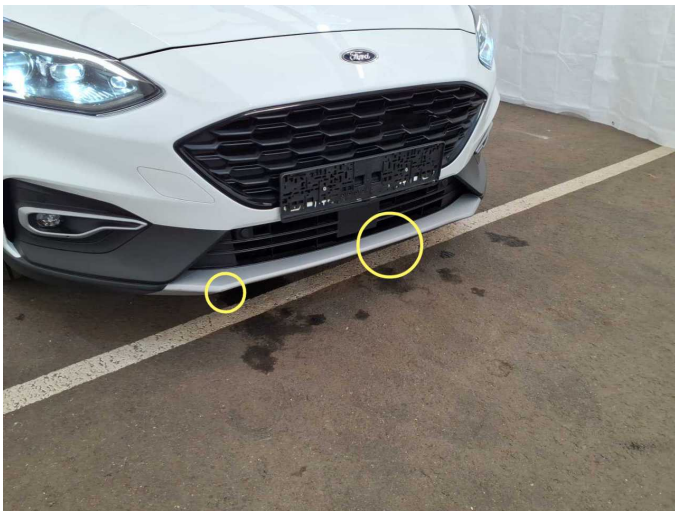
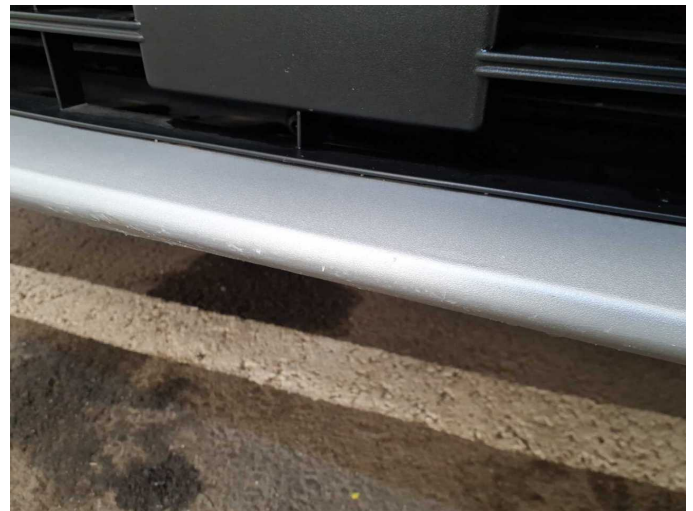
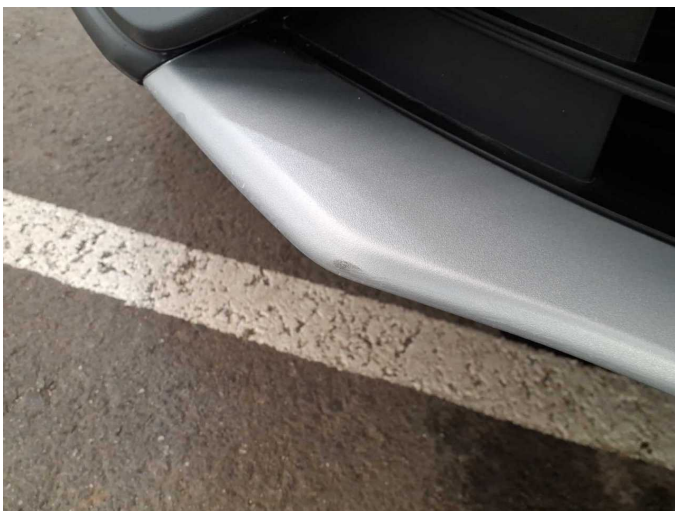
Damage 1: Front bumper: Spoiler - Scratch(es) - Loss in value

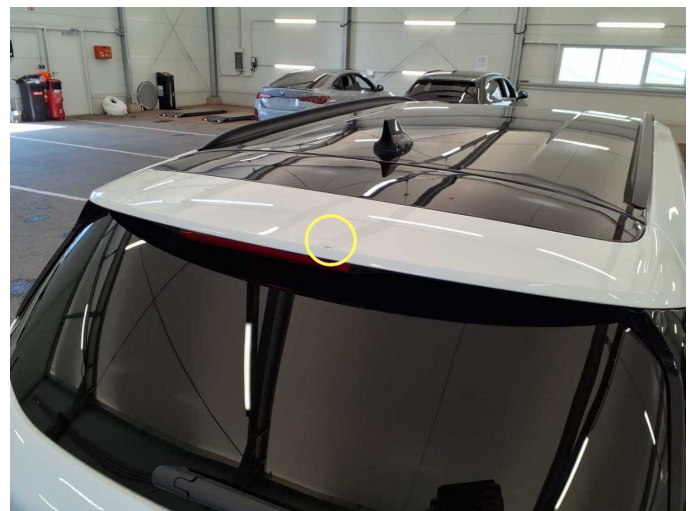
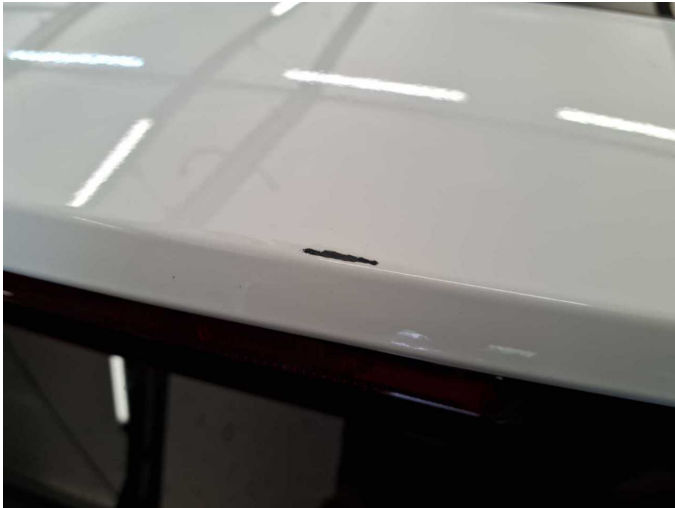
Damage 2: Boot lid / rear door: Rear spoiler - Scratch(es) - Smart repair

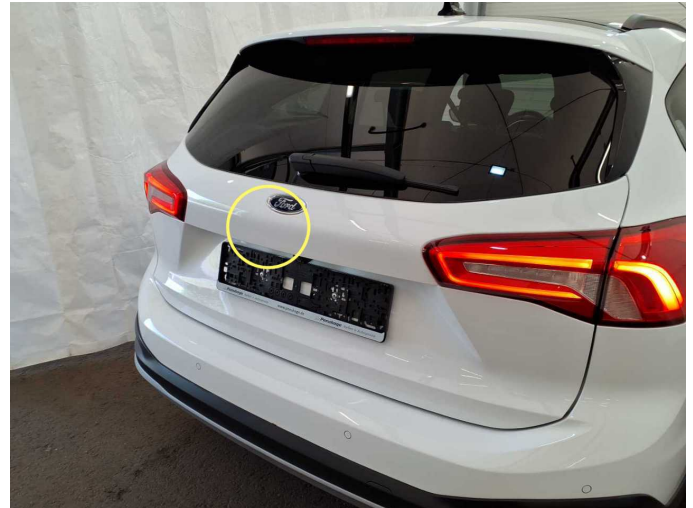
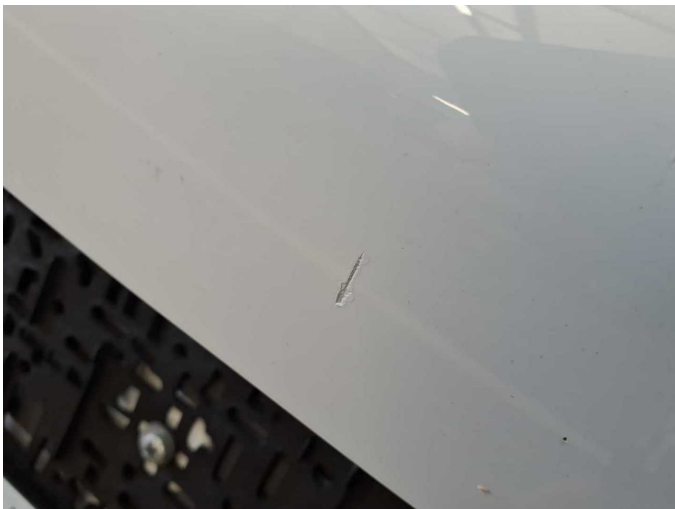
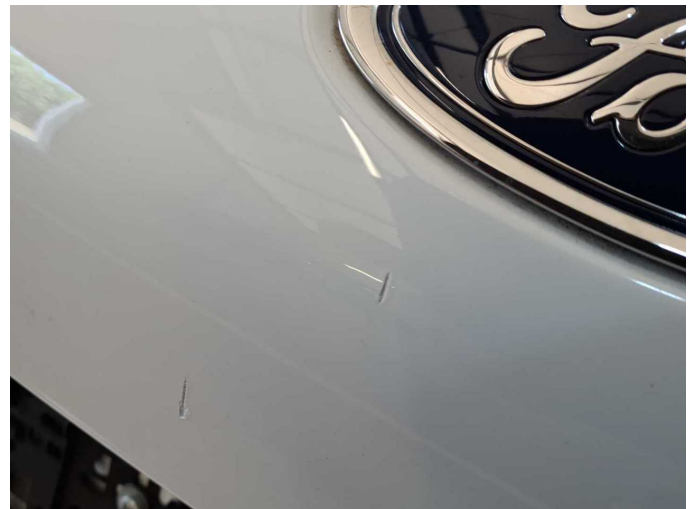
Damage 3: Boot lid / rear door: Boot lid - Scratch(es) - Smart repair

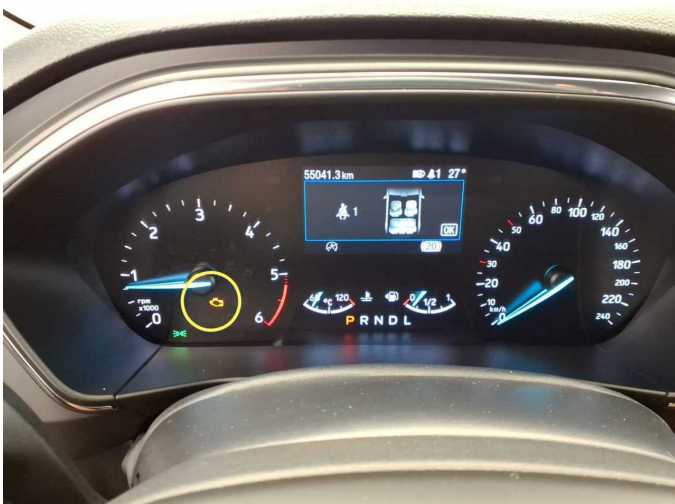
Damage 4: Instrument panel: Indicator light (Motorkontrollleuchte, nicht fahrbereit) - on - Perform diagnosis

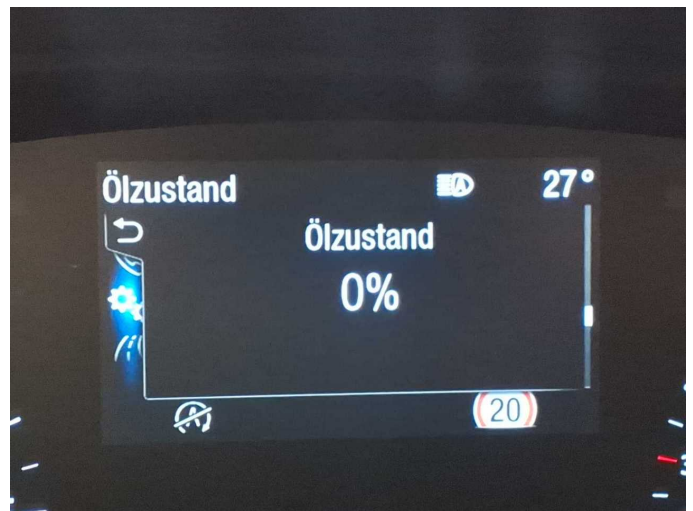
Damage 5: Misc.: Inspection / maintenance - Due - Perform

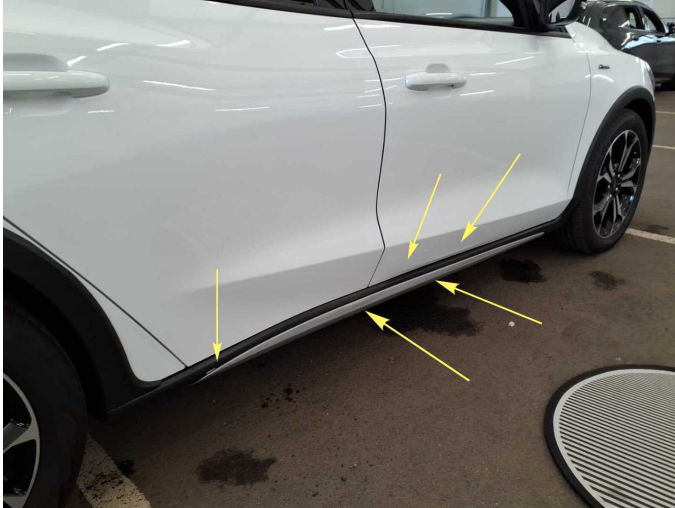
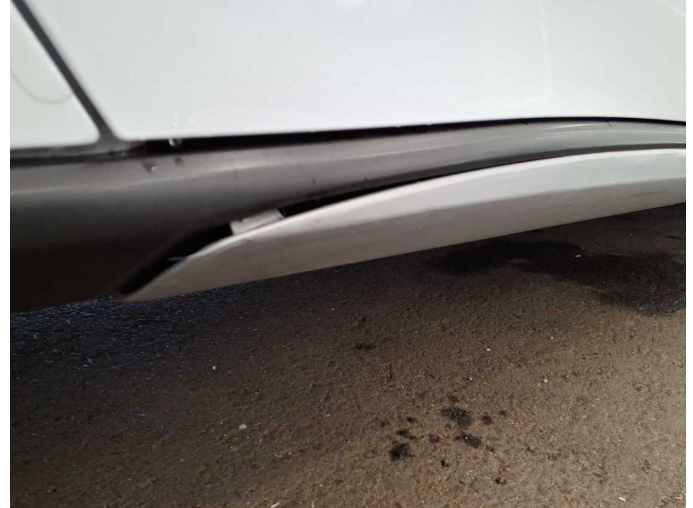
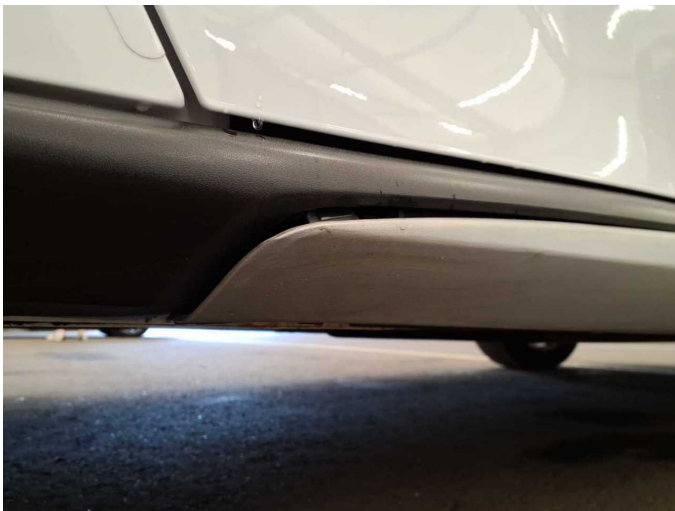
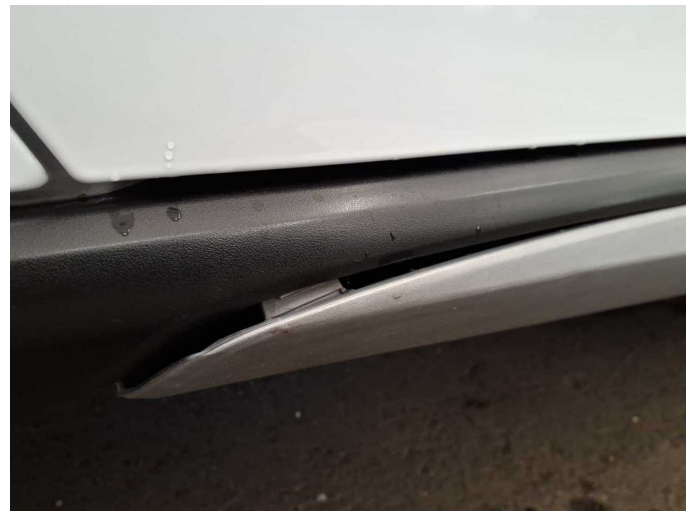
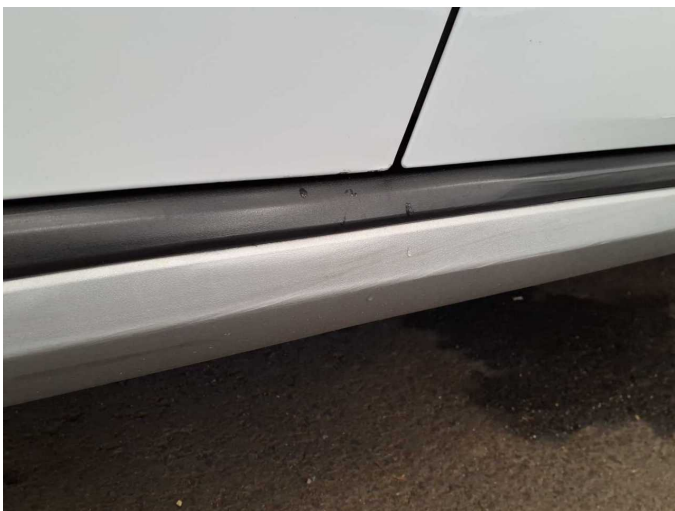
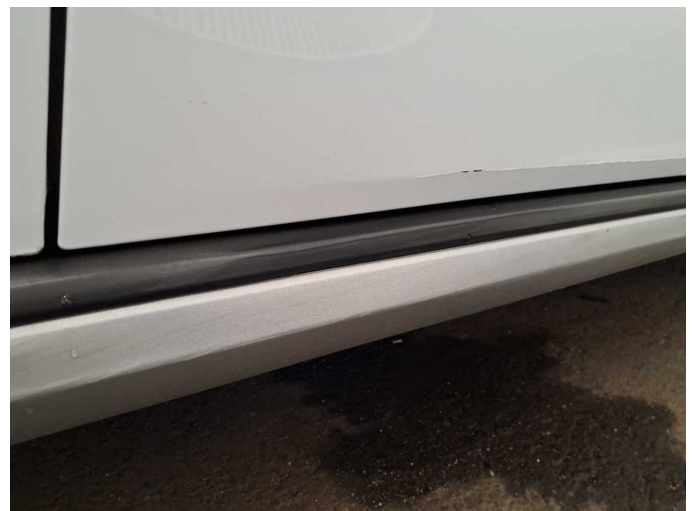
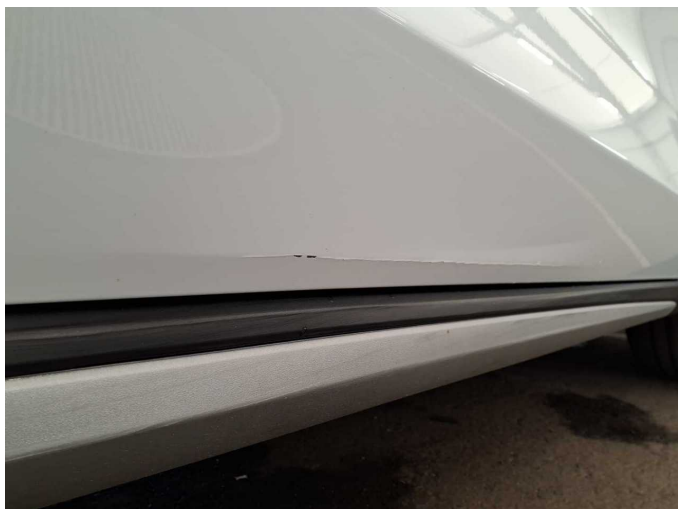
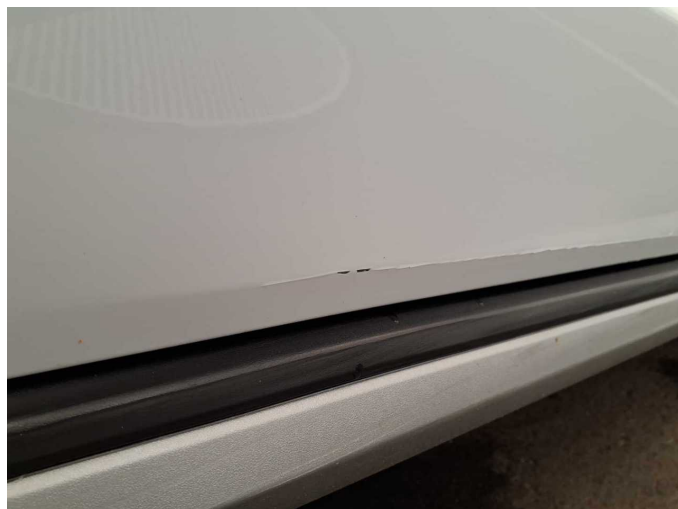
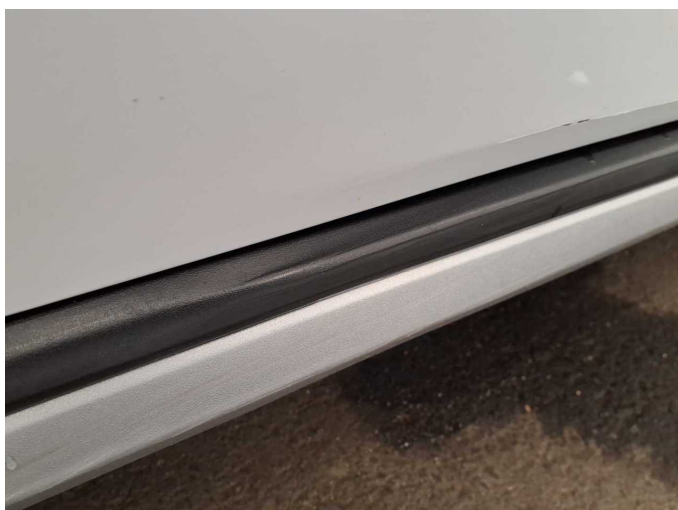
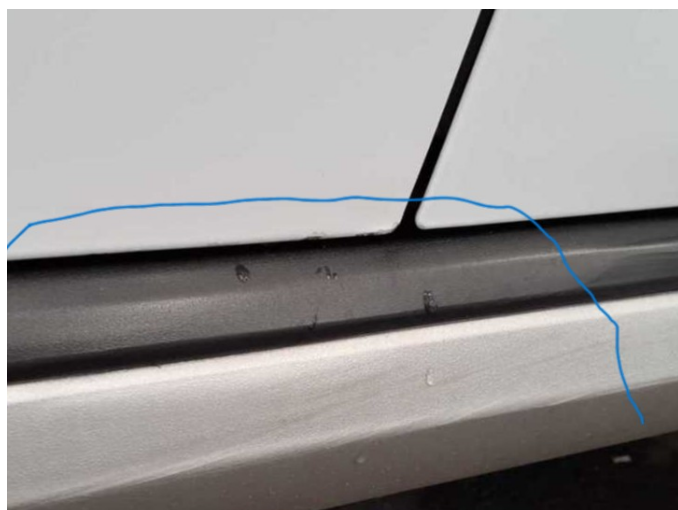
No.	Accident
1	Side right

Accident 1: Side right
