Expertise

Protocol number: 46643414  
Order No. / Reference: 26577975  
Inspection date: 21 Jul 2026

| Manufacturer: Opel | Model: Grandland 1.5 D Automatik Business Elegance |
| VIN: W0VZCYHZ0N6806060 | |

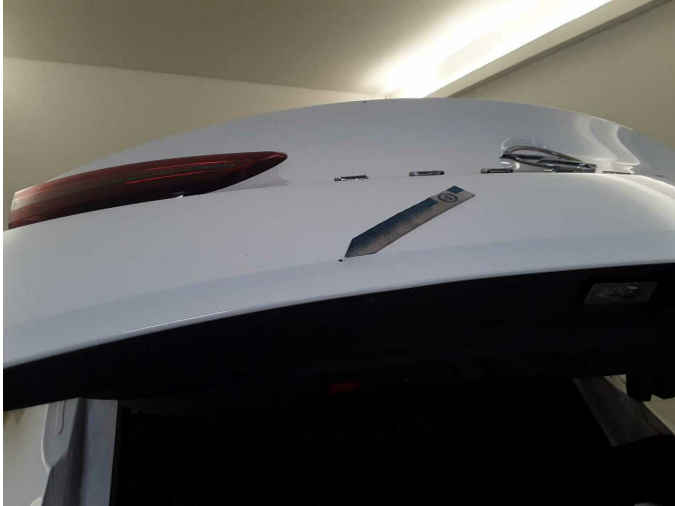
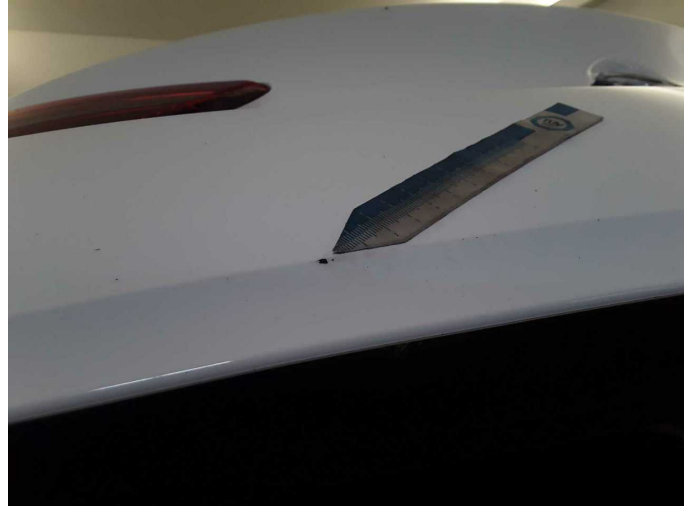
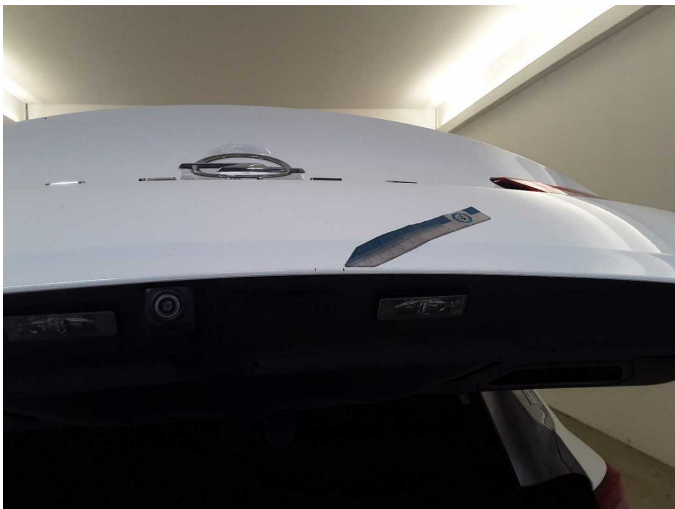
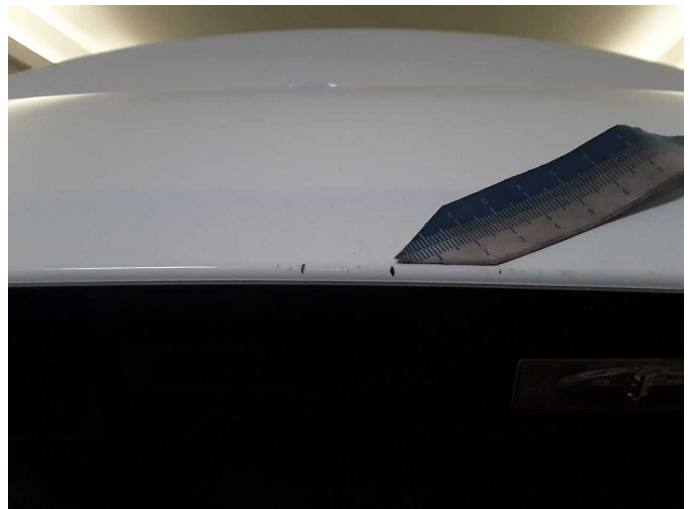
| No. | Component group | Description |
|---|---|---|
| 1 | Boot lid / rear door | Boot lid - Scratched - Cover / polish |

**Damage 1:** Boot lid / rear door: Boot lid - Scratched - Cover / polish

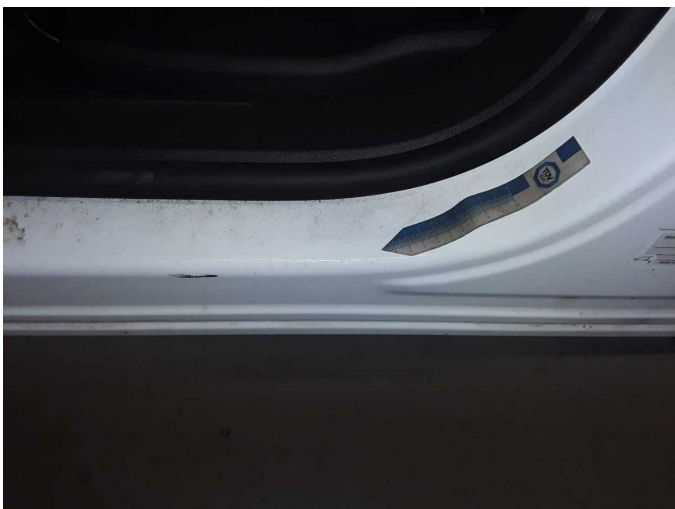
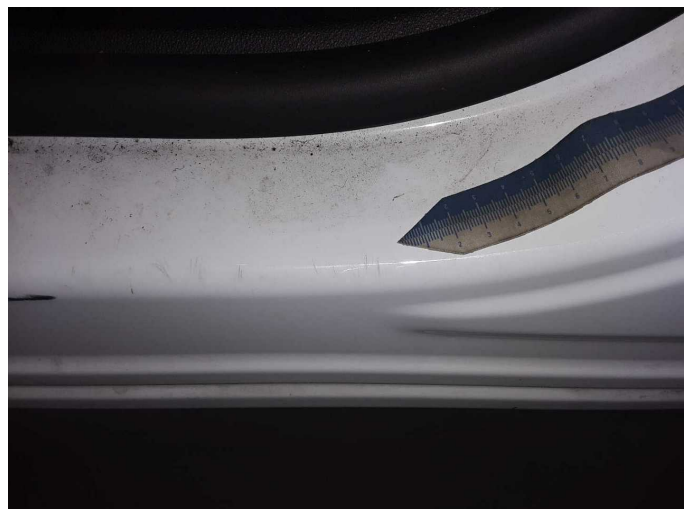
| No. | Component group | Description |
|---|---|---|
| 2 | Sill - left side | Sill - Scratched - Cover / polish |

**Damage 2:** Sill - left side: Sill - Scratched - Cover / polish

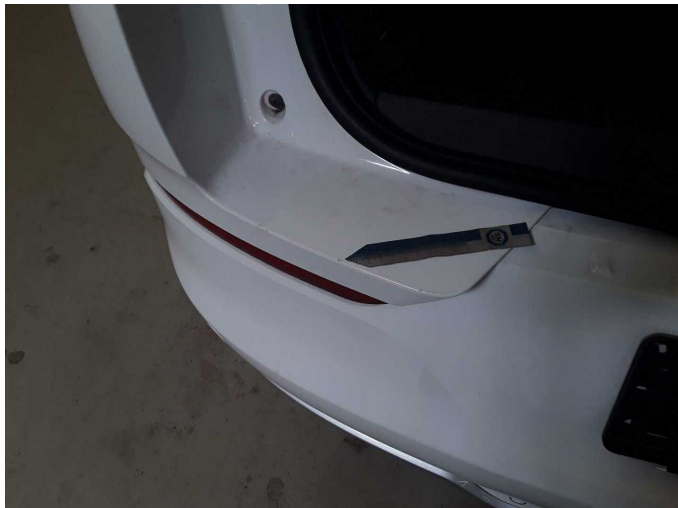
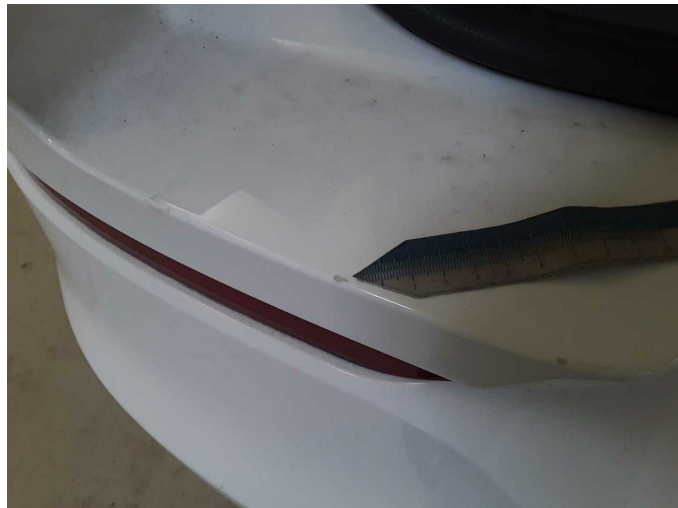
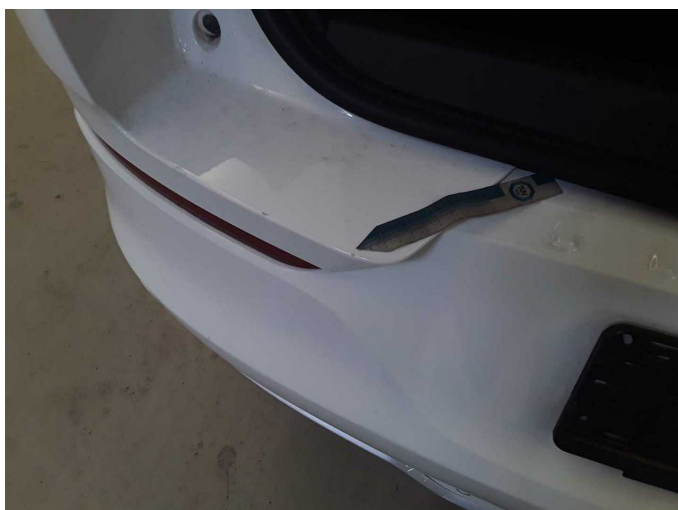
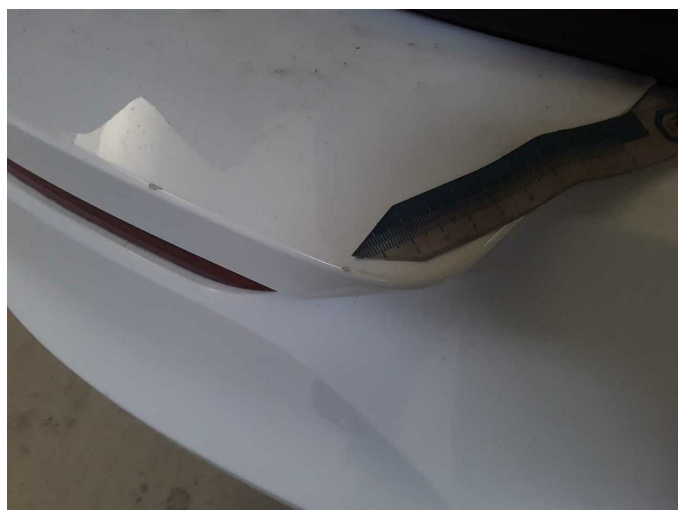
| No. | Component group | Description |
|---|---|---|
| 3 | Rear bumper | Rear bumper - Scratched - Cover / polish |

**Damage 3:** Rear bumper: Rear bumper - Scratched - Cover / polish

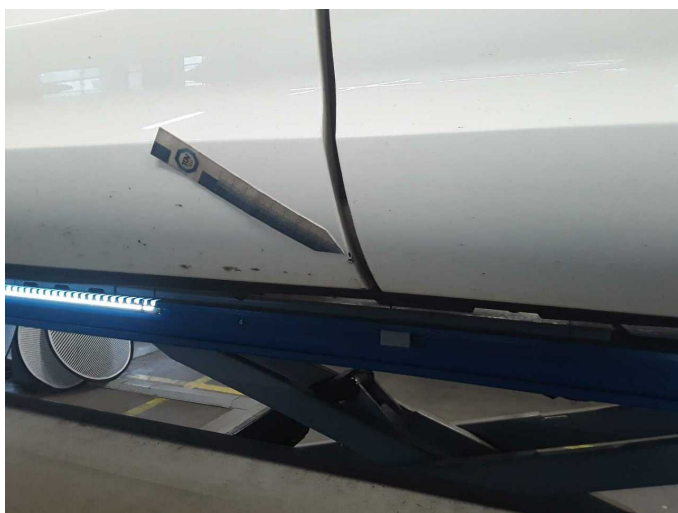
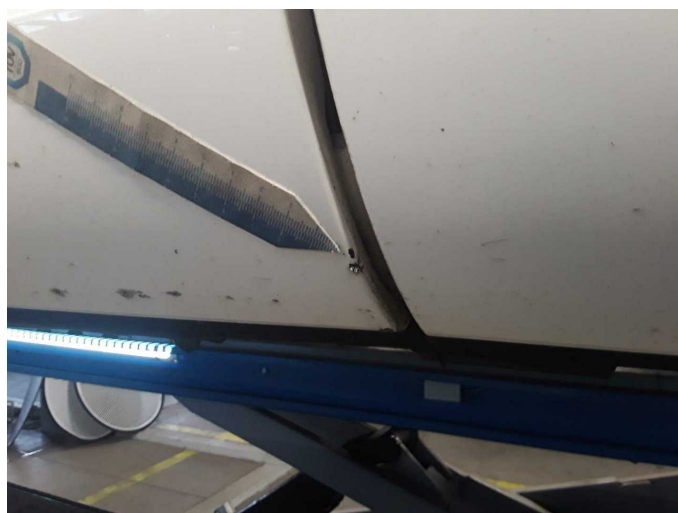
| No. | Component group | Description |
|---|---|---|
| 4 | Trim / covers | Door trim - front left side - Scratched - Smart repair |

**Damage 4:** Trim / covers: Door trim - front left side - Scratched - Smart repair

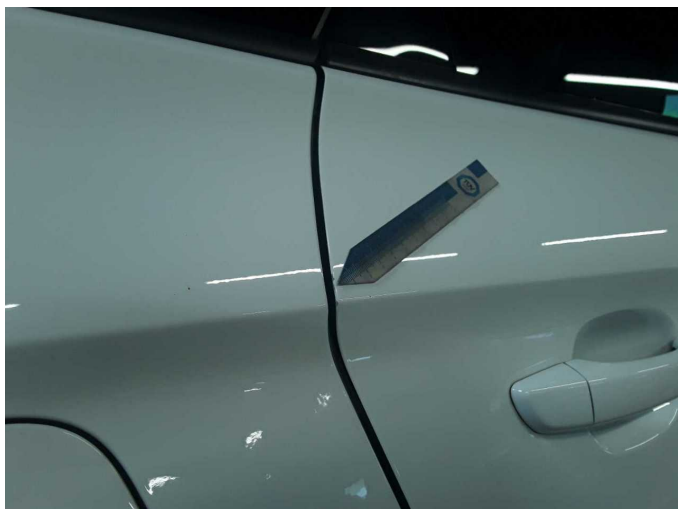
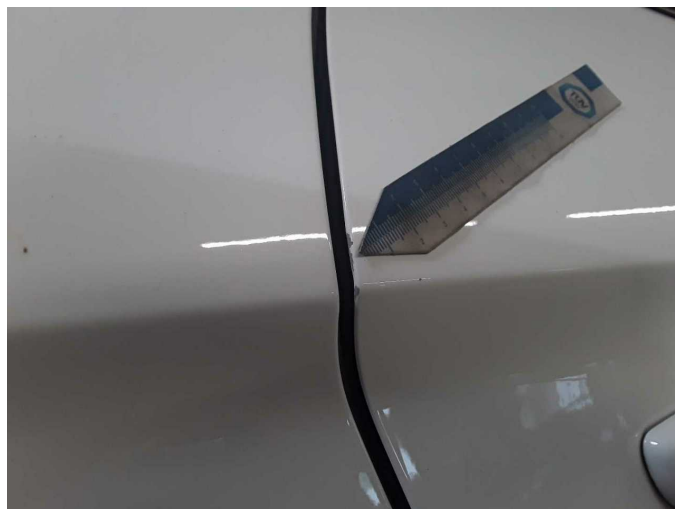
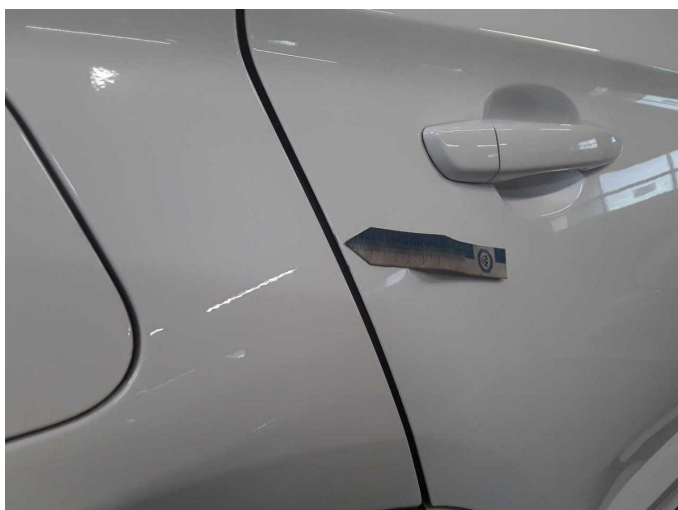
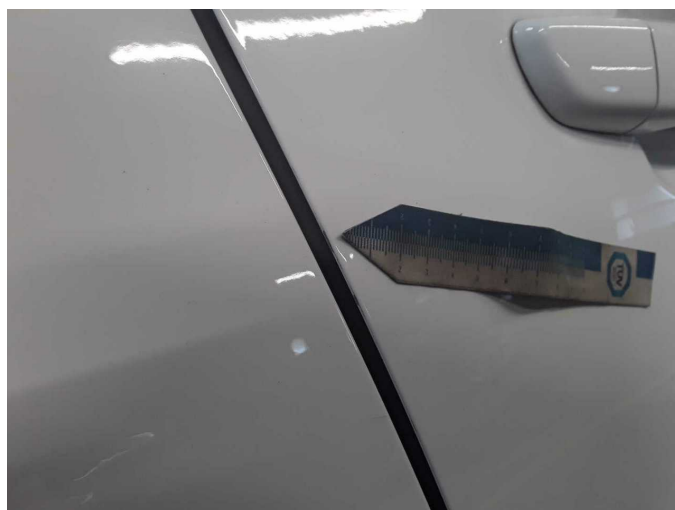
| No. | Component group | Description |
|---|---|---|
| 5 | Door - rear right side | Door - Scratched - Smart repair |

**Damage 5:** Door - rear right side: Door - Scratched - Smart repair

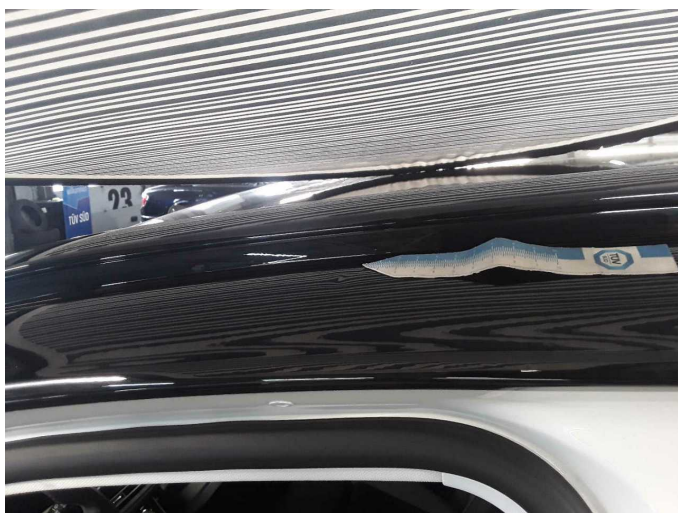
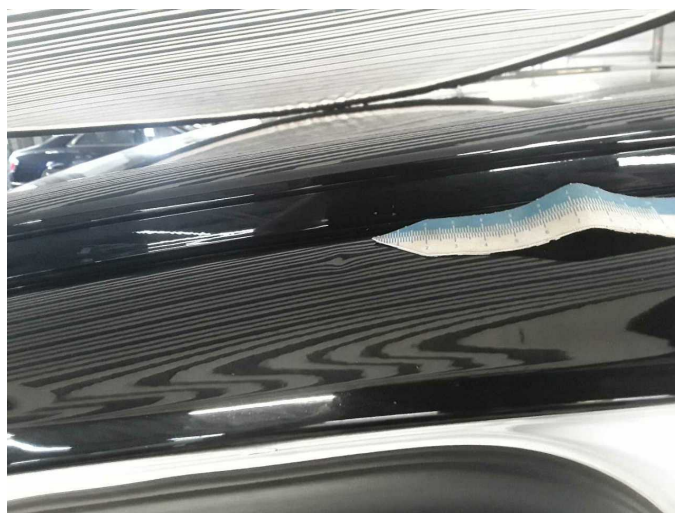
| No. | Component group | Description |
|---|---|---|
| 6 | Roof | Roof rail - left side - dent(s) - Smooth repair work |

**Damage 6:** Roof: Roof rail - left side - dent(s) - Smooth repair work

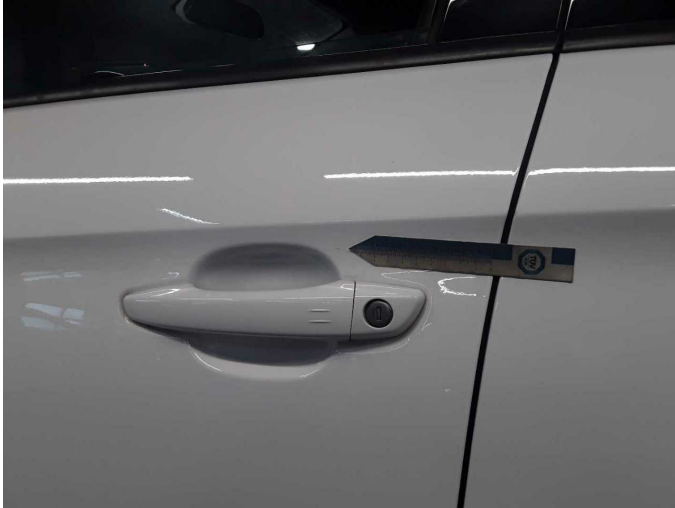
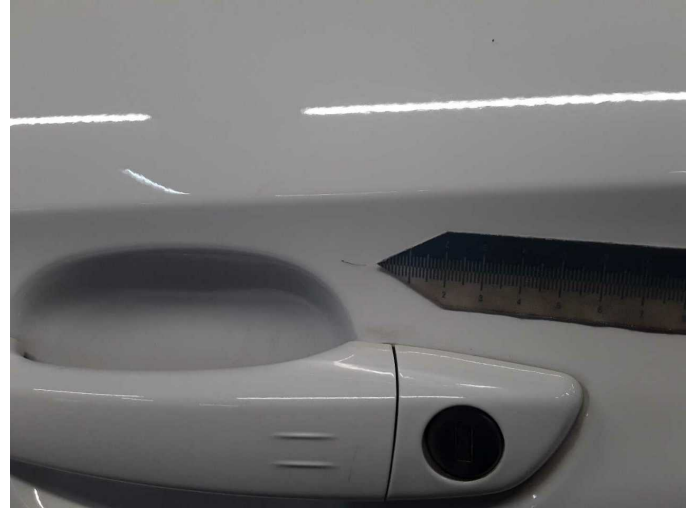
| No. | Component group | Description |
|---|---|---|
| 7 | Door - front left side | Door - Scratch(es) - Smart repair |

**Damage 7:** Door - front left side: Door - Scratch(es) - Smart repair

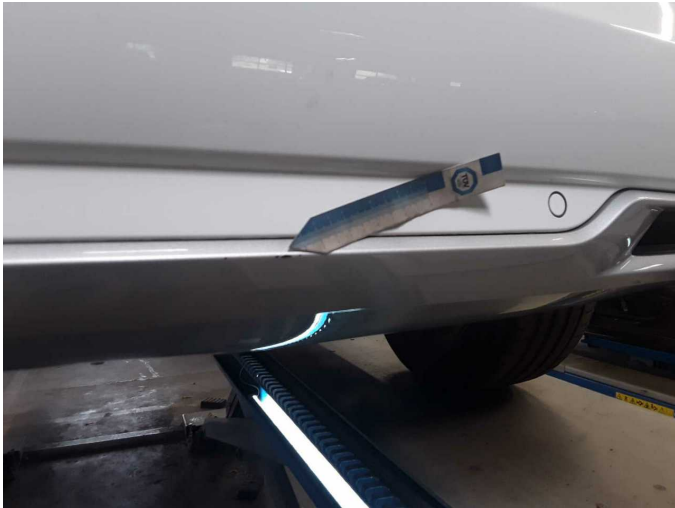
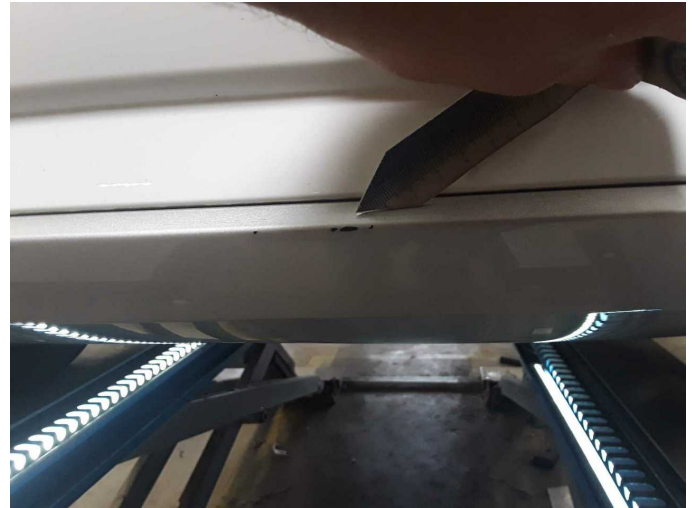
| No. | Component group | Description |
|---|---|---|
| 8 | Rear bumper | Spoiler - Scratched - Smart repair |

**Damage 8:** Rear bumper: Spoiler - Scratched - Smart repair

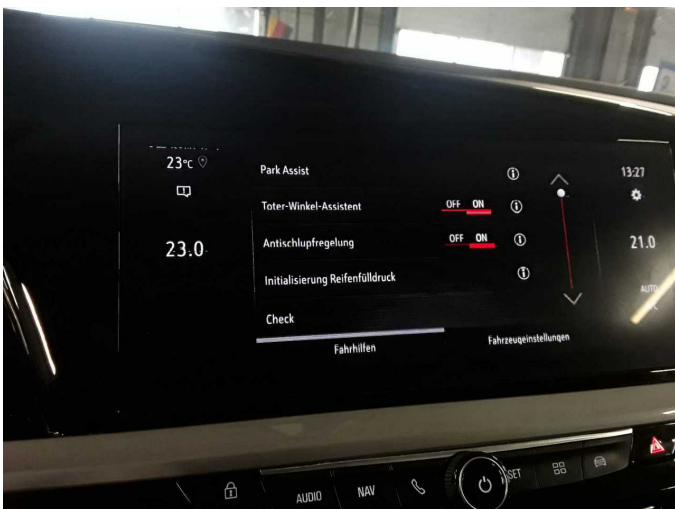
| No. | Component group | Description |
|---|---|---|
| 9 | Multimedia system | Multimedia system (Flackert) - Sub-function - Perform diagnosis |

**Damage 9:** Multimedia system: Multimedia system (Flackert) - Sub-function - Perform diagnosis

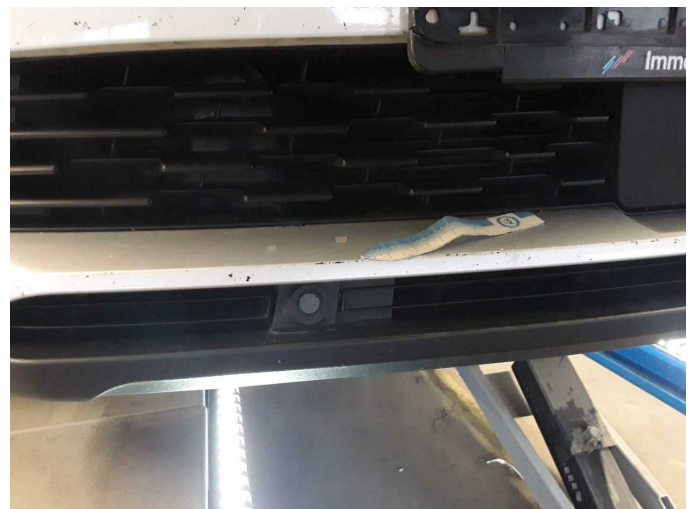
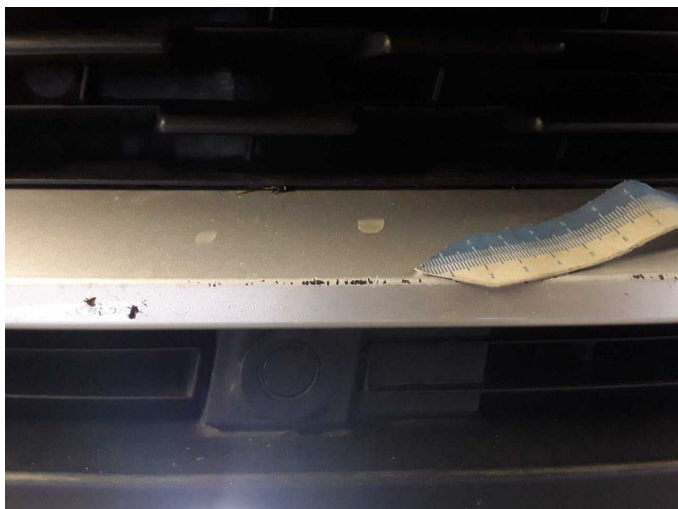
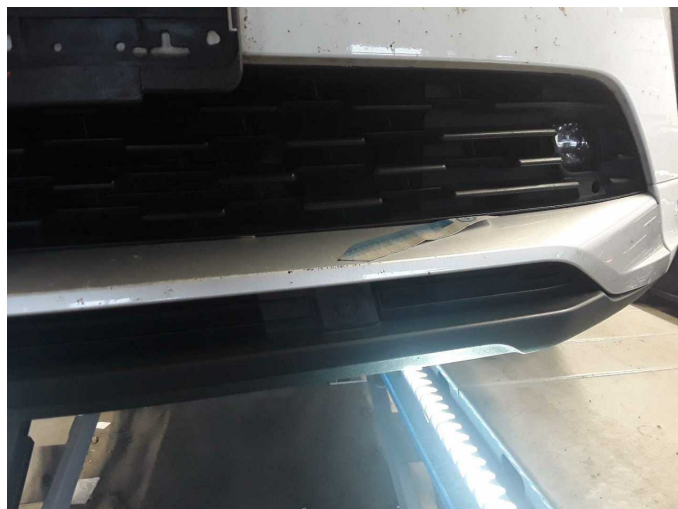
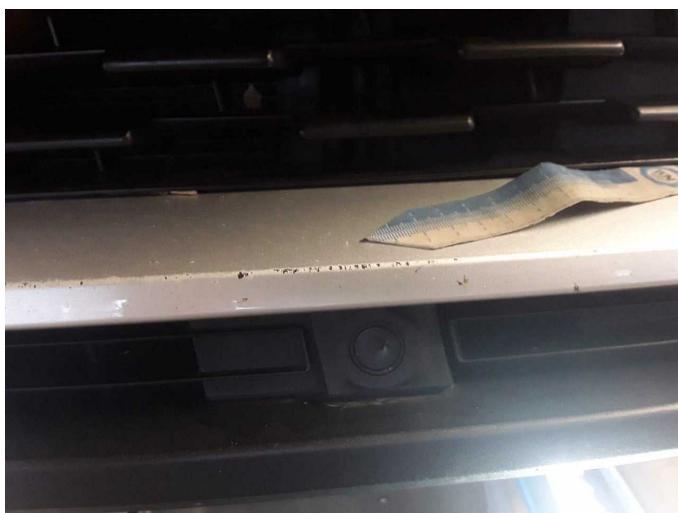
| No. | Component group | Description |
|---|---|---|
| 10 | Front bumper | Spoiler - Scratched - Smart repair |

**Damage 10:** Front bumper: Spoiler - Scratched - Smart repair
