Expertise

Protocol number: 46166303
Order No. / Reference: 26501194
Inspection date: 25 Jun 2026

Manufacturer: Ford

Model: Focus Turnier 1.5 EcoBlue Start-Stopp-System Aut. TITANIUM

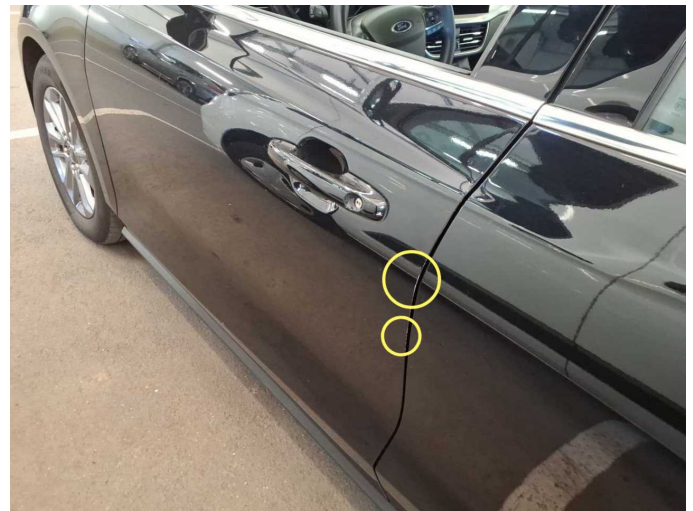
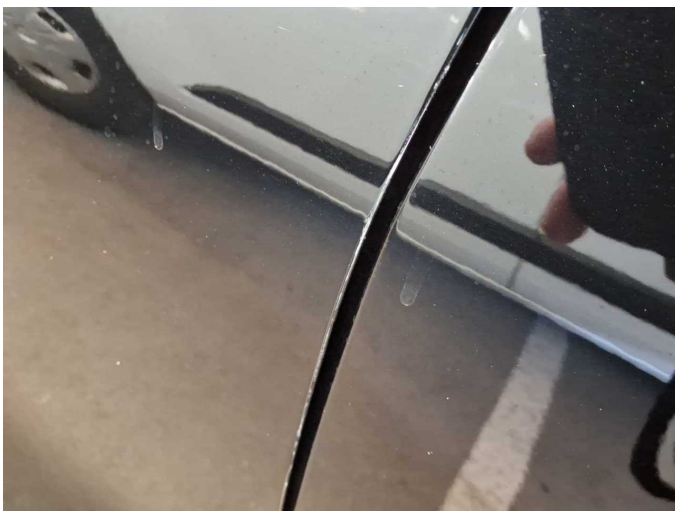
Damage 1: Door - front left side: Door edge - Scratch(es) - Smart repair

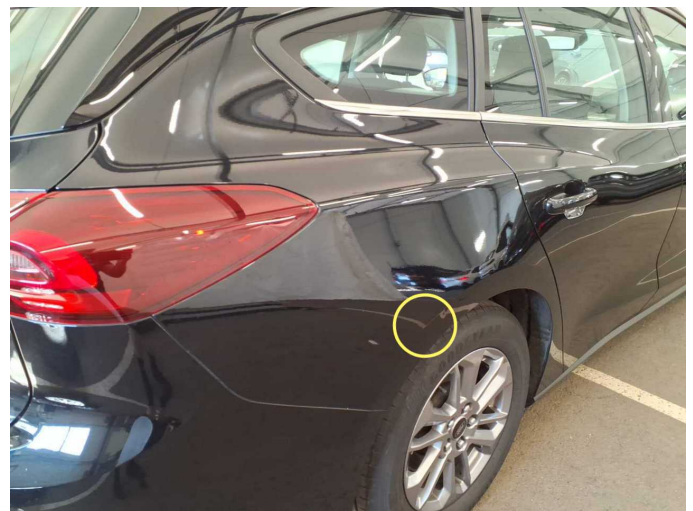
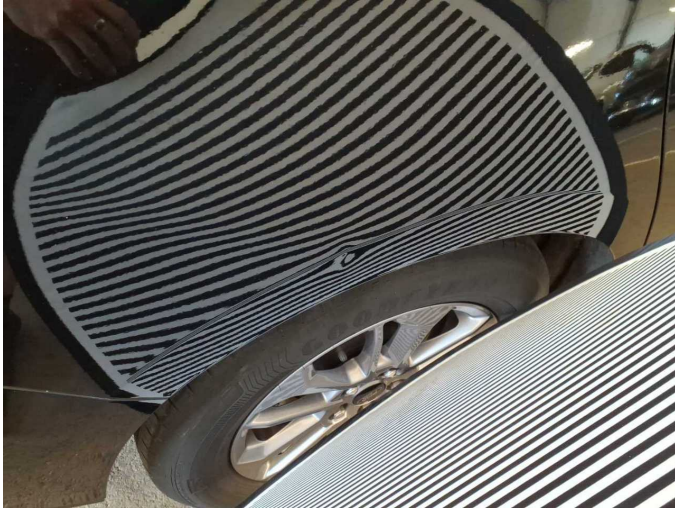
Damage 2: Side panel - rear right side: Side panel - dent(s) - Smooth repair work

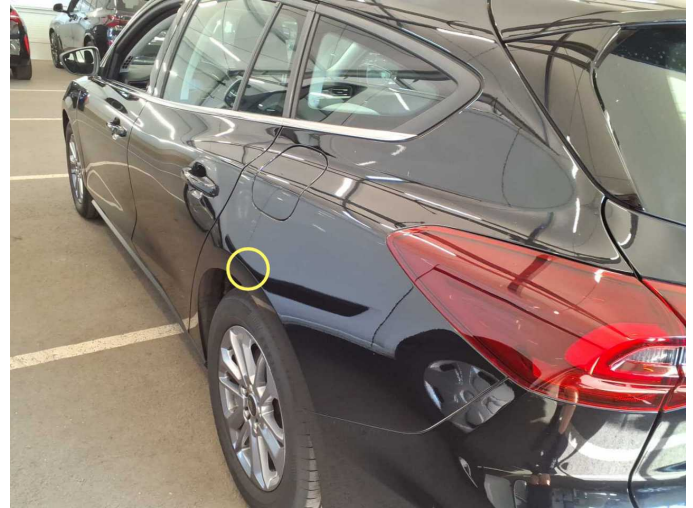
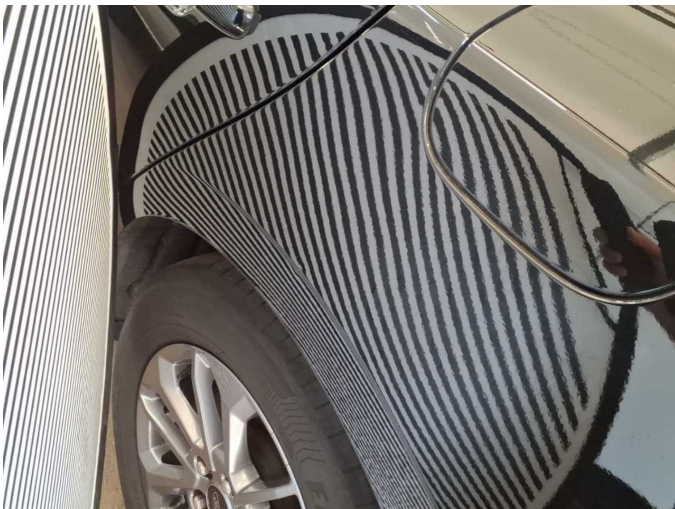
Damage 3: Side panel - rear left side: Side panel - dent(s) - Smooth repair work

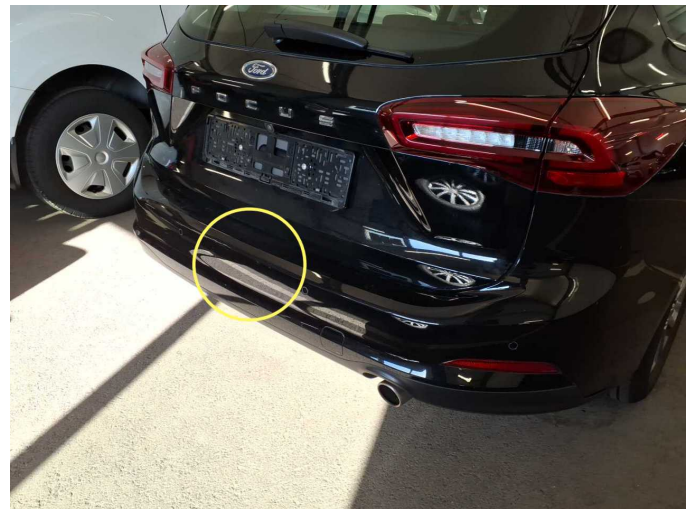
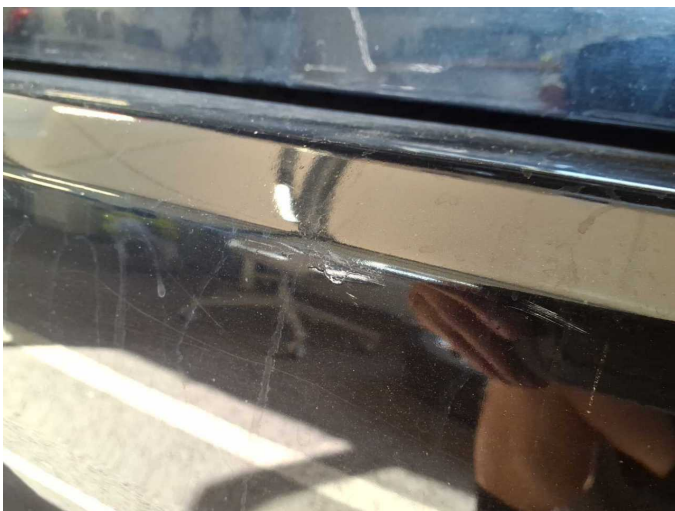
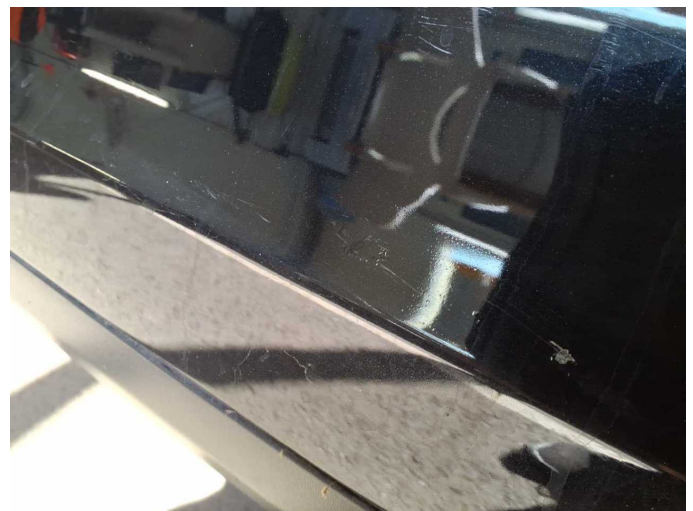
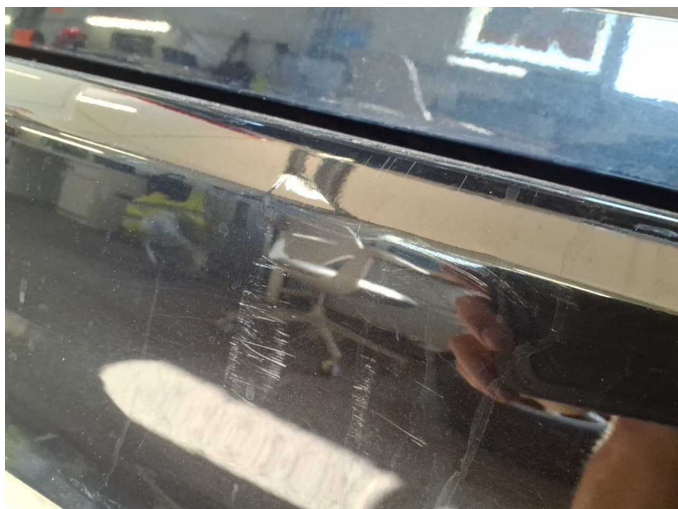
Damage 4: Rear bumper: Rear bumper - Paint defect - Paint

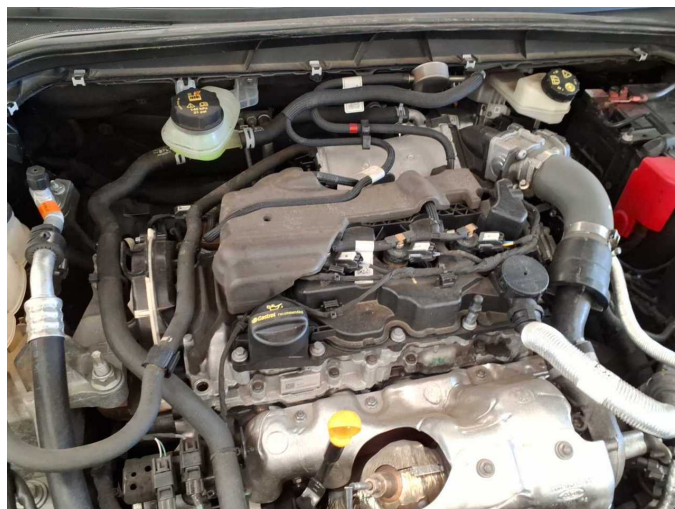
Missing part 1: Engine: Engine cover - Missing - Replace
