## Expertise

Protocol number: 46130200  
Order No. / Reference: 26516969  
Inspection date: 22 Jun 2026

Model: GLC 300 d 4Matic 9G-TRONIC

VIN: W1N2539191F982993

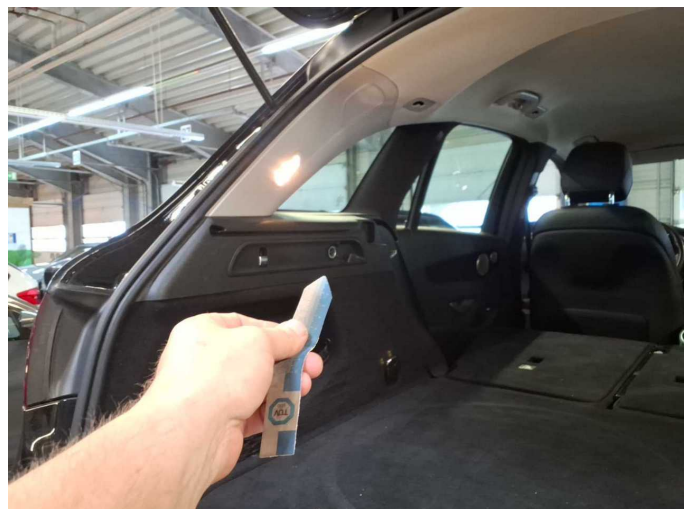
Damage 1: Electrical system: Power socket - Damaged - Replace

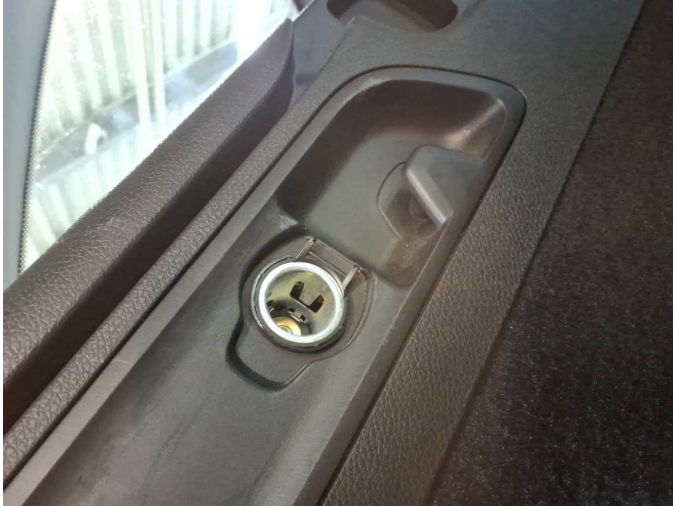
**Damage 1:** Electrical system: Power socket - Damaged - Replace

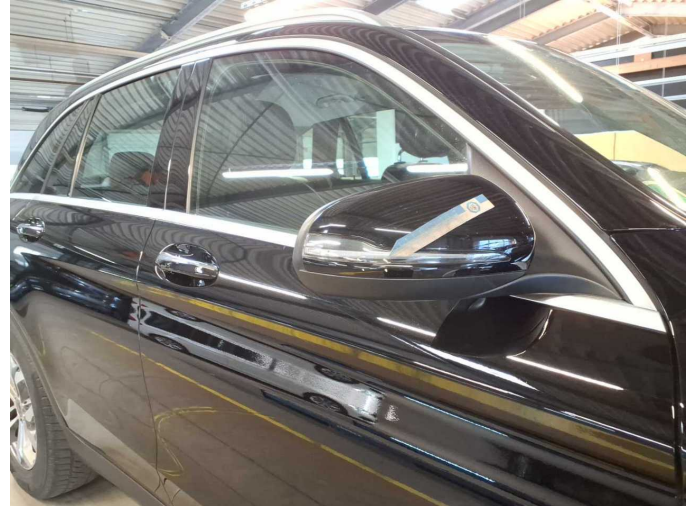
**Damage 2:** Wing mirror - right side: Cap - Scratch(es) - Smart repair

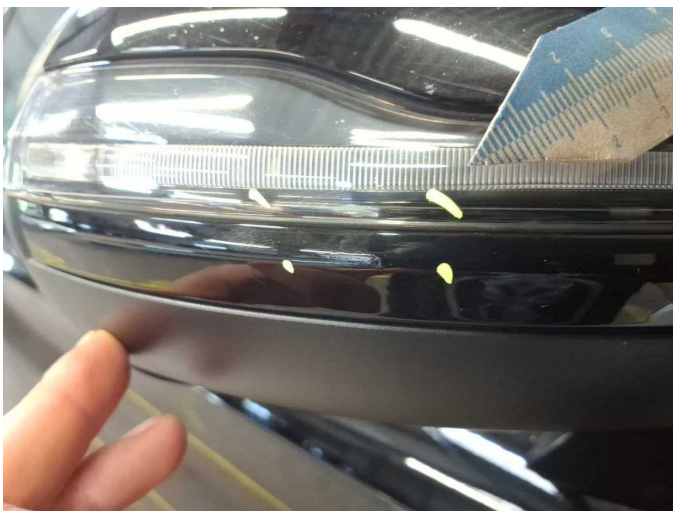
**Damage 2:** Wing mirror - right side: Cap - Scratch(es) - Smart repair

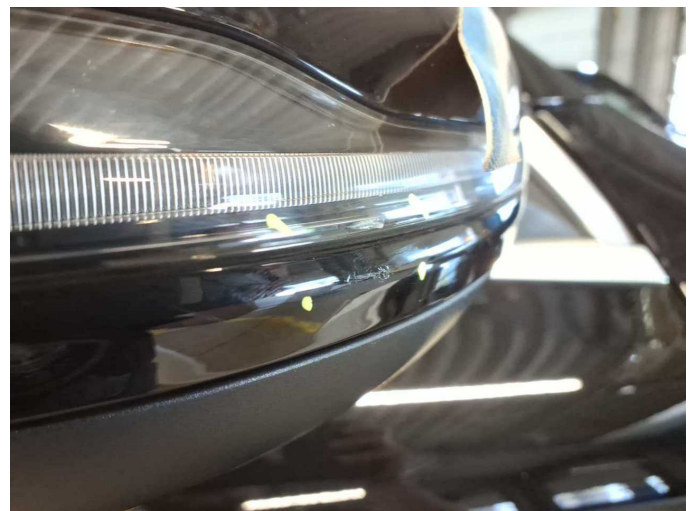
**Damage 2:** Wing mirror - right side: Cap - Scratch(es) - Smart repair

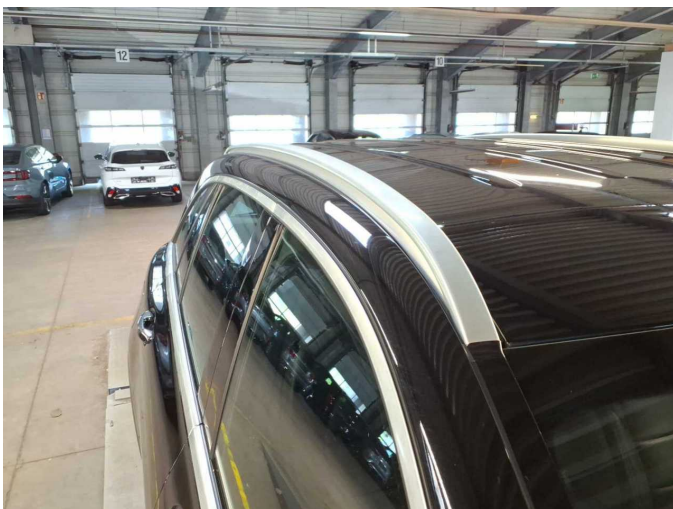
**Damage 3:** Roof: Roof rail - right side - dent(s) - Smooth repair work

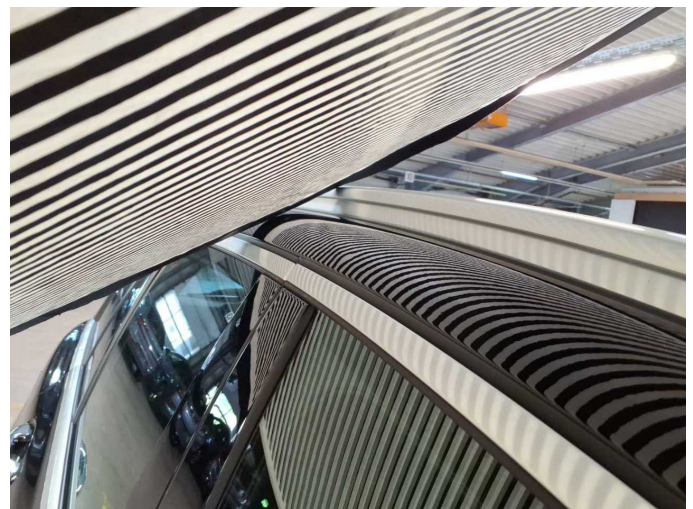
**Damage 3:** Roof: Roof rail - right side - dent(s) - Smooth repair work

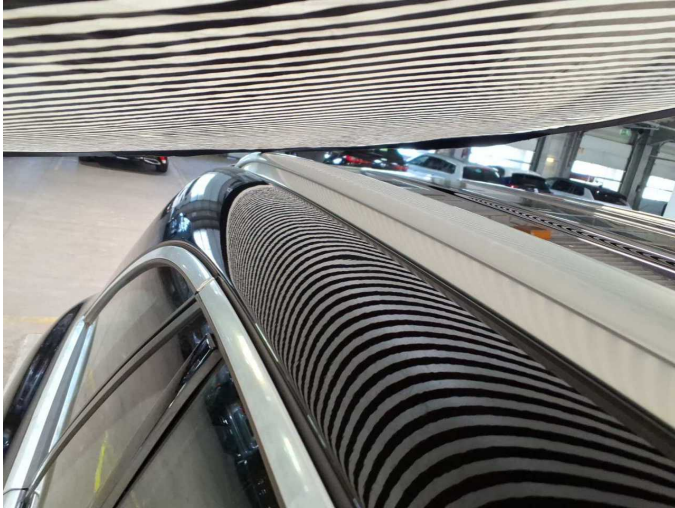
**Damage 3:** Roof: Roof rail - right side - dent(s) - Smooth repair work

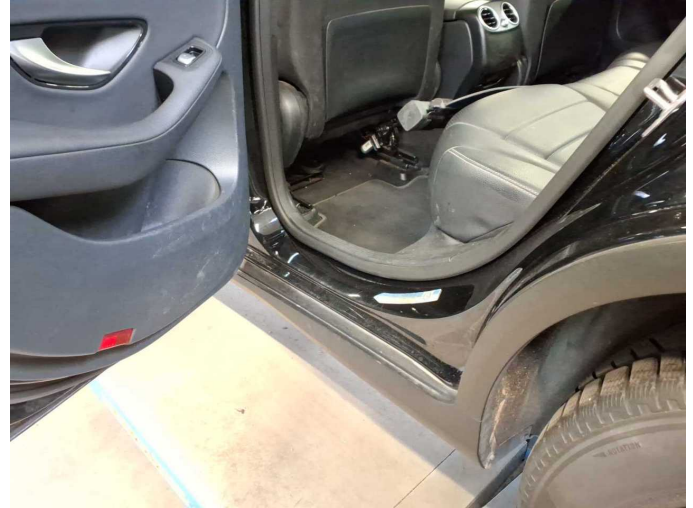
**Damage 4:** Sill - left side: Sill - Scratch(es) - Smart repair

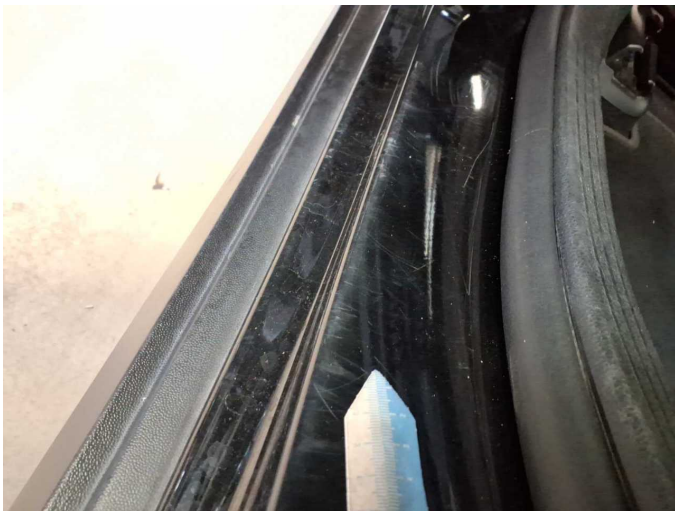
**Damage 4:** Sill - left side: Sill - Scratch(es) - Smart repair

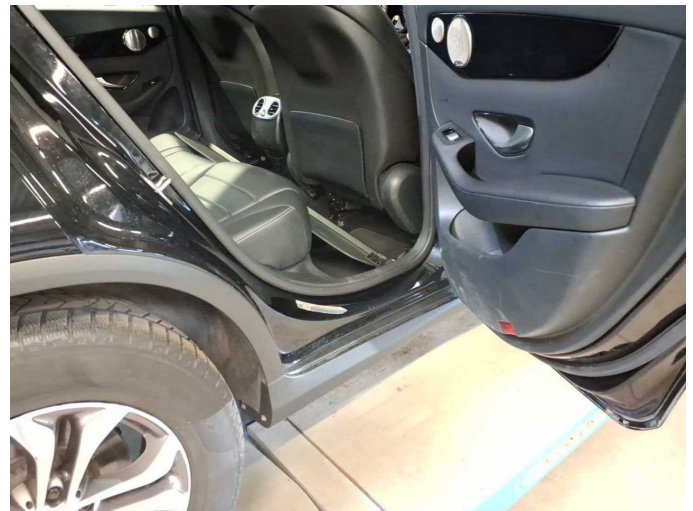
**Damage 5:** Sill - right side: Sill - Scratch(es) - Smart repair

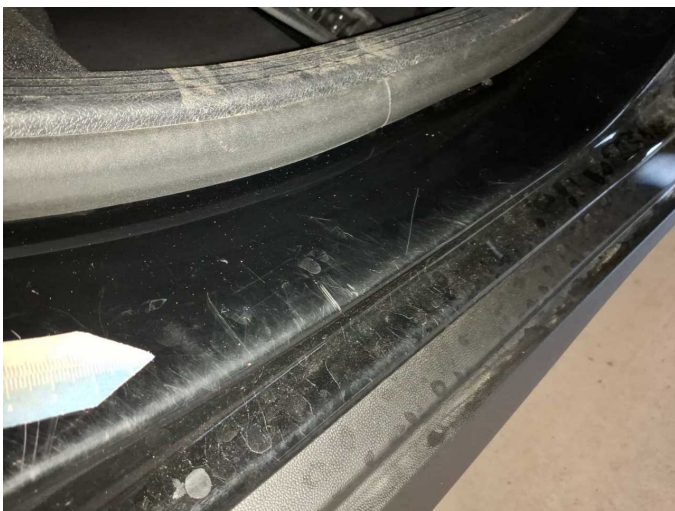
**Damage 5:** Sill - right side: Sill - Scratch(es) - Smart repair

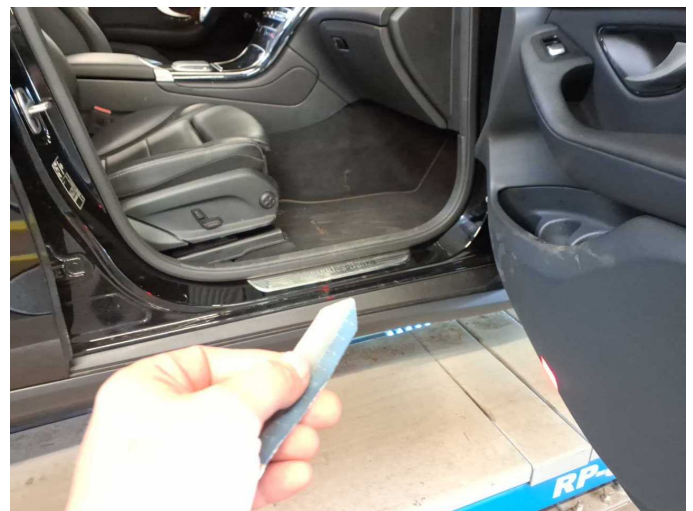
**Damage 5:** Sill - right side: Sill - Scratch(es) - Smart repair

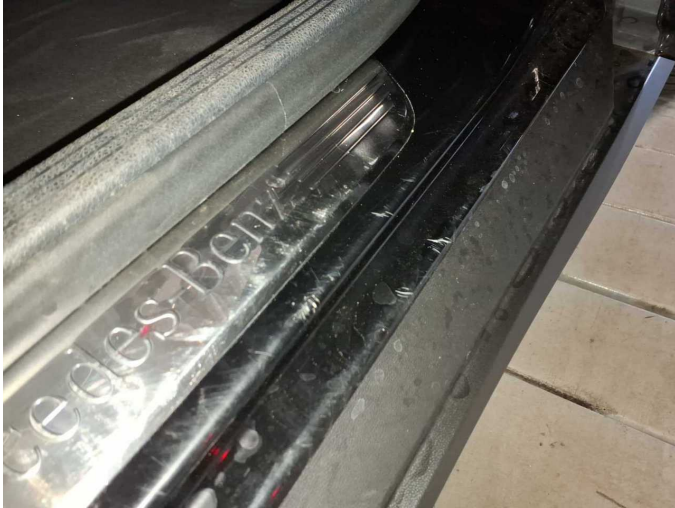
**Damage 5:** Sill - right side: Sill - Scratch(es) - Smart repair

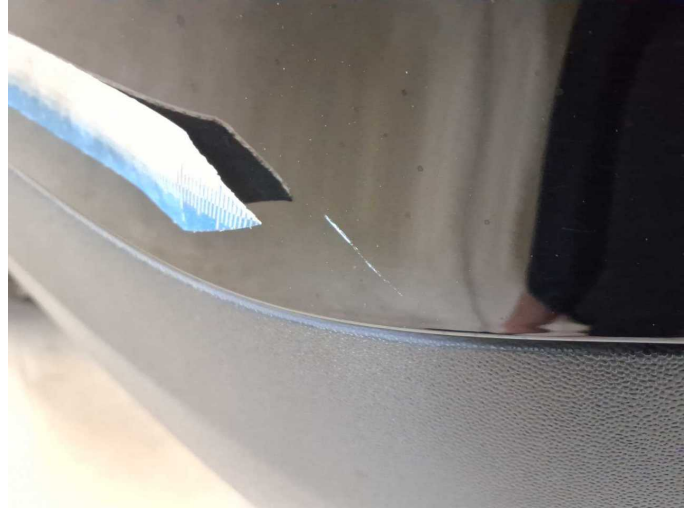
**Damage 6:** Rear bumper: Rear bumper - Scratched - Smart repair

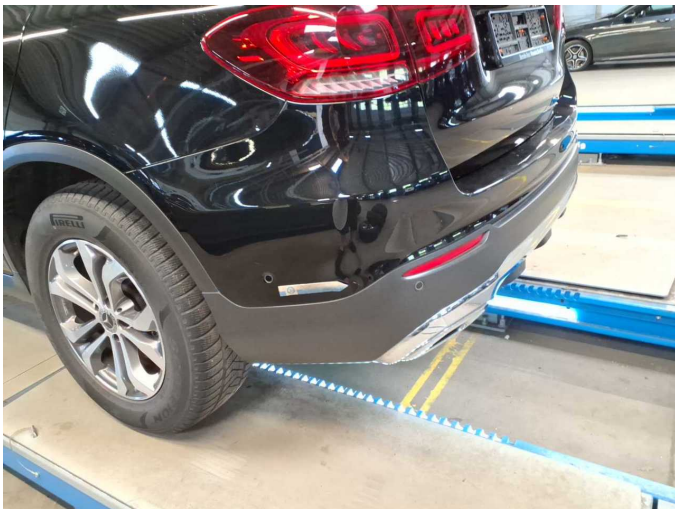
**Damage 6:** Rear bumper: Rear bumper - Scratched - Smart repair

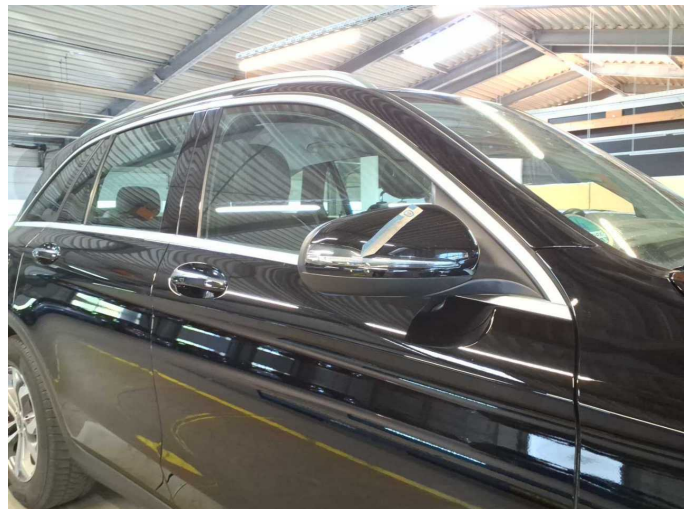
**Damage 7:** Indicator - front: Mirror - right side - Broken / torn - Replace

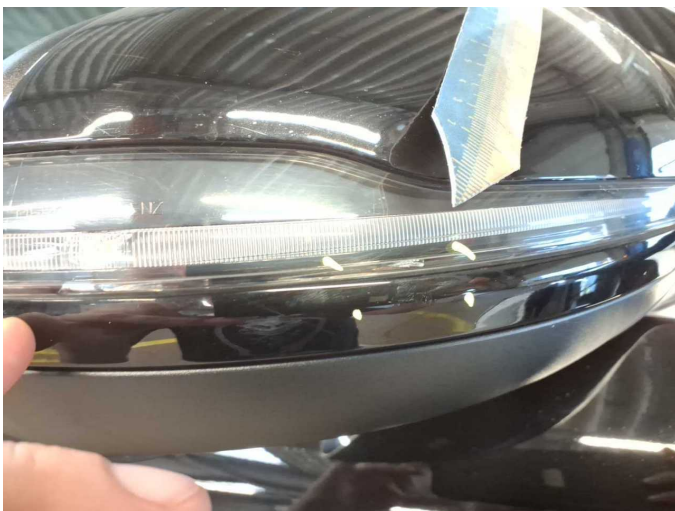
**Damage 7:** Indicator - front: Mirror - right side - Broken / torn - Replace

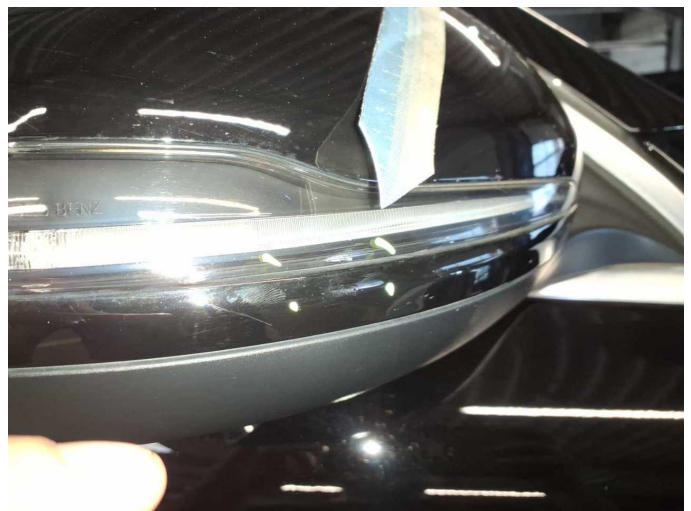
**Damage 7:** Indicator - front: Mirror - right side - Broken / torn - Replace

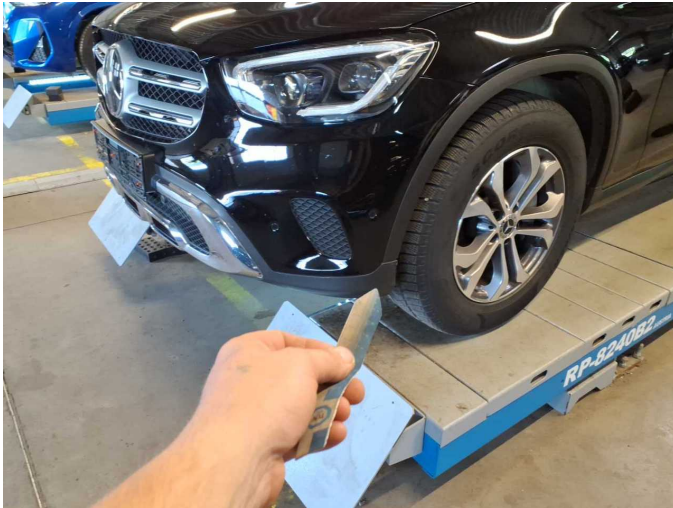
**Damage 8:** Front bumper: Spoiler - Scratched - Loss in value

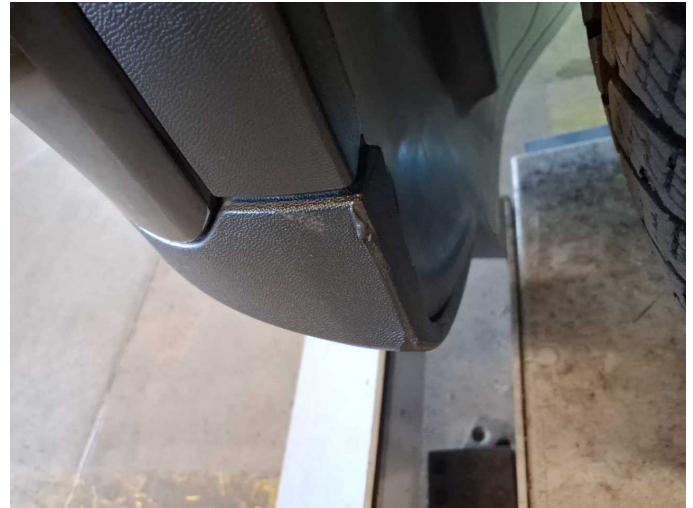
**Damage 8:** Front bumper: Spoiler - Scratched - Loss in value

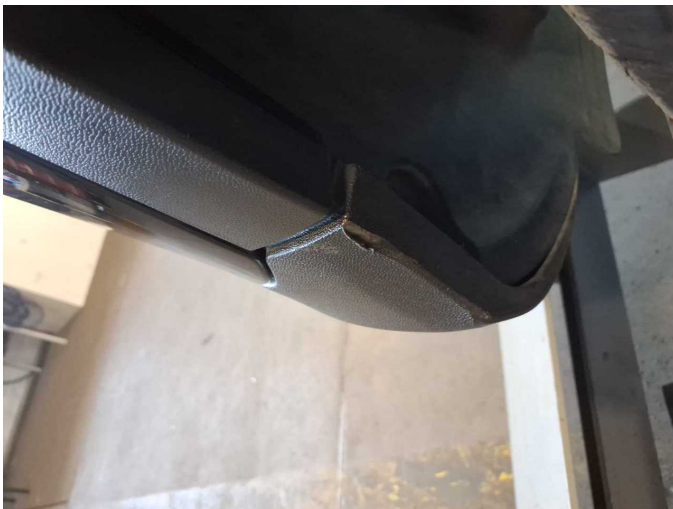
**Damage 8:** Front bumper: Spoiler - Scratched - Loss in value

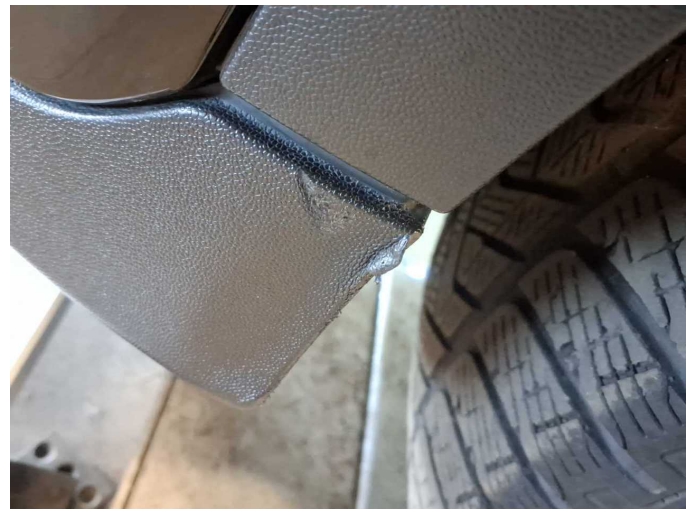
**Damage 8:** Front bumper: Spoiler - Scratched - Loss in value

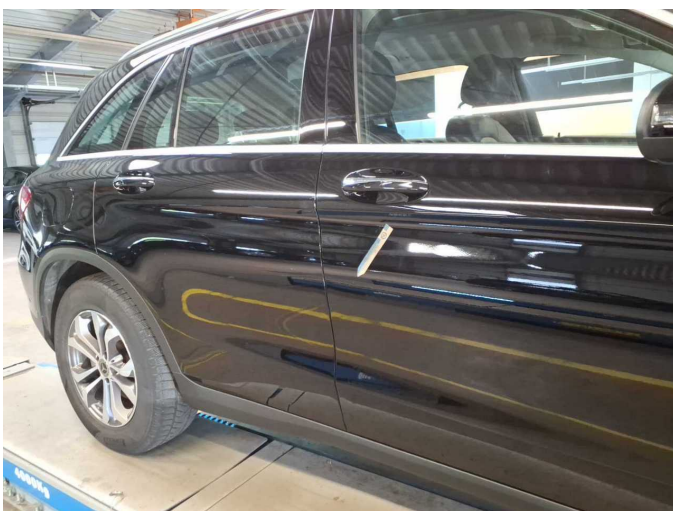
**Damage 9:** Door - front right side: Door - Dent / paintcoat damage - Smart repair

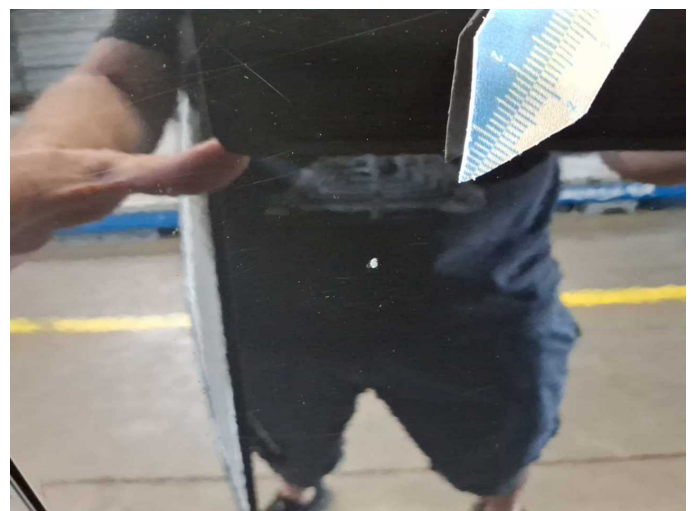
**Damage 9:** Door - front right side: Door - Dent / paintcoat damage - Smart repair

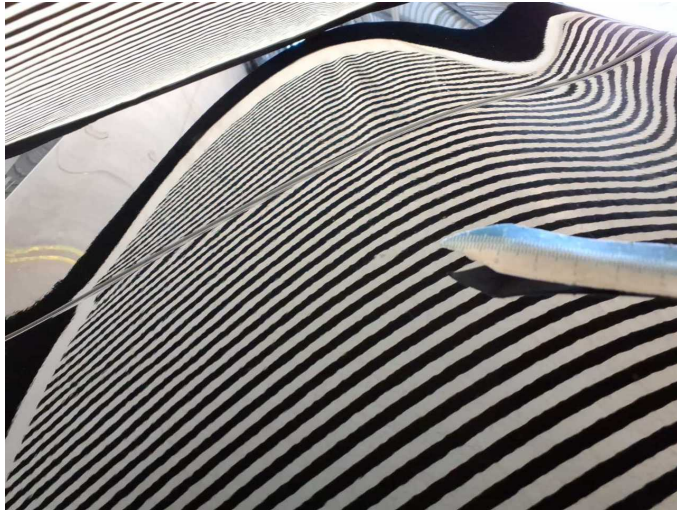
**Damage 9:** Door - front right side: Door - Dent / paintcoat damage - Smart repair

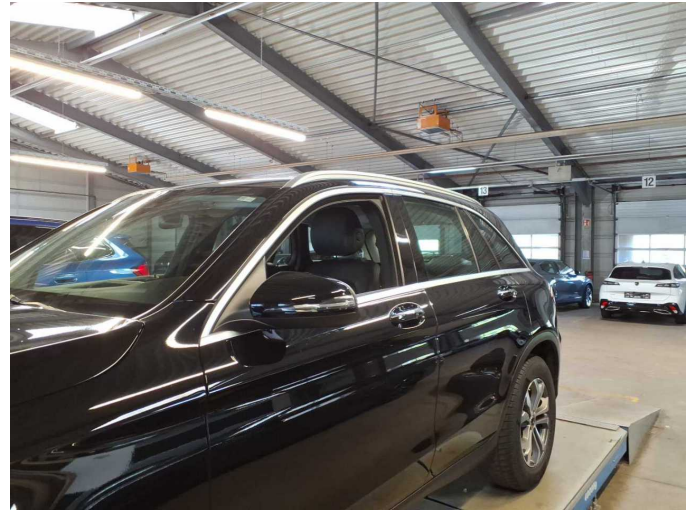
**Damage 10:** Body: Body (Chromleisten und Dachreling) - Paint defect - Loss in value

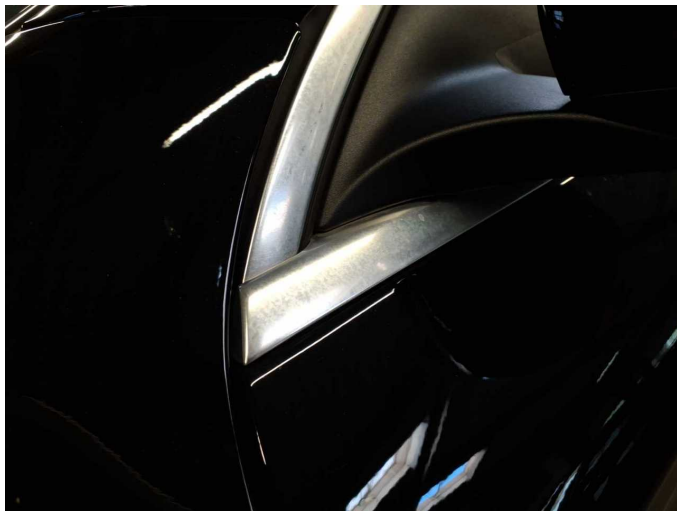
**Damage 10:** Body: Body (Chromleisten und Dachreling) - Paint defect - Loss in value

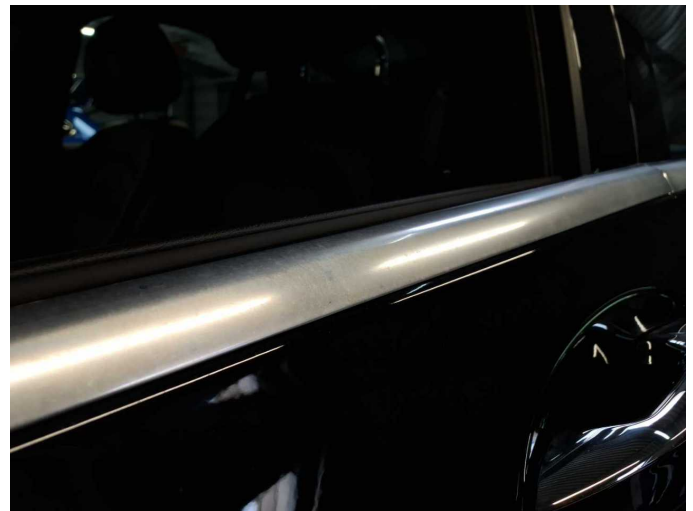
**Damage 10:** Body: Body (Chromleisten und Dachreling) - Paint defect - Loss in value

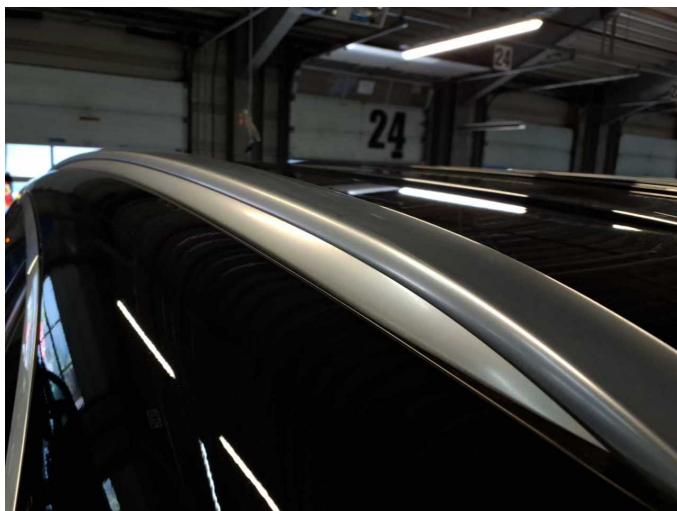
**Damage 10:** Body: Body (Chromleisten und Dachreling) - Paint defect - Loss in value

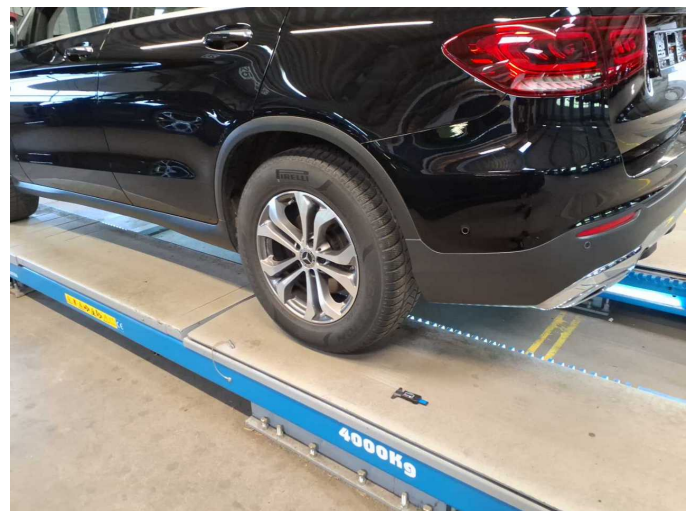
**Damage 11:** Wheel / tyres: Tyres - complete set (Winterreifen) - Worn - Replace

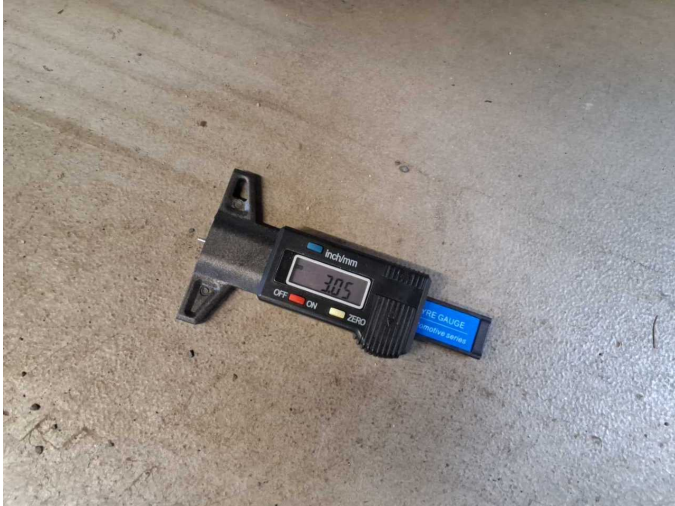
**Damage 11:** Wheel / tyres: Tyres - complete set (Winterreifen) - Worn - Replace

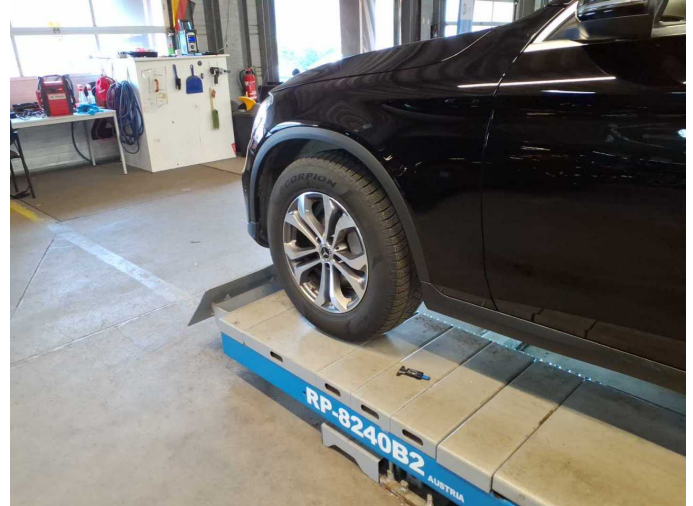
**Damage 11:** Wheel / tyres: Tyres - complete set (Winterreifen) - Worn - Replace

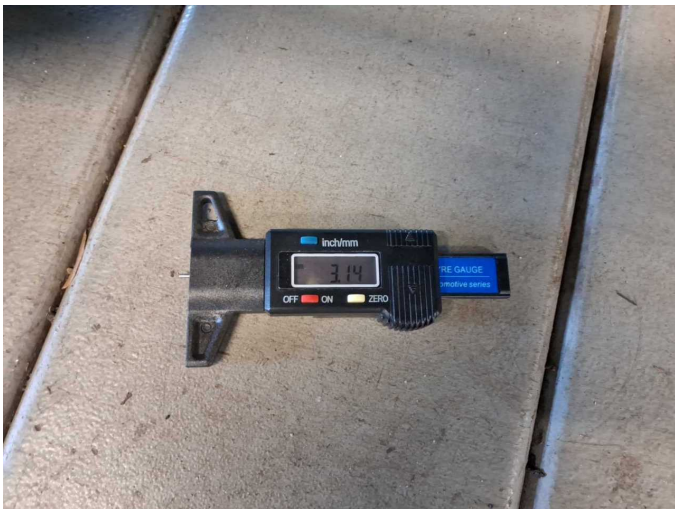
**Damage 11:** Wheel / tyres: Tyres - complete set (Winterreifen) - Worn - Replace

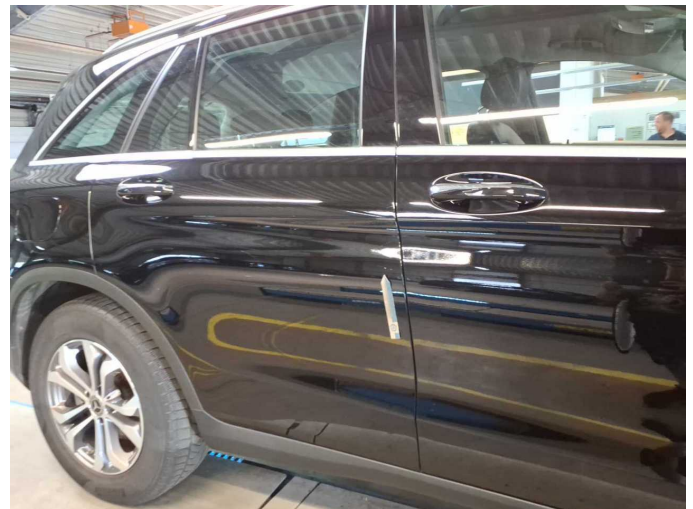
**Damage 12:** Door - rear right side: Door - dent(s) - Paint

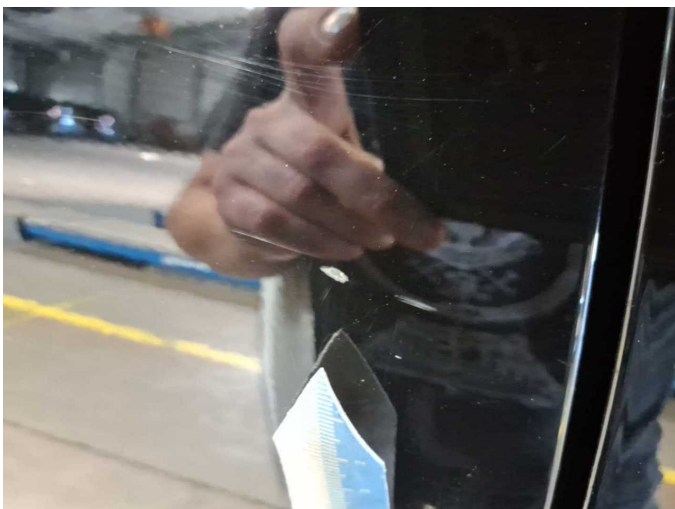
**Damage 12:** Door - rear right side: Door - dent(s) - Paint

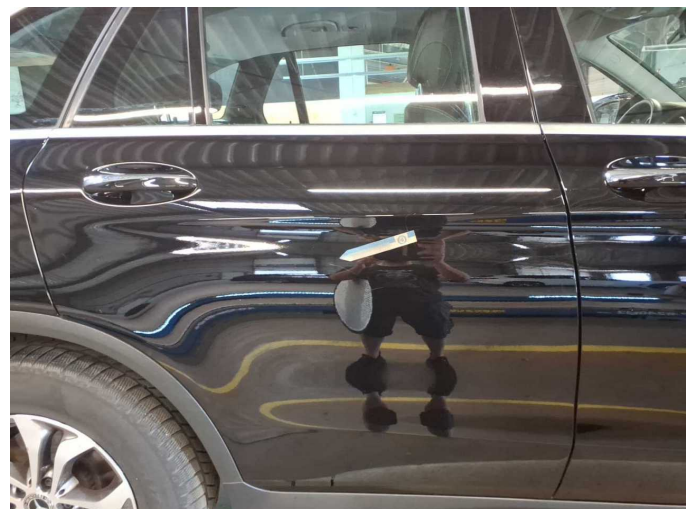
**Damage 12:** Door - rear right side: Door - dent(s) - Paint

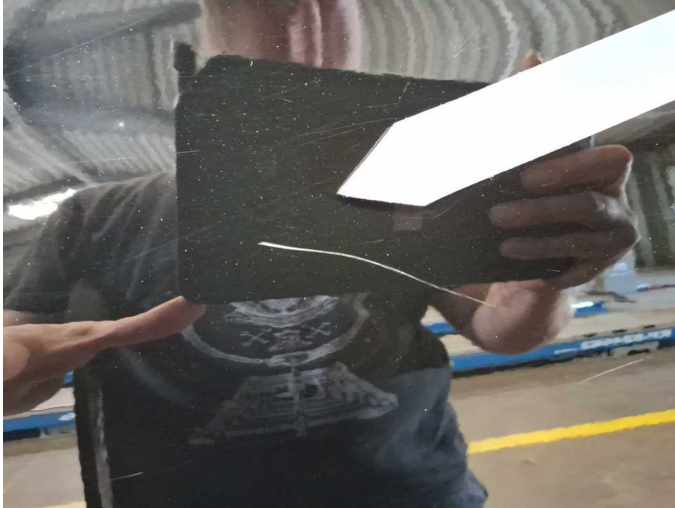
**Damage 12:** Door - rear right side: Door - dent(s) - Paint

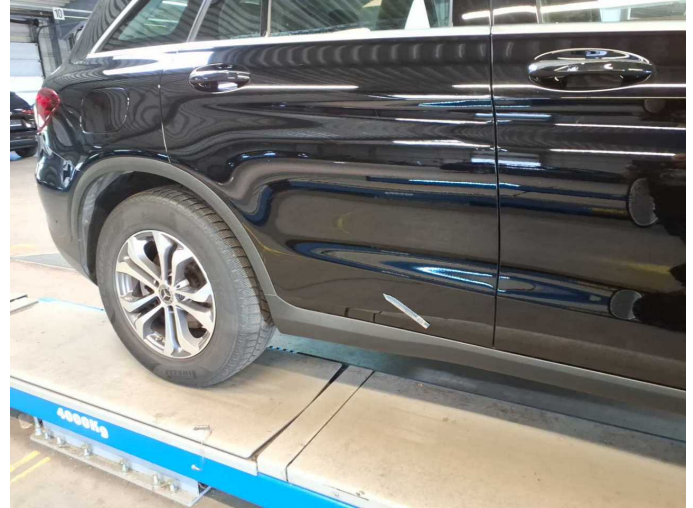
**Damage 12:** Door - rear right side: Door - dent(s) - Paint

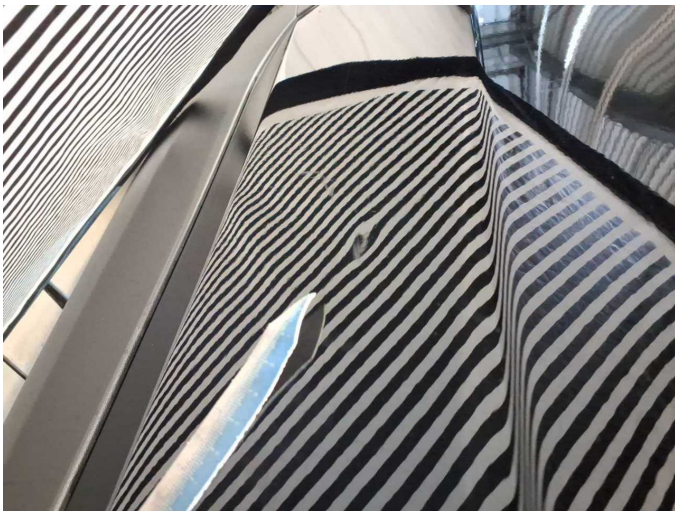
**Damage 12:** Door - rear right side: Door - dent(s) - Paint

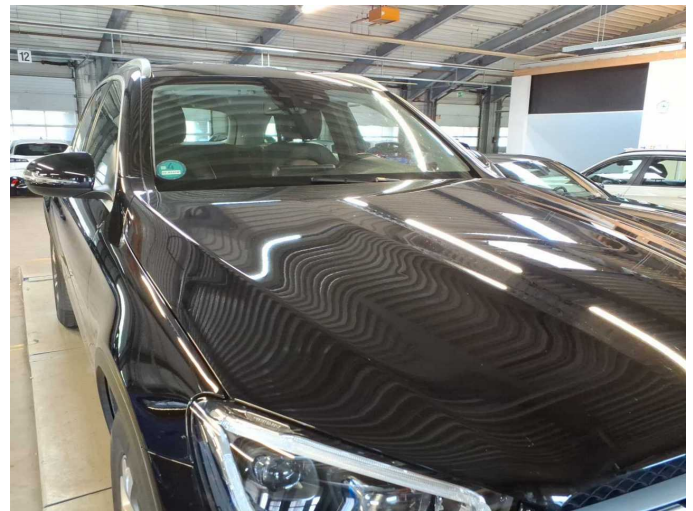
**Damage 13:** Bonnet: Bonnet - dent(s) - Paint

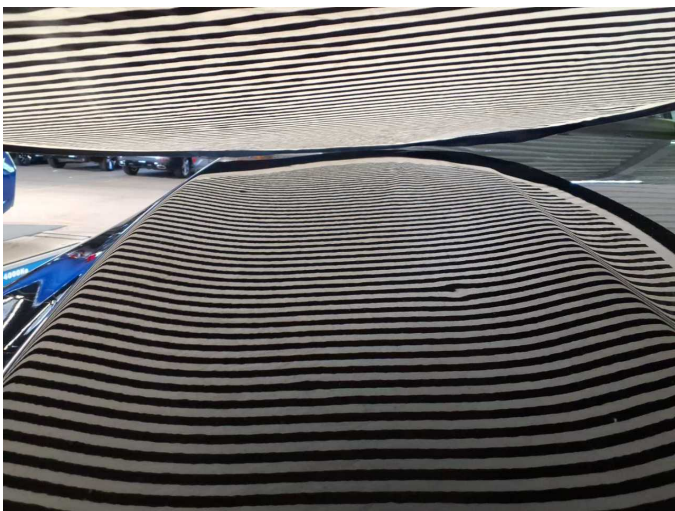
**Damage 13:** Bonnet: Bonnet - dent(s) - Paint

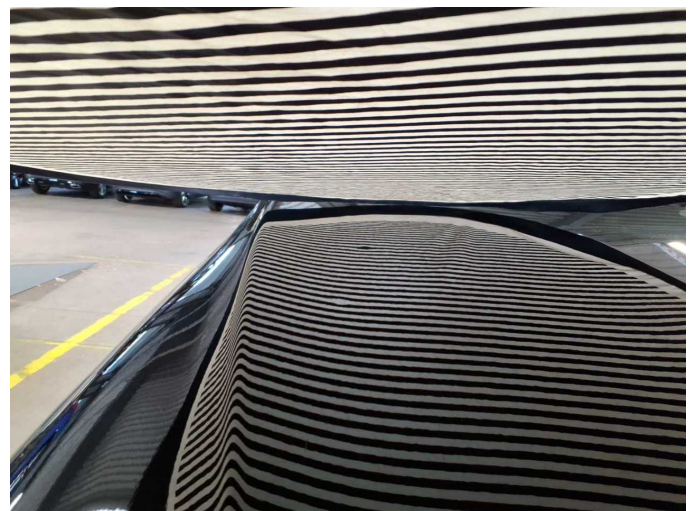
**Damage 13:** Bonnet: Bonnet - dent(s) - Paint

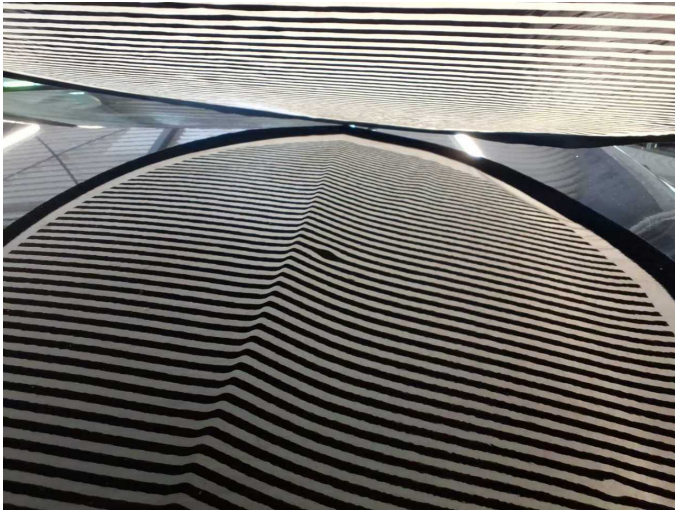
**Damage 13:** Bonnet: Bonnet - dent(s) - Paint

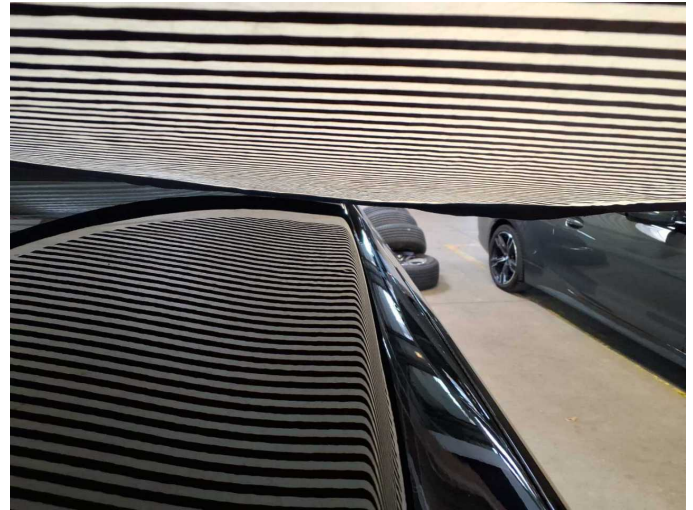
**Damage 13:** Bonnet: Bonnet - dent(s) - Paint

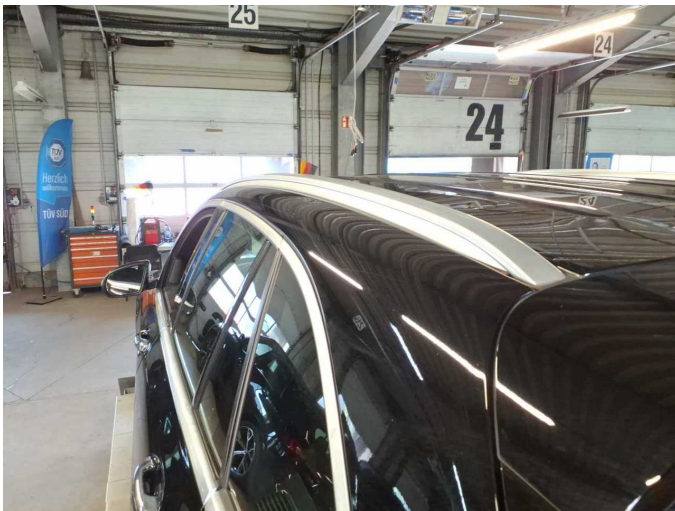
**Wear and tear 3:** Roof: Roof rail - left side - dent(s) - No deduction

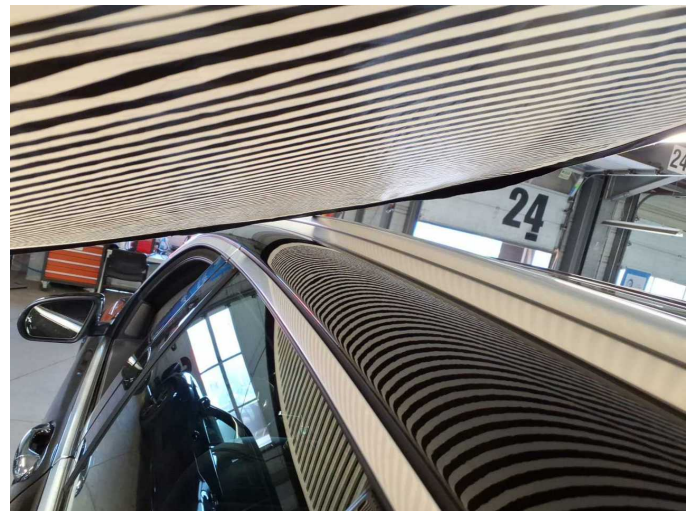
**Wear and tear 3:** Roof: Roof rail - left side - dent(s) - No deduction

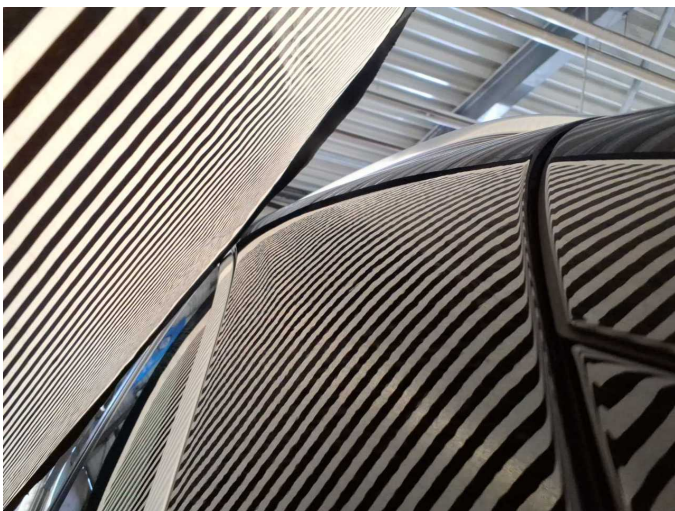
**Wear and tear 3:** Roof: Roof rail - left side - dent(s) - No deduction
