Expertise

Protocol number: 46507640  
Order No. / Reference: 26559086  
Inspection date: 9 Jul 2026

Manufacturer: Opel

Model: Insignia Sports Tourer 2.0 Diesel Aut. Elegance

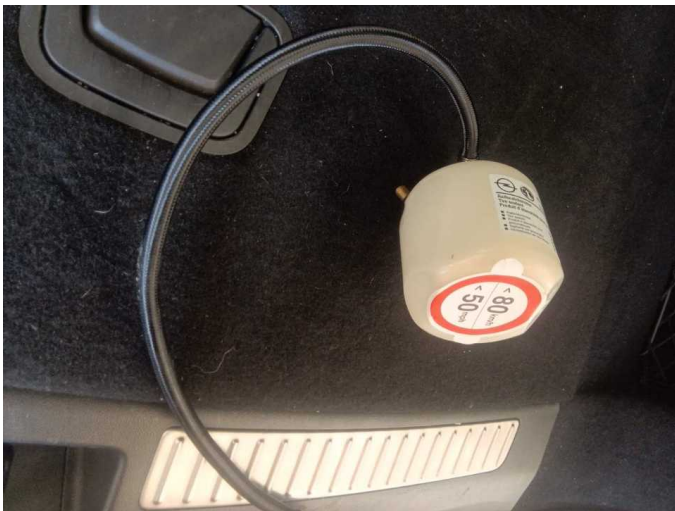
| No. | Component group | Description |
|---|---|---|
| 1 | Equipment | Tirefit filler - Empty - Replace |

**Damage 1:** Equipment: Tirefit filler - Empty - Replace

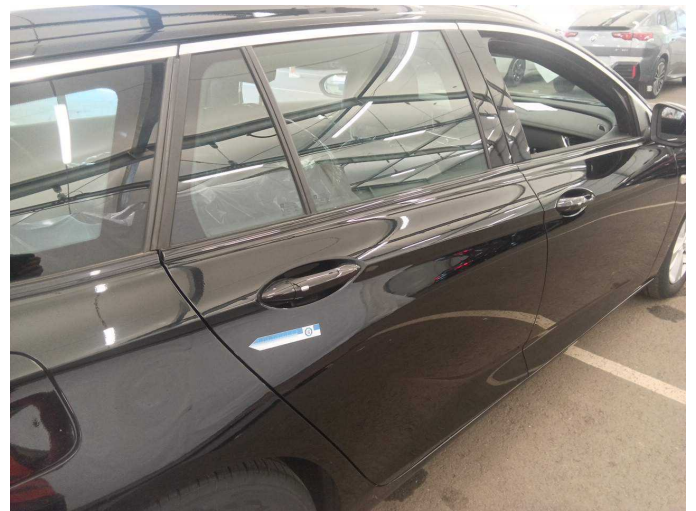
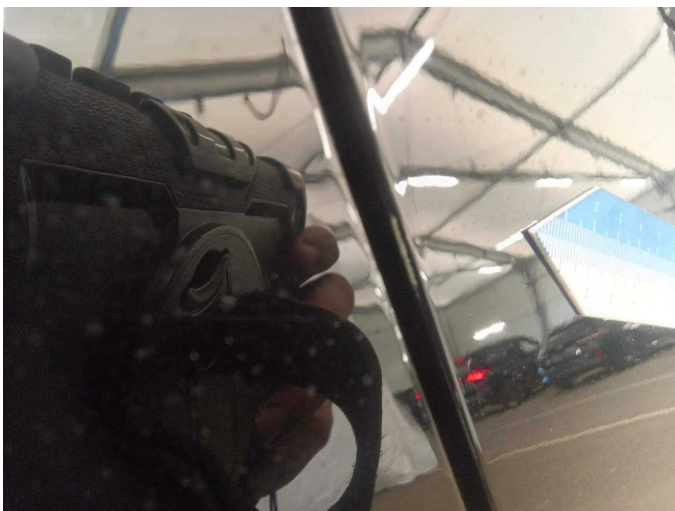
| No. | Component group | Description |
|---|---|---|
| 2 | Door - rear right side | Door edge - Scratch(es) - Smart repair |

**Damage 2:** Door - rear right side: Door edge - Scratch(es) - Smart repair

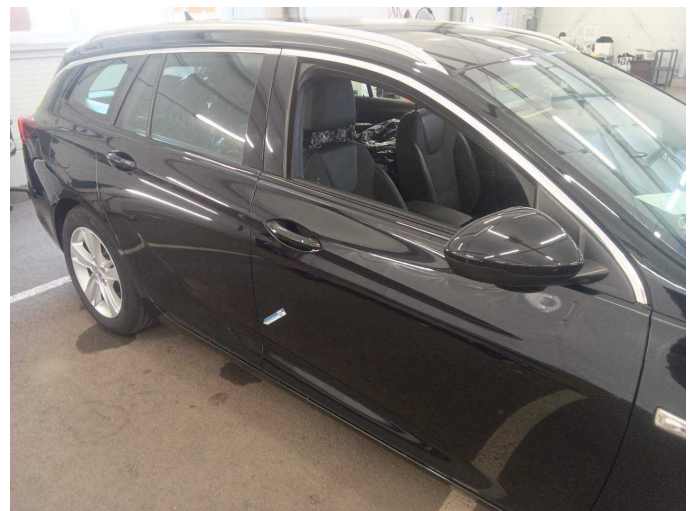
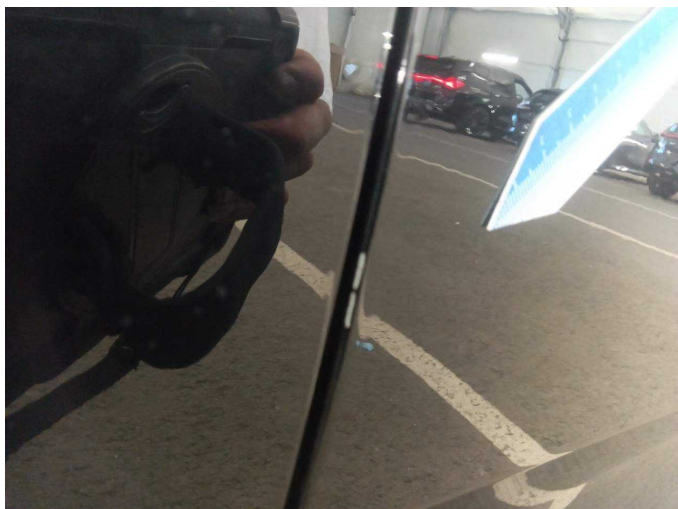
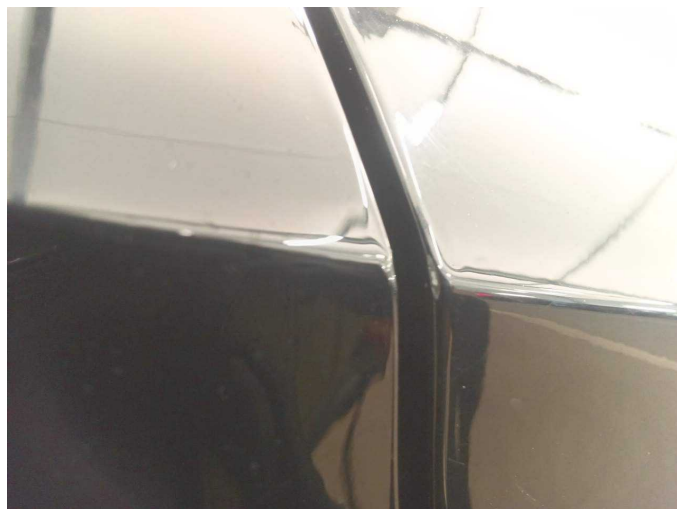
| No. | Component group | Description |
|---|---|---|
| 3 | Door - front right side | Door edge - Scratch(es) - Smart repair |

**Damage 3:** Door - front right side: Door edge - Scratch(es) - Smart repair

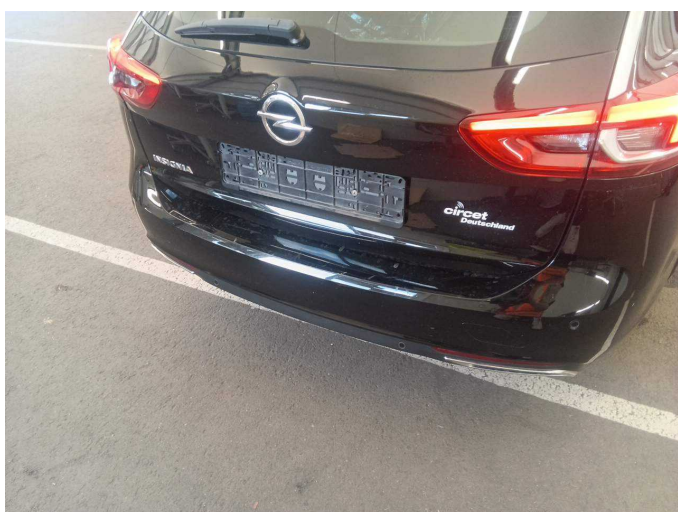
| No. | Component group | Description |
|---|---|---|
| 4 | Boot lid / rear door | Boot lid - Glued / labelled - De-glue / neutralise |

**Damage 4:** Boot lid / rear door: Boot lid - Glued / labelled - De-glue / neutralise

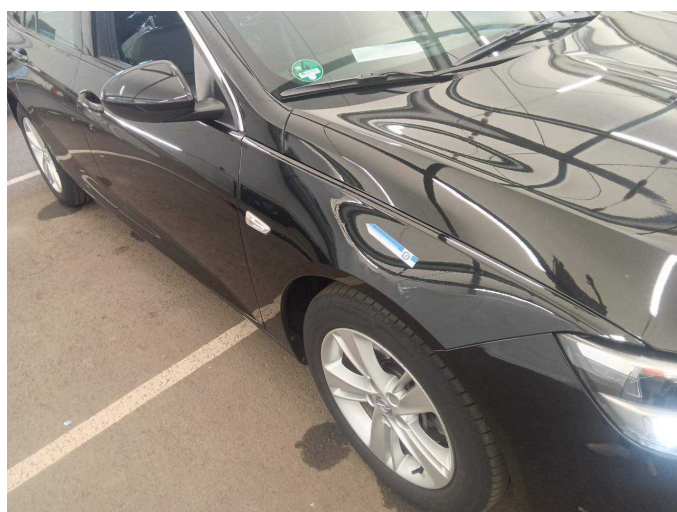
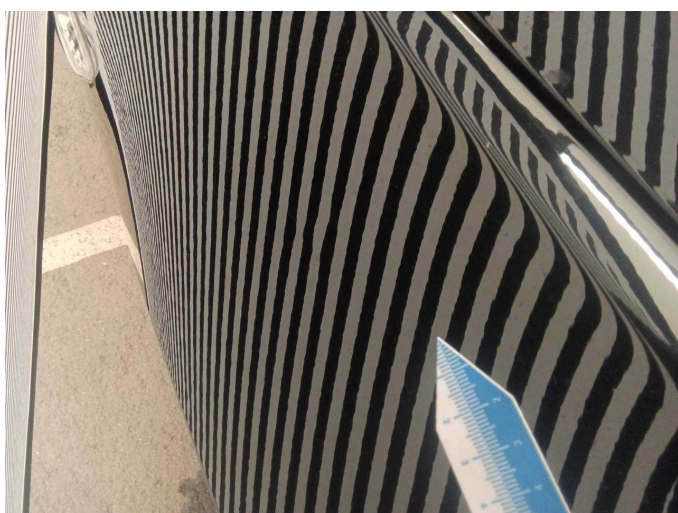
| No. | Component group | Description |
|---|---|---|
| 5 | Mudguard - right side | Mudguard - right side - dent(s) - Smooth repair work |

**Damage 5:** Mudguard - right side: Mudguard - right side - dent(s) - Smooth repair work

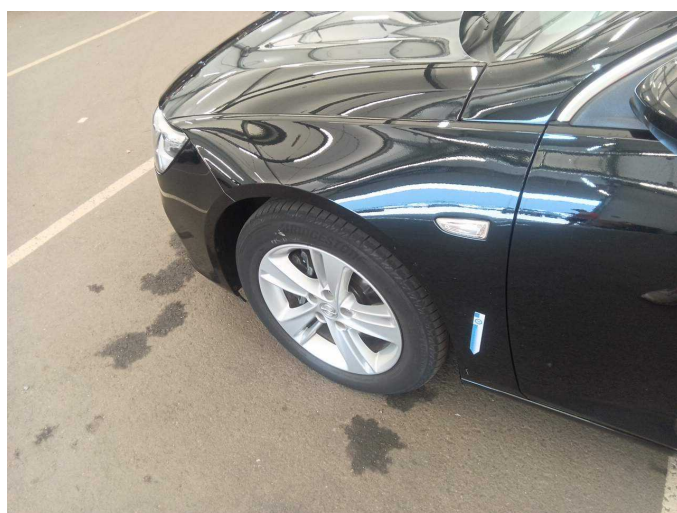
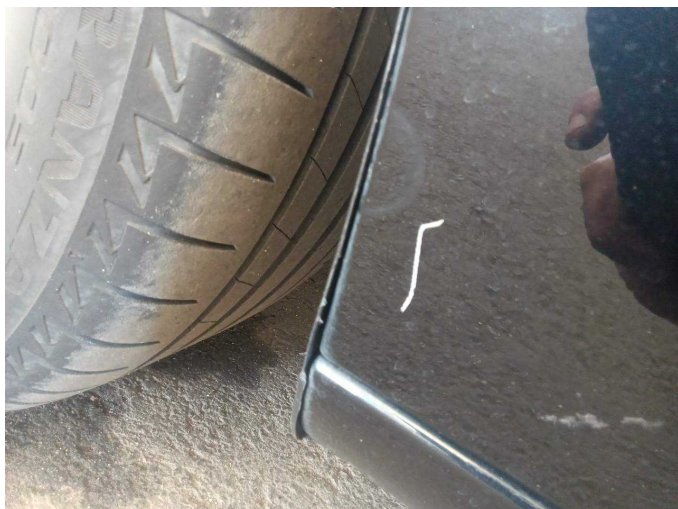
| No. | Component group | Description |
|---|---|---|
| 6 | Mudguard - left side | Mudguard - left side - Scratch(es) - Paint |

**Damage 6:** Mudguard - left side: Mudguard - left side - Scratch(es) - Paint

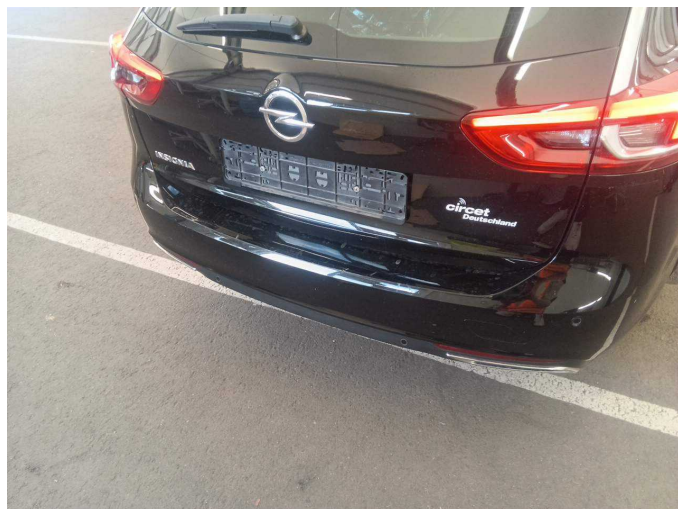
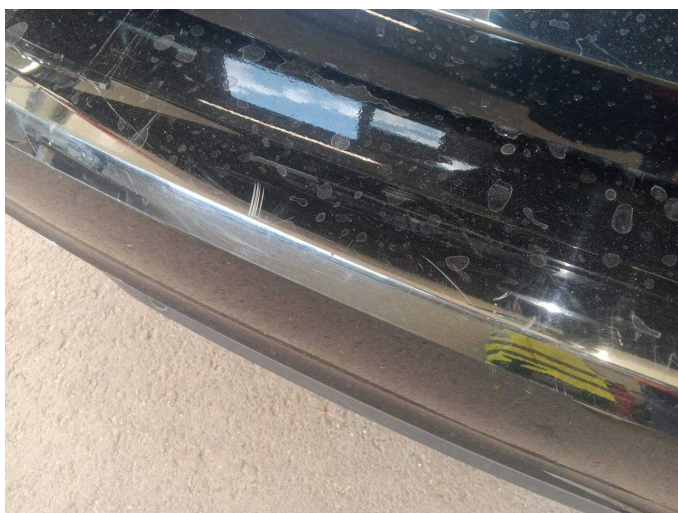
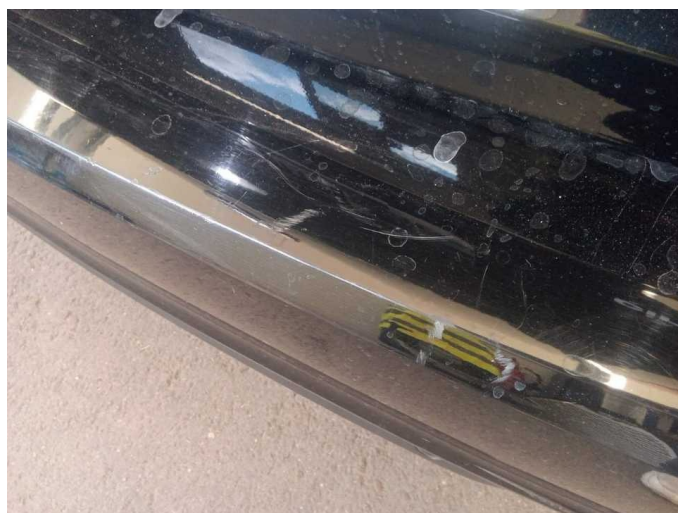
| No. | Component group | Description |
|---|---|---|
| 7 | Rear bumper | Rear bumper - Scratch(es) - Paint |

**Damage 7:** Rear bumper: Rear bumper - Scratch(es) - Paint

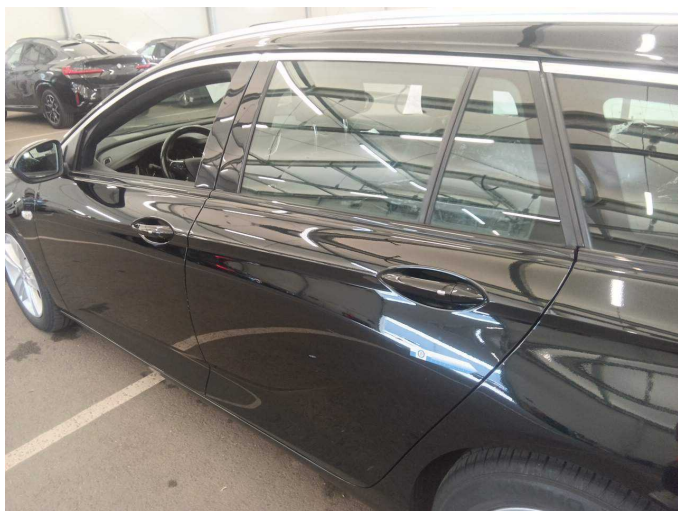
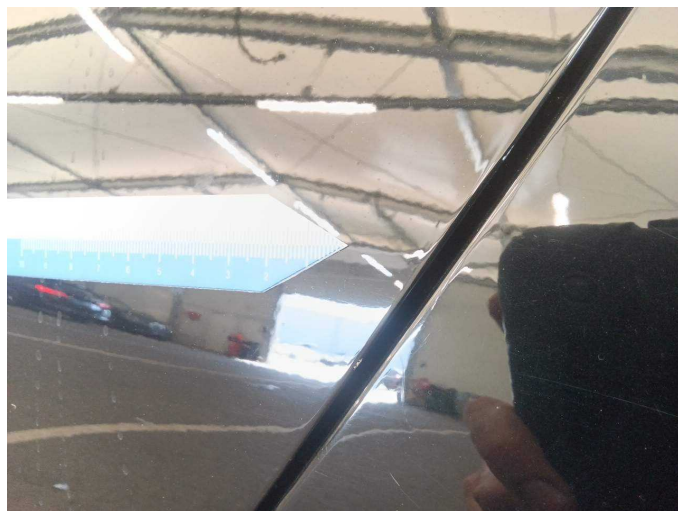
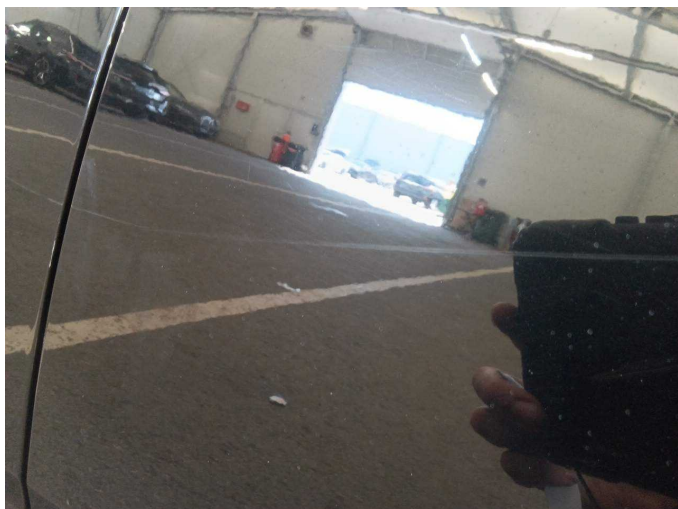
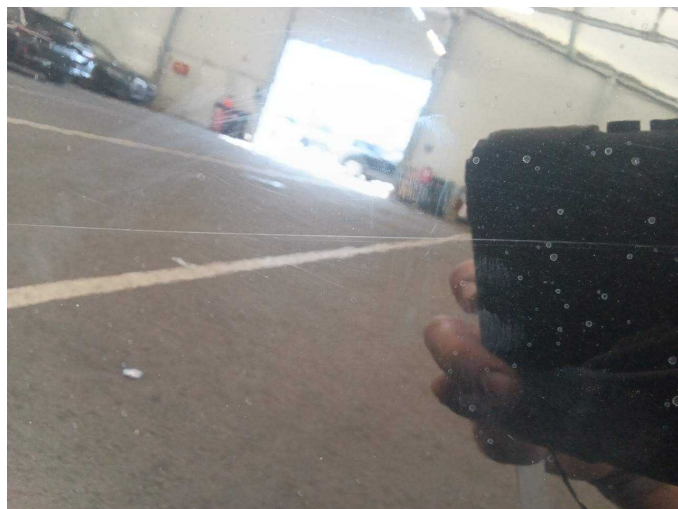
| No. | Component group | Description |
|---|---|---|
| 8 | Door - rear left side | Door - Scratch(es) - Paint |

**Damage 8:** Door - rear left side: Door - Scratch(es) - Paint

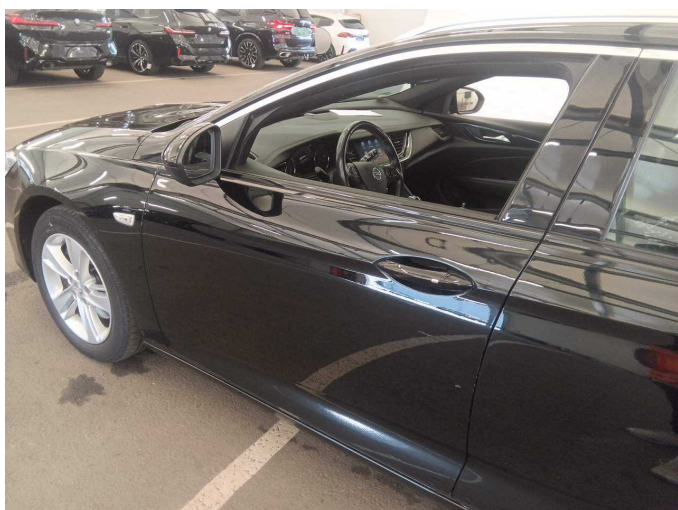
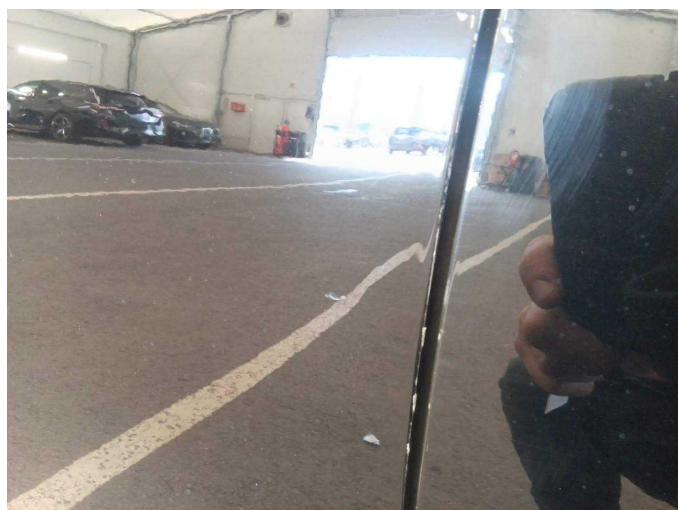
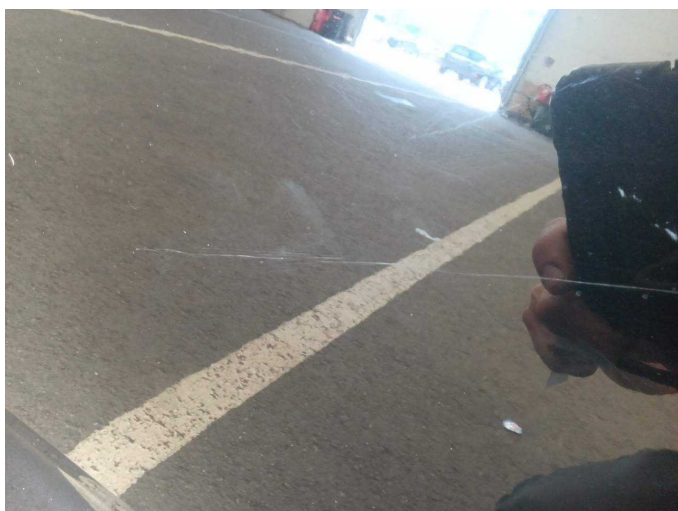
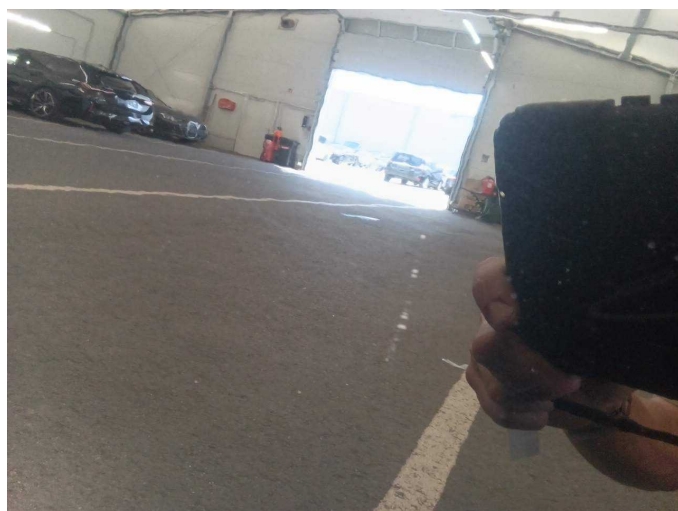
| No. | Component group | Description |
|---|---|---|
| 9 | Door - front left side | Door - Scratch(es) - Paint |

**Damage 9:** Door - front left side: Door - Scratch(es) - Paint

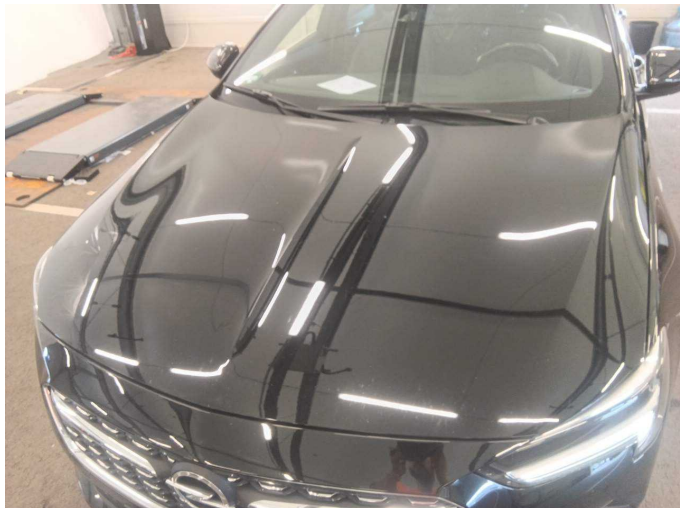
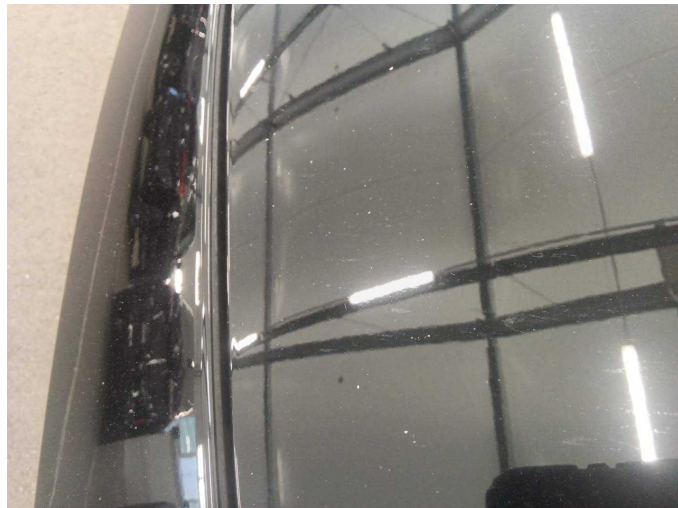
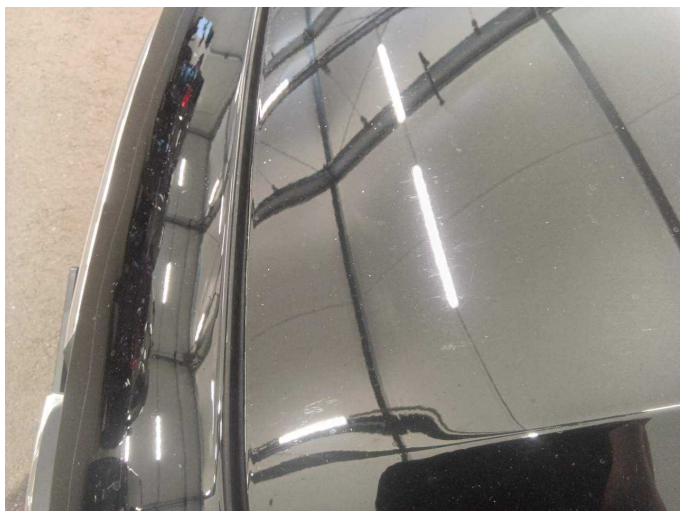
| No. | Component group | Description |
|---|---|---|
| 10 | Bonnet | Bonnet (Übermäßige Steinschläge) - Stone chips - Paint |

**Damage 10:** Bonnet: Bonnet (Übermäßige Steinschläge) - Stone chips - Paint

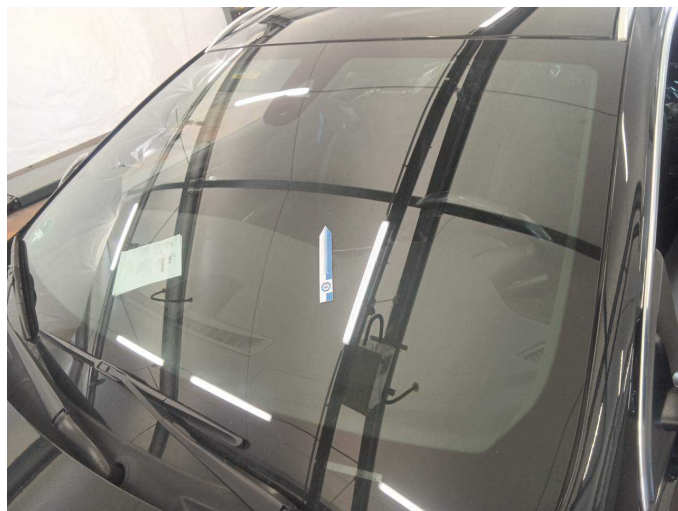
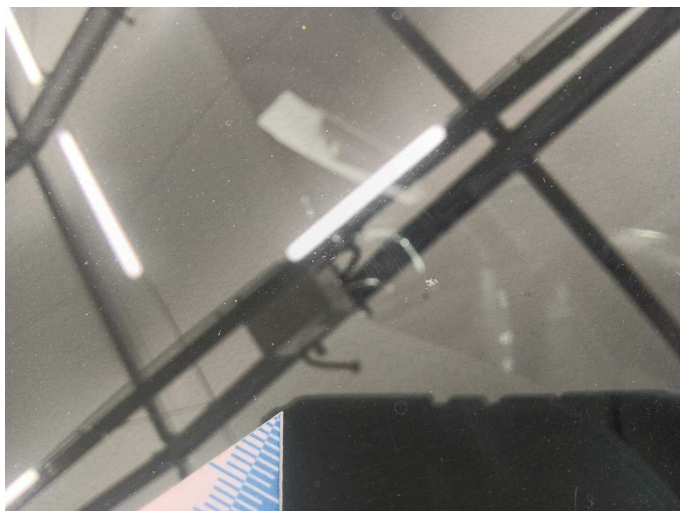
| No. | Component group | Description |
|---|---|---|
| 1 | Vehicle glazing | Windscreen - Stone chips - No deduction |

**Wear and tear 1:** Vehicle glazing: Windscreen - Stone chips - No deduction
