## Expertise

Protocol number: 46179601  
Order No. / Reference: 26499281  
Inspection date: 26 Jun 2026

Manufacturer: Ford

Model: Mondeo Turnier 2.0 EcoBlue Aut. Titanium

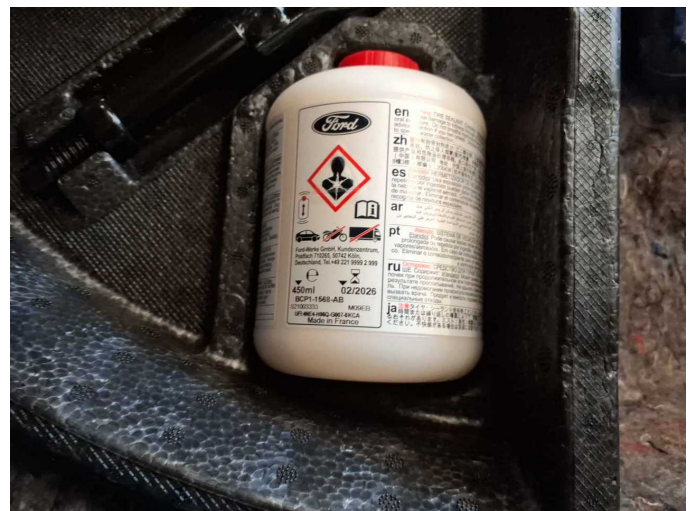
Damage 1: Equipment: Tirefit filler - Expired - Replace

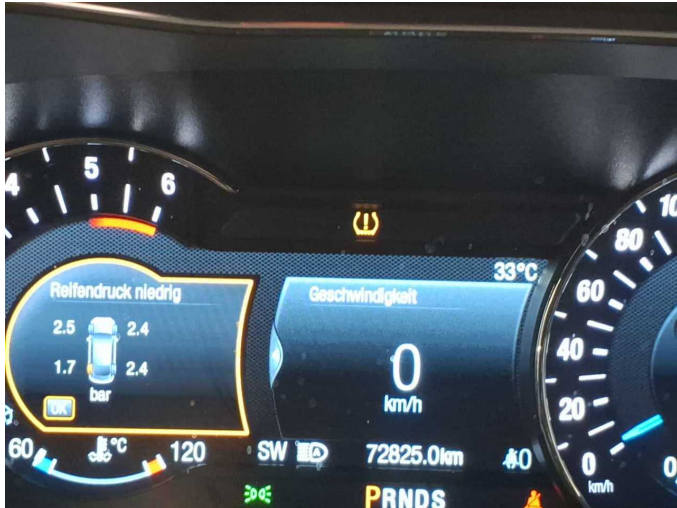
**Damage 2:** Instrument panel: Indicator light (Reifendruck Kontrollleuchte) - on - Perform diagnosis

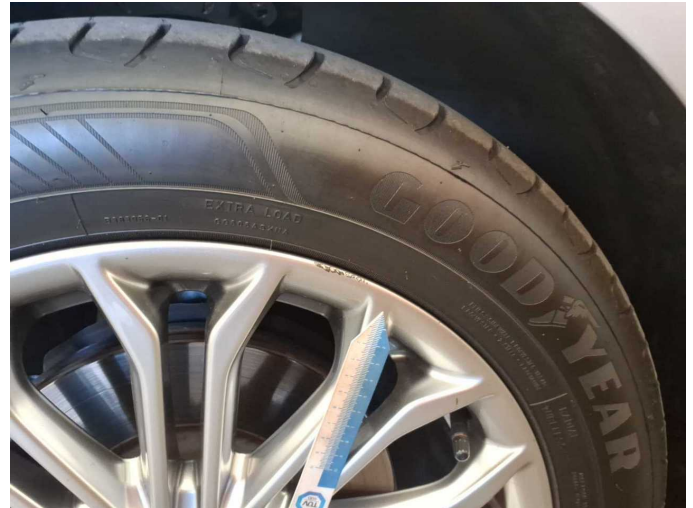
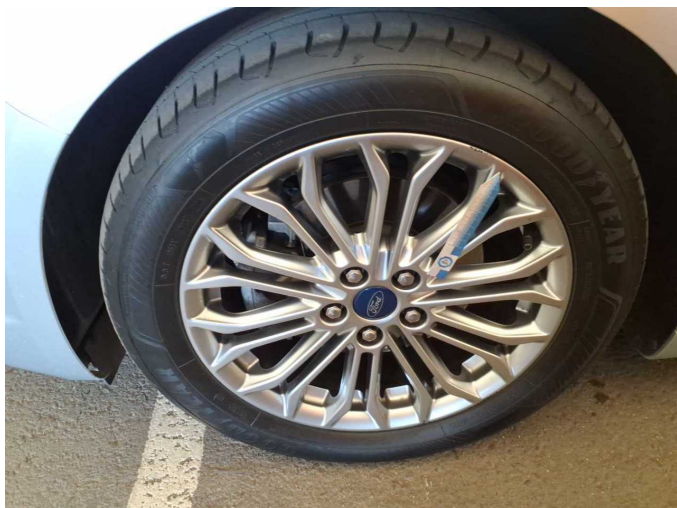
**Damage 3:** Wheel / tyres: Alloy rim - front left side - Scratch(es) - Loss in value

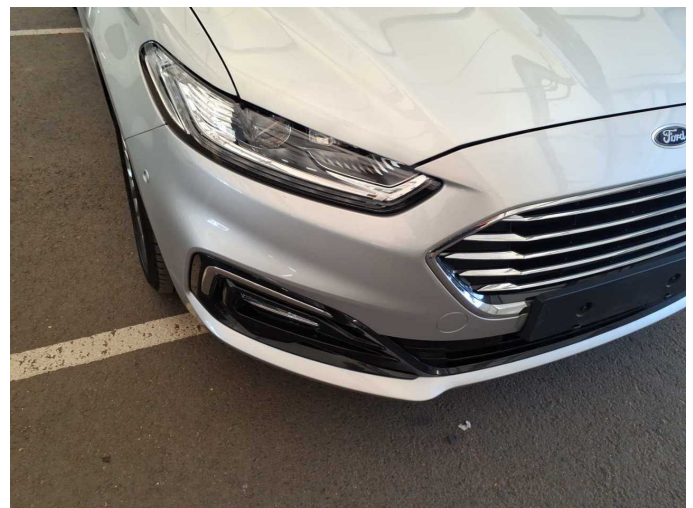
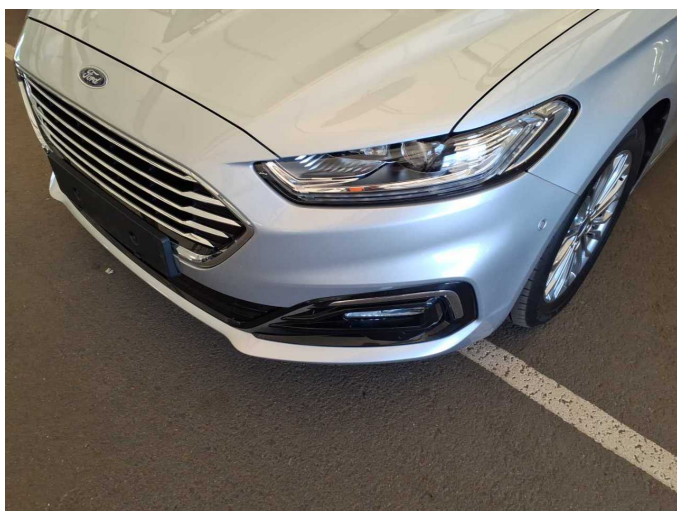
**Wear and tear 1:** Front bumper: Front bumper - Stone chips - No deduction

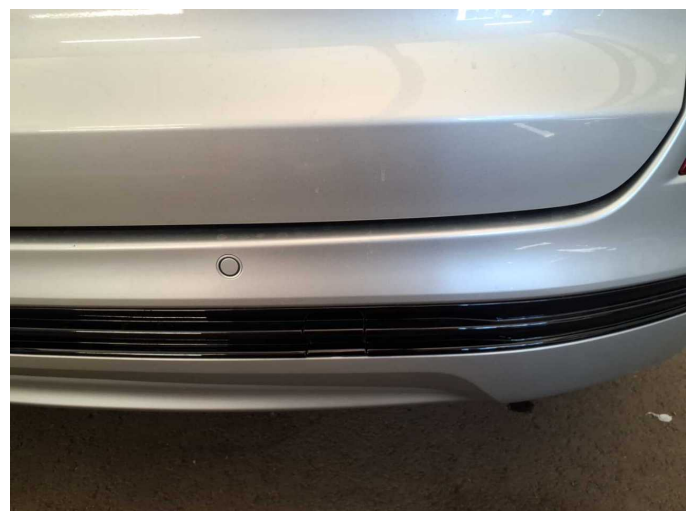
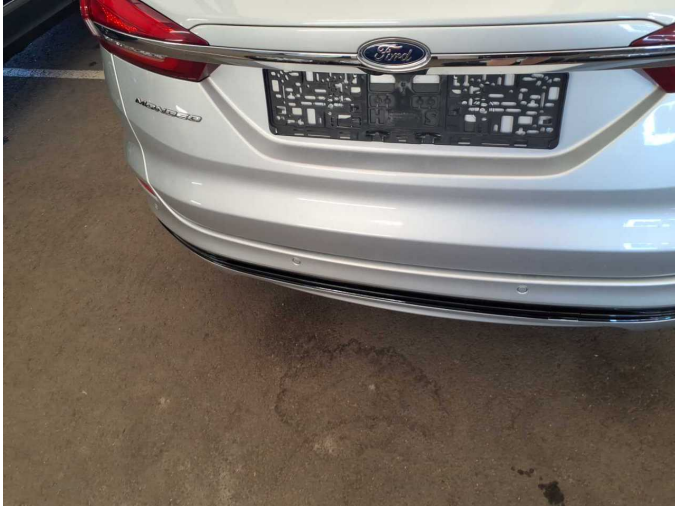
**Wear and tear 2:** Rear bumper: Rear bumper - Scratch(es) - No deduction

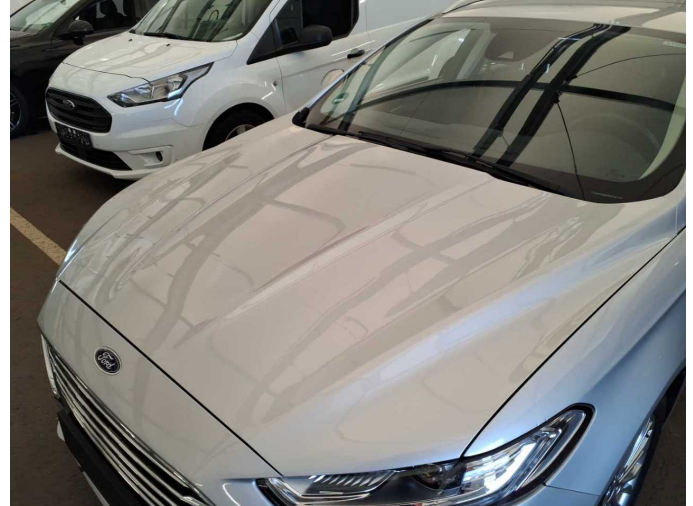
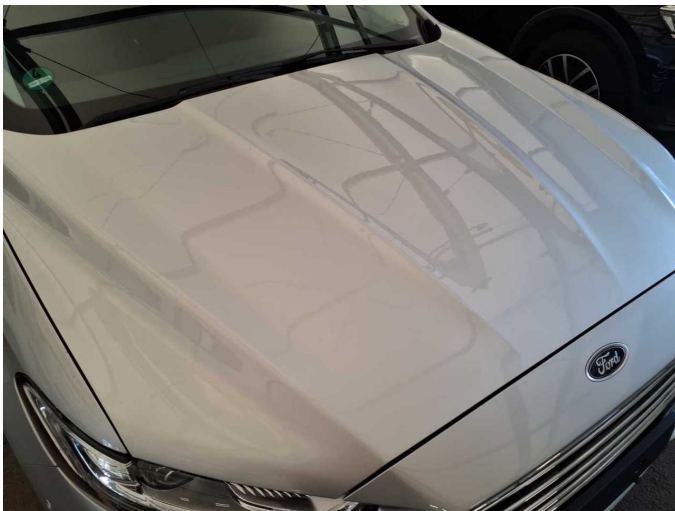
**Wear and tear 4:** Bonnet: Bonnet - Stone chips - No deduction

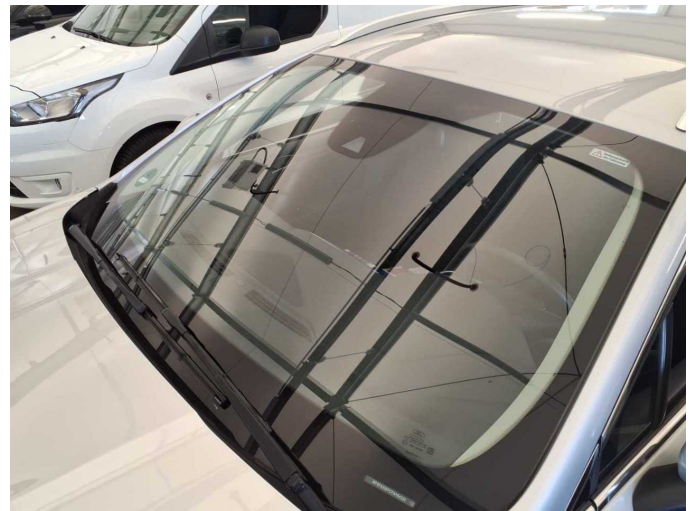
**Wear and tear 5:** Vehicle glazing: Windscreen - Stone chips - No deduction

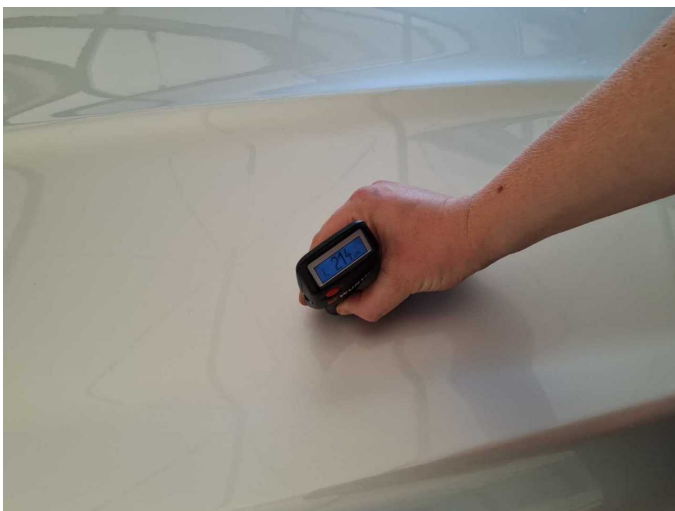
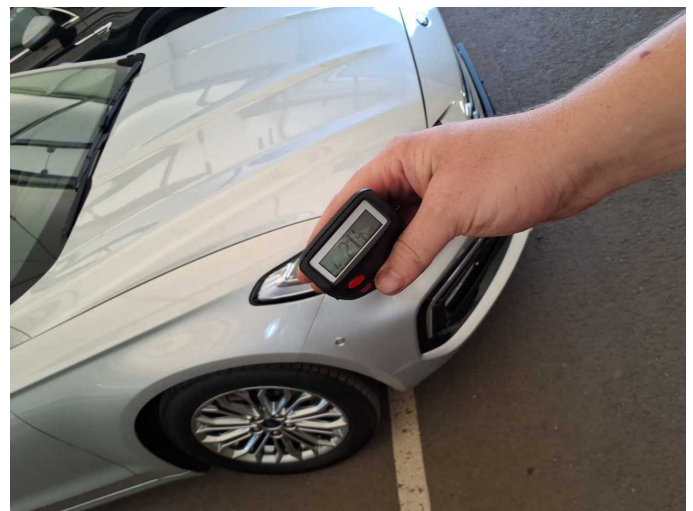
Bonnet 214  $\mu\text{m}$  |

**Repainting 1:** Bonnet
