Expertise

Protocol number: 46447697  
Order No. / Reference: 26311031  
Inspection date: 8 Jul 2026

Manufacturer: Mercedes-Benz  
VIN: W1VVLFEZXT4558337

Model: Vito 116 CDI Tourer Lang Aut. PRO

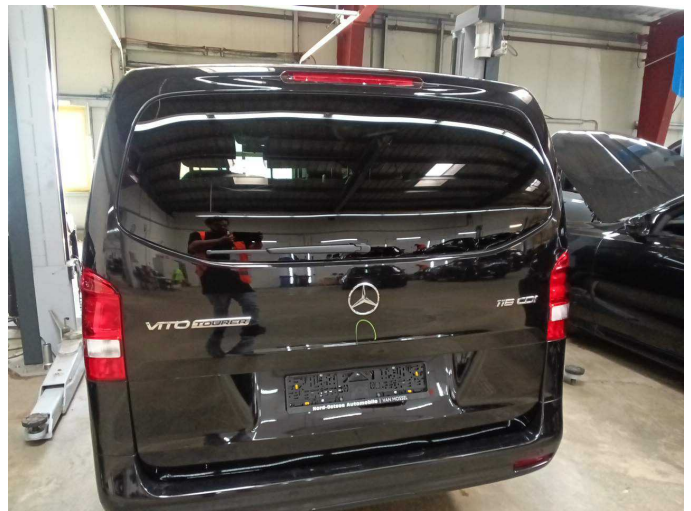
| No. | Component group | Description |
|---|---|---|
| 1 | Boot lid / rear door | Boot lid - Scratch(es) - Smart repair |

**Damage 1:** Boot lid / rear door: Boot lid - Scratch(es) - Smart repair

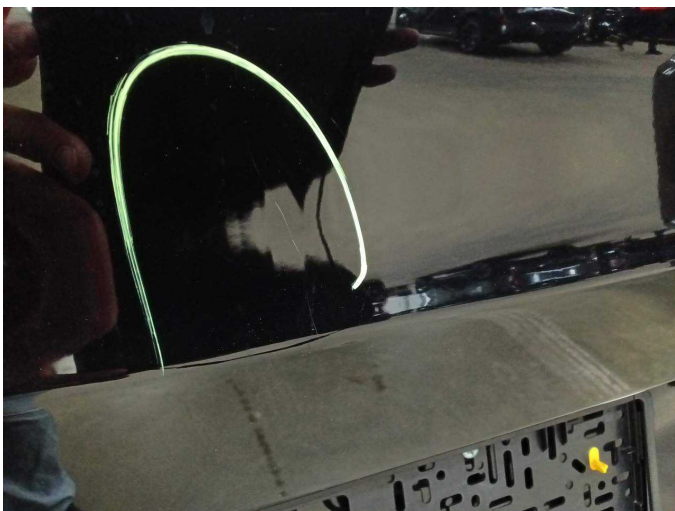
**Damage 1:** Boot lid / rear door: Boot lid - Scratch(es) - Smart repair

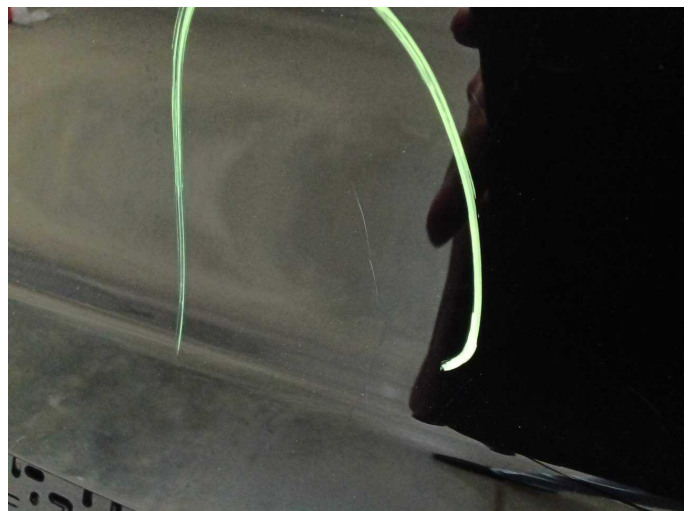
**Damage 1:** Boot lid / rear door: Boot lid - Scratch(es) - Smart repair

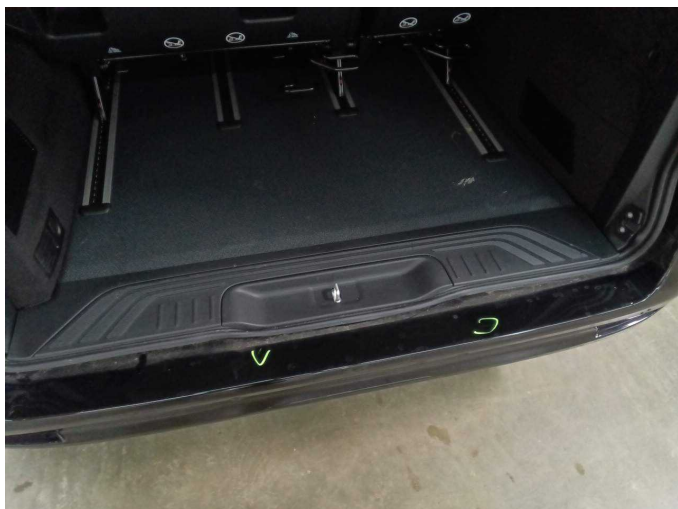
| No. | Component group | Description |
|---|---|---|
| 2 | Trim / covers | Boot sill cover - Scratch(es) - Replace |

**Damage 2:** Trim / covers: Boot sill cover - Scratch(es) - Replace

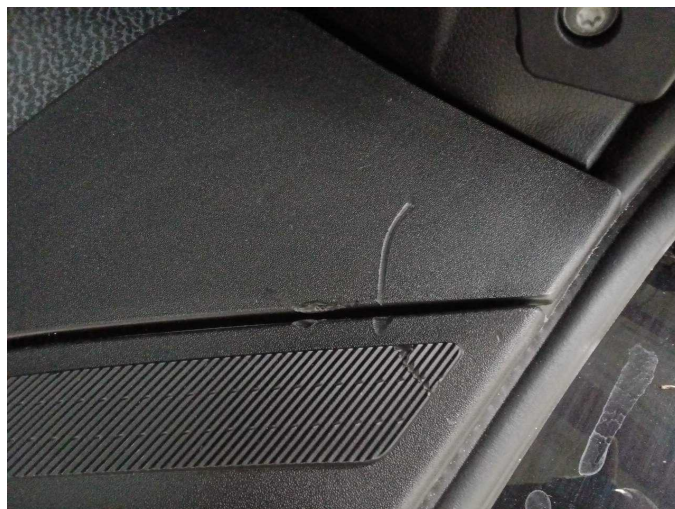
**Damage 2:** Trim / covers: Boot sill cover - Scratch(es) - Replace

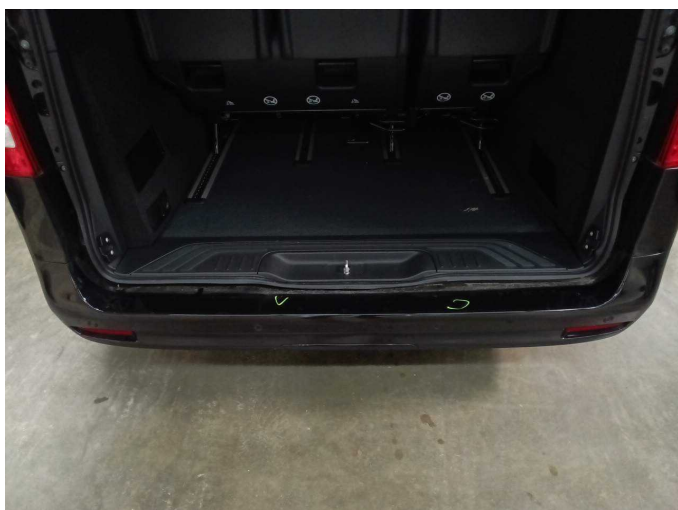
| No. | Component group | Description |
|---|---|---|
| 3 | Rear bumper | Rear bumper - Scratch(es) - Paint |

**Damage 3:** Rear bumper: Rear bumper - Scratch(es) - Paint

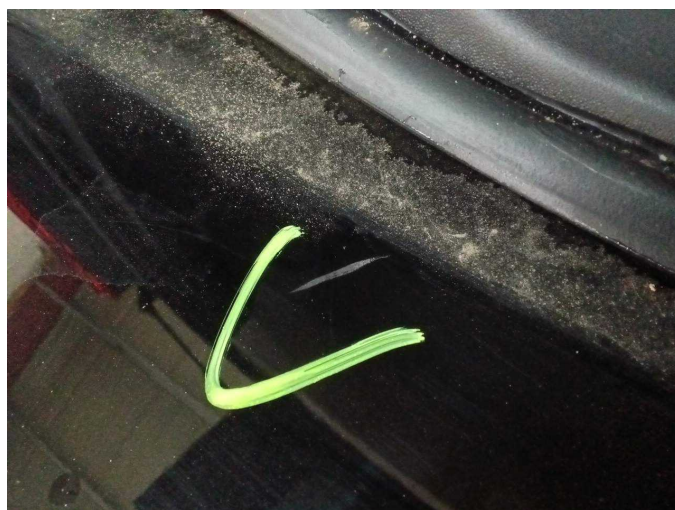
**Damage 3:** Rear bumper: Rear bumper - Scratch(es) - Paint

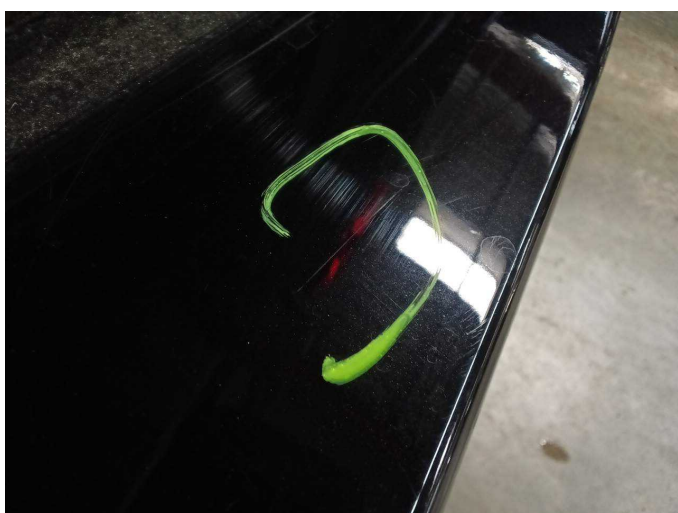
**Damage 3:** Rear bumper: Rear bumper - Scratch(es) - Paint

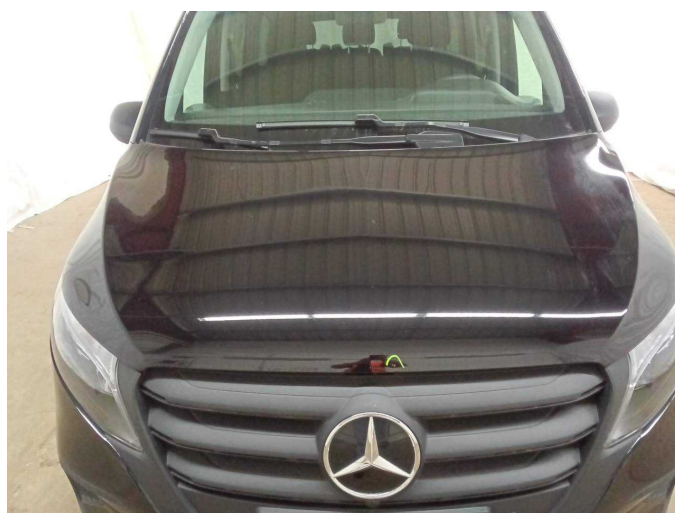
| No. | Component group | Description |
|---|---|---|
| 4 | Bonnet | Bonnet - Dent / paintcoat damage - Repair and paint |

**Damage 4:** Bonnet: Bonnet - Dent / paintcoat damage - Repair and paint

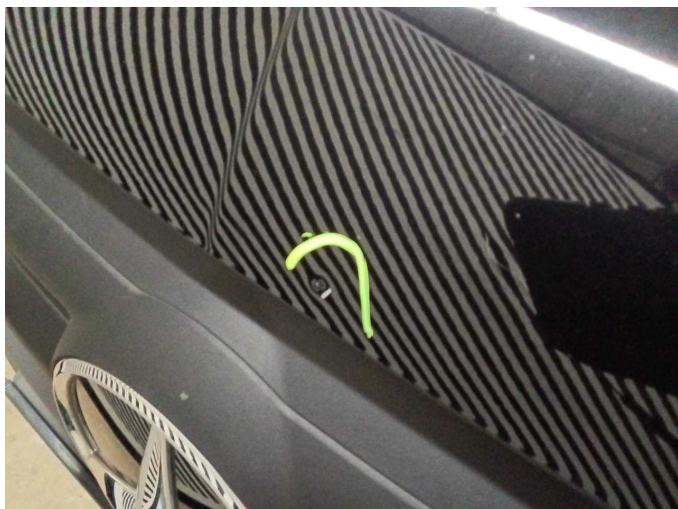
**Damage 4:** Bonnet: Bonnet - Dent / paintcoat damage - Repair and paint
