Expertise

Protocol number: 46887168  
Order No. / Reference: 26847373  
Inspection date: 4 Aug 2026

Manufacturer: Skoda  
VIN: TMBJP6NJ2MZ062876

Model: Fabia Combi 1.0 TSI Best of Clever

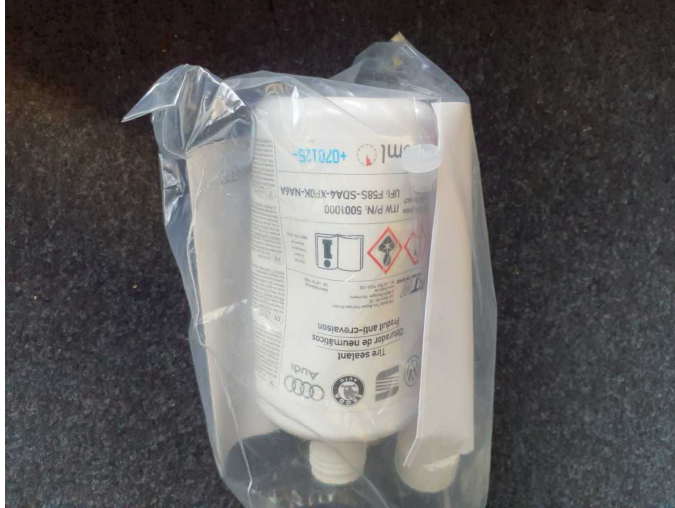
| No. | Component group | Description |
|---|---|---|
| 1 | Equipment | Tirefit filler - Expired - Replace |

**Damage 1:** Equipment: Tirefit filler - Expired - Replace

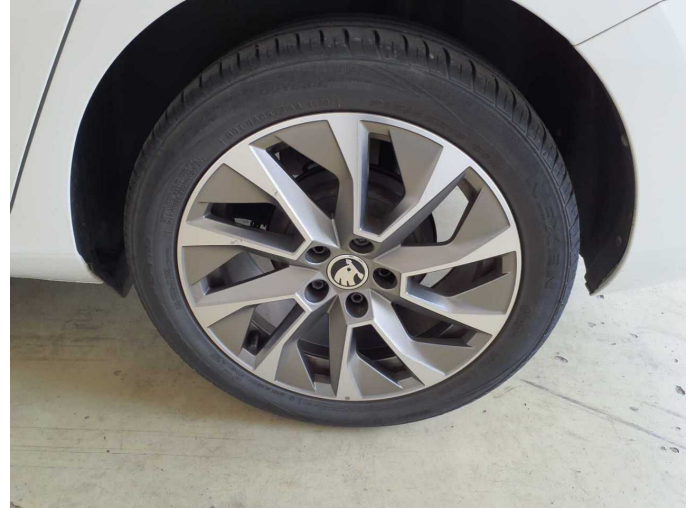
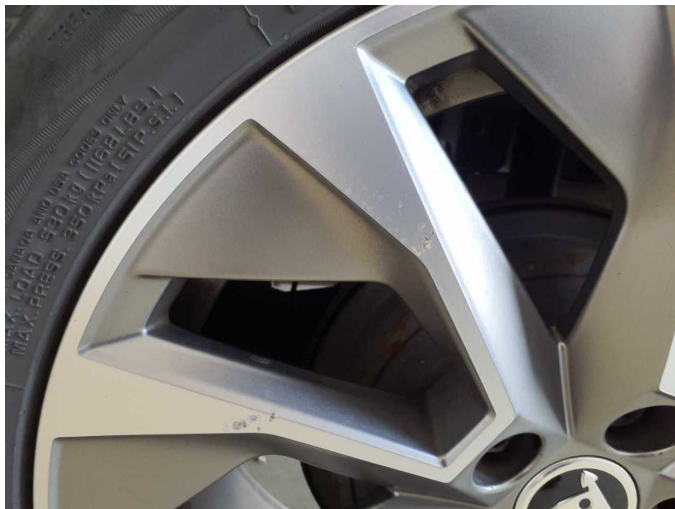
| No. | Component group | Description |
|---|---|---|
| 2 | Wheel / tyres | Alloy rim - rear left side - Scratch(es) - Loss in value |

**Damage 2:** Wheel / tyres: Alloy rim - rear left side - Scratch(es) - Loss in value

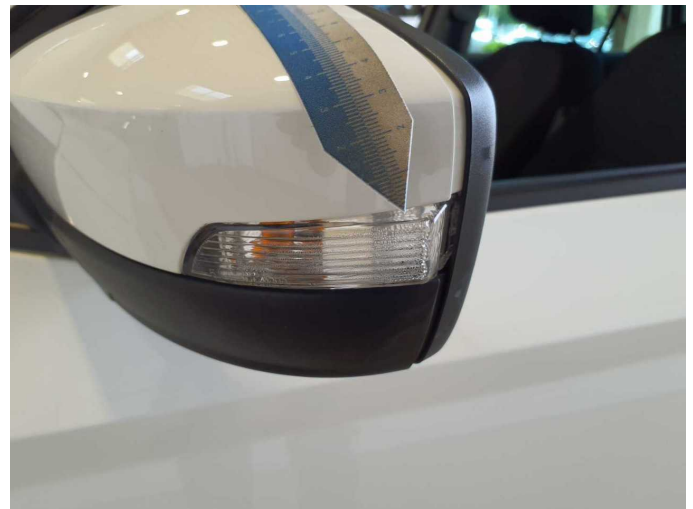
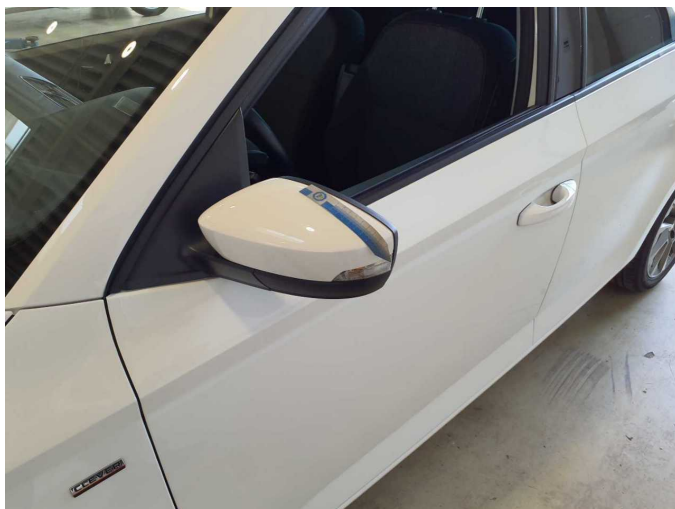
| No. | Component group | Description |
|---|---|---|
| 3 | Indicator - front | Mirror - left side - Leaking - Replace |

**Damage 3:** Indicator - front: Mirror - left side - Leaking - Replace

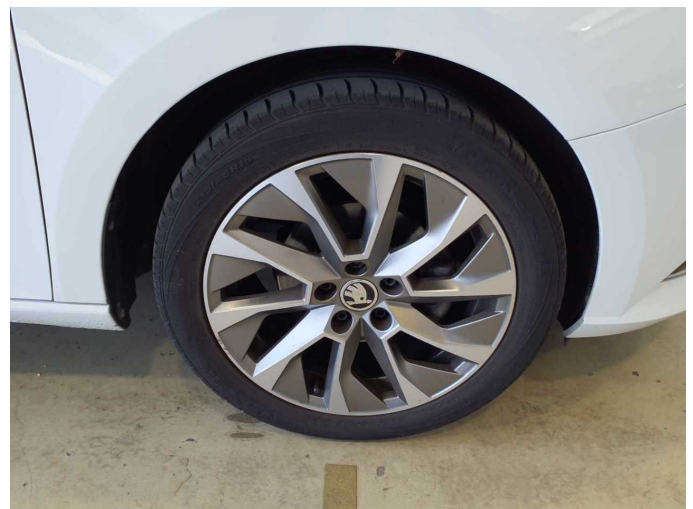
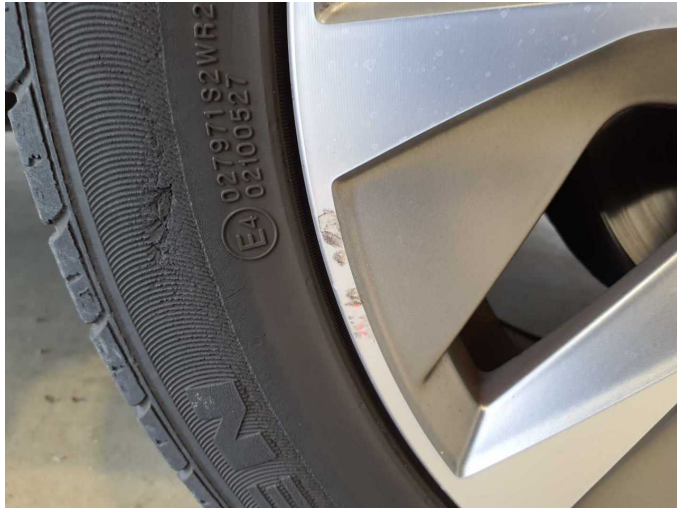
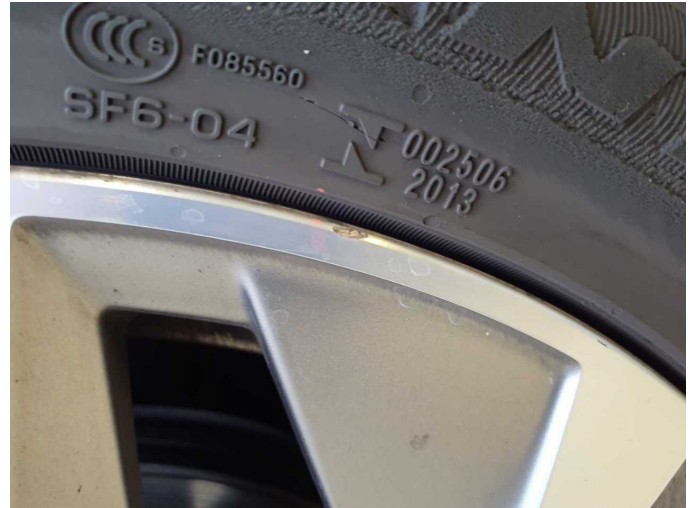
| No. | Component group | Description |
|---|---|---|
| 4 | Wheel / tyres | Alloy rim - front right side - Scratch(es) - Loss in value |

**Damage 4:** Wheel / tyres: Alloy rim - front right side - Scratch(es) - Loss in value

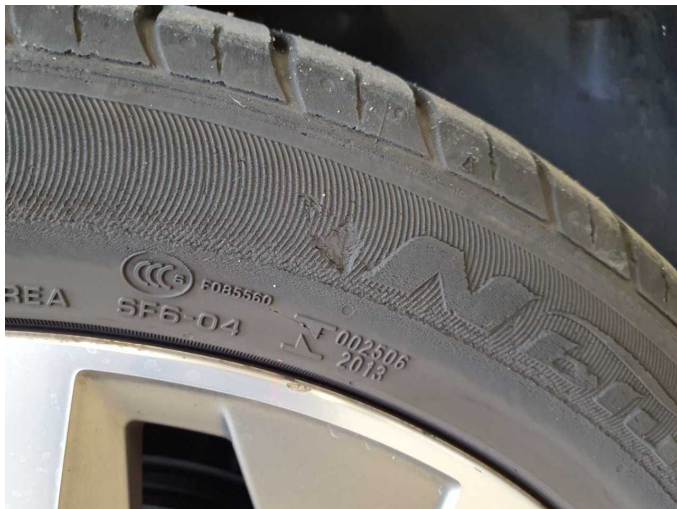
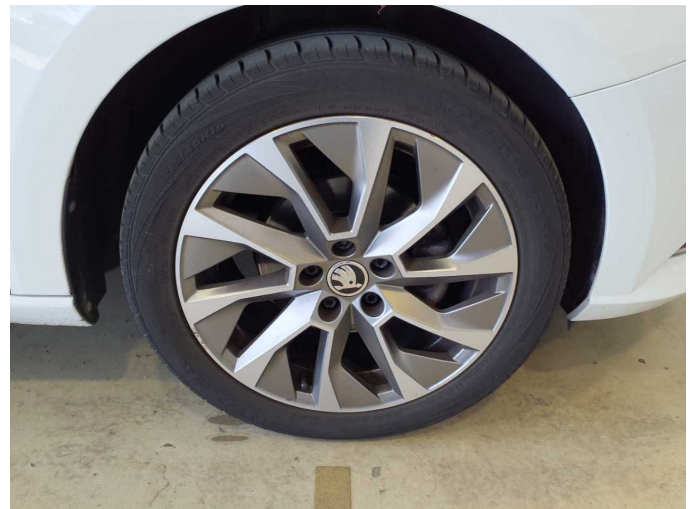
| No. | Component group | Description |
|---|---|---|
| 5 | Wheel / tyres | Tyre - front right side - Porous / cracked - Replace |

**Damage 5:** Wheel / tyres: Tyre - front right side - Porous / cracked - Replace

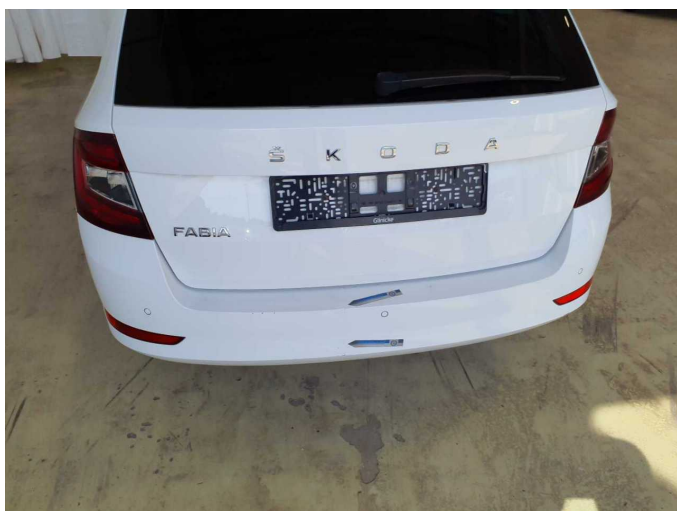
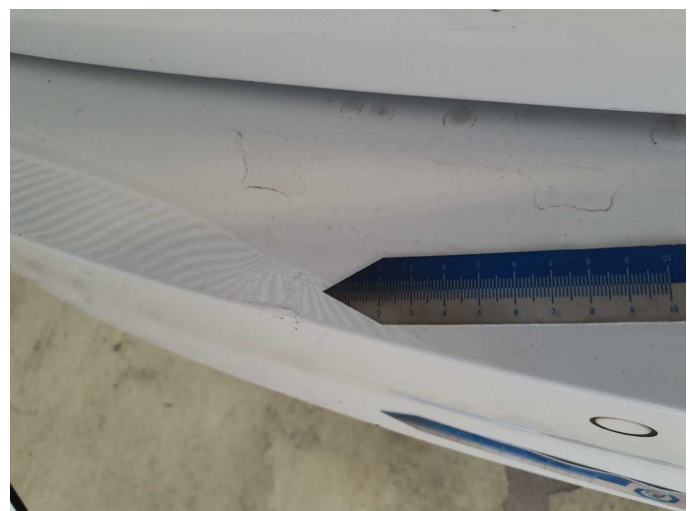
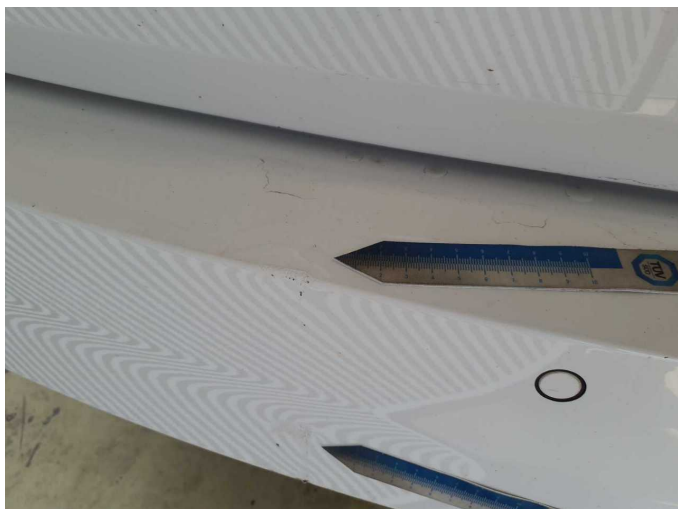
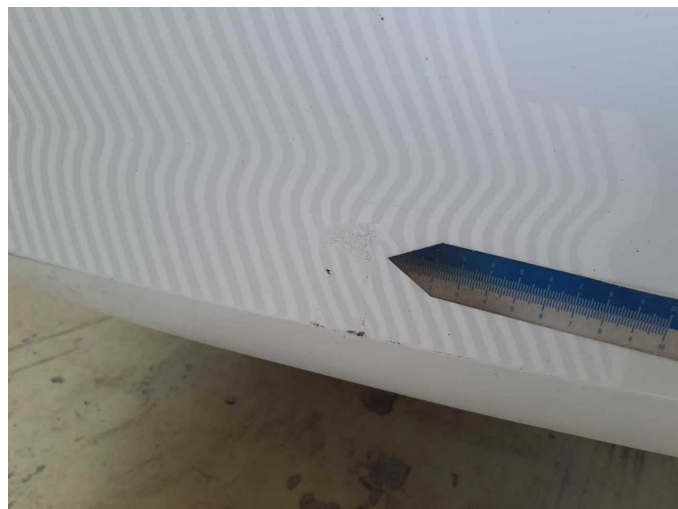
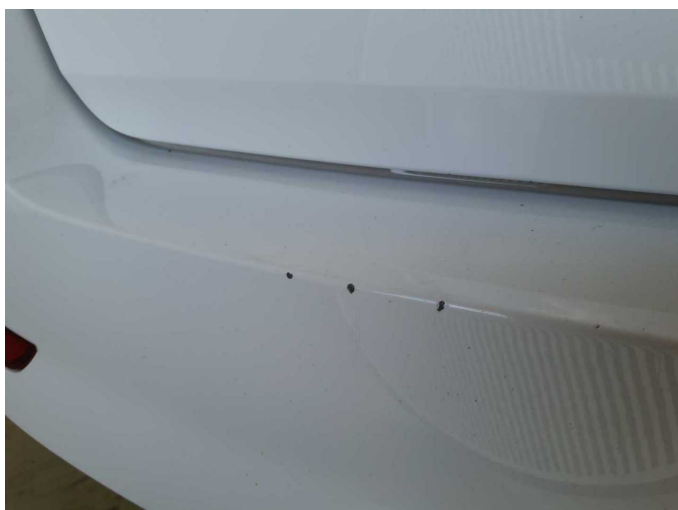
| No. | Component group | Description |
|---|---|---|
| 6 | Rear bumper | Rear bumper - Dent / paintcoat damage - Repair and paint |

**Damage 6:** Rear bumper: Rear bumper - Dent / paintcoat damage - Repair and paint

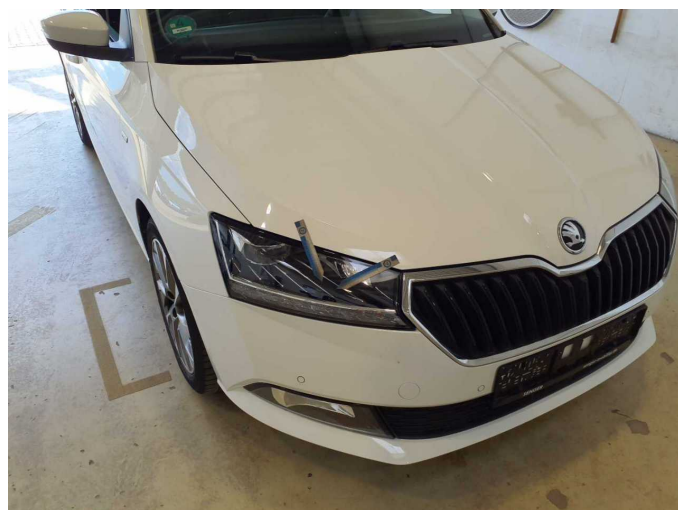
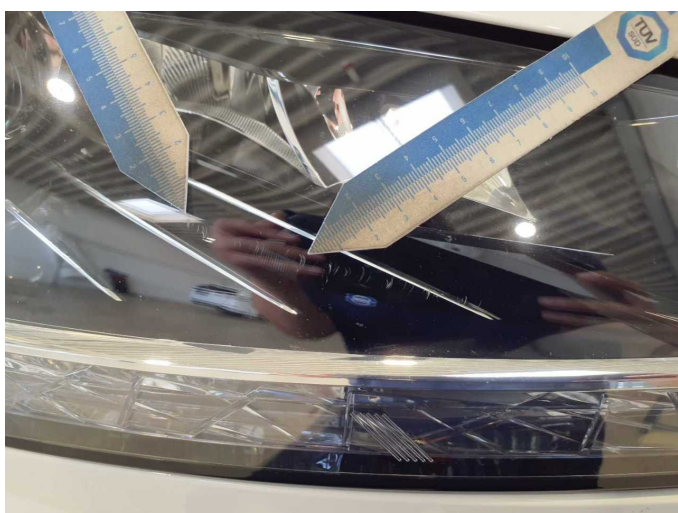
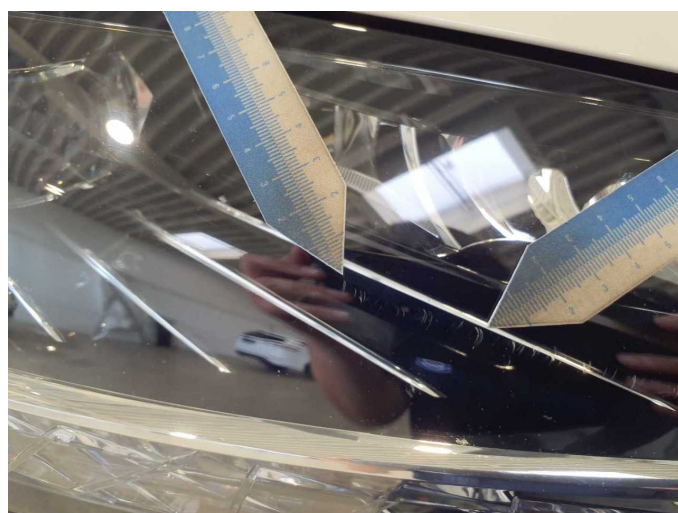
| No. | Component group | Description |
|---|---|---|
| 7 | Headlight | Headlight - right side - Scratch(es) - Replace |

**Damage 7:** Headlight: Headlight - right side - Scratch(es) - Replace

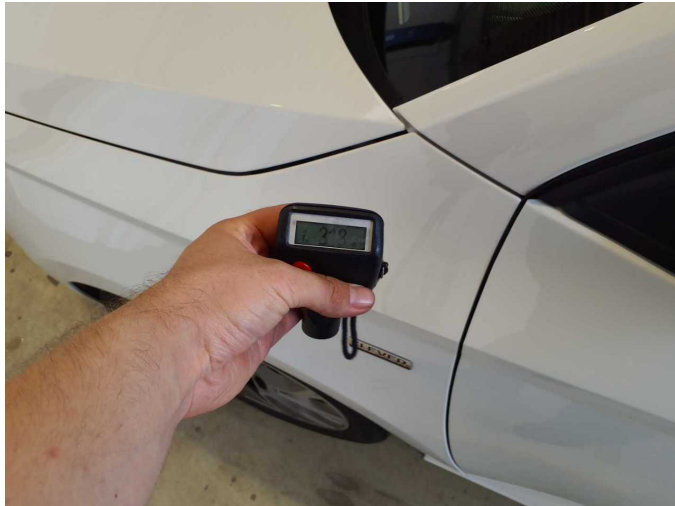
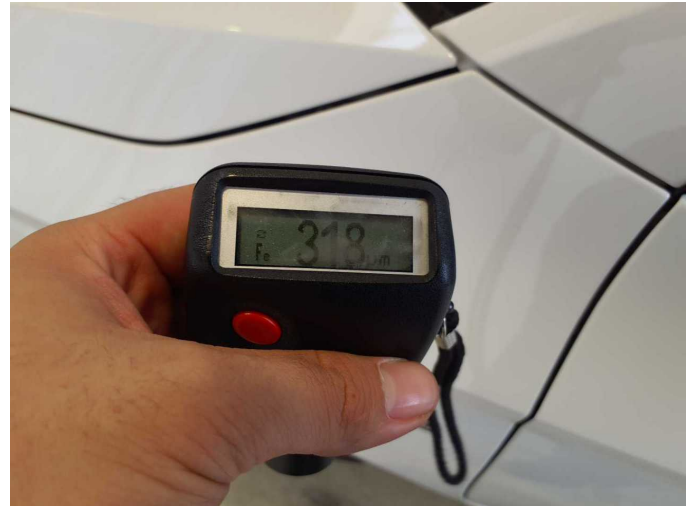
| Mudguard - left side | 318 µm | Mudguard - right side | 182 µm |

**Repainting 1:** Mudguard - left side

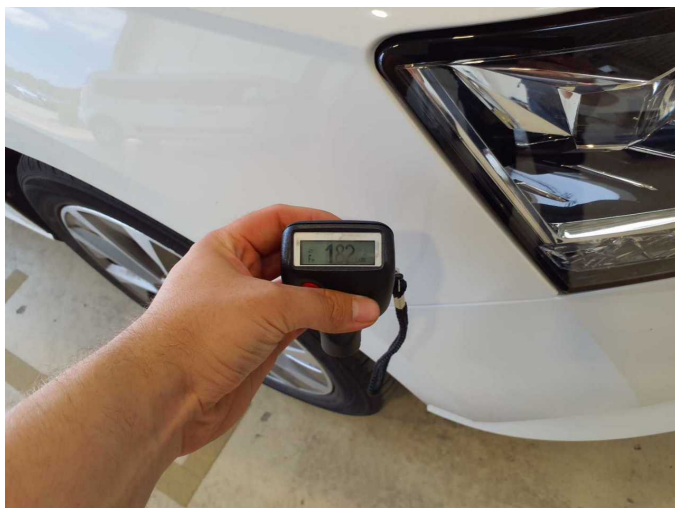
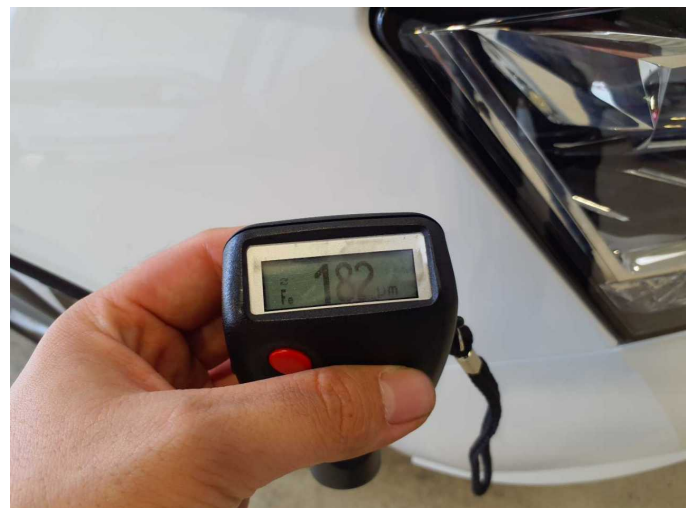
**Repainting 2:** Mudguard - right side

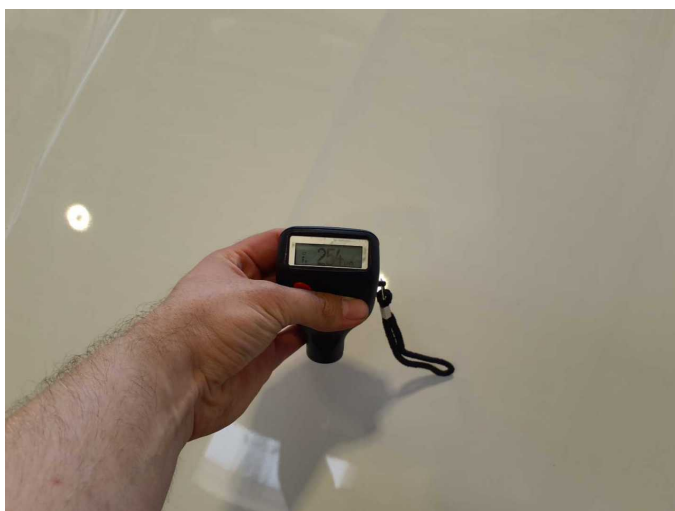
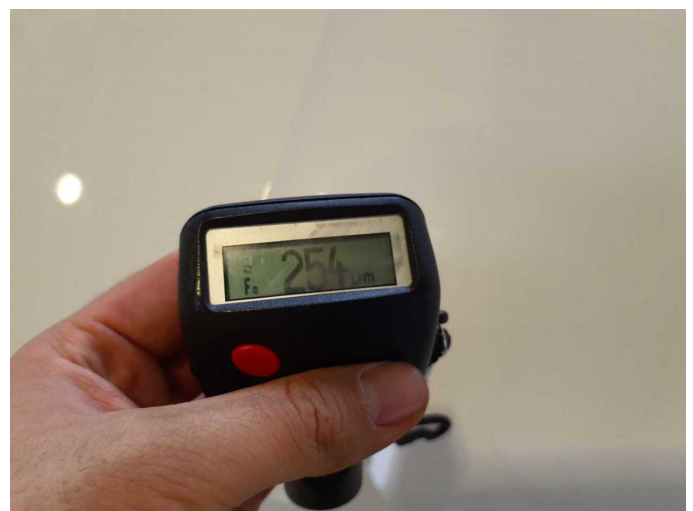
| Bonnet | 254 µm | Door - rear left side | 184 µm |

**Repainting 3:** Bonnet

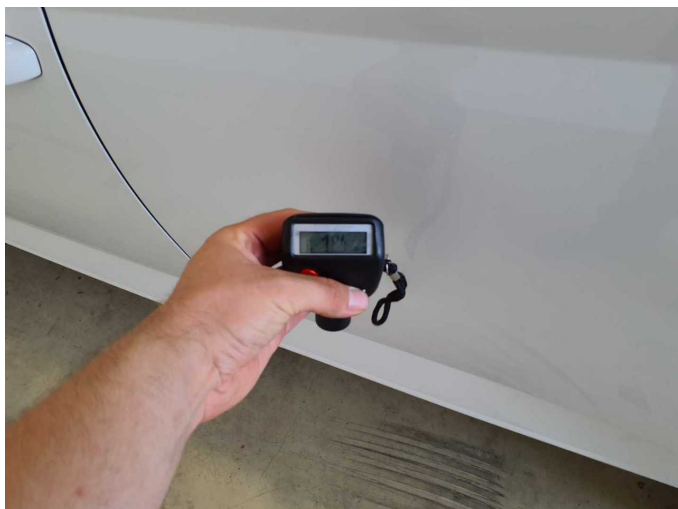
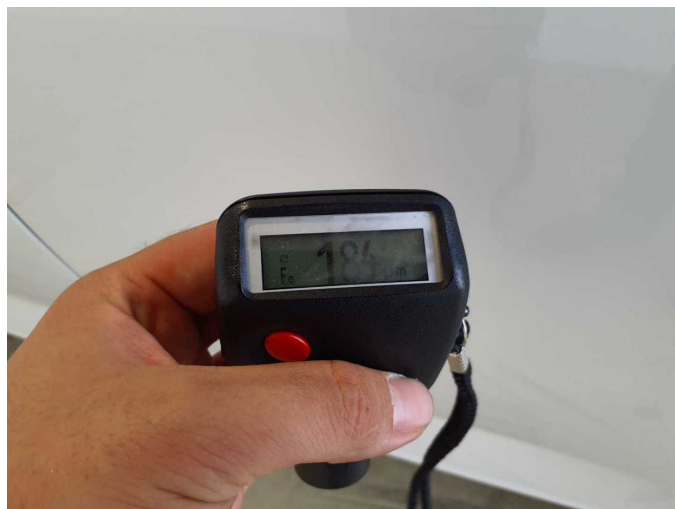
**Repainting 4:** Door - rear left side

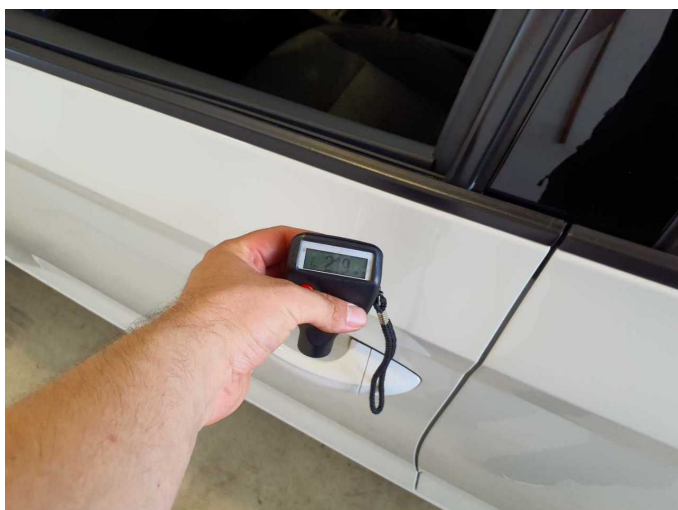
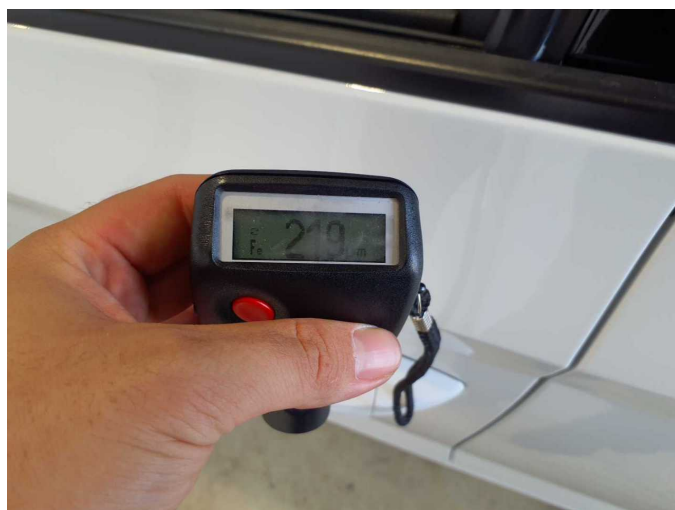
| Door - front left side | 219 µm | | |

**Repainting 5:** Door - front left side
