Expertise

Protocol number: 46012611
Order No. / Reference: 26495150
Inspection date: 18 Jun 2026

Manufacturer: Volkswagen

Model: Golf Variant 2.0 TDI SCR DSG R-Line

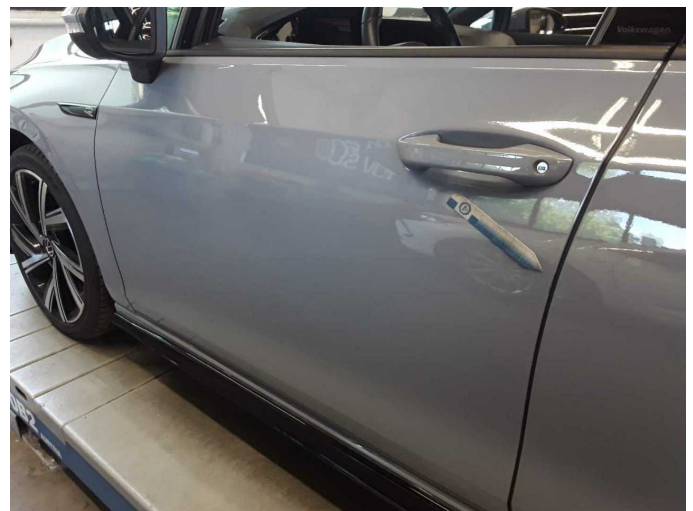
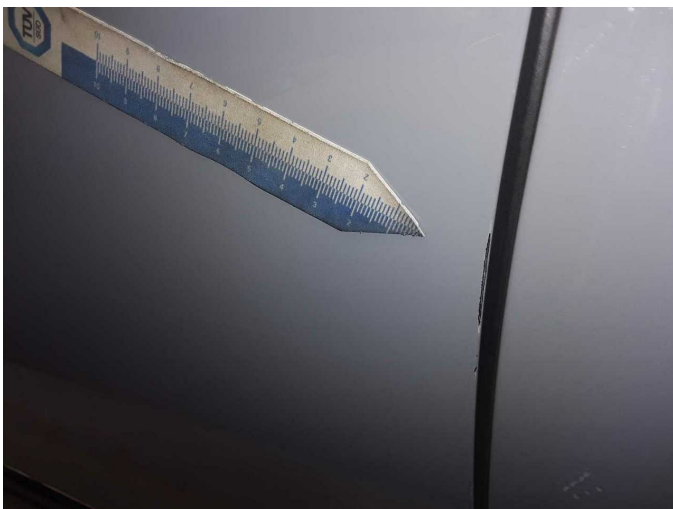
Damage 1: Door - front left side: Door - Scratch(es) - Smart repair

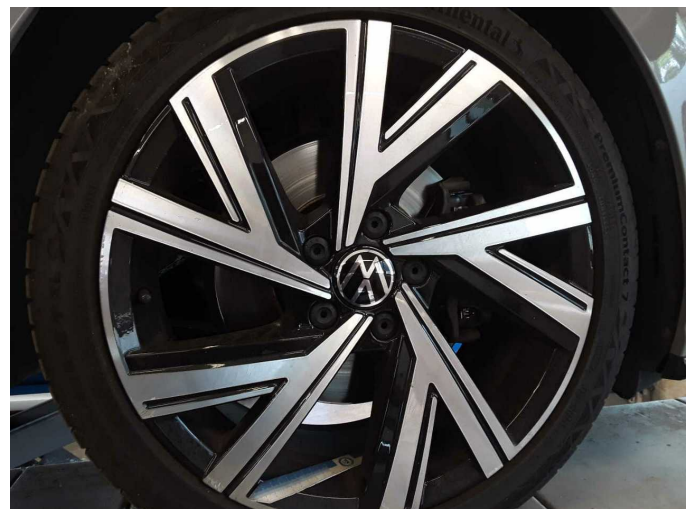
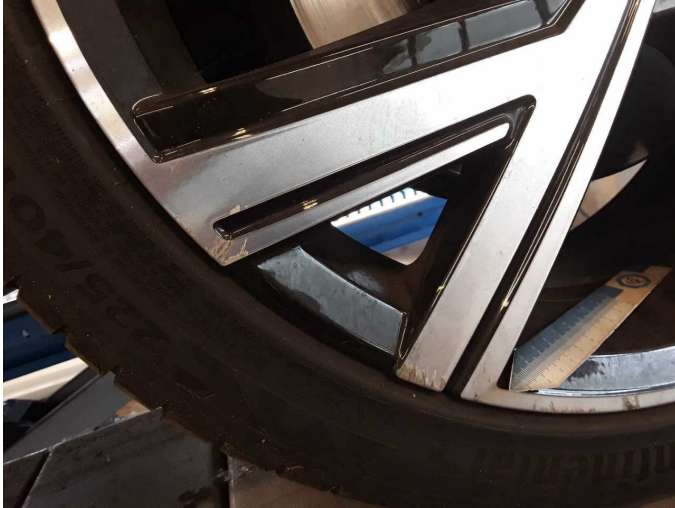
Damage 2: Wheel / tyres: Alloy rim - front right side - Scratched - Loss in value

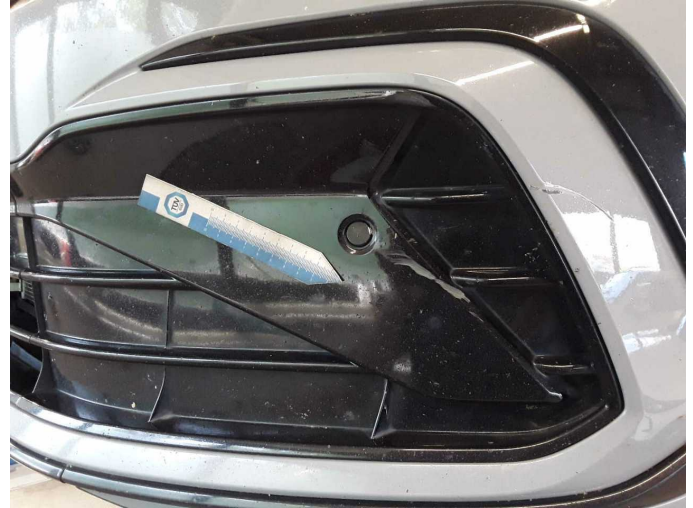
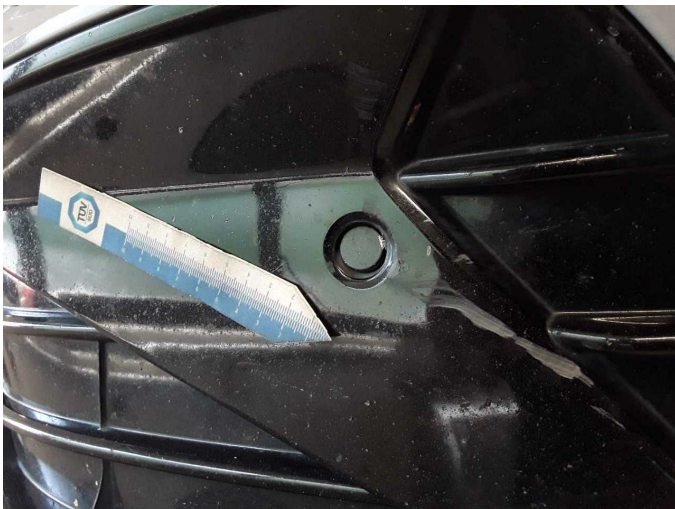
Damage 3: Front bumper: Parking sensors - left side - Damaged - Replace

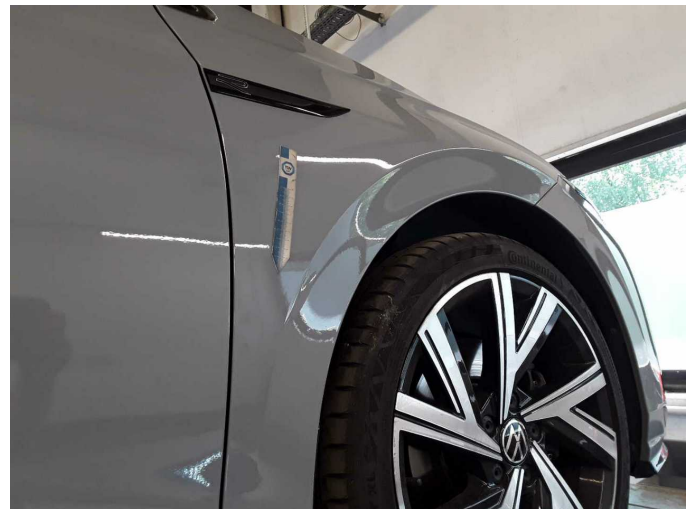
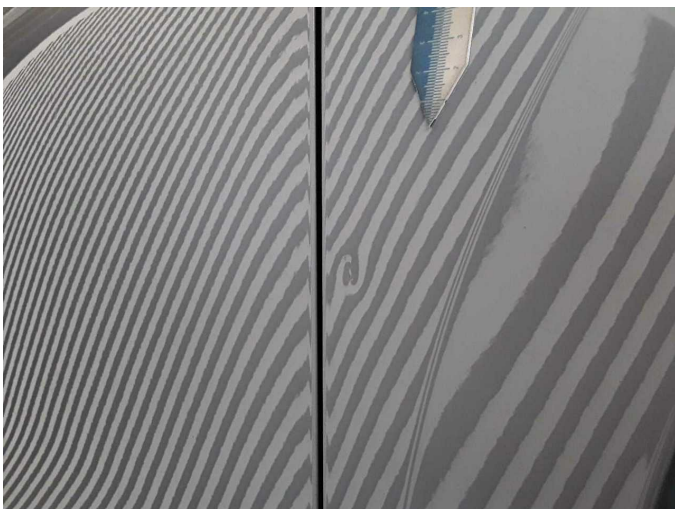
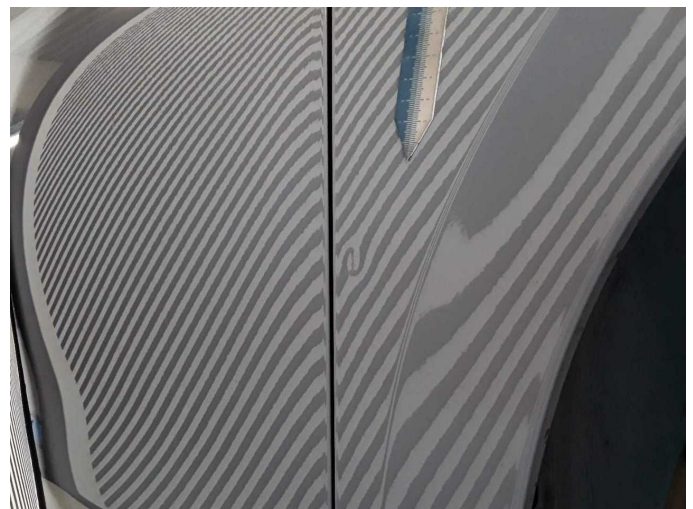
Damage 4: Mudguard - right side: Mudguard - right side - Deformed - Repair and paint

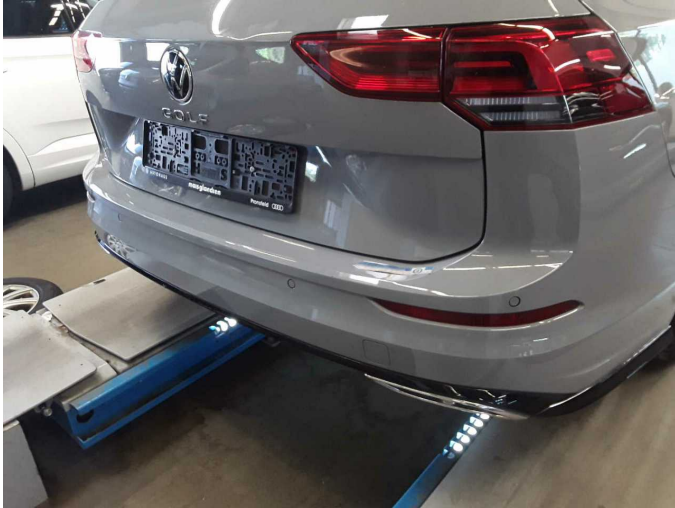
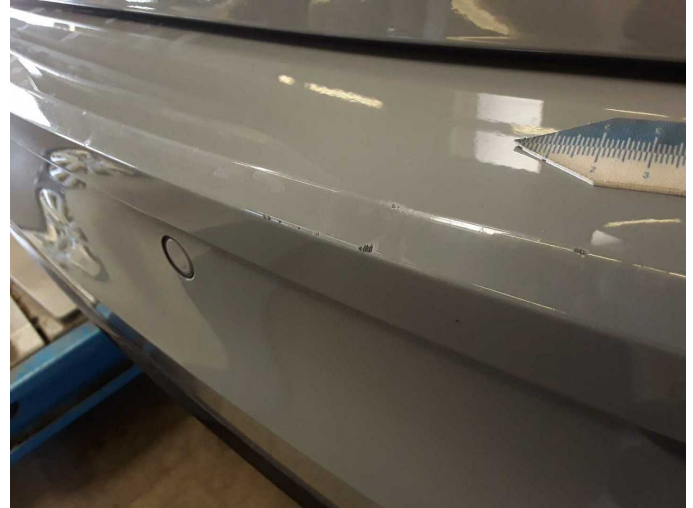
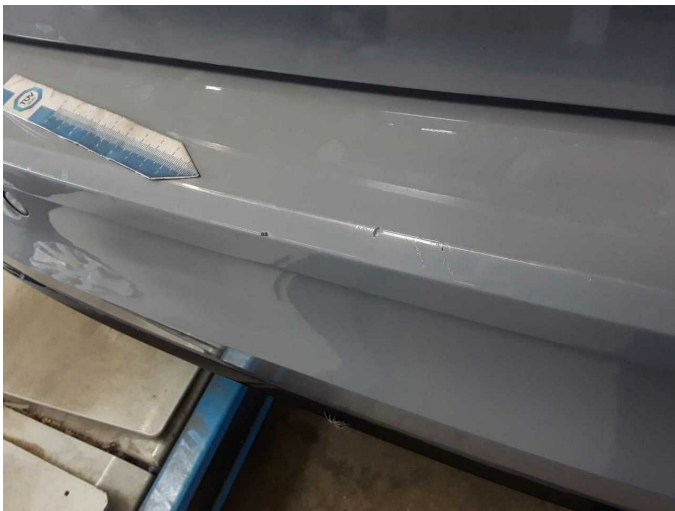
Damage 5: Rear bumper: Rear bumper - Scratch(es) - Paint

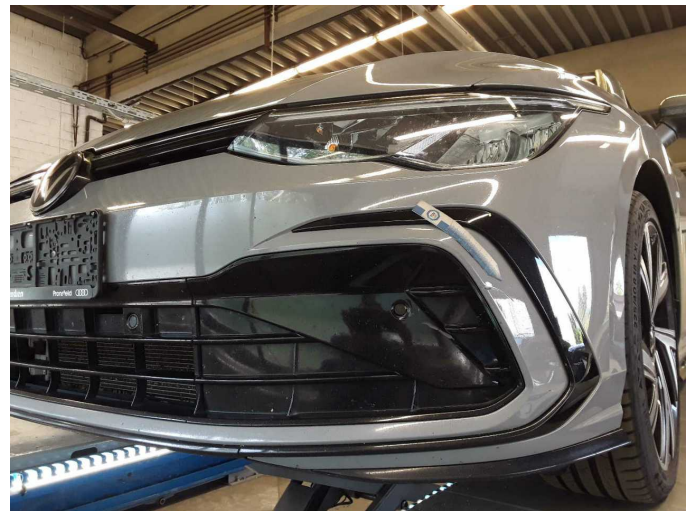
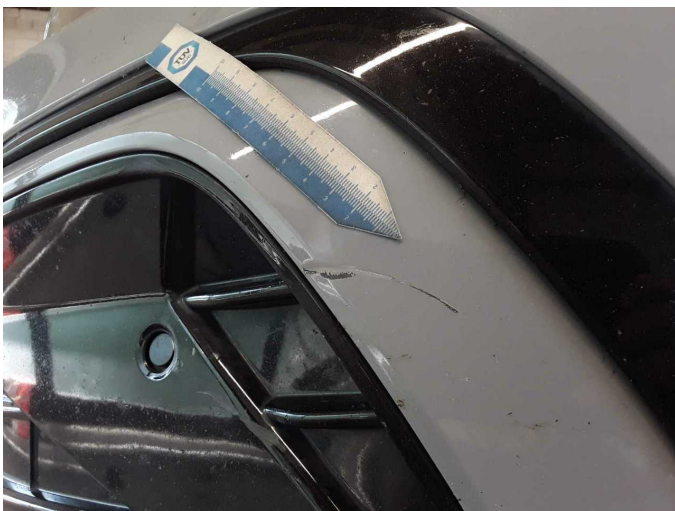
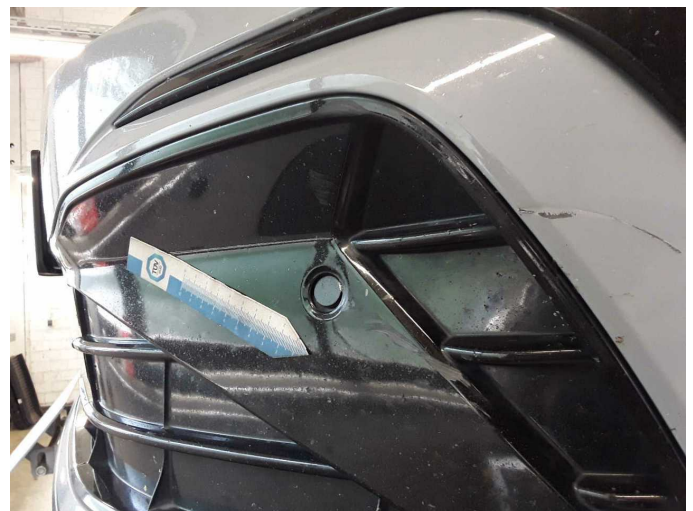
Damage 6: Front bumper: Front bumper - Scratched - Paint

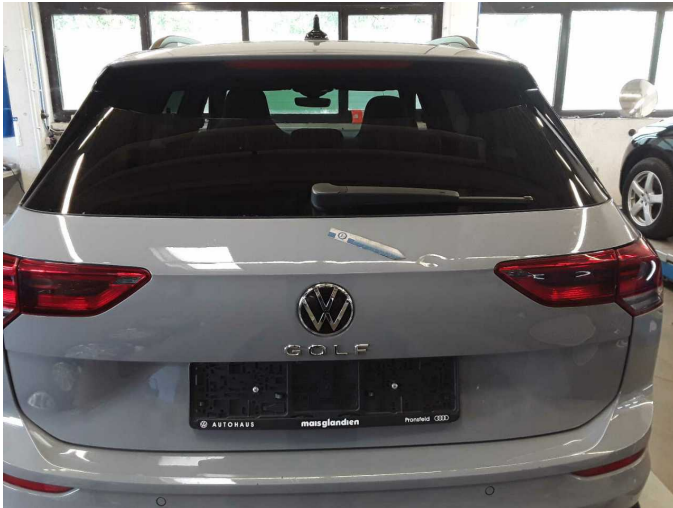
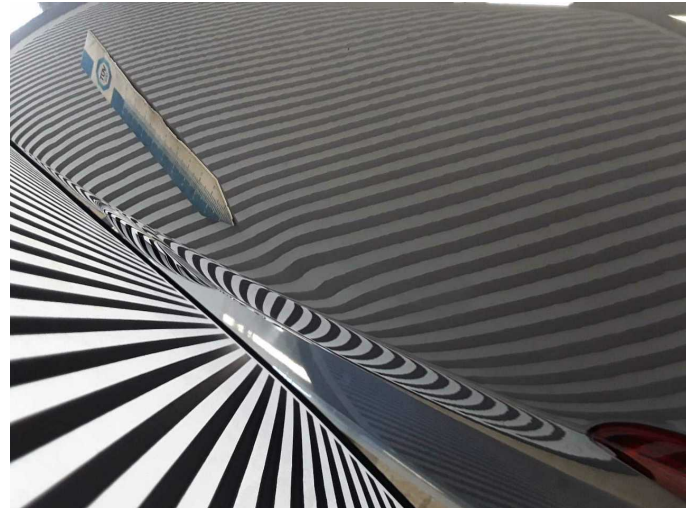
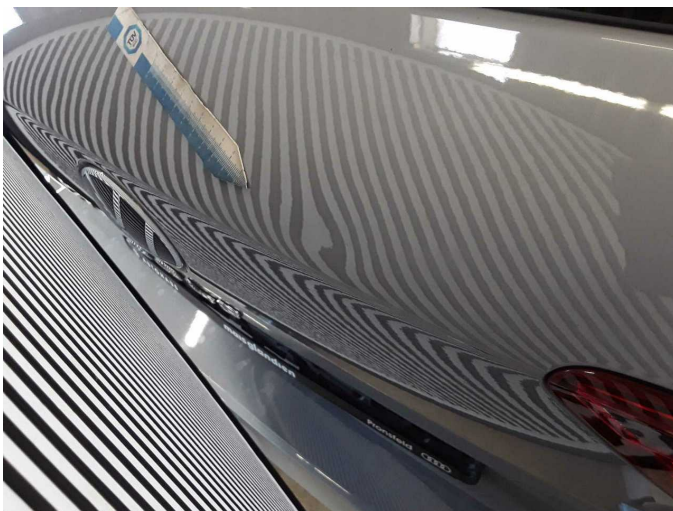
Damage 7: Boot lid / rear door: Boot lid - Deformed - Repair and paint

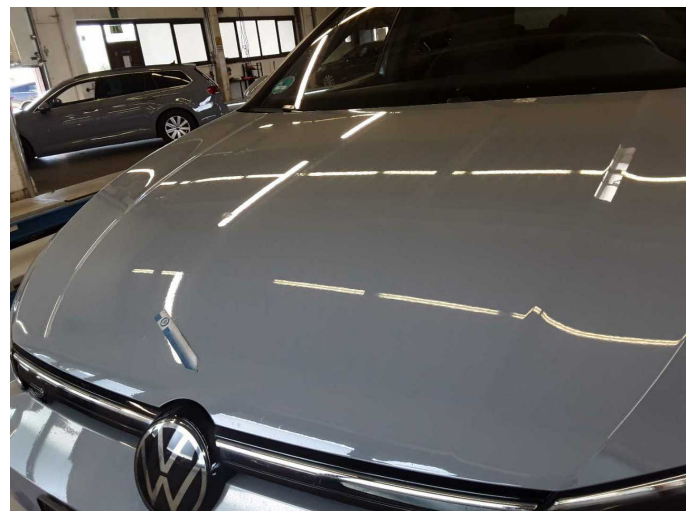
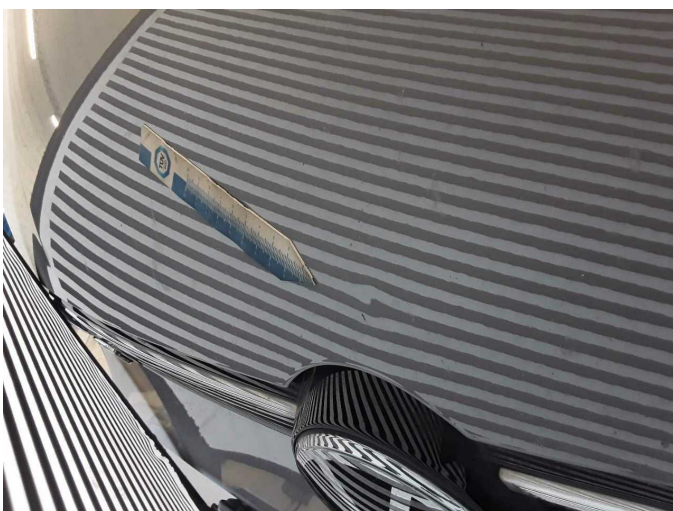
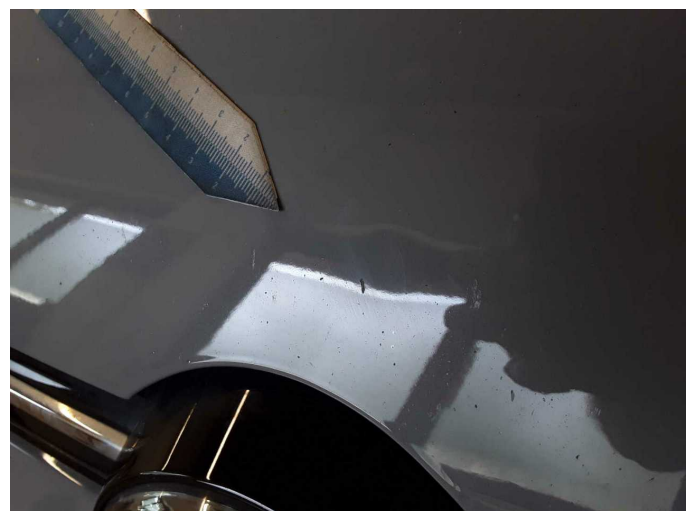
Damage 8: Bonnet: Bonnet - Dent / paintcoat damage - Repair and paint

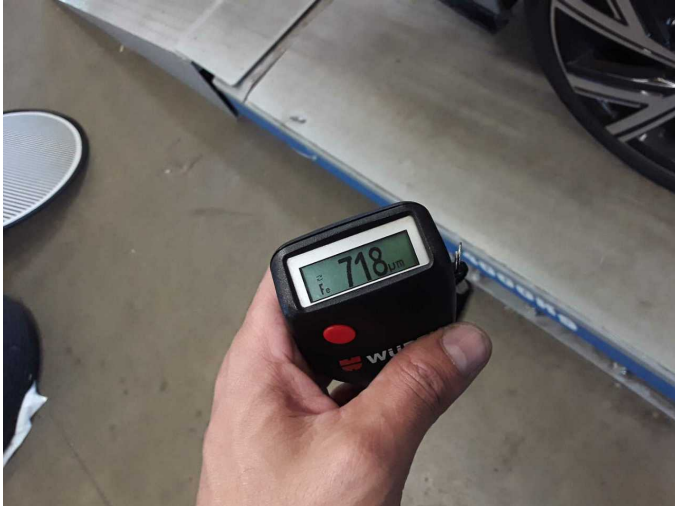
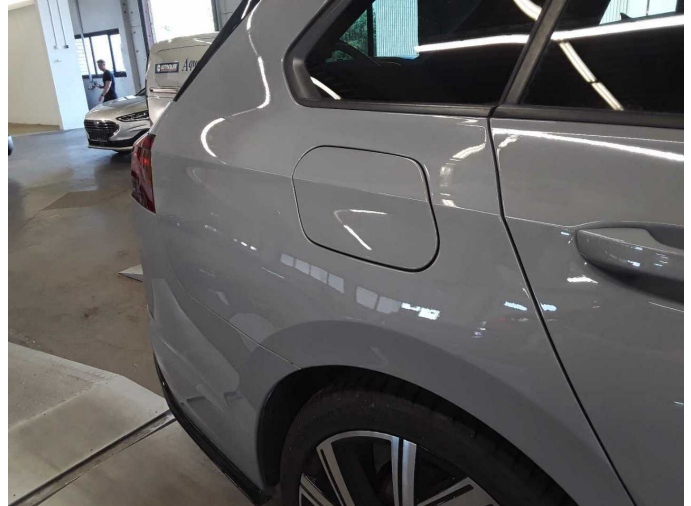
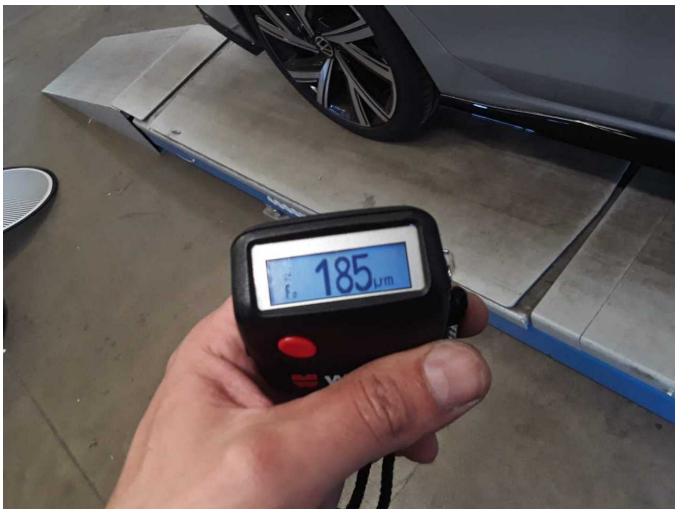
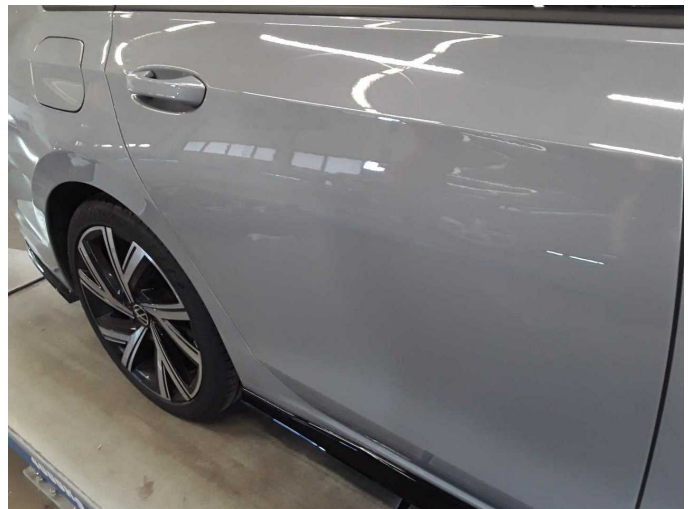
1 Side panel - rear right side, Door - rear right side, Professionally carried out, Invoice of repair done Non-existent

Side panel - rear right side	718 µm	Door - rear right side	186 µm
------------------------------	--------	------------------------	--------

Repainting 1: Side panel - rear right side, Door - rear right side
